Performance of Transportation Systems During the 9/3/2000 Yountville Earthquake

by Mark Yashinsky, Caltrans Office of Earthquake Engineering

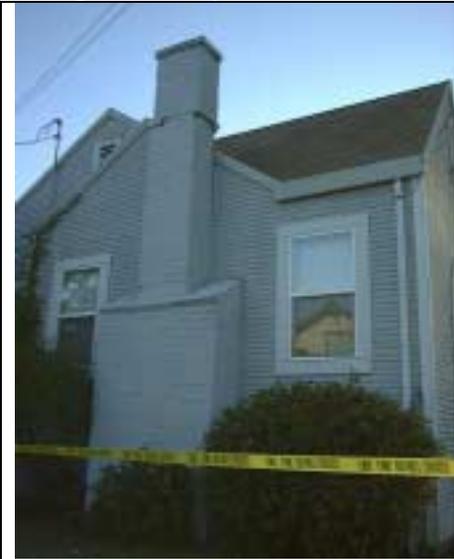
After talking with city engineers, county firefighters, and surveying the area, we estimate that there were hundreds of residences with broken chimneys (Fig. 3 & 4), damaged

Figure 3. Broken Chimney.

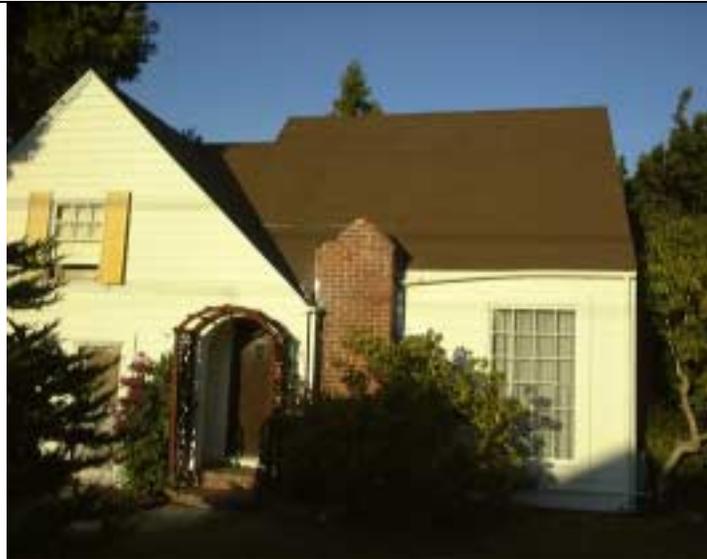
Figure 4. Fallen Chimney.

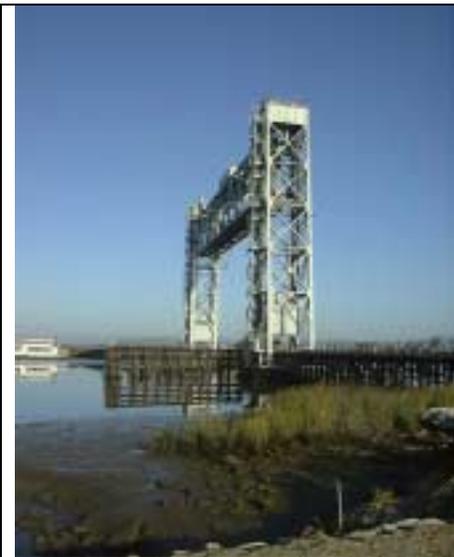
Both the California Northern Railroad and the Napa Valley Railroad immediately dispatched inspection crews after the earthquake and reported no damage had occurred. In fact, the Napa Valley Railroad ran a 'Wine Train' several hours after the earthquake. The Northwestern Pacific Railroad has a handsome vertical lift railway bridge over the Napa River just south of the City of Napa. This bridge remains raised to allow boat traffic since the railroad is currently out of service. An inspection crew went out on Monday, September 11th and reported that no damage had occurred (Figures 5 and 6).

Figure 5. Brazos Railroad Bridge.

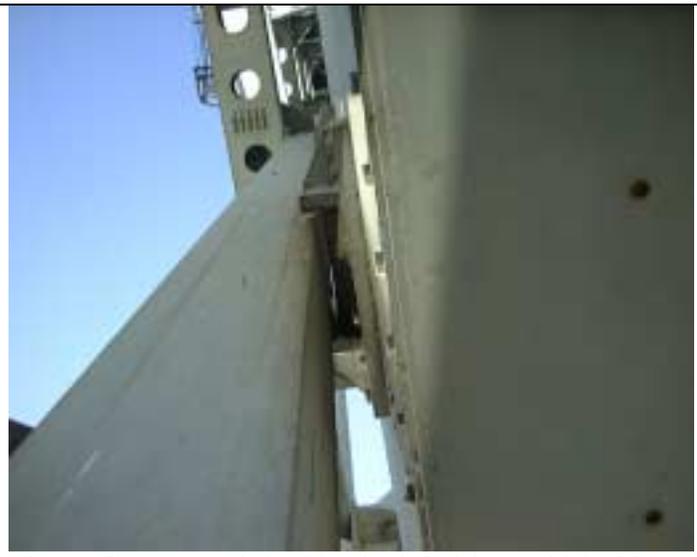
Fig. 6. Counterweight, Vertical Guide, and Marking.

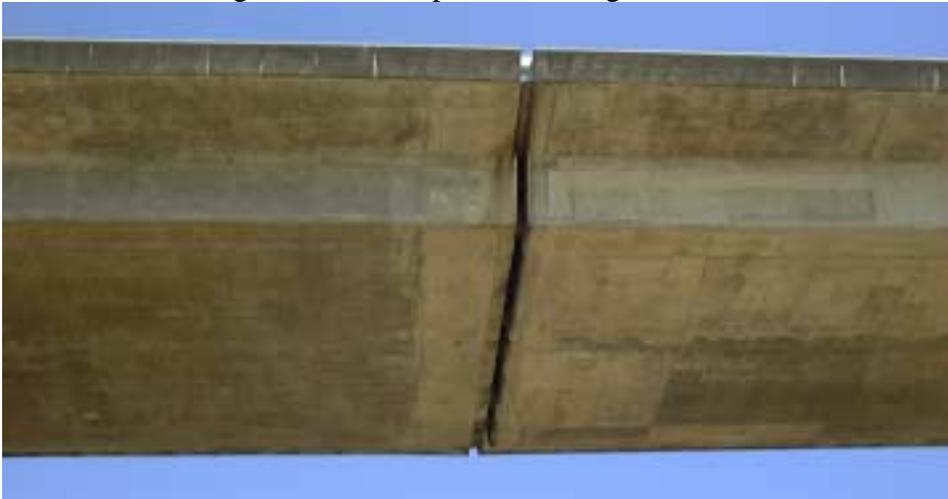
- **The Napa River Bridge and Overhead** (Br. #21-0049) was built in 1977. It is a 13 span precast, segmentally constructed, concrete box girder bridge that carries State Route 29 over the Napa River (see Figure 7). The bridge is supported on tall single-column bents and end-diaphragm abutments; all on pile caps that were retrofitted in the 1990's. The structure is composed of four frames separated by three unusual hinges. Instead of a bench for the longer cantilevered span to rest on, they are supported by concrete pistons with steel stoppers. The earthquake widened the hinge openings (and moved the bearings) an inch or two, but the very large gaps (Figure 8) are a pre-existing condition (Figures 9 and 10).

Figure 8. Hinge Opening at Napa River BOH.

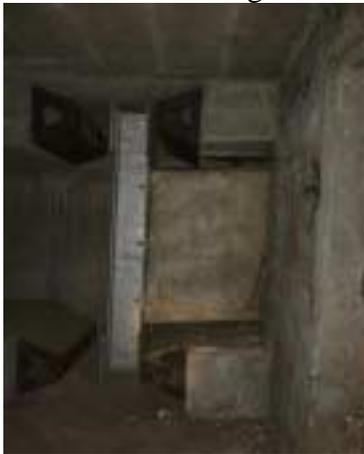
Figure 9. Hinge.

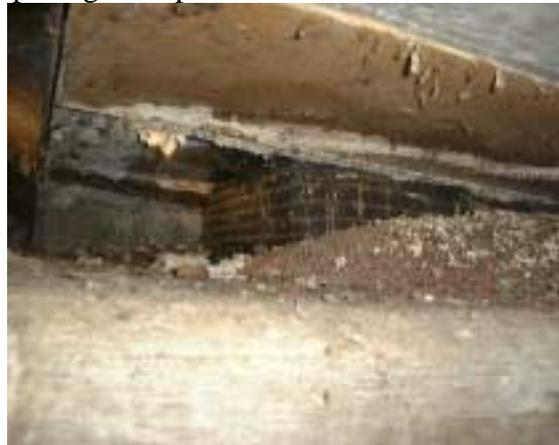
Figure 10. Bearing.

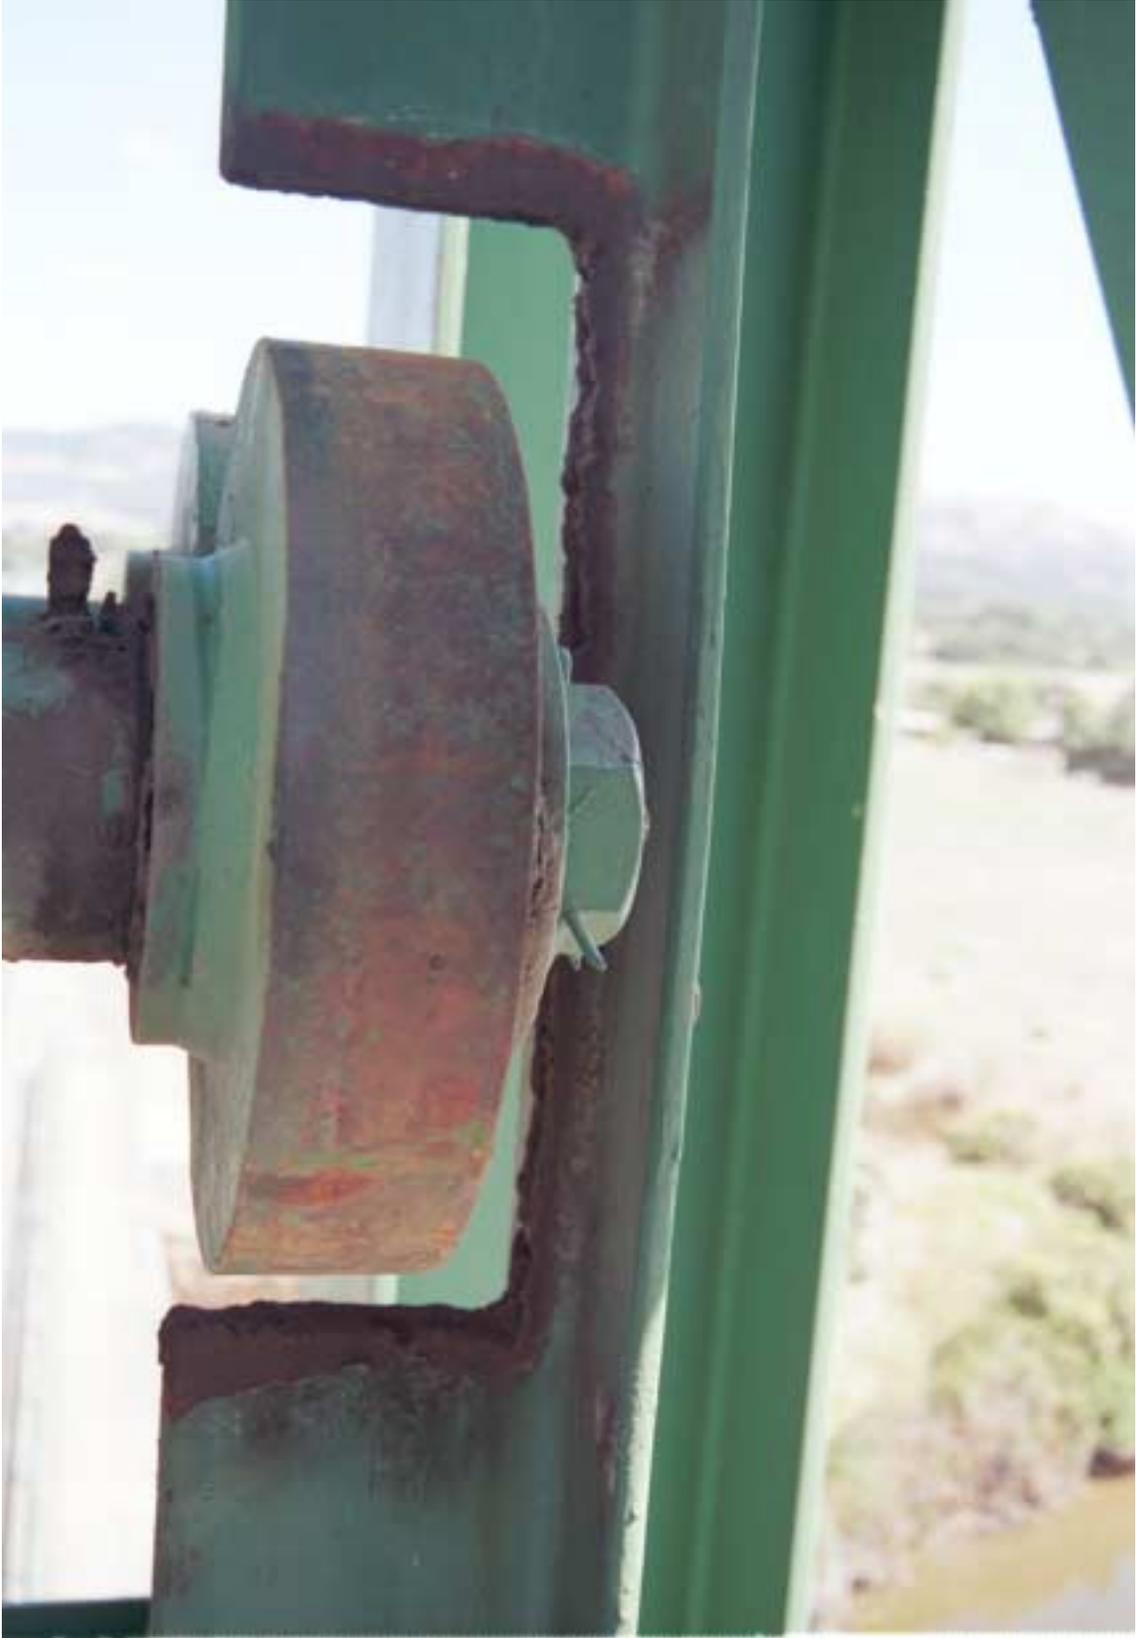
- **The Maxwell Bridge** (Br. #21-0075) is a two-lane vertical lift bridge (with a main span of 132 ft) that was built in 1949 (Figures 11 and 12). It was recently retrofitted to provide greater seismic resistance for the maximum credible earthquake. This retrofit included some work to the towers that carry large concrete counterweights to lift the bridge. The main vertical tower members are 'double (back-to-back) angle sections from which small squares were (almost completely) gas-cut out to allow the counterweight to move freely both transversely and longitudinally after knocking out the cut pieces (instead of banging against the tower legs during the earthquake). The metal squares were left in so the guides on the counterweight wouldn't bind against the holes. During the earthquake, the retrofit worked perfectly, with the guides knocking out the cut metal squares, thus allowing it to swing without hitting the tower legs (Figure 13 and 14). However, the metal squares fell onto the roadway, which could have banged up a vehicle or even endangered a driver if the earthquake had occurred when someone was on the road. Therefore, the designer has asked that the plates be tack-welded back onto the channels (to help guide the counterweight) and that little chains should be attached to keep the plates from falling onto the roadway during the next earthquake.

Figure 13. Retrofit for Longitudinal Movement.

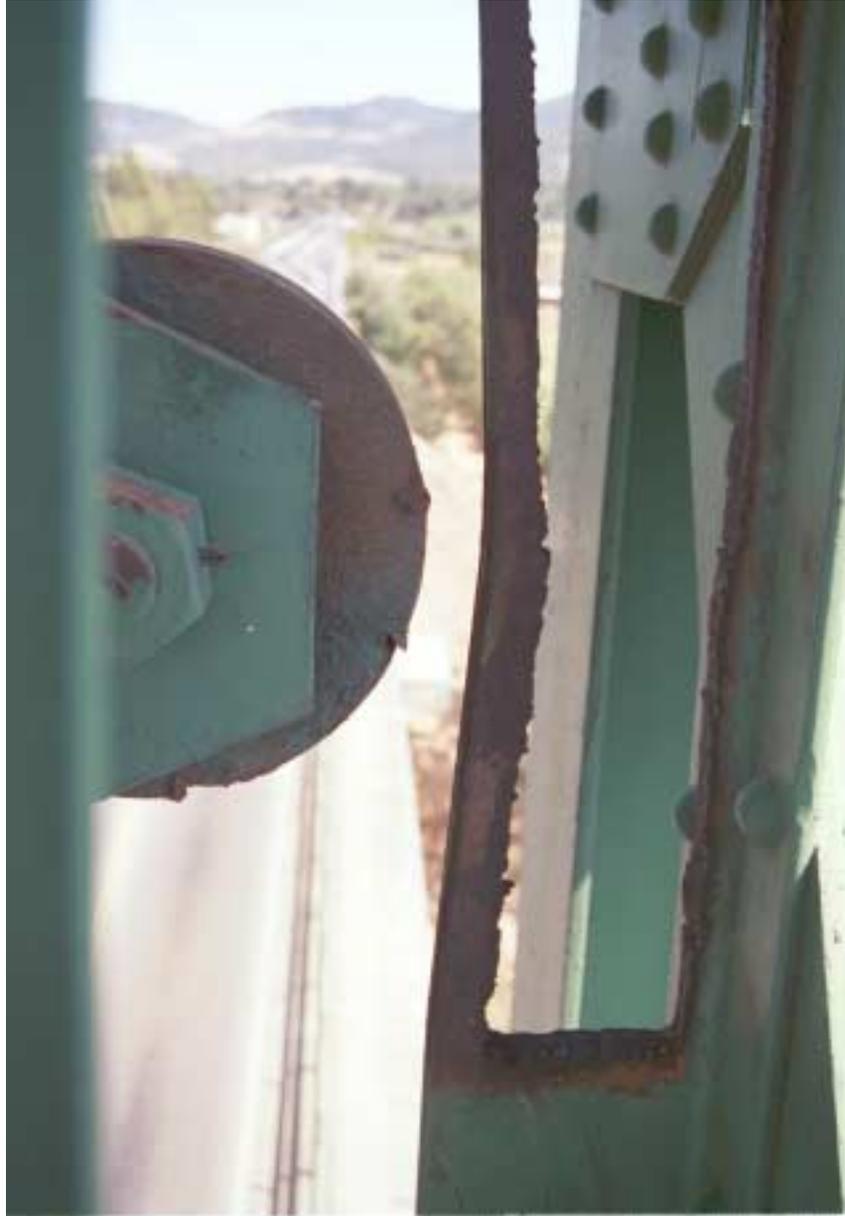
Figure 14. Retrofit for Transverse Movement.

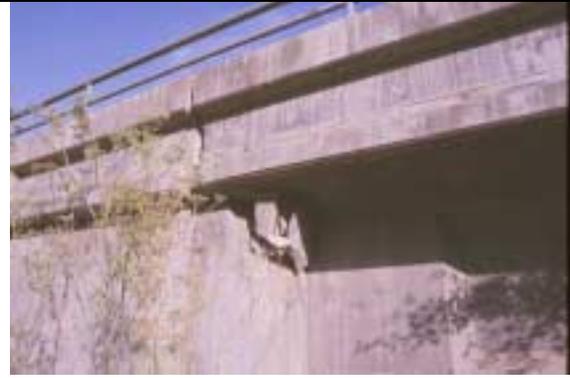
- **The Yountville Crossroad Bridge** (Br. ##21C-0116) is a two-lane, locally owned bridge that crosses over the Napa River and Conn Creek just east of Yountville. The superstructure is six simple spans of five precast concrete I-girders on elastomeric rubber pads and with a continuous deck (Figure 14). The substructure is pier walls and seat-type abutments. There was a pre-existing problem at this bridge. The elastomeric bearings had delaminated, allowing the deck to settle onto the exterior shear keys of the eastern abutment and causing the concrete to spall and expose some reinforcement. The spall was patched however, the bearings were never replaced and during the earthquake, the precast I-girders of the eastern span moved sufficiently to spall the exterior shear keys again (Figure 15). Otherwise, the bridge was in good condition.

Figure 15. Spalled Abutment.
