**The
California Department of Transportation
(CALTRANS)
Post Earthquake Inspection Team
PEQIT**

**Prepared by
California Department of Transportation
Division of Engineering Services, Earthquake Engineering
November 7, 2001**

WELCOME TO THE CALTRAN'S POST EARTHQUAKE INVESTIGATION TEAM

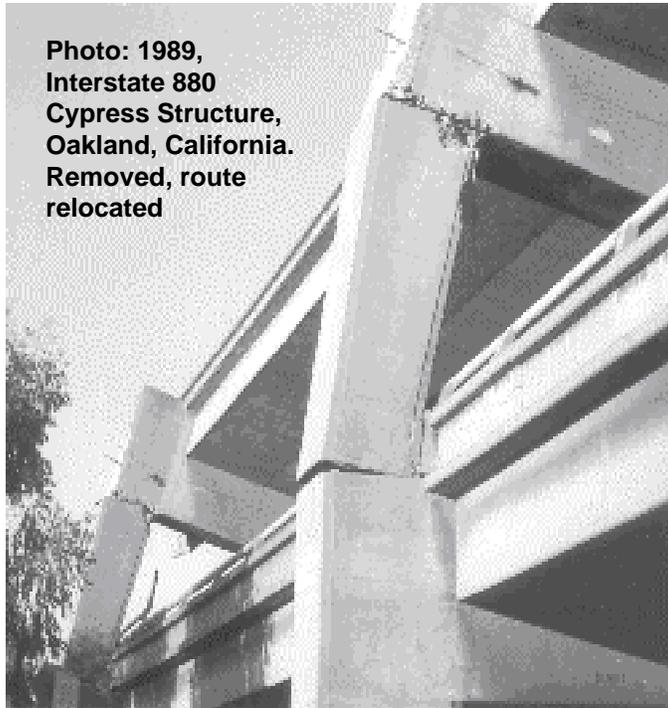
**Photo: 1989,
Interstate 880
Cypress Structure,
Oakland, California.
Removed, route
relocated**

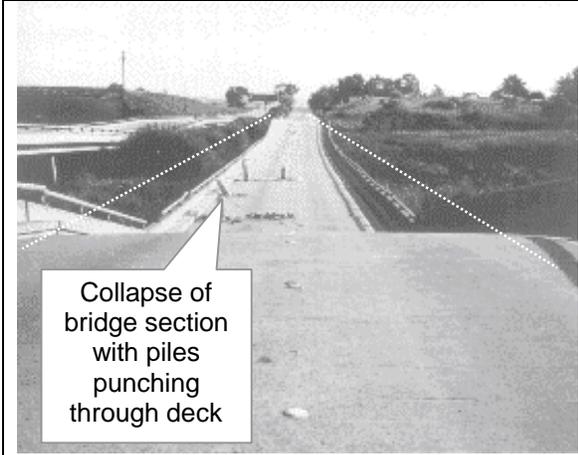
1989 Loma Prieta – State Route 1, Watsonville area weak soil caused column failure.

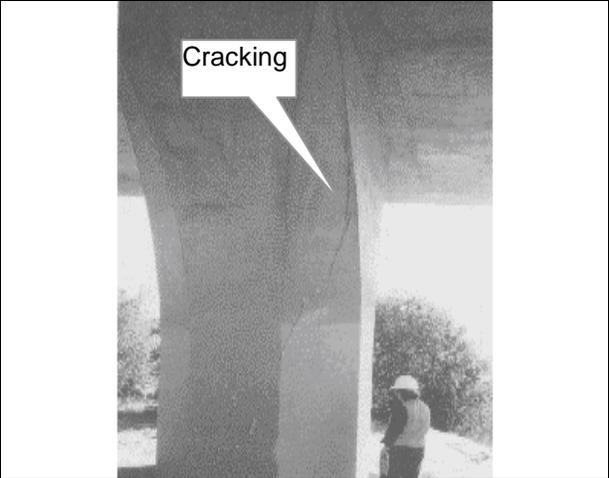
1994 Northridge – Interstate 5 and State Route 118 interchange, torsional damage on column

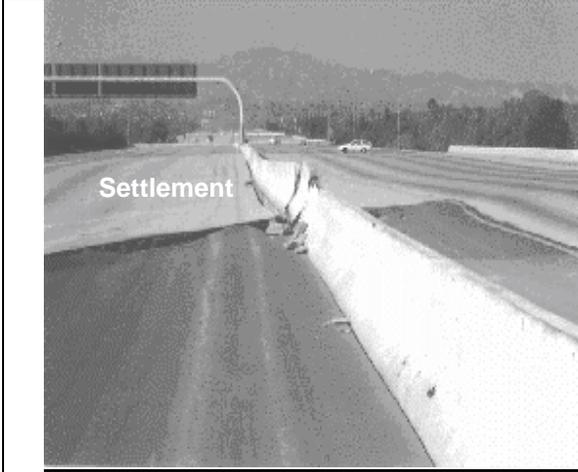
1994 Northridge - State Route 118, San Fernando Valley, bridge settlement and approach settlement.

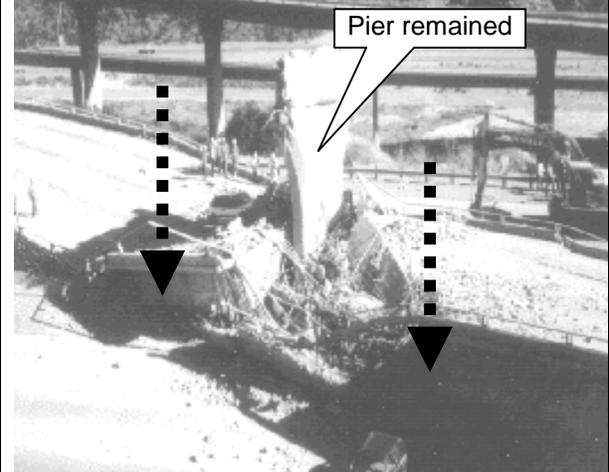
1994 Northridge, Interstate 5 and State Route 14 interchange superstructure collapse.

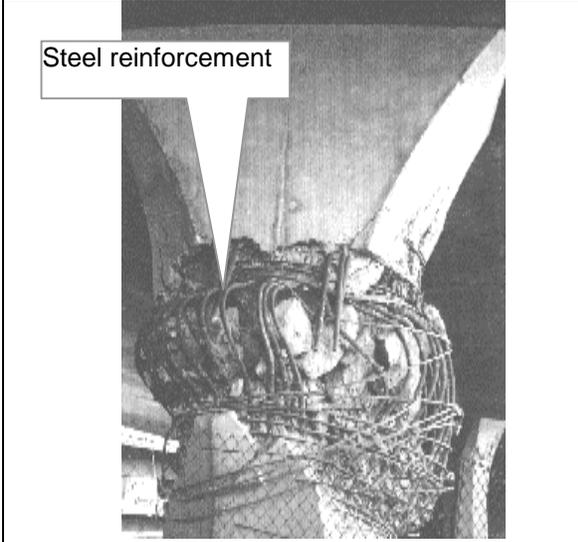
1994 Northridge – Major Damage to flared bridge column

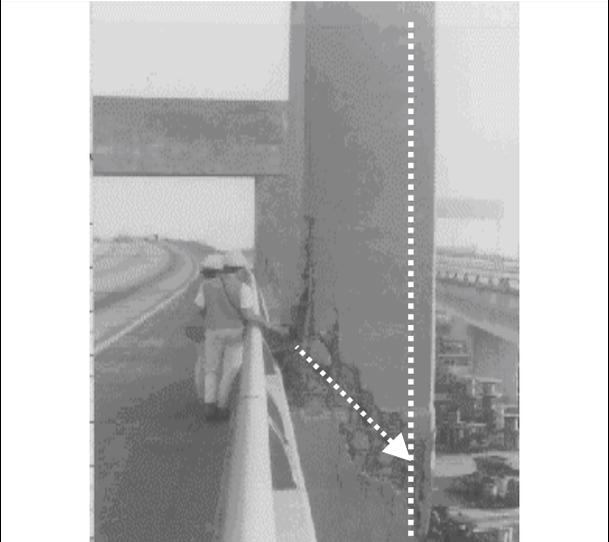
1989 Loma Prieta - Interstate 280 in San Francisco joint shear damage at outrigger bent.

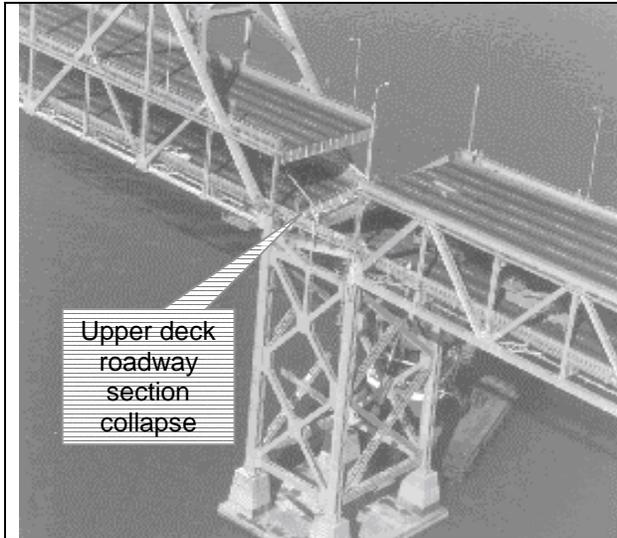
Upper deck roadway section collapse

1989 Loma Prieta - Interstate 80, San Francisco-Oakland Bay Bridge, structural vibration caused bridge damage.

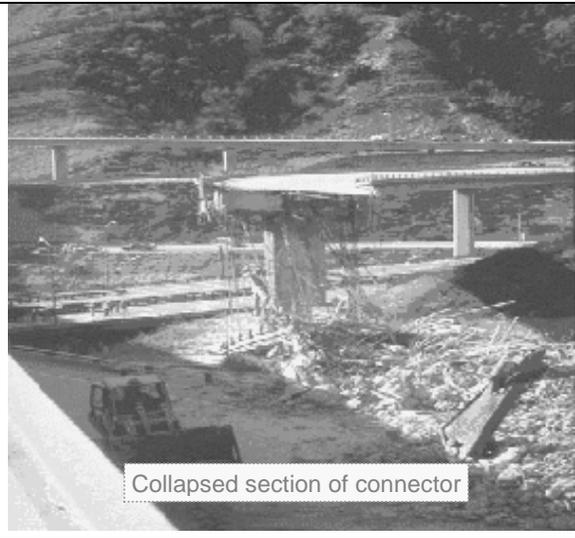
Collapsed section of connector

1994 Northridge - Interstate 5 and State Route 14 interchange damage, collapse of bridge.

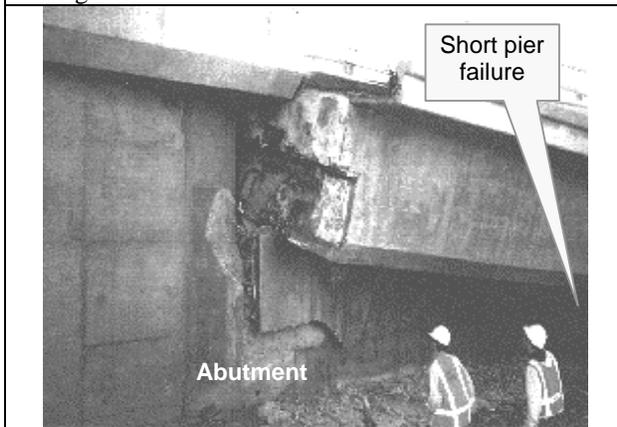
Short pier failure

1994 Northridge - the State Route 14 and Interstate 5 Interchange north connector collapsed as a result of failure of short stiff pier,

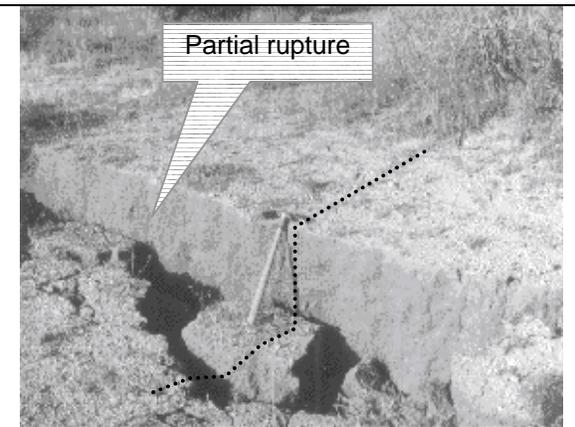
Partial rupture

1992 Landers - Fault Rupture

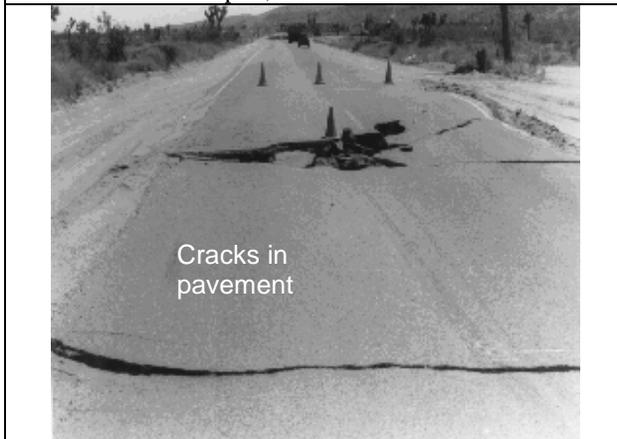
Cracks in pavement

1992 Landers - Surface deformations, cracks in pavement

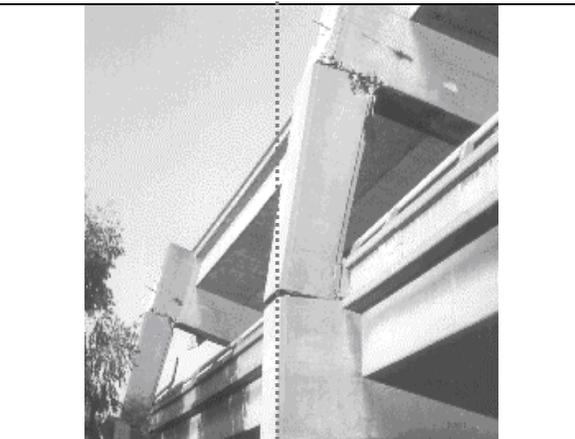
1989 Loma Prieta - Interstate 880, Oakland, Cypress double deck Viaduct damage. Removed, replaced with bridge on a different alignment.

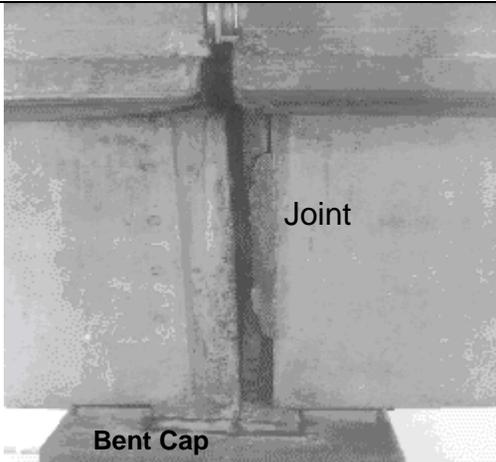
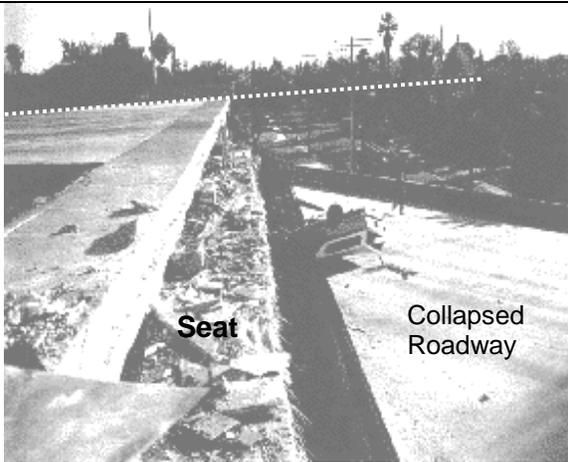
<p>1994 Loma Prieta - Napa River Bridge, minor damage at precast girder joint.</p>	<p>1994 Northridge - Mission Gothic U.C., column failure resulted in bridge unseating at abutment.</p>

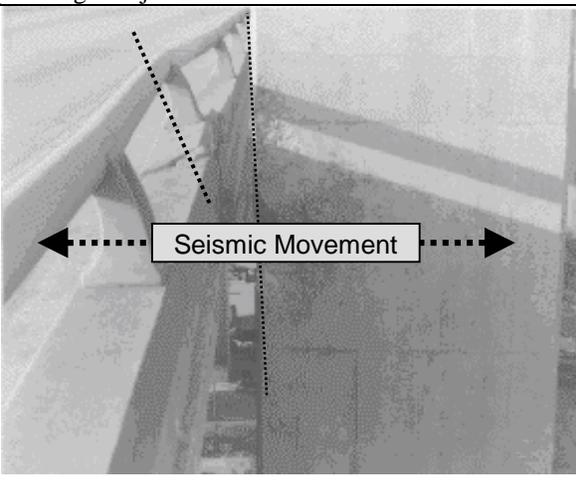
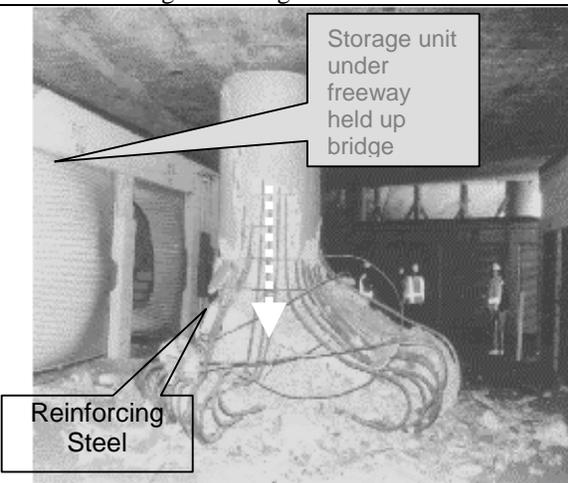
<p>1989 Loma Prieta - Interstate 280 San Francisco, banging damage, roadway hitting column</p>	<p>1994 Northridge - Interstate 10 Los Angeles, La Cienega U.C. Concrete column damage</p>

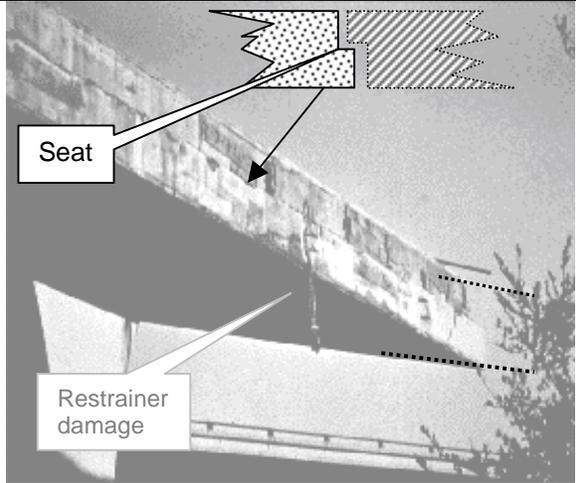
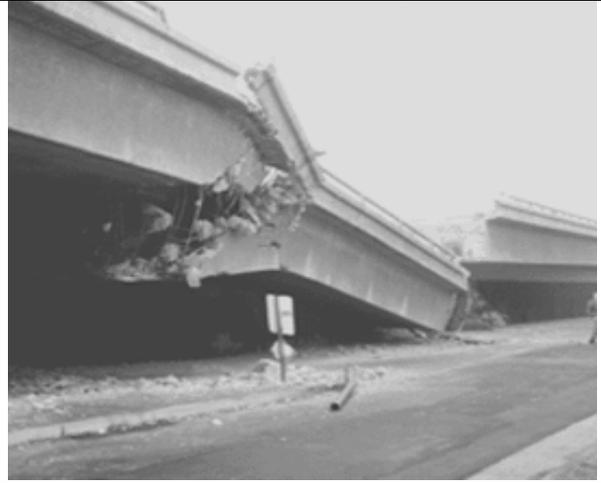
<p>1994 Northridge - Interstate 5, San Fernando Valley, Galvin Canyon crossing. Adjacent span collapse due to unseating.</p>	<p>1994 Northridge - Interstate 10, La Cienega Bl. Column failure, bridge collapse</p>
