Surface Dusting of Formed Concrete

State of California
Division of Highways
Materials and Research Department

SURFACE DUSTING OF FORMED CONCRETE

During the summer of 1952 reports were received in the Laboratory of an unsatisfactory condition of the surface of concrete which was observed upon removal of plywood forms on two structures which were parts of freeway construction in Los Angeles County. The structures involved were the Colorado Street Arch, VII-L.A-161-Pas, Contract 51-14VC16 and Bronson Avenue Overcrossing, VII-L.A-2-L.A, Contract 51-14VC21-F.

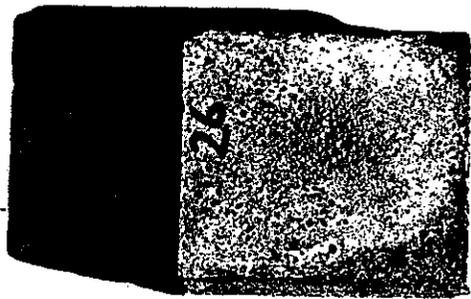
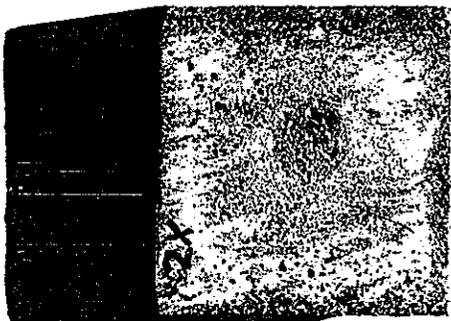
Figure 1.

In addition to informal classification of surface condition such as by appearance, scratch hardness or finger abrasion, the two faces of each mortar block were subjected to the abrasion of 1000 grams (500 grams in Series 2 and 3) of steel shot falling a distance of about 42 inches through a 1-inch tube. The abrasive effect was sufficient to remove all soft mortar within a circle about 1 inch in diameter but mortar that had hardened normally was scarcely affected by the shot. In general, each surface could be classified definitely as "sound" or "dusted". Degrees of dusting were classified as slight (1/32"), moderate (1/16"), or severe (1/8"). Figure 1 shows two specimens with "severe dusting",

Nos. 6X and 21A, each with two abraded areas. The remaining three specimens are sound. No. 26 was cast against an oiled glass plate.

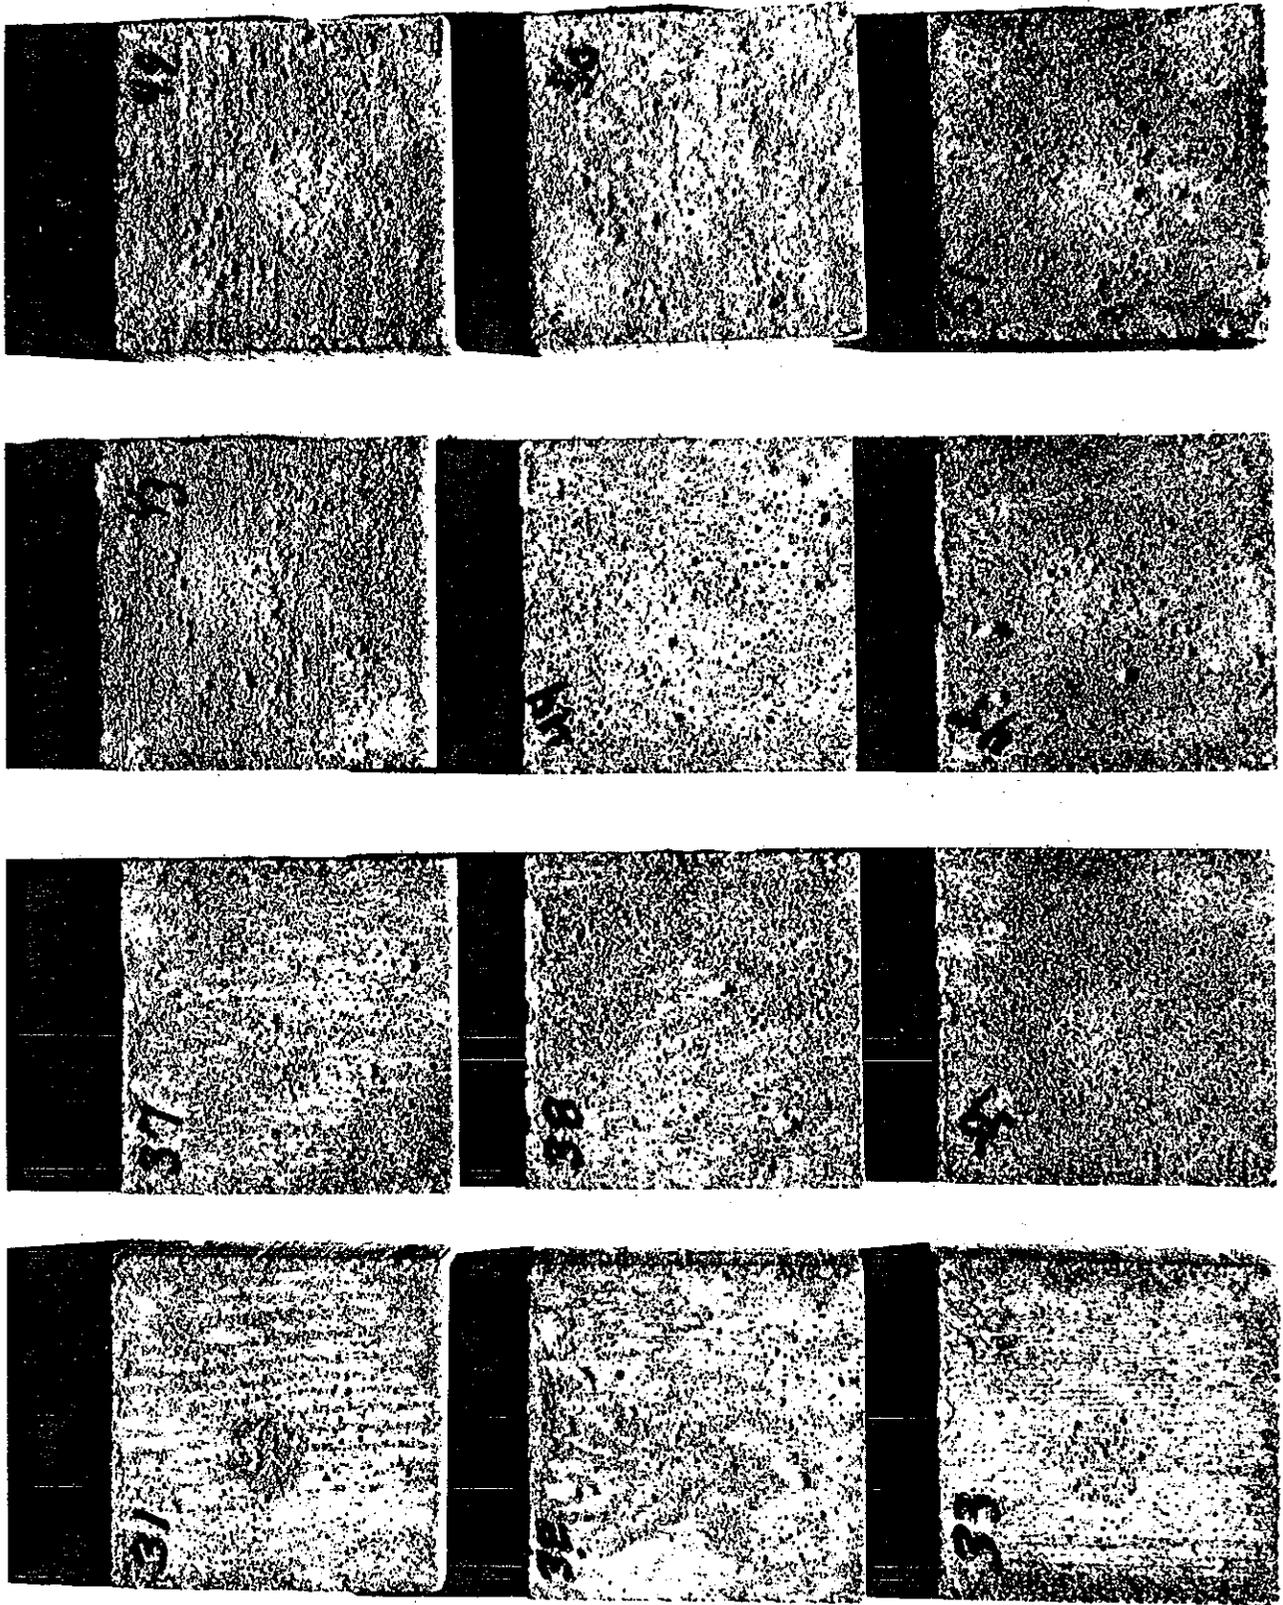
Figure 2.

The duration of exposure to outside weathering was found to have an important effect on the degree of dusting produced on the mortar. For the exposures involved the results were as follows:

Length of Exposure	Degree of Dusting
None	None
3 days	Very Light
7 days	Light
14 days	Moderate

Figure 2 shows rather imperfectly, the appearance of part of the mortar blocks after the sand abrasion test. The vertical rows from left to right are of mortar blocks cast against panels exposed for 0, 3, 7 and 14 days respectively.
