San Jose State College Sound Survey of Ventilation System  
Noise in Speech-Drama Building Addition

November 1961

Louis Bourget

State of California  
Department of Public Works  
Division of Highways  
Materials and Research Department

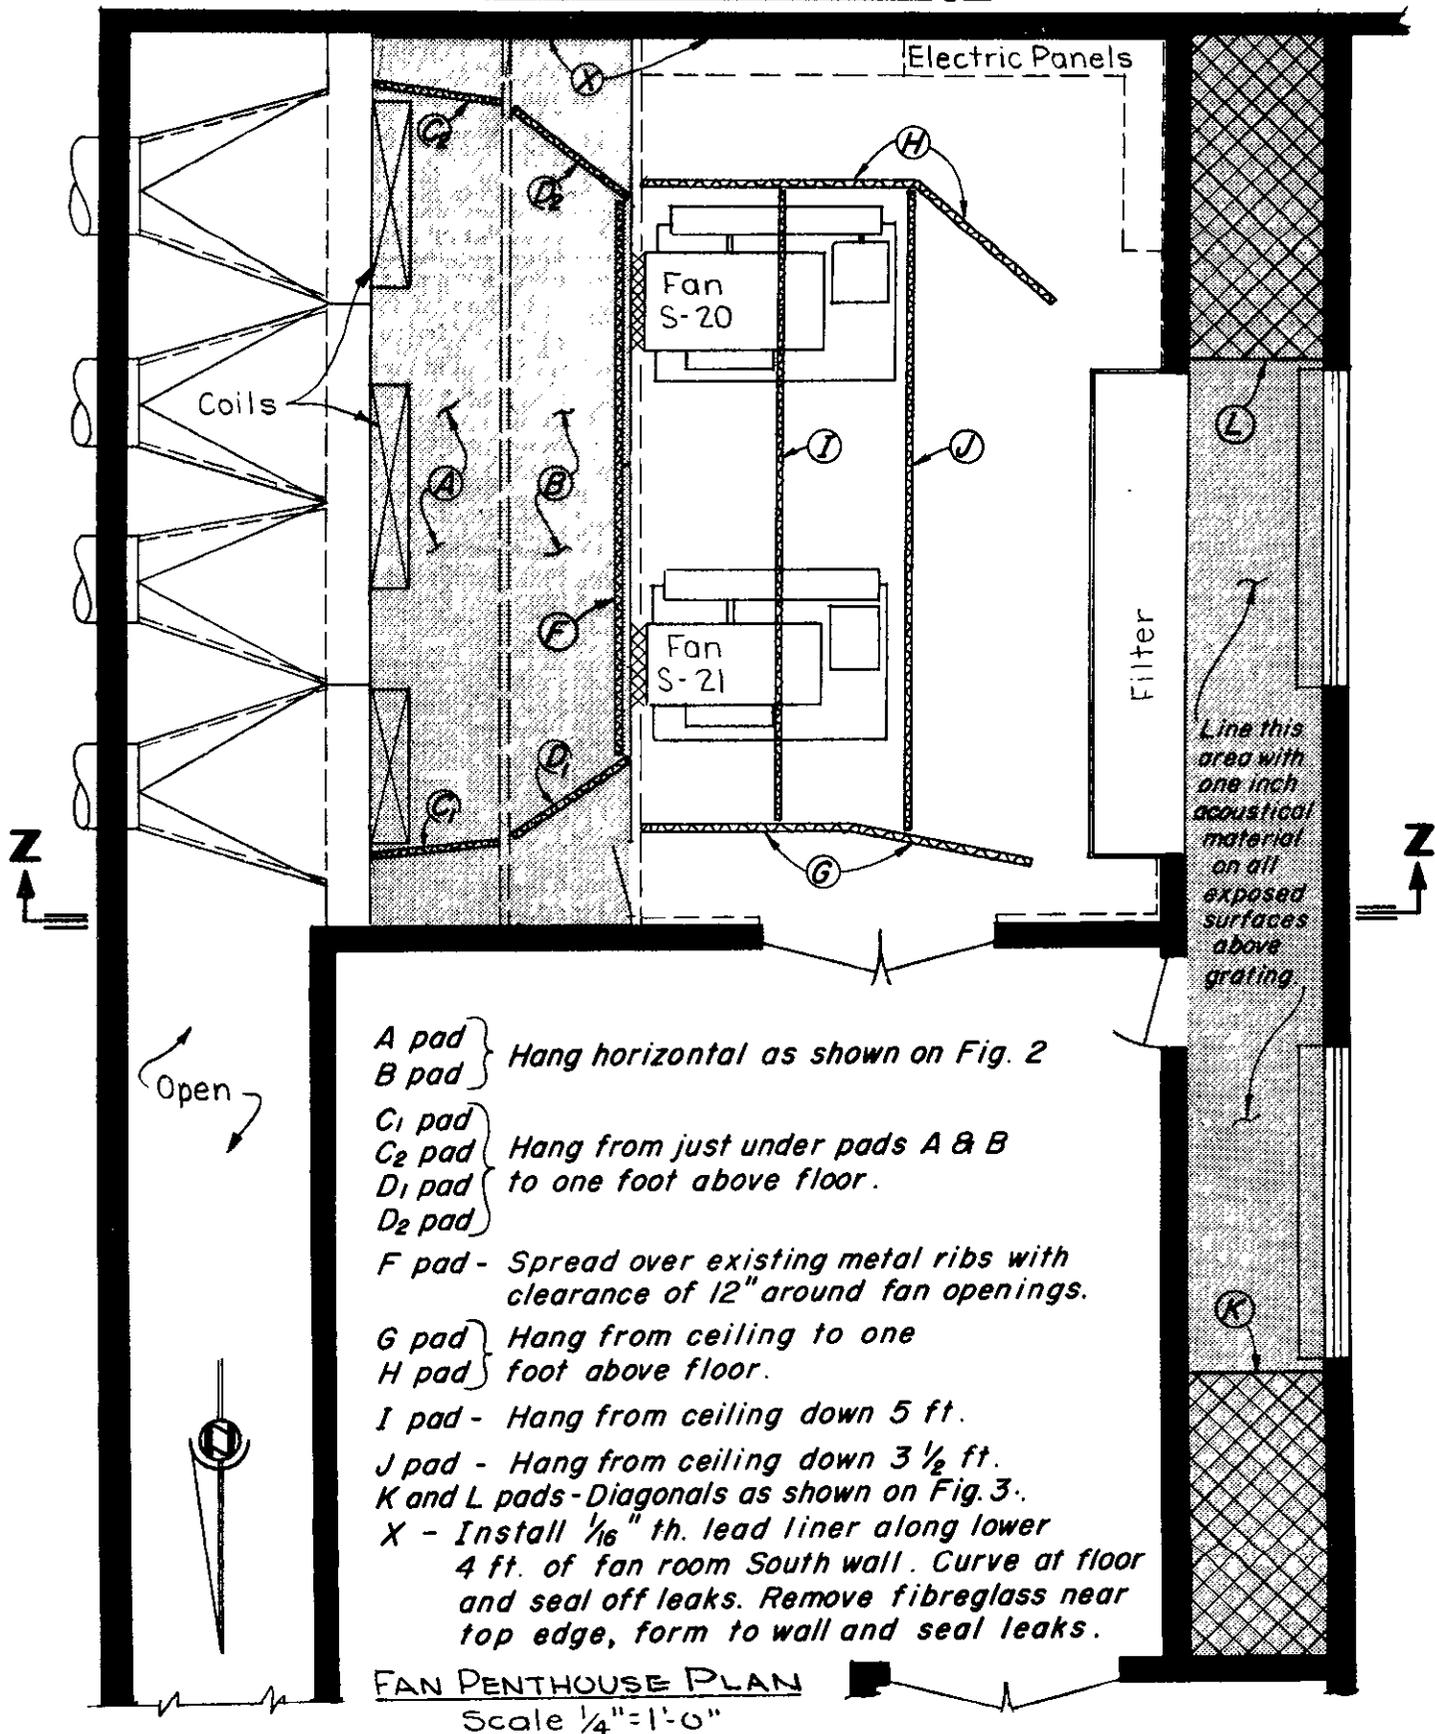
Figure 1

The intense noise levels developed within the fan room are due to very high fan (and air) velocities and inadequate acoustical damping of the open air spaces. This leads to strong excitation of all possible room modes from frequencies as low as 28 cps for the 20 foot fundamental and 51 cps for the 11 foot fundamental. Harmonics of these frequencies extend throughout the audible range and are mixed with intense white (hissing) noise generated by the air action across sharp edges and turns. If at all possible, the fan speeds should be reduced at least 25 percent. There is evidence of excessive delivery in many rooms because of the abundance of white noise that is now generated across the diffuser blades at the room outlets. 4,5,6,7

Recommended acoustical treatment and modifications are shown on Figures 1, 2, and 3. All acoustical pads are of the type shown on Figure 4. The materials recommended and method of fabrication are described.

Pads C1 and D1 (in Figures 1 and 2) should be wide enough so that they may be tied together where they meet at the dividing grille so as to minimize the air gap at this junction. The same comment applies to pads C2 and D2.

The diagonal pads K and L, in the return air shaft (Figures 1 and 3), should be mounted with their edges snugly against the walls to minimize air gaps at all pad edge and wall junctions.

The lead (metal) liner X along the lower south side of the fan room (Figure 1) reduces noise penetration into the return air space above the rooms.
