A Study of Various Paint Systems Applied to Leffingwell and San Simeon Creek Bridges in a Corrosive Marine Atmosphere

April 1964

State of California
Department of Public Works
Division of Highways
Materials and Research Department

Progress Report

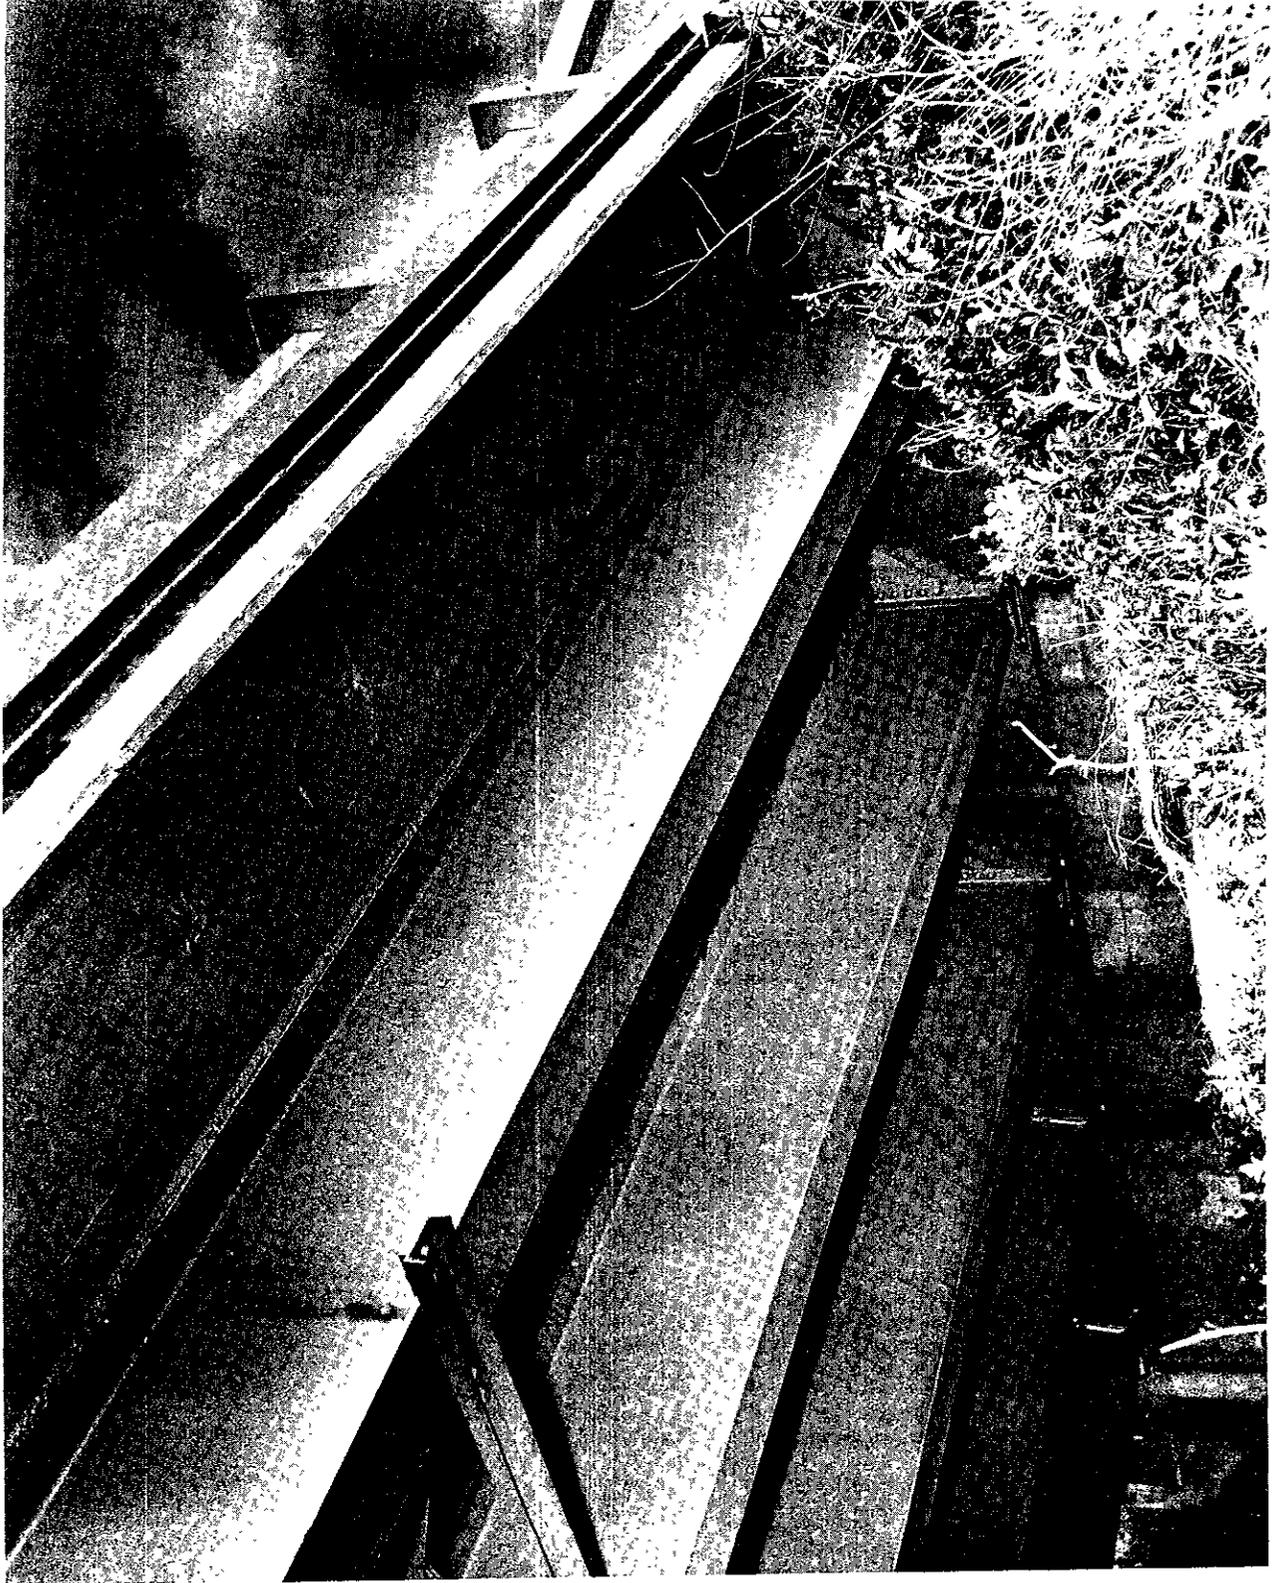
Ends of several bracing members showing tubercules. Some rust around bearings. A few spots on bottom of bottom flange and on bottom flange edges. Top flange edge rust growing slowly.
Rating: 8.

Photograph No. 1. Leffingwell Creek Bridge. Span 1, South Section
System No. 4. Painted October 1958 - Photographed March 2, 1964.

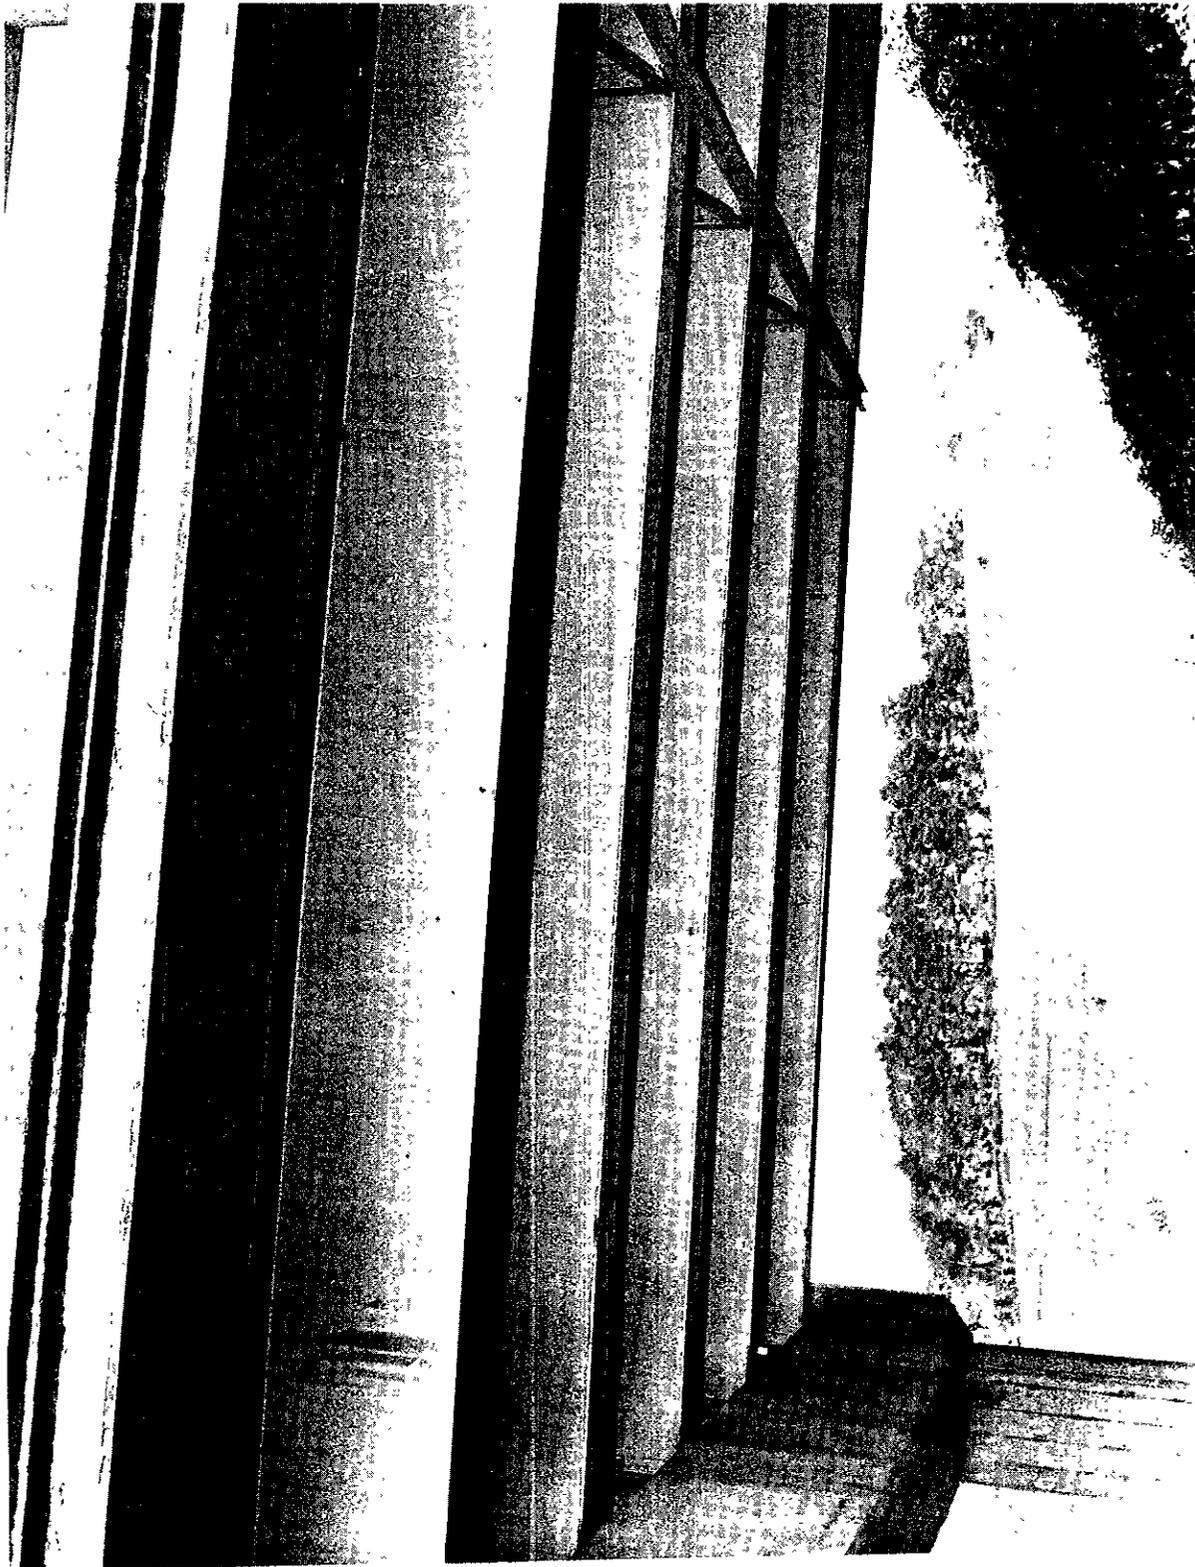
Photograph No. 2. Leffingwell Creek Bridge. Span 1, North Section
System No. 4 (except front beam which is System No. 5). Painted
October 1958 - Photographed March 2, 1964.

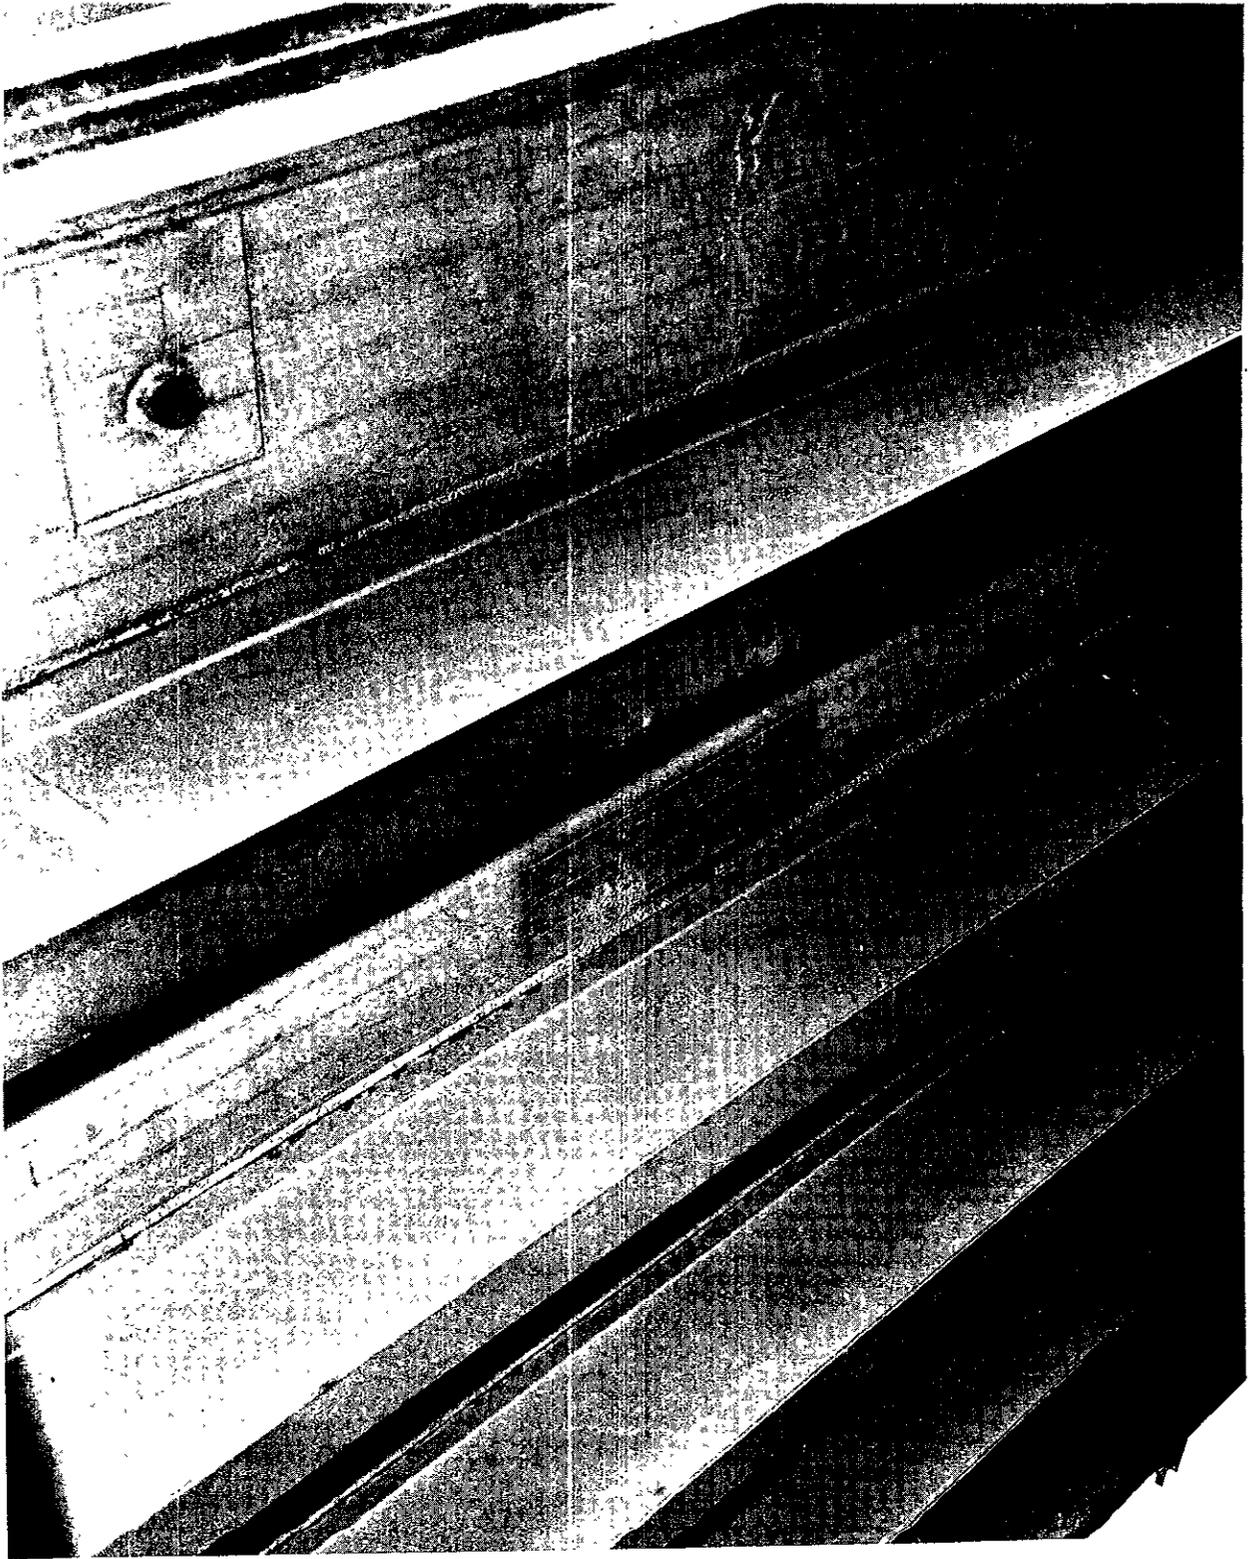
Photograph No. 3. Leffingwell Creek Bridge. Span 1, North Section (close-up picture) System No. 4 (except front beam which is System No. 5). Painted October 1958 - Photographed March 2, 1964.

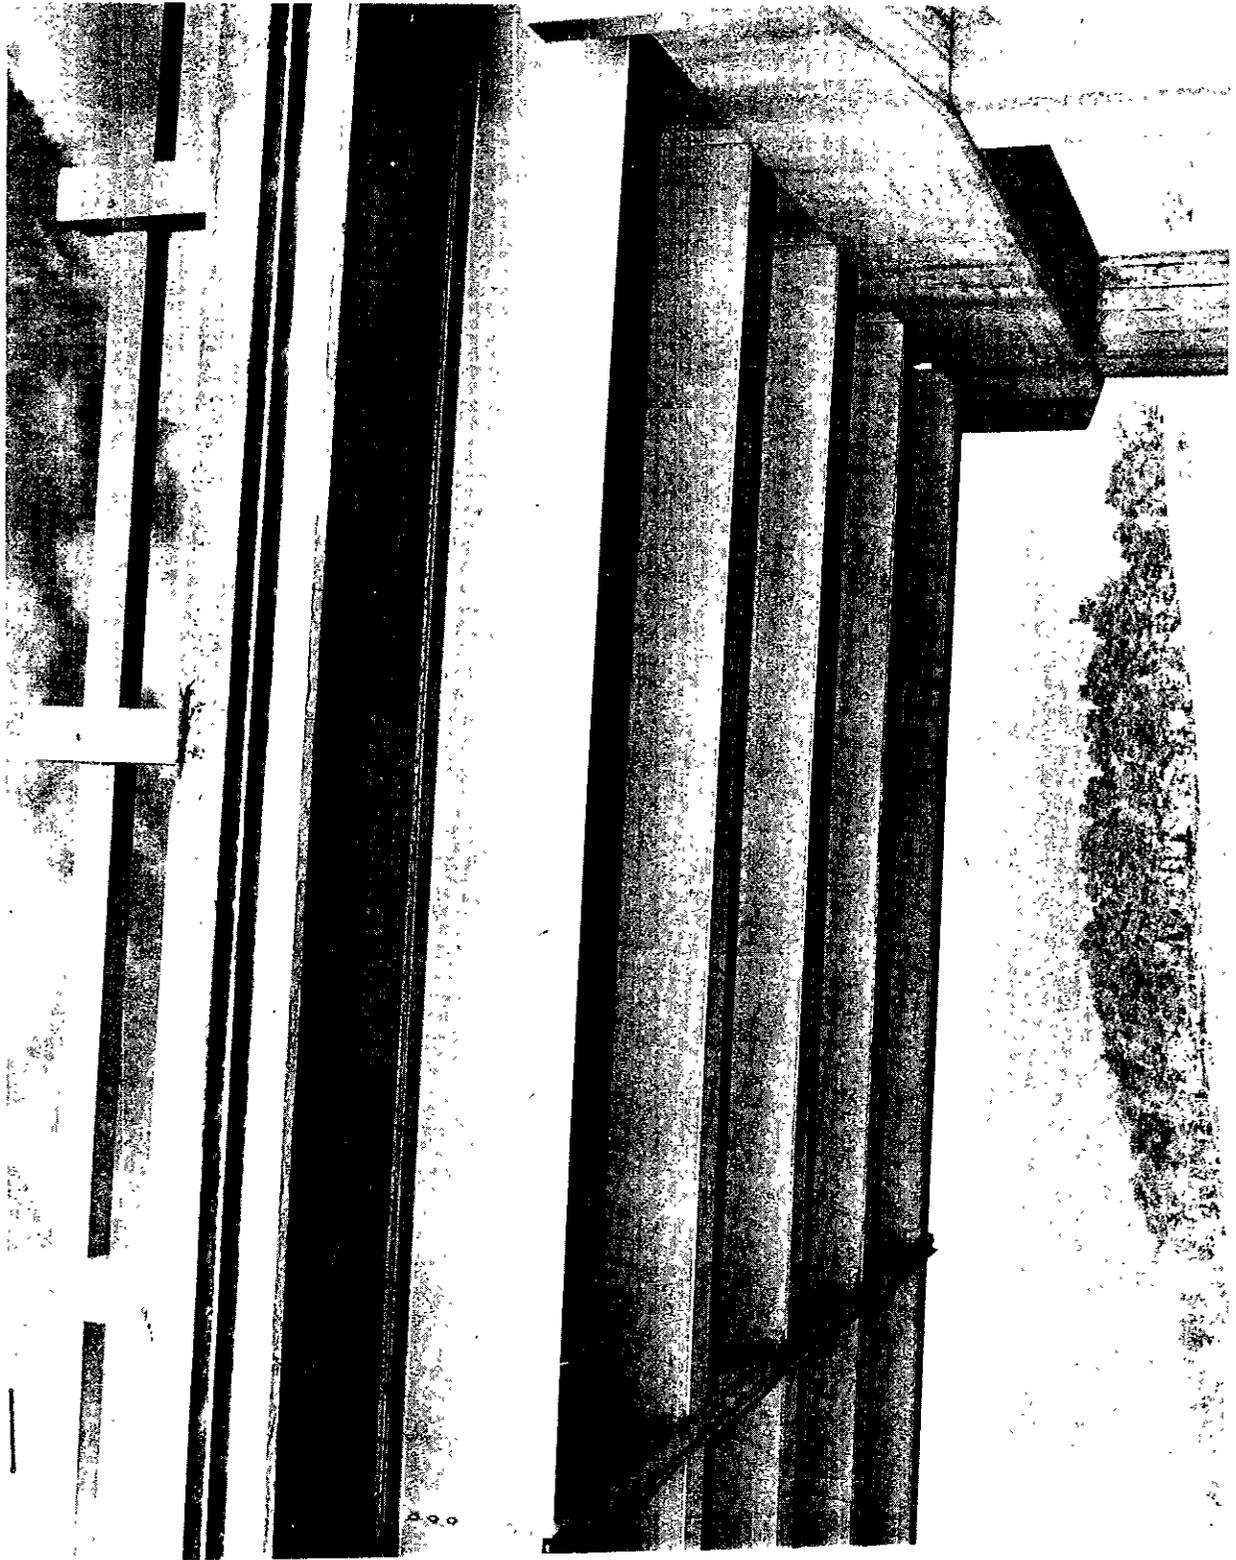
Examination of Photographs 4, 6, 9 and 10 shows the almost perfect condition after nearly six years of the sections of Spans 2, 4 and 5 where coating System No. 1 was used. Reference to the reprint from California Highways and Public Works describes this system which consists of a commercial inorganic zinc silicate paint, a vinyl wash primer bonding coat and a vinyl topcoat. Although the all vinyl, System No. 4, which is known to be an excellent coating in marine atmospheres, shows breakdown on the upper and lower flanges due to underfilm corrosion, very little of this has occurred where the inorganic zinc silicate primer was used under a vinyl topcoat.

Good shape. Rust or rust stain along top edge of top flange does not appear to be growing much. Bracing good. Light rust on steel slivers has not penetrated steel proper.
Rating: 9+

Photograph No. 4. Leffingwell Creek Bridge. Span 2, South Section
System No. 1. Painted October 1958 - Photographed March 2, 1964.

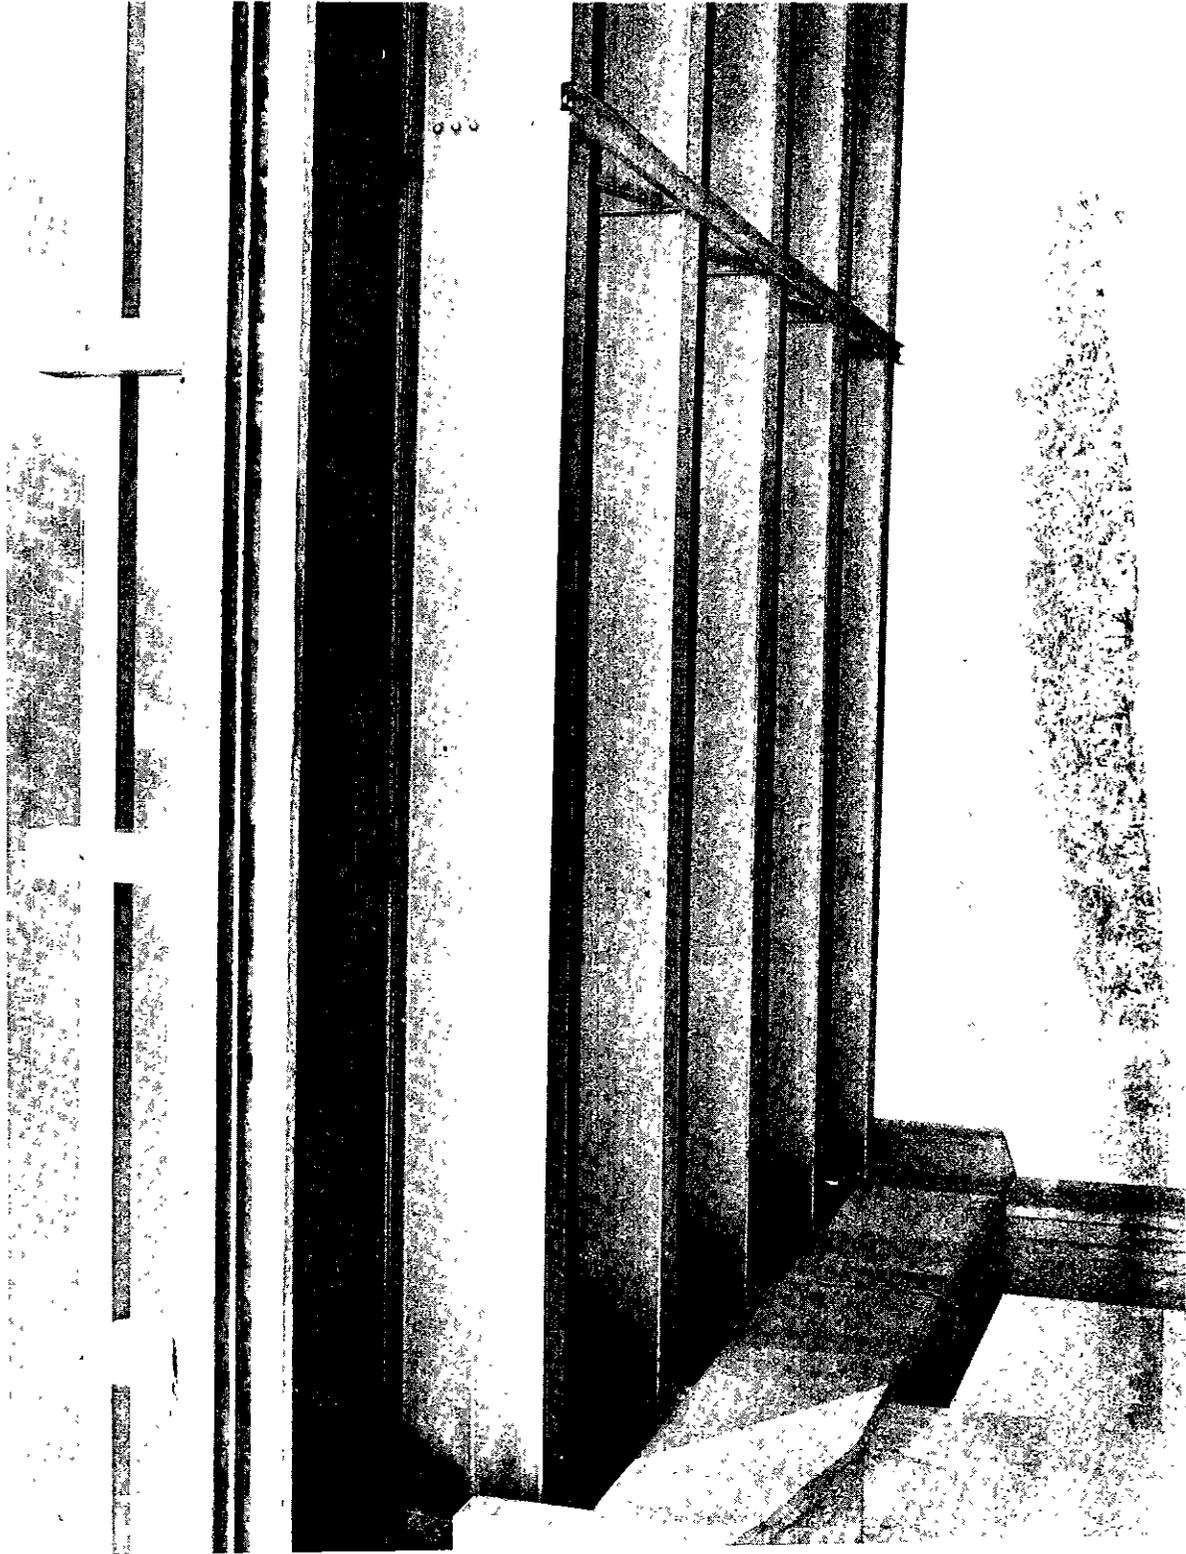
Considerable rust throughout on webs. Worst area on webs near pier.
Rating: 6.5

Photograph No. 5. Leffingwell Creek Bridge. Span 2, North Section
System No. 2. Painted October 1958 - Photographed March 2, 1964.

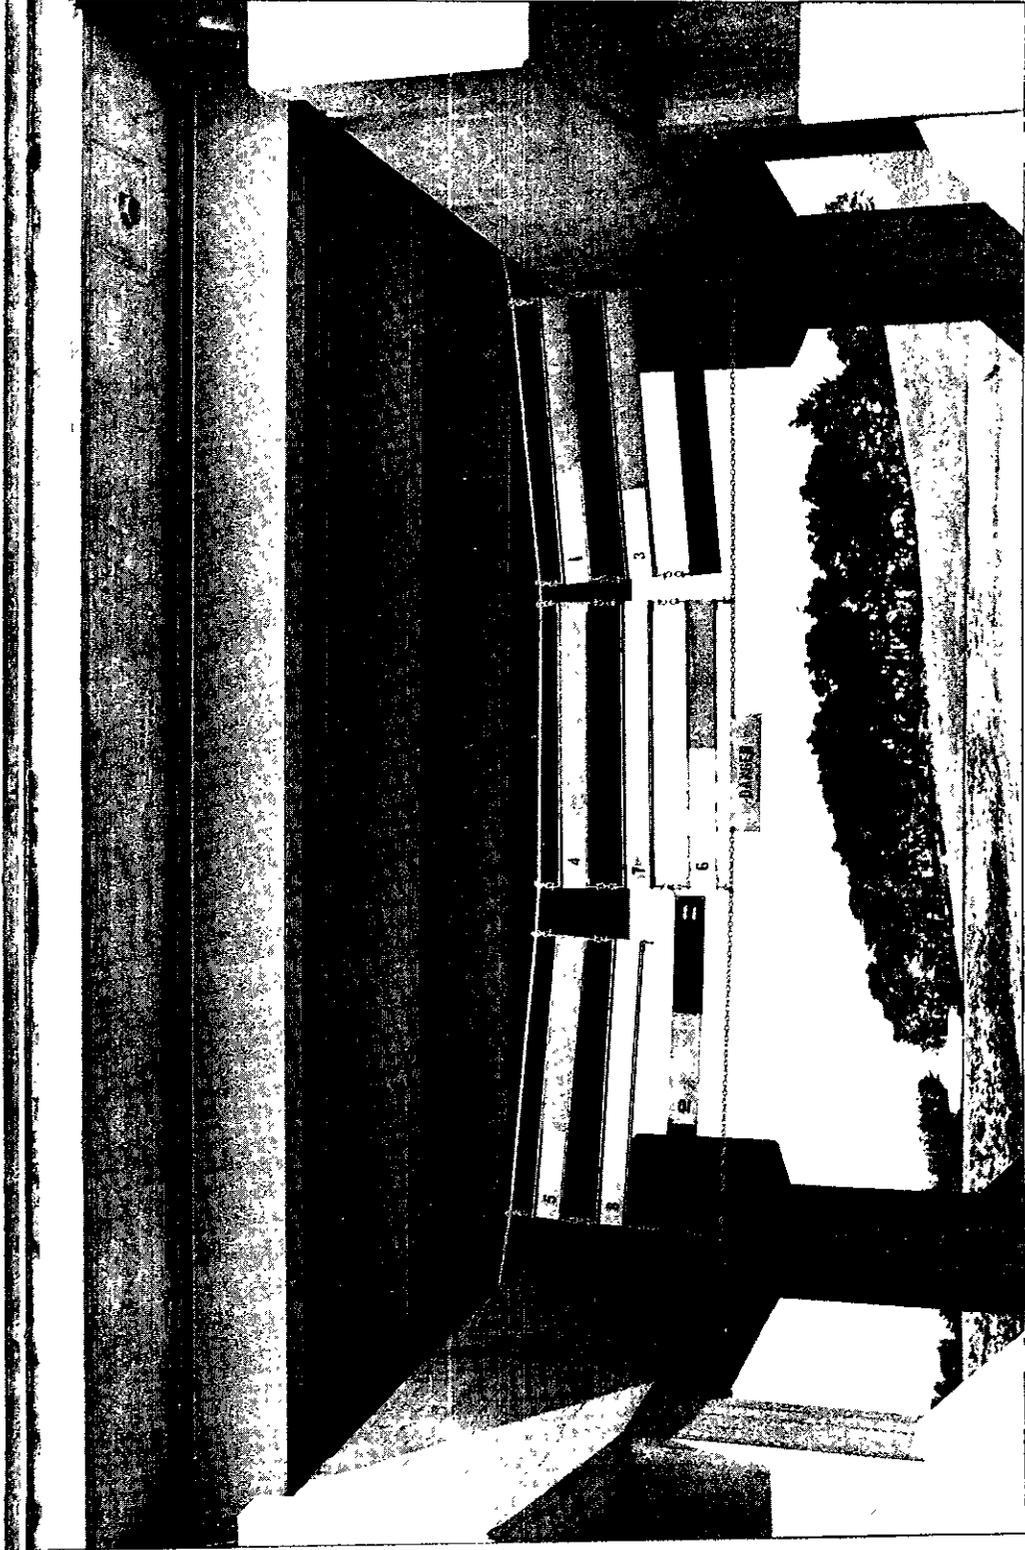
Paint System No. 3, an epoxy formulation applied in October 1958 on Span 3, was replaced by a Laboratory formulated zinc silicate paint and a vinyl green topcoat, State Specification 61-F-75, in June 1962. The formulation data for the Laboratory inorganic zinc silicate coating, 1R310, is included in this report. The original epoxy system deteriorated so rapidly that severe breakdown was noted within one year after its application. This may be noted by referring to Figure 5 of the reprint from the article in the California Highways and Public Works magazine.

Prior to applying the vinyl green topcoat, State Specification 61-G-75, on Span 3 over the Laboratory formulated inorganic zinc silicate primer 1R310, the excess curing agent used over the inorganic zinc silicate primer was removed by scrubbing with water and wire brushes and a bonding coat of vinyl wash primer applied. In the scrubbing operation, some of the inorganic zinc silicate primer was removed from the steel because of its not having had sufficient time to cure properly in the foggy weather. It is necessary to remove the curing solution to secure adhesion of the vinyl wash primer, State Specification 52-G-52, to the inorganic zinc silicate primer. Despite the inadvertent removal of some of the zinc primer, Span 3 appears to be in excellent condition after almost two years of exposure.

Photograph No. 6. Leffingwell Creek Bridge. Span 3. Originally painted in October 1958 with System No. 3. Repainted in June 1962 with Laboratory Formulated Inorganic Zinc Silicate, Formula IR310, and Vinyl Green Topcoat, State Specification 61-G-75. Original System No. 3, an epoxy system failed within a few months after application. Photographed March 2, 1964.

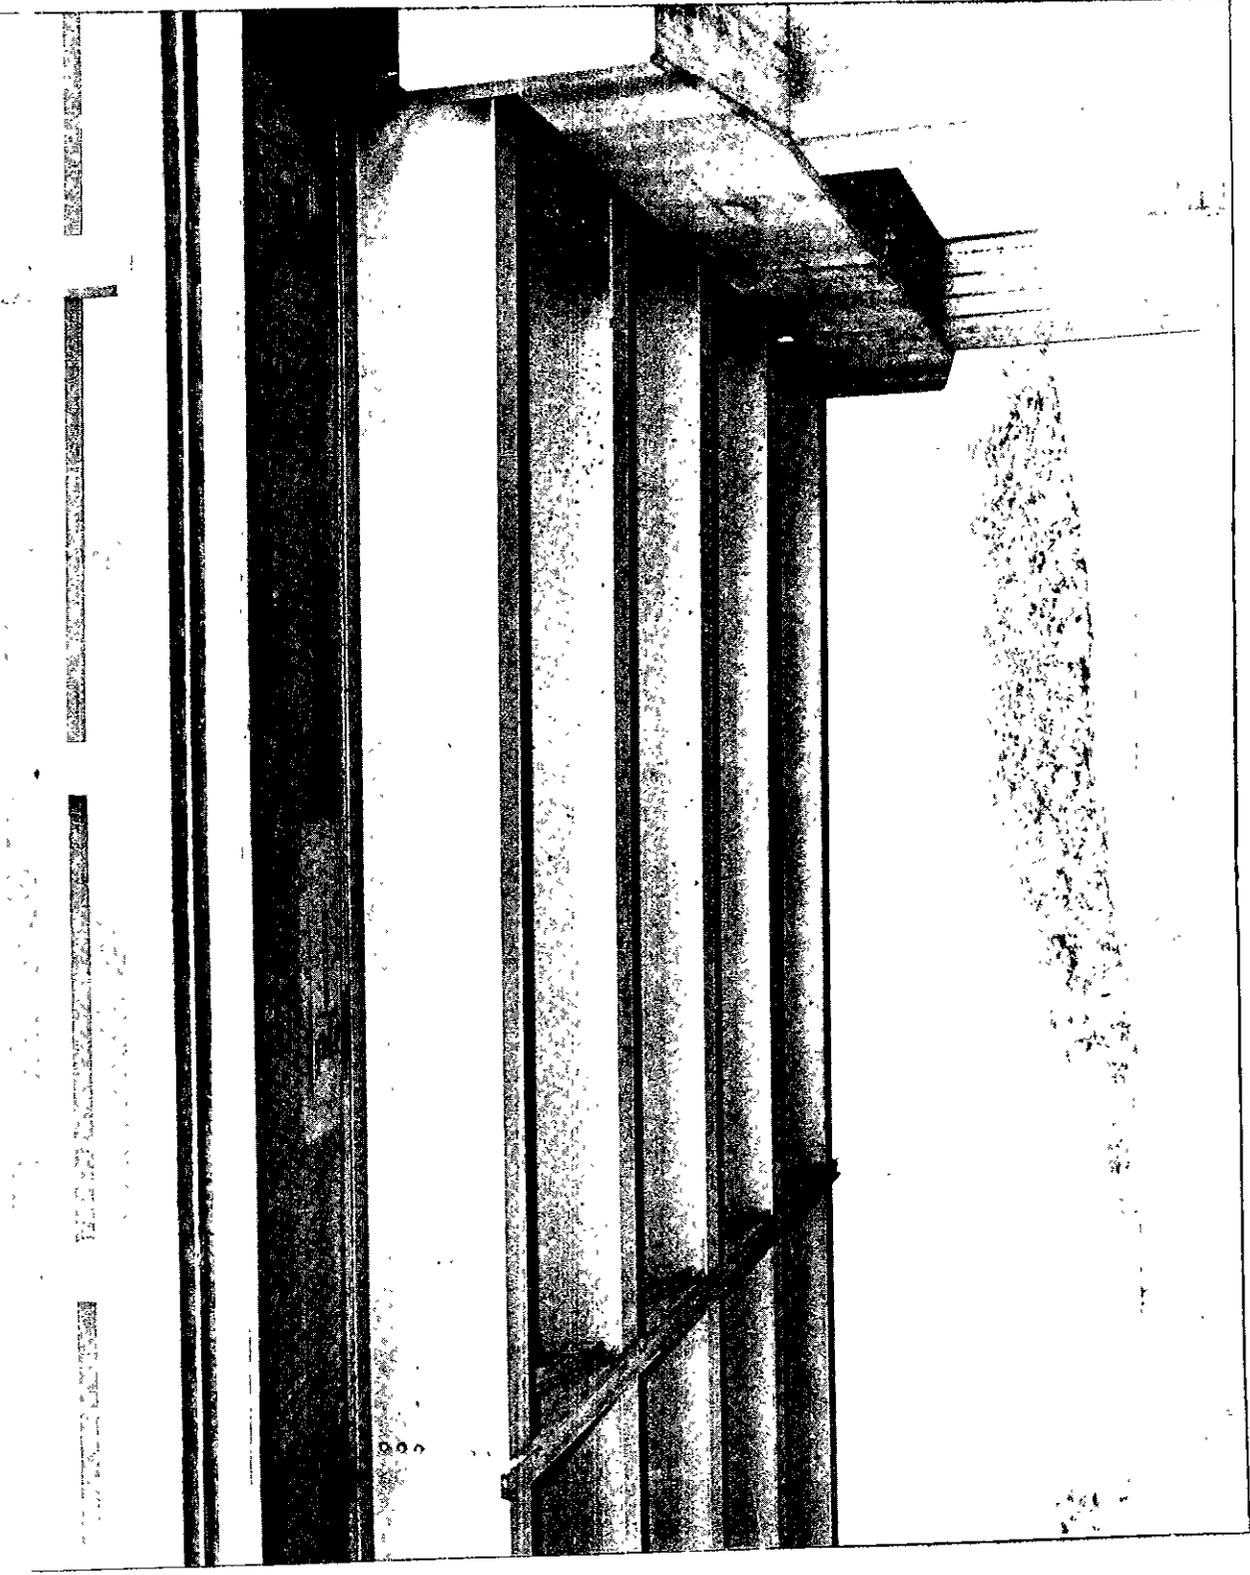
- Span 4 - System No. 2, Total 8 mils.
Freckle rust throughout. This system is a "bust" for coastal exposures.
Rating: 6
- Span 4 - System No. 1, Total 6 mils.
Only rust is on abrasions and laminations.
Excellent shape.
Rating: 9+
- Span 5 - System No. 1, Total 6 mils.
Condition similiar to Span 4, System No. 1.
Very good.
Rating: 9+
- Span 5 - System No. 2, Total 8 mils.
Better shape than same system in other spans. Some rust on bottom and top flanges and on flange edges.
Rating: 7.5
- Spans
6, 7, 8 - System No. 4, Total 6 mils.
Very good shape for 6 years exposure.
Light rust scattered throughout mainly on flange edges, bracing member edges and ends and around bearings.
Rating: 8

Photograph No. 7. Leffingwell Creek Bridge. Span 4, South Section
System No. 2. Painted October 1958 - Photographed March 2, 1964.

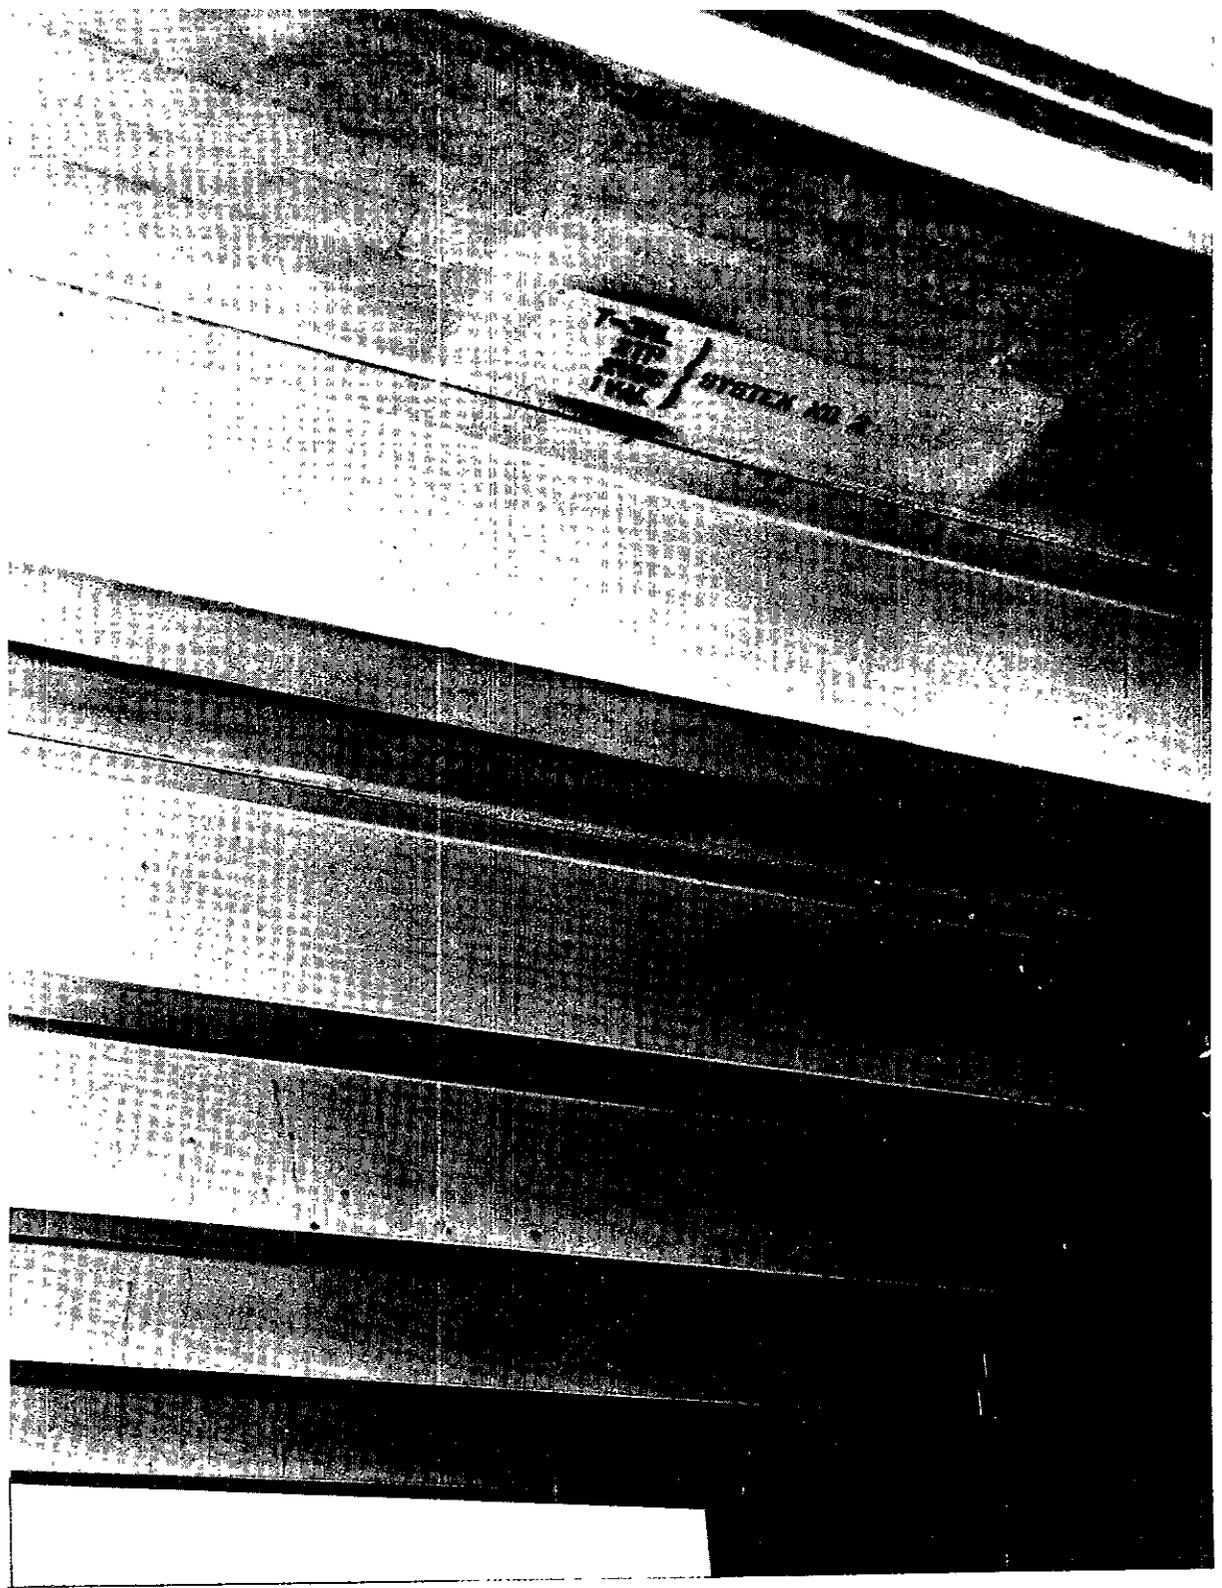
Photograph No. 8. Leffingwell Creek Bridge. Span 4, South Section
(close-up picture) System No. 2. Painted October 1958 - Photographed
March 2, 1964.

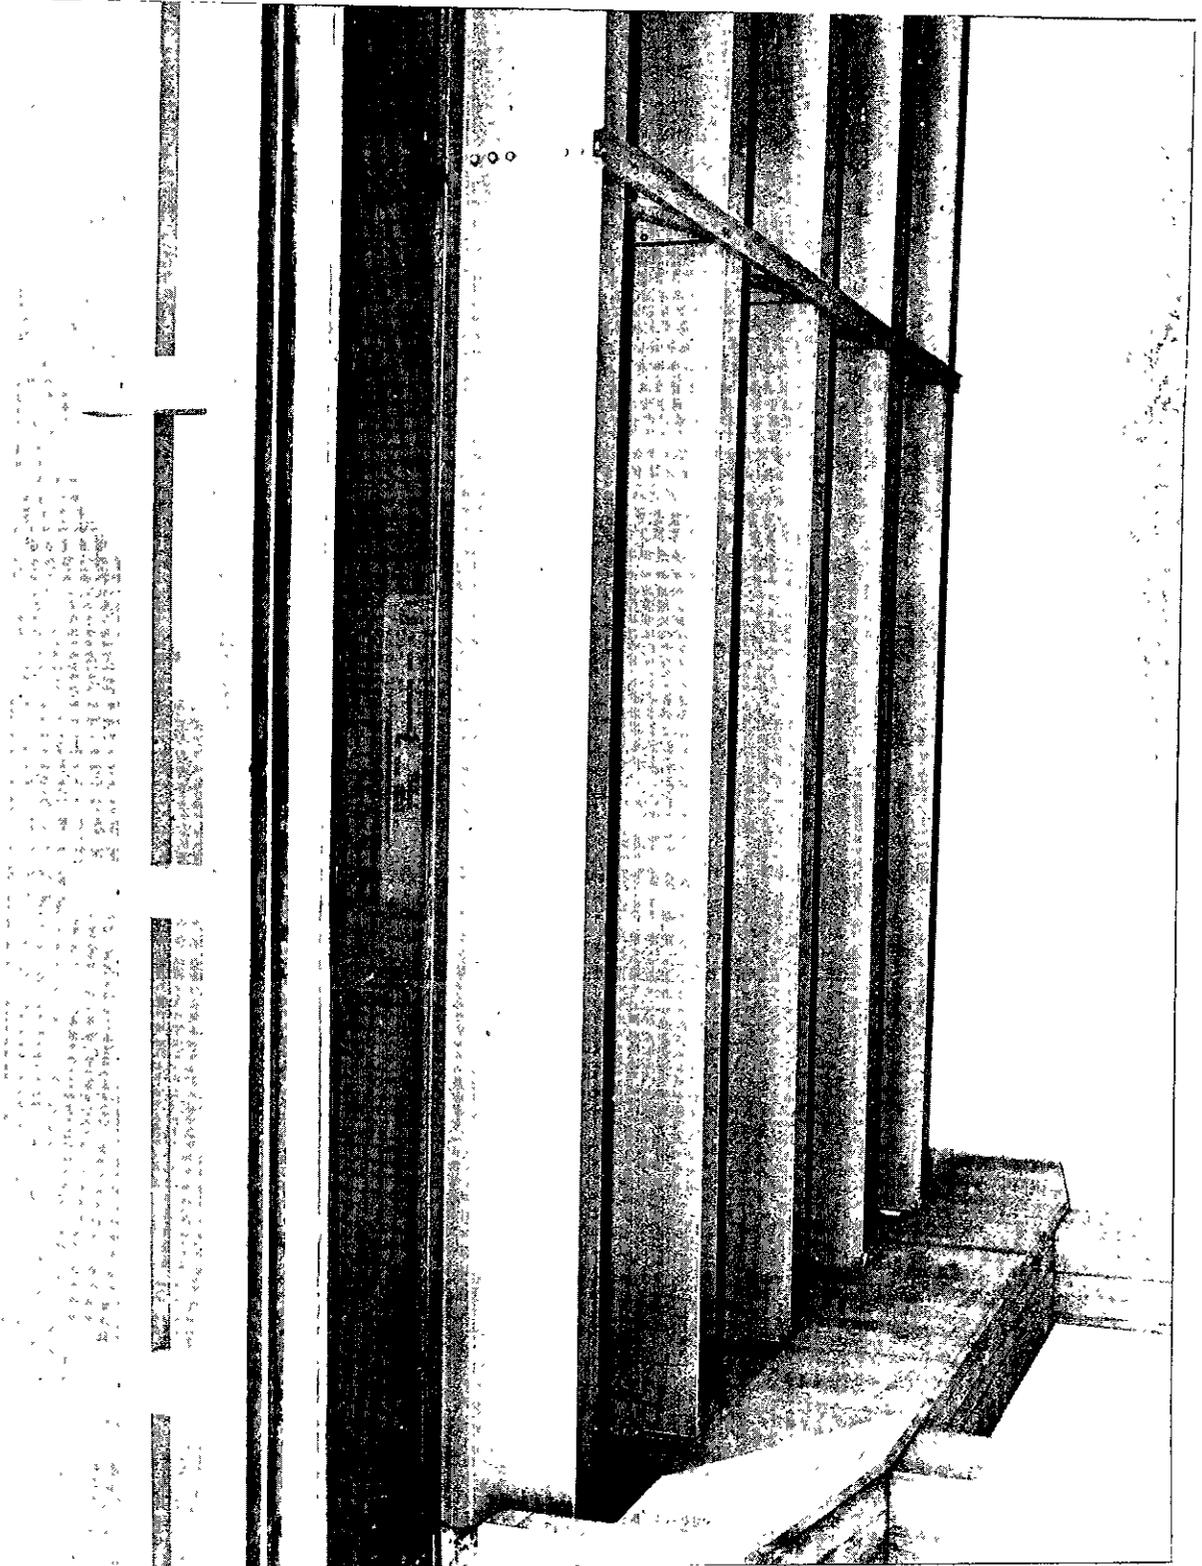
Photograph No. 9. Leffingwell Creek Bridge. Span 4, North Section
System No. 1. Painted October 1958 - Photographed March 2, 1964.

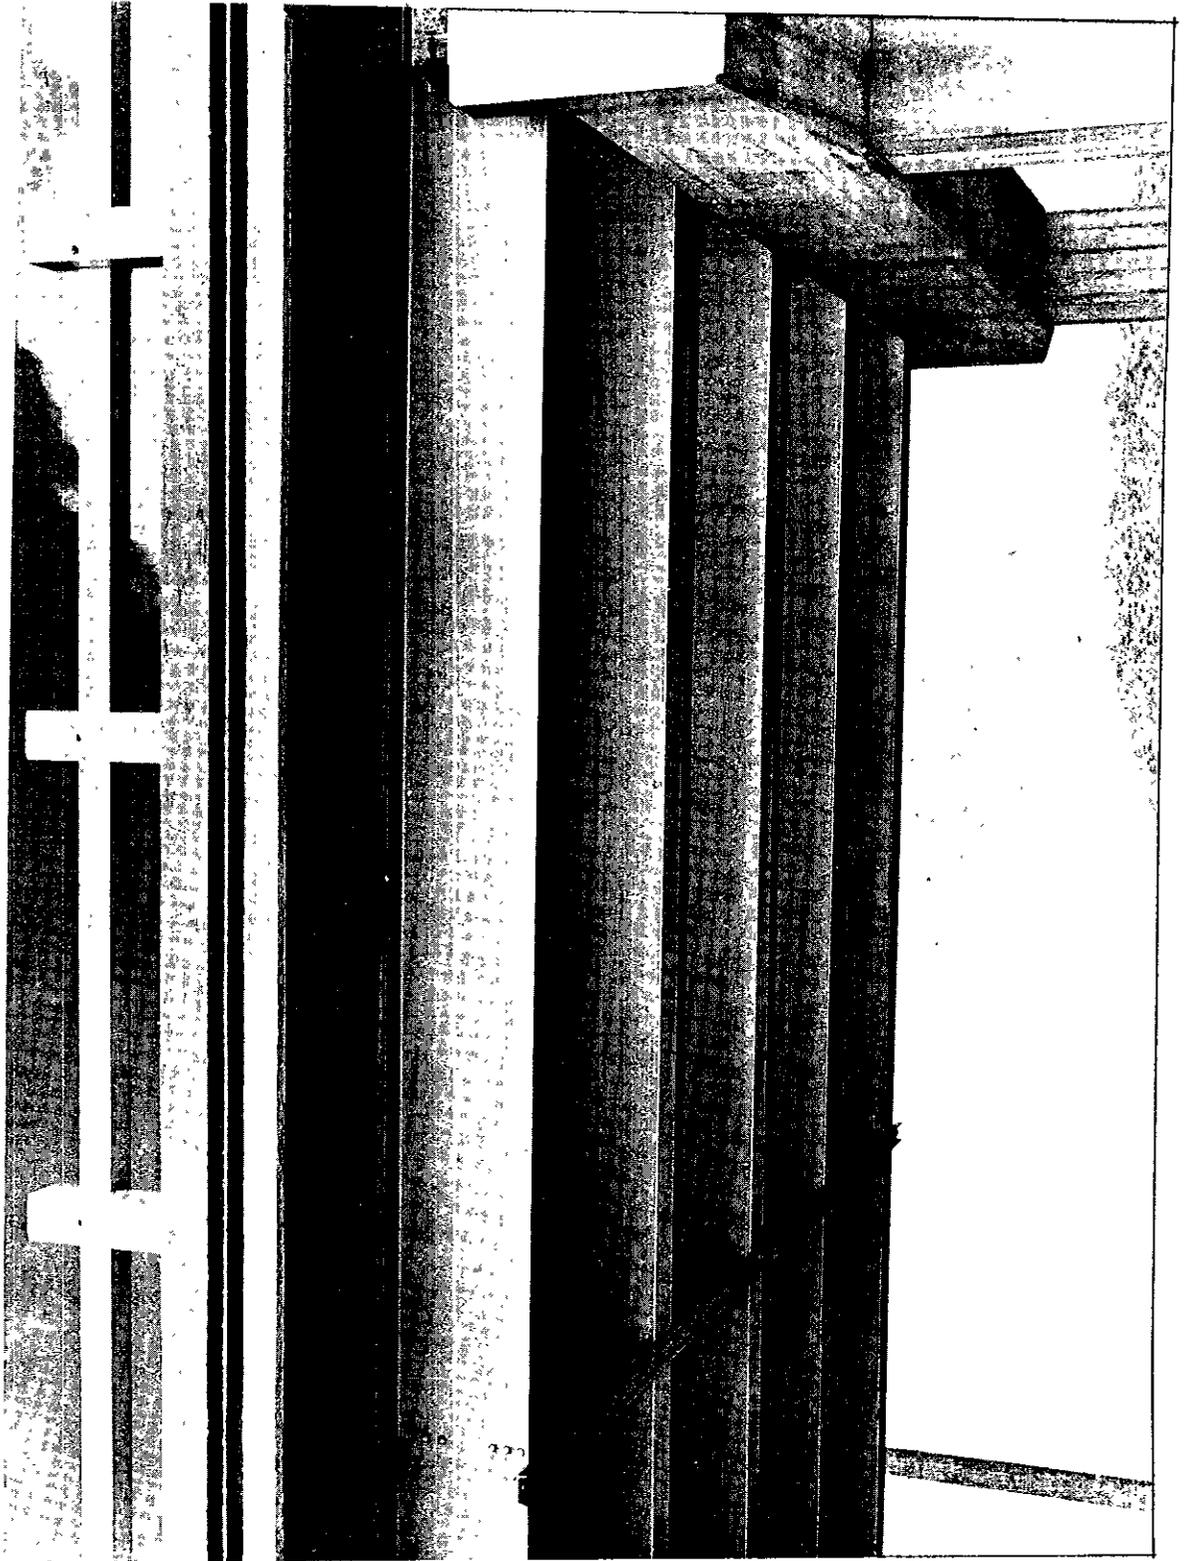
Photograph No. 10. Leffingwell Creek Bridge. Span 5, South Section
System No. 1. Painted October 1958 - Photographed March 2, 1964.

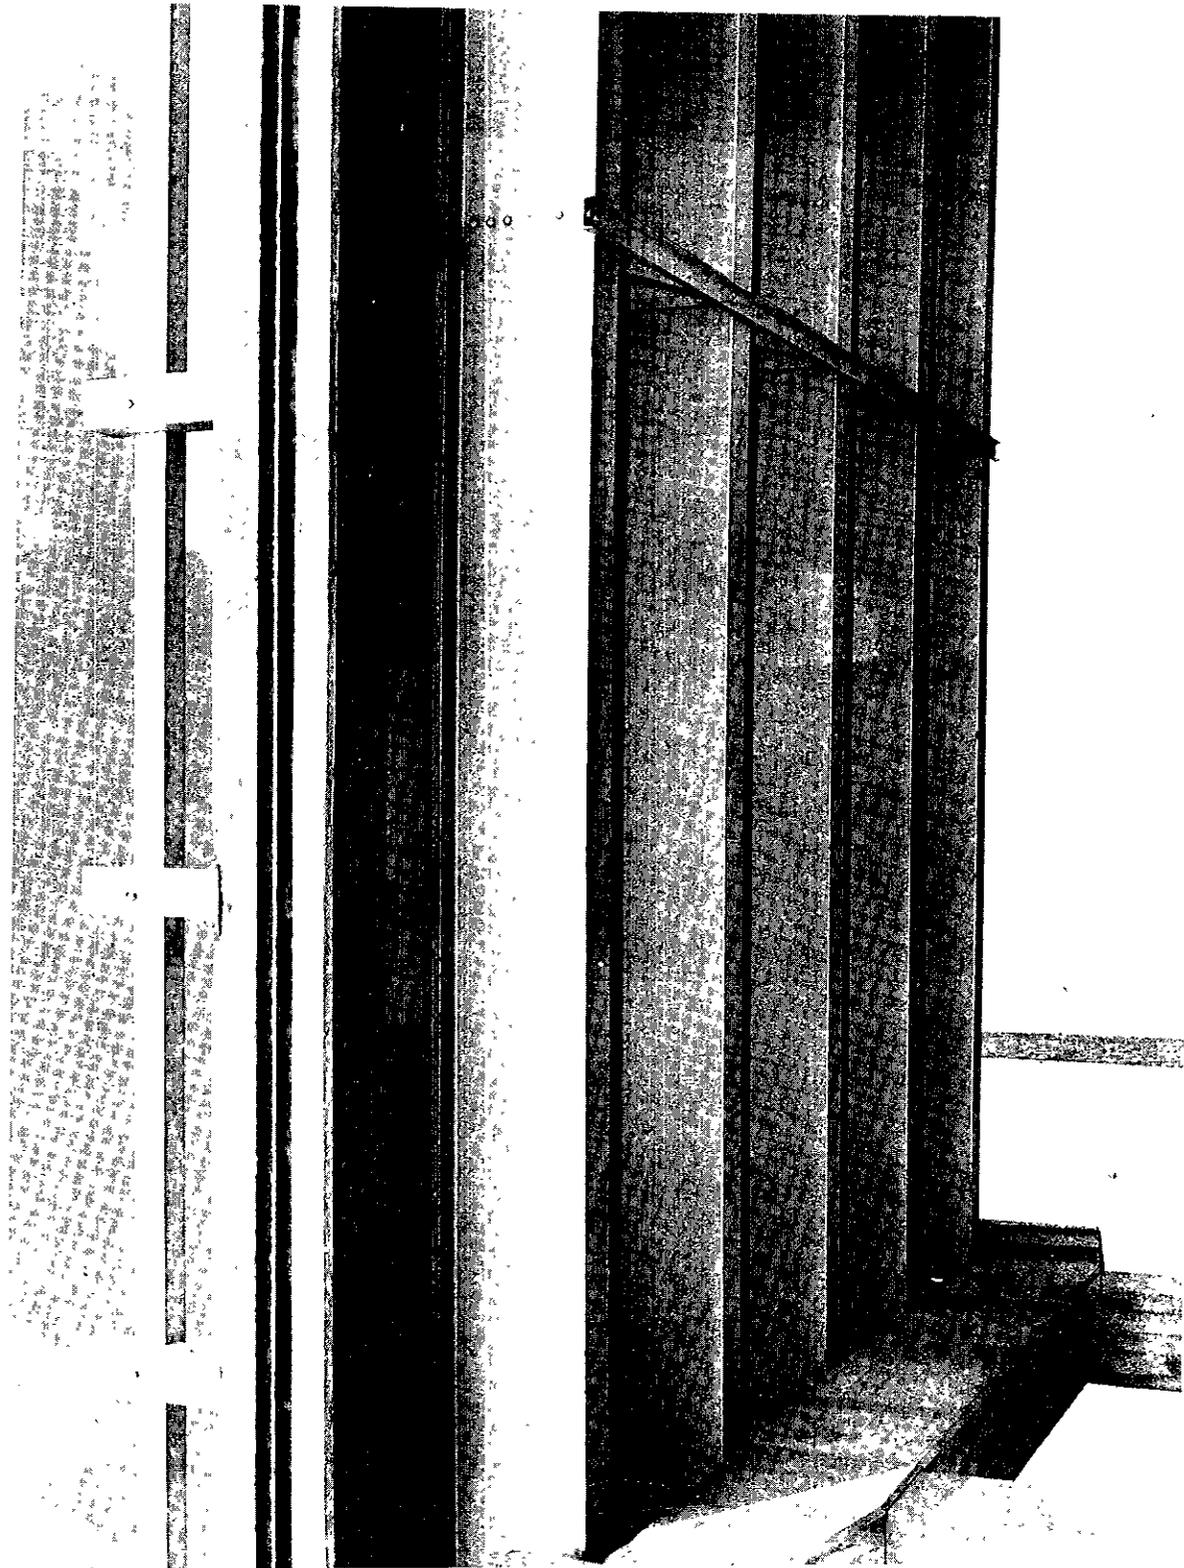
Photograph No. 11. Leffingwell Creek Bridge. Span 5, North Section
System No. 2. Painted October 1958 - Photographed March 2, 1964.
