A Study of Various Paint Systems Applied to Leffingwell and San Simeon Creek Bridges in a Corrosive Marine Atmosphere

April 1964

State of California
Department of Public Works
Division of Highways
Materials and Research Department

Progress Report

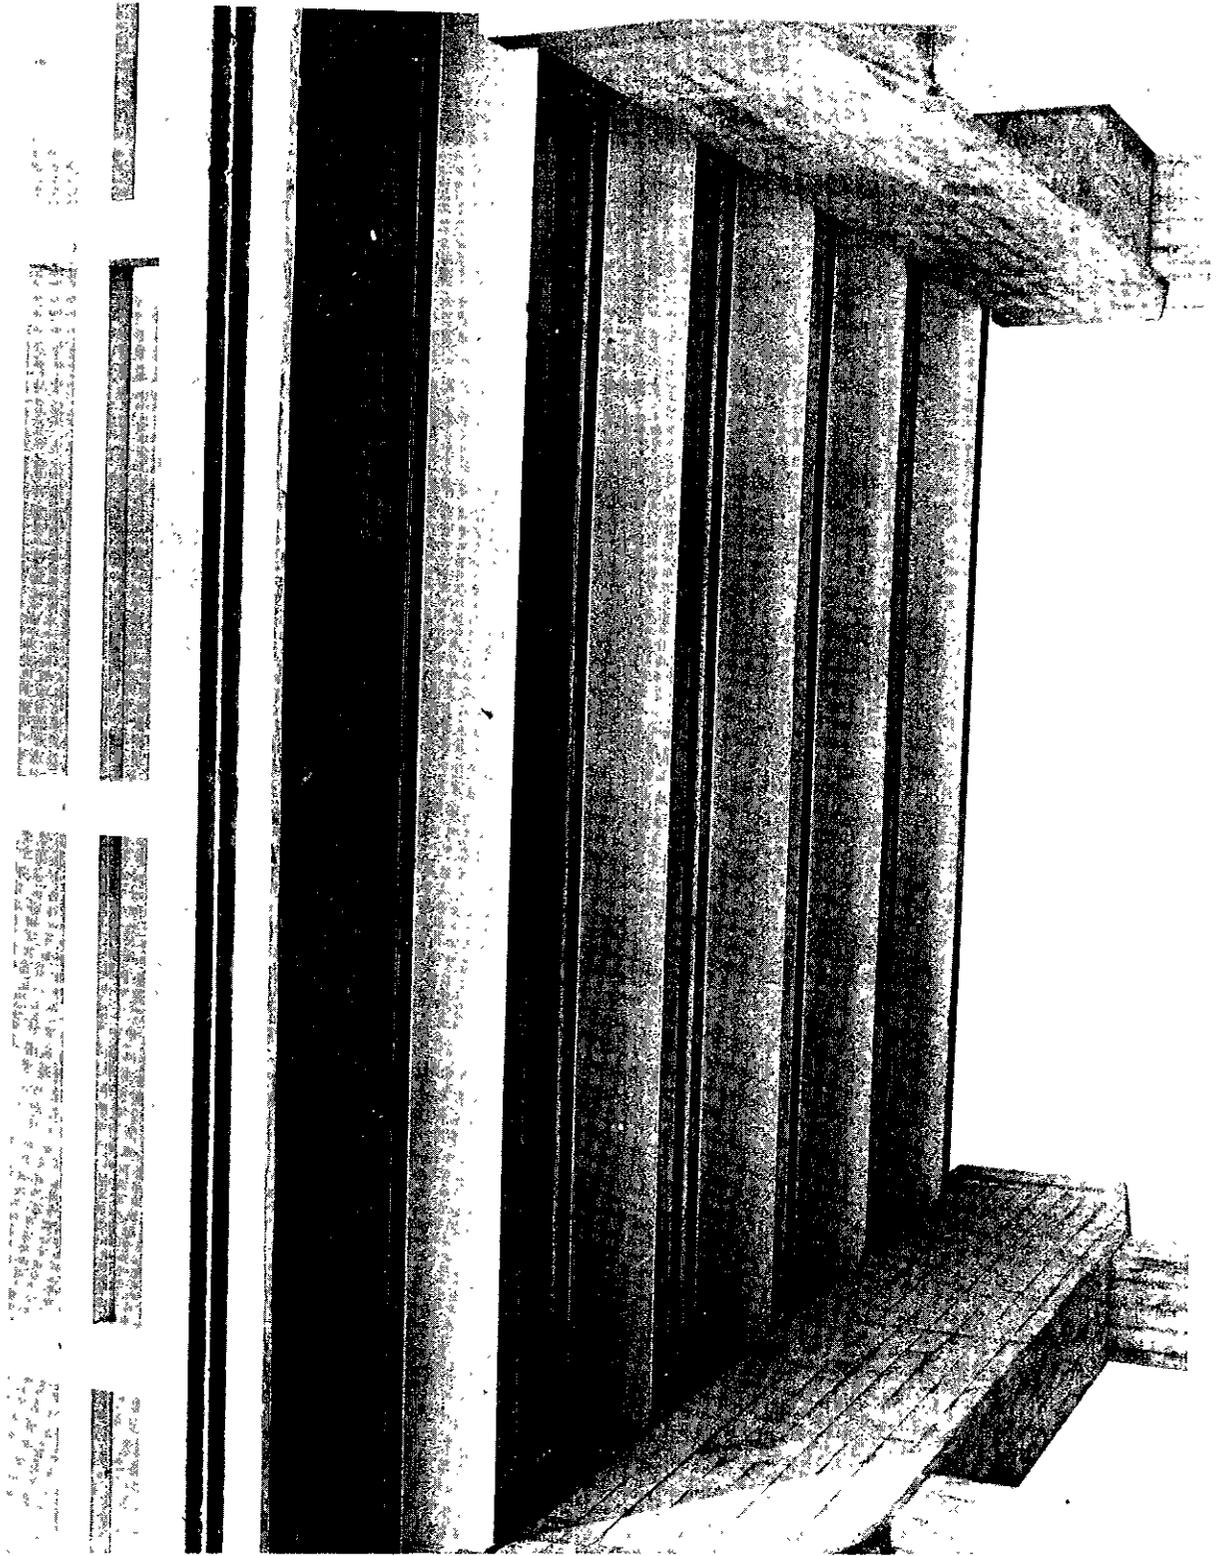
Photograph No. 12. Leffingwell Creek Bridge. Span 6, System No. 4.
Painted October 1958 - Photographed March 2, 1964.

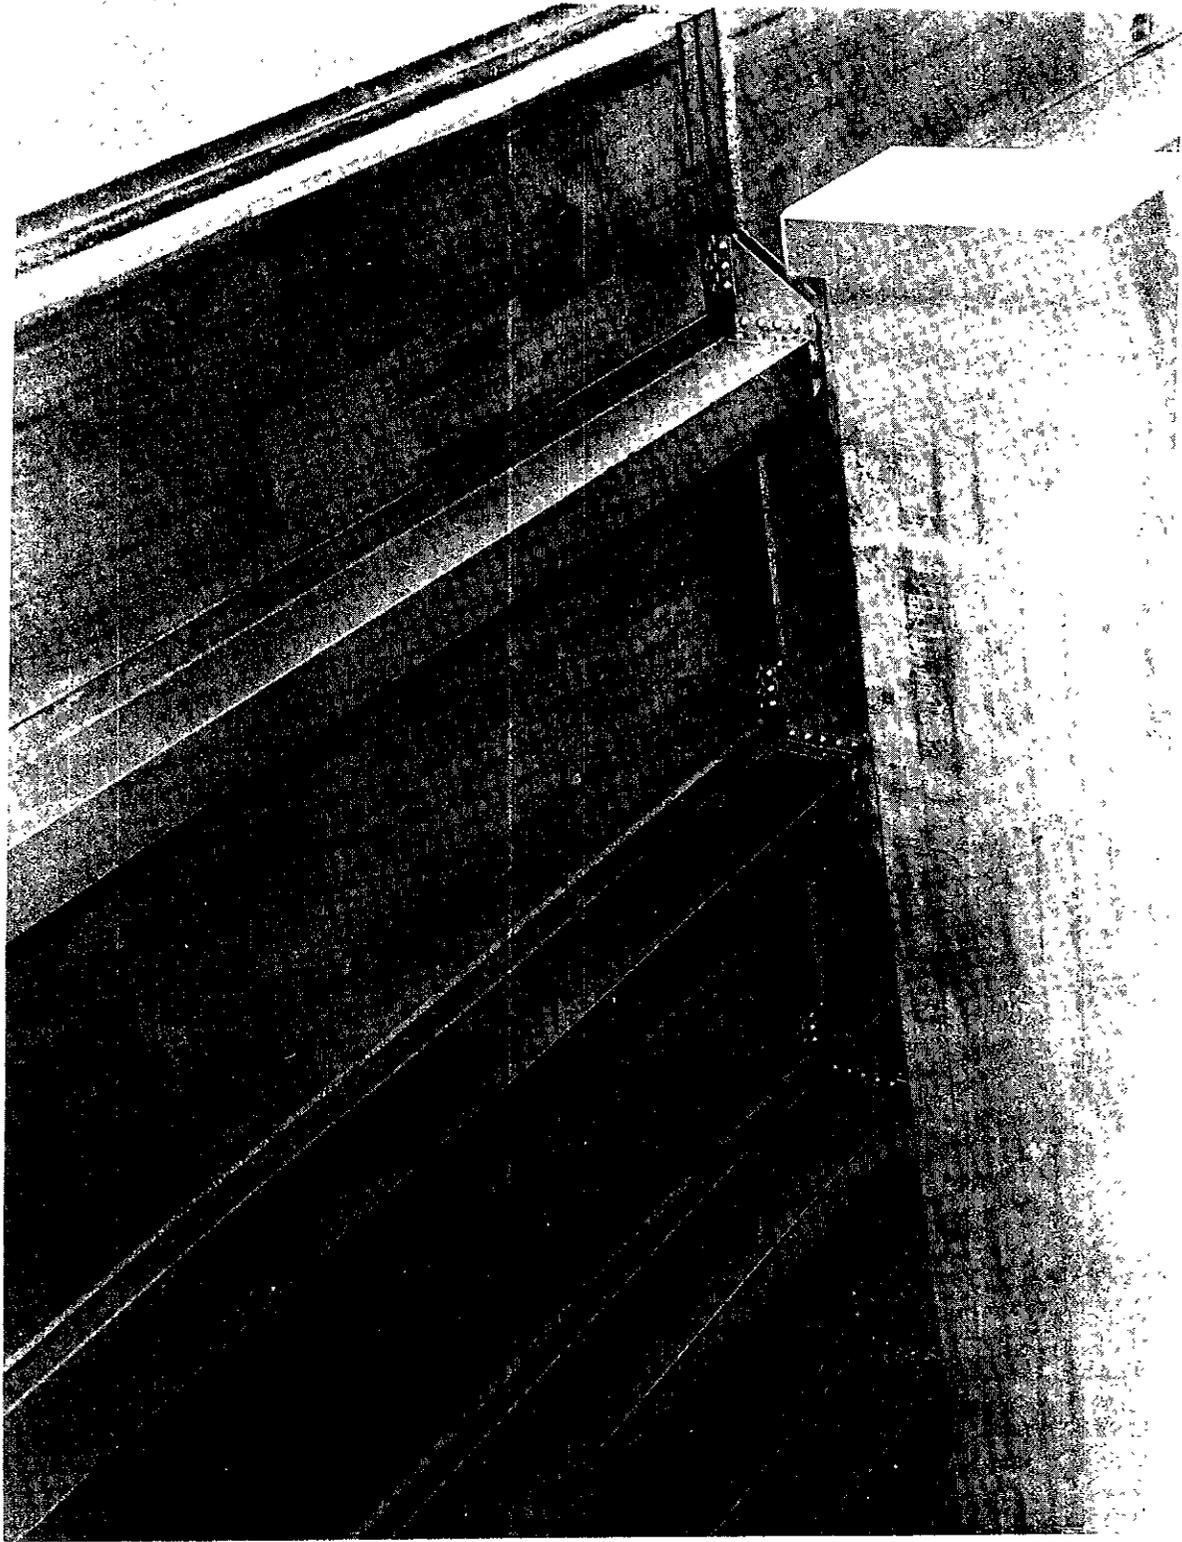
Photograph No. 13. Leffingwell Creek Bridge. Span 6 (close-up picture) System No. 4. Painted October 1958 - Photographed March 2, 1964.

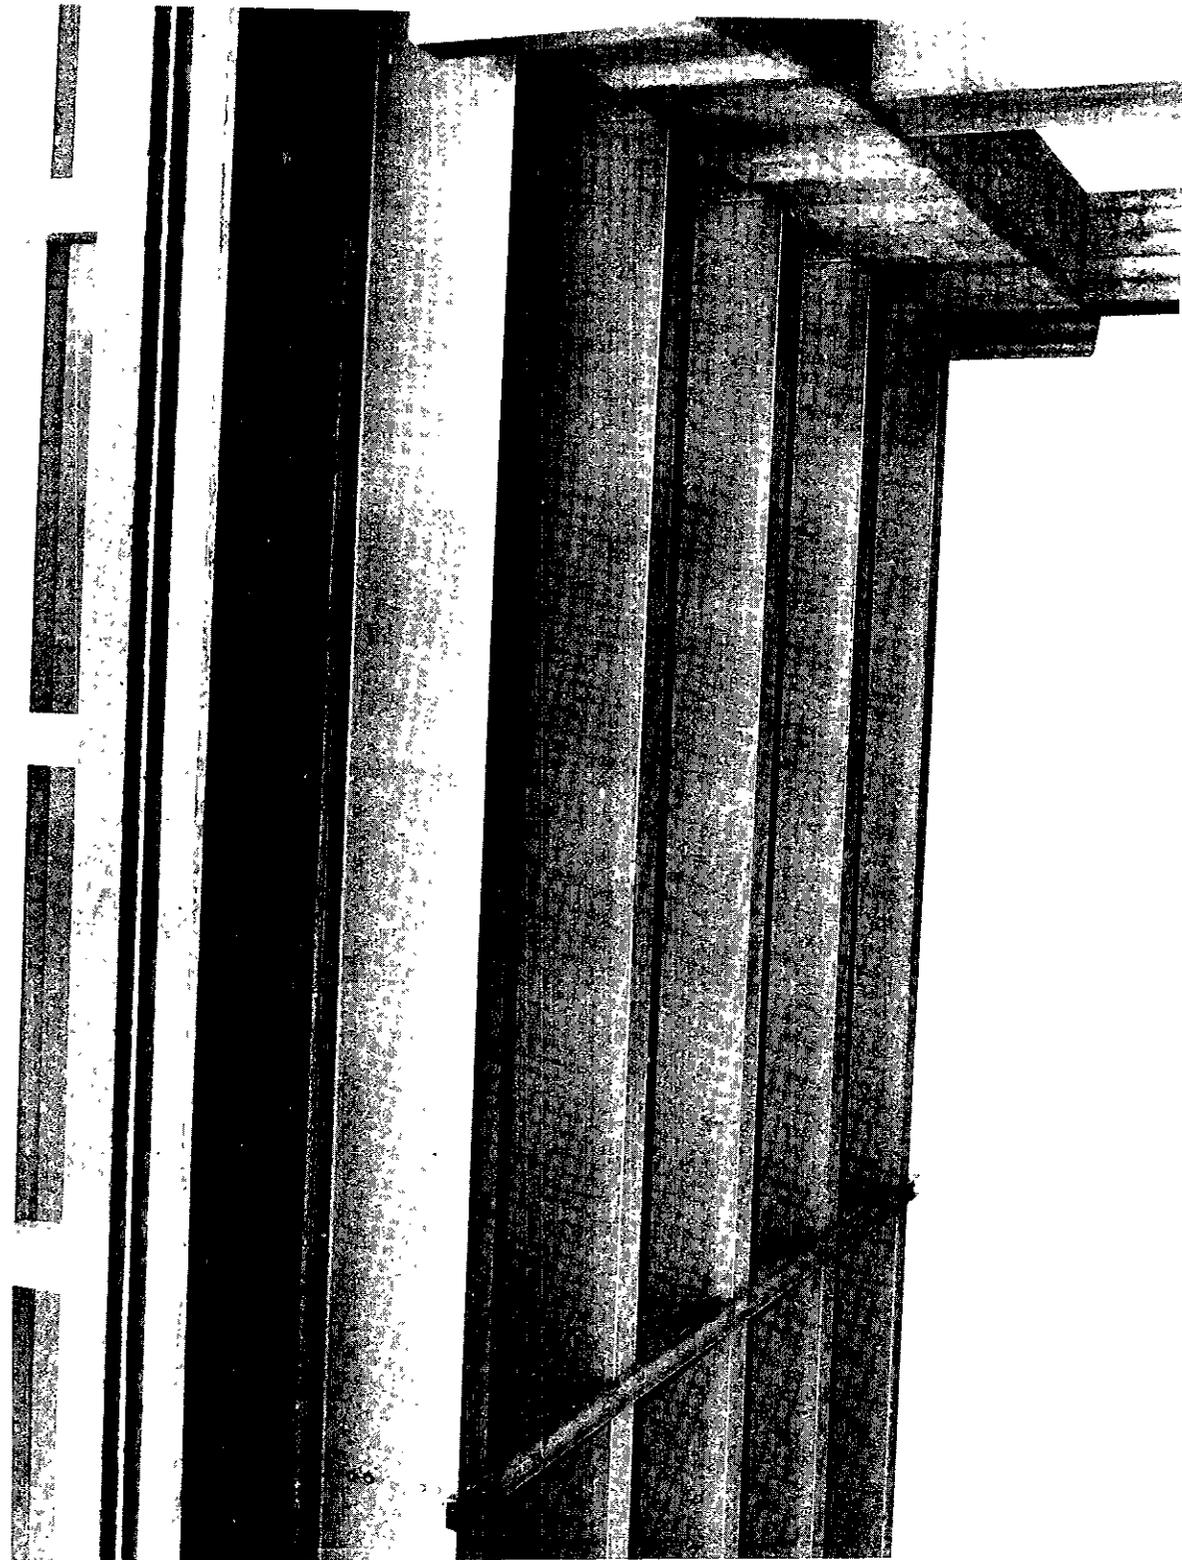
Photograph No. 14. Leffingwell Creek Bridge. Span 7, South Section
System No. 4. Painted October 1958 - Photographed March 2, 1964.

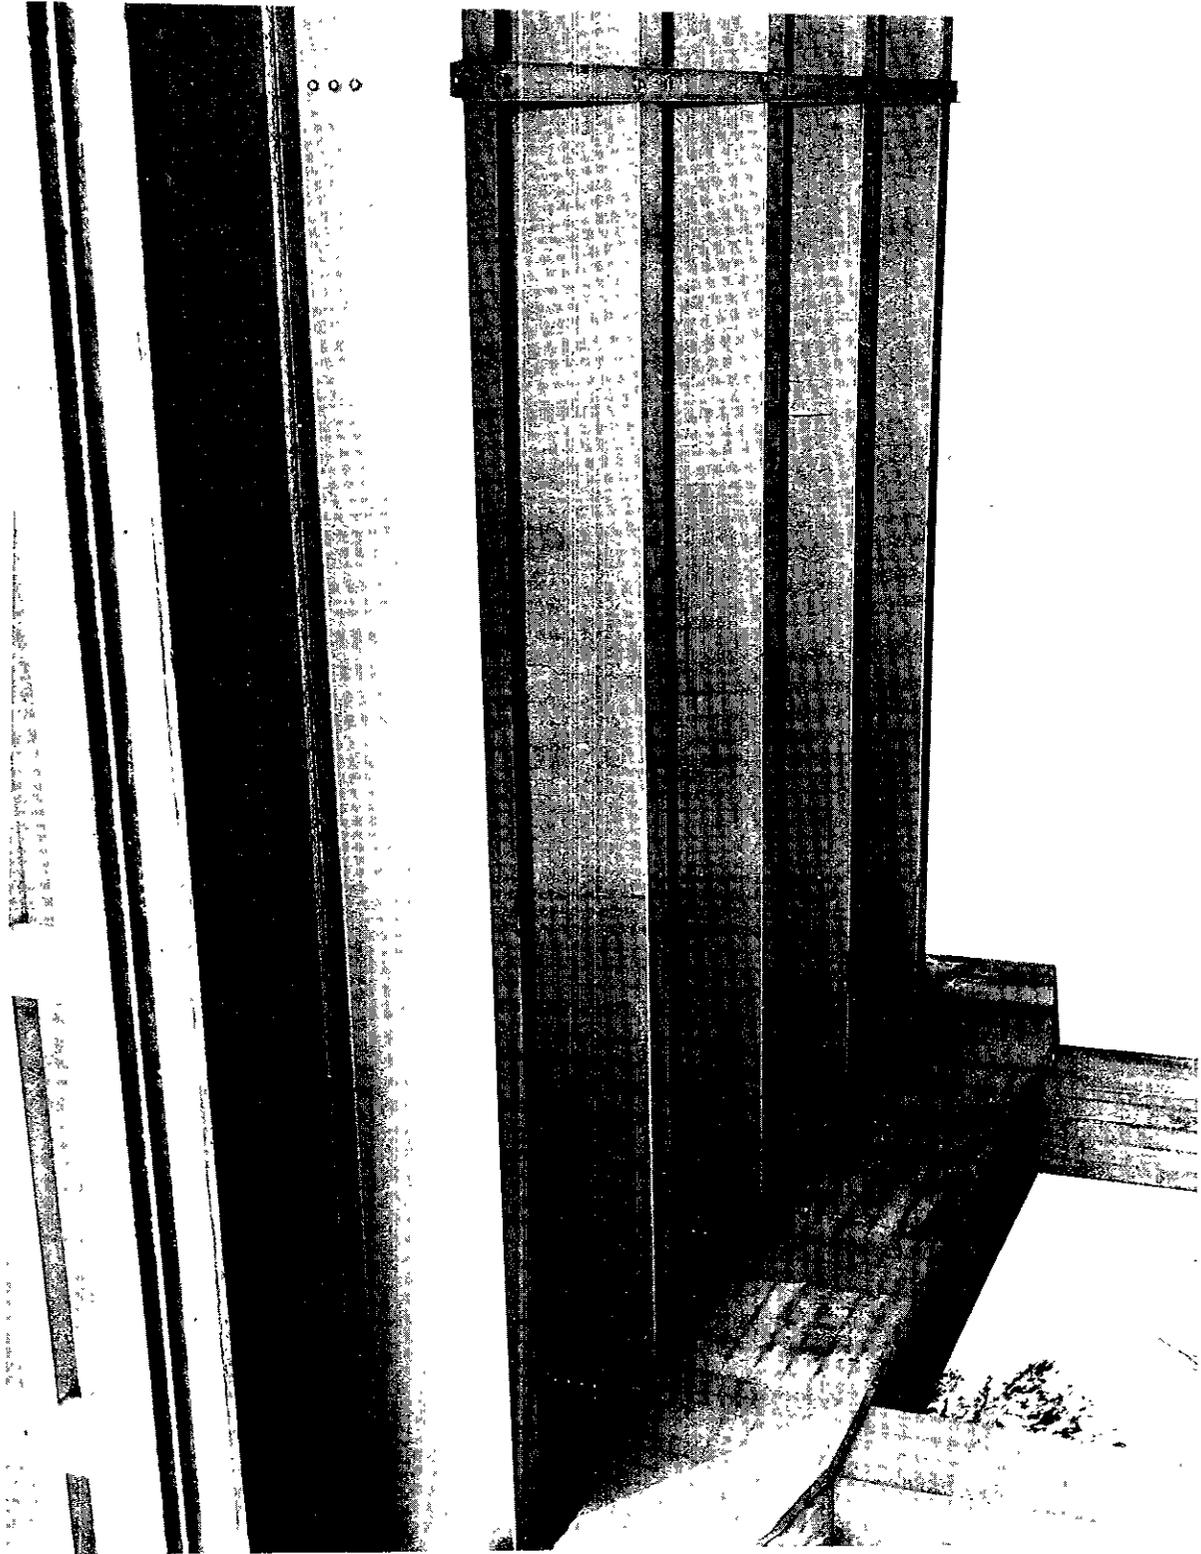
Photograph No. 15. Leffingwell Creek Bridge. Span 7, North Section
System No. 4. Painted October 1958 - Photographed March 2, 1964.

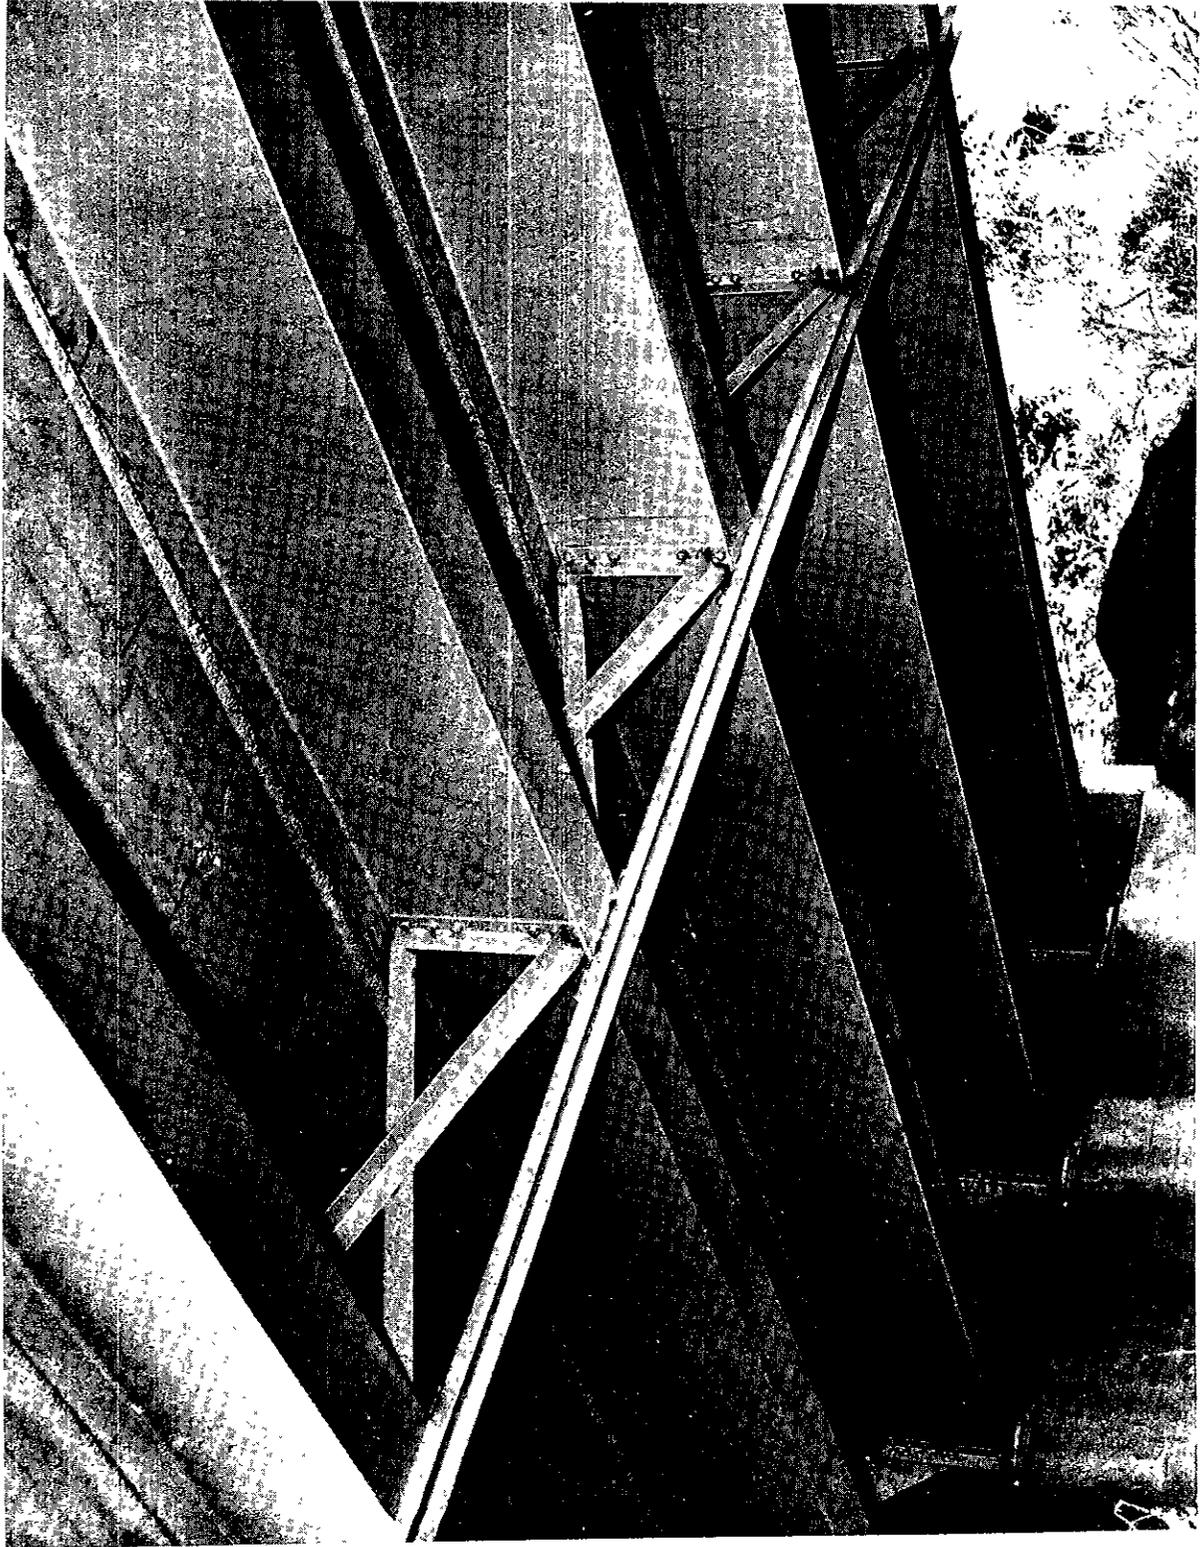
Photograph No. 16. Leffingwell Creek Bridge. Span 8 (close-up picture) System No. 4. Painted October 1958 - Photographed March 2, 1964.

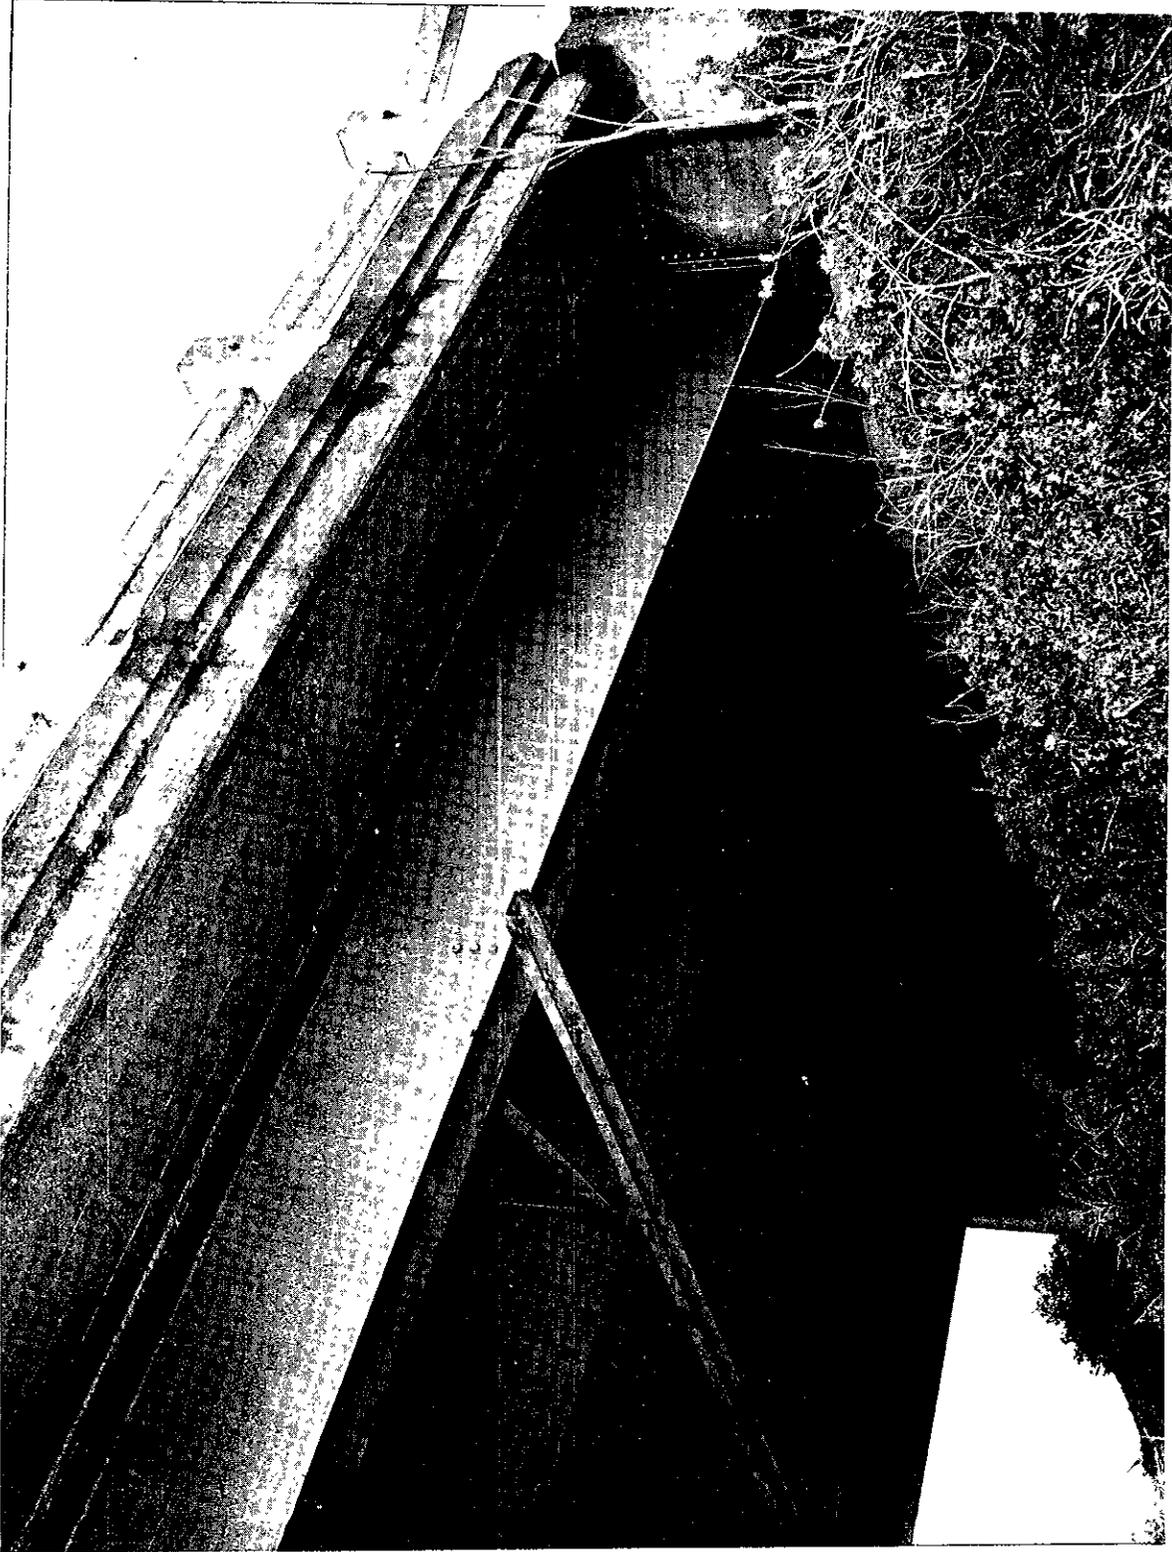
The three southerly spans of the San Simeon Creek Bridge, Spans 1, 2 and 3, were completely sandblasted and painted with 4 mils of a basic lead silico chromate primer corresponding to Federal Specification TT-P-00615a, Type I, followed by 2 mils of a phenolic iridescent green topcoat, State Specification 58-G-79. The other spans of the bridge were spot sandblasted and spot primed with a red lead primer, State Specification 58-G-53, followed by the application of the phenolic iridescent green topcoat. The photographs are graphic evidence that the basic lead silico chromate priming system is at least equal to that of the red lead priming system in corrosion protection. However, neither of these systems provide the protection equal to that provided by the inorganic zinc silicate or vinyl systems which were applied on the Leffingwell Creek Bridge.

Photograph No. 17. San Simeon Creek Bridge. South End, Span 1.
4 mils Basic Lead Silico Chromate, Federal Specification TT-P-00615a,
Type I, and 2 mils Phenolic Iridescent Green, State Specification
58-G-79. Painted June-October 1959 - Photographed March 3, 1964.

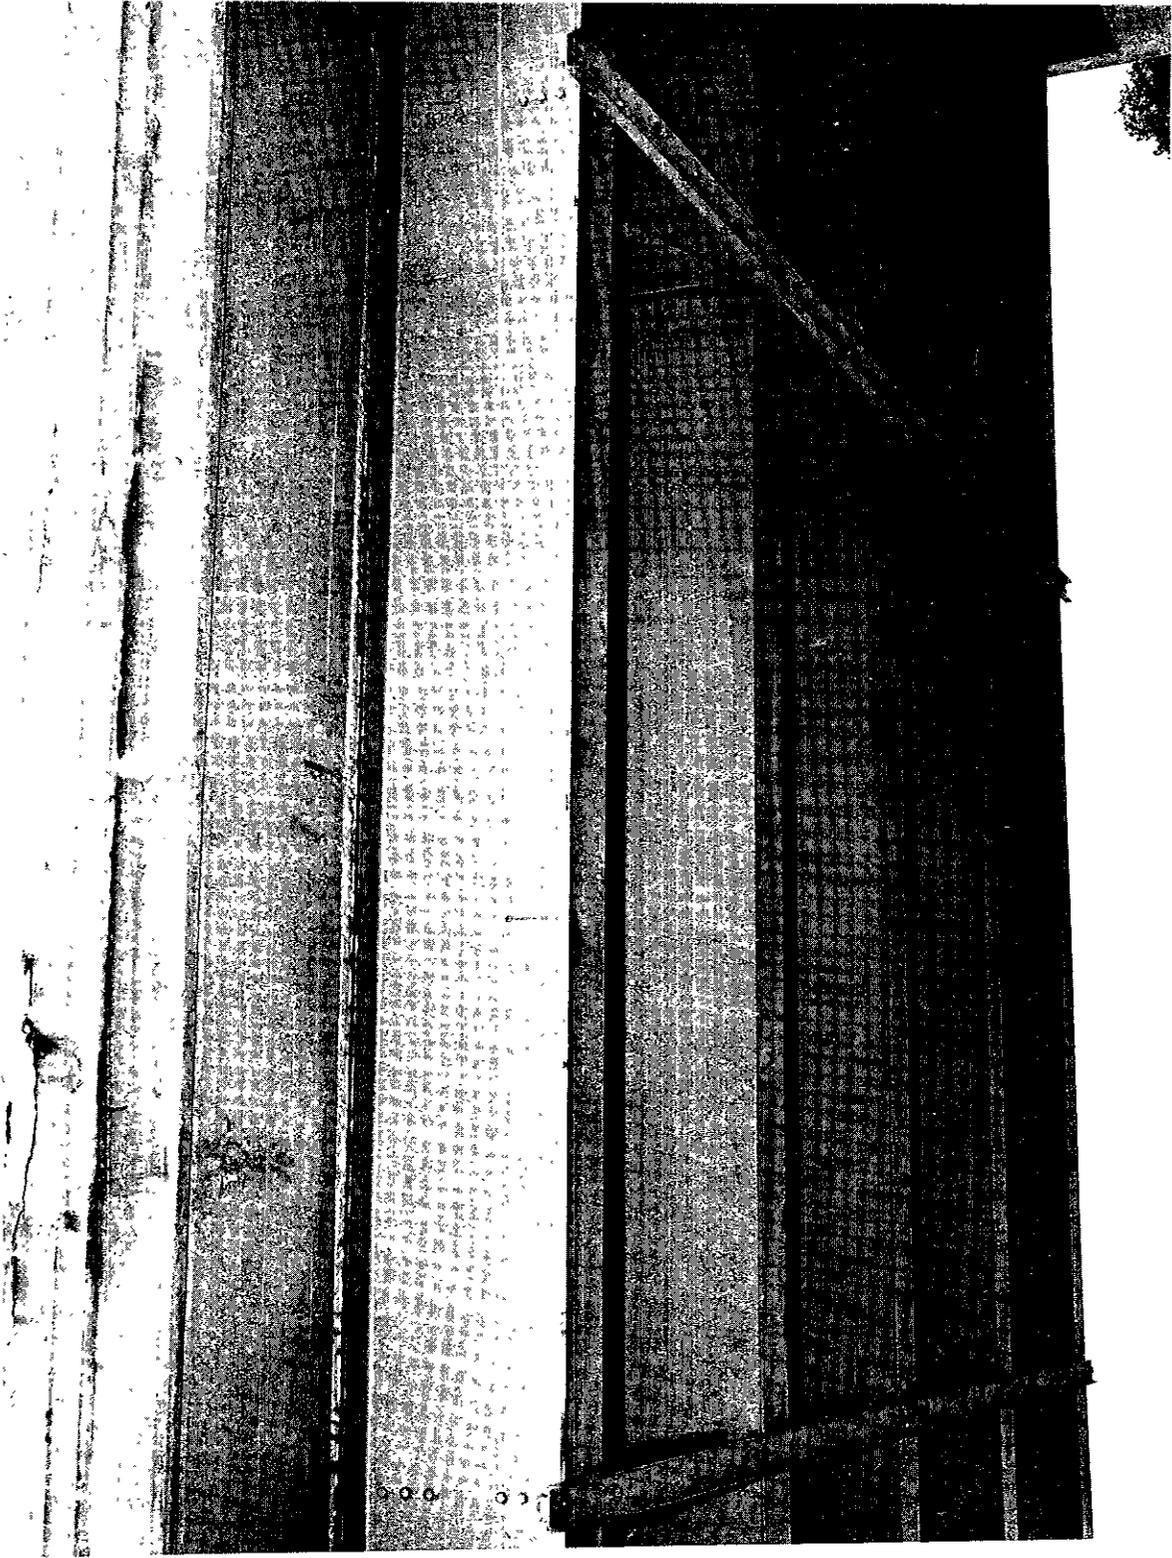
Photograph No. 18. San Simeon Creek Bridge. Span 1, Section 2.
4 mils Basic Lead Silico Chromate, Federal Specification TT-P-00615a,
Type I, and 2 mils Phenolic Iridescent Green, State Specification
58-G-79. Painted June-October 1959 - Photographed March 3, 1964.

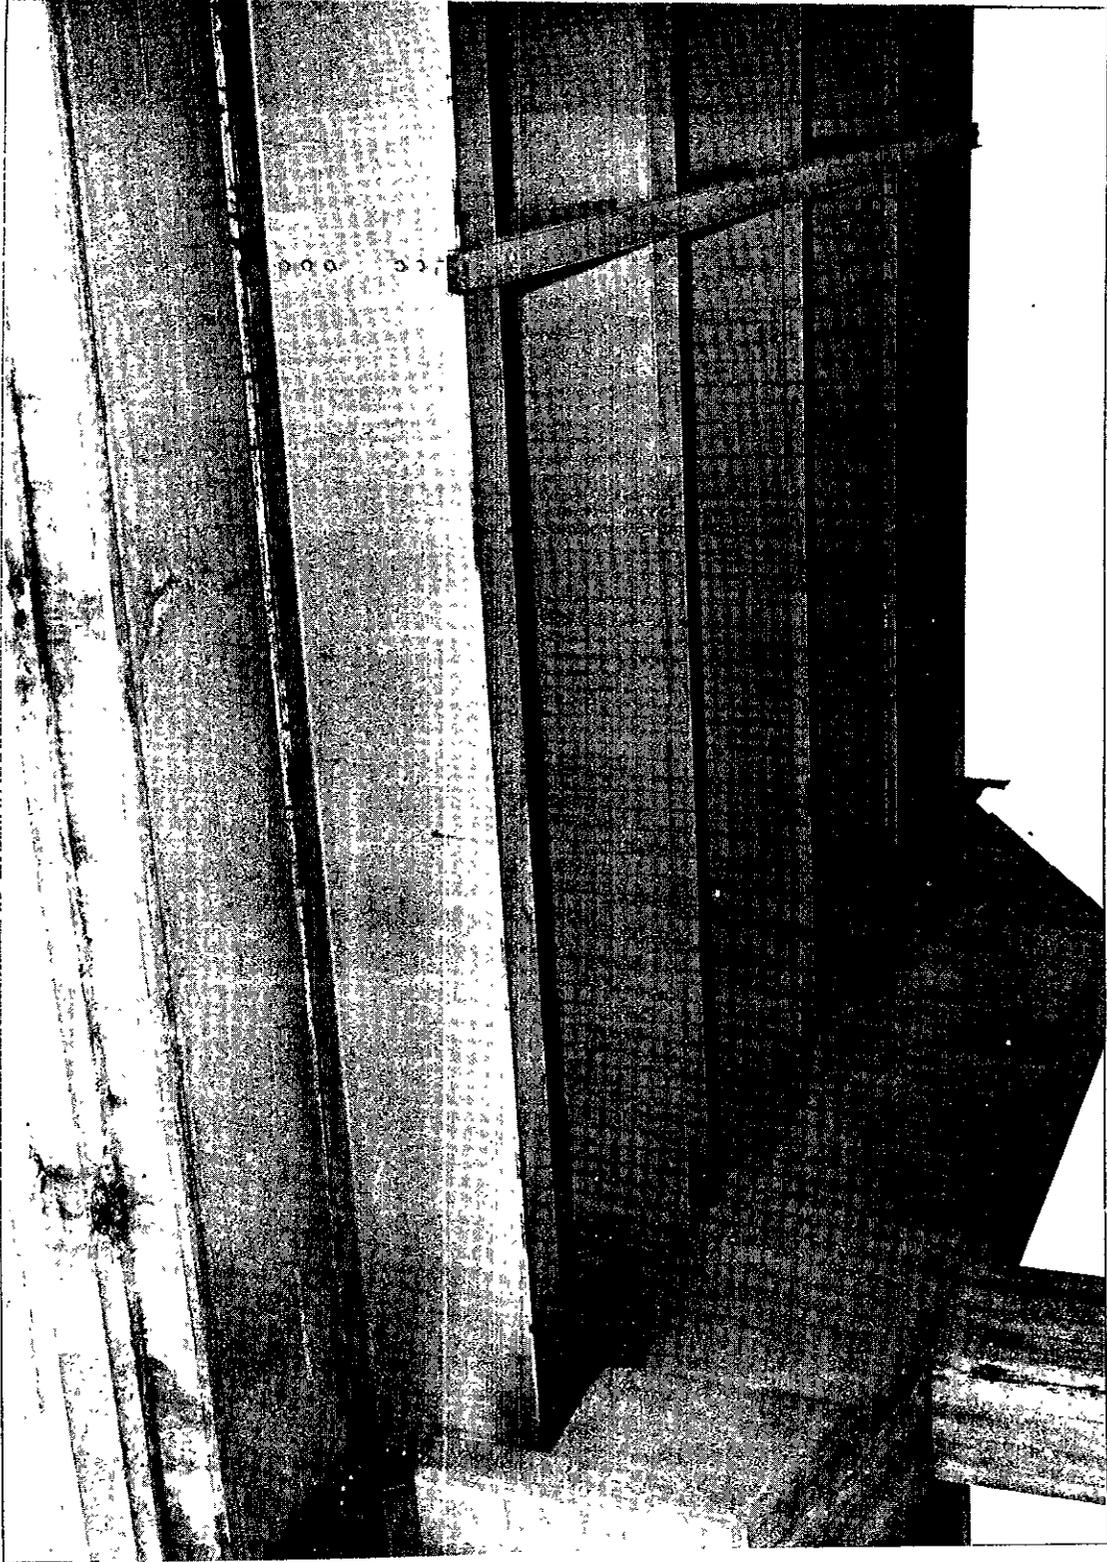
Photograph No. 19. San Simeon Creek Bridge. Span 1, Section 3.
4 mils Basic Lead Silico Chromate, Federal Specification TT-P-00615a,
Type I, and 2 mils Phenolic Iridescent Green, State Specification
58-G-79. Painted June-October 1959 - Photographed March 3, 1964.

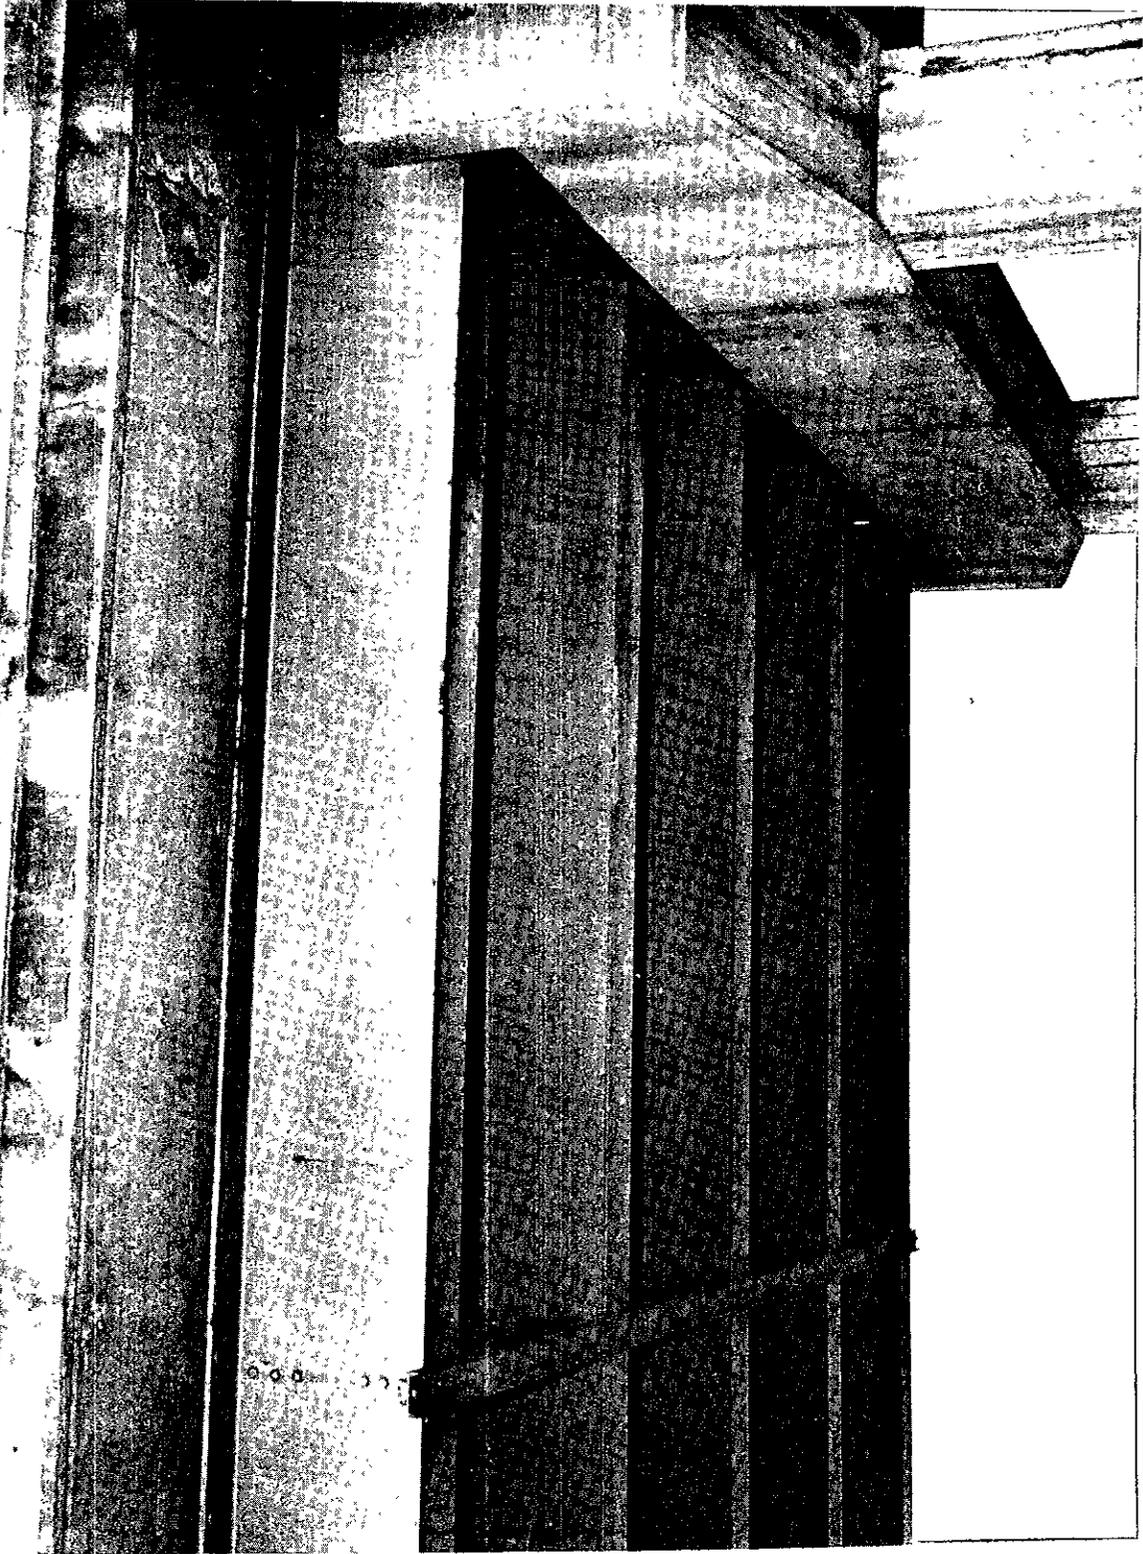
Photograph No. 20. San Simeon Creek Bridge. Span 2, Section 1.
4 mils Basic Lead Silico Chromate, Federal Specification TT-P-00615a,
Type I, and 2 mils Phenolic Iridescent Green, State Specification
58-G-79. Painted June-October 1959 - Photographed March 3, 1964.

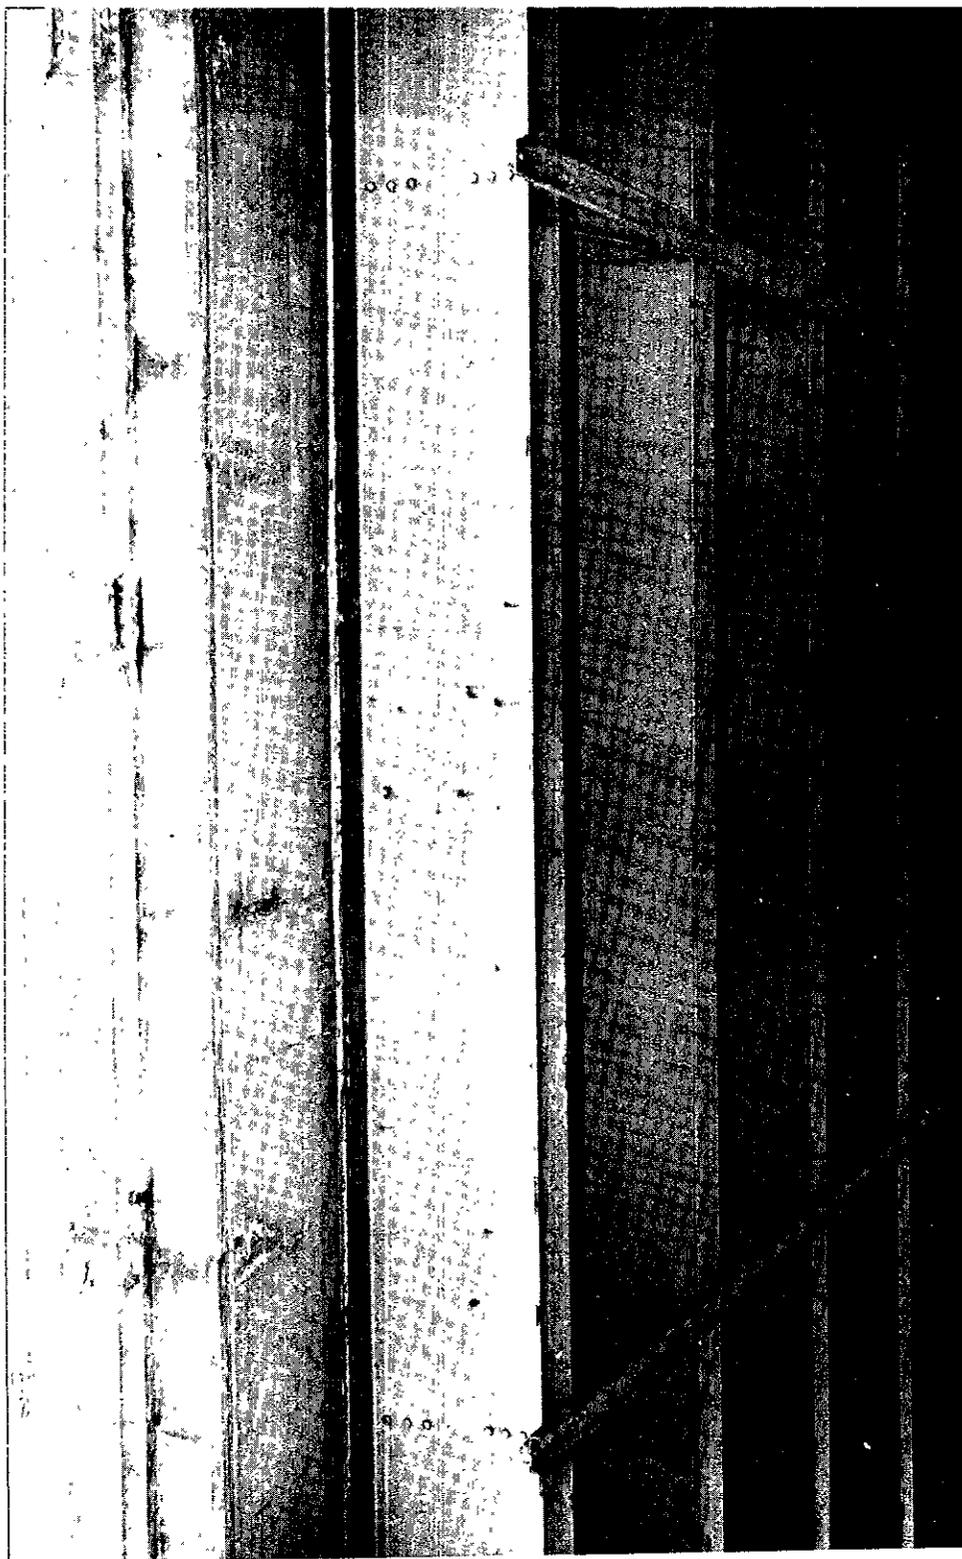
Photograph No. 21. San Simeon Creek Bridge. Span 2, Section 2.
4 mils Basic Lead Silico Chromate, Federal Specification TT-P-00615a,
Type I, and 2 mils Phenolic Iridescent Green, State Specification
58-G-79. Painted June-October 1959 - Photographed March 3, 1964.

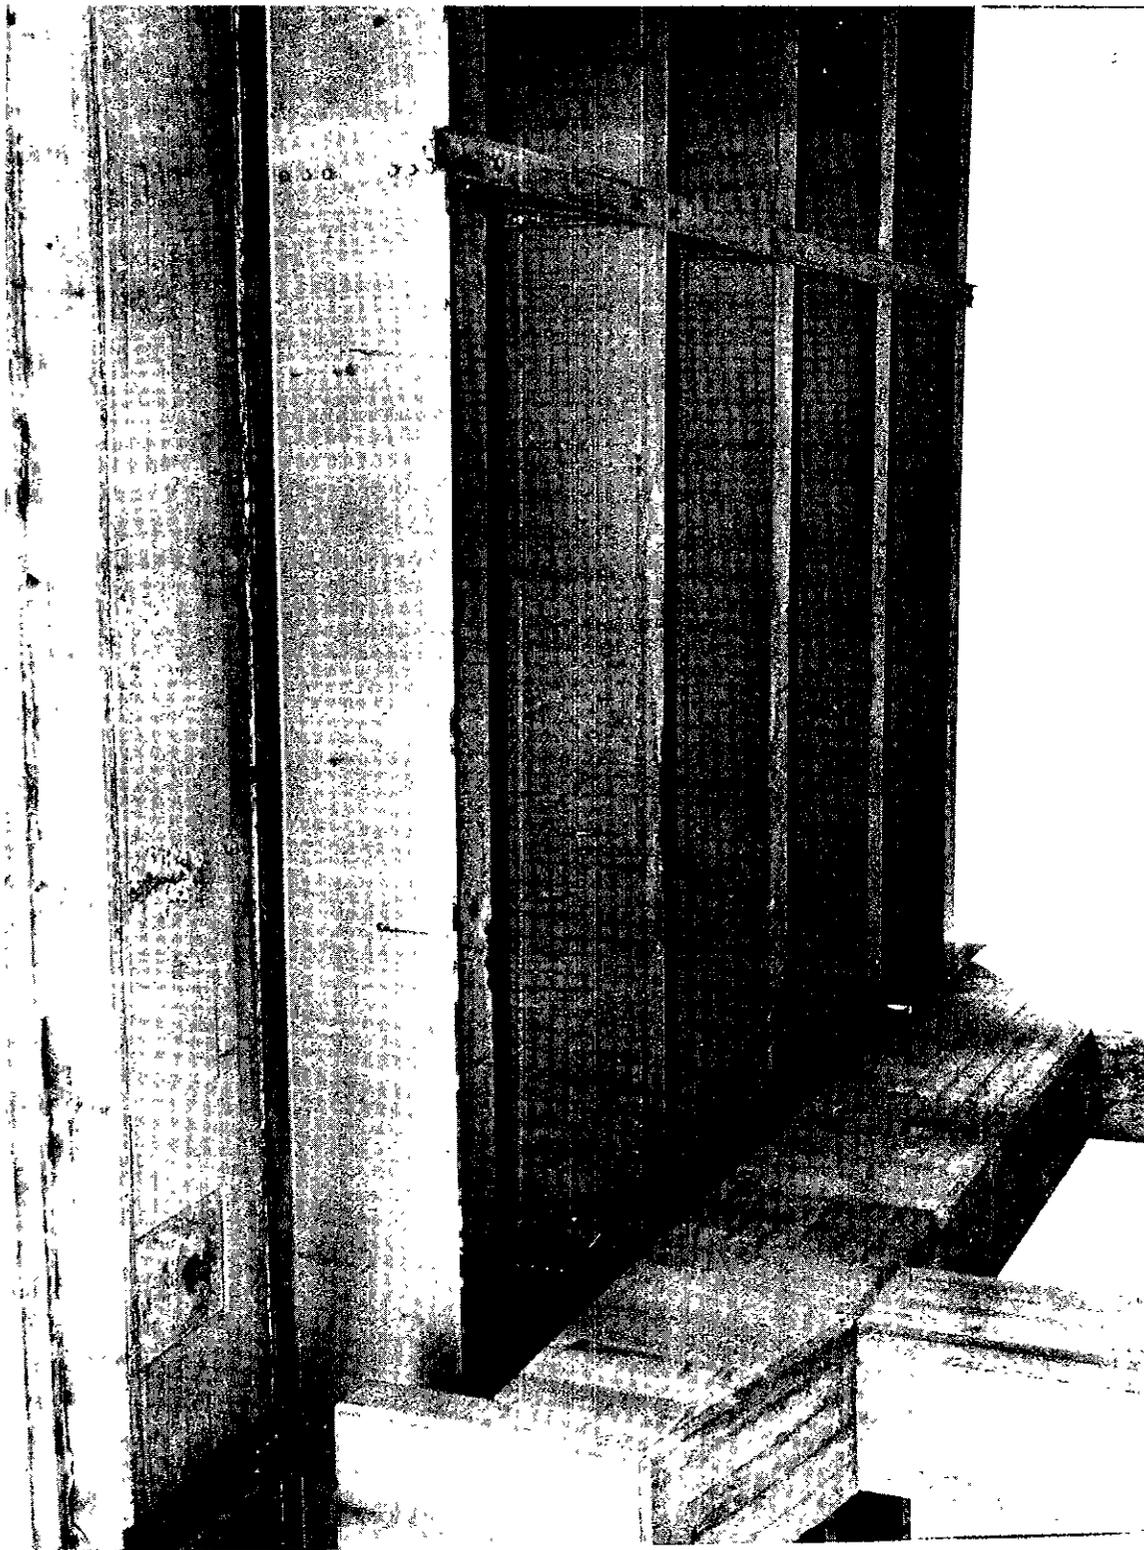
Photograph No. 22. San Simeon Creek Bridge. Span 2, Section 3.
4 mils Basic Lead Silico Chromate, Federal Specification TT-P-00615a,
Type I, and 2 mils Phenolic Iridescent Green, State Specification
58-G-79. Painted June-October 1959 - Photographed March 3, 1964.

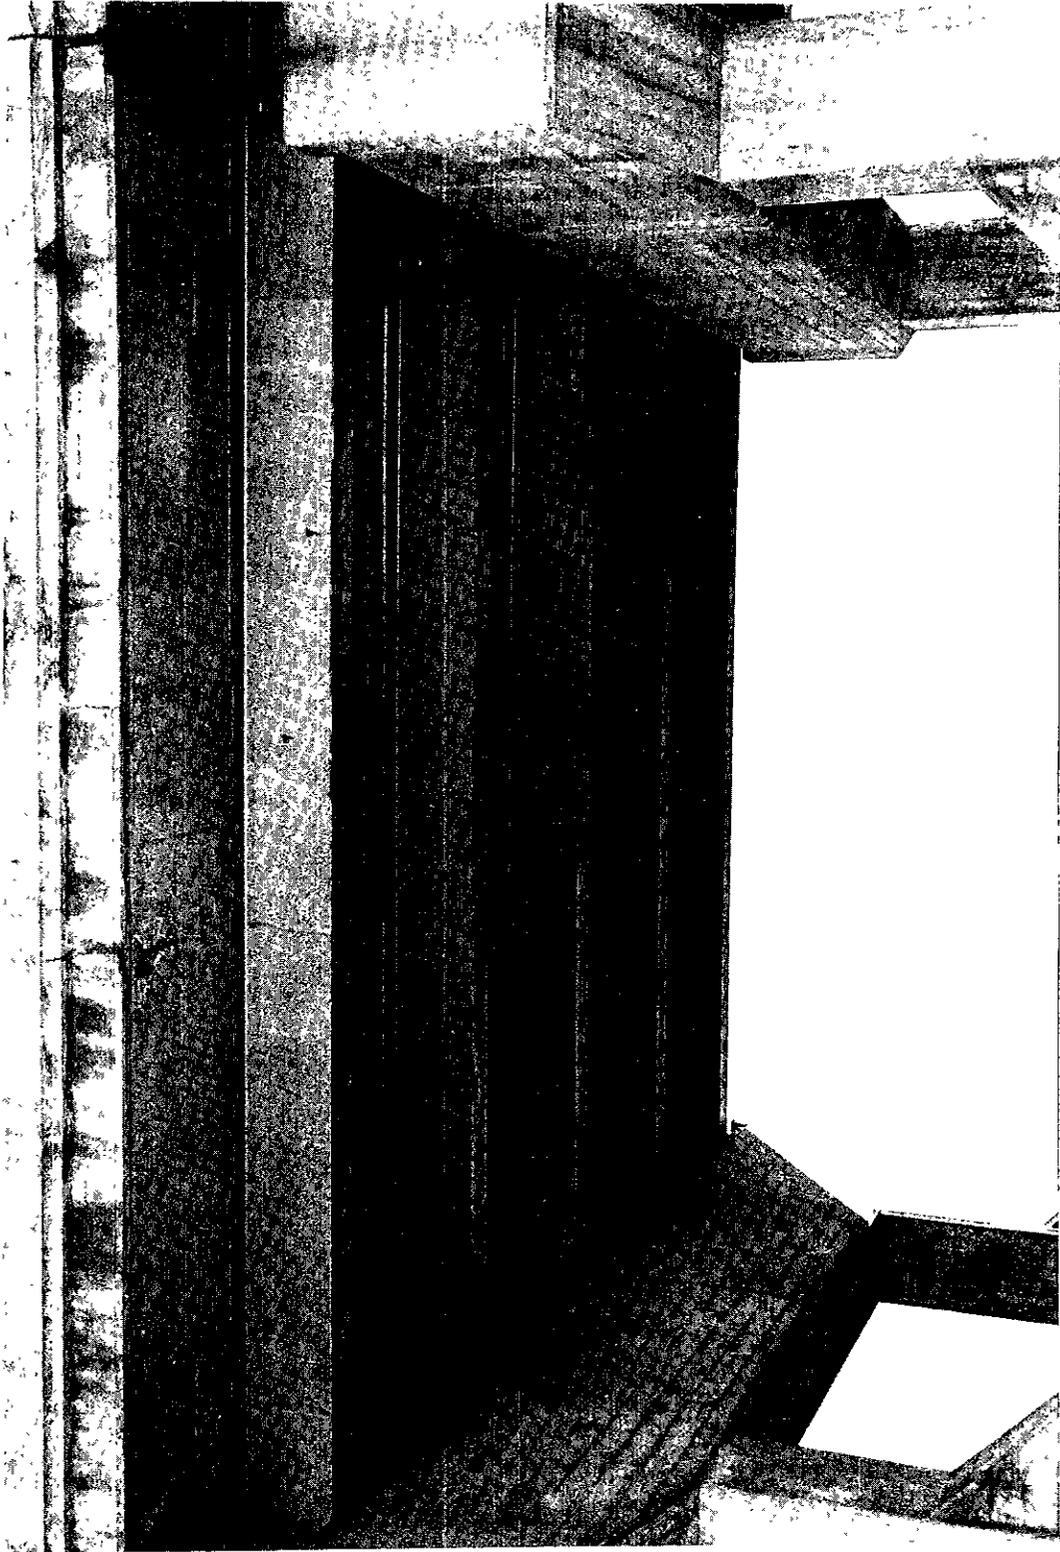
Photograph No. 23. San Simeon Creek Bridge. Span 3. 4 mils Basic Lead Silico Chromate, Federal Specification TT-P-00615a, Type I, and 2 mils Phenolic Iridescent Green, State Specification 58-G-79. Painted June-October 1959 - Photographed March 3, 1964.
