A Study of Various Paint Systems Applied to Leffingwell and San Simeon Creek Bridges in a Corrosive Marine Atmosphere

April 1964

State of California
Department of Public Works
Division of Highways
Materials and Research Department

Progress Report

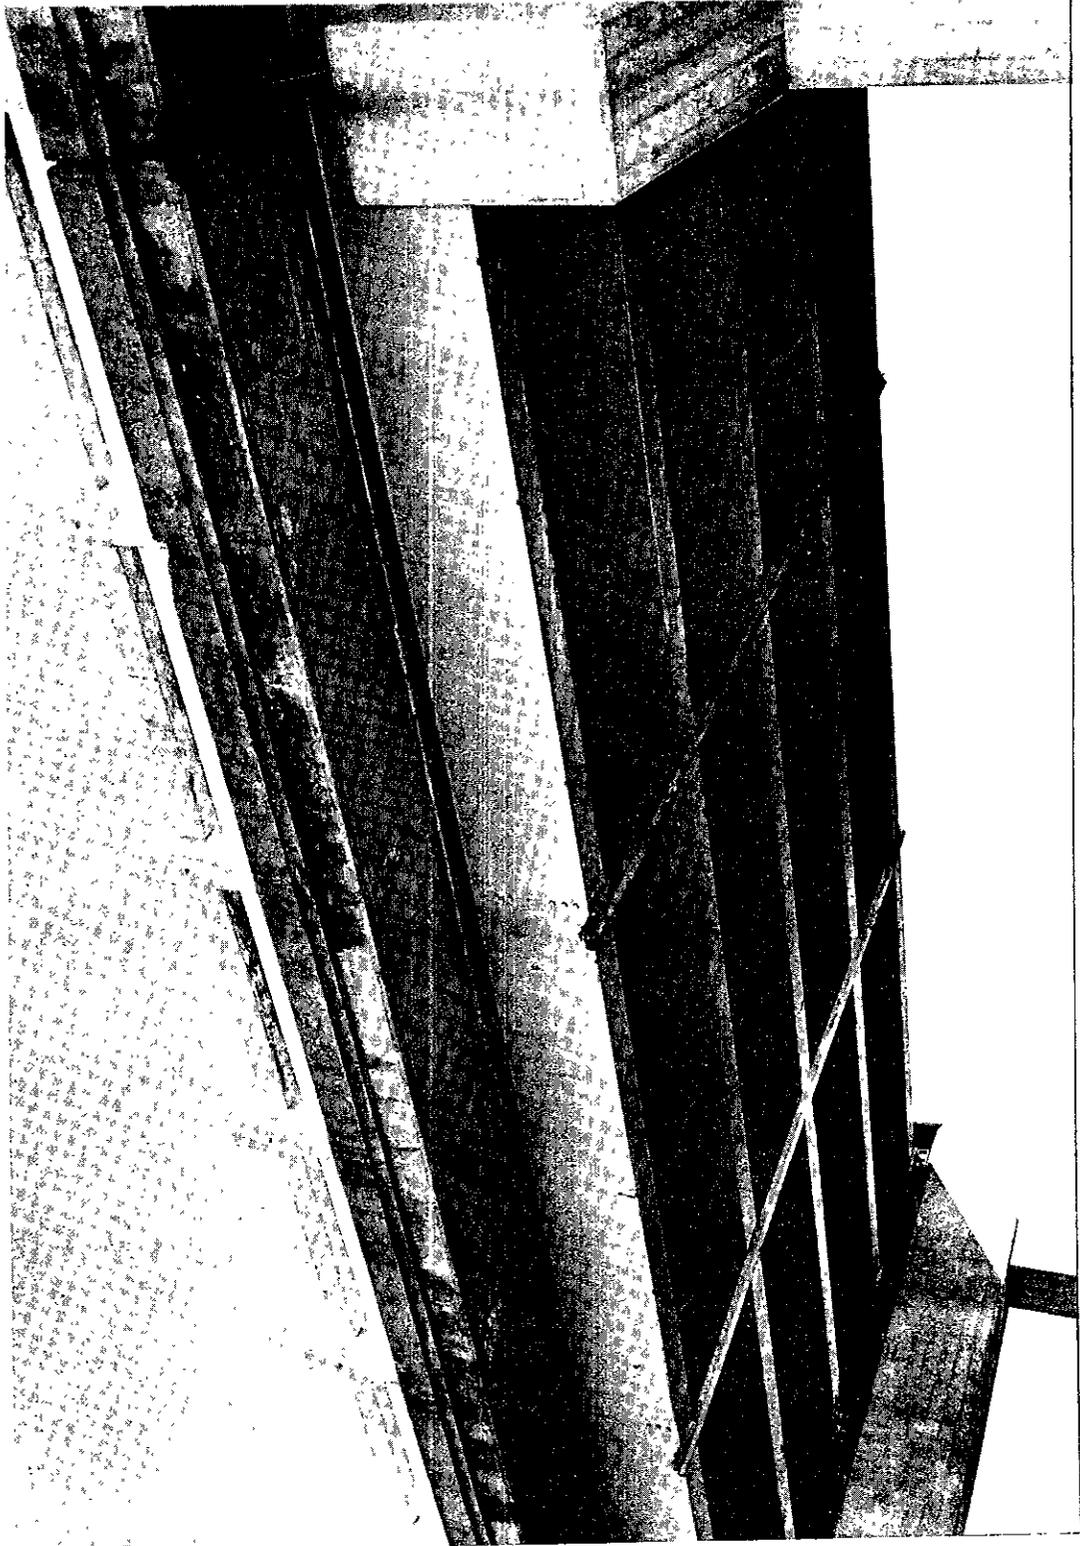
Photograph No. 24. San Simeon Creek Bridge. Span 4. 4 mils Red Lead Primer, State Specification 58-G-53, and 2 mils Phenolic Iridescent Green, State Specification 58-G-79. Painted June-October 1959 - Photographed March 3, 1964.

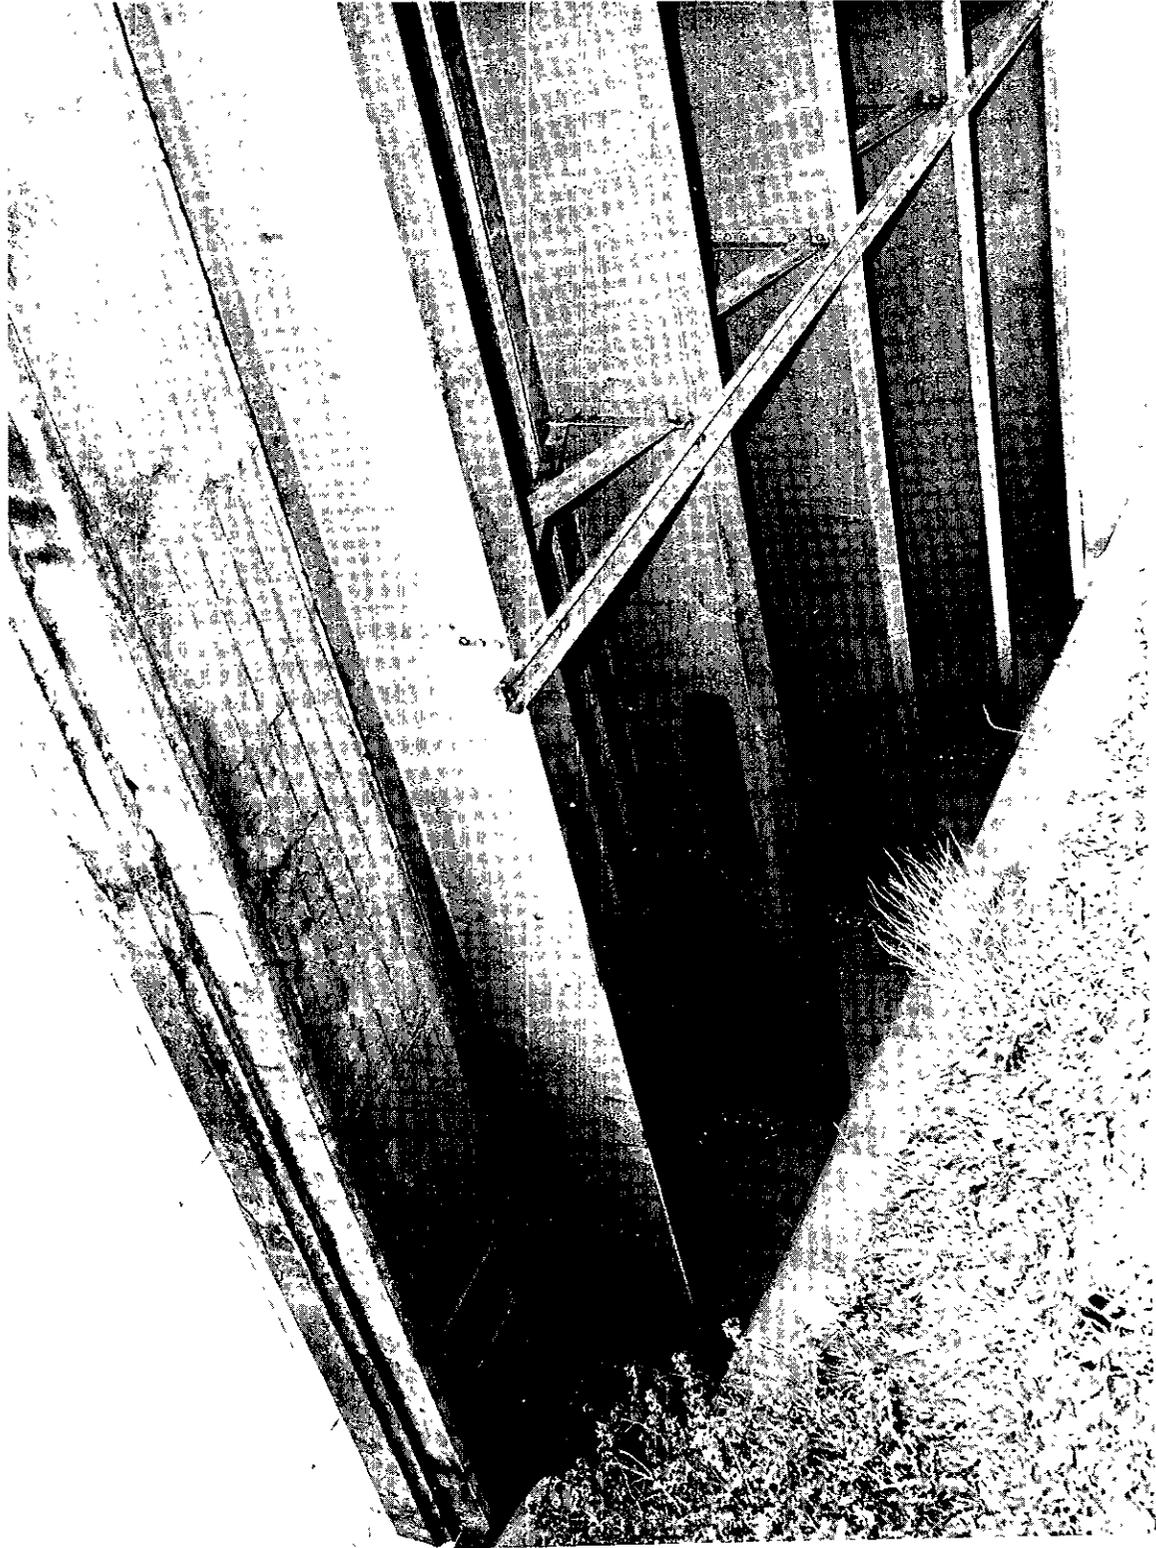
Photograph No. 25. San Simeon Creek Bridge. North End Abutment Span. 4 mils Red Lead Primer, State Specification 58-G-53, and 2 mils Phenolic Iridescent Green, State Specification 58-G-79. Painted June-October 1959 - Photographed March 3, 1964.

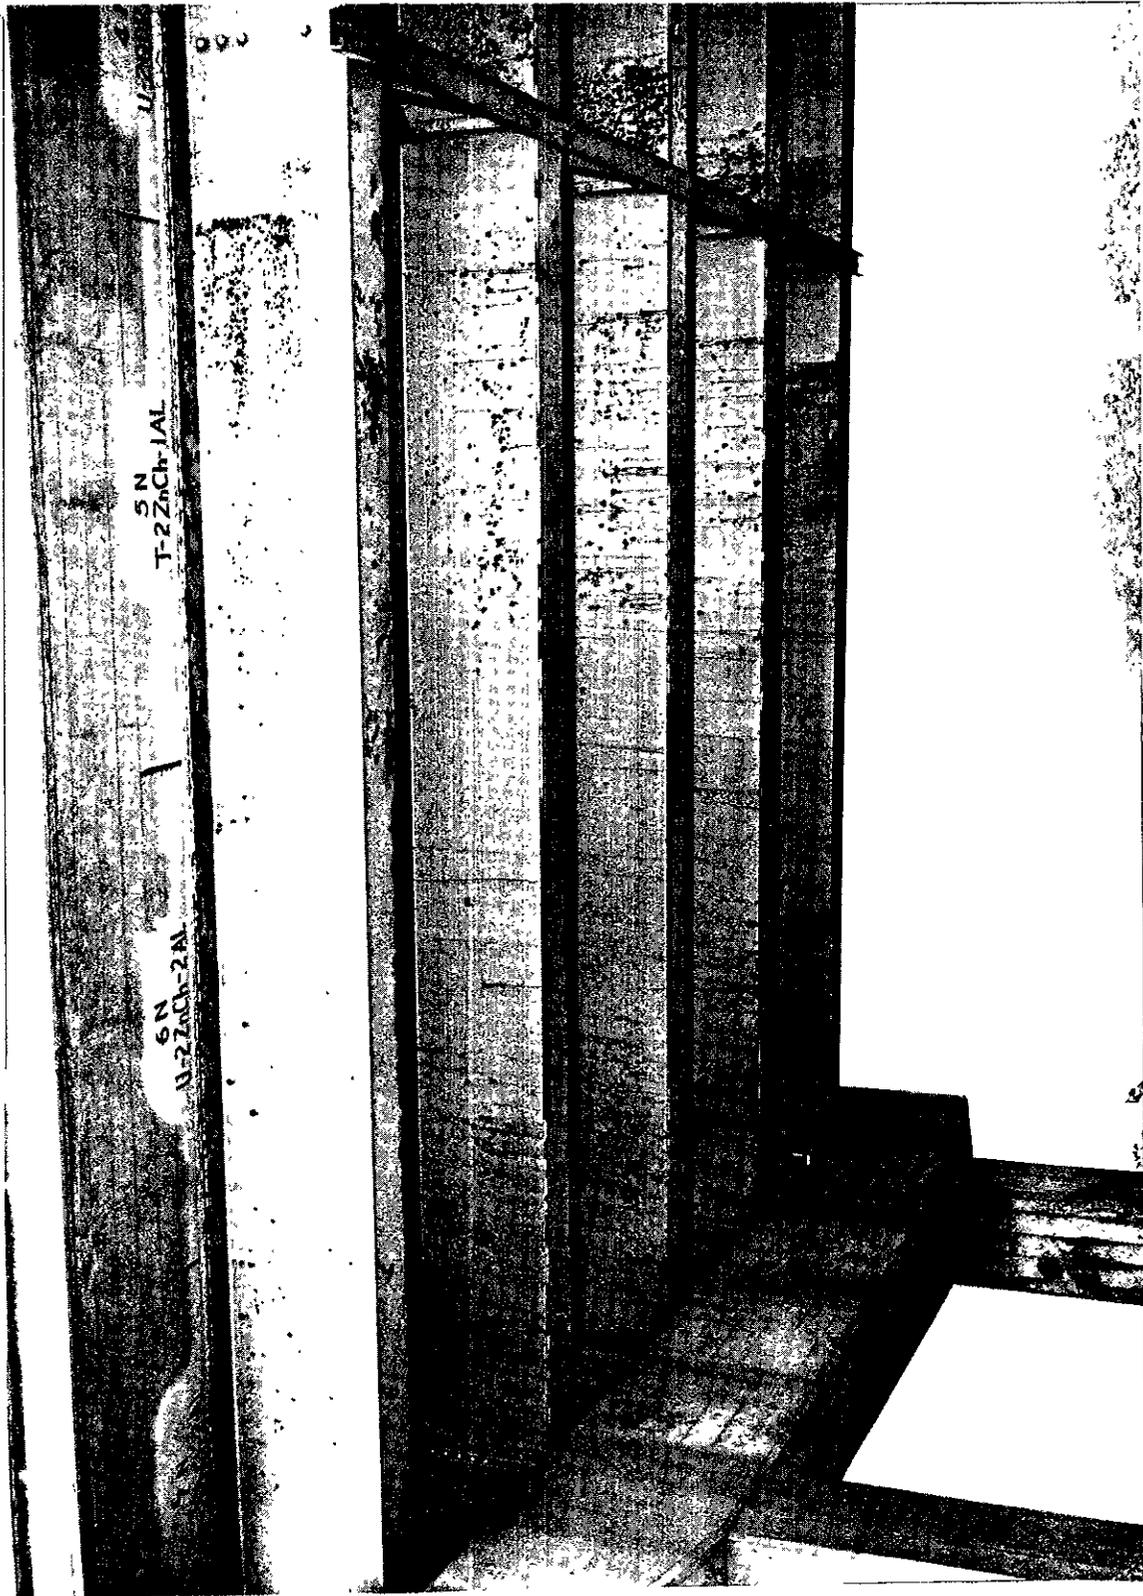
Photograph No. 26. Condition of the average paint system applied to Leffingwell Creek Bridge in 1952 as of October 1958.

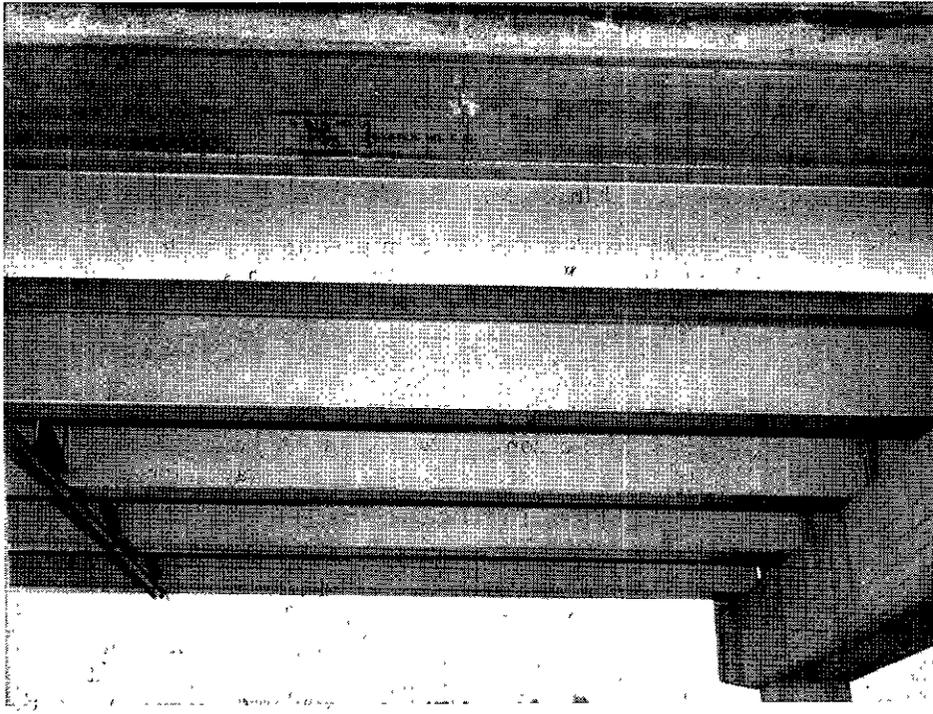
FIGURE 3—Under view of the south portion of Span 2 on which Painting System No. 1 was used.

As of the date of May 10, 1961, the best system appeared to be No. 1 (Figure 3), the inorganic chemically cured zinc coating with the complete

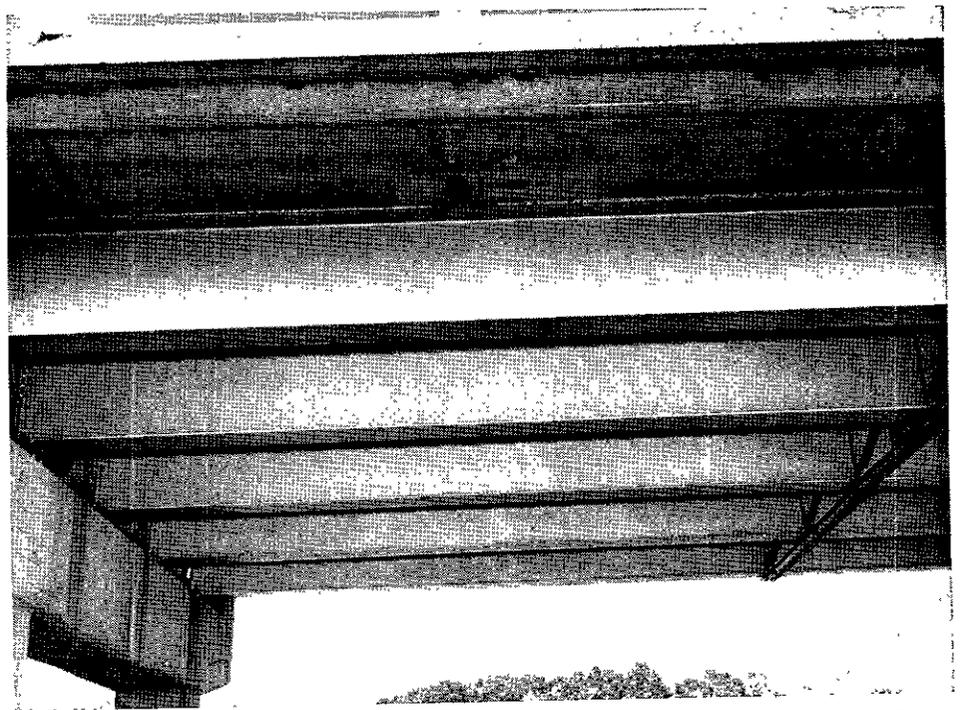
FIGURE 4—Under view of the north portion of Span 2 on which Painting System No. 2 was used.

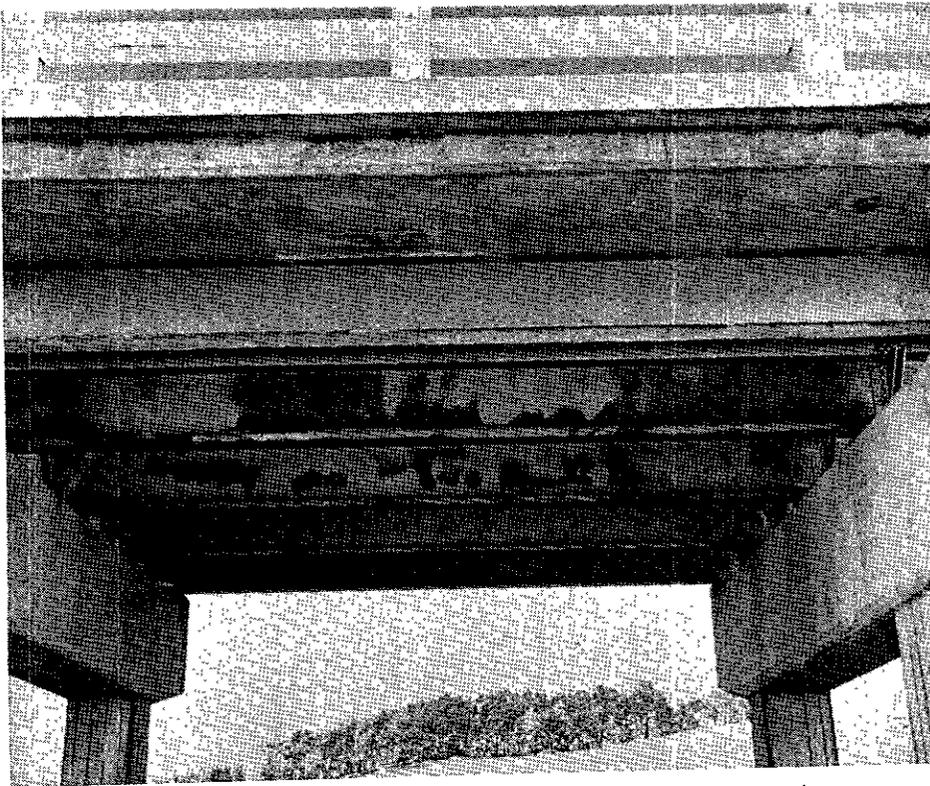
vinyl System No. 4 (Figure 6) almost equivalent to System No. 1 in durability. The greatest failure occurred in the 100% solids epoxy coating represented by System No. 3 and as shown in Figure No. 5. It may be of significance that the application of System No. 3 was not preceded by a vinyl wash treatment. It has not been customary to use this treatment in advance of epoxy coatings.

This report is a progress report and no definite conclusions, other than the complete failure of the epoxy coating represented by System No. 3, can be drawn for another two or three years.

FIGURE 5—Under view of Span 3 on which Painting System No. 3 was used.

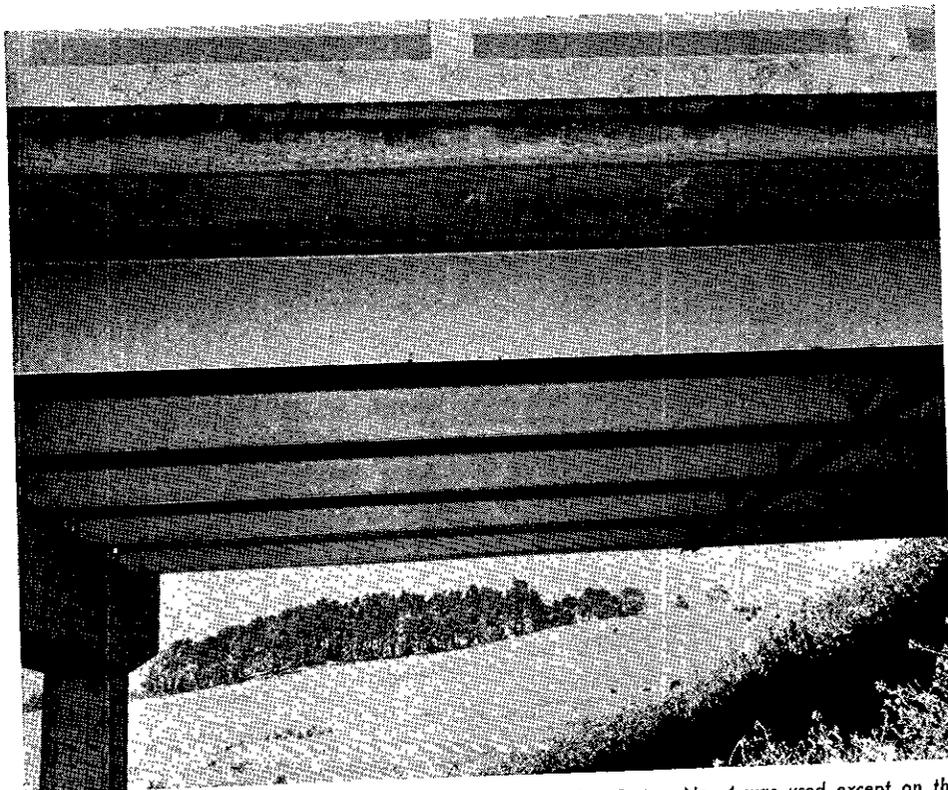
FIGURE 6—Under view of the north portion of Span 1. Painting System No. 4 was used except on the stringer in the foreground on which System No. 5 was used.

A rating of System No. 5 is not justified because of the relatively small area to which this system was applied.
