Study of Lime Treated Sections On Road 10-SJ-580, 132

February 1968

Study of Lime Treated Sections on Road 10-SJ-580,132

NEAR TRACY, CALIFORNIA

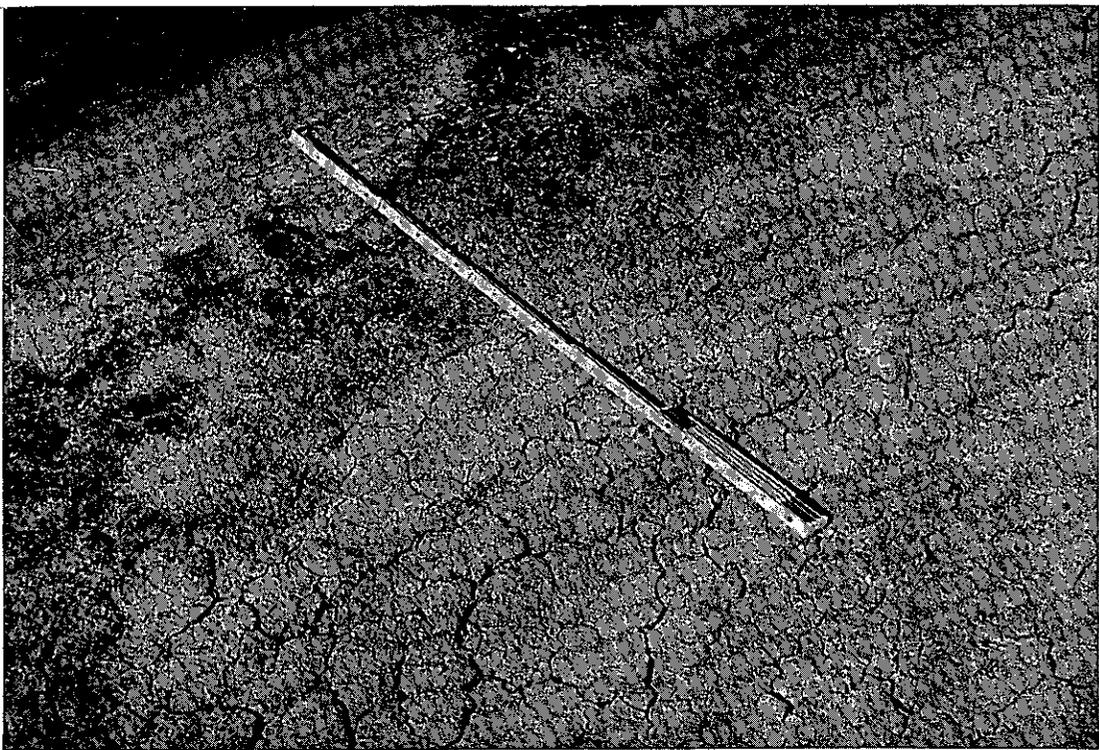
FIGURE 3B

The cracking was probably due to drying and consequent shrinking of the lime treated material. As a comparison, Figure 3B shows cracking in the native soil. The extensive cracks indicate the clayey nature of the soil. The northbound lanes were also treated with 4% lime at a moisture content of about 32%. It was not known if this section also cracked since the subbase layer was placed shortly after the lime treatment. This work was performed during March, 1965.

Crack pattern in the untreated soil along the shoulder.

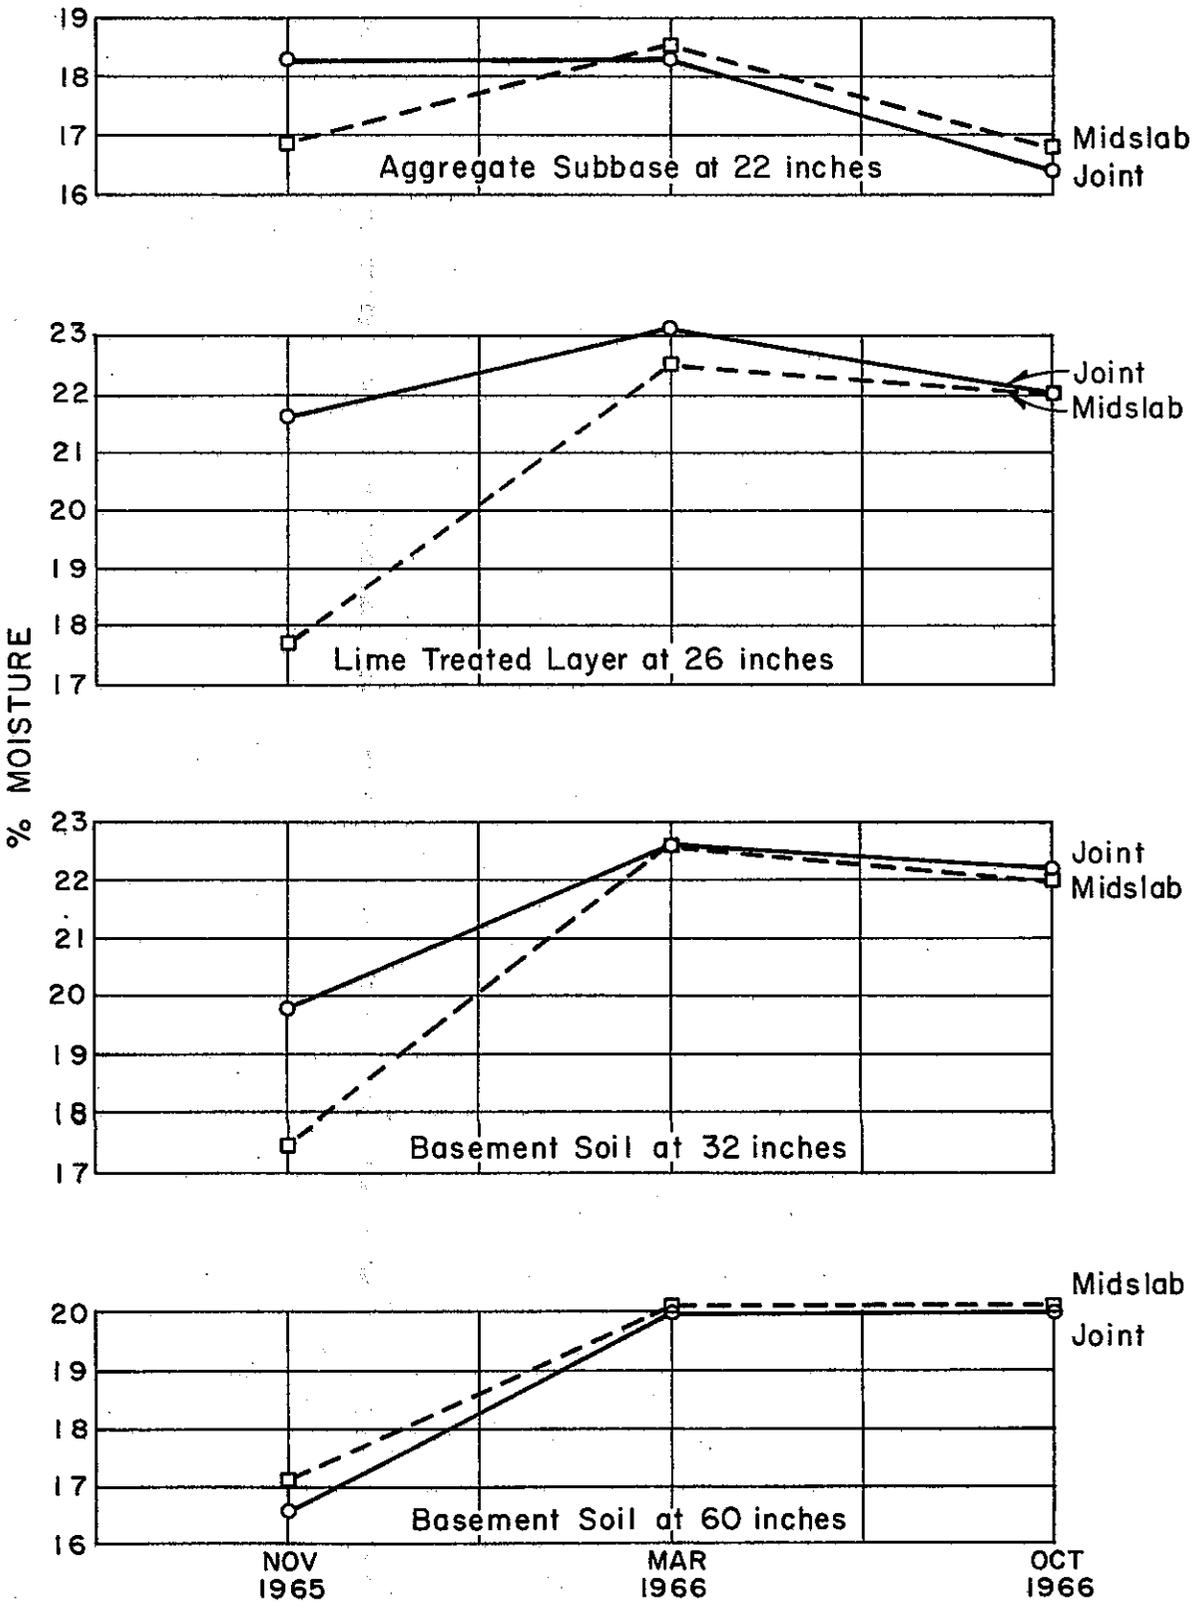
Figure 6

1. The aggregate subbase in the lime treated section (Figure 6) shows a much higher moisture content than in the untreated control sections (Figures 7 and 8). This indicates that the lime treated layer is acting as an effective moisture barrier and preventing the surface water from entering the basement soil.

3. The basement soil moistures are considerably higher in the lime treated section than in the untreated control section. It is believed that this is due to the moisture vapor condensation phenomena that is occurring under the relatively impermeable lime treated layer. This is a desirable feature of lime treatment since uniform elevation of moisture in the basement soil minimizes PCCP curl or distortion

AVERAGE PERCENT MOISTURE AT 4 LIME TREATED LOCATIONS
30" STRUCTURAL SECTION

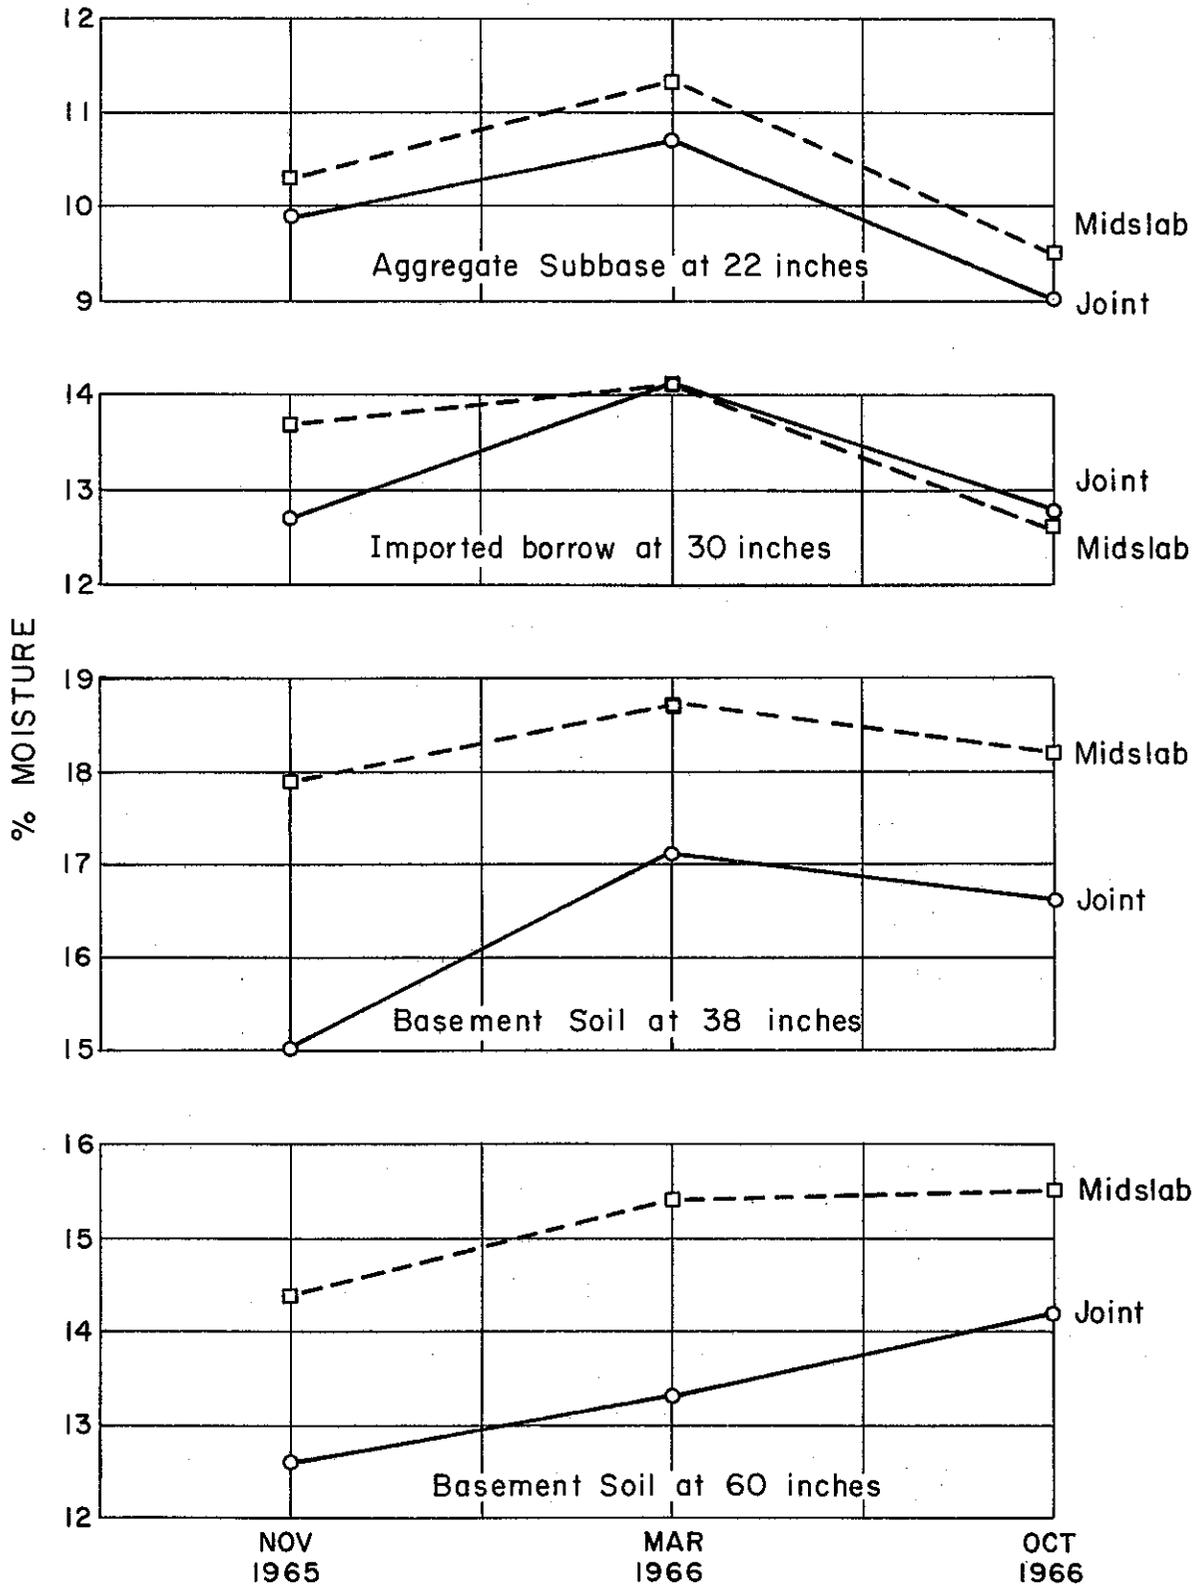
Figure 7

due to differential swelling. This phenomena does not occur in the untreated control sections since there is a 12" permeable layer of aggregate subbase directly over the fine grained imported borrow and basement soil.

AVERAGE PERCENT MOISTURE AT 2 UNTREATED LOCATIONS

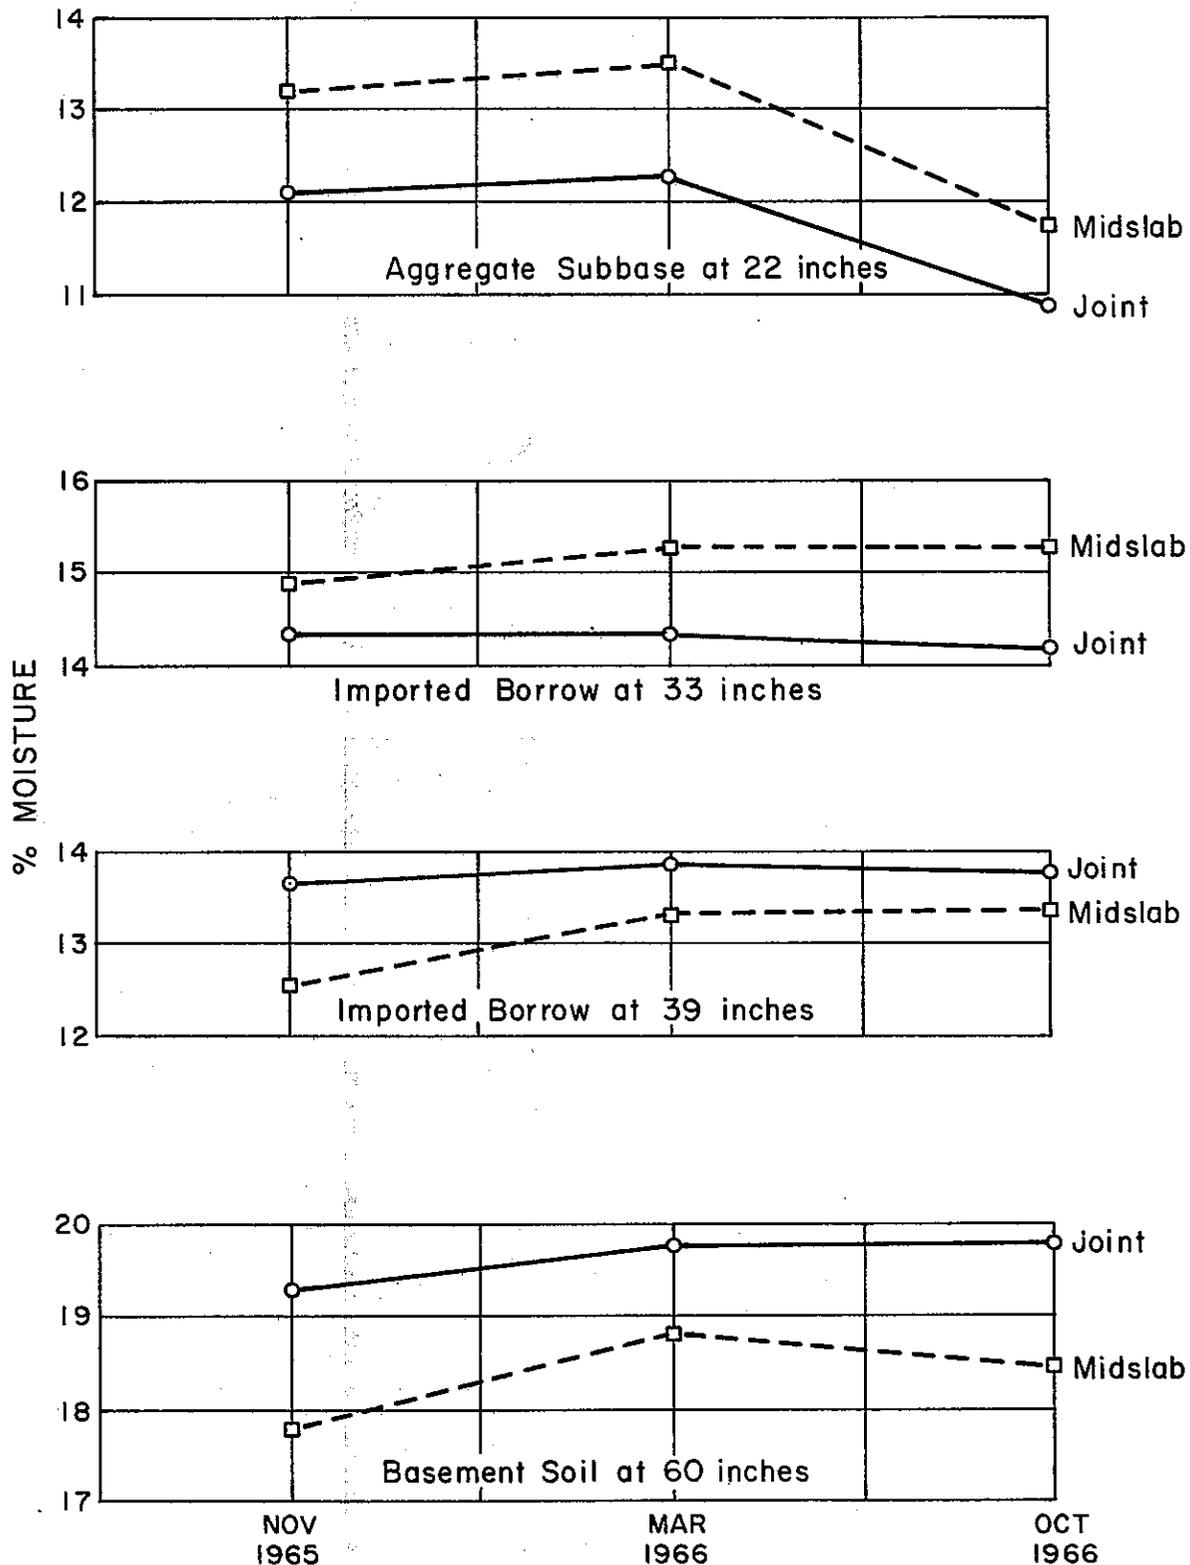
Figure 8

AVERAGE PERCENT MOISTURE AT 2 UNTREATED LOCATIONS 4' CONTROL SECTION

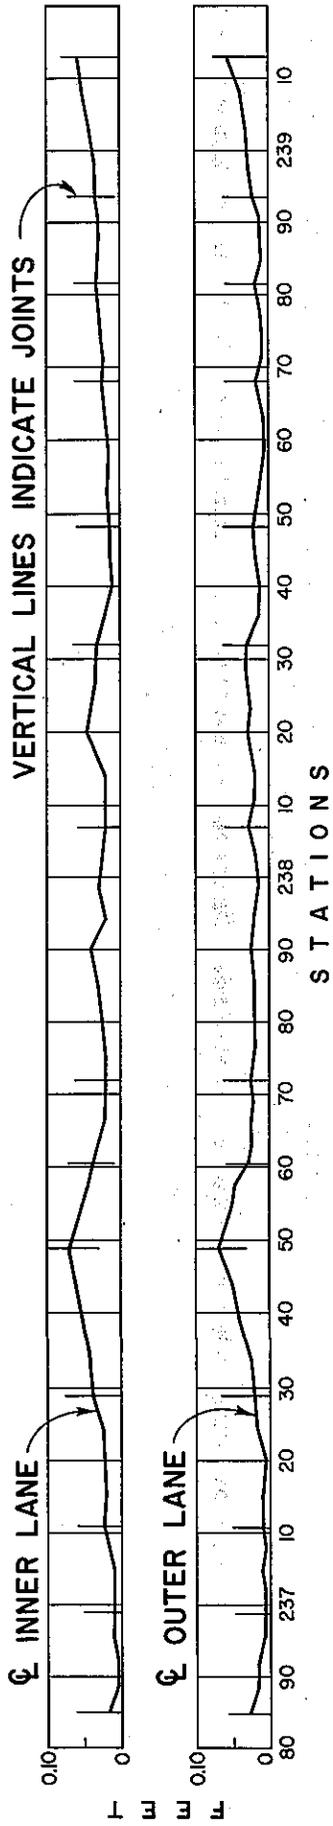
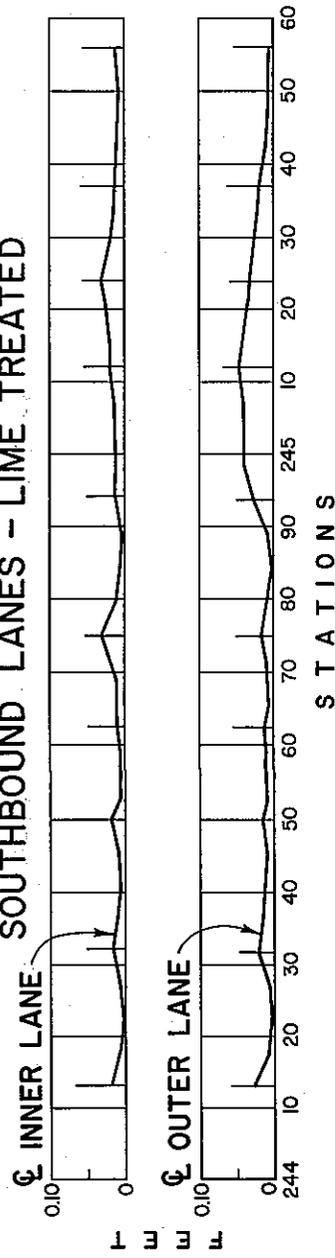
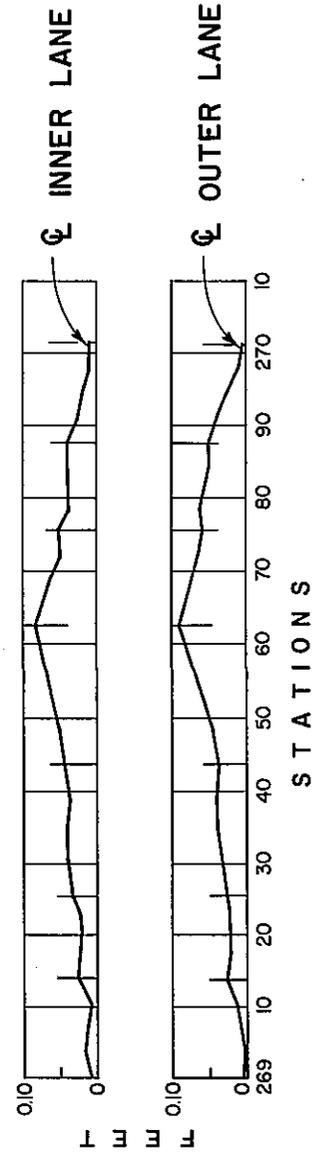
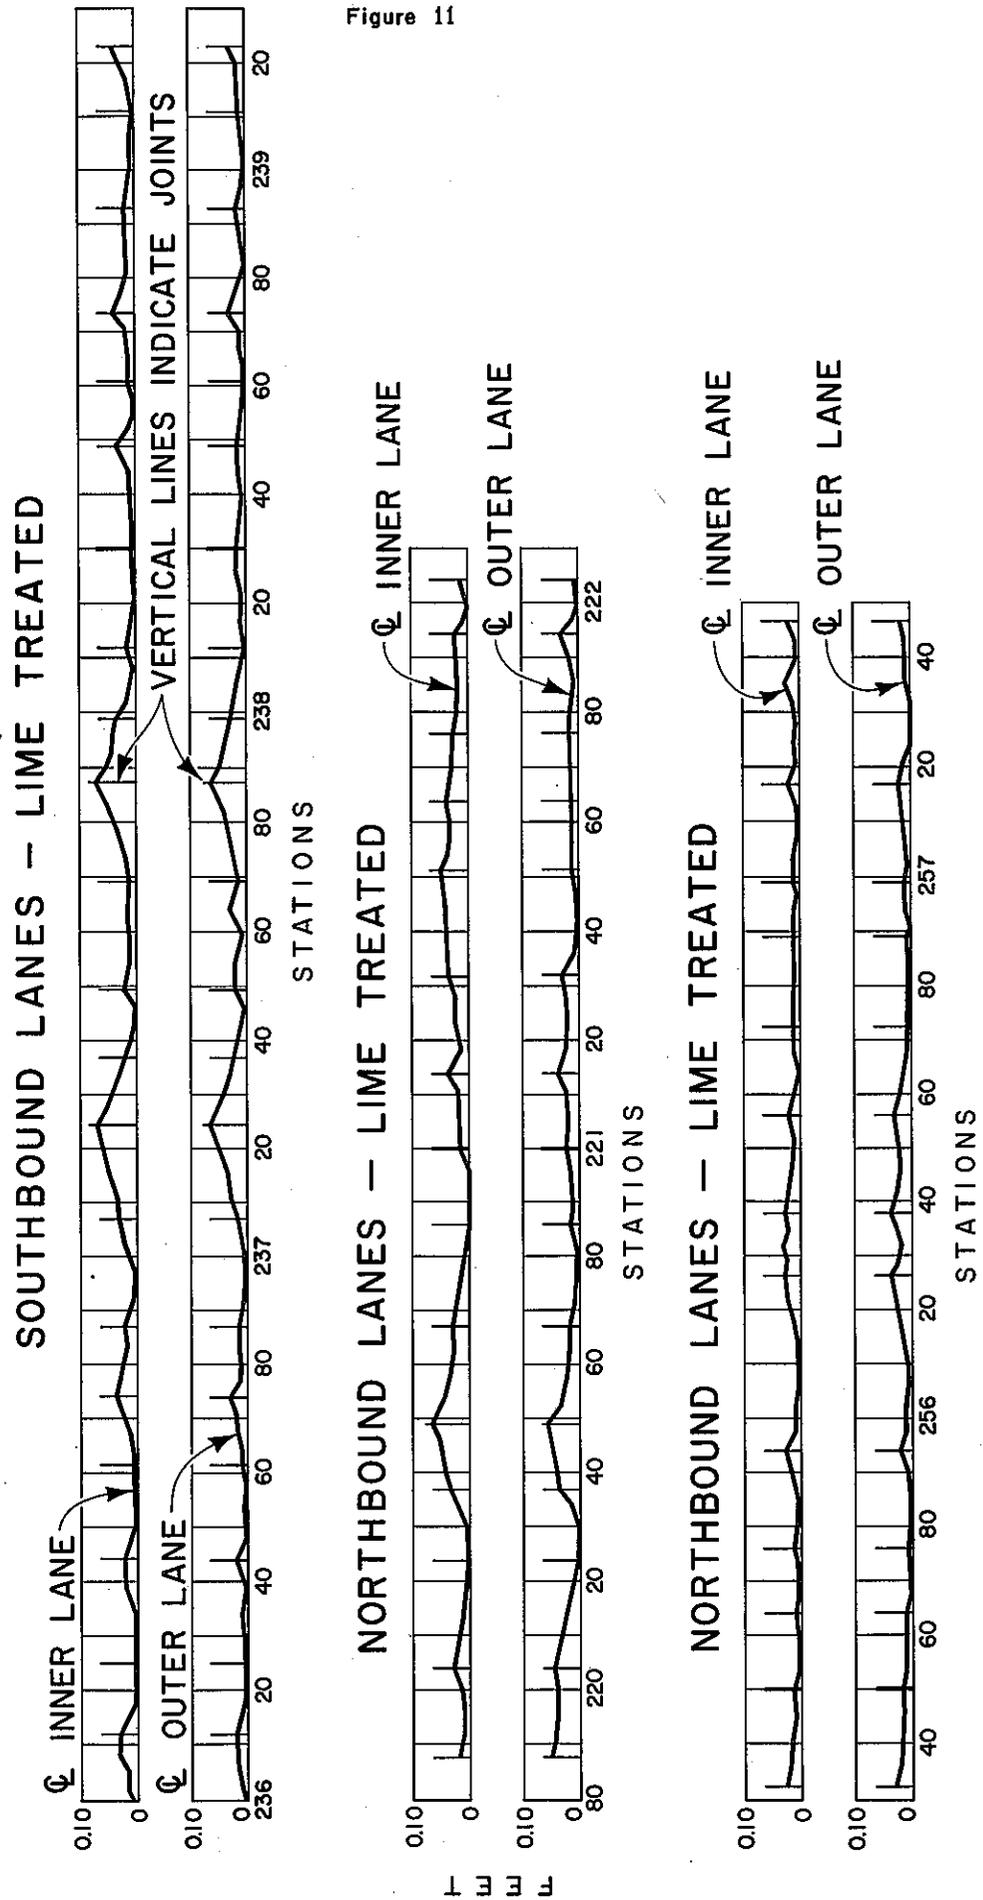
Figure 10

PROFILES FROM ENGINEER'S LEVEL - JULY 1966
