Wind Screen Subdues Gale Force Winds On A Mountain Bridge

Nordlin, Eric F. and Bourget, Louis

State of California
Department of Public Works
Division of Highways
Materials and Research Department

Interim Report

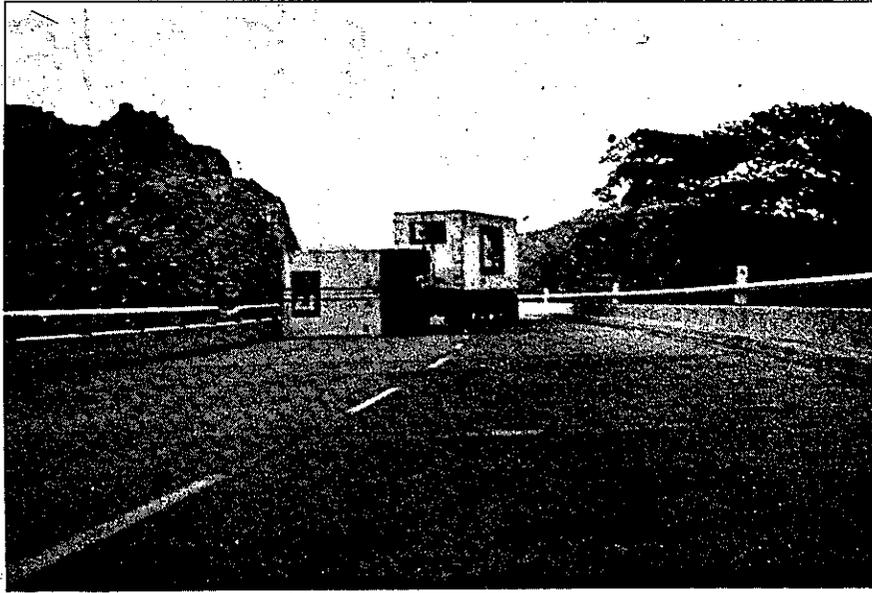
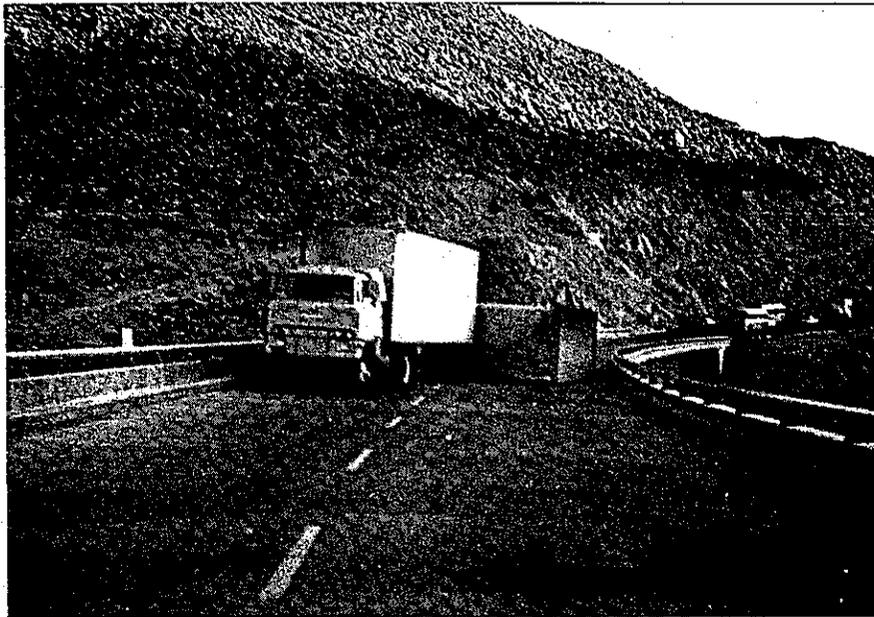
The two-way use of the westbound lanes began in December 1963 and continued while a few comments of strong but sporadic westwinds came in from various sources. These comments were dramatically verified on April 2, 1964, when two truck and trailer combinations traveling in the westbound lane had their trailers overturned on Devils Canyon Bridge No. 1, between 0130 and 0230 in the morning (Figures 2 and 3). This bridge runs from north to south, and west winds are at normal incidence. The bridge was completely blocked by the overturned vehicles in two separate places and all traffic was halted for over 10 hours. Fortunately, there were no human injuries, and the California Highway Patrol was able to prevent any collisions with the trucks and trailers. The portent of accidents of greater severity was very clear. Either a collision or crushing accident could have occurred had any other vehicles been in the eastbound lane. Had the trucks been traveling in the eastbound lane, the trailers would likely have toppled over the barrier rail. After this accident, the California Division of Highways and the California Highway Patrol jointly assumed the responsibility to restrict truck and camper traffic during too frequent periods of high winds.

FIG. 2 TWO LARGE TRUCK TRAILERS BLOWN OVER WITHIN
30 MINUTES. 0145 AND 0215, APRIL 2, 1964.

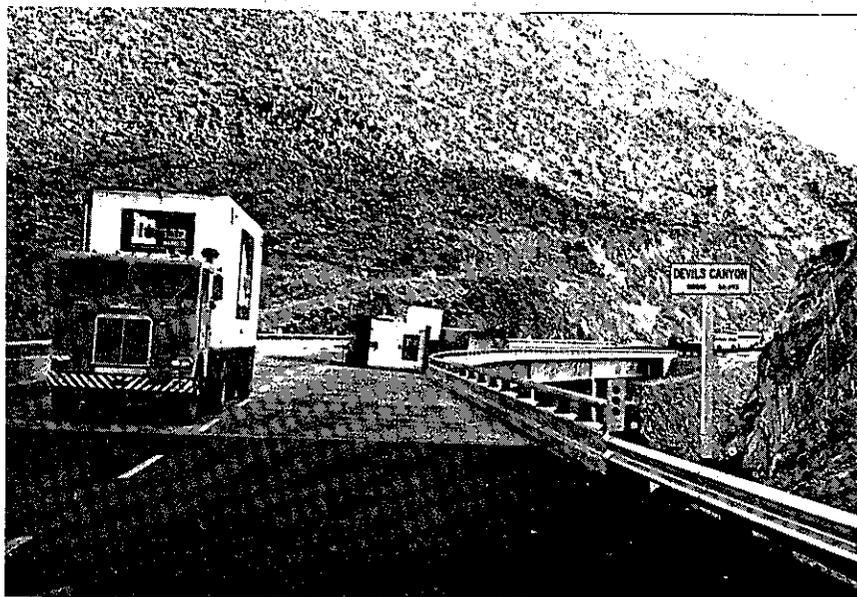
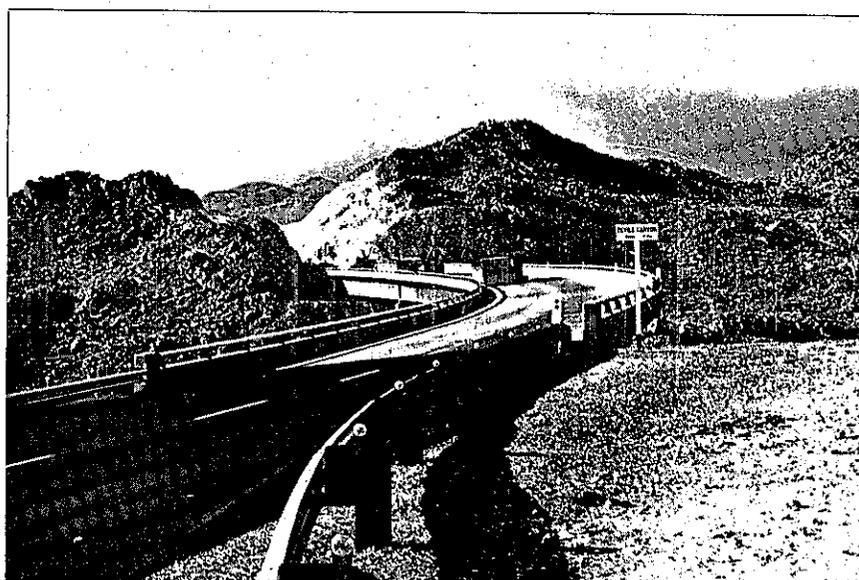
FIG. 3 THE HIGHWAY WAS CLOSED FOR MORE THAN 10 HOURS

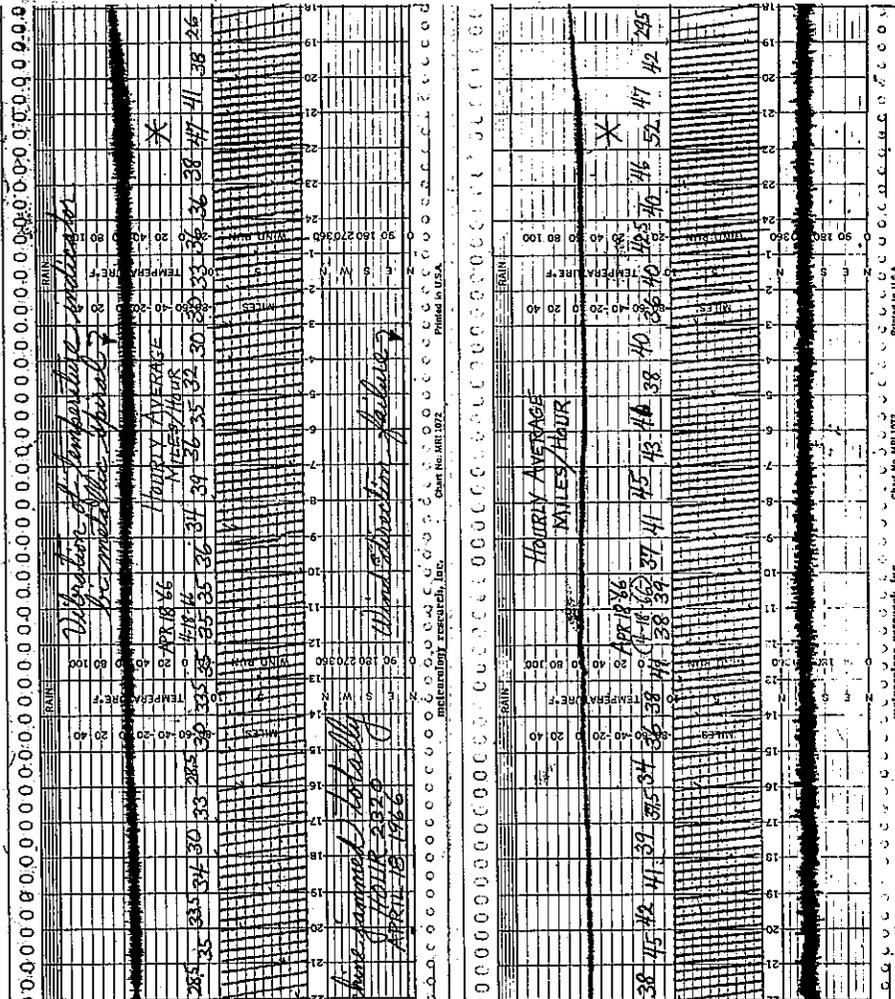
FIGURE 10 WIND CHART SAMPLES - BEFORE WIND SCREEN

The following Table 1 summarizes the predominant west cross-wind data recorded at the two instrumentation locations during the recording period prior to installation of the wind screen along the west side of the bridge. Figure 10 shows chart samples from the wind measuring instruments at the two locations prior to the wind screen installation.

BEFORE WIND SCREEN
 9' ABOVE DECK
 21 TO 47 MPH
 WEST WINDS

FREE WINDS
 40' BELOW BRIDGE
 28.5 TO 52 MPH
 WEST WINDS

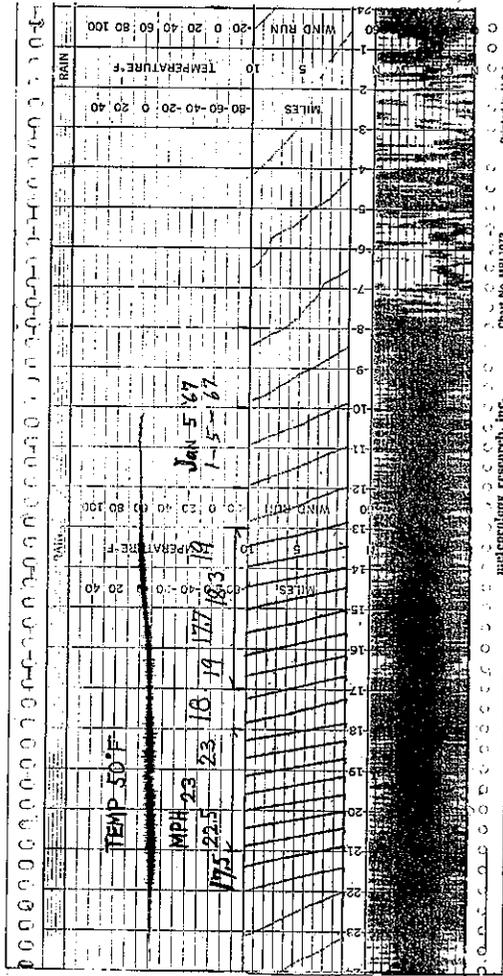
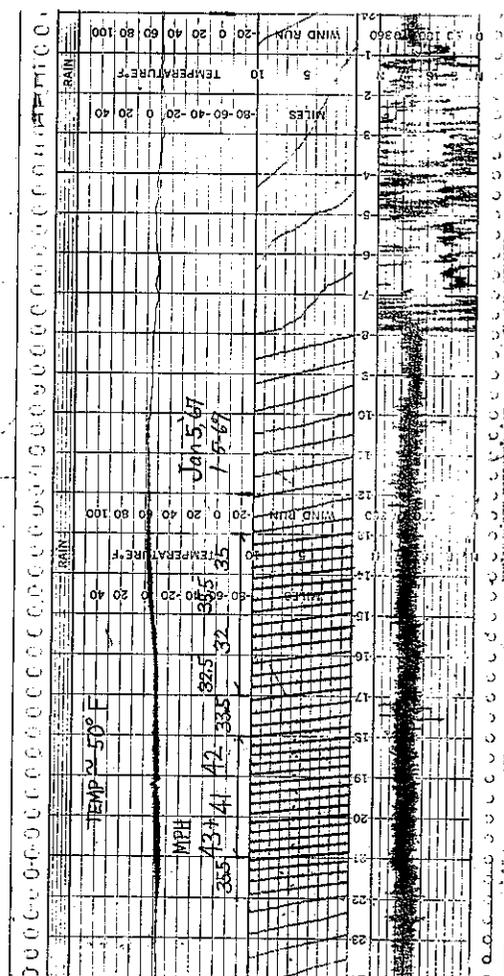
FIGURE 11 WIND CHART SAMPLES -- AFTER WIND SCREEN

Some salient comments must be made before reporting the wind data obtained after the wind screen was installed. The crosswinds are no longer measurable on the bridge due to some low velocity south head winds that now find a protected path behind the wind screen for the full length of the bridge. The south head winds have replaced the damaging west crosswinds as the predominant wind on the bridge. The highest head wind velocity measured over a 6 month period was an hourly average of 23 mph. The crosswind that filters through the screen is completely turned within one inch of the screen surface and merges with the head wind. It is estimated that the screen is reducing the crosswind to about 0.35 of the free west wind velocity. A comparison of the south head winds on the bridge after erection of the wind screen and the west free winds is shown for informational value in the following Table 2. Figure 11 shows chart samples from the wind measuring instruments at the two locations after the wind screen installation.

AFTER WIND SCREEN
 9' ABOVE DECK
 18 TO 23 MPH
 SOUTH HEADWINDS

FREE WINDS
 40' BELOW BRIDGE
 32 TO 43 MPH
 WEST CROSSWINDS

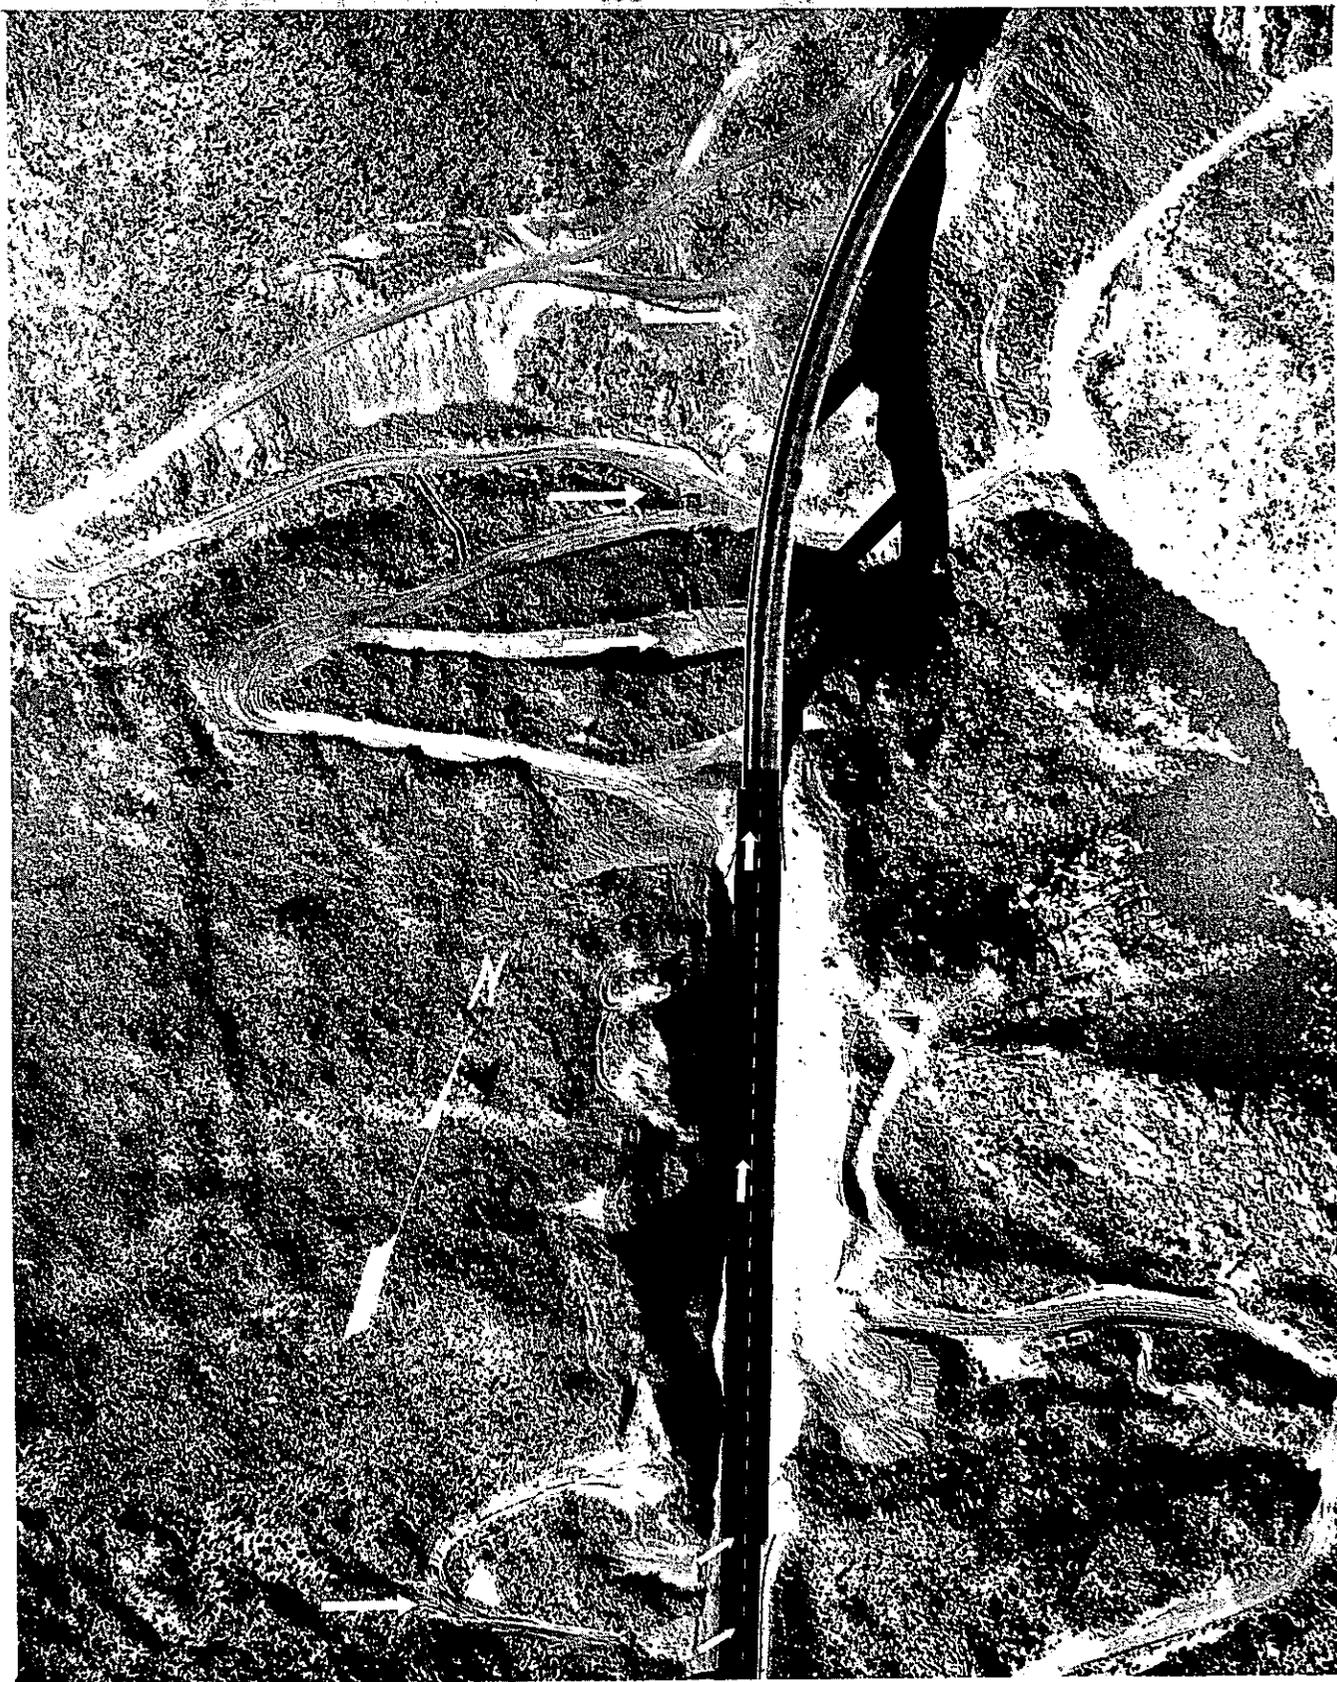
Some of the strong west winds over the entire area find a spillway beyond the south pass of the bridge. The contours of the terrain at this location reduce and deflect the west wind to a half velocity head wind that filters through the south gap traveling north on the bridge (Figure 12). This head wind was readily turned by the predominant west crosswind on the bridge before the screen was installed and no evidence of a head wind appeared on the wind instruments mounted near the center of the bridge (Figure 13). After the screen was installed, the west crosswind was so drastically reduced that the south head wind became the predominant wind measured on the bridge.

FIGURE 12 DIRECT WESTWINDS CAUSE STRONG CROSSWINDS
DEFLECTED WESTWINDS CAUSE LESSER HEADWINDS

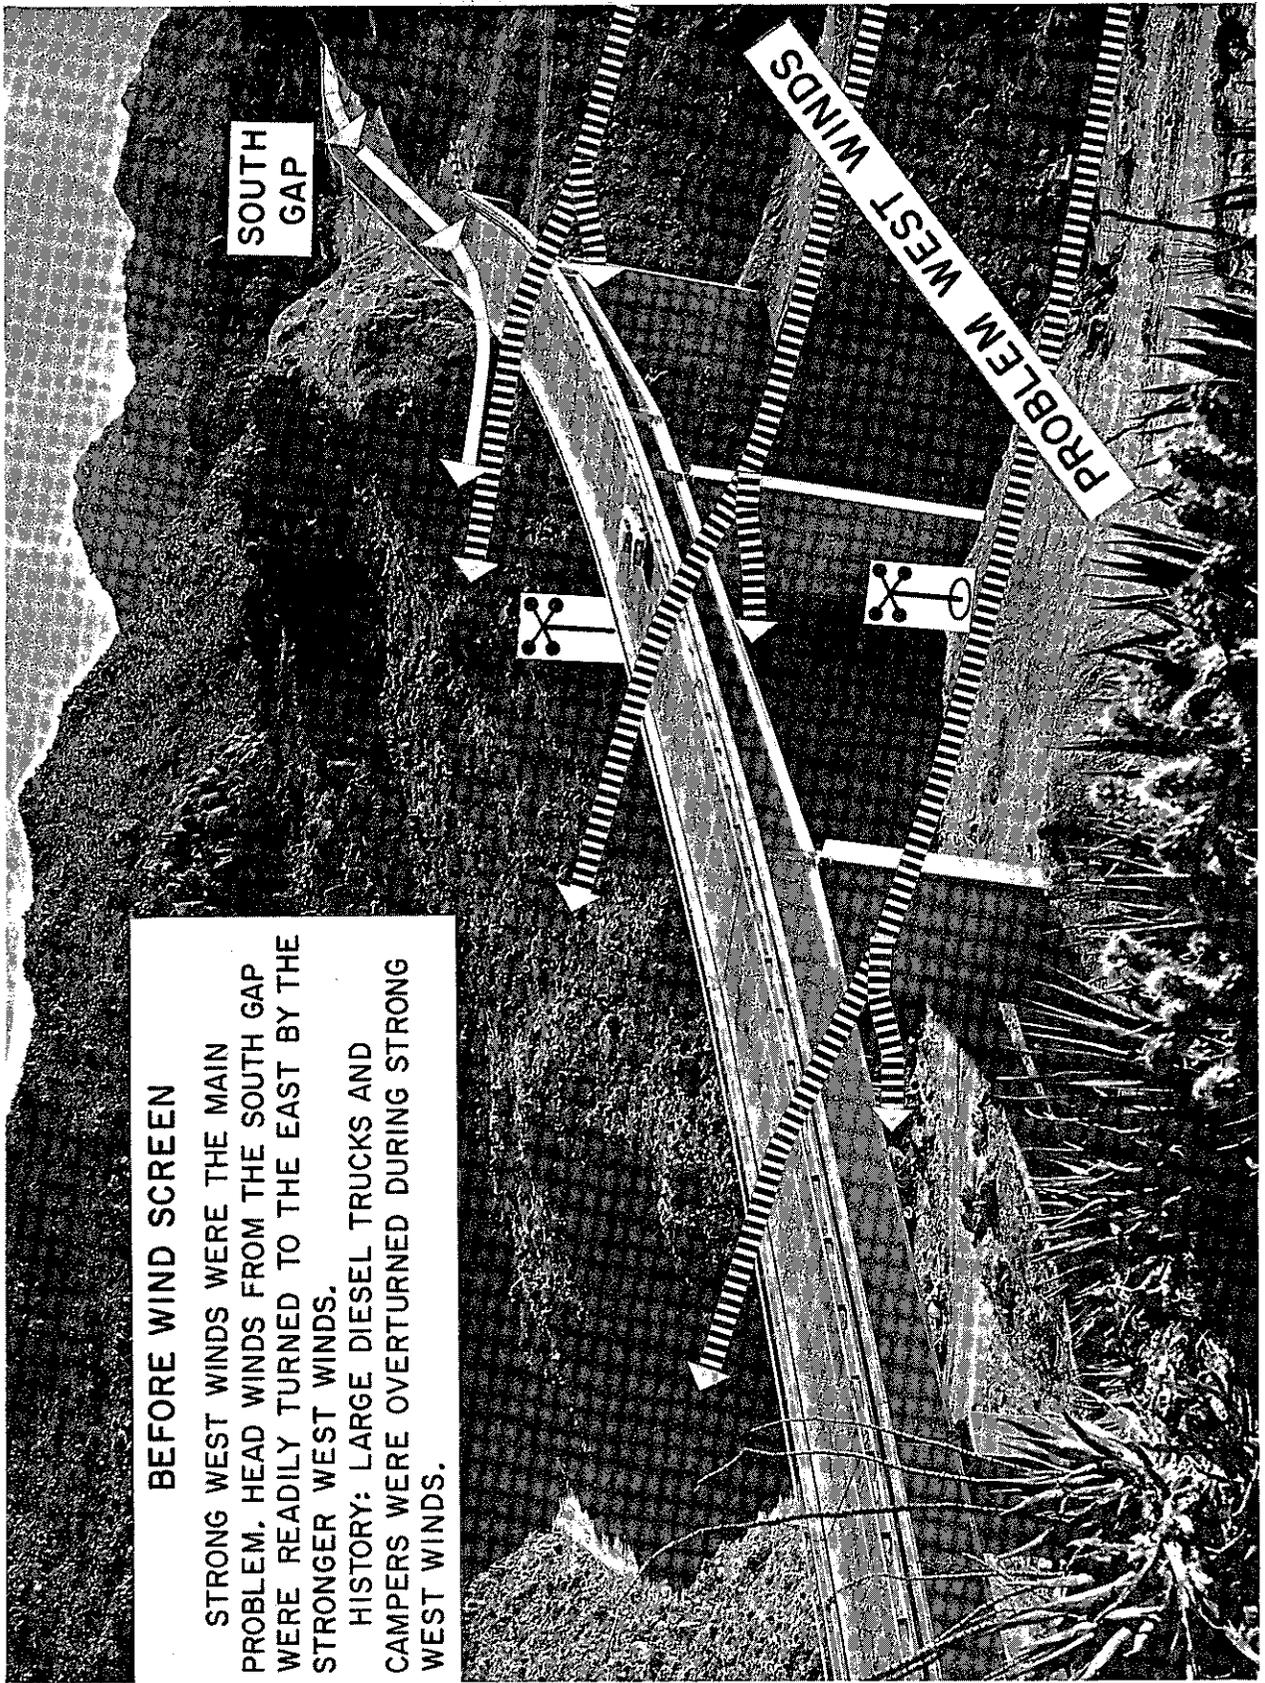
FIGURE 13 CONDITIONS BEFORE WIND SCREEN

BEFORE WIND SCREEN
STRONG WEST WINDS WERE THE MAIN PROBLEM. HEAD WINDS FROM THE SOUTH GAP WERE READILY TURNED TO THE EAST BY THE STRONGER WEST WINDS.
HISTORY: LARGE DIESEL TRUCKS AND CAMPERS WERE OVERTURNED DURING STRONG WEST WINDS.

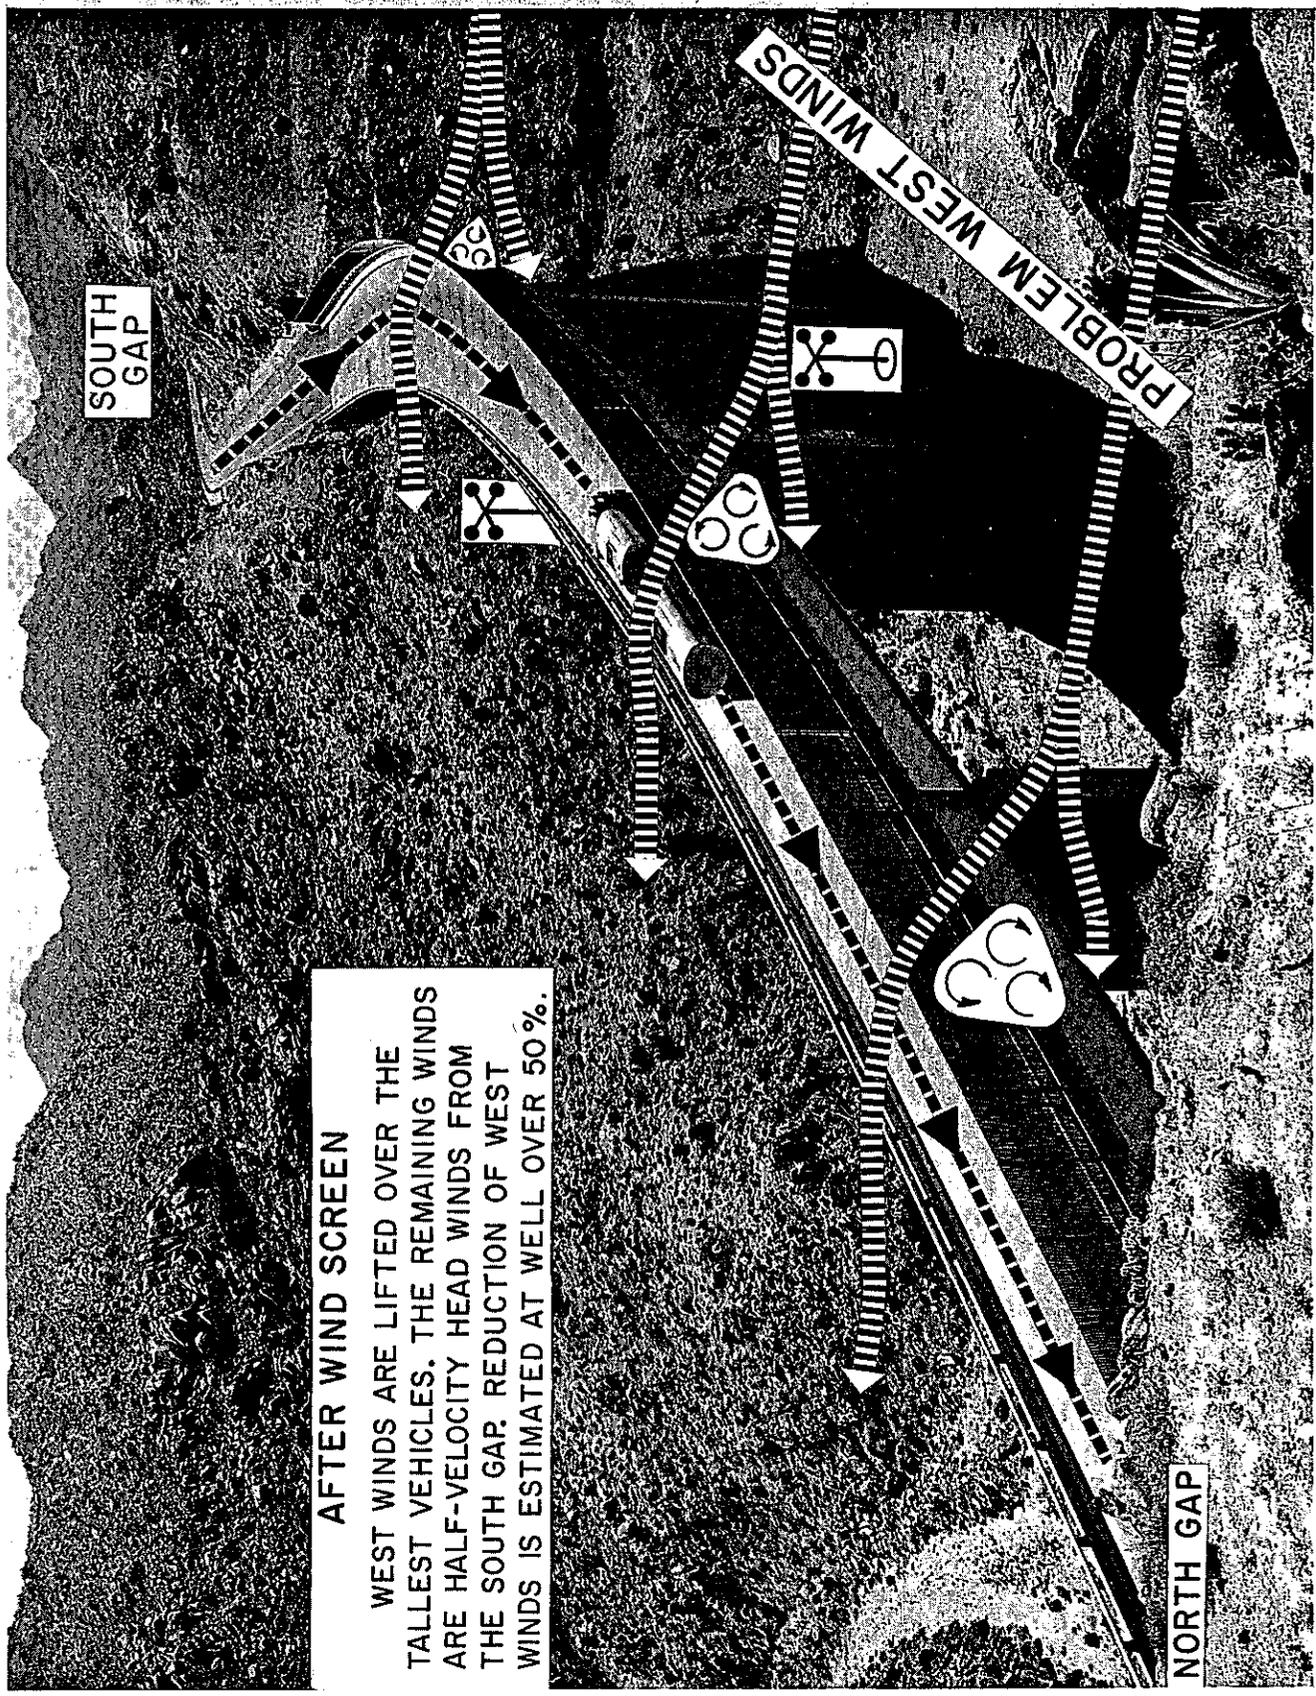
FIGURE 14 CONDITIONS AFTER WIND SCREEN

Wind flag probes were also valuable in disclosing the beneficial lifting of the crosswinds as a result of the turbulence produced on the windward face of the screen. The amount of wind lift varies with the wind speed thus producing a higher zone of protection when it is most needed for tall trucks during strong wind gusts. Typical values of extra wind lift varied from 20 to over 30 percent higher than the wind screen itself during the tests. This extra lift was sustained across the entire 37 foot width of the bridge (Figures 14, 15, and 16).

WEST WINDS ARE LIFTED OVER THE TALLEST VEHICLES. THE REMAINING WINDS ARE HALF-VELOCITY HEAD WINDS FROM THE SOUTH GAP. REDUCTION OF WEST WINDS IS ESTIMATED AT WELL OVER 50%.

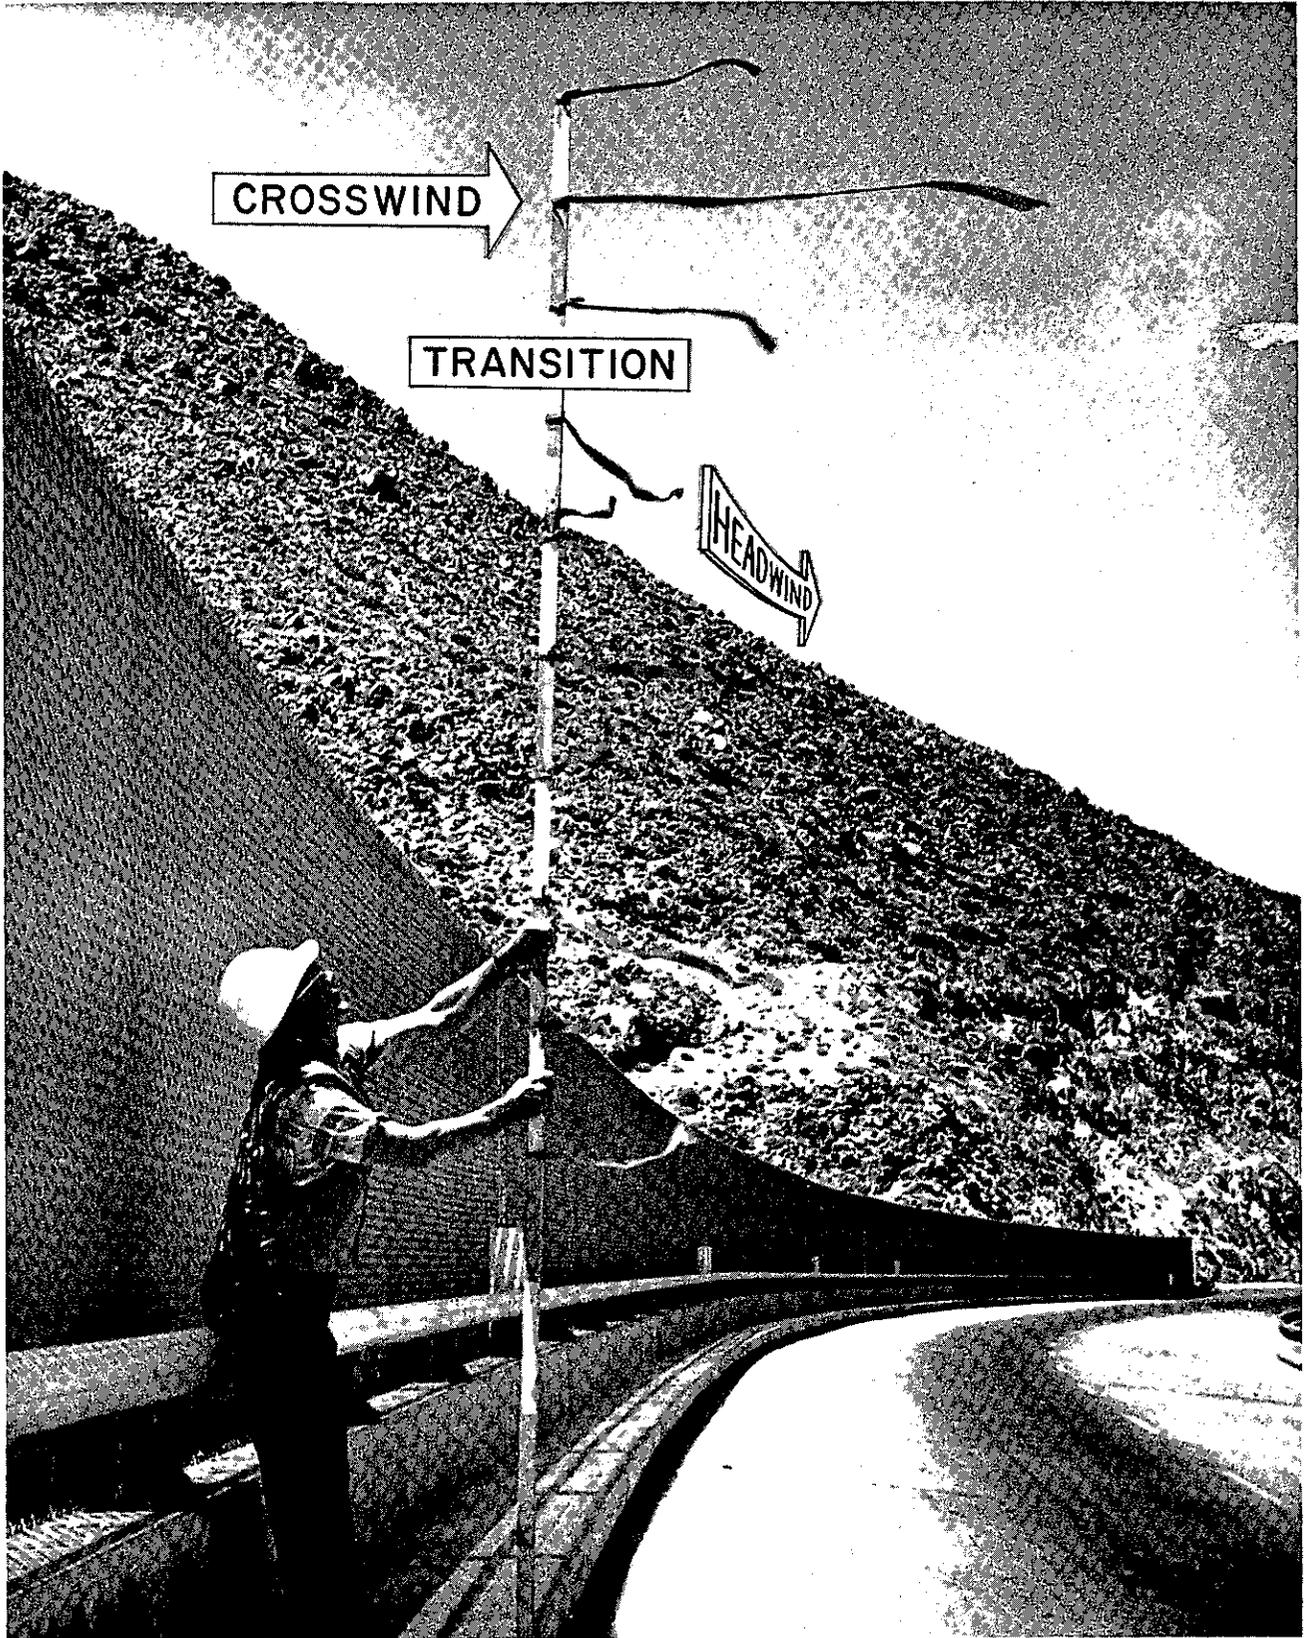
FIGURE 15

STRONG CROSSWINDS ARE DEFLECTED OVERHEAD
LESSER HEADWINDS REMAIN ON BRIDGE

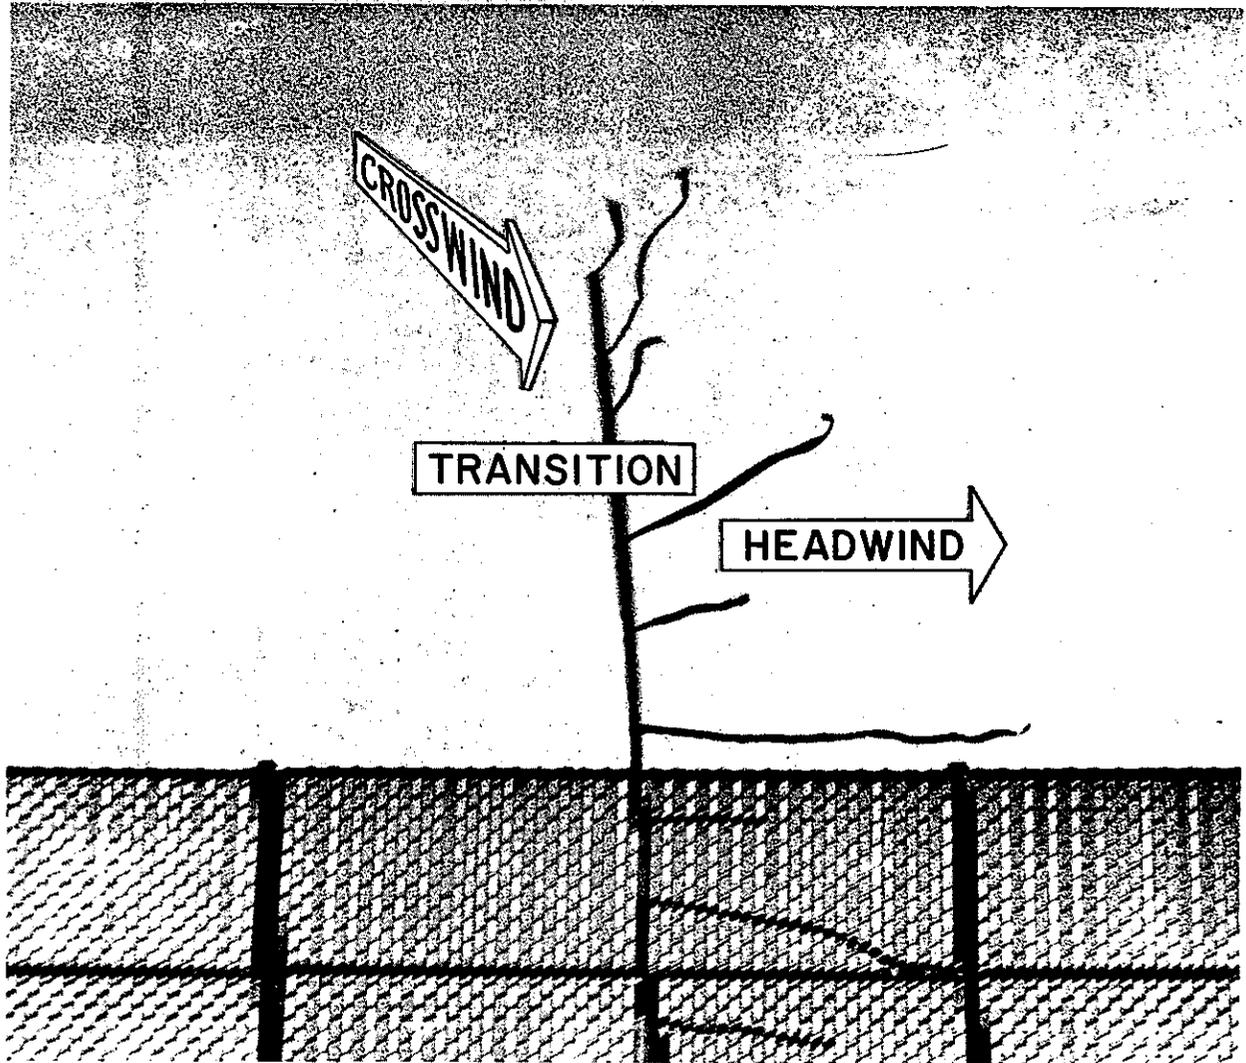
FIGURE 16

SAME AS FIGURE 15, FACING THE SLATTED SCREEN
