Evaluation of Corrugated- Perforated Plastic Pipe For Highway Underdrains; Memo Report

Research Project No. 646634

Subject: Evaluation of corrugated, perforated plastic pipe for highway underdrains.

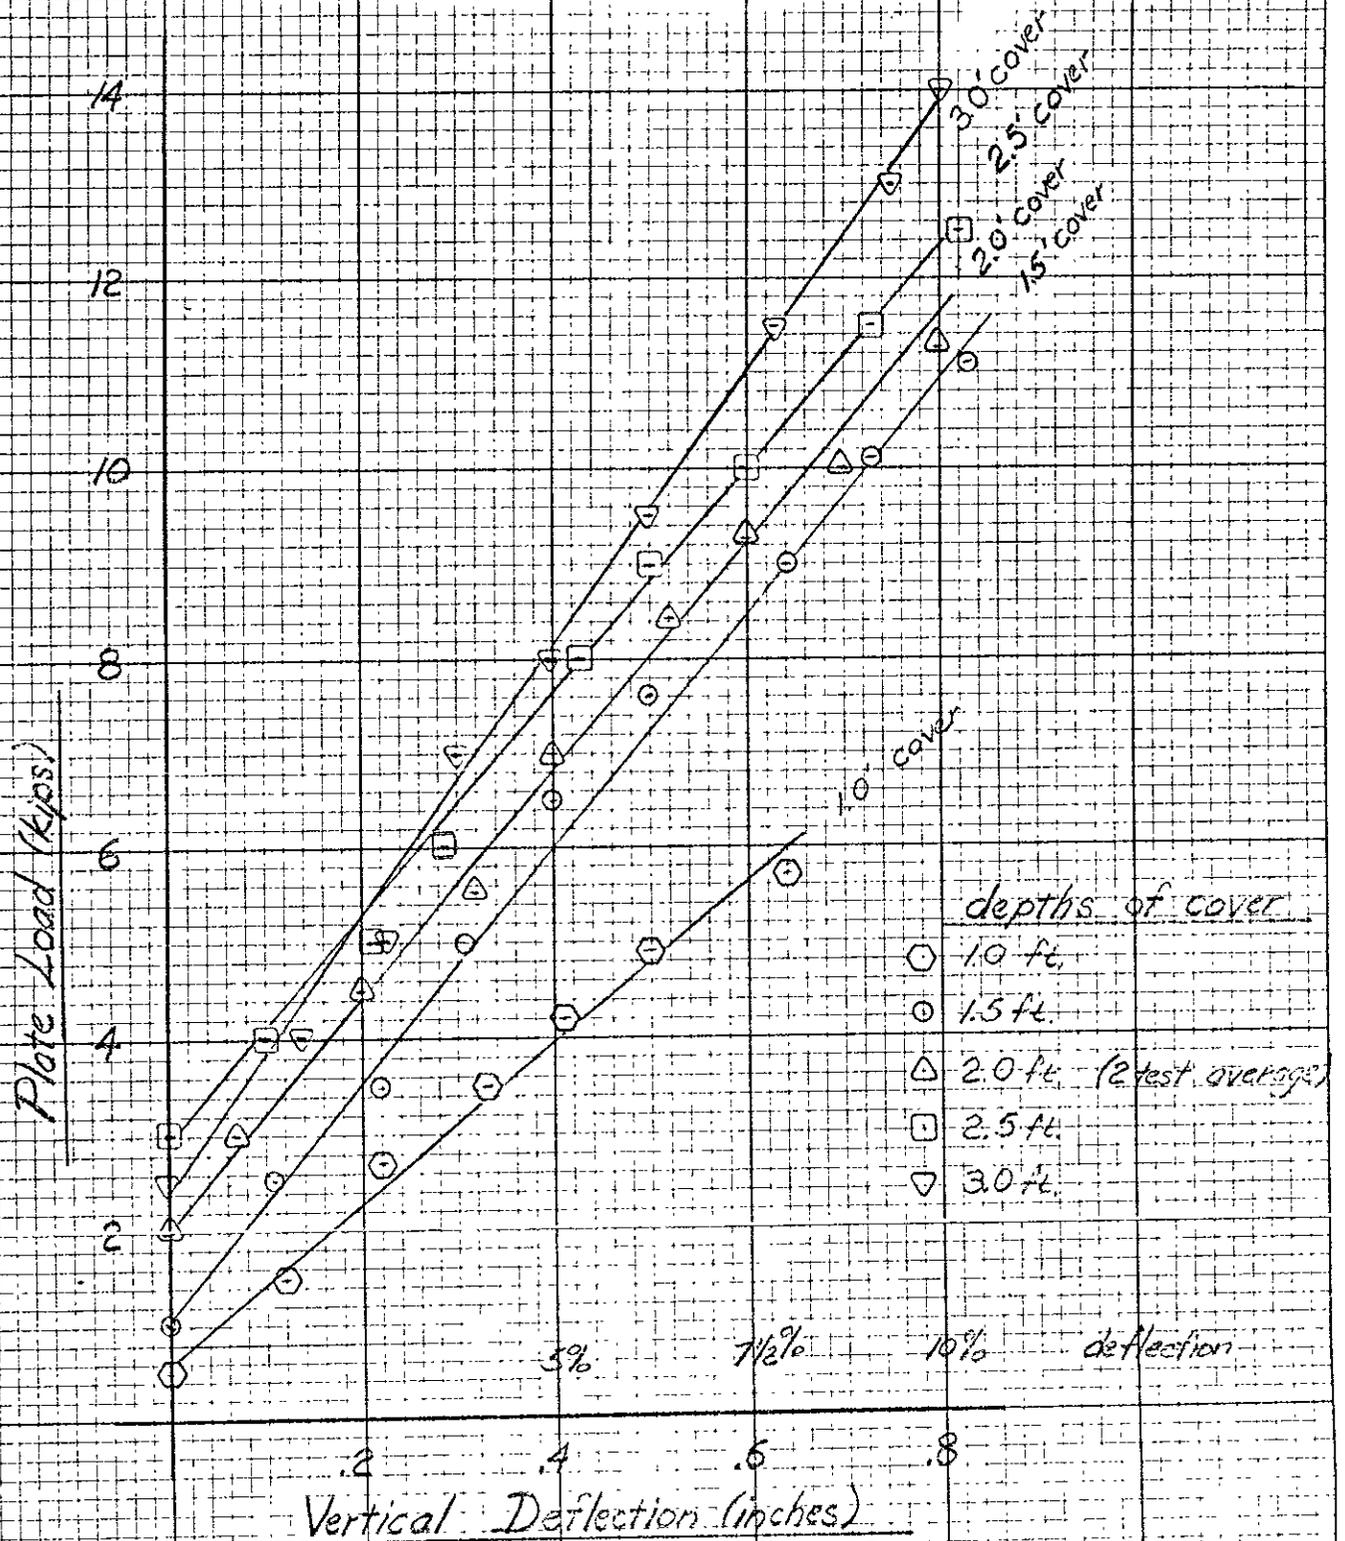
Figure 2

The pipe specimen was placed on a 3" sand bed. Deflection was measured through the movement of a wood strip secured longitudinally to the inside top of the pipe. All movements were observed and recorded through the plexiglass walls. Graphs of load vs. deflection for various depths of cover (Figure 2) and load vs. depth of cover for various deflections (Figure 3) are attached.

8" polyethylene, .67" x 1" annular corrugated, perforated pipe — $t = .05"$, $w = 1.20 \text{ lb/ft}$

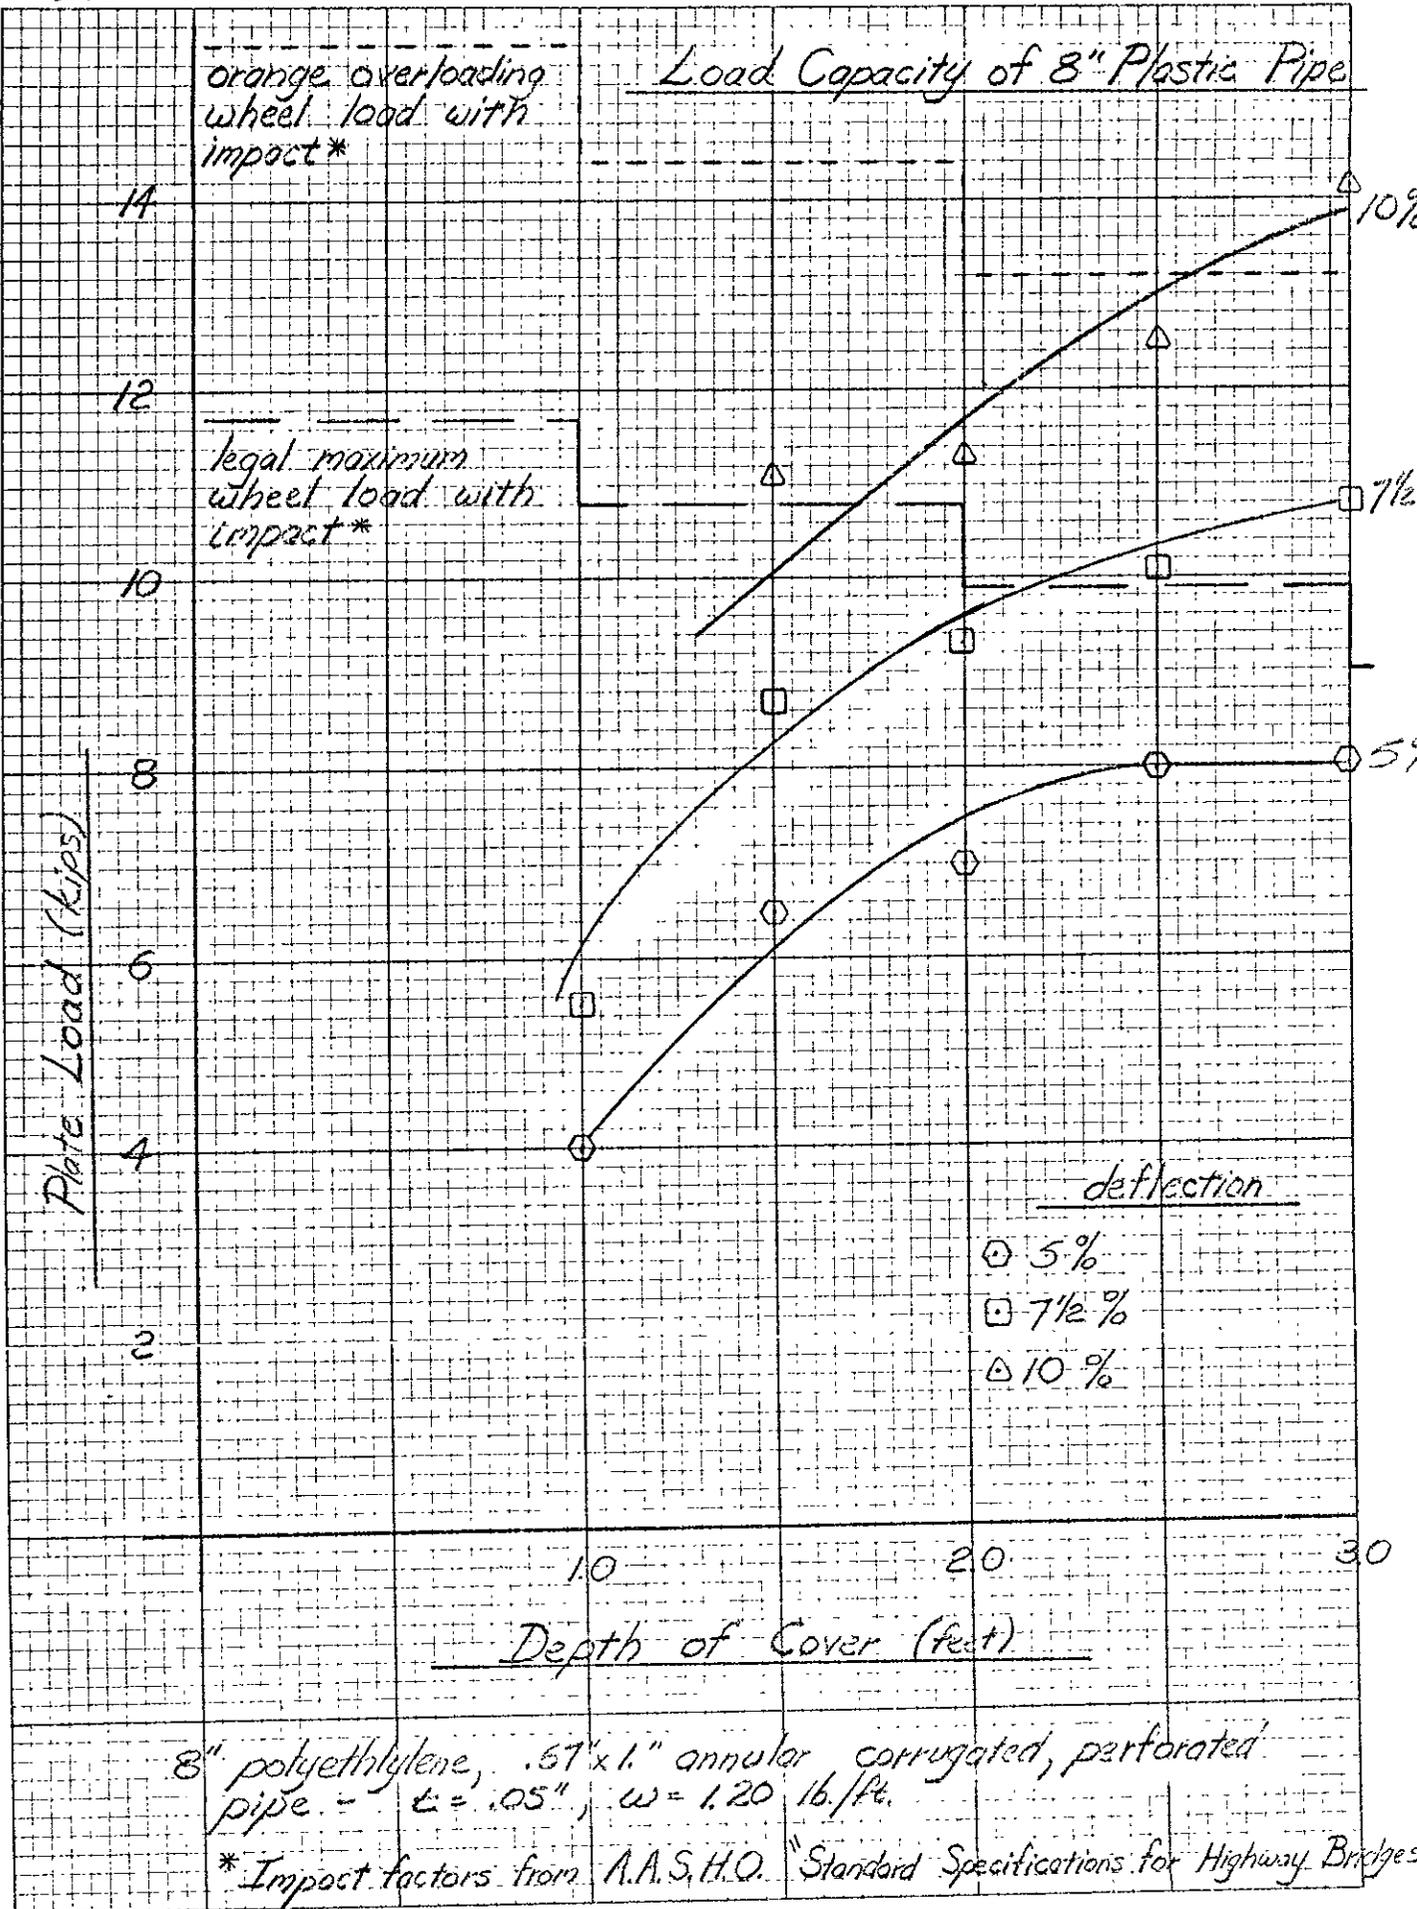
Figure 3

A legal maximum wheel load of 9^k and a standard 12^k Orange Overload were plotted on the load vs. depth of cover for various deflections graph (Figure 3). The Orange Overload was considered typical for off-road construction vehicles traveling on the incomplete highway structural section. Impact was included and based upon the AASHO "Standard Specifications for Highway Bridges" recommendation for culverts. Impact factors for various depths of cover are summarized below:

If a 5% nominal pipe diameter deflection is used as a failure criteria, then the pipe cannot support a legal 9^k wheel load with 3.0 ft. or less of cover. However, if a 7-1/2% deflection is permitted, the same wheel load may be carried with a minimum of 2.3 ft. of cover. These figures are based on a factor of safety of 1.0 and load distribution through the soil cover.

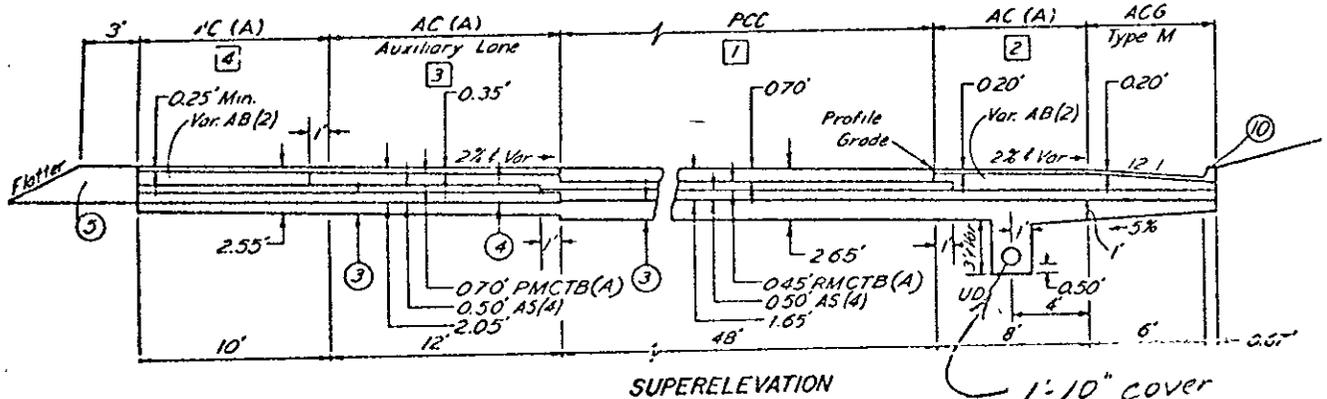
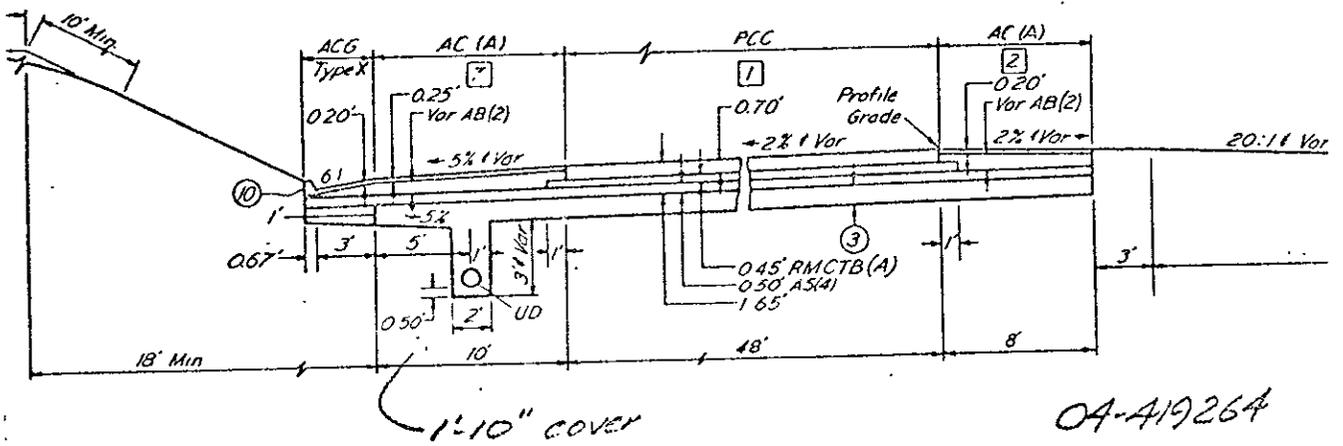
Figure 4

Based upon the results of the sand box crushing tests, the corrugated perforated plastic pipe does not appear feasible for a highway underdrain. Underdrains are usually placed with the subbase of the highway structural section and backfilled with 2 ft. to 3 ft. of cover. Attached are typical cross section diagrams of two underdrain installations under current contract (Figure 4). Overloading of the pipe from heavy construction equipment during placement of base and paving material would be very difficult to control or eliminate. The combination of shallow depth of cover and heavy construction live loads would more than likely fail the plastic pipe. The plastic pipe may have adequate strength when used in subsurface drainage applications if placed out of the structural section where heavy construction equipment traffic is unlikely. Unfortunately, this is not very common in highway construction.
