September 1973

LANDLOCK AS A SPRAY-ON EROSION CONTROL AGENT

TRANSPORTATION LABORATORY
RESEARCH REPORT
CA-DOT-TL-1139A-140-73-32

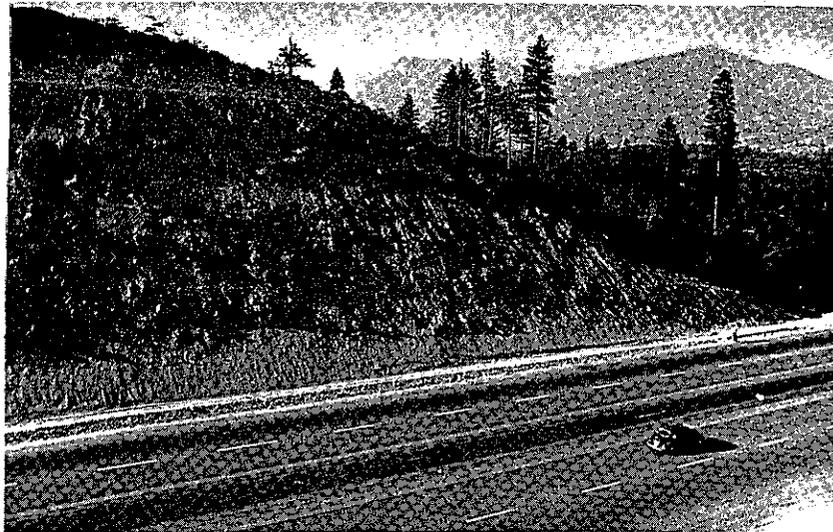
Plate 1 Weed after Landlock treatment

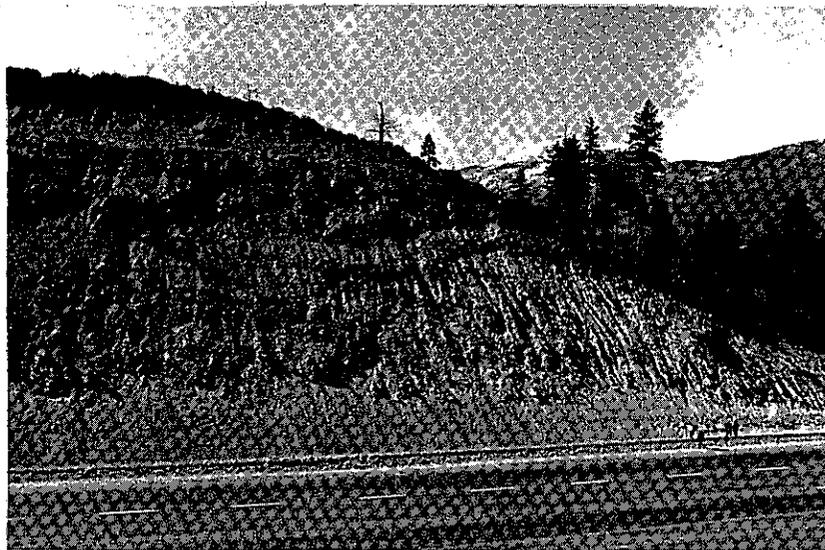
The stress of frost-heave and the freeze-thaw action broke the Landlock blanket into small pieces which, due to the steepness of the slope, fell to the gutter (see Plates 1 and 2). The treatment did, however, appear to increase the growth in the fertile cut flanks before it failed.

Plate 2 Weed after 1 winter

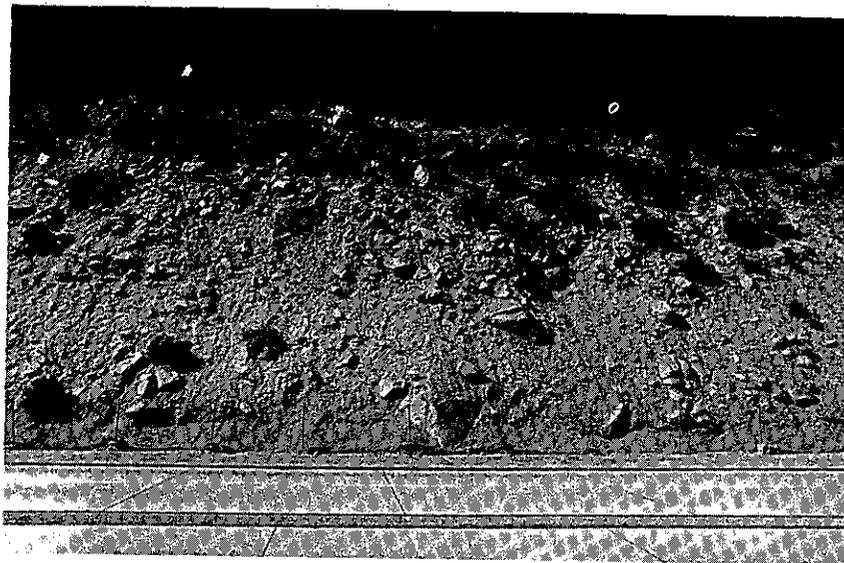
Plate 3 Farad after treatment

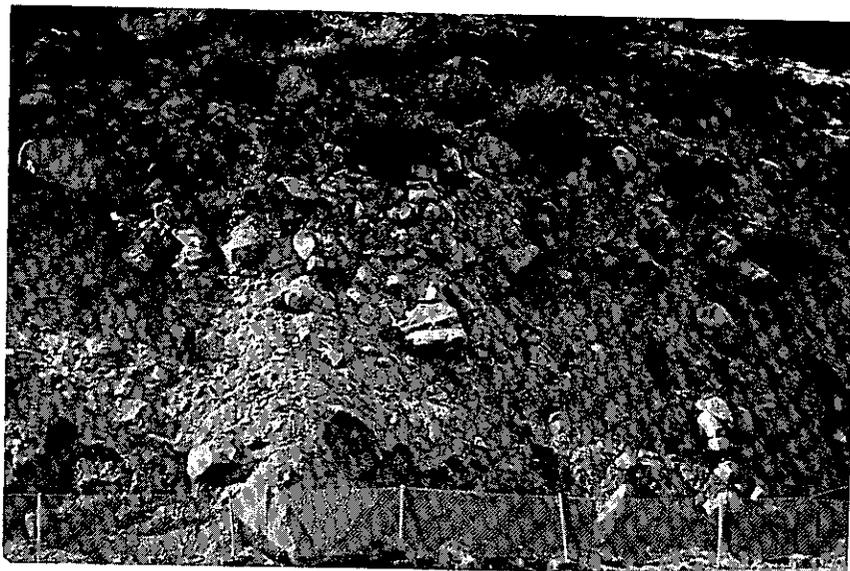
The Landlock blanket was broken up by frost-heave, animal traffic, and rubble which fell from the slope above the cut face. Thus, rockfall or sediment deposition in the gutter was not reduced (see Plates 3-5). There was no significant increase in vegetation.

Plate 4 Farad after 1 winter

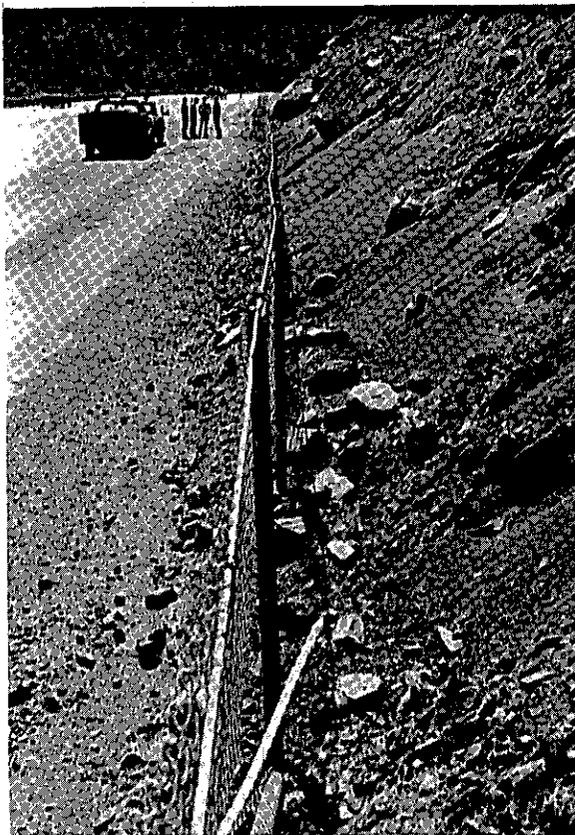
Plate 5 Farad gutter rubble
after 1 winter

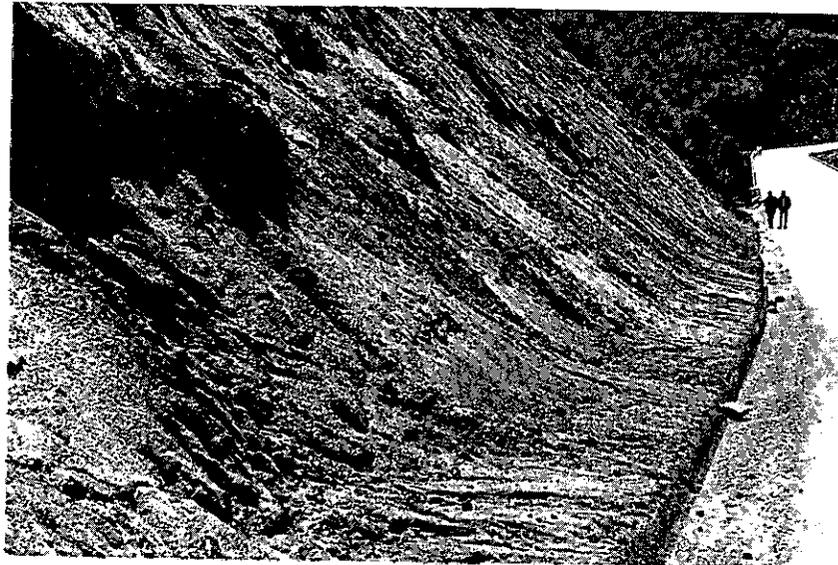
The steepness of this slope and the frost action encountered destroyed the Landlock blanket. However, some vegetation was established in the loose material within the rills, and in the Landlock blanket which is falling off (see Plates 6-9).

Plate 7 Buck Meadows after 1 winter

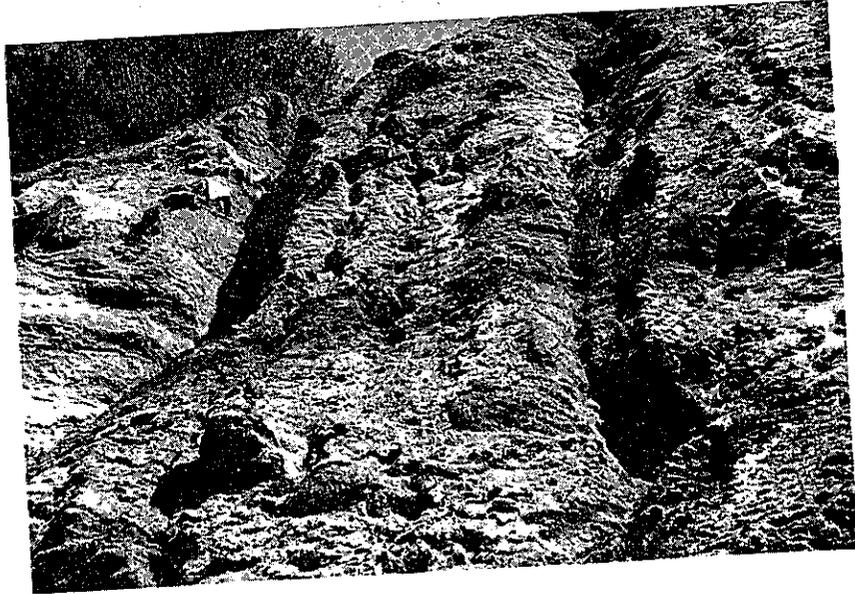
Plate 8 Vegetation in loose rills at Buck Meadows

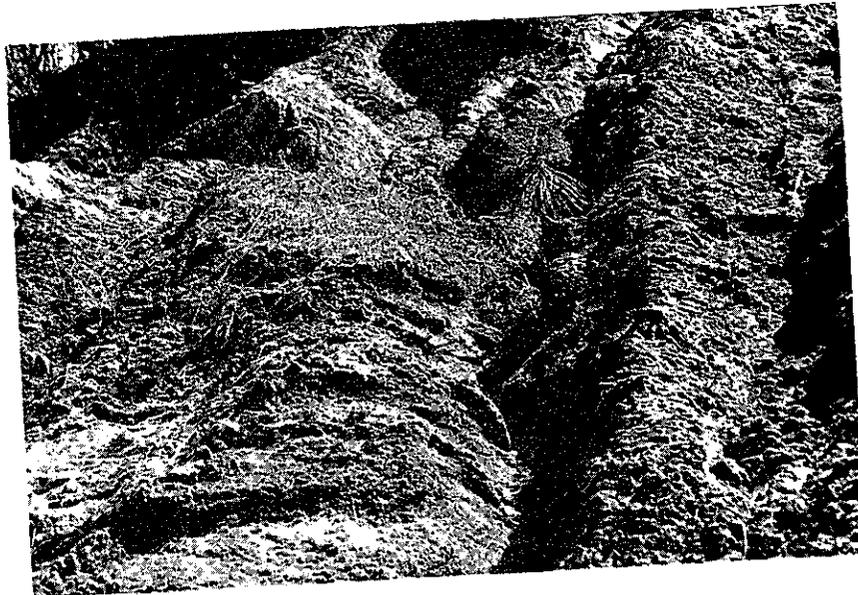
Plate 9 Vegetation in loose Landlock blanket

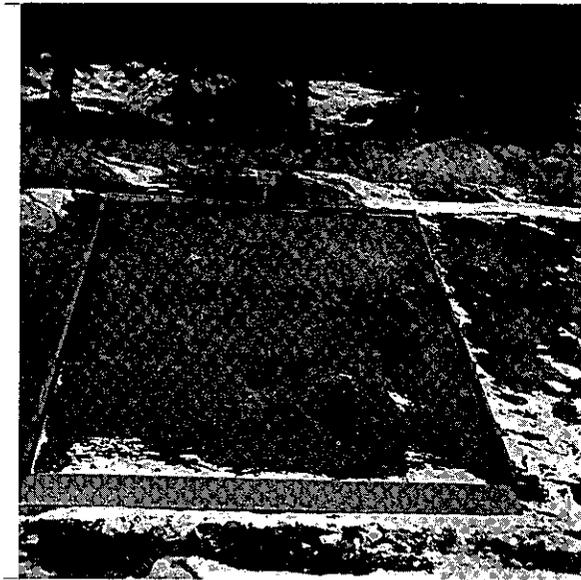
A large portion of the sediment collected originated from ant hills and rodent burrows (see Plate 14). The exact amount attributed to animals is impossible to measure. Since this effects the whole slope and its erosion characteristics, the sediments contributed by animal activity are included in our analysis. At this location the Landlock plot only yielded 83% of the sediment which was measured as yield from the control plot. Further investigation may substantiate the decrease in the sediment lost from a slope when treated with Landlock.

Plate 14 Landlock at Luther Pass with loose mound (dark spot) from rodents

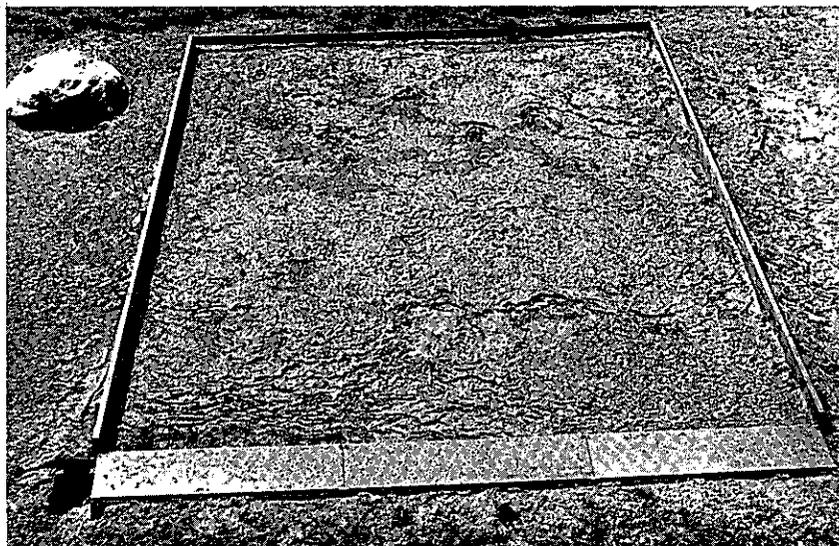
The animal activity and freeze-thaw action which takes place here destroyed the integrity of the 3M blanket allowing erosion to take place in many places (see Plate 15). There appears to be no increase in vegetation in the treated area as compared to the control plot.

Plate 15 Landlock at Luther Pass after frost action of 1 year

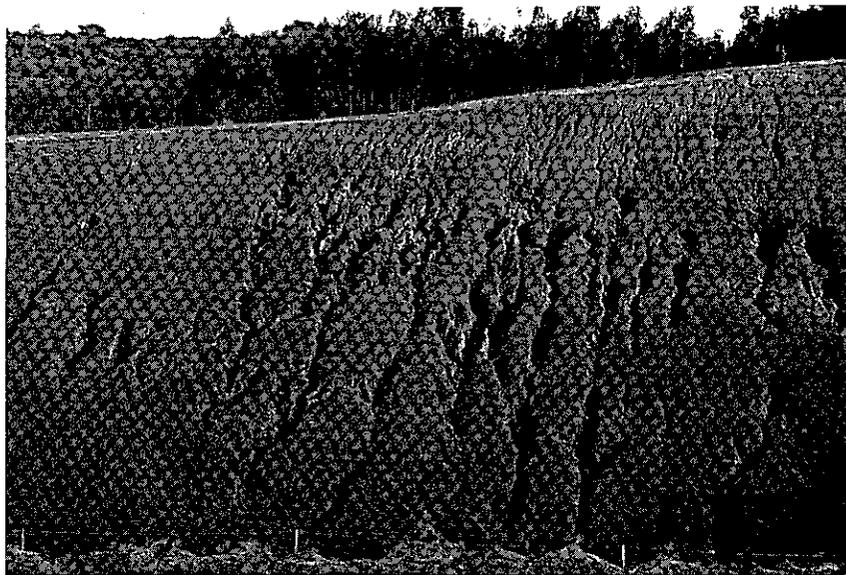
At this location, in this climate, it soon became apparent that 112 gals/A was not enough polymer and that 138 gals/A was marginal. The applications here should probably have been at a minimum of 150 gals/A. It was also evident that cospraying delayed the germination of the vetch by approximately three weeks. It had no apparent effect upon the ultimate yield of vetch cover, or any other vegetative cover, however. The 3M treatment at 138 gals/A was clearly superior to that at 112 gals/A and the control plot (see Plates 16-18).

Plate 17 Landlock at 112 gals/A at Prunedale

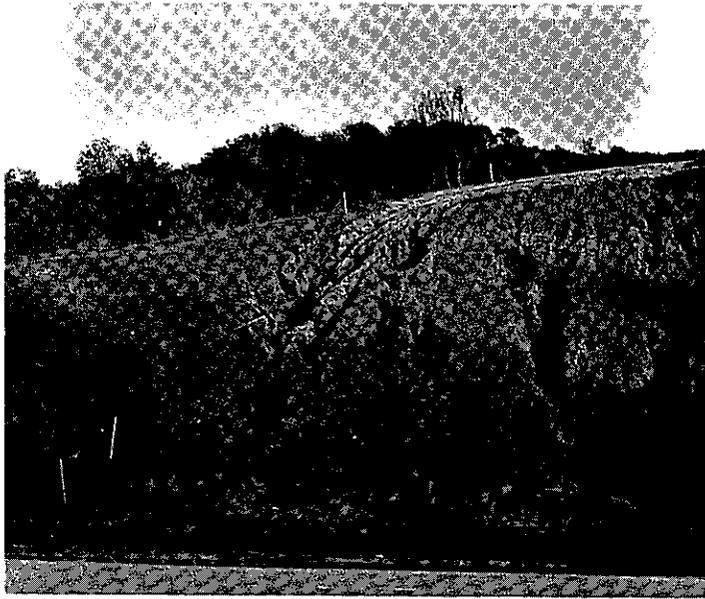
Plate 18 Untreated area at Prunedale

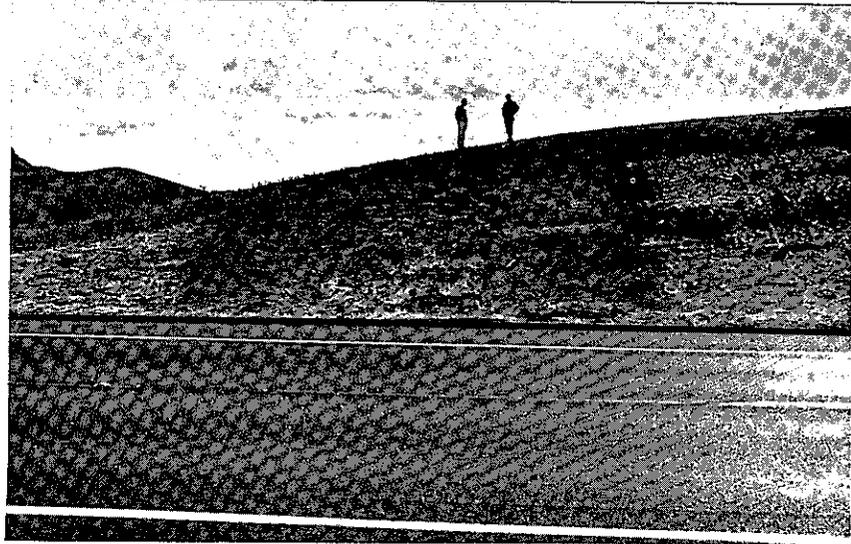
At this location it was apparent that the polymer was superior to the control or fiber only treatment, both in erosion control and vegetation establishment (see Plates 19 and 20). The use of fiber in combination with the polymer yielded better vegetation establishment than polymer alone. These results were obtained with a polymer application rate that is unrealistic at this time.

Plate 19 Buellton after 1 month (Landlock and fiber on the left 2/3 of the dark area)

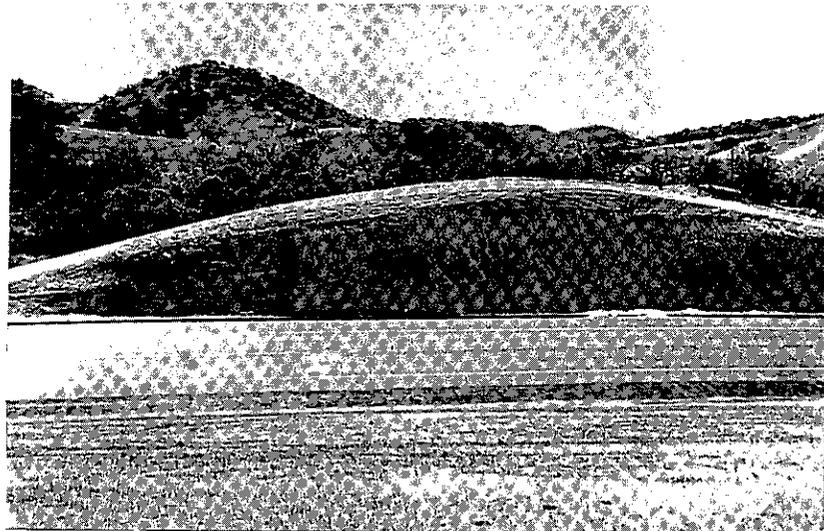
Plate 20 Buellton after 4 months

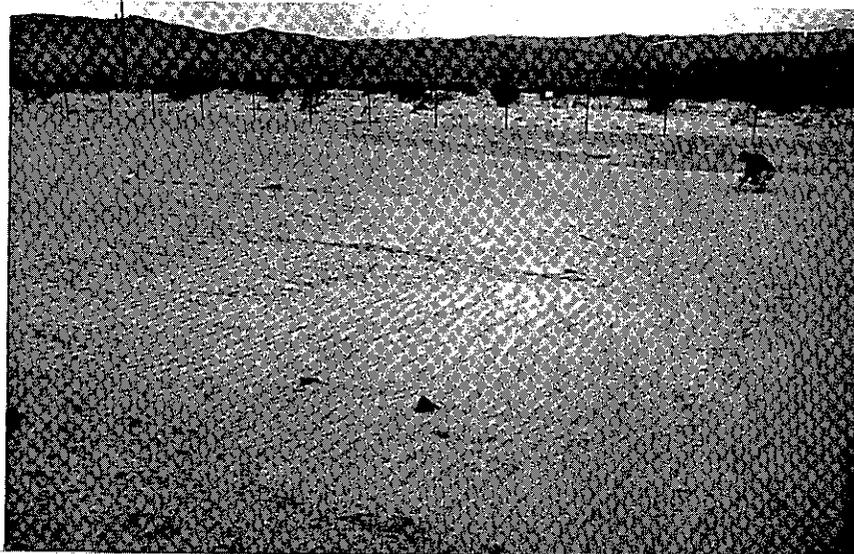
progressing from the fence toward the roadway. Plots 1 and 2 used 240 gals/A and Plots 3 and 4 each had half this amount. Plot 4 was prewet to a depth of two inches before spraying. The ratio of water to polymer used was 10:1. Periodic inspection was maintained until April 4, 1973. No significant wind erosion was apparent. Much of the treatment was covered with sand deposited from up wind areas. It was still intact as of April 4, 1973 and performing well (see Plates 21 and 22).

Plate 21 Landlock with deposited sand

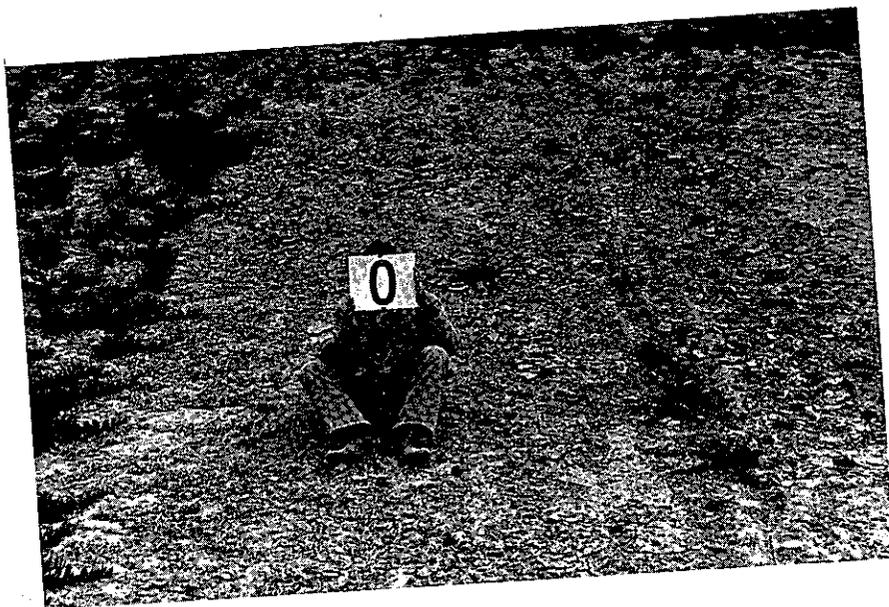
#21 DCA-70 with some dead grass at top
9-10-72

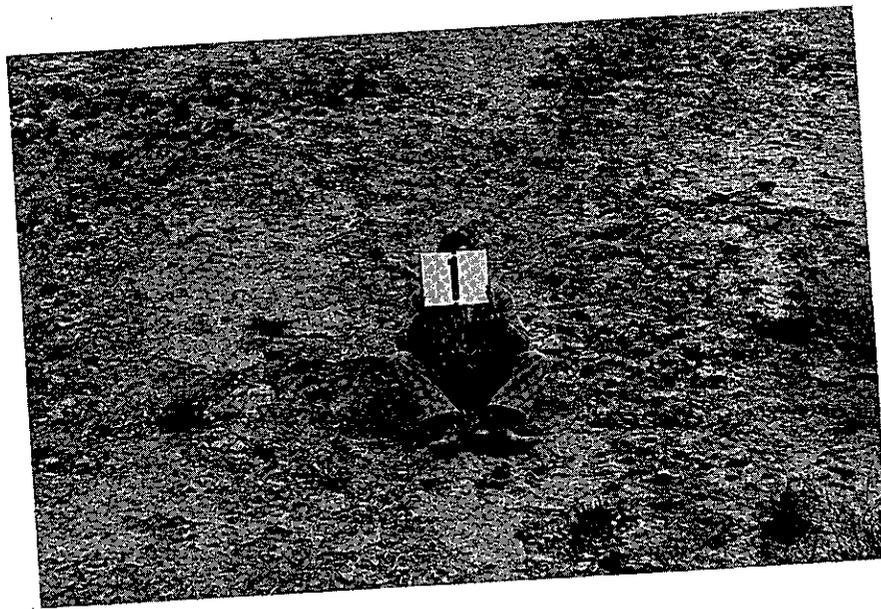
#22 DCA-70 Some grass
9-10-72 Note footprints from lower right to
top center.

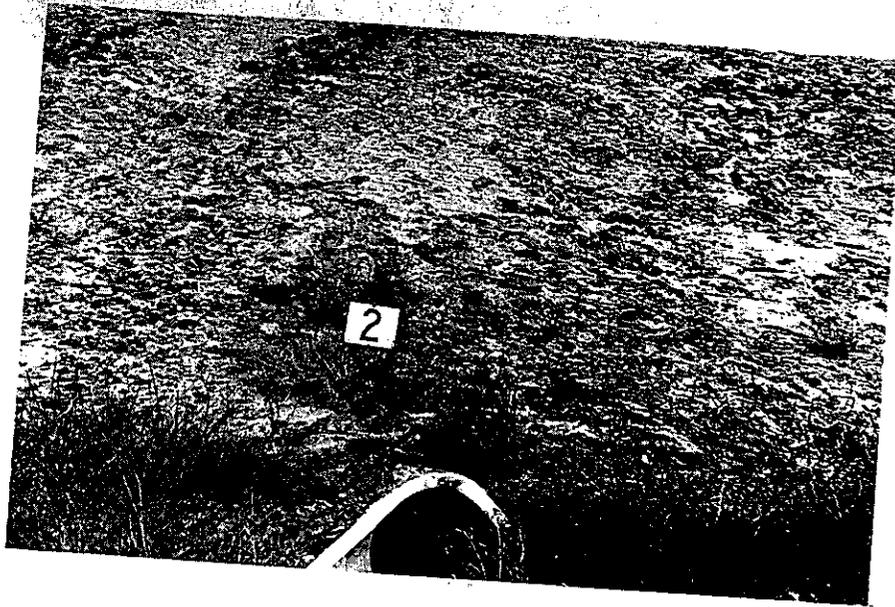
#23 9-10-72 Note native vegetation below treated area
