CA-DOT-TL-6392-5-74-14

Dynamic Tests Of Metal Beam Guardrail, Series XXVII

Transportation Laboratory
California Division of Highways
Sacramento, California 95819

Interim Report

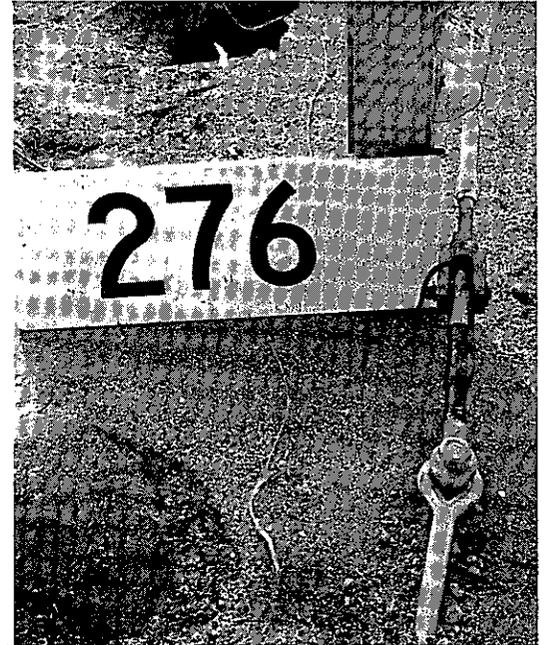
Figure 11
Cable End Anchor Used
on Barrier for Test
276

To correct this condition, two changes were made to the barrier design for Test 276; (1) a swaged fitting and clevis were used to replace the five cable clips on the cable end anchorage to provide a positive anchorage and (2) twelve inch long backup sections of W-section beam were placed behind the beam at alternate posts where beam splices did not occur. These backup sections reduced the tendency of the rail to tear along the hard sharp edge of the steel blocks and posts. The results of Test 276 proved the effectiveness of these modifications.

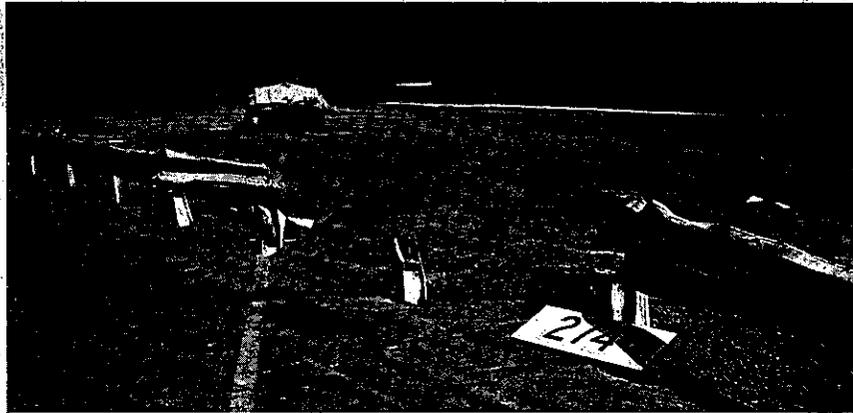
Figure 24, Test 274 Barrier Damage

Shearing of the "W" section beam occurred at the downstream edge of post #6 (posts numbered from upstream end). The beam was detached from post #6 and bent back around post #5. Two major bends occurred in the downstream segment: the first where post #7 had been attached and the second at the upstream edge of post #8. All 13 posts were twisted and displaced; post #1 was displaced 18 inches (0.457 m) downstream, and post #13 was displaced 15 inches (0.381 m) downstream. Posts #5, #6 and #7 were twisted and bent down near the ground about their minor axes with virtually no displacement of the posts in the ground. Slippage of the cable through five cable clips occurred at the upstream anchorage. These clips had been torqued to 50 ft-lbs (6.92 m-kgf) twice, including once on the day before the test. The bolt between the beam and block was sheared at posts #2, #3, and #12, and this bolt pulled through the beam at posts #5 #6, #7 and #8. At post #7 one bolt connecting the block to the post pulled through the flange of the block. The block at post #6 was buckled flat, and local buckling of block flanges occurred at several posts near impact. Barrier damage is shown in Figure 24 in Discussion of Test Results.

The barriers impacted in Tests 272, 273 and 276 all met the above requirements. There were no indications that the barriers were on the brink of failure. The barrier impacted in Test 274 was penetrated which was unacceptable. An analysis of that failure is described in a later section. Figures 22 through 25 show barrier damage for all four tests. Figures 26 through 30 show closeup views of posts near the impact area for Test 276. The backup plates at posts #4 and #8 clearly resisted excessive bending of the W-section beams at the posts. Samples of soil from the barrier test site were tested. A copy of the soil report is contained in the Appendix in Section D. This report indicates the soil was quite strong. It consisted of a layer

of stiff, overconsolidated clay in the top 1.5 feet (.457 m) of soil and a layer of sandy clay with gravel and clayey sand with gravel (commonly called "hardpan") from 1.5 to 4.5 feet (0.457 - 1.37 m) of depth. This stiff soil probably gave the barrier added apparent stiffness and forced the wood posts near impact to shear and the steel posts to bend rather than yielding in the soil. However, the major restraining force in the barrier appears to come from the W-section beam as evidenced by Test 274 where the cable anchor slipped and the W-section tensile strength could not be developed.

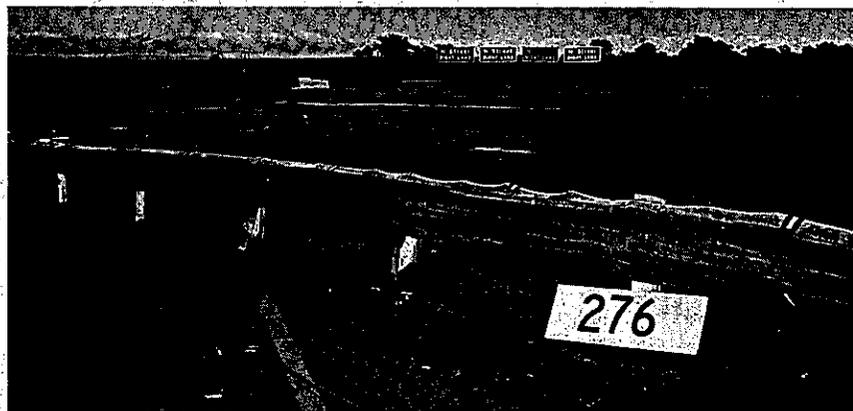
Figure 25, Test 276 Barrier Damage

Barrier damage consisted mainly of moderate twisting and bending of posts #5, #6 and #7 although none of the posts were bent to the ground. Separation of the metal beam guardrail from the steel post block occurred only at post #6. Severe buckling of the blocks occurred at posts #5, #6, and #7. A maximum of 3/8" (9.5 mm) slippage of a beam splice occurred at post #5. Minor twisting of the posts and blocks occurred at posts #4 and #8. Barrier damage is shown in Figures 25 through 30 in Discussion of Test Results.

Table 5 shows the barrier rail and post deflections for Tests 272, 273 and 276. The diagram on Table 5 and Figures 22 through 25 show that the rail deflected in a smooth curve as desired. The figures also show the damage to the barrier posts at the area of impact.

The deflection of the rail in Test 276 is less than that for Tests 272 and 273 and may account for the relatively low longitudinal vehicle deceleration. Table 6 compares the barrier rail deflections of these tests with other test series. This table clearly shows that the permanent barrier rail deflections were in the same range as those recorded for previous test series. It should be noted that the vehicle kinetic energy at impact for Tests 272, 273 and 276 was appreciably higher than that for other tests in the table. Barrier damage in Tests 272 and 273 was very

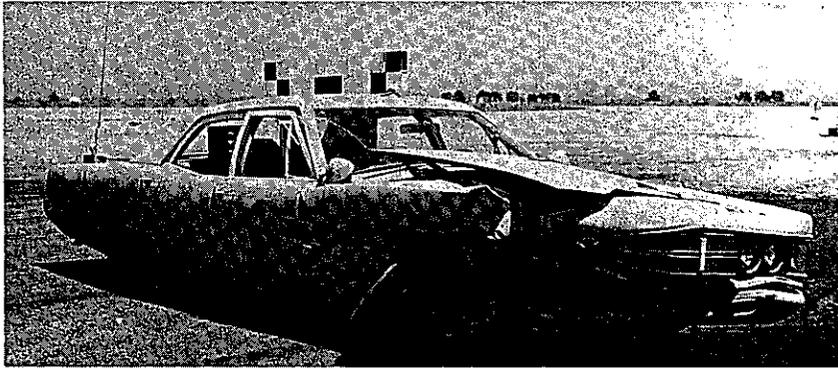
Figure 31, Test 272 Vehicle Damage

Principal damage to the vehicle included: a severely crushed right front bumper and fender, severe damage to the right front wheel, cracked windshield, crushed and jammed right front door, right door post torn loose at roof, and crimps in the roof on the right side. The car could not be driven away. There was no intrusion of vehicle parts or barrier components into the passenger compartment. Vehicle damage is shown in Figure 31 in Discussion of Test Results.

Figures 31 through 34 compare the vehicle damage incurred in the four tests. Comparing Tests 272, 273 and 276 the damage to the right front portion of the vehicle was quite severe and roughly similar for all tests. The right front wheel was disabled in all three tests.

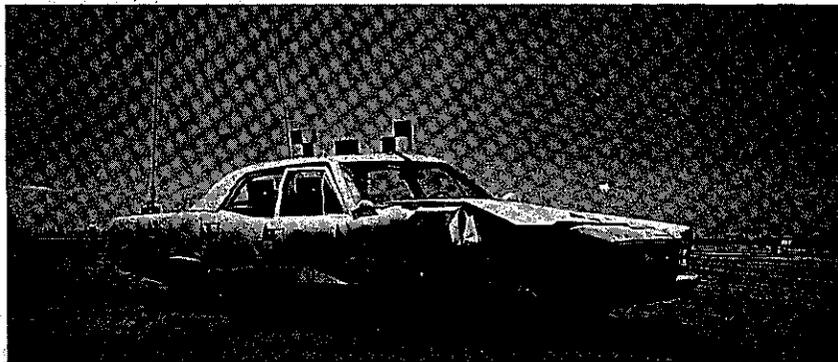
Figure 32, Test 273 Vehicle Damage

Principal damage to the vehicle included: severely crushed right front bumper and fender, severe damage to the right front wheel, cracked windshield, crushed and jammed right front door, and the

right door post torn loose at the roof. The car could not be driven away. There was no intrusion of vehicle parts or barrier components into the passenger compartment. Vehicle damage is shown in Figure 32 in Discussion of Test Results.

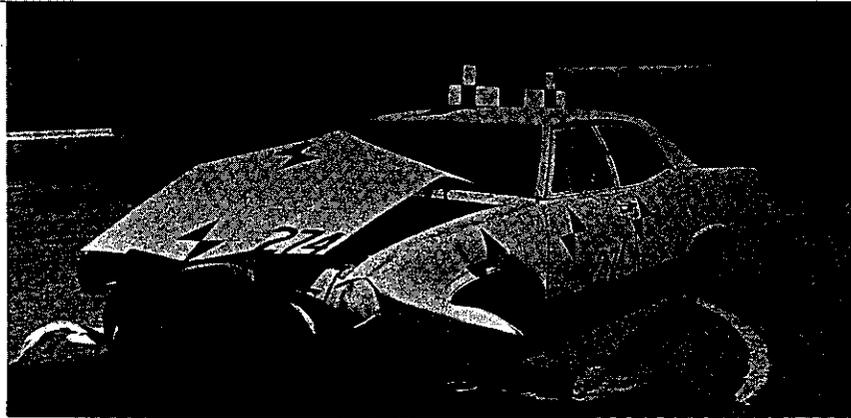
Figure 33, Test 274 Vehicle Damage

Principal damage to the vehicle included: severely crushed left and right front fenders and bumper, broken headlights, crushed hood, the engine moved upward about 12 inches (0.305m), the left front door jammed, and the left and right front tire movement were restricted. The car could not be driven away. There was no intrusion of vehicle parts or barrier components into the passenger compartment. No marks were apparent on the dummy or vehicle interior that would indicate a dummy to vehicle impact except for a five inch (127 mm) deformation of the steering wheel away from its original plane. The dummy was found lying on its right side on the car seat. The driver's seat back was broken. Vehicle damage is shown in Figure 33 in Discussion of Test Results.

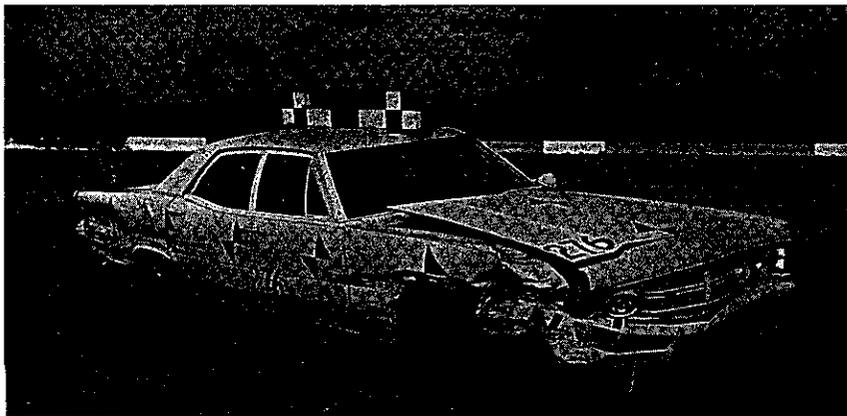
Figure 34, Test 276 Vehicle Damage

Principal damage to the vehicle included: severe crushing of the right front fender and bumper, jamming of the left and right front doors, damage to the right front wheel structure, and moderate crushing of the right rear fender. Vehicle damage is shown in Figure 34 in Discussion of Test Results.
