CA-TL-7108-78-10

Slope Erosion Control Using Fiberglass Roving and Reinforced Paper Matting With Grass

**SLOPE EROSION CONTROL
USING FIBERGLASS ROVING
AND REINFORCED PAPER MATTING
WITH GRASS**

11 - SD - 805, P.M. 12.3

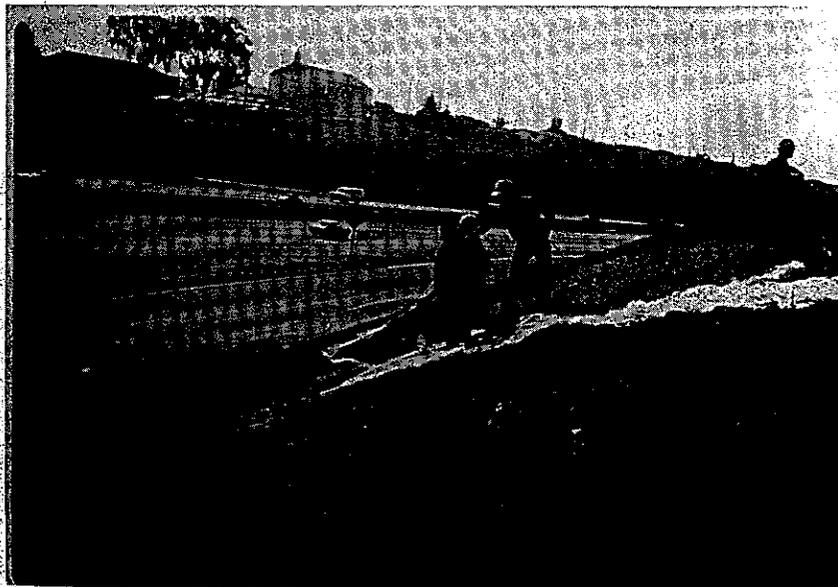
Photo 4. Placing Fiberglass Roving

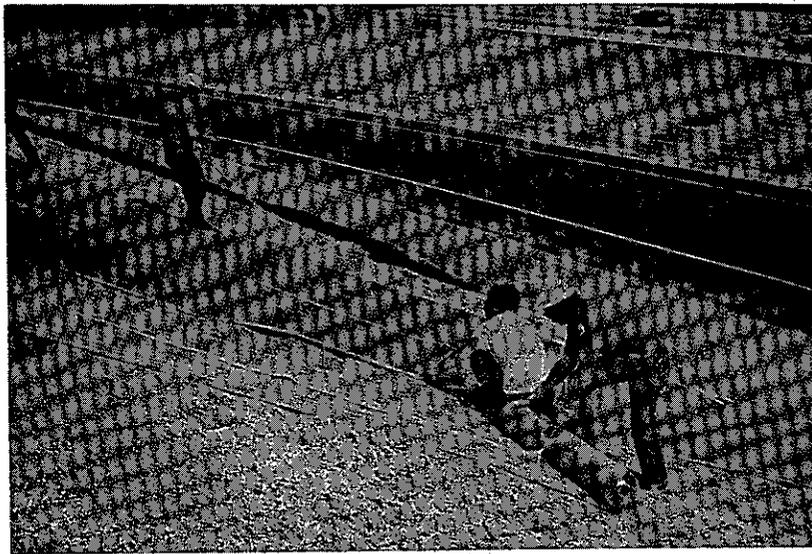
Photo 5. Placing Hold-Gro Mat and
Fiberglass Roving

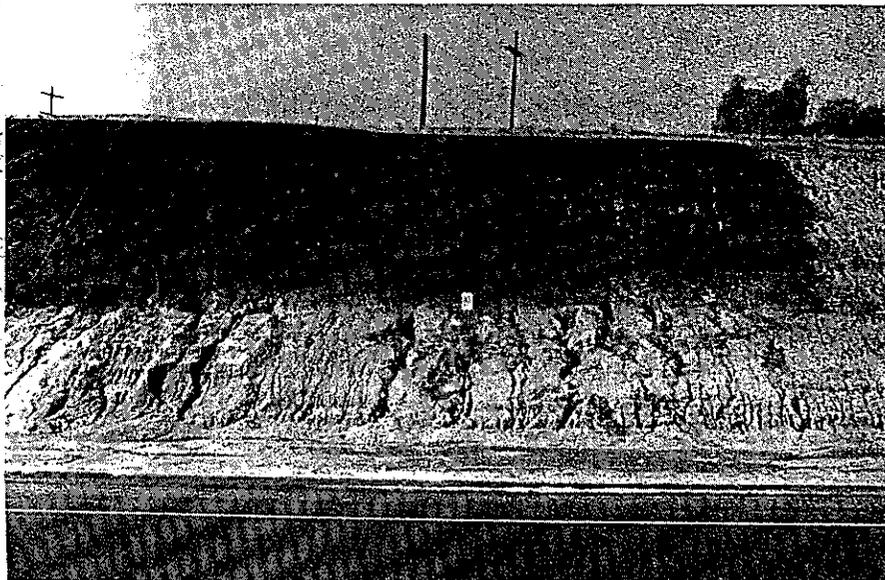
Photo 13. Plot A Immediately After
Installation October 26,
1976

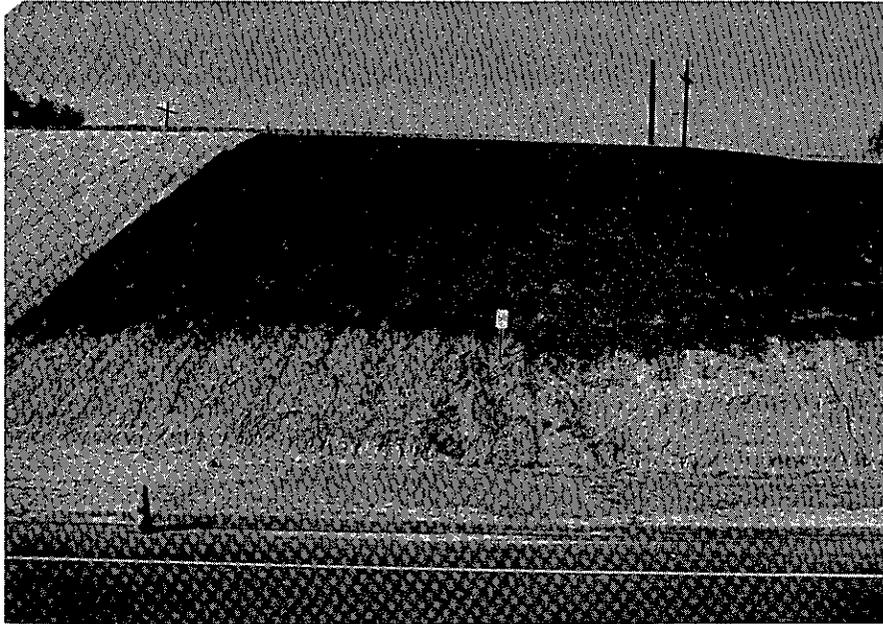
Photo 14. Plot B Immediately After
Installation October 26,
1976

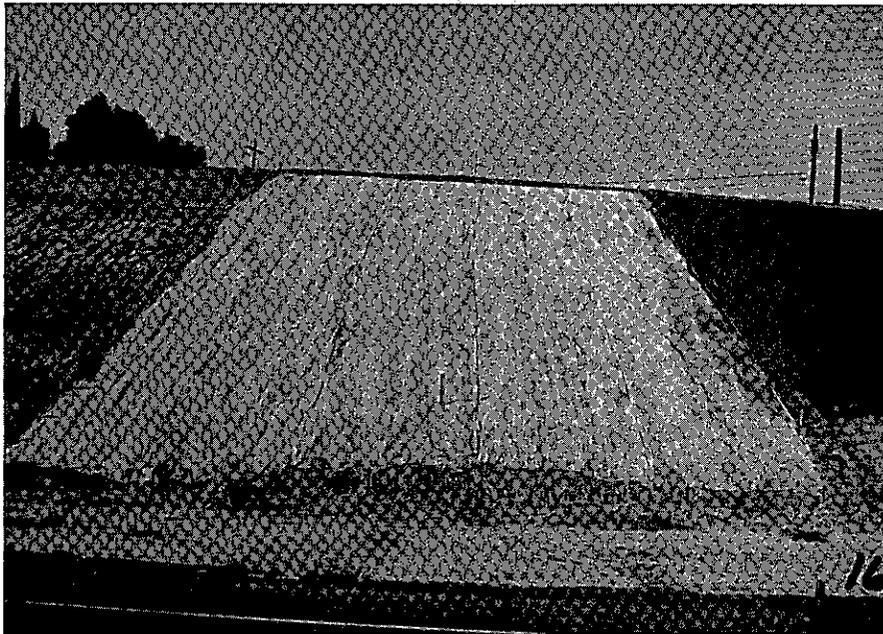
Photo 15. Plot C Immediately After
Installation October 26,
1976

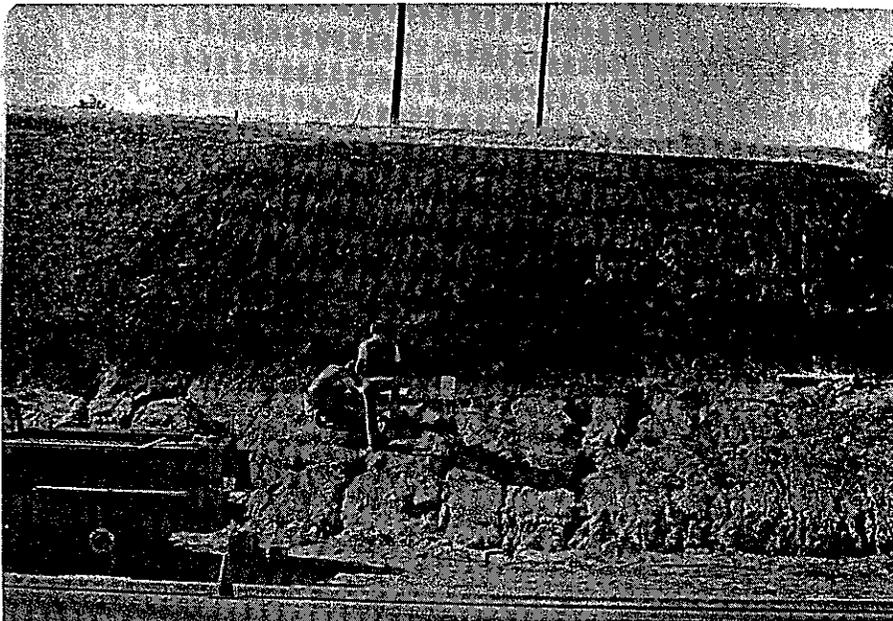
Photo 17. Plot A 7 Weeks After Installation
December 15, 1976

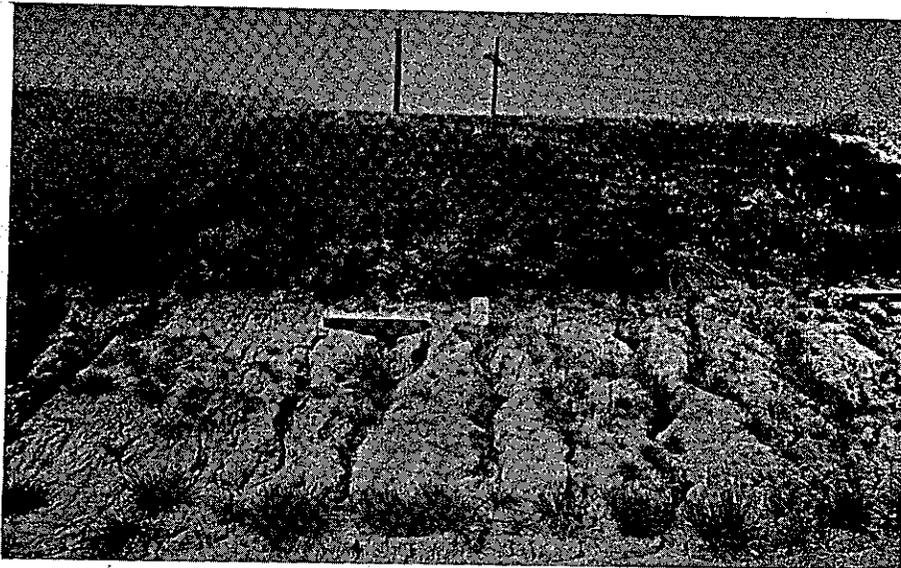
Photo 23. Plot A 23 Weeks After
Installation April 4, 1977

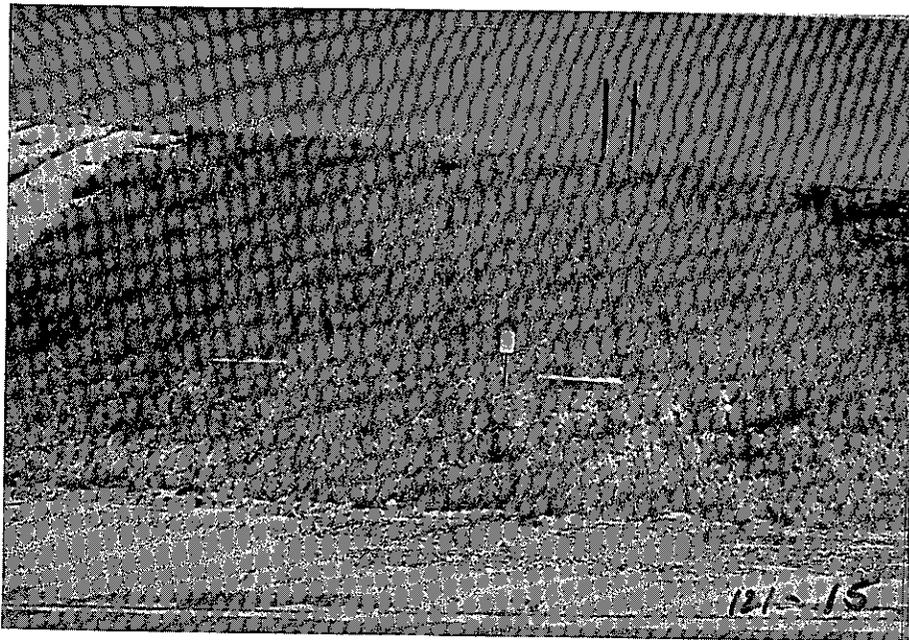
Photo 24. Plot B 23 Weeks After Installation
April 4, 1977

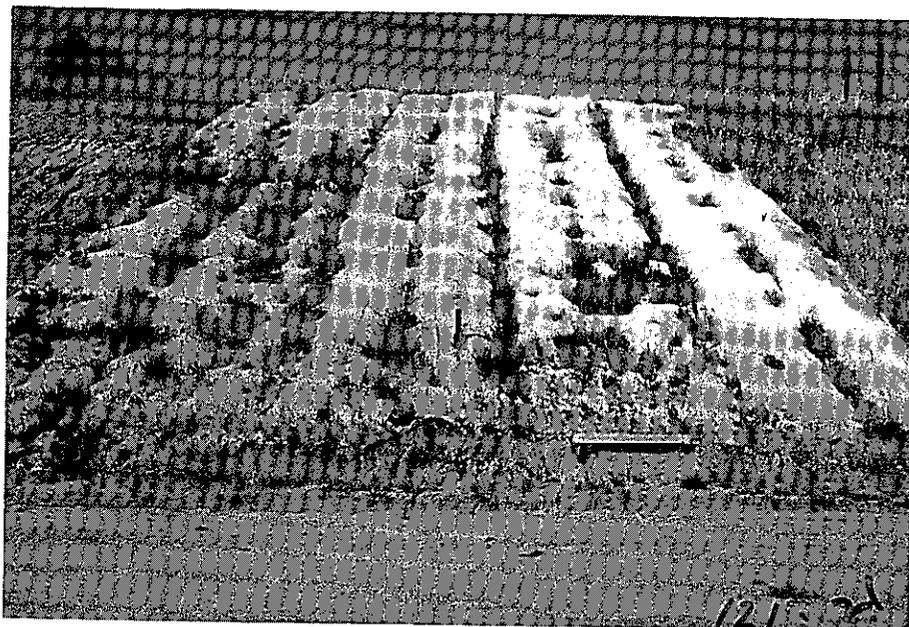
Photo 25. Plot C 23 Weeks After Installation
April 4, 1977
