FHWA/CA/TL-80/17

Roadway Damage During The San Fernando, California, Earthquake Of February 9, 1971

February 1981

Office of Transportation Laboratory
California Department of Transportation
Sacramento, California 95819

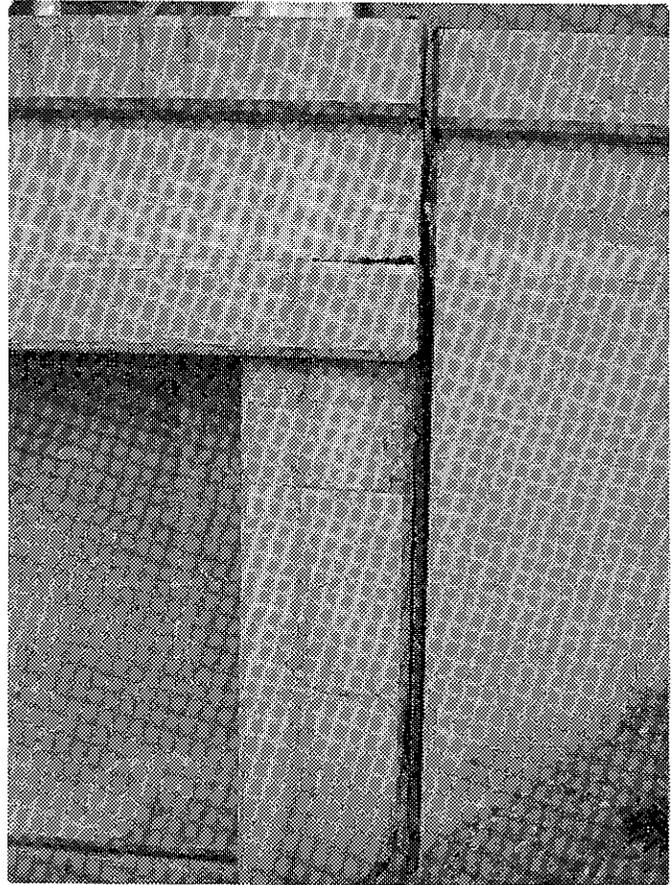
Damage to the Rinaldi Street Undercrossing consisted of abutment settlement, shattering of the abutment corners, and wingwall movement. Settlement and separation of the south abutment wingwall are shown in Photo No. 1.

Photo 1. Looking easterly at south abutment of Rinaldi Street Undercrossing. Note settlement of wingwall, separation at construction joint, and crack in diaphragm.

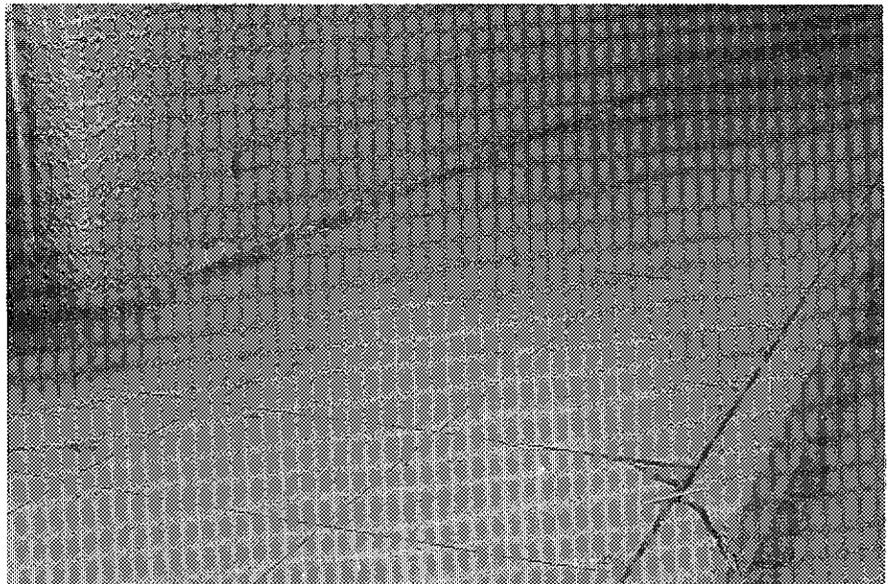
Photo 3. Typical curb crack and displacement caused by forces from curtain wall movement. Note cracks in sidewalk adjacent to curtain wall.

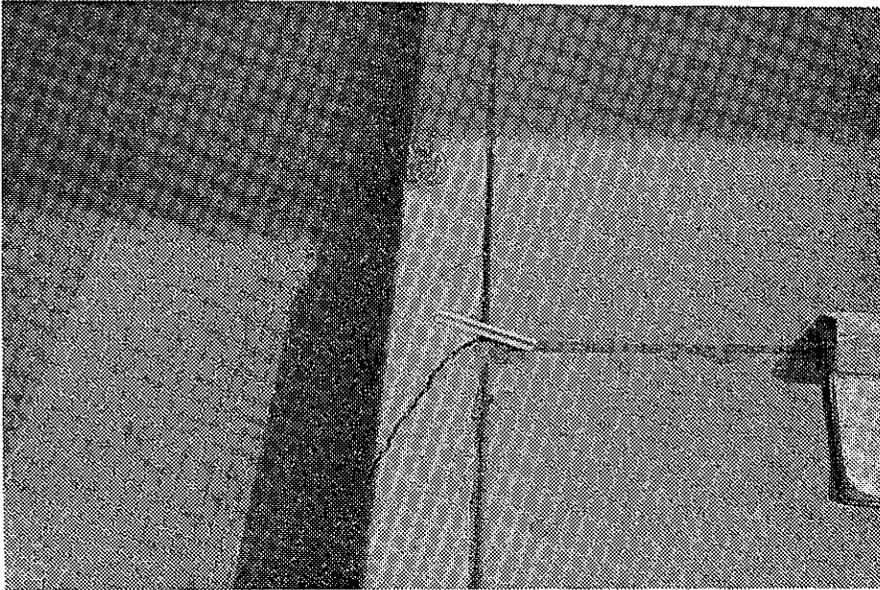
Photo 4. Typical curb crack and displacement caused by forces from curtain wall movement.

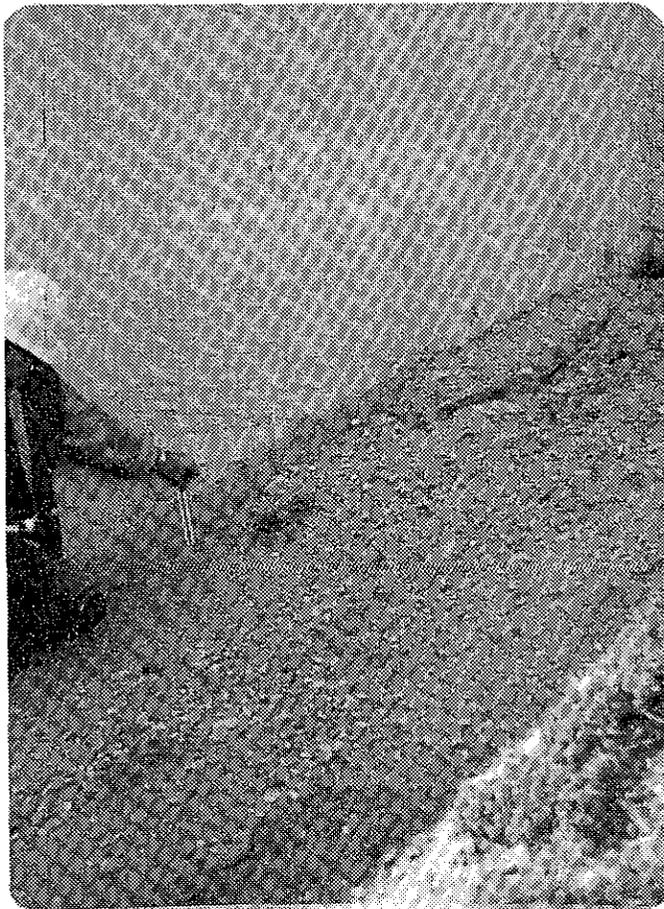
Photo 5. Looking westerly at northeast wingwall of San Fernando Mission Boulevard Undercrossing. Note fill settlement relative to wingwall.

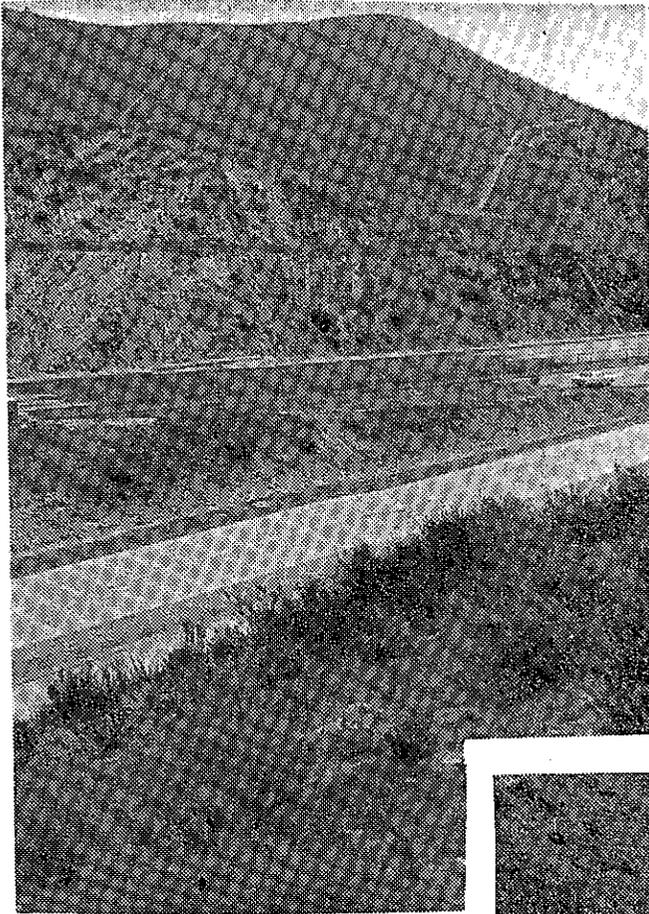
An earthquake-induced slump failure occurred at this location in a cut slope, shown in the center of Photo 14. The failure was confined entirely to the upper three-fourths of the 100-foot high cut.

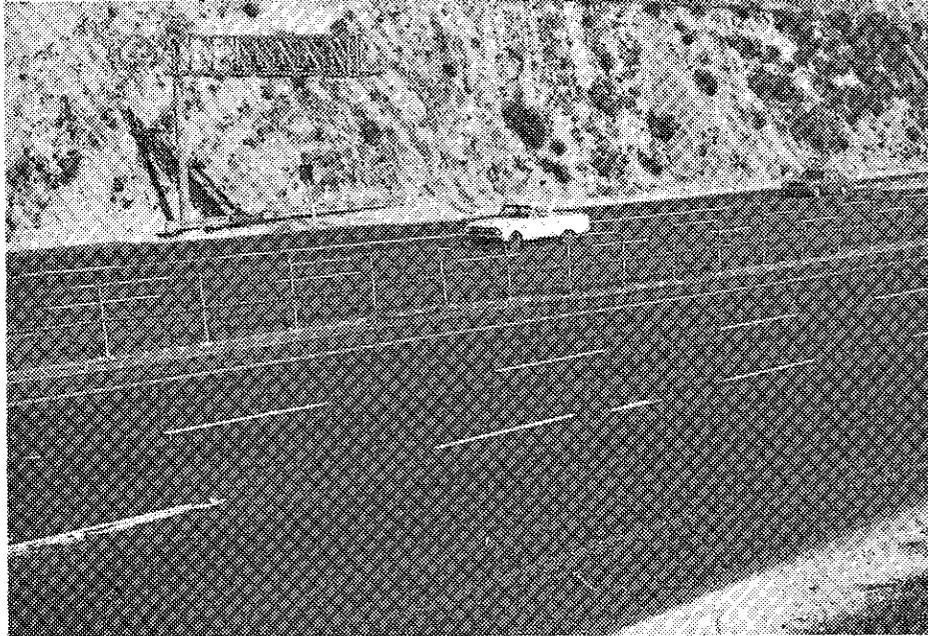
Photo 10. Looking westerly across truck lane pavement. Fault trace extended up cut slope in background.

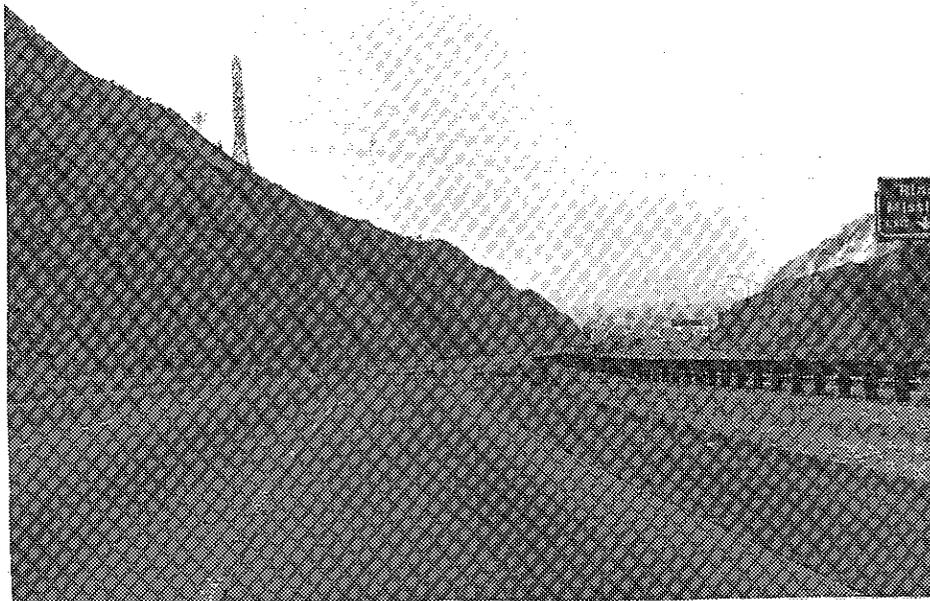
Photo 11. Looking easterly across the patched area of Route 5. A break in profile of the median fence may be noted directly in line with the vehicle near the center of photo.

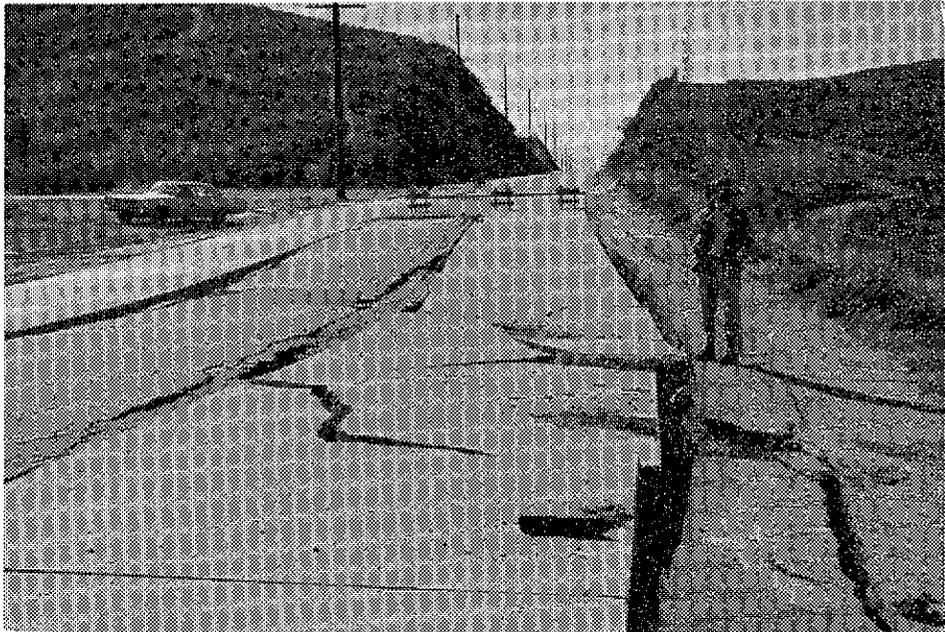
At this location, a Blucher Avenue fill slid toward the reservoir, as shown in the lower right center of Photo 6. Lateral movement of the fill and pavement damage are shown in Photo 15. Failure of the fill was possibly due to liquefaction of the saturated foundation material, although no supporting evidence to that effect was found.

Photo 15. Looking southerly along Blucher Avenue at results of fill movement to the west.

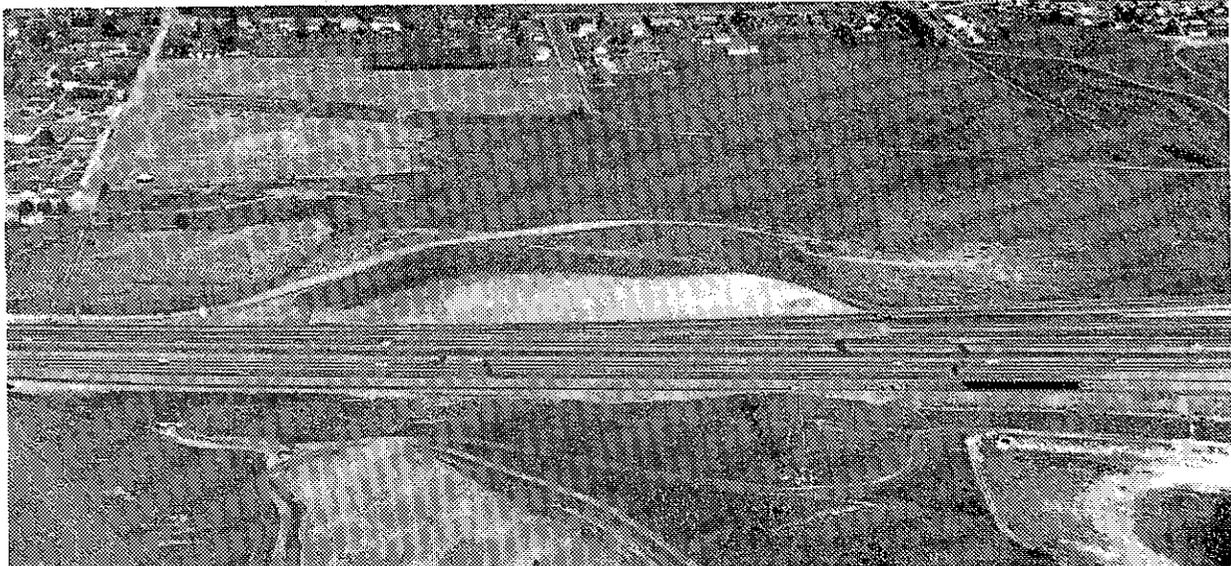
The top of the cut slope (Photo 25) was distressed by slope-shattering and transverse cracks, shown in detail in Photo 26.

Photo 25. Looking northeasterly at Route 5. Cut slope in top center sustained cracking. Note patches in pavement.

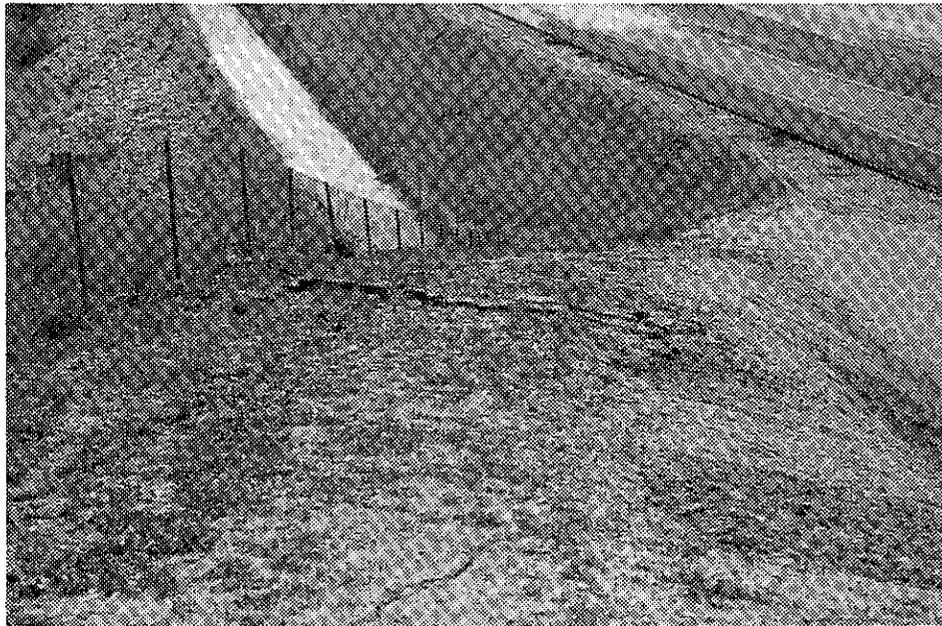
Photo 26. Typical cracks in cut slope shown in Photo 25.

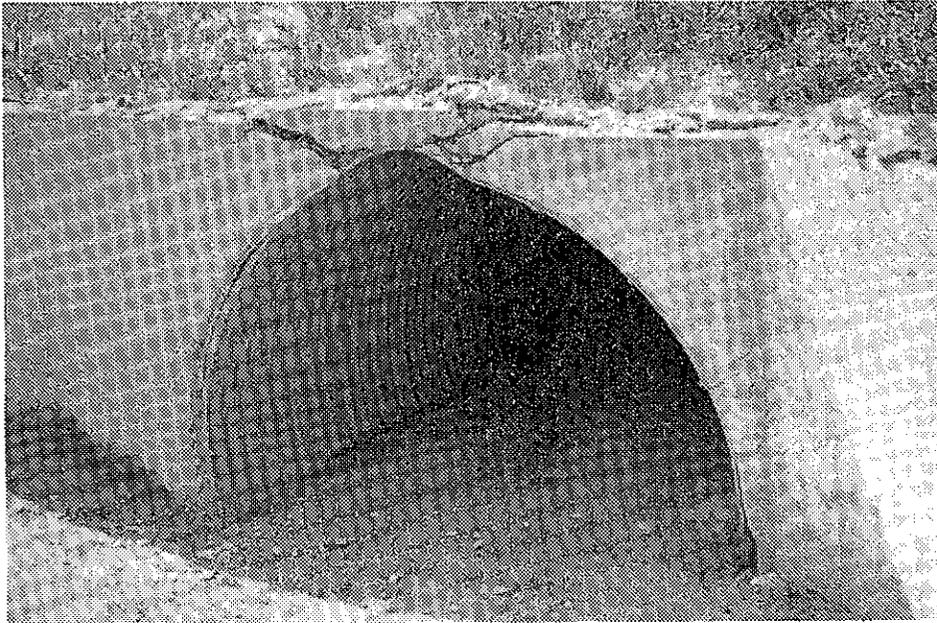
Photo 27. Cracking and distortion in drainage structure headwall.

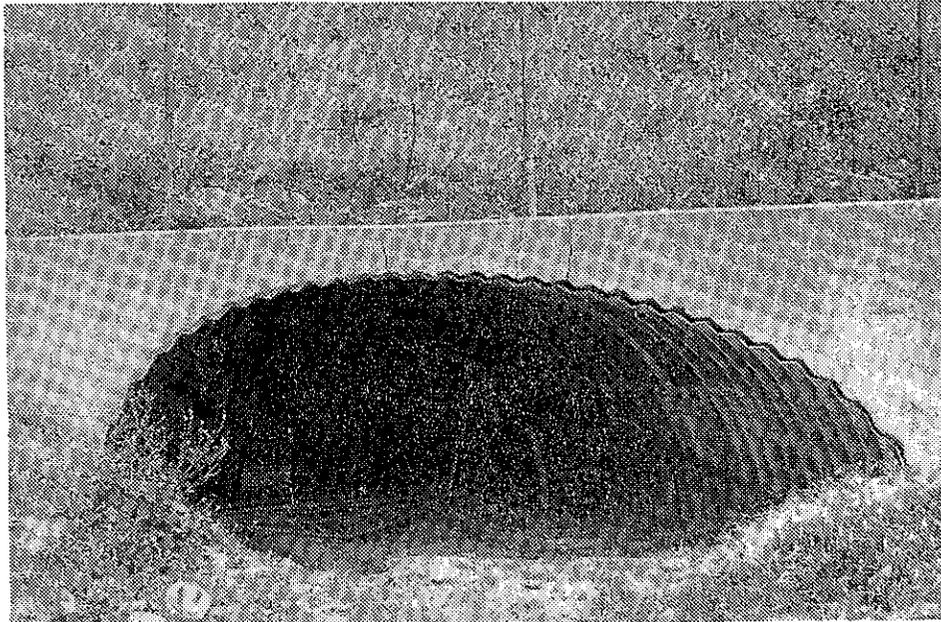
Photo 28. Cracking in drainage structure endwall. Note separation of concrete and metal at top of structure.

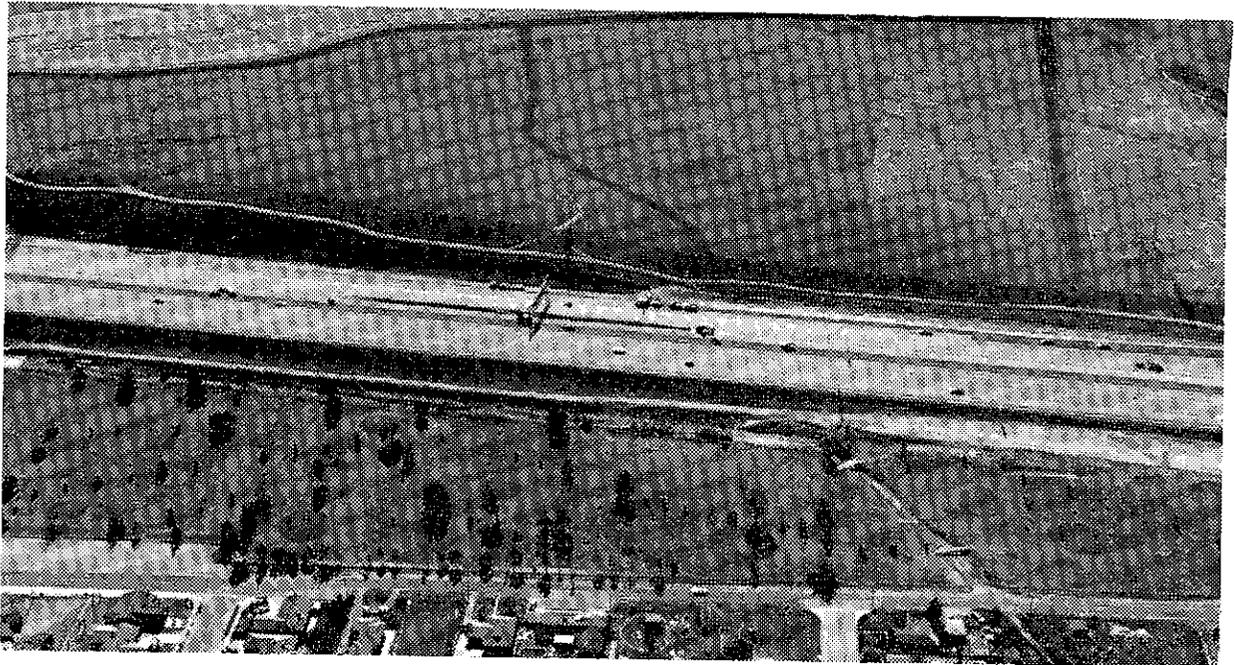
Rotational movement occurred in the cut slope on the west side of the freeway shown in Photo 29. The movement, although small, was sufficient to develop cracks behind the top of cut (Photos 30 and 31) and to upthrust the south-bound roadway surface and cause slab separation, which required patching. Four hundred feet to the south, another upthrust bulge occurred in the roadway but it did not require immediate repairs. It was not obvious upon first observation that slope movements of this nature were the cause of the roadway riding surface damage.

Photo 29. Looking westerly at Route 5.

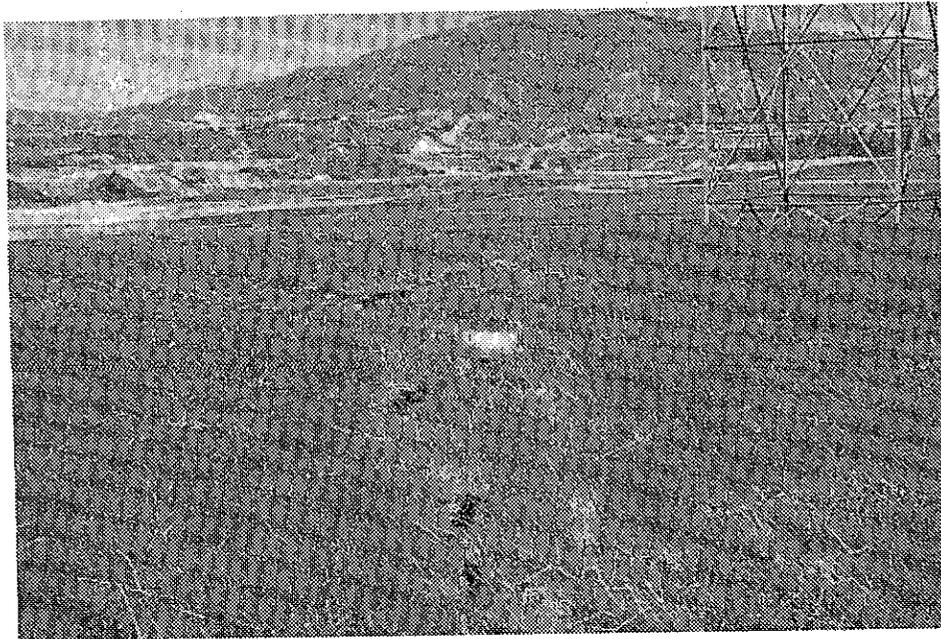
Photo 31. Cracking behind top of cut slope.

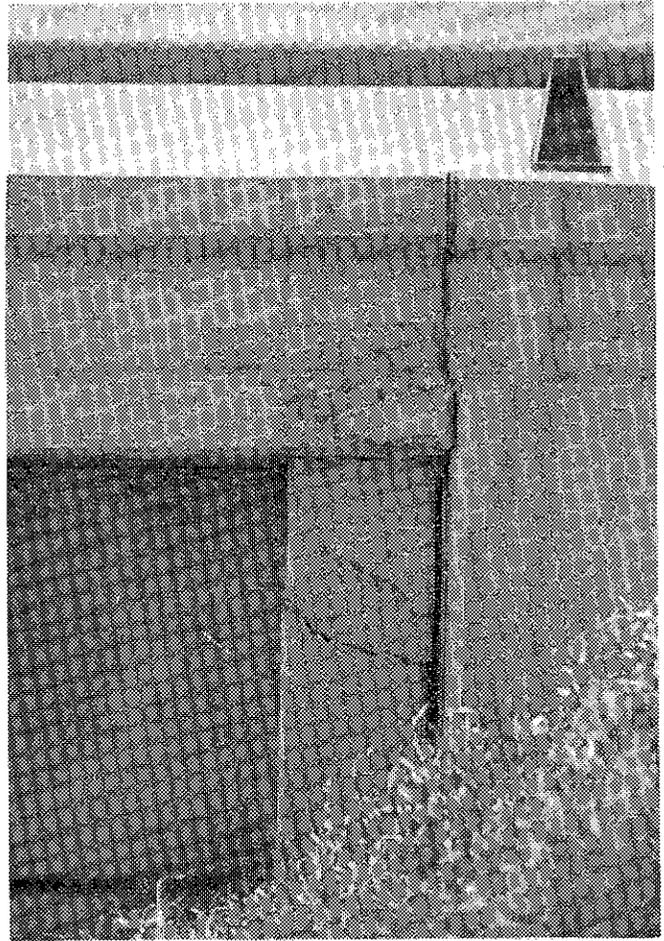
Photo 34. Separation and settlement of wing wall, cracking of abutment diaphragm, Roxford Street Undercrossing.

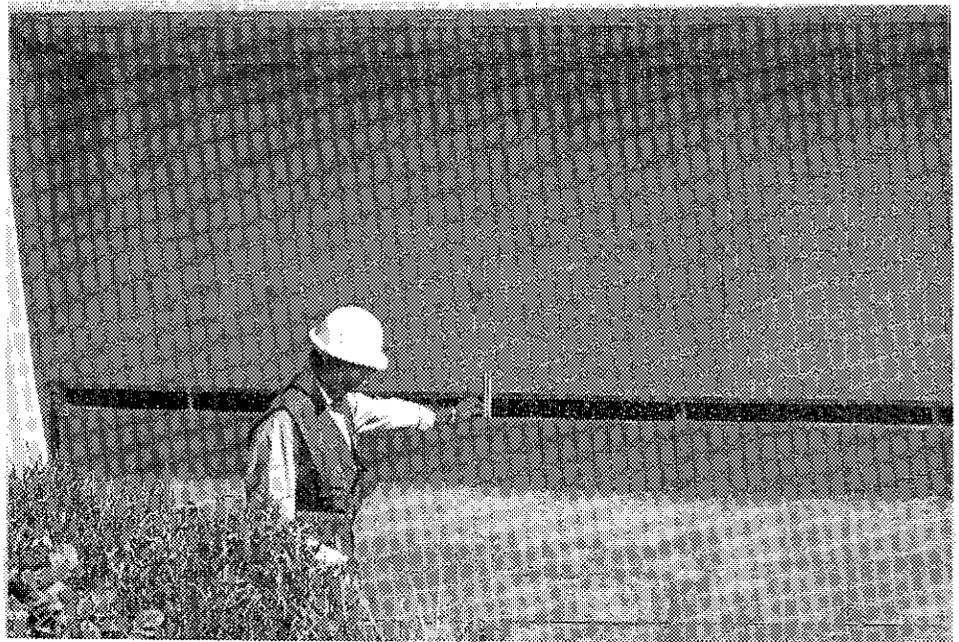
Photo 35. Settlement of concrete curtain wall from bridge girder. Note exposed rebars along separation.

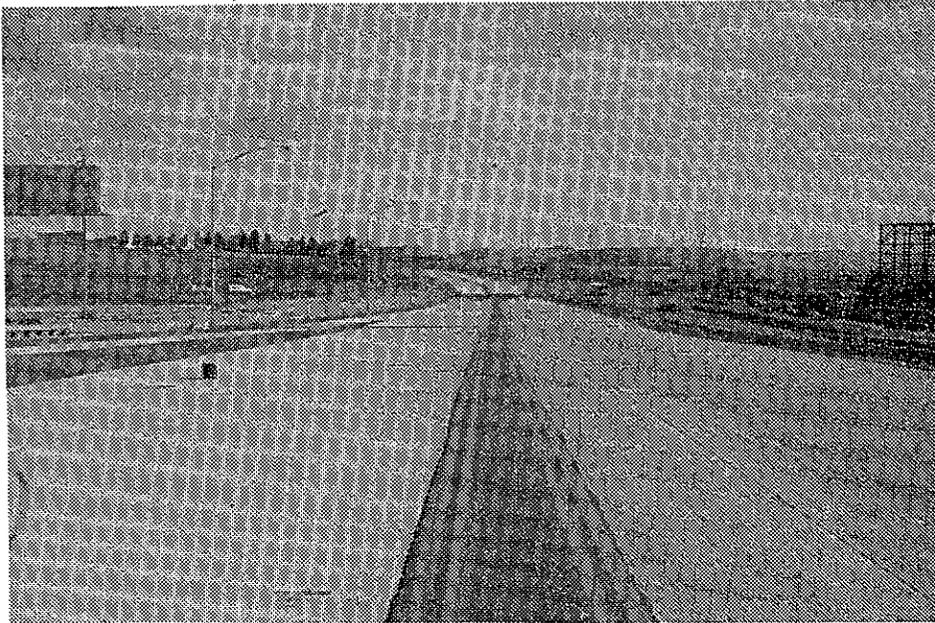
Photo 38. Looking south along Route 5. Note displacement of striping to right (west) caused by Juvenile Hall slide.

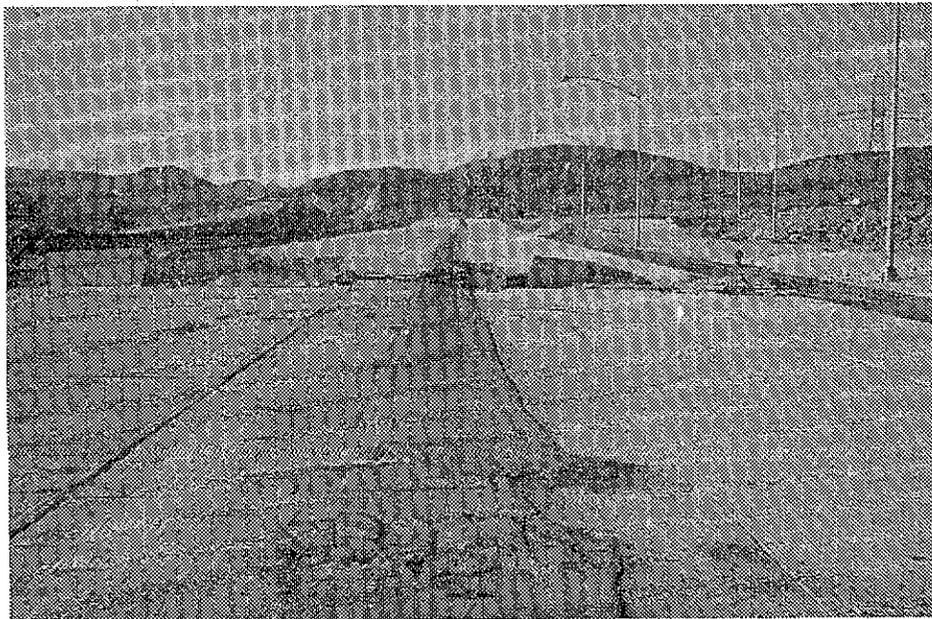
Photo 39. Looking north along Route 5. Note relative lateral slab displacement sharply delineated by striping. Northerly limit of slide displacement is shown by striping in far background. Note pavement buckle caused by extreme thrusting of slabs.

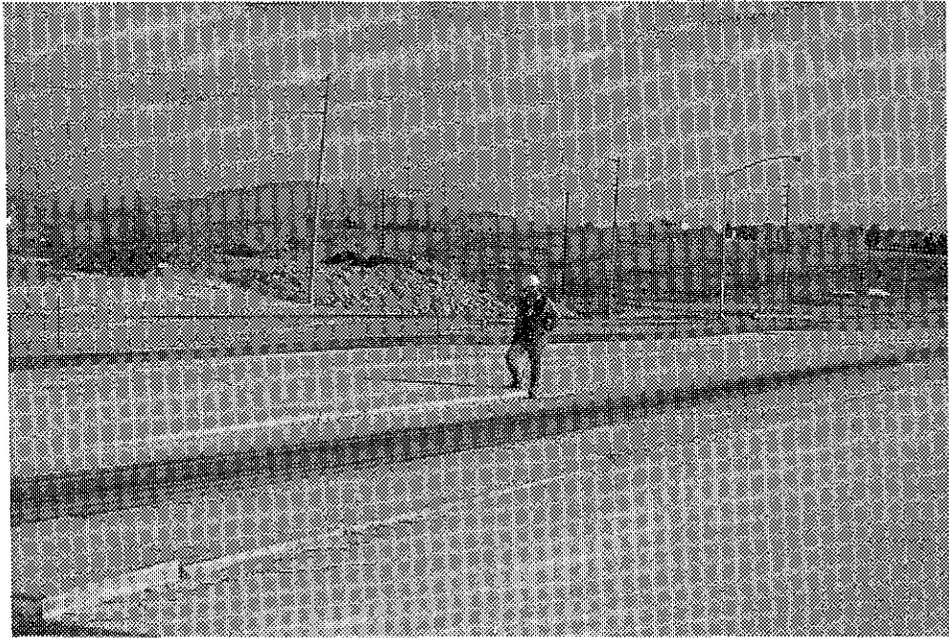
Lateral movement of the roadway along the northern flank of the slide resulted in separation, rotation, and differential heaving of pavement slabs as illustrated in Photo 40. Photos 41-43 show other features of the slide, detailed analyses of which may be found in References 7 and 9.

Photo 40. Looking southeasterly at Route 5. Northern flank of Juvenile Hall slide crossed pavement here, resulting in pavement slab movement.

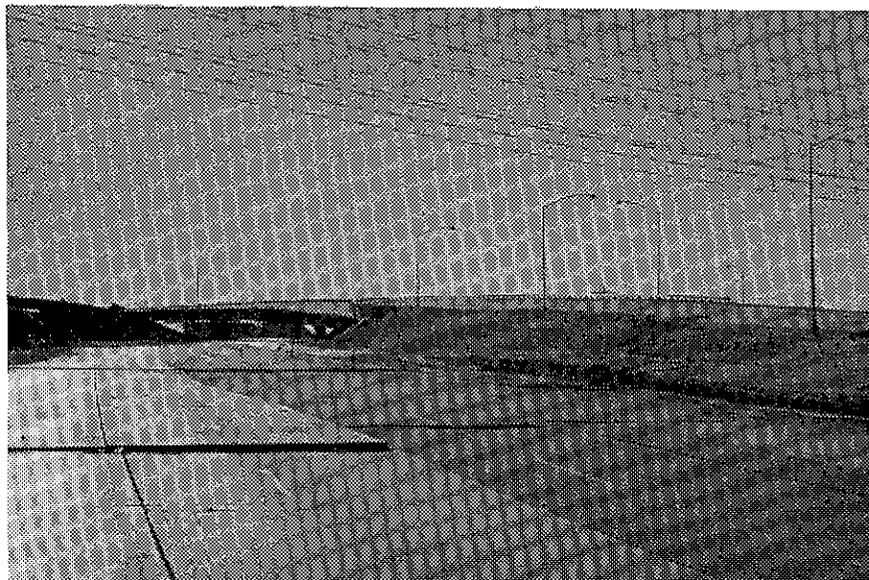
Pavement slabs were faulted badly across the northbound roadbed of Route 5 and Connectors C-Y, D-Y, and M-Y. As may be noted from Photos 46, 47, and 48, typical faulting and slab separation occurred at both longitudinal and transverse joints. The large displacement shown in Photo 47 is the result of a large crack extending up the fill slope. An interesting feature of the pavement distress is that Route 5 at this location is essentially at original ground level (Figure 7) although the slab behavior was typical of pavement on fills.

Photo 46. Looking southeasterly at Route 5 northbound truck lanes. Note slab separation, laterally and vertically, at joints. Damaged D-Y Connector Structure is in background.

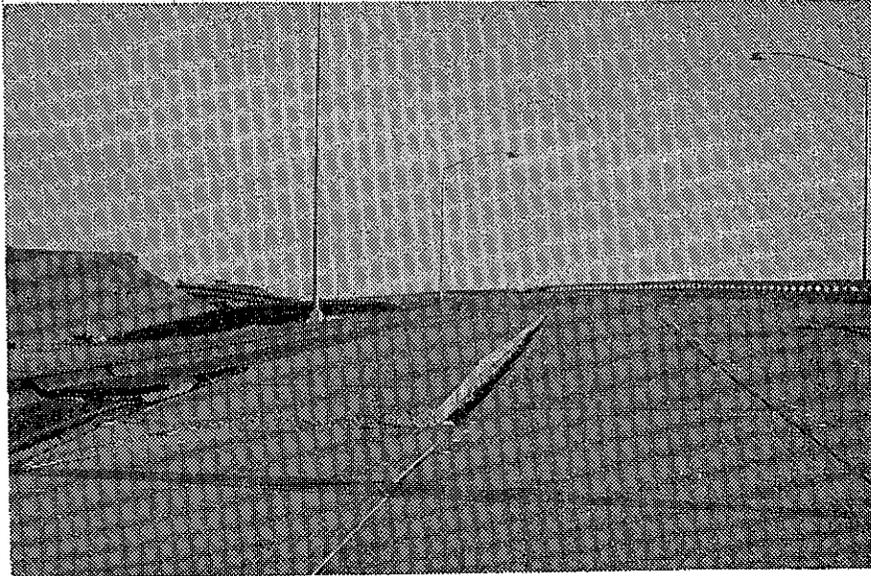
Photo 47. Looking southeasterly along Connector D-Y, at damaged fill-supported pavement.

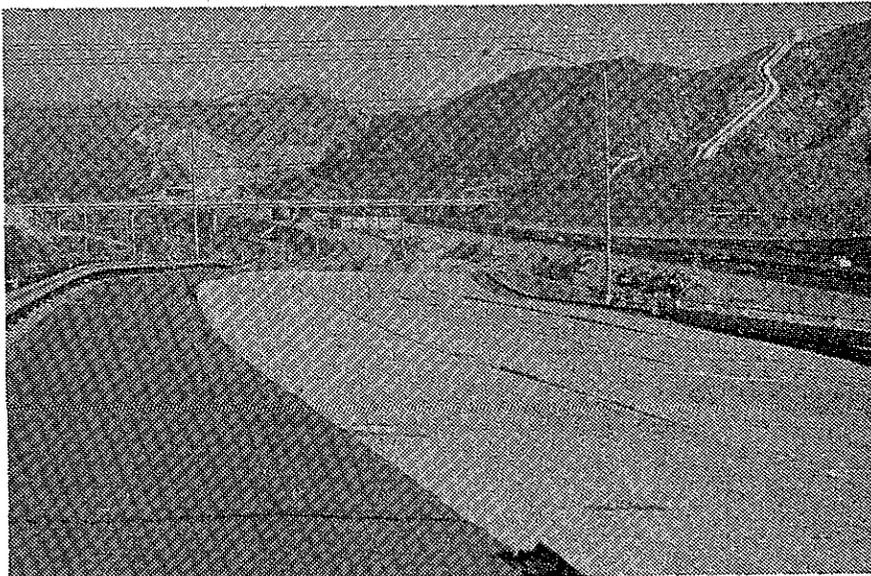
Photo 48. Looking northwesterly along Connector D-Y, at pavement slab faulting, separation, and undulations due to fill movement.

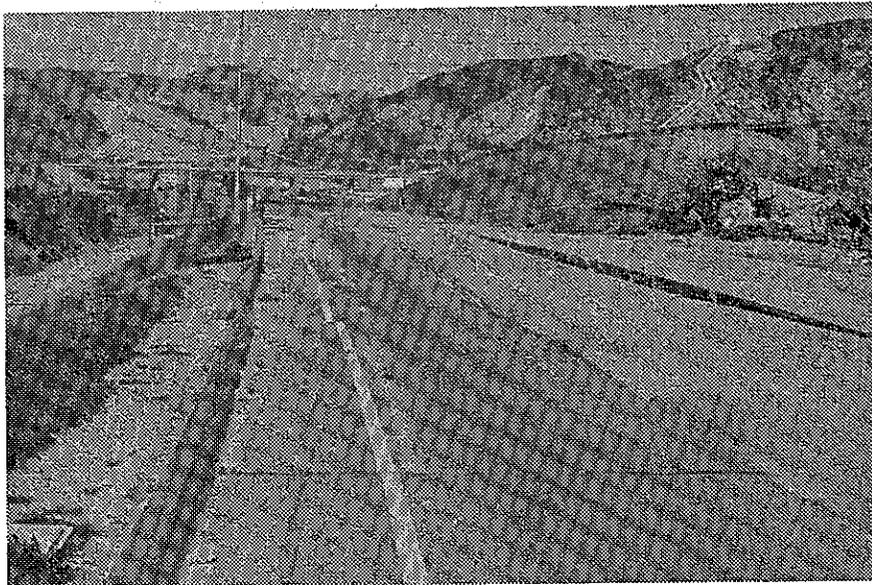
The pavement of the Route 5 Southbound Truck Freeway was faulted and displaced laterally due to shearing action in the fill (Photo 49). The shear pattern, traced diagonally down the fill slope, outlined a complete volume of material that probably would have collapsed had strong motion been of a longer duration. The roadway profile and alignment were deformed as shown in Figures 11 and 12.

Photo 49. Looking northerly at damaged pavement of Route 5 southbound truck freeway caused by fill movement.

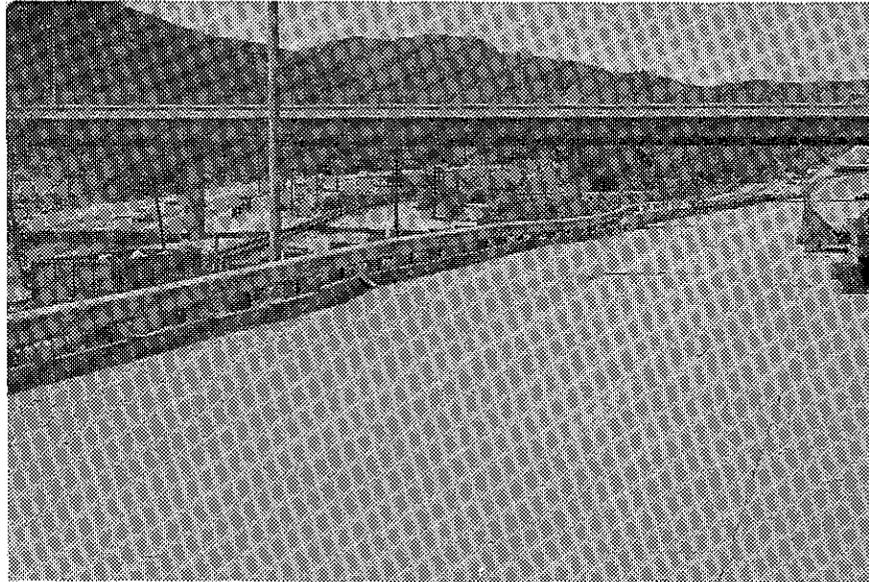
Photo 50. Looking northerly at undulating pavement of Route 5 caused by differential settlement. Balboa Boulevard Overcrossing structure is in background.

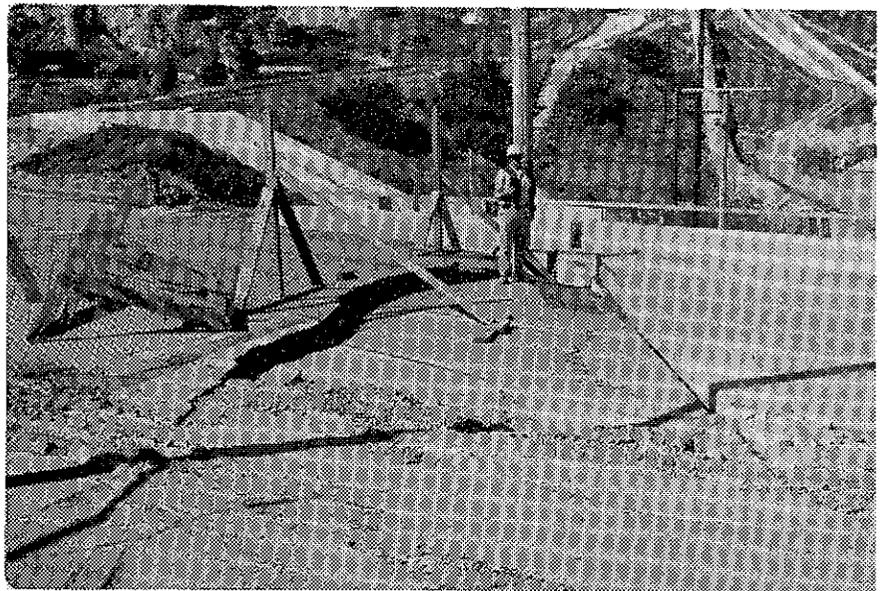
Backfill at the northwesterly abutment of Br. 53c-316 settled about 8 inches as shown in Photo 53. The settlement is clearly defined in the photograph because the pavement was asphalt concrete which does not provide a bridging effect as do the portland cement concrete slabs.

Photo 53. Settlement of abutment backfill at northerly end of Bridge 53c-316.

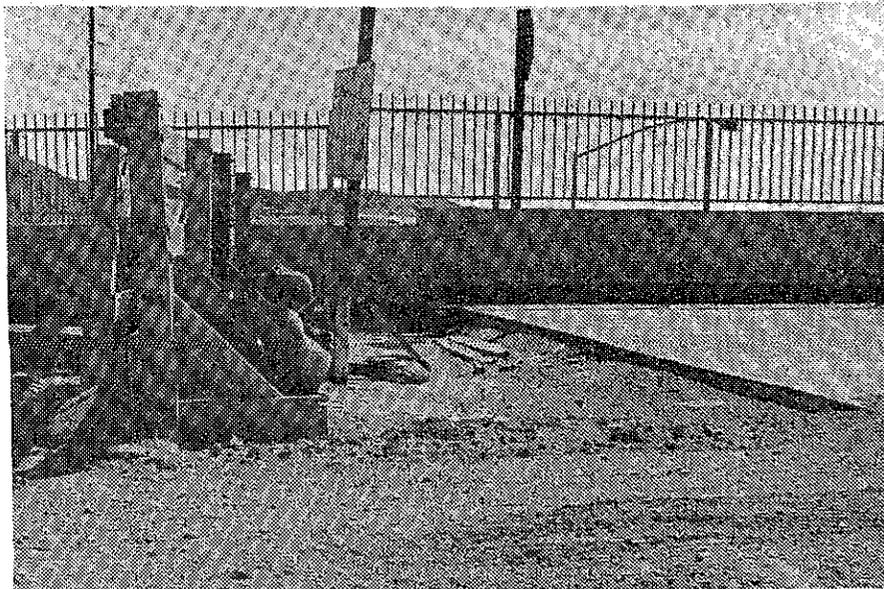
Both approaches to Balboa Boulevard Overcrossing suffered backfill settlement. Photo 54 shows the easterly approach settlement of about 8 inches at the bridgedeck and wingwall joint. The bridge abutment was founded on piles while the wingwalls were on spread footings founded in the embankment. Approximately 25 feet of fill rests over original ground at the easterly bridge approach.

Photo 54. Approach and wingwall settlement at easterly end of Balboa Boulevard Overcrossing.

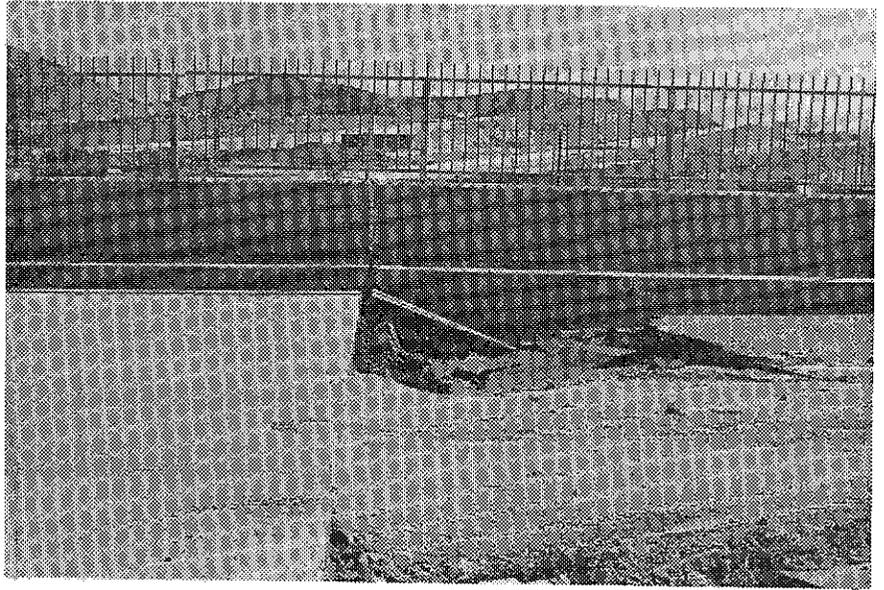
The westerly approach was constructed in cut section with both the bridge abutment and wingwalls founded on spread footings. Backfill at the paving notch settled several inches, while the bridge deck and wingwall remained in essentially the same place, as shown in Photo 55. The abutment failed in shear and rotation about a horizontal axis as shown in Photo 56 and tended to arch the deck as can be seen along the neat line of the concrete guardrail shown in Photo 57.

Photo 55. Westerly approach to Balboa Boulevard Overcrossing. Note abutment backfill settlement but lack of differential settlement between wingwall and abutment.

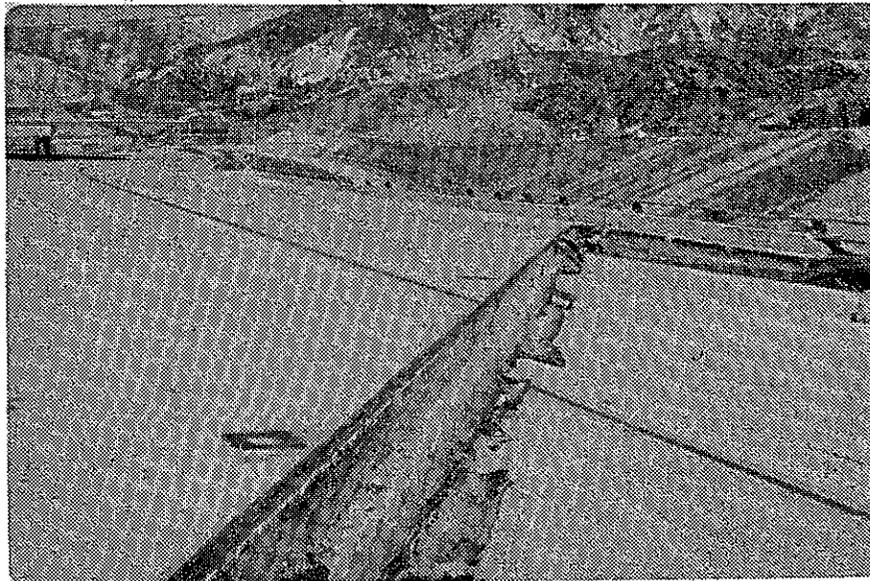
The vertical alignment of the bridge and retaining wall (wingwall) remained essentially the same, as can be seen in Photo 59. Since both were founded on spread footings in very dense original ground, and the vertical alignment remained uniform, the observed settlement is believed to be due to densification and loss of backfill material into voids created by the superstructure displacement during strong seismic shaking.

Photo 59. Settlement at the easterly approach to Bridge 53-1991R on the D-Y Connector, Route 5/210 Interchange.

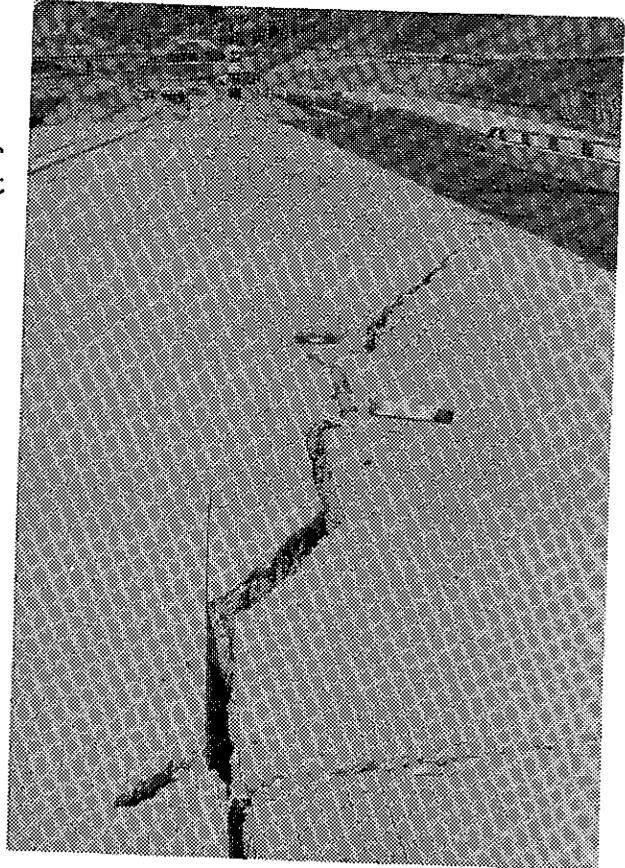
Photo 60. Cracking and movement of D-Y Connector pavement immediately west of Bridge 53-1991R.

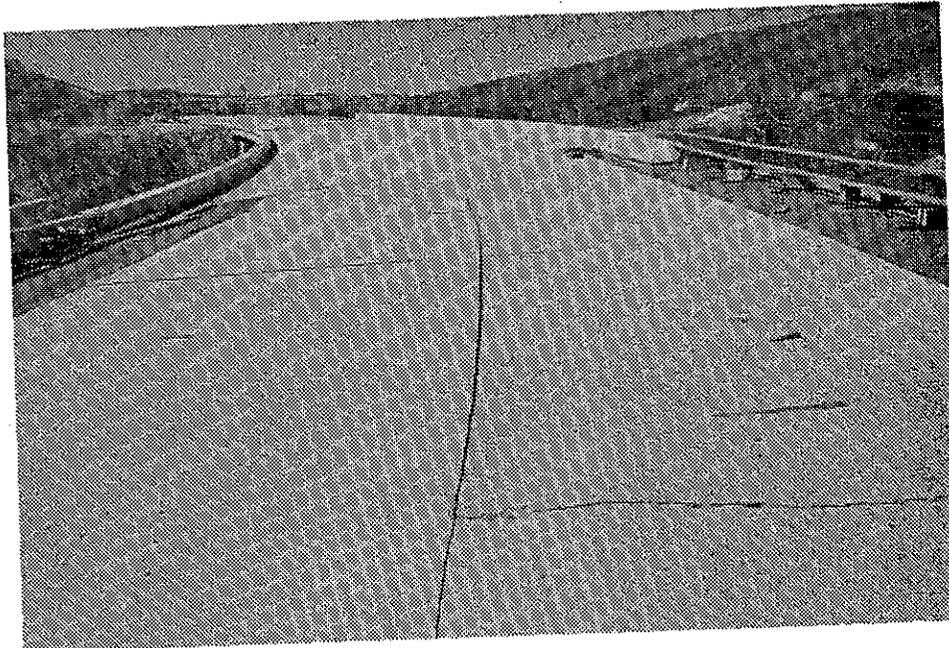
Photo 61. Pavement cracks and movement at the easterly approach to Bridge 53-1988L on the A-Y Connector, Route 5/210 Interchange.

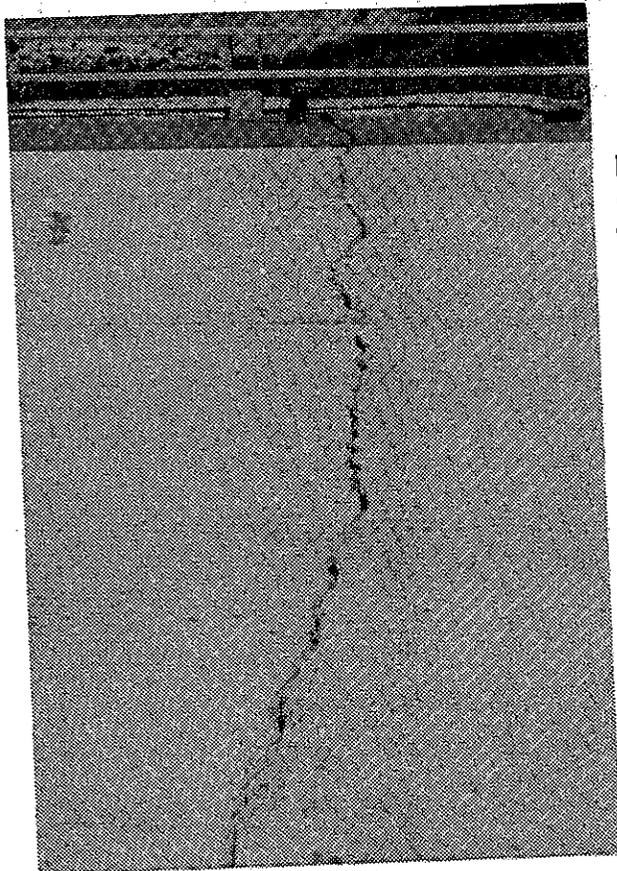
Photo 62. Transverse pavement crack at cut/fill contact near easterly approach to Bridge 53-1988 on the A-Y Connector.

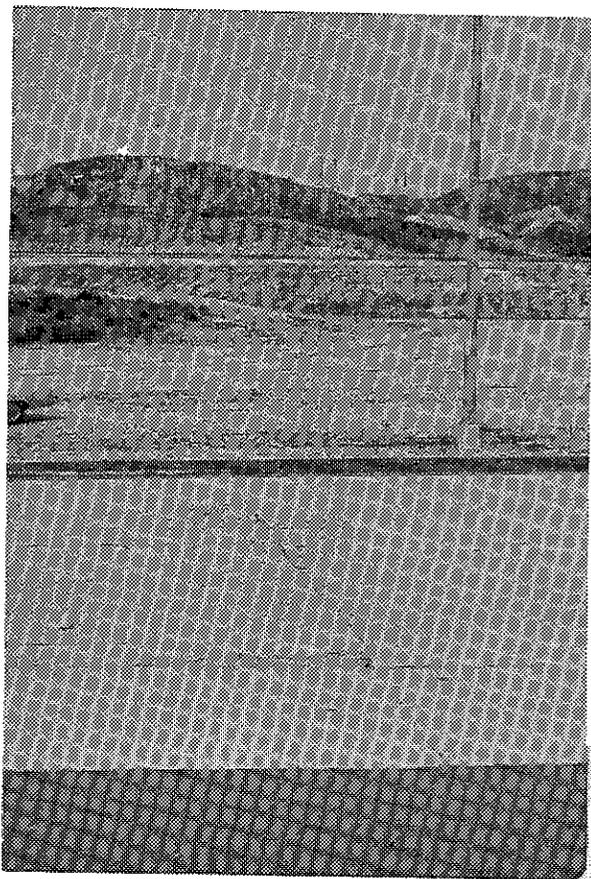
Photo 66. Transverse pavement crack on Connector C-Y. (Light standard is same as shown in Photo 65.)

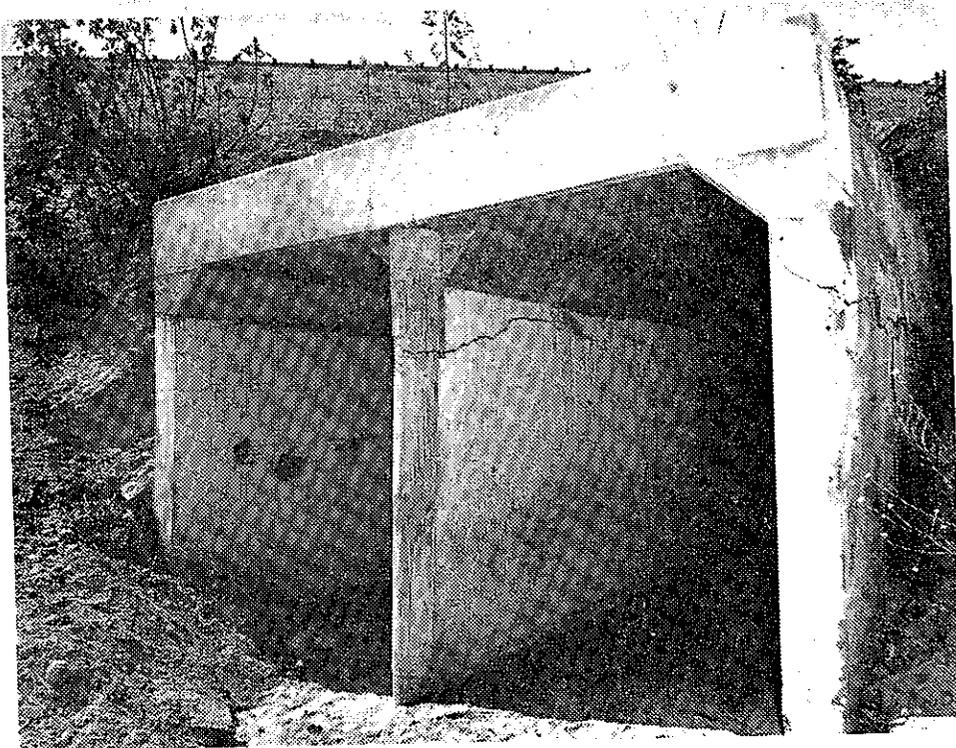
Photo 68. Cracking in reinforced concrete double box culvert. Note vertical members are out of plumb.

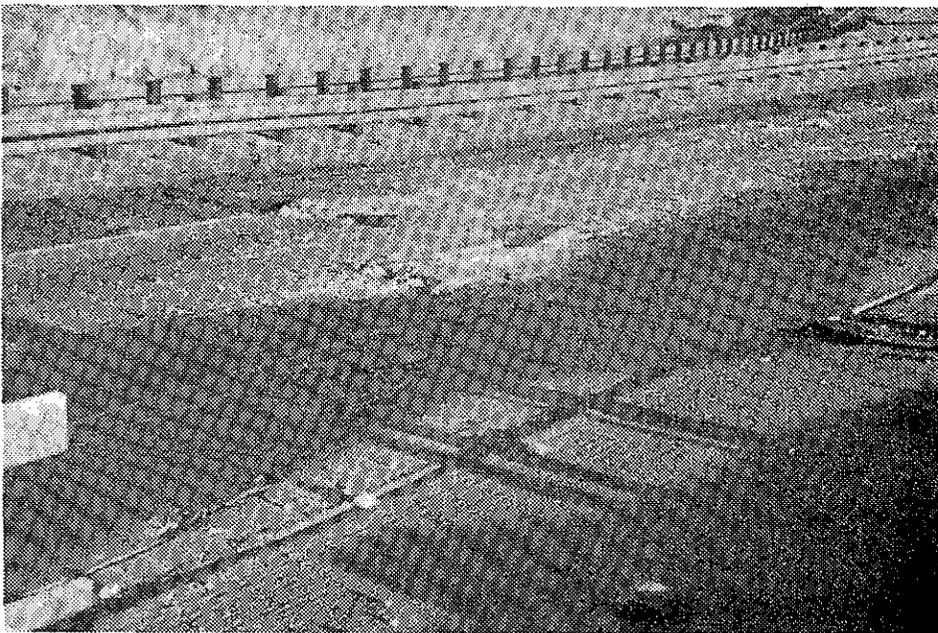
Photo 75. Closer view of pavement damage shown in Photo 74.

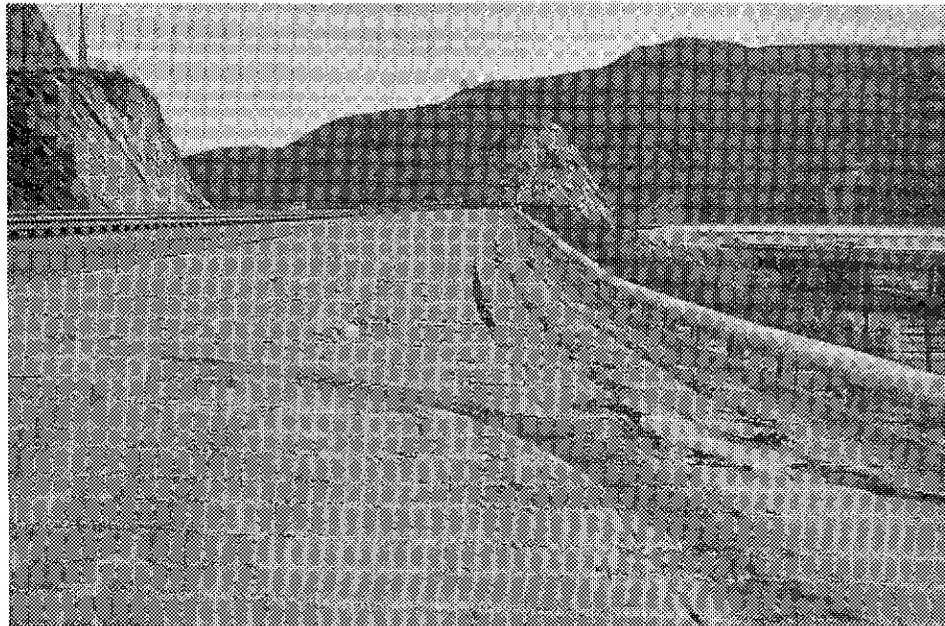
Photo 76. Longitudinal cracking in pavement due to lateral movement at top of cantilever retaining wall. Pavement has been broken mechanically for removal.

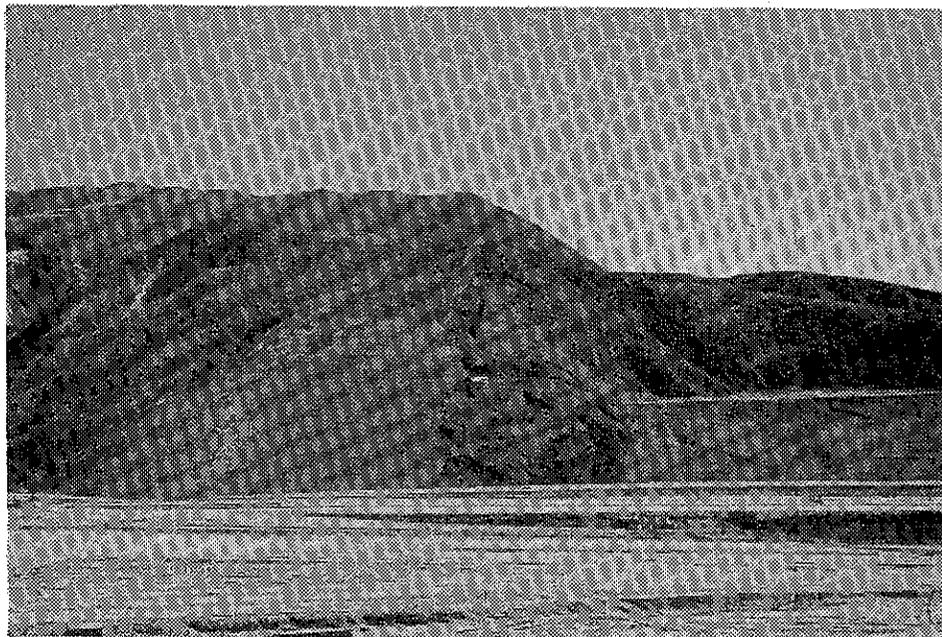
Photo 79. Looking easterly at a slide in a cut slope, immediately south of the Route 5/14 Interchange.
