FHWA/CA/TL-80/17

Roadway Damage During The San Fernando, California, Earthquake Of February 9, 1971

February 1981

Office of Transportation Laboratory
California Department of Transportation
Sacramento, California 95819

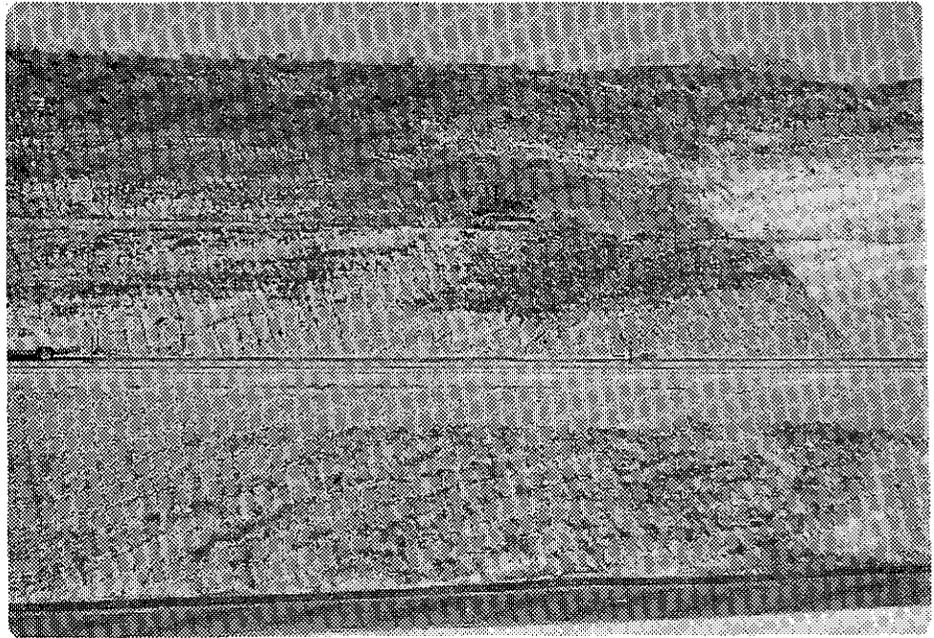
Photo 80. Looking easterly at quake-activated ancient slide in cut slope.

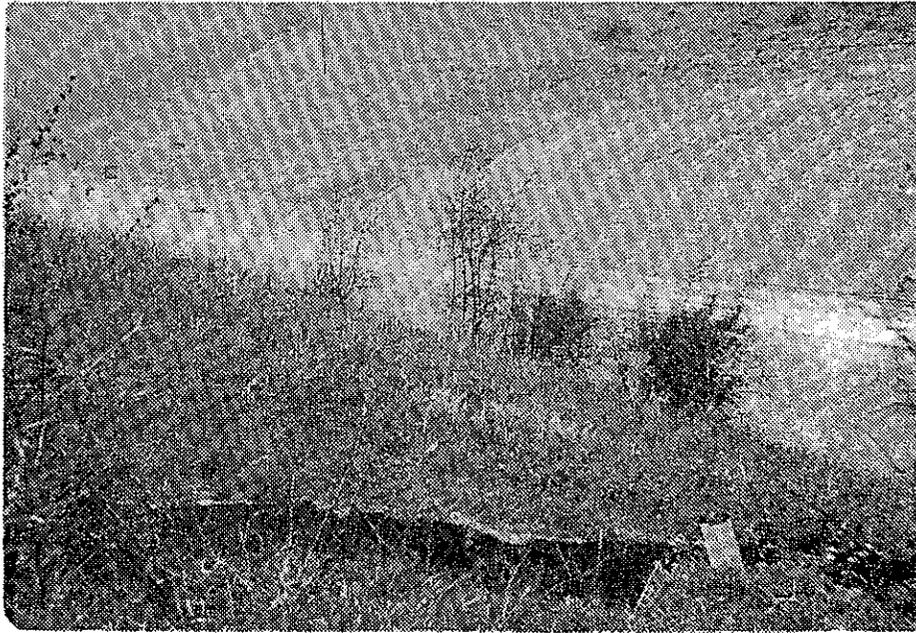
Photo 82. Ground breakage at top of cut slope on east side of Route 5.

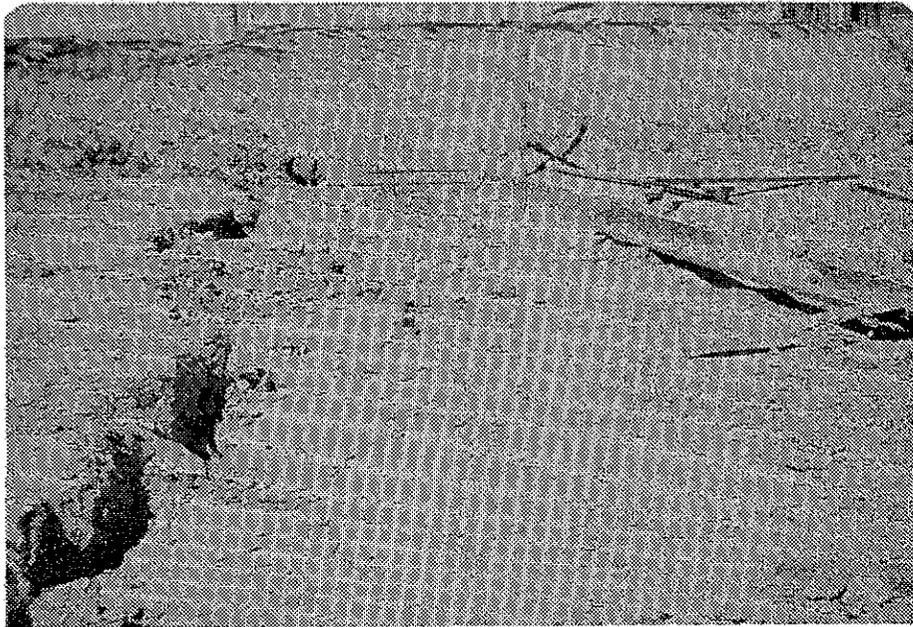
Photo 86. Abutment backfill settlement at the Via Princessa Undercrossing. Note large crack which delineates limit of backfill.

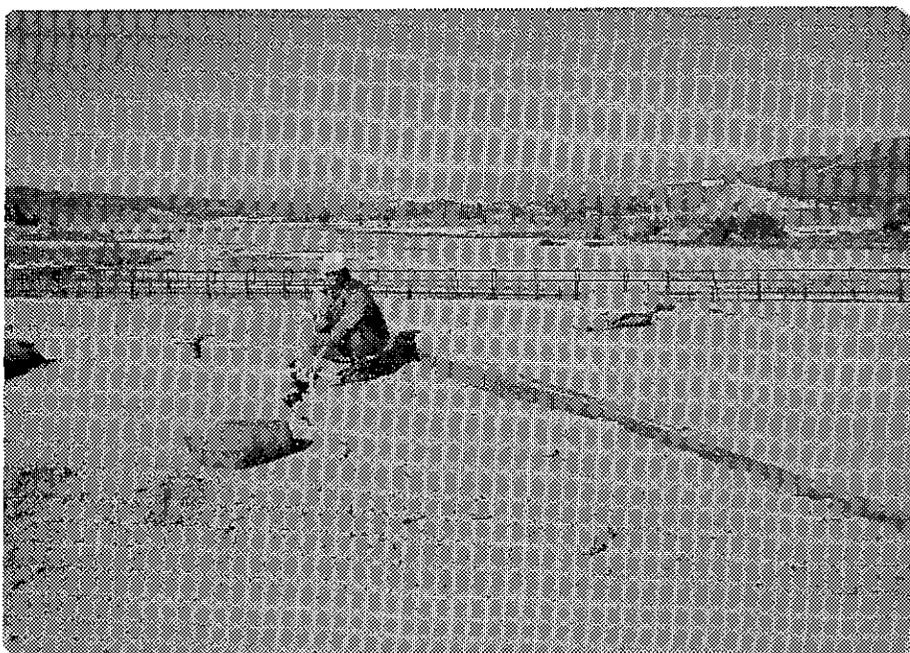
photo 89. Abutment backfill settlement at the Santa Clara River Bridge (west abutment, west-bound structure).

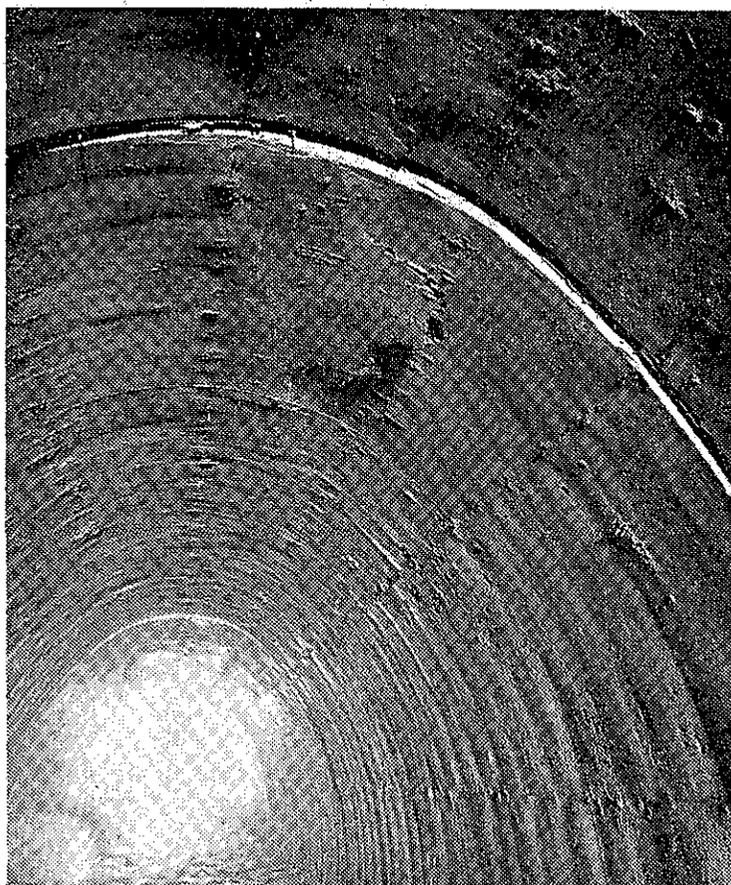
Photo 91. Minor spalling and joint separation in an 11-foot concrete arch culvert.

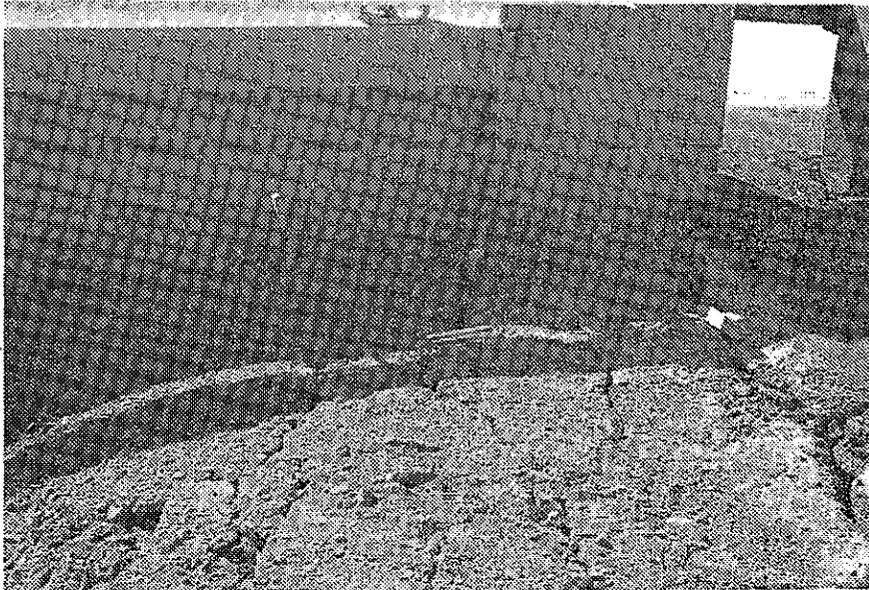
Photo 97. Fill cracking and settlement in median at Yarnell Street Undercrossing.

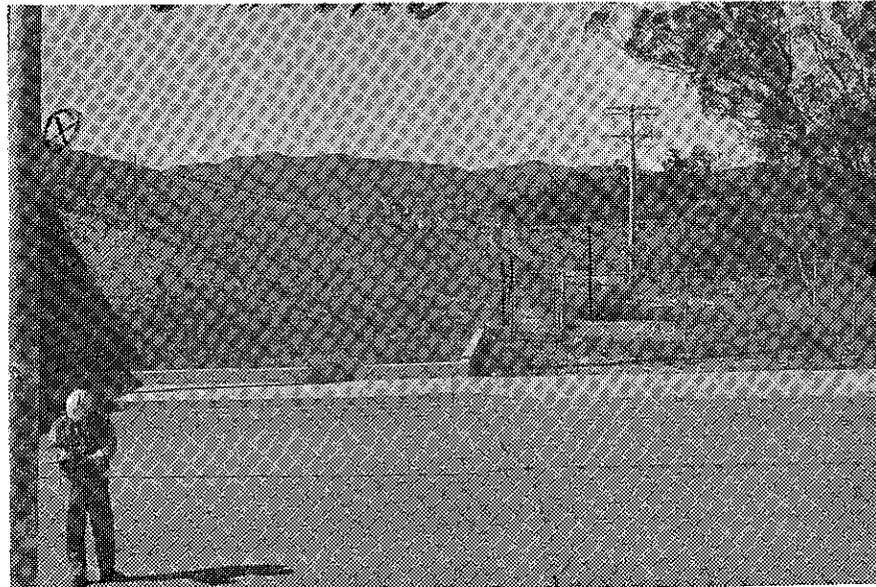
Photo 100. Looking west across Glenoaks Boulevard at tension cracks in AC pavement caused by differential settlement.

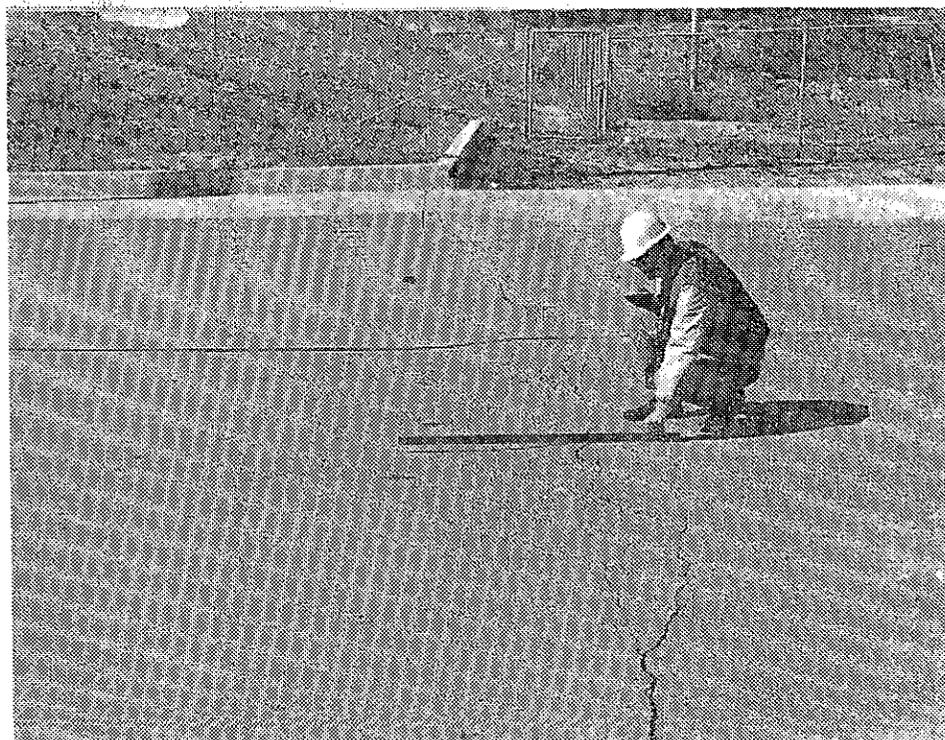
Photo 101. Looking west across Glenoaks Boulevard at tension cracks in AC pavement caused by differential settlement.

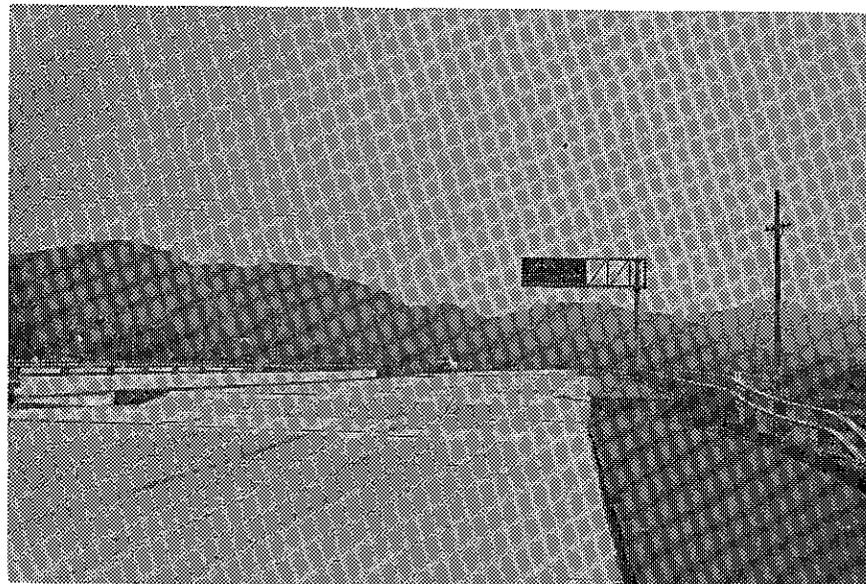
Photo 104. Looking east at the eastbound structure of the Roxford Street Undercrossing. Note settlement of pavement relative to structure deck. Note also separation of pavement slabs and the broken approach slab. The tire skid marks leave little doubt as to the whereabouts of one motorist at the time of the earthquake.
