FHWA/CA/TL-87/10

The Effectiveness of Portland Cement Concrete Pavement Rehabilitation Techniques

August 1987

Office of Transportation Laboratory
California Department of Transportation
Sacramento, California

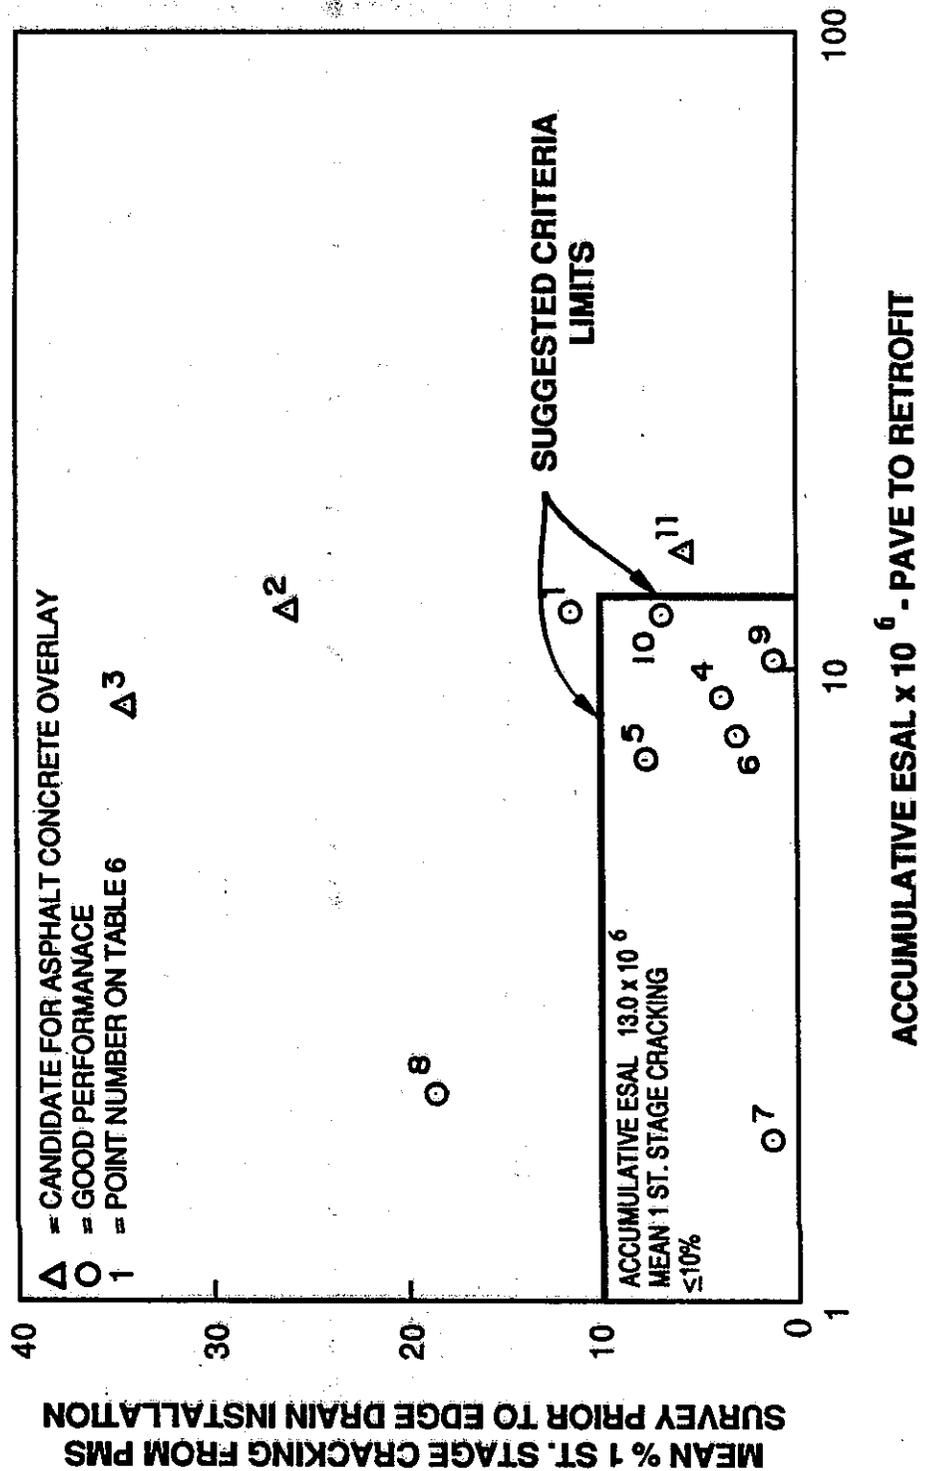
Figure 2, RETROFIT EDGE DRAIN PERFORMANCE 1985 PMS SURVEY

Point No.	Dist	Co.	Rt	Edge Drain Limits	Year Paved	Year Installed	Years W/O Edge drains	Accum** ESAL x 10=6	Cracking Prior to Installation		Cracking Prior to 1985 Performance		
									%1st L	%3rd R	%1st L	%3rd R	
1	2	Teh	5	0/23.0	'66	'83	17	12.4	10	12	3	1	0
2	2	Teh	5	24.5/28.6	'65	'80	15	12.4	27	21	4	2	Δ
3	2	Sha	5	11.5/19.0	'67	'80	13	8.8	30	35	6	4	Δ
4	3	Yo1	5	6.2/10.0	'69	'82	13	9.1	4	2	2	1	0
5	3	Co1	5	18.7/21.5	'71	'79	8	7.2	7	8	3	1	0
6	3	Gle	5	0/7.6	'70	'79	9	8.0	3	1	1	0	0
7	4	Son	101	42.9/44.9	'75	'80	5	1.8	1	1	0	0	0
8	4	Son	101	44.8/48.8	'75	'81	6	2.1	19	16	1	3	0
9	6	Fre	5	52.4/55.2	'71	'82	11	10.2	1	1	0	1	0
10	10	SJ	205	4.0/13.1	'70	'79	9	12.2	7	6	0	0	0
11	10	SJ	580	9.0/15.3	'66	'81	15	15.5	6	4	0	1	Δ

L = Left outside lane.
R = Right outside lane.
*The symbol Δ, failing indicates the PCCP is now a rehabilitation candidate.
**At the time edge drains were installed.
