| 4. TITLE AND SUBTITLE<br><b>INVESTIGATION OF THE CRASHWORTHINESS OF BARRIER MOUNTED HARDWARE:<br/>BARRIER MOUNTED SIGN AND SIGNPOST</b> | | 5. REPORT DATE<br><br><b>June 2011</b> | |
| 9. PERFORMING ORGANIZATION NAME AND ADDRESS<br><b>Roadside Safety Research Group<br/>California Department of Transportation<br/>5900 Folsom Blvd.<br/>Sacramento CA. 95819</b> | | 10. WORK UNIT NO. | |

# INVESTIGATION OF THE CRASHWORTHINESS OF BARRIER MOUNTED HARDWARE: BARRIER MOUNTED SIGN AND SIGNPOST

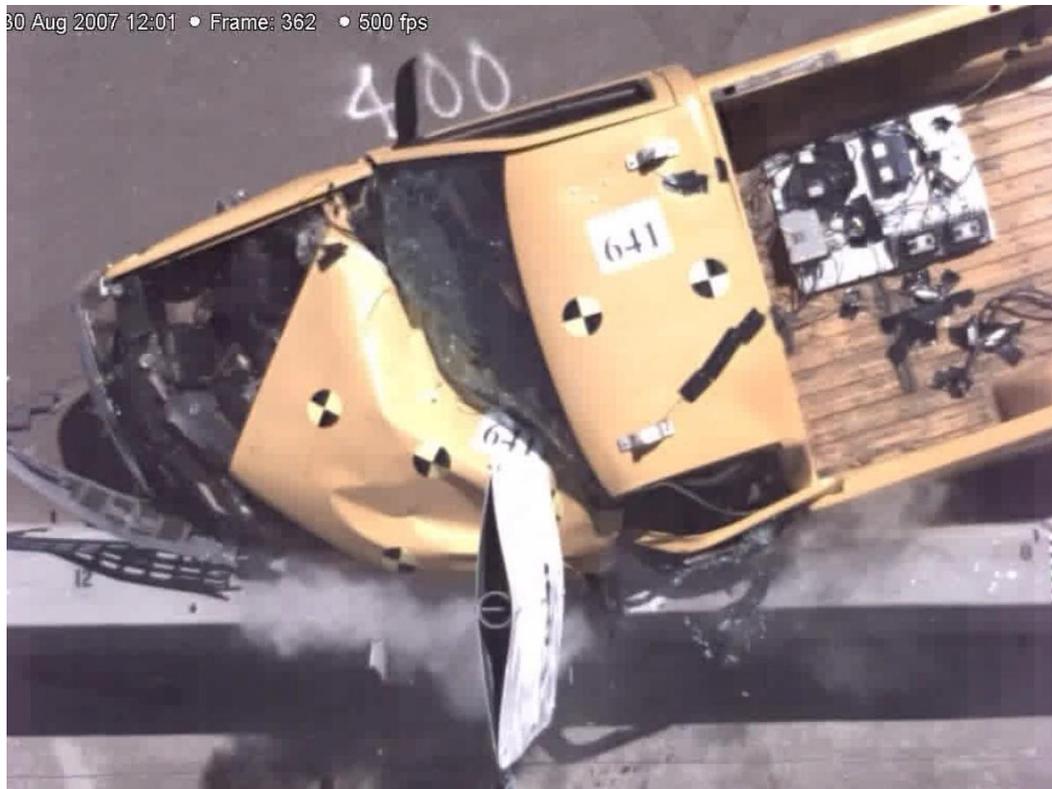
Figure 2-7 Vehicle Impacting Signpost and Barrier

The vehicle was parallel and had full contact with the barrier at 0.254 seconds after impact. Also, the front grill had completely broken away from the vehicle and was thrown along the top of the barrier. The brake flash bulb located on the top of the vehicle triggered at 0.284\* seconds after impact and occurred while the vehicle was fully airborne. The vehicle lost contact with the barrier at 0.414 seconds. At 0.634 seconds all four of the vehicle's tires were in contact with the ground. The grill of the vehicle crossed to other side of the barrier at 1.184 seconds. The final resting place of the grill was in the opposing traffic side of the barrier. The vehicle came to rest at 3.064 seconds after the impact.

1. The impact of a  $\frac{3}{4}$ -ton pick-up truck into the 101.6-mm (4-in) O.D. steel signpost mounted to a Type 60 barrier caused significant occupant compartment deformation on the impacted side of the vehicle, which could cause excessive injuries to the driver and passengers. The majority of the vehicle deformation consisted of 1) hood snagging on the post and 2) sheet metal tearing on the transverse mounting bolts.
2. There was an excessive amount of debris that could become a hazard to on-coming traffic.
3. The barrier successfully redirected the vehicle as designed and had cosmetic damage only.
4. The signpost assembly successfully remained on the concrete barrier and would require minor maintenance.
5. Based on the conclusions listed above, the saddle-mounted sign support is not crash-worthy according to NCHRP Report 350 criteria.

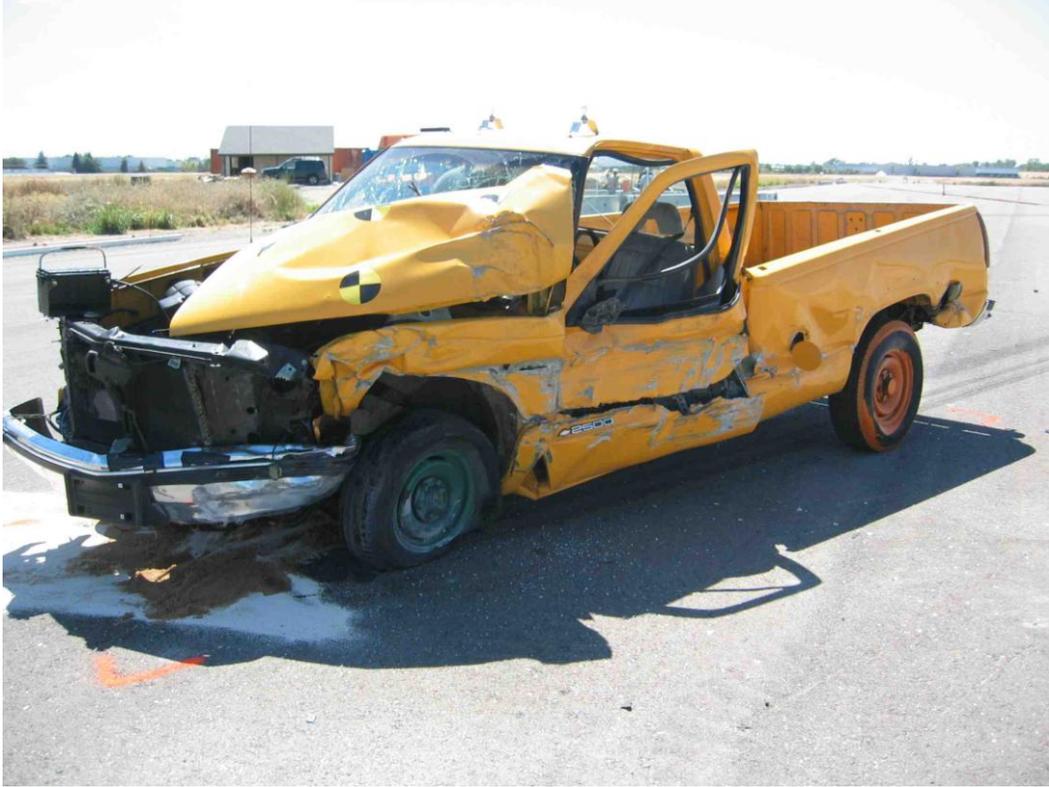
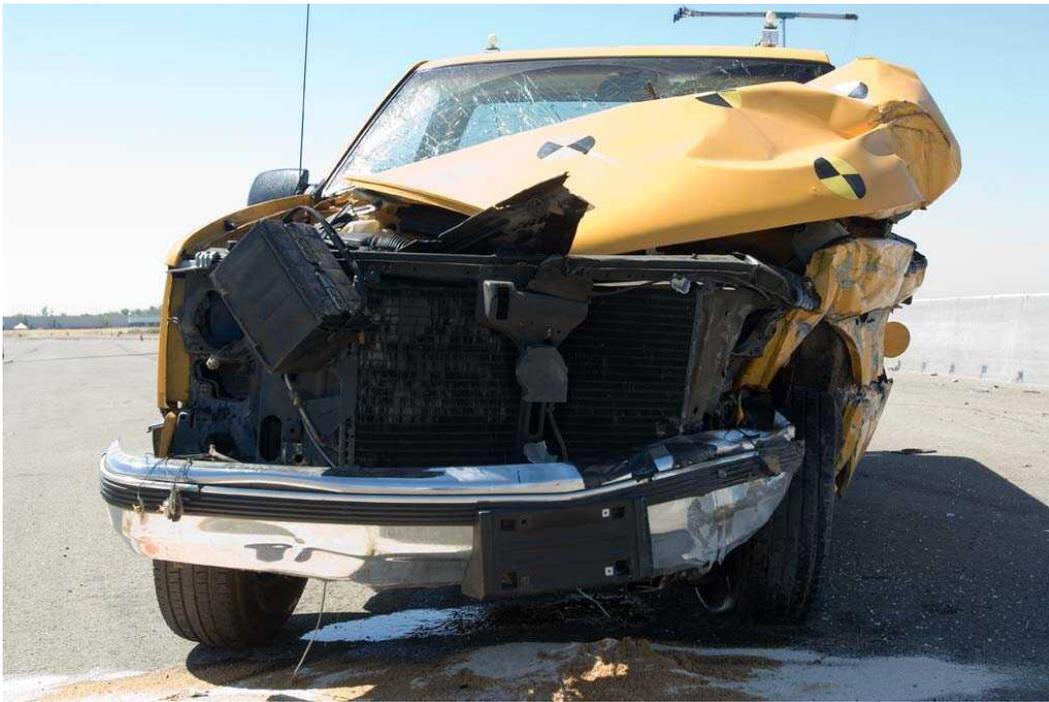
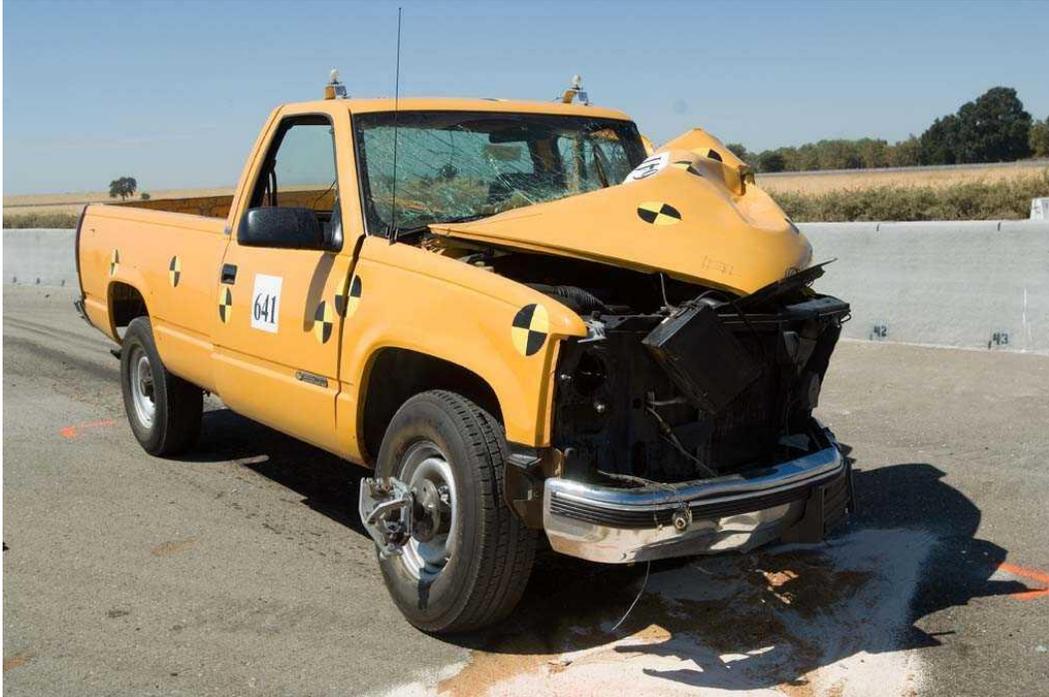
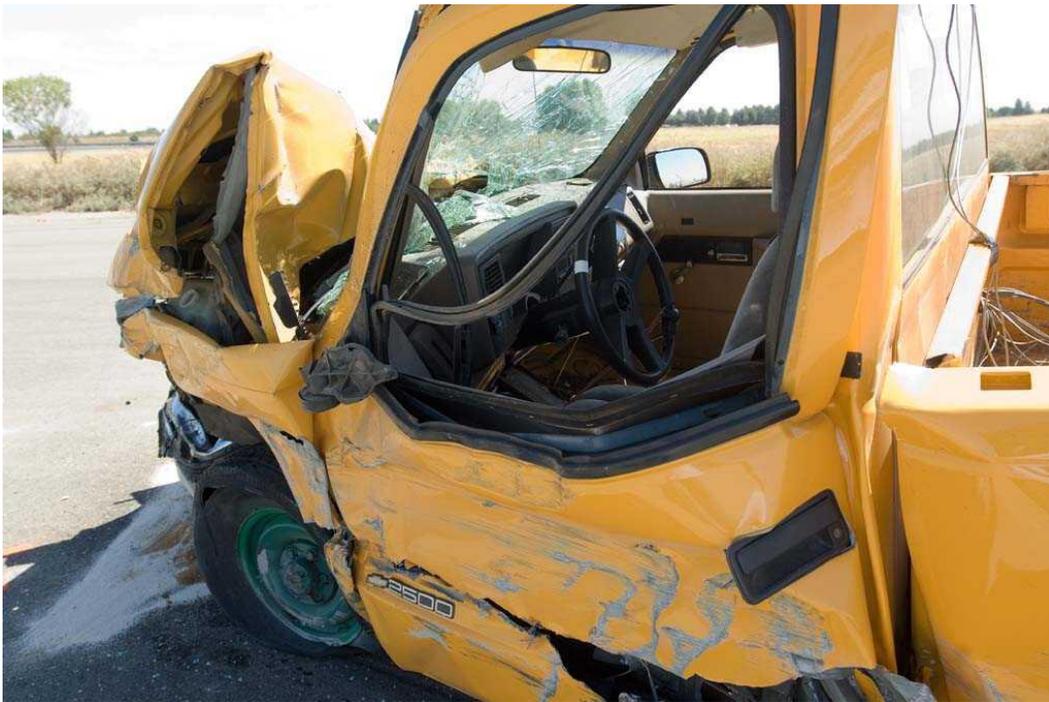
The driver's side front quarter of the vehicle sustained significant damage in the initial impact with the barrier. The amount of damage increased as the hood impacted the signpost. The front left wheel was pushed backward 340 mm (13.4 in) from its initial location. The hood penetrated the windshield by 250 mm (9.8 in) measured from the bottom center of the windshield to the resting place of the hood. The vehicle's battery had been thrown out of the engine compartment but was still held in place by the negative terminal cable. The top of the driver side door had buckled outward from the vehicle's frame. The jagged slice down the side of the vehicle caused by the signpost bolts is due to the sustained contact with the barrier. Inspection of the occupant compartment revealed that the dashboard was pushed back 202 mm (8.0 in) toward the driver. The driver side had a peak loss of 98 mm (4.0 in) measured between the bottom of the dashboard and the floorboard.

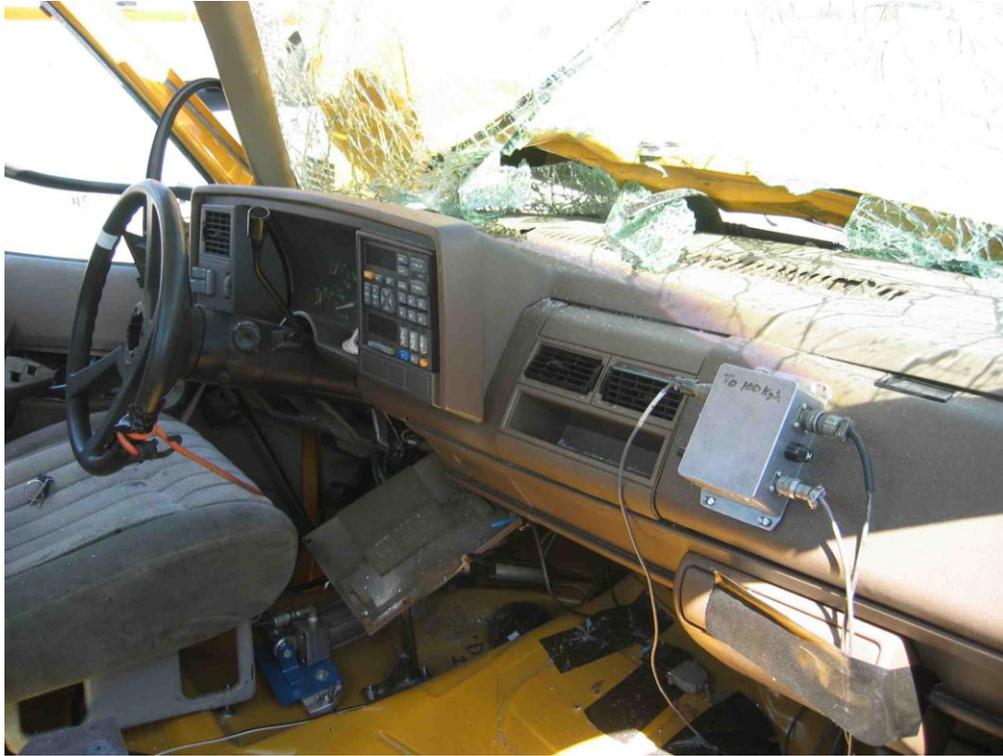
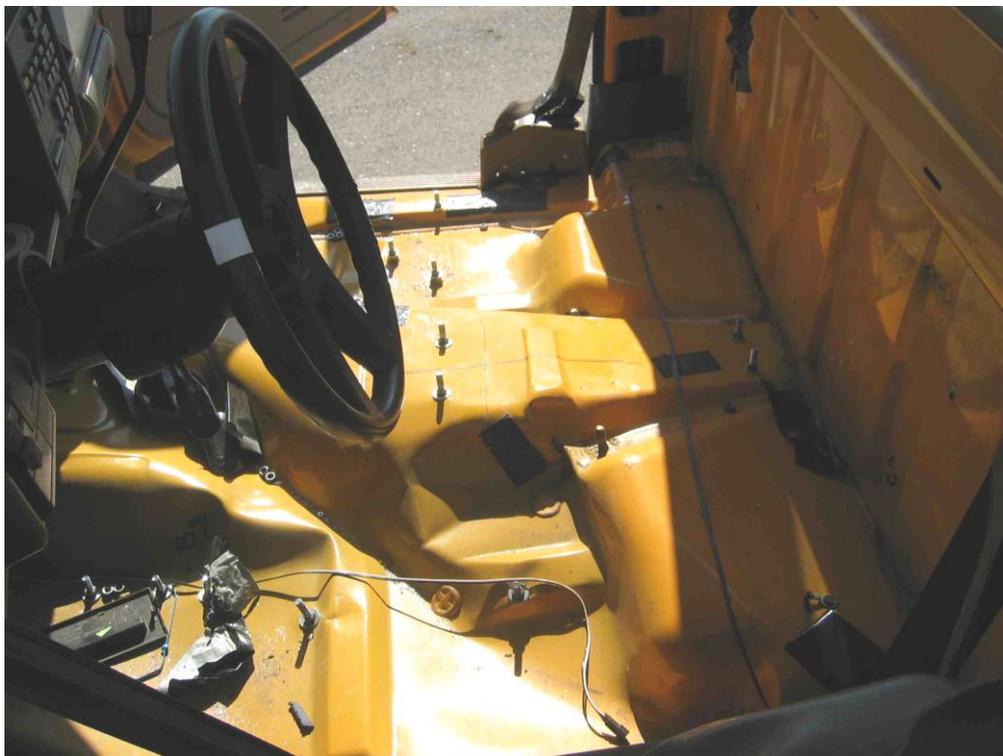
The occupant risk for this test is unacceptable. The hood penetrated the windshield by 250 mm (10 in) and would have showered the occupants with glass. The front grill broke off and would have been a hazard to opposing traffic. The battery was almost thrown from the vehicle and was only restrained by the negative terminal wire. There was excessive deformation on the driver side of the occupant compartment. Table 2-2 has a summary of the occupant risk. (Due to problems with the data acquisition system, there was no usable information to find the occupant impact velocities or ridedown accelerations.)

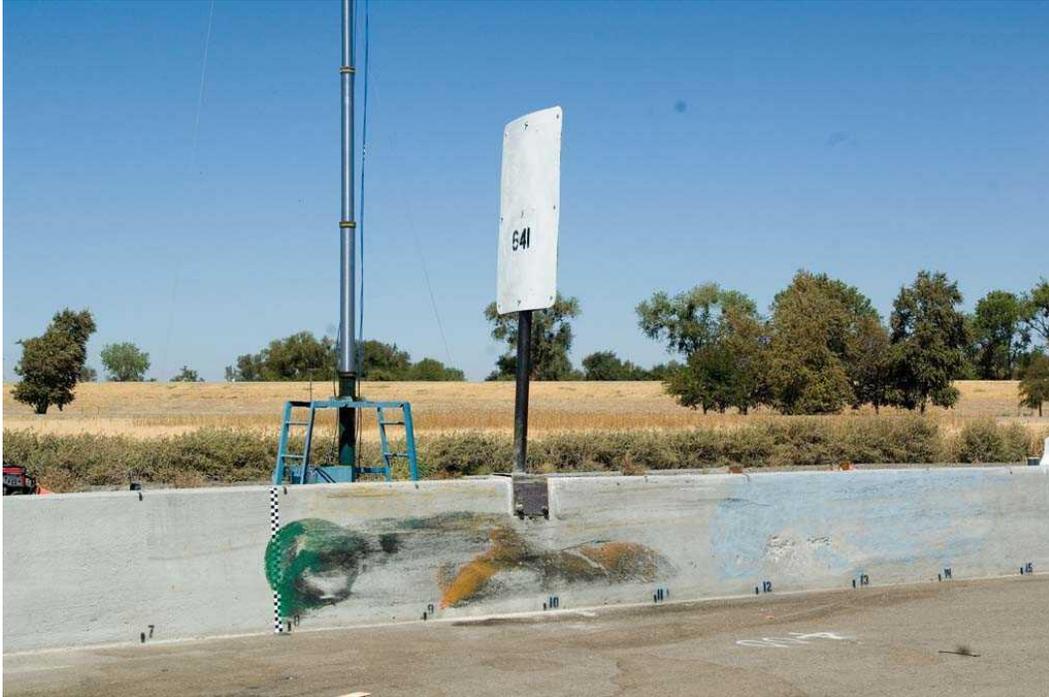
Figure 2-16 Impact Area After Test

There was only cosmetic damage to the barrier. The signpost saddle was pushed 19 mm (0.75 in) downstream and the two bolts were also bent slightly downstream. The sign pole had a dynamic deflection of 10.6° and a static deflection of 3.4° leaning downstream of impact.
