Erreca and Westley SRRA Waterless Urinals

Case Study

Prepared by: Division of Engineering Services
Water and Wastewater Branch
August 2014

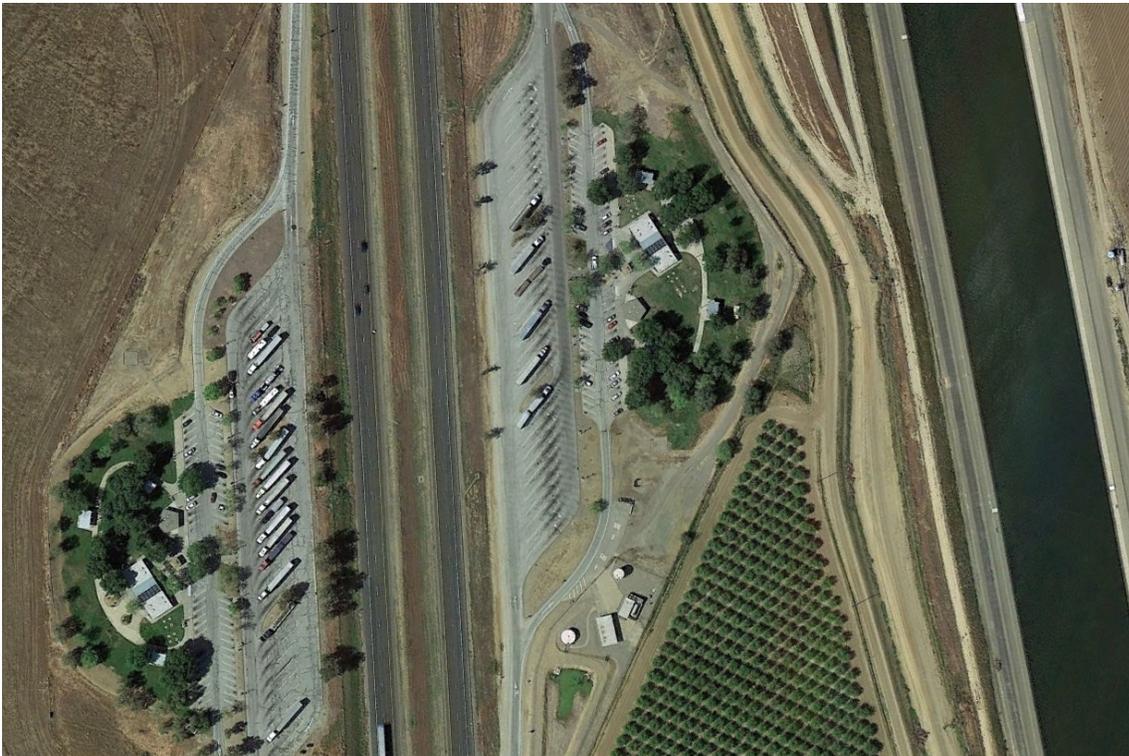
Figure 1: Aerial view of Erreca Rest Area with California aqueduct to the right

Erreca SRRA is located in Caltrans District 10, on Interstate 5, 0.7 miles north of the Fresno county border. This rest area receives nearly 1.5 million visitors each year and has had problems in the past finding enough available water to keep the rest area operational for the entire year. Water is currently drawn directly from the California Aqueduct under the authority of the San Luis Water District. Supply is limited though, and water allocations typically run out before the end of the year forcing the district to find other sources of water available for purchase. This problem, along with a broader district wide mandate in 2005 to cut water usage by 20%, lead the maintenance staff to explore avenues for reducing water usage.

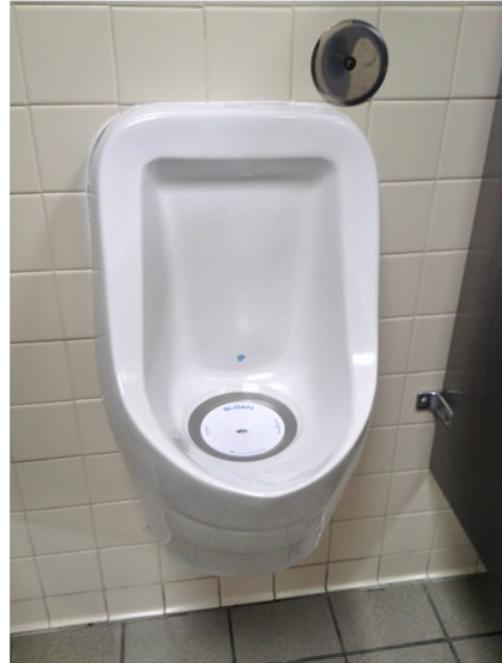
Figure 2: Sloan Waterless Urinal

Sloan Model: WES-4000

These waterless urinals remain notably clean in appearance due to their porcelain construction. They also remain relatively odor free during normal operation. Initially, there were fears regarding the porcelain urinals being vandalized. Fortunately, only one of these urinals has had to be replaced due to vandalism in their nearly 10 years of use. One criticism of this fixture is its small diameter outlet hole which leads to a residual buildup inside of the fixture's urine collection chamber underneath the cartridge.

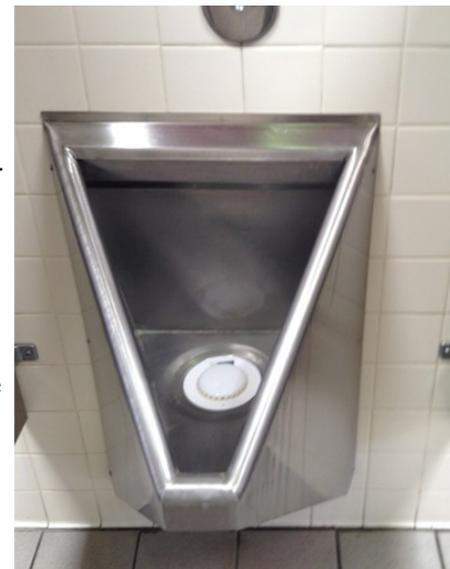
Figure 3: Zeroflush Waterless

Zeroflush Model: ZF-301

These fixtures are very durable and vandal resistant due to their stainless steel construction. However, properties

of the stainless steel in addition to pooling along the flat bottom of the fixture, has lead to considerable staining and discoloration which appears to be permanent.

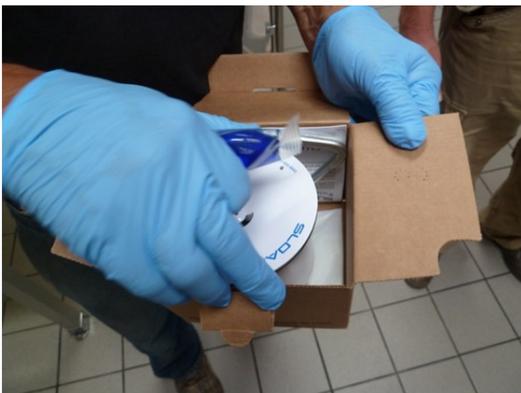
Figure 4: Typical cartridge replacement kit

1. The staff receives a cartridge replacement kit sold by the manufacturer which includes a cartridge removal tool, a new cartridge, a disposal bag, a new cartridge, a small packet (2-3 oz. for Sloan)(10oz for Zero-Flush) of blue sealant fluid and an instructions manual.

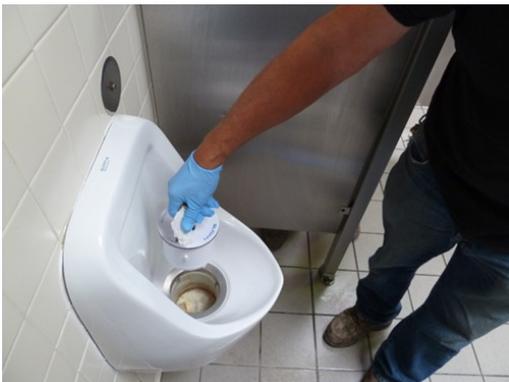
Figure 5: removal of Spent Cartridge

2. The spent cartridge is removed from the urinal using the metal tool provided in the re-

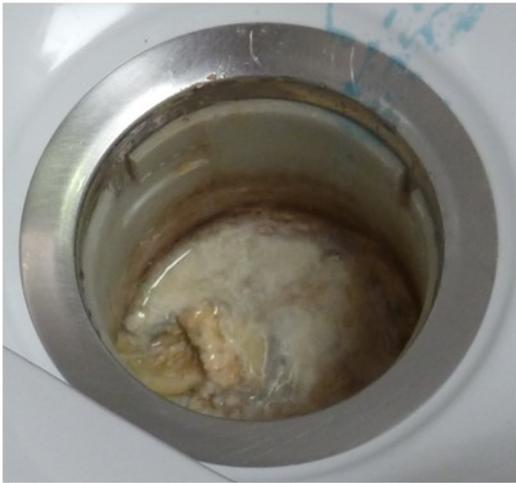
Figure 6: Buildup accumulated after two to three weeks of use

3. The urine collection chamber is then cleaned with a toilet brush. A slimy sediment buildup is usually found collecting inside of the chamber and must be removed.

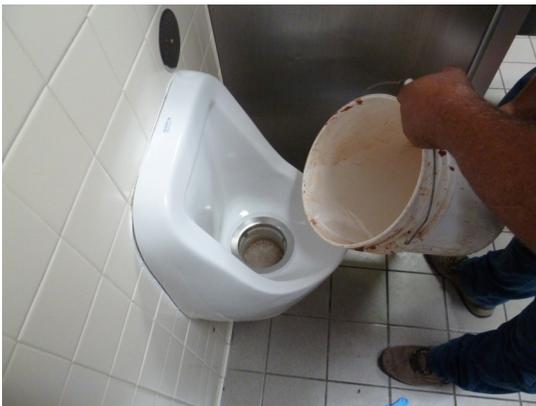
Figure 8: Flushing the urinal

4. The urinal is then flushed with 5 gallons of hot water.

Cleaning solutions were also not readily available to the staff for flushing the urinal in step 4. The urinals were instead flushed with only hot water. This is probably effective at flushing out most sediment but the addition of one of Sloan's approved cleaning solutions would improve performance. (See attachment 3)

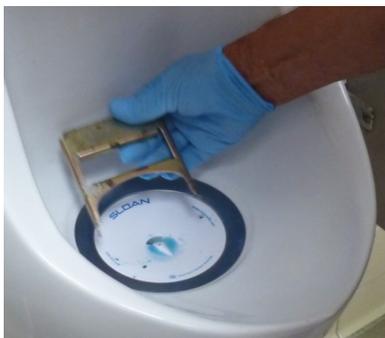
Figure 9: Installed new cartridge

5. The new cartridge is then inserted into the urinal and blue sealant solution is poured over the top of the cartridge where it seeps in through a hole on the top of the cartridge.

The last key deviation from the manufacturer's recommendation is in step 5. Here the manufacturer's replacement instructions call for the cartridge to be preloaded with a quart of water prior to pouring in the sealant fluid. This step ensures that sealant fluid is not lost during the urinal cartridge's first use. It seems that the omission of this quart of preloaded water

is not causing any loss in effectiveness of the sealant fluid system, as there was no noticeable smell. However, if this procedure is added to the maintenance process it may be possible to conserve a noticeable amount of sealant fluid and so extend the life of the cartridges.

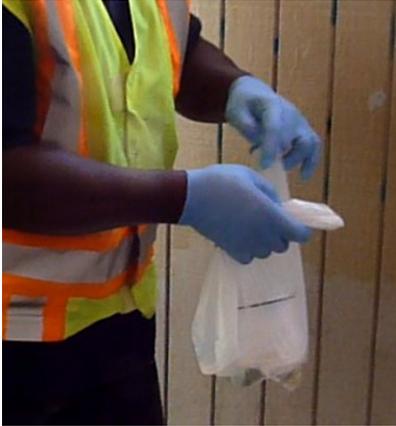
Figure 10: Disposal of spent Cartridge

6. The spent cartridge is placed in the supplied plastic bag and then placed in the trash receptacle.

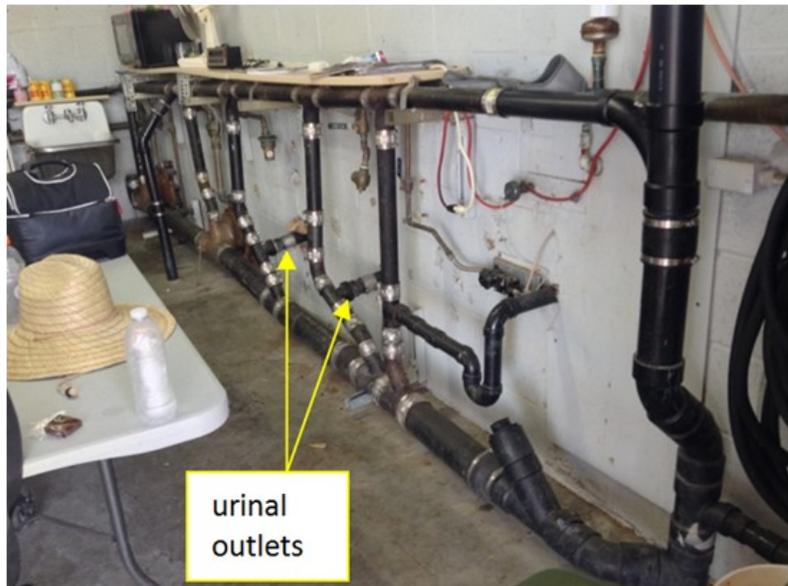
Figure 11: PVC plumbing at South Bound Erreca Rest Area

The plumbing directly behind these urinals occasionally gets clogged with urine sediment at which point it has to be fixed by Caltrans staff. To clear the clog the section of piping with the sediment is removed and scrubbed. It is then thoroughly rinsed and replaced. It is estimated that this occurs every 3 to 4 years. A couple remedies have been suggested to address this problem. The first modification which has been made on the Southbound side of Erreca SRRA is a switch to PVC piping for all of the comfort station plumbing. The

expectation is that the smoother surface of the PVC will deter buildup. The second idea is to improve the cartridge maintenance routine so that the urinals can be more thoroughly cleaned and flushed.

One recommendation for future rest areas, is to design the plumbing system so that the urinals are the last fixture in the line before it is routed away from the building. This will allow the flow of the other bathroom fixtures to aid in washing away urine sediments from the piping directly behind the urinal. At Erreca rest area this was not a significant problem since the plumbing is configured in exactly this manner. However, at Westley rest area urine sedimentation within the piping is a much more common problem due to the plumbing configuration which isolates the urinal piping from the flow of the other bathroom fixtures.

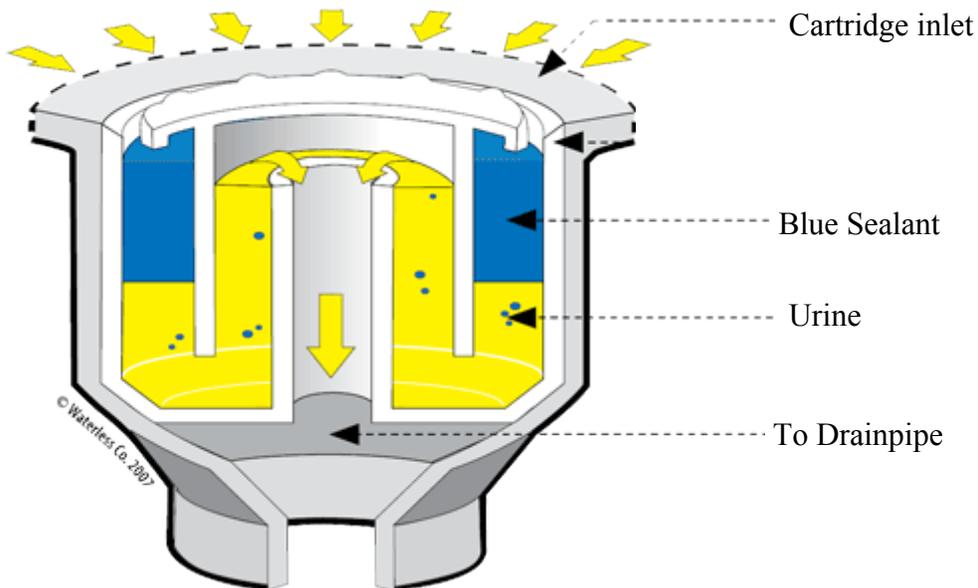
Figure 15: Typical Waterless Urinal Cartridge

These are by far the most widely available and prevalent type of waterless urinal. The urinal works by utilizing a sealant fluid which is lighter than water. This fluid floats on top of water and urine creating a seal which allows urine to flow through while sewer gases remain trapped beneath it.
