Reports on Experiments with Continuous Reinforcement in Concrete Pavements- California

REPORTS ON EXPERIMENTS WITH CONTINUOUS REINFORCEMENT IN  
CONCRETE PAVEMENTS - CALIFORNIA

Thos. E. Stanton, Materials and Research Engineer  
California Division of Highways

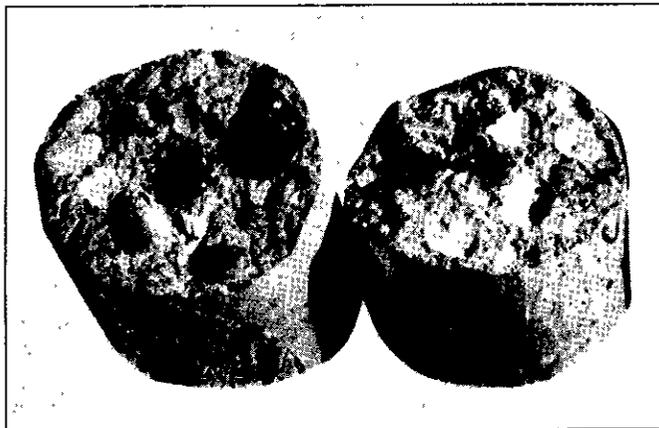
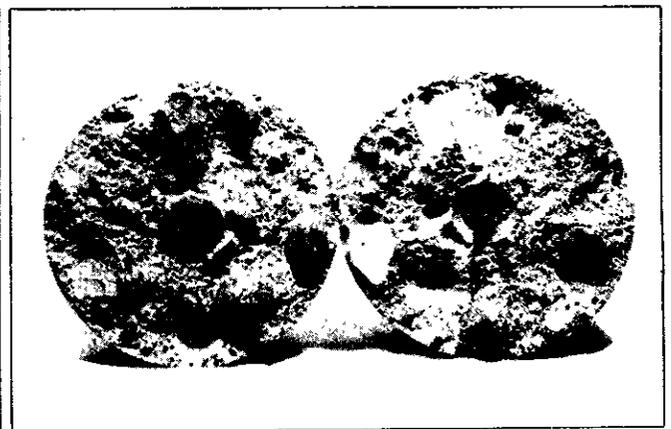
# FRACTURES OF TENSILE TEST SPECIMENS

STANDARD CONCRETE

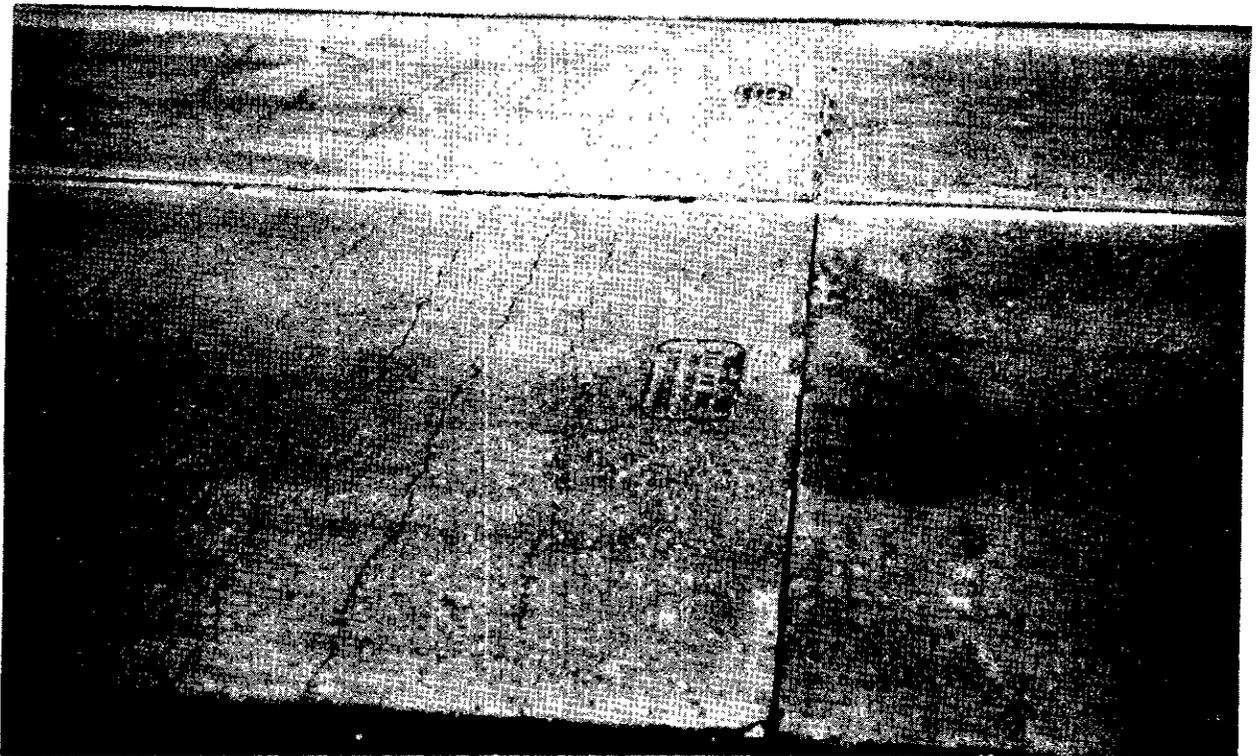
(a) At Station 7+90

(b) At Station 25-63

Fig. 19 Photographs of pavement at construction joints, showing difference in crack pattern at end of one days run and start of next days run.

As will be noted in the crack record diagrams (Fig. 16) the slab lengths were likewise greater just before the construction joint at the end of each day's pour but quite short at the start of the next day's pour, notwithstanding the continuity of the reinforcing across the construction joint (Figs. 16 and 19).

The effect of time of day and/or order of construction is likewise apparent from the crack development at the construction joints where even though the reinforcing steel is carried continuously across the construction joint the crack incidence is much less at the end of the day's run, just before reaching the construction joint, than during the first hour of the succeeding day when the incidence is somewhat greater than the average.
