Recording Strains at the End Zone of a Prestressed Concrete
I Girder Without End Blocks

May 1963

State of California
Department of Public Works
Division of Highways
Materials and Research Department

RECORDING STRAINS AT THE END ZONE
OF A PRESTRESSED CONCRETE I GIRDER
WITHOUT END BLOCKS

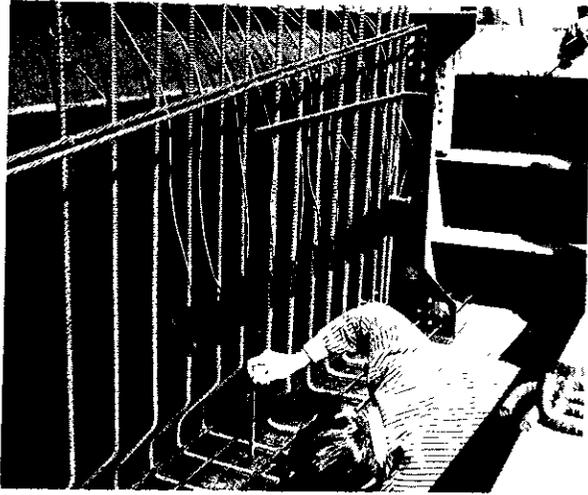
Figure 2A

Strain gaged stirrups and
6 pretensioned strands.

The first phase of the girder construction was to place two top steel strands and four bottom steel strands in the girder forms. The stirrups, premounted with strain gages in the laboratory, were then put in place along with the rest of the stirrups on that one girder side (see Figures 2A and 2B). The remaining strands were then put in place and tensioned (see Figure 3). The strain gages on the stirrups were placed 19" up from the soffit and were spaced and numbered according to Figure 4. Figure 5 shows the types of strain gaged reinforcing bars and the strain gage numbering system. Figure 6 shows complete steel frame in the end section of the girder.

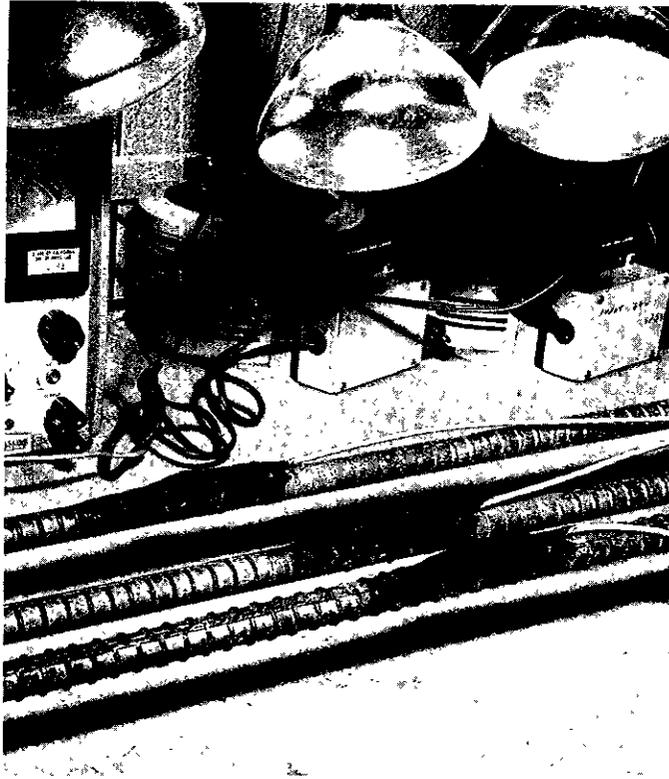
Figure 18
Curing of waterproofing.

The gage was now ready for waterproofing. MIBK primer solution was wiped on the plastic insulation so the waterproofing epoxy would adhere to it. The waterproofing epoxy was a two part epoxy-Thiokol mixture. It consists of two separately bulk packaged mixtures. One part by weight of Mixture #1 was mixed with two parts by weight of Mixture #2. The mixture in its uncured stage is like a heavy grease paste and does not sag. It cures to a solid elastic material. The uncured epoxy was applied to the gage area and the lead wires. The epoxy was only put halfway around the bar. It was then put under heat lamps and allowed to cure. A thin coat of Herecrol (RC-9) Synthetic Rubber Coating was brushed on the cured epoxy and up on the plastic insulation to complete the waterproofing. See Figure 18. Since time was limited, the reinforcing steel bars were put in water for only 16 hours in order to check the waterproofing. The reinforcing bars were ready for installation after the waterproofing tests.
