Dynamic Tests Of An Energy Absorbing Barrier Employing Steel Drums

MATERIALS AND RESEARCH DEPARTMENT
RESEARCH REPORT
NO. M & R 636405-2

DYNAMIC TESTS OF AN
ENERGY ABSORBING BARRIER EMPLOYING
STEEL DRUMS

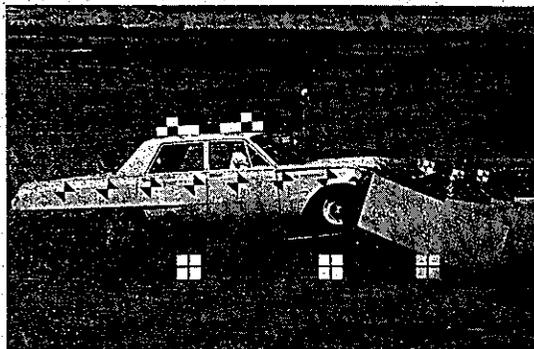
Barrier Depth	19.6 Ft.	Test No.	221
No. of Drums	41	Date	9-11-69
Permanent Displacement of Barrier Nose	10.7 Ft.	Vehicle Weight	1968 Dodge
Deceleration Distance-Passenger Compartment	16.5 Ft.	(w/Dummy and Instrumentation)	4690 Lbs. ²
Maximum Vehicular Deformation	16.5 In.	Impact Velocity	64.2 MPH
Steering Column Collapse ¹	3.4 In.	Impact Angle	Head-On
Passenger Compartment Deceleration (Highest 50 ms avg.)	10.3 G's	Dummy Restraint	Lap Belt
Vehicle Average Deceleration-Calculated	8.4 G's

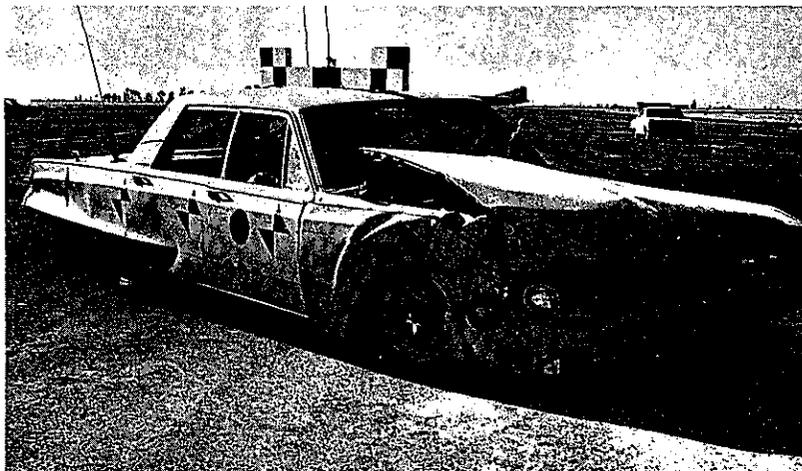
FIGURE 14

Vehicle damage included severe crushing of the right front quarter panel, jamming of the right front door, scars on the right doors and right rear panel, and displacement of the radiator to the point of touching one fan blade (see Figure 14, below). See Plate 4 (following page) for additional test data.

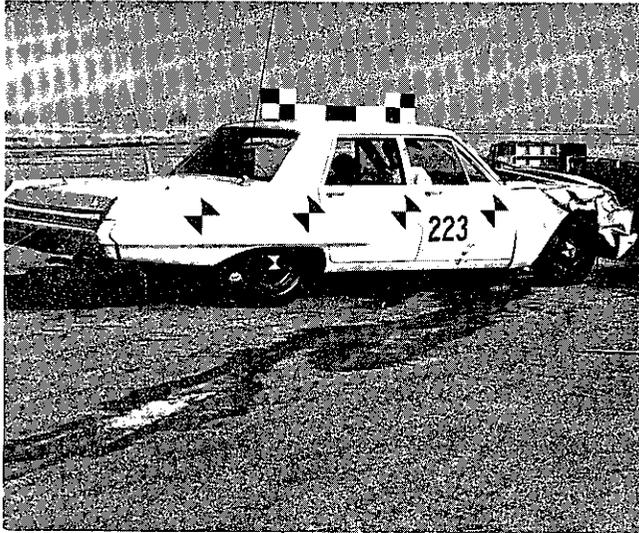
Vehicle damage consisted of a crimp in the roof on the passenger side, extensive hood deformation, slight displacement of the left front quarter panel, and 3.6 inches of (energy absorbing) steering column collapse (see Figures 16 and 17). There was a slash high on the cheek of the dummy driver and the windshield was broken in front of the dummy passenger. The dummy passenger was badly cut on the tip of the bridge of his nose, over his right eye and on his forehead, and on the right side of his face and cheek. This dummy's lower legs were removed before the crash; this may have contributed to some excessive movement of his upper body during the collision.

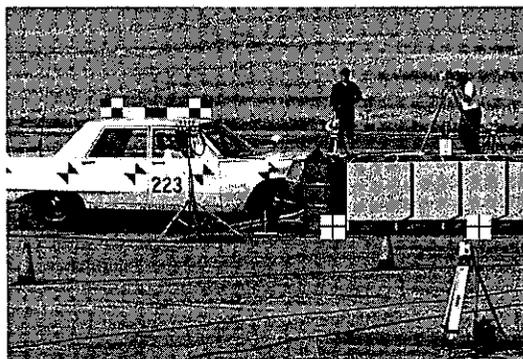
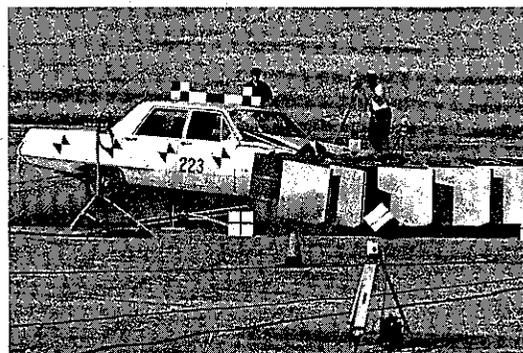
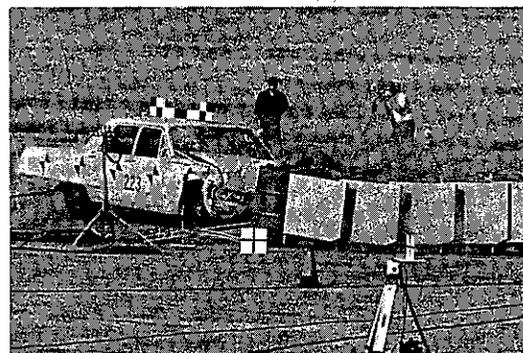
Barrier Depth	19.6 Ft.	Test No.	223
No. of Drums	41	Date	12-5-69
Permanent Displacement of Barrier Nose	5.5 Ft.	Vehicle Weight	1968 Dodge
Deceleration Distance-Passenger Compartment	13.2 Ft.	(W/Dummy and Instrumentation)	4740 Lbs. ³
Maximum Vehicular Deformation	14.5 In.	Impact Velocity	53.6 MPH
Steering Column Collapse ¹	3.6 In.	Impact Angle	9° (Nose)
Passenger Compartment Deceleration	10.9 G's Long.	Dummy Restraint	Lap Belt
(Highest 50 ms avg.)			
Vehicle Average Deceleration-Calculated	7.2 G's ²

The movies showed the car being ejected outward from the barrier due to the elastic energy stored within the barrier. The clockwise rotation of the car was probably caused by a moment couple consisting of the vehicular momentum, acting through the vehicle CG, and this "elastic" energy, acting through the centroid of the vehicle-barrier contact interface. See Plate 5 (following page) for additional test data.

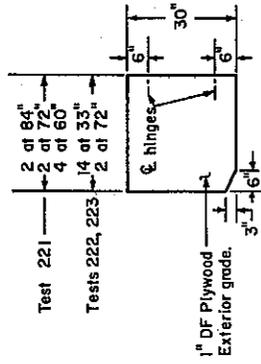
ENERGY ABSORBING BARRIER DETAILS

FENDER PANELS

NOSE CABLE ANCHOR

55 GALLON TIGHT HEAD DRUM

Thus, the test barrier was designed to decelerate a 4700 pound vehicle impacting headon or at an angle of 10° with the barrier axis at an impact velocity of 60 mph without subjecting the vehicular passenger compartment to an average deceleration greater than 10 G's. (This choice of a relatively shallow 10° angle has since been justified, at least to some extent, by reports from several other states indicating that in-service energy absorbing barriers are being impacted headon in almost all cases.) The construction details for the barrier are shown on Exhibit 1.
