CA-TL-78-20

A Comparison of Highway Slope Erosion Estimates By The Mechanical Slope Template, Sediment Collection Trough, and Slope Erosion Transect Survey Methods

August 1978

Interim Report

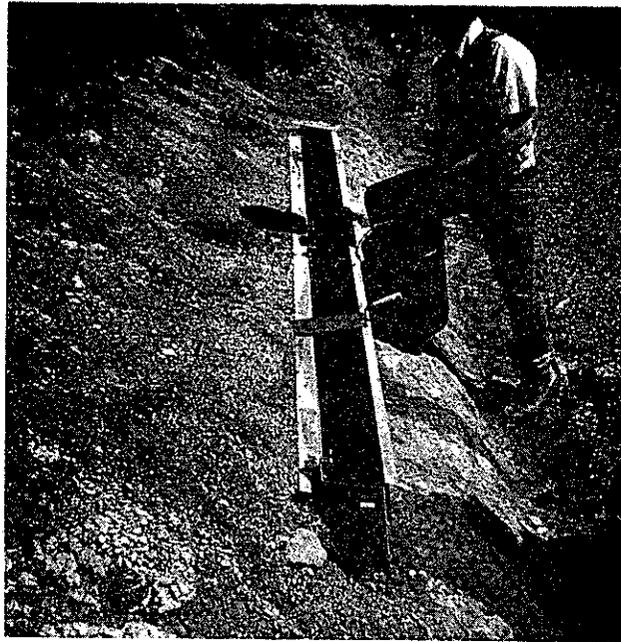
Another technique that is used less frequently is the Sediment Collection Trough method(1). This method requires the installation of a metal trough on a slope that traps sediment as it erodes from the slope. The sediment is periodically removed, dried, and weighed. The accumulated sediment is plotted relative to the amount of rainfall that fell during the monitoring period. The resulting curve is then used to estimate potential erosion quantities for various rainfall amounts for slopes having characteristics similar to the monitored slope. This technique usually requires monitoring through at least one winter season and possibly more, depending on the accuracy desired. The Sediment Collection Trough method is also used to evaluate the effectiveness of erosion control treatments that are applied to highway slopes(2).

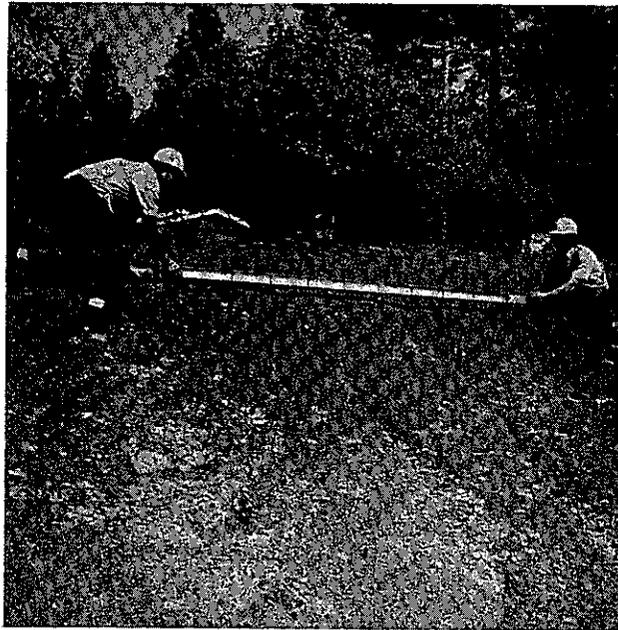
Mechanical Slope Template

A third method that has not been utilized to any extent by Caltrans involves the use of a device called a mechanical slope template to measure changes in the configuration of the slope as erosion occurs(1). To use this technique, reference points are established on a slope. An initial set of readings is obtained by placing the mechanical slope template between two of the points and measuring the distance between the template and the slope surface at one foot (.305 m) intervals. The process is repeated at several places on the slope. After a series of storms, measurements are again taken and the difference between these and the initial readings is used to calculate the volume of sediment that was eroded. An in-place soil density reading is taken to convert the soil volume to a weight. Measurements must be taken over a minimum of one winter season. The results are highly dependent on antecedent moisture and the characteristics of the rainfall (rainfall intensity, amount, frequency, and duration). For this reason, accurate results are usually obtained by monitoring over several winter seasons. This method may be useful in cases where the difference in erosion rates at various locations on a slope needs to be identified; information is desired on the rate of sediment transport in the downslope direction as the soil erodes; erosion is so rapid that the capacity of sediment collection trough would be exceeded using normal monitoring procedures; or where there is limited space at the base of a slope to install a sediment collection trough. TransLab used this method on a limited basis during some erosion studies in the Lake Tahoe Basin in 1973(3).

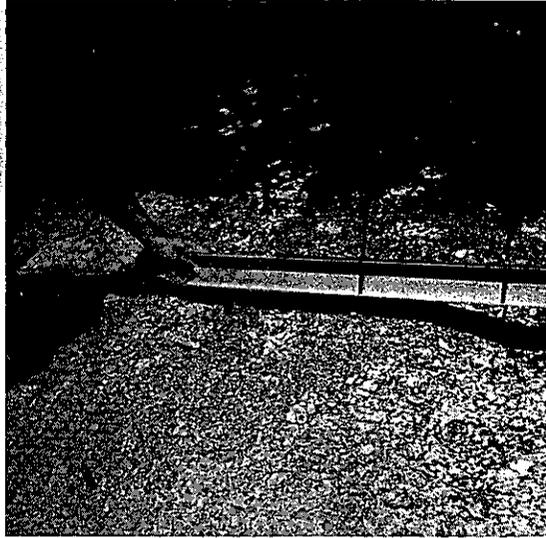
3. With the template in place, the wing nuts were loosened and the top plate was moved to unlock the rods which then slid through the holes until they touched the slope surface. If one of the rods did not slide through the hole, one of the individuals closest to the stuck rod would tap it with a four foot (1.2 m) lath until the rod slid through.

Template rods locked in
"up" position

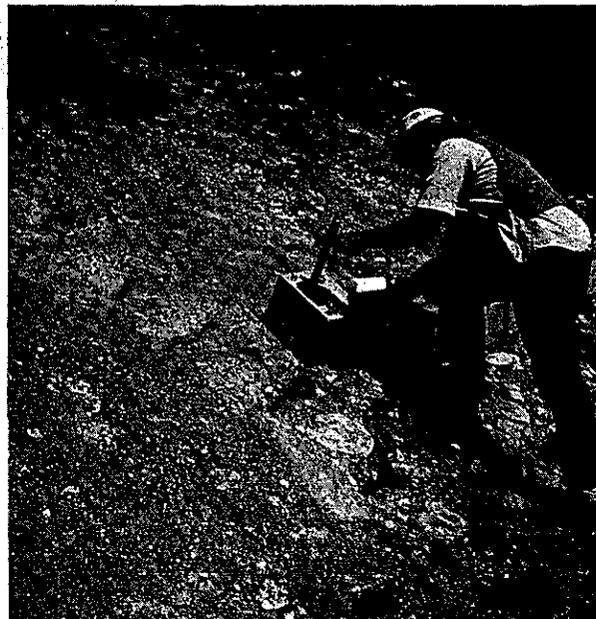
A grading analysis was performed on the sediment collected after one storm period. Also, an in-place density determination was made with a nuclear soil density gage.

In-place soil density being measured with a nuclear soil density gage.

The Slope Erosion Transect Survey and Mechanical Slope Template methods provide volumetric information on slope erosion whereas the Sediment Collection Trough procedure gives the information on a weight basis. Therefore, in-place soil density was determined to provide for a comparison of data between the methods. The in-place soil density was determined to be 109 lbs/cubic foot ($1,745 \text{ kg/m}^3$).
