Development Of A Rebar Dowel Anchorage System For Attaching The California Type 25 Concrete Barrier To Existing Bridges

June 1979

Office of Transportation Laboratory
California Department of Transportation
Sacramento, California 95819

Final Report

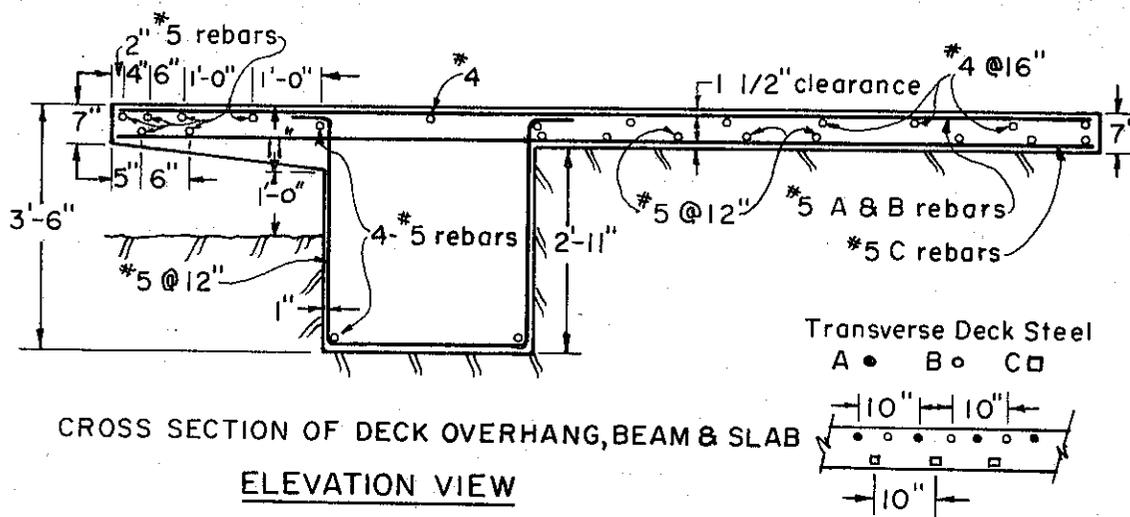
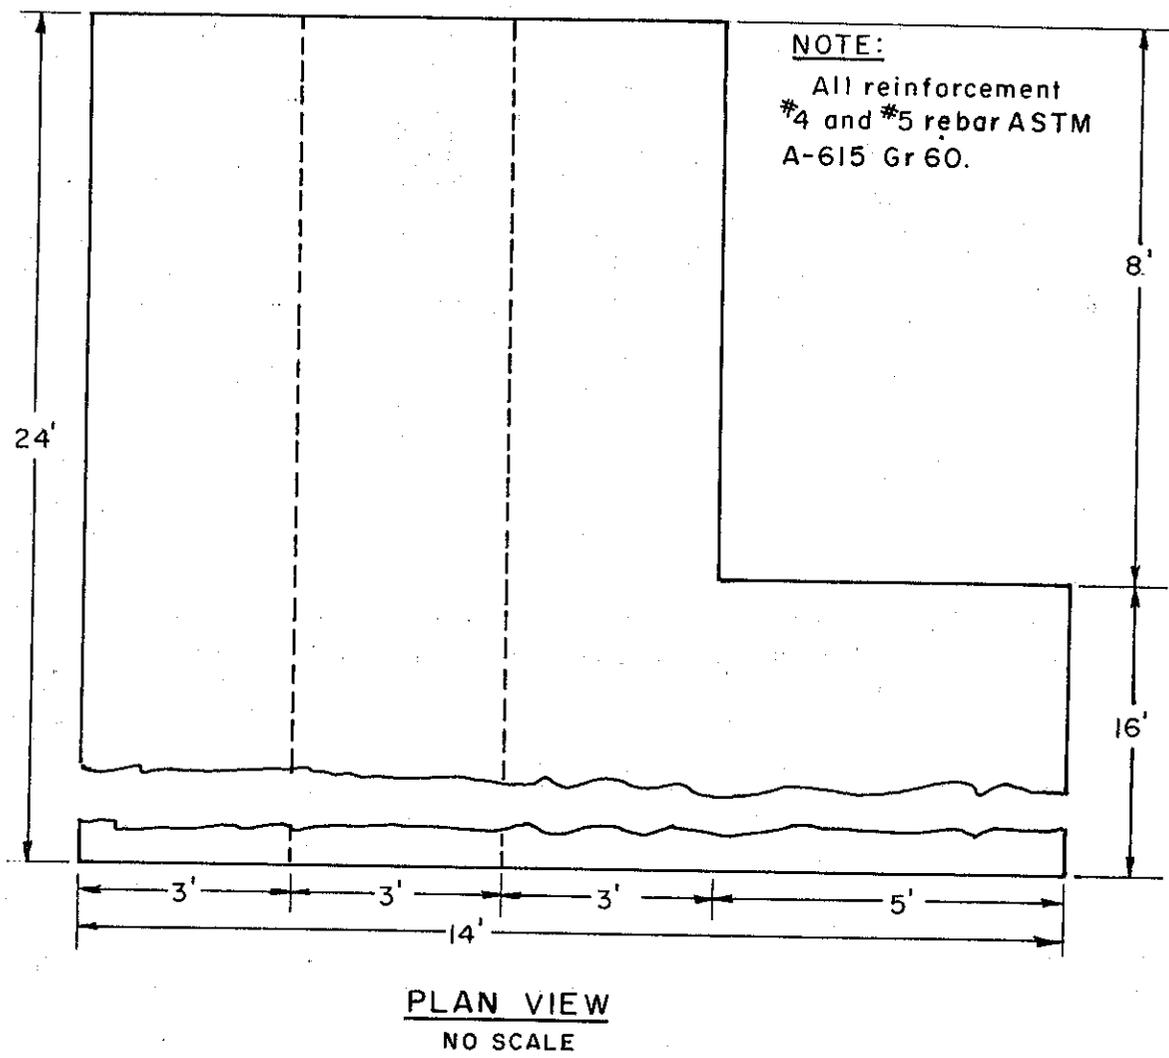
Figure 1. Plan view of simulated bridge deck.

In, order to carry out the planned barrier load tests, a 24-foot-long reinforced concrete simulated bridge deck overhang test section was constructed. The dimensions and reinforcing steel sizes and spacings were typical of older bridges built in California. A large beam section was formed adjacent to and continuous with the deck overhang section in order to stabilize the overhang while performing horizontal load tests on various planned replacement barrier prototype test sections and to simulate continuity provided by an exterior reinforced concrete bridge girder. A large earth-supported concrete slab section was built adjacent to and continuous with the deck overhang. This slab, having a thickness of 7 inches and a reinforcing steel pattern similar to that of a typical bridge deck, provided a suitable concrete section to conduct pullout tests on bonded rebar dowels. Figure 1 shows a plan view of the test site and a structural cross section indicating concrete dimensions, as well as size and position of reinforcing steel.

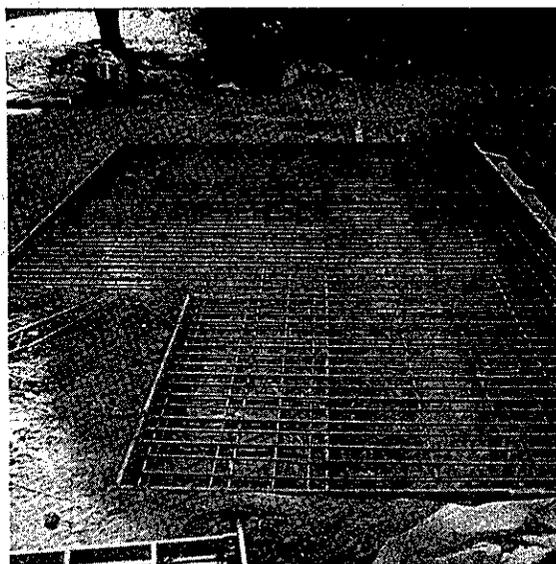
Figure 2. Overall view of test site prior to placing concrete for simulated bridge deck.

The reinforcing steel used in the concrete slab, beam, and deck overhang conformed to requirements in ASTM Designation: A615, Grade 60 (see Figure 2). The rebar size and spacing used were similar to those in the Bridge Planning and Design Manual, dated May 1970 (Figure 3). Reinforcing in the deck overhang was positioned as for a typical Type 25 Concrete Bridge Barrier; details are shown in Drawing B0-5, page 85 of the 1975 Caltrans Standard Plans (Figure 4).

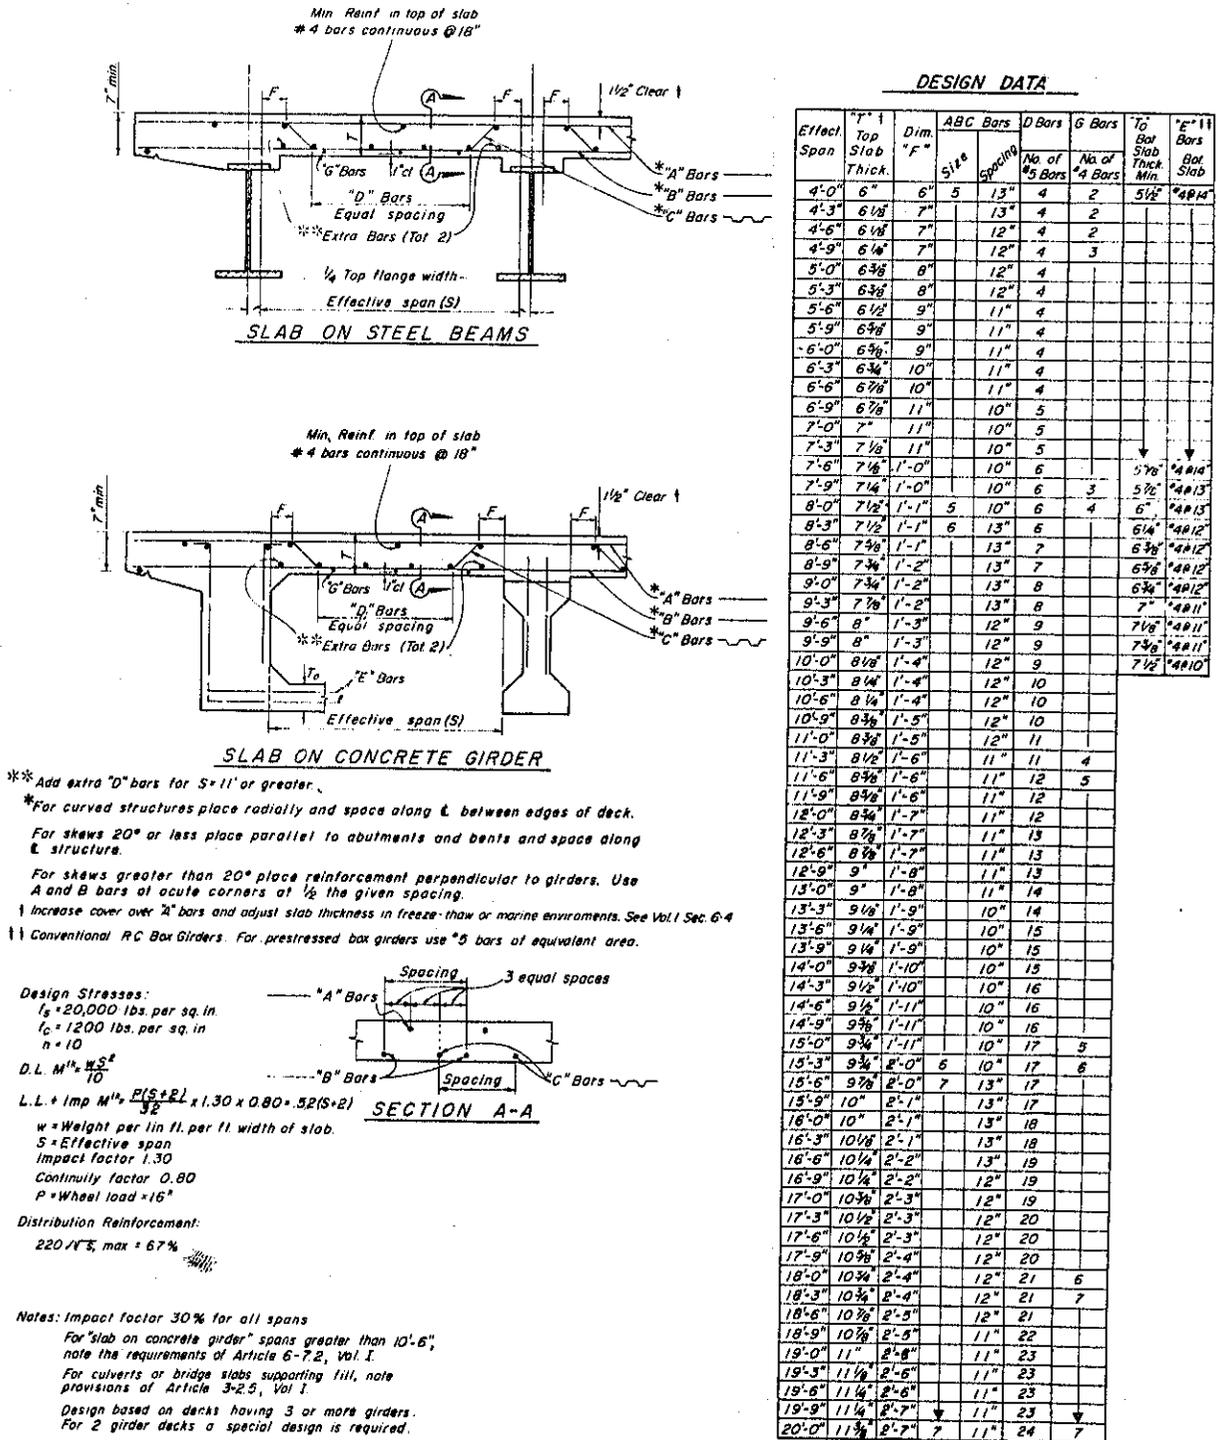
Figure 3. Size and position of reinforcing steel in a typical bridge deck.

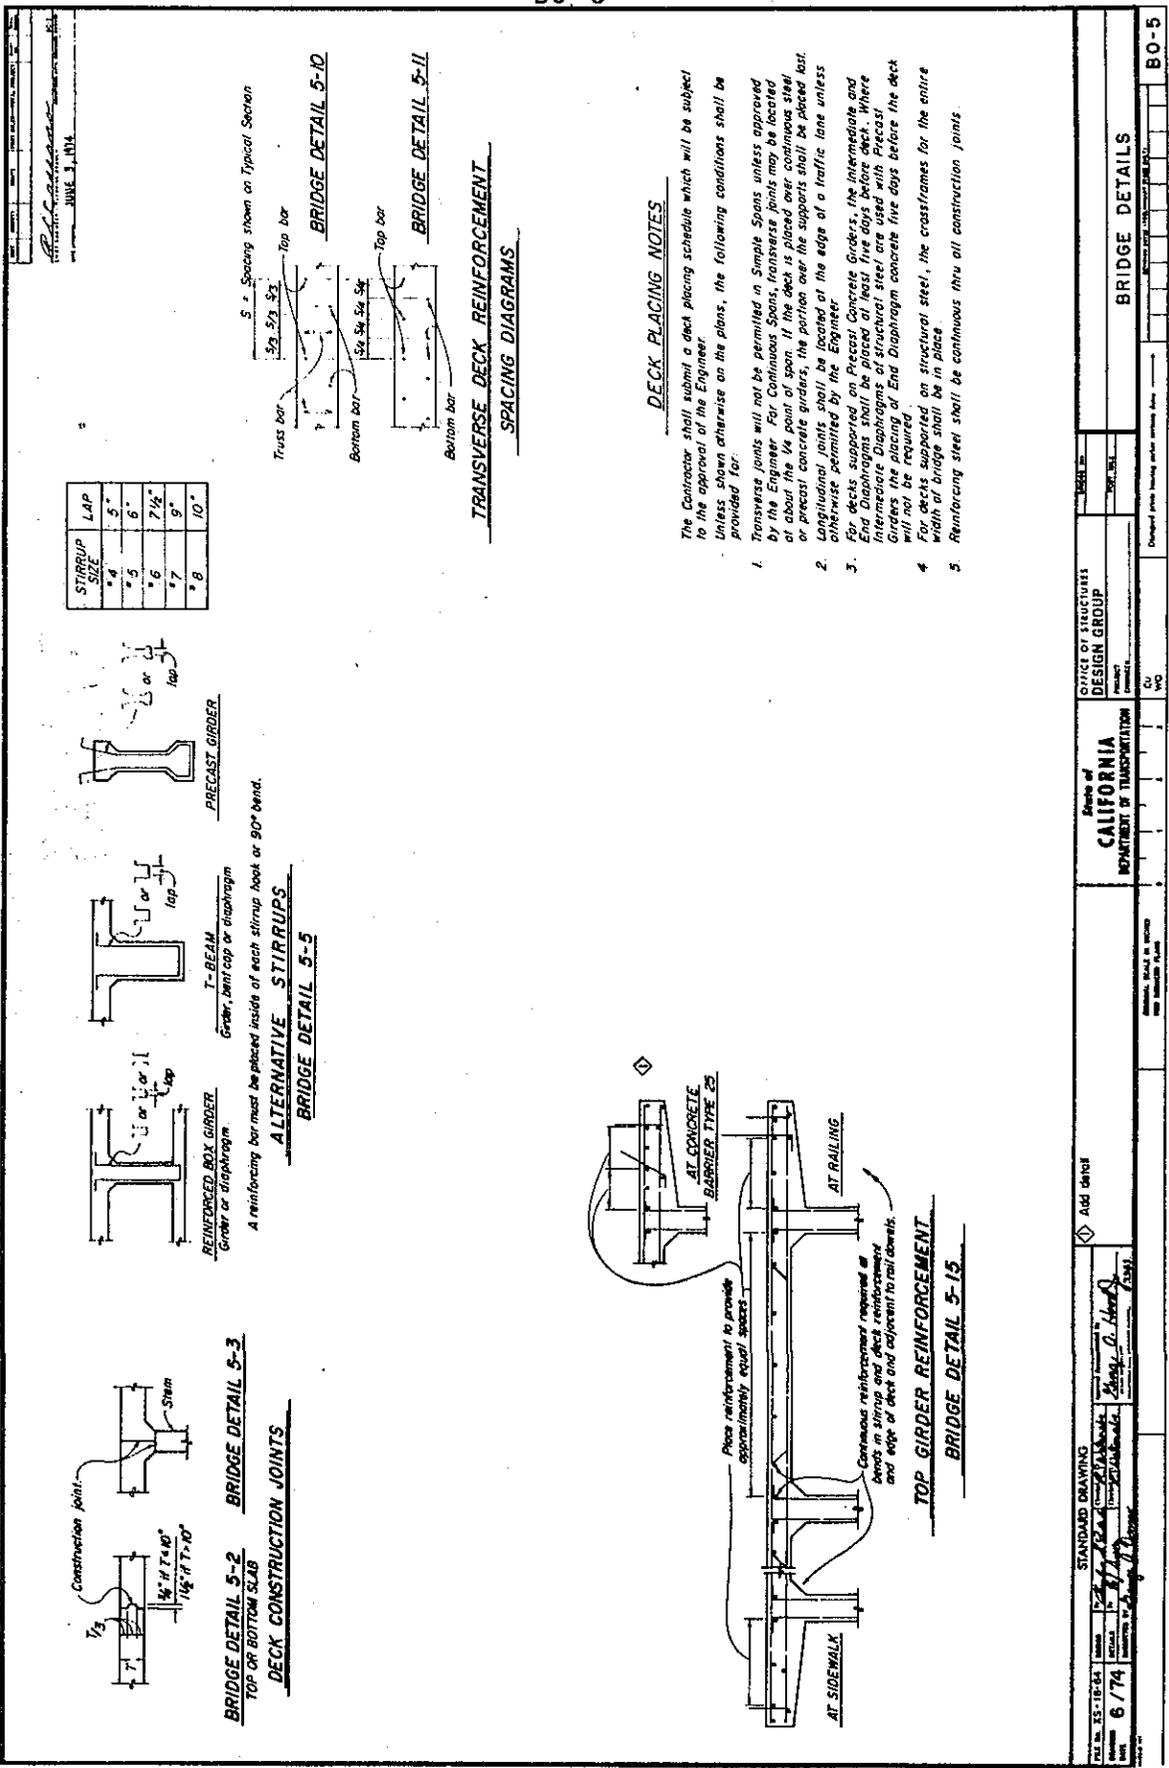
Figure 4. Position of reinforcing steel in a bridge deck overhang beneath a Type 25 Concrete Bridge Barrier.

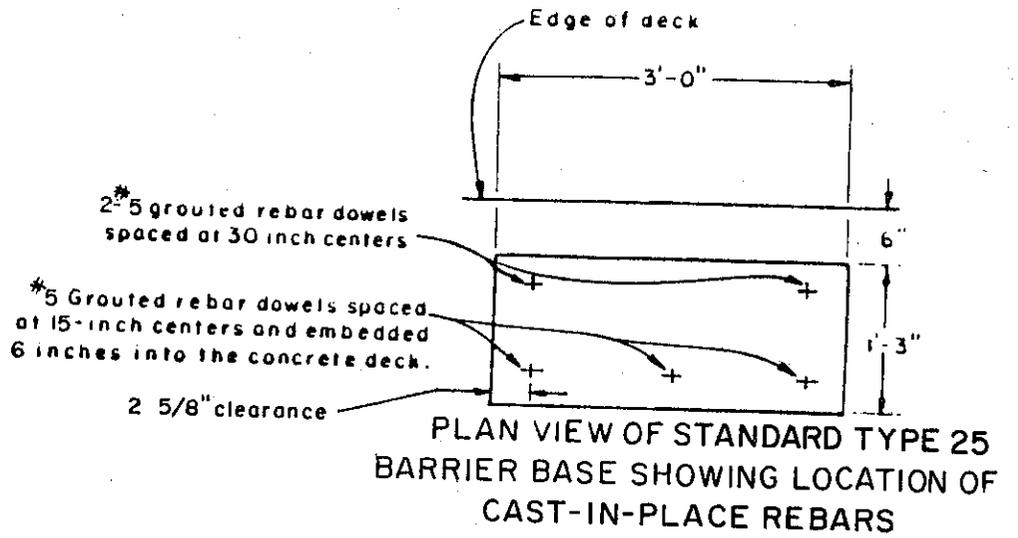
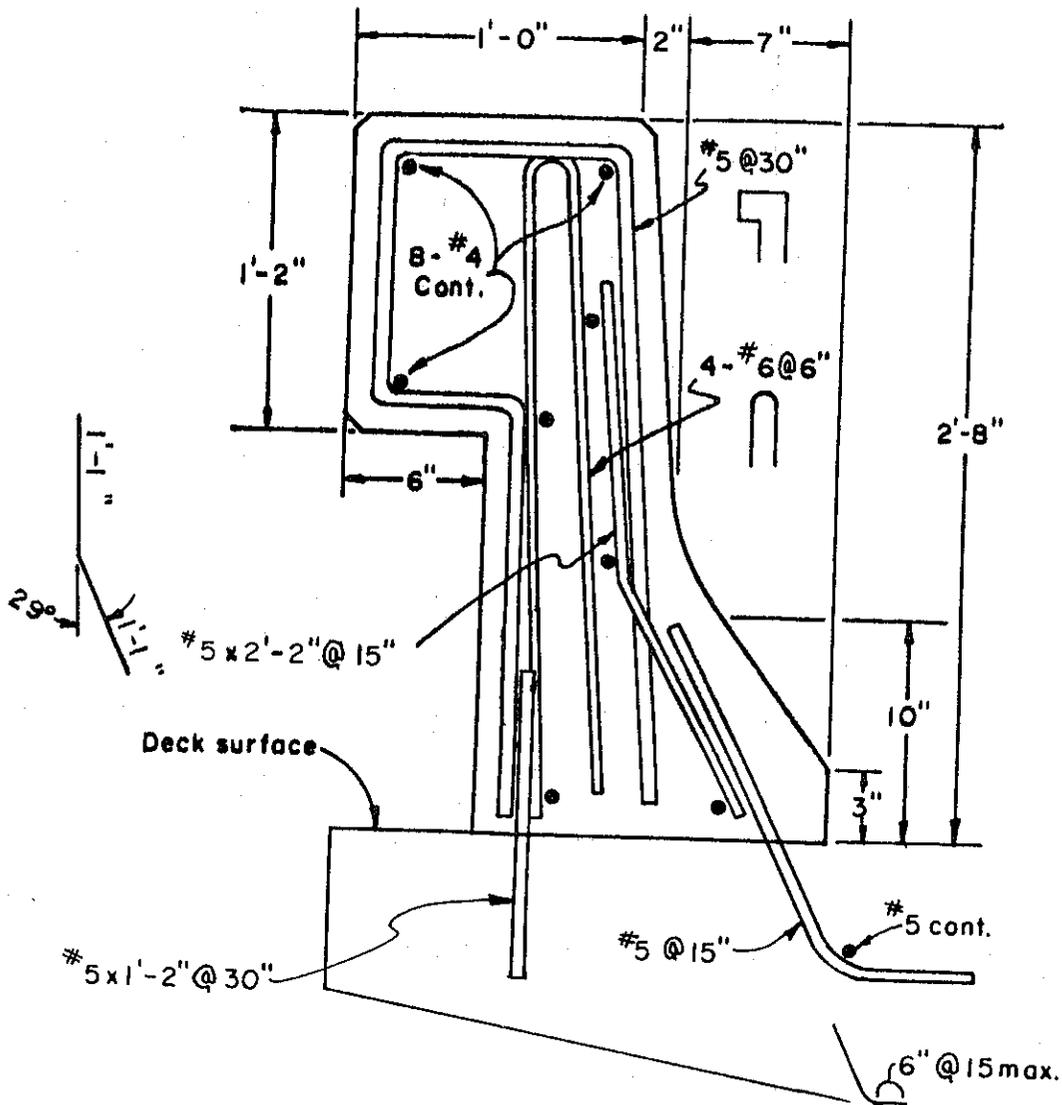
Figure 6. Steel reinforcement in the standard Type 25 Concrete Bridge Barrier section, anchored with #5 cast-in-place rebars - Series I, Test Number 2.

To prevent possible concrete barrier failure in the neck region, and to purposely concentrate load on the anchoring rebars at the base of the barrier sections, additional "hair pin" reinforcement, consisting of four #6 rebars, was included in the "neck" regions of each barrier section as shown in Figures 6, 7, and 8.

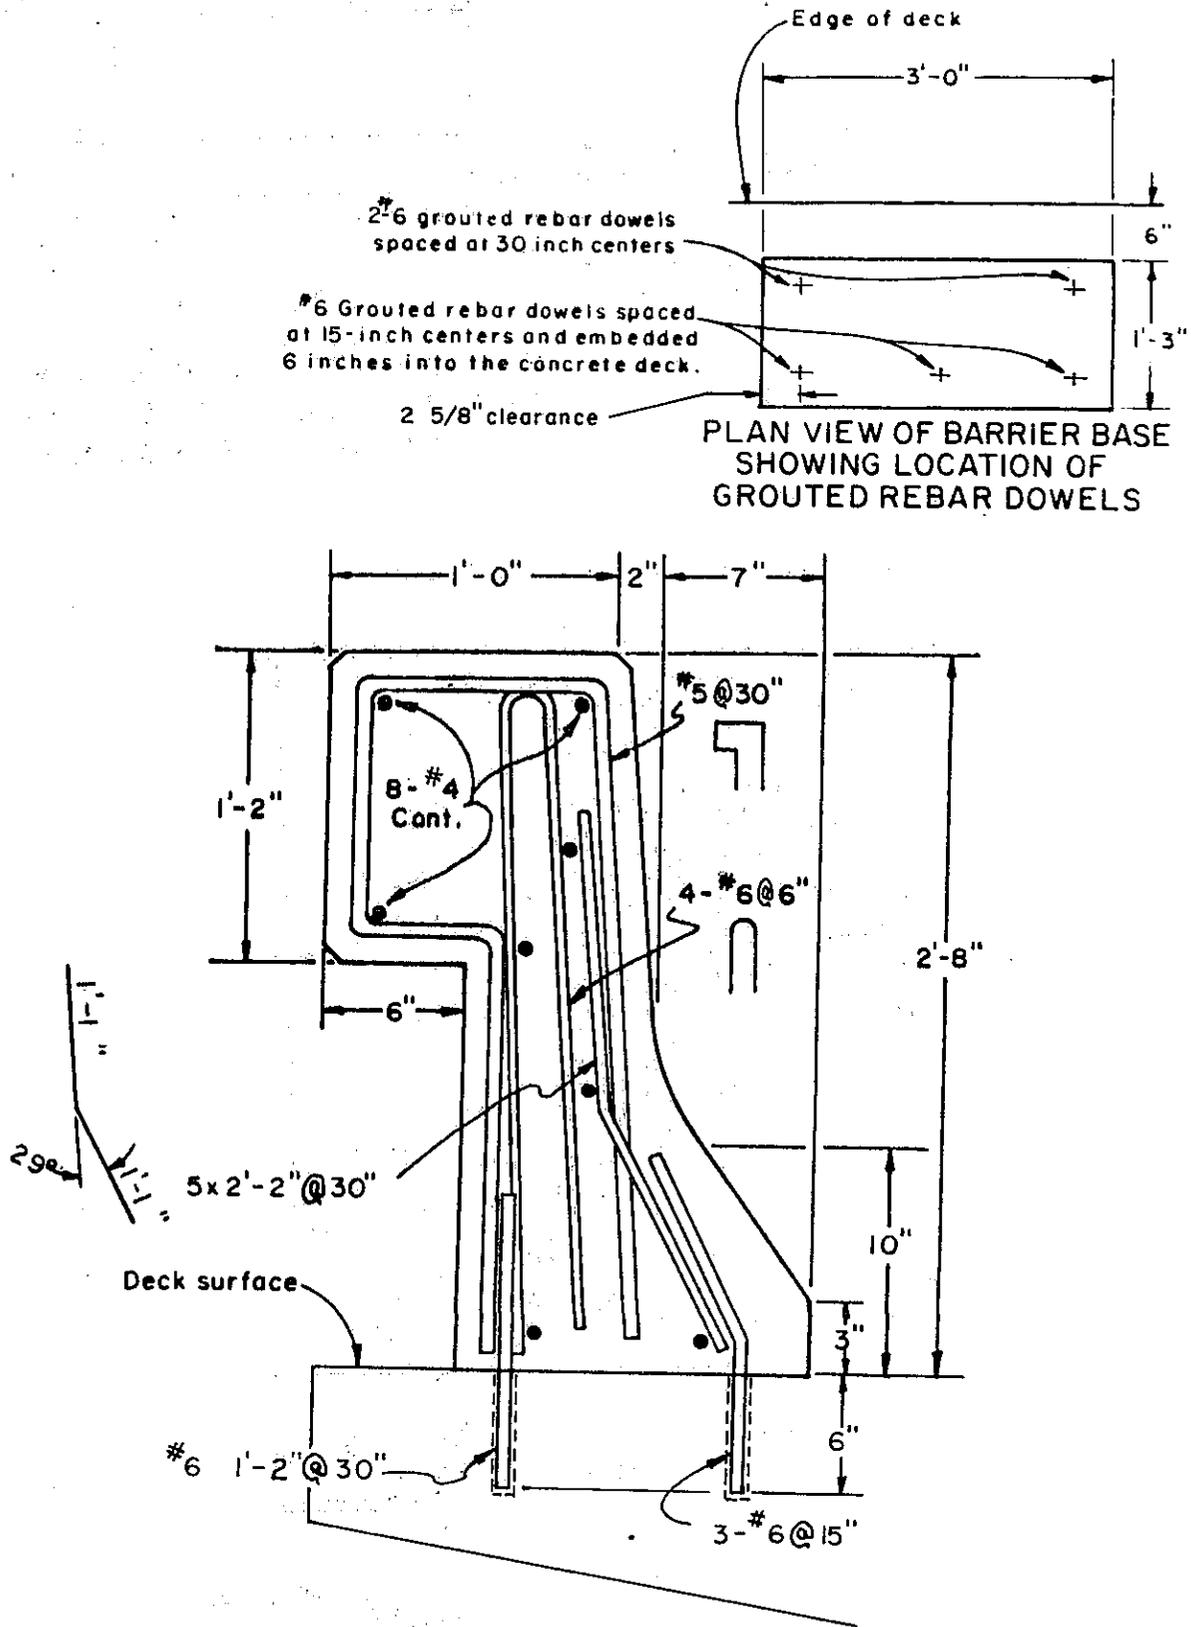
(Rebar dowels bonded with Type II Modified portland cement grout)

Figure 7. Steel reinforcement in the Type 25 Replacement Barrier prototype, anchored with #6 rebars, embedded 6 inches - Series I, Test Number 1.

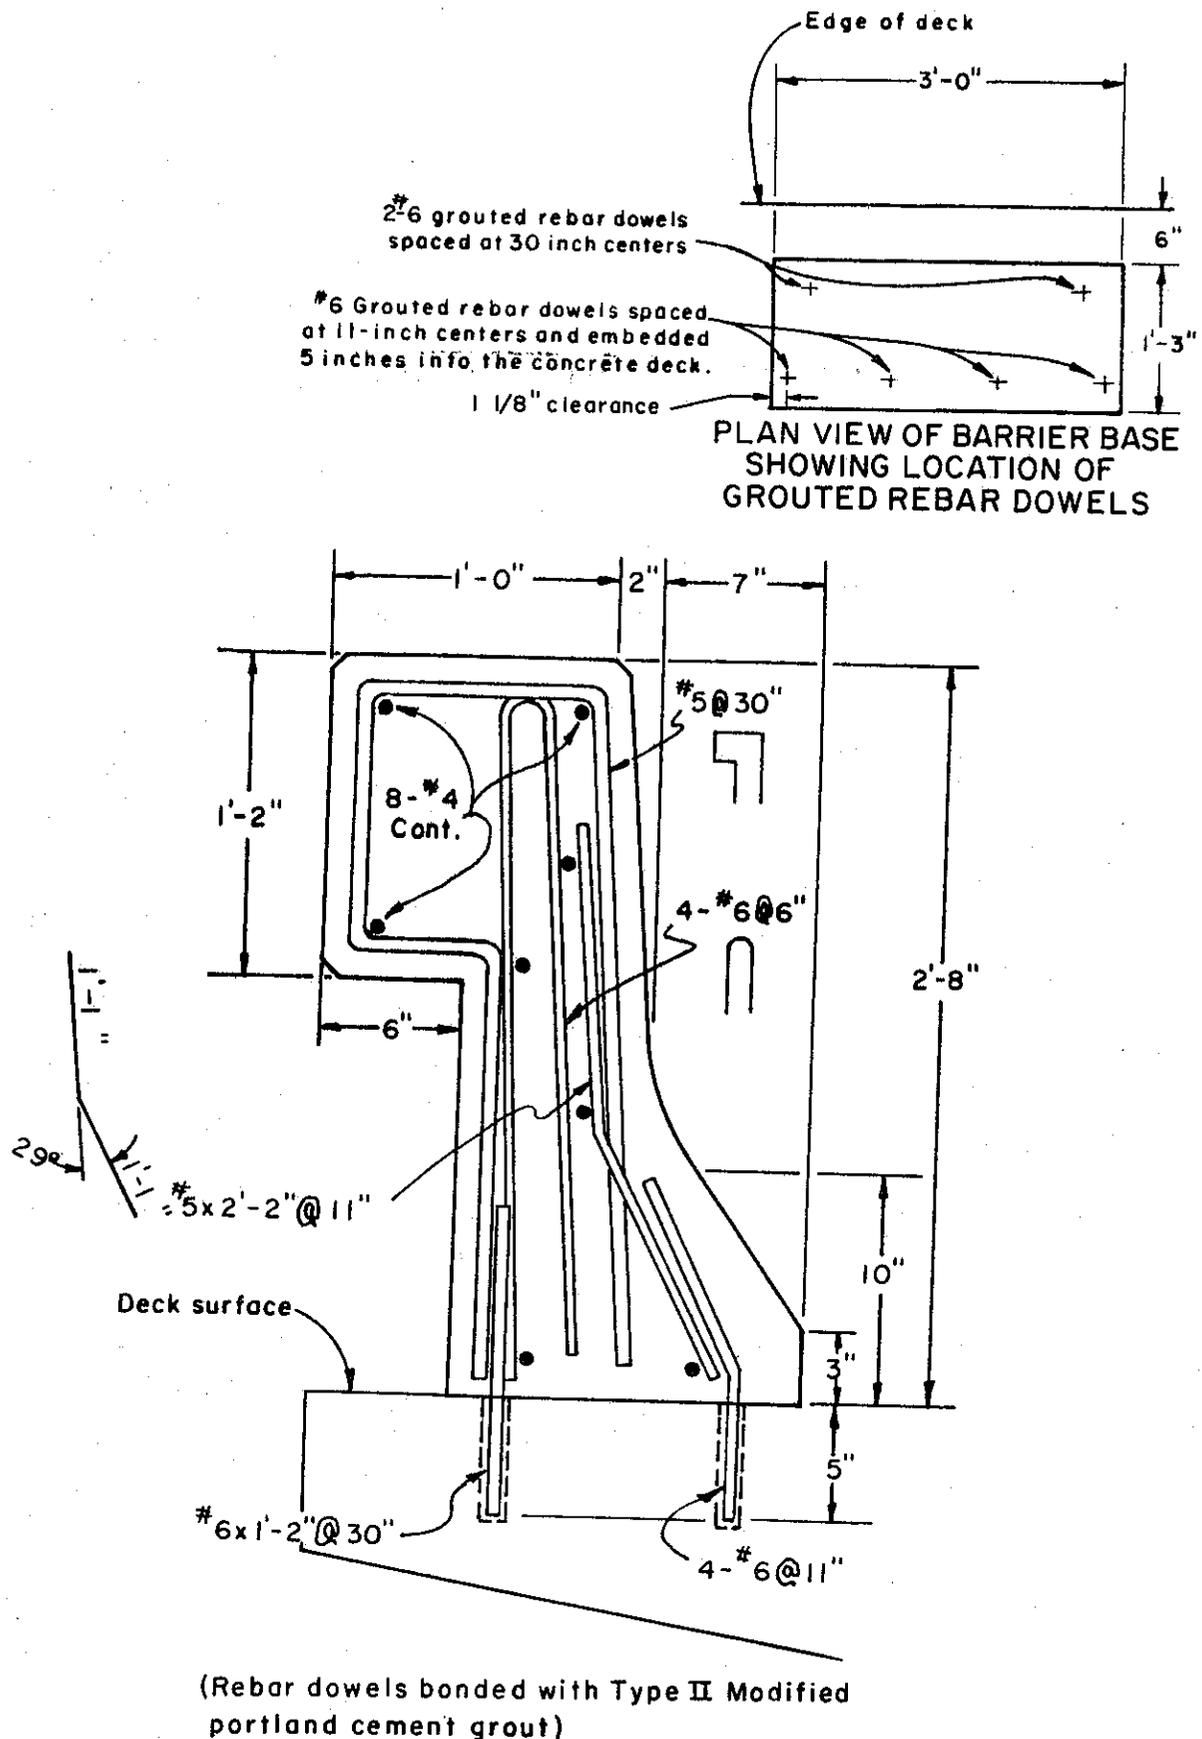
Figure 8. Steel reinforcement in the Type 25 Replacement Barrier prototype, anchored with #6 rebars, embedded 5 inches - Series I, Test Number 3.

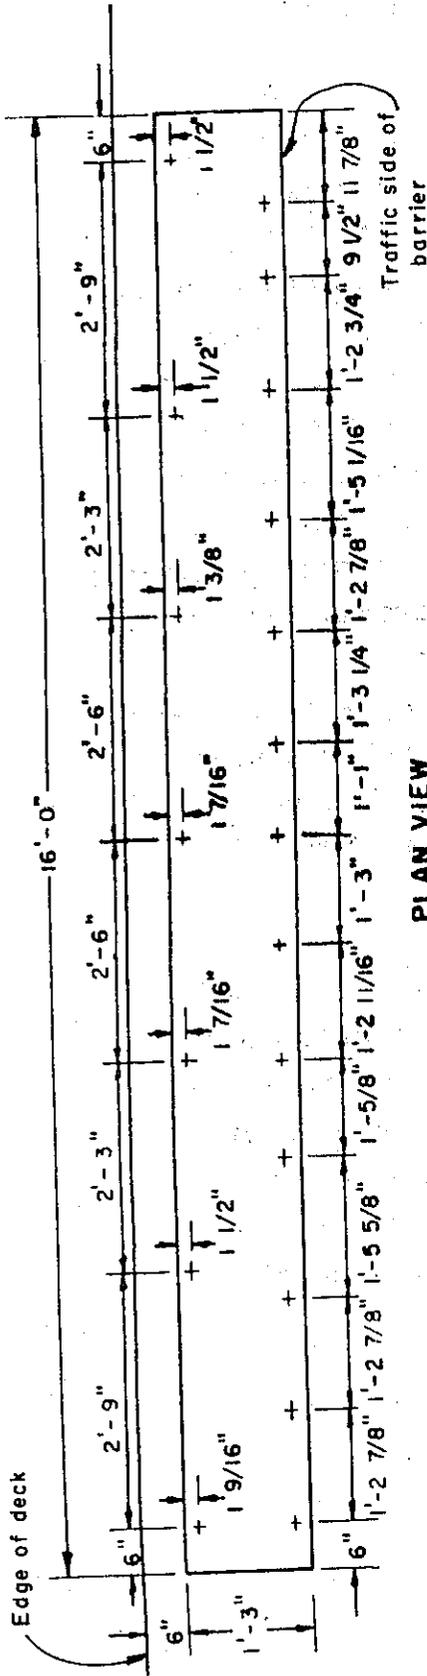
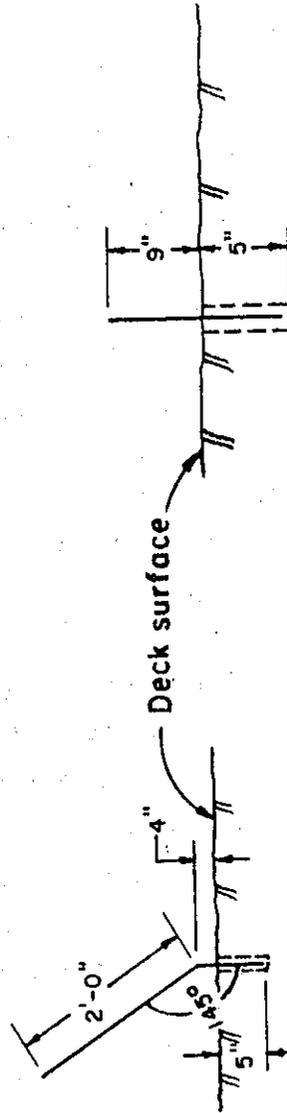
Figure 9. Locations of grouted rebar dowels in the 16-foot-long replacement barrier section - Series II test.

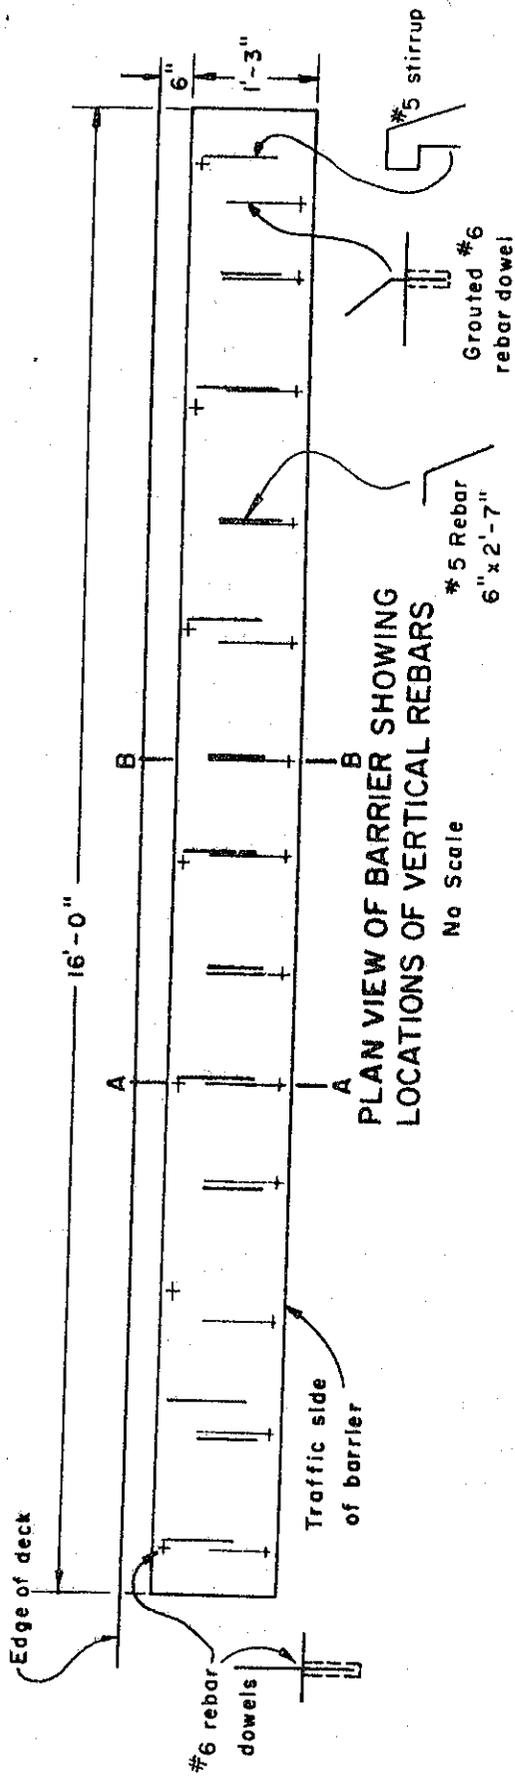
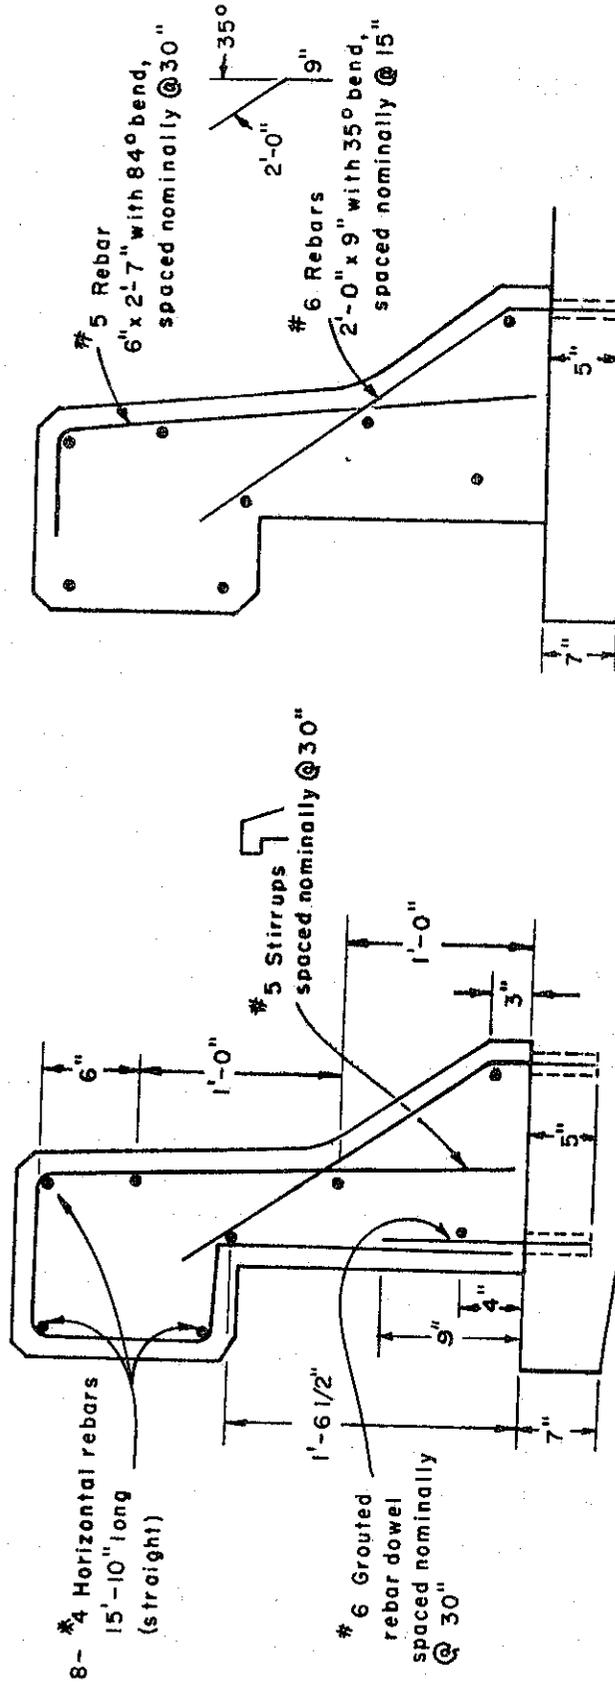
Figure 10. Dimensions and locations of reinforcing steel in the 16-foot-long replacement barrier section - Series II test.

The remaining rebar was tied in place (see Figure 10) and the necessary formwork was positioned after the grouted rebar dowels had cured for 3 days. The barrier concrete was poured and the barrier was load tested after the concrete had cured for 9 days and had attained a compressive strength of 3550 psi. At that time, the grout bonding the anchoring rebar dowels into the bridge deck had cured for a total of 14 days.

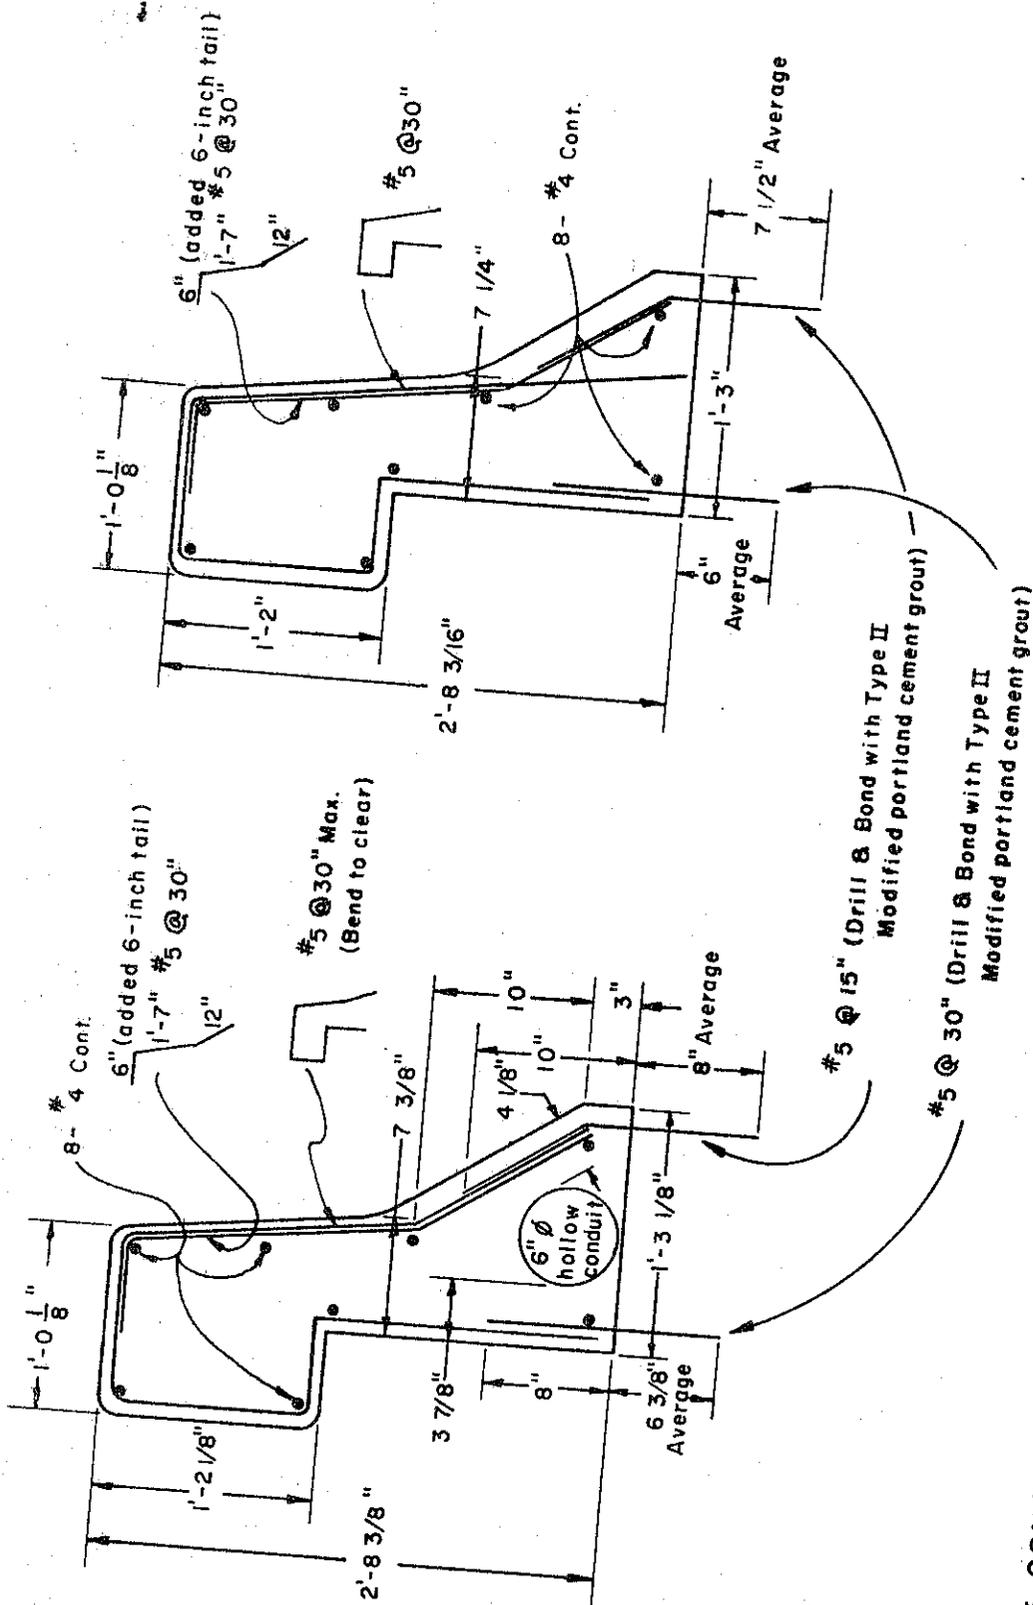
A. TYPE 25 CONCRETE BRIDGE BARRIER SECTION WITH 6-INCH DIAMETER CONDUIT

Figure 11. Reinforcing steel in the 6 1/2-foot-long concrete barrier sections - Series III tests.

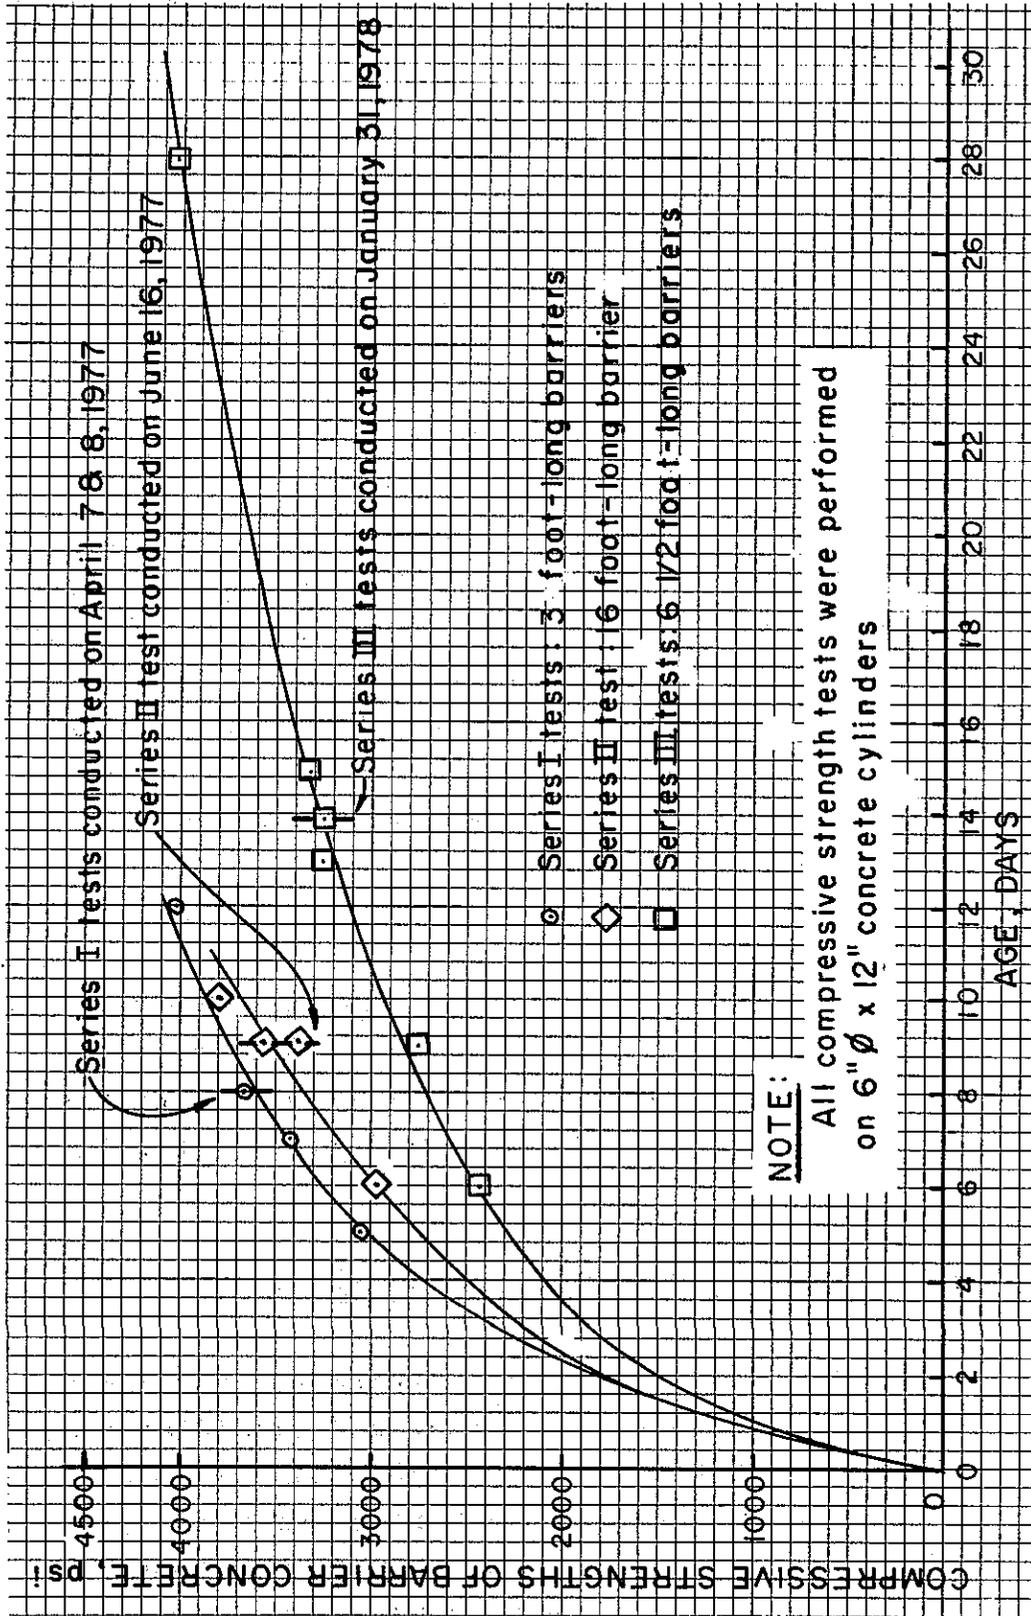
Figure 14. Plots of curing time versus strength for concrete used in Series I, II, and III barriers.

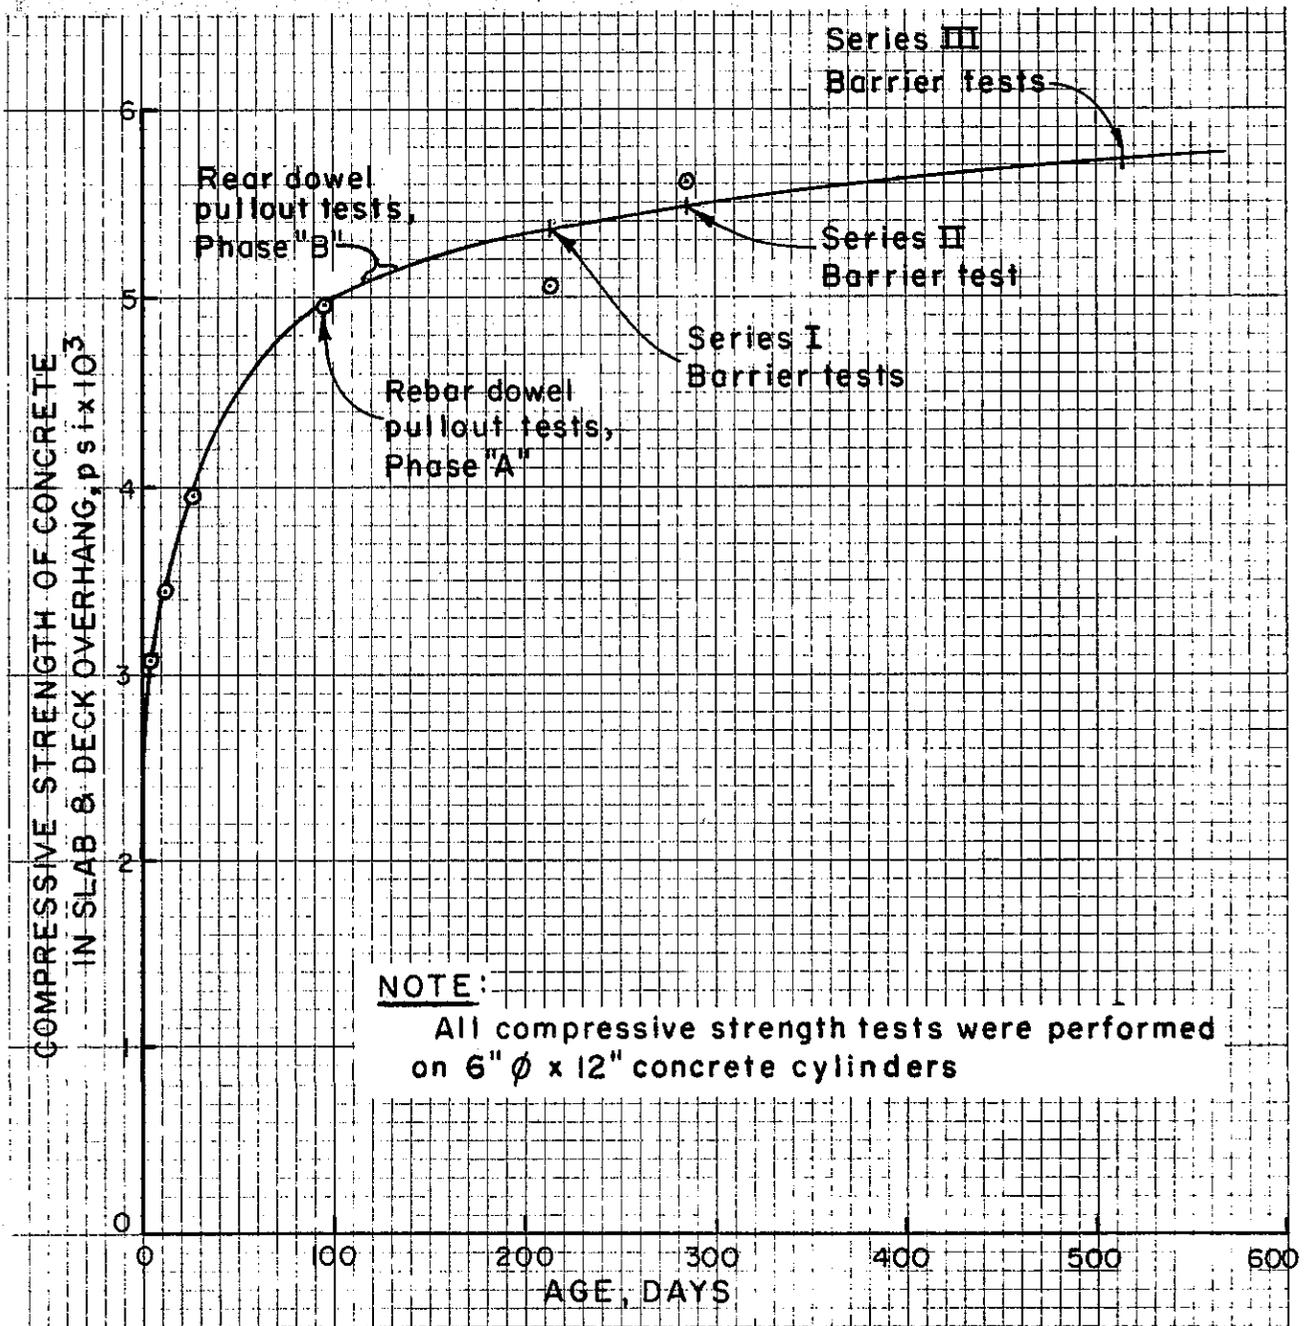
Figure 15. Plot of age versus compressive strength for concrete in test slab and deck overhang.

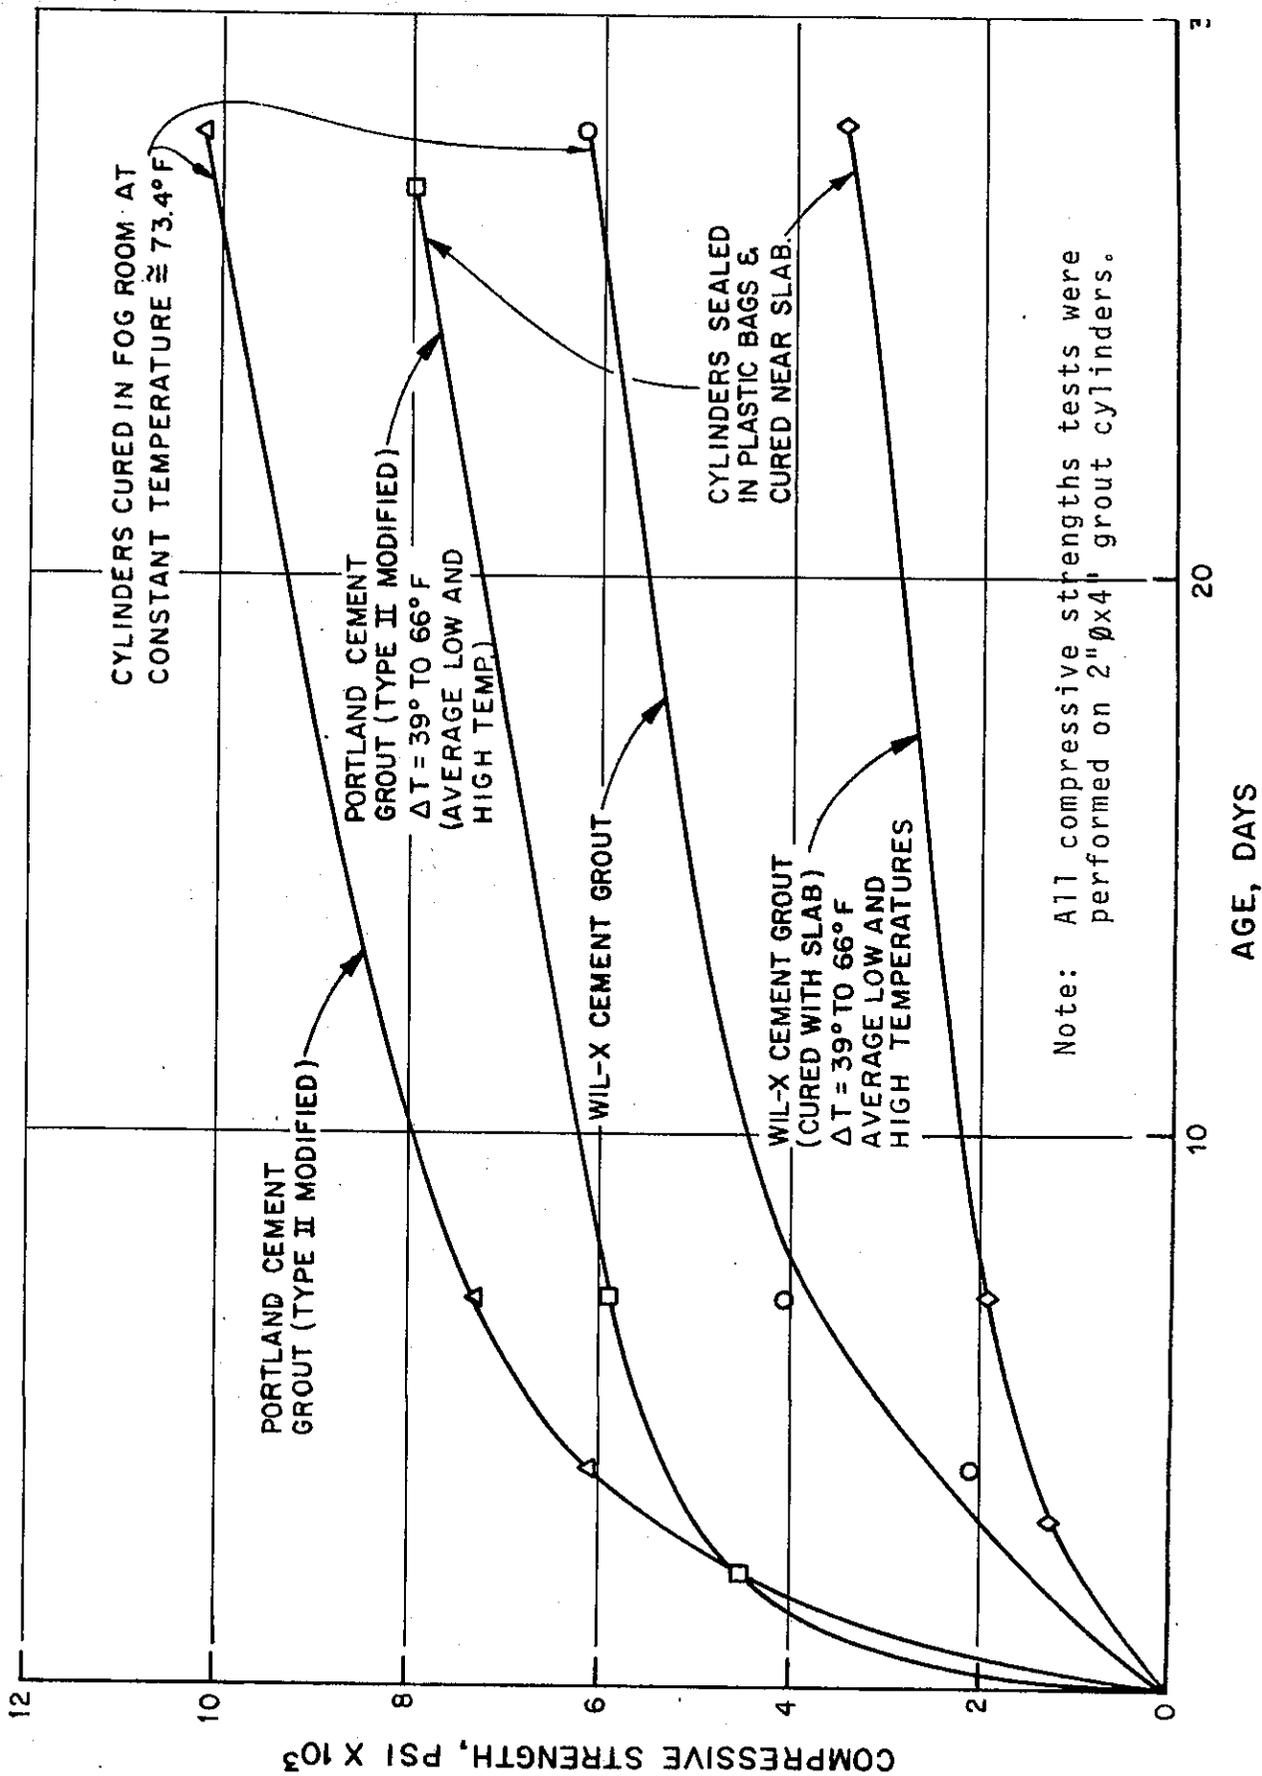
Figure 16. Plots of age versus compressive strength of Type II portland cement grout and Wil-X cement grout, and cured in different environments.
