Development Of A Rebar Dowel Anchorage System For Attaching The California Type 25 Concrete Barrier To Existing Bridges

June 1979

Office of Transportation Laboratory
California Department of Transportation
Sacramento, California 95819

Final Report

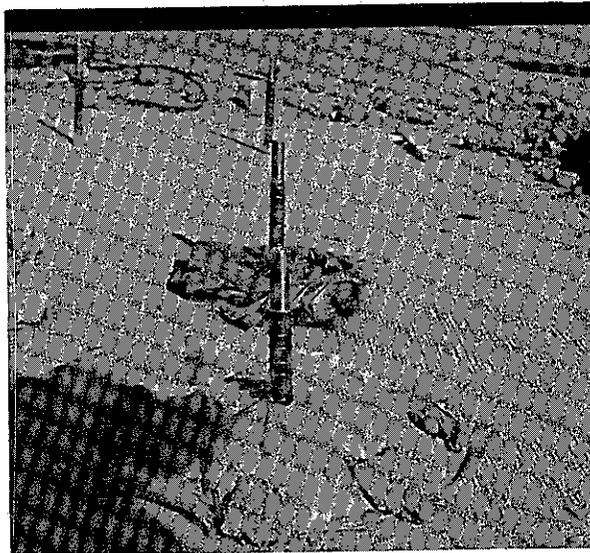
Figure 18. Curing of grout surrounding #6 rebar dowels using wet rags and plastic sheet.

The holes were filled half full of grout, then the rebar was slowly inserted, and jiggled to remove air and consolidate the grout. In Figure 17, a freshly grouted rebar is shown. After placement, all the portland cement grout was covered with wet rags and plastic sheet to retain moisture (see Figure 18).

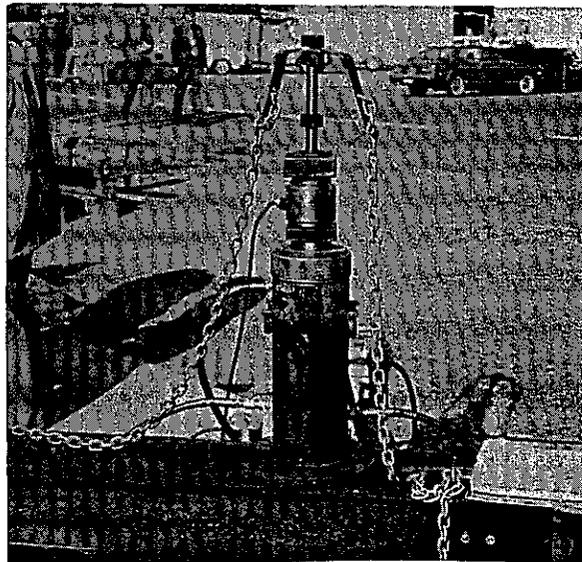
Figure 19. View of loading apparatus sitting on channel beams.

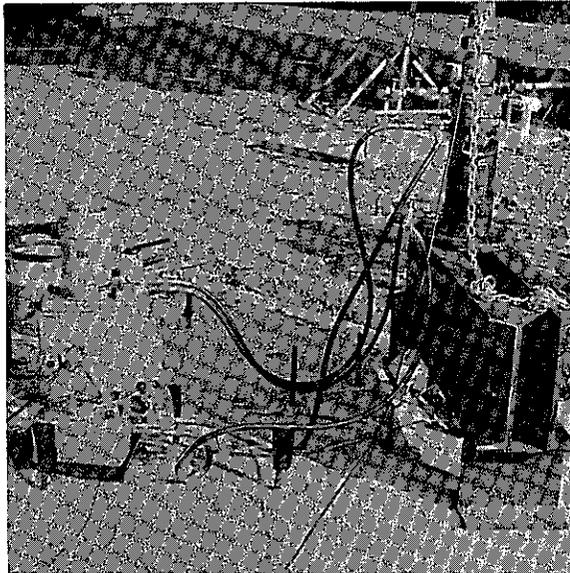
Figure 20. Pumps and test apparatus used in rebar pullout tests.

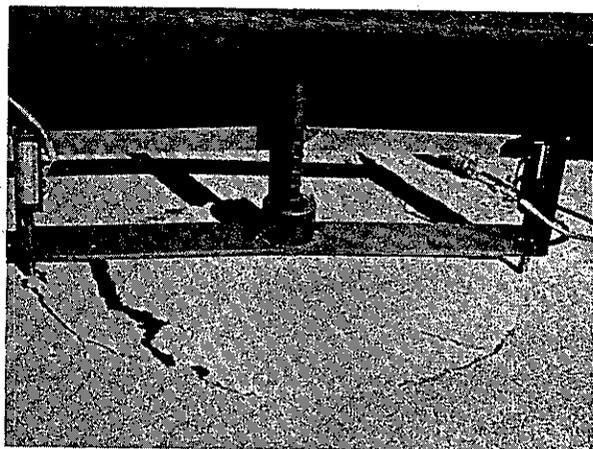
Figure 21. Steel bracket and potentiometers used to measure vertical movement of bonded rebars during pullout.

So that only bond slippage and/or rebar elongation below the surface of the concrete could be measured, the bracket was attached to the rebar dowels just above the concrete surface. Figure 21 shows the bracket with potentiometers attached.

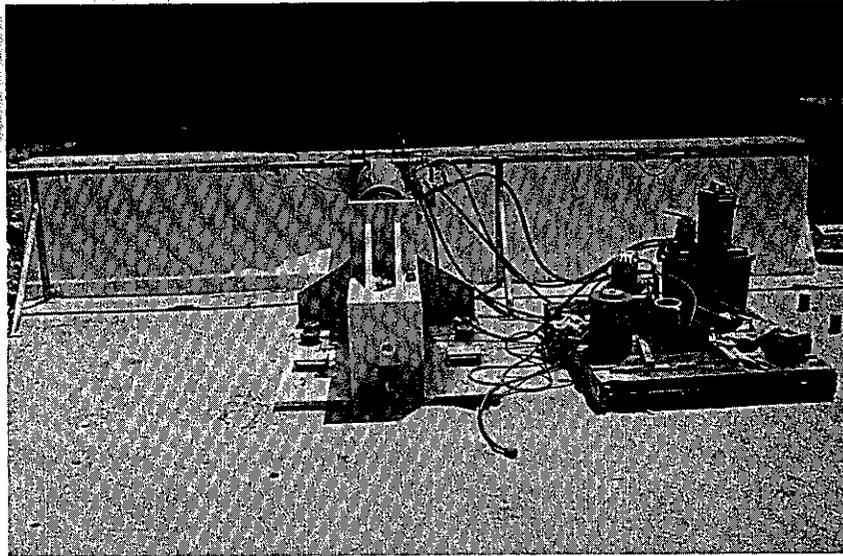
Figure 22. Front view of 16-foot-long barrier, Series II test, shown with load frame and testing apparatus.

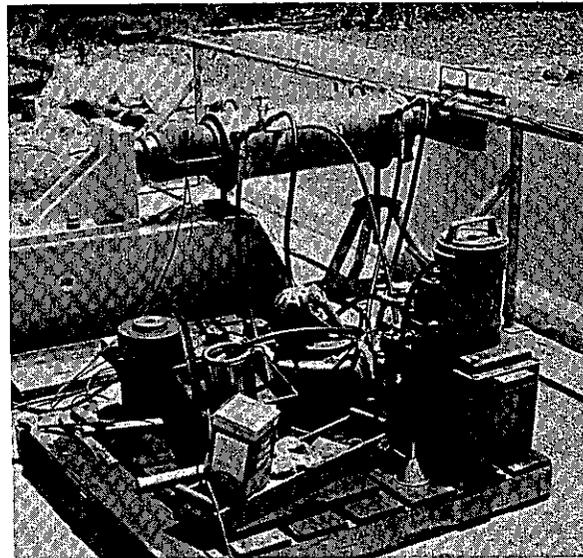
Figure 23. Side view of load frame and testing apparatus - Series II test.

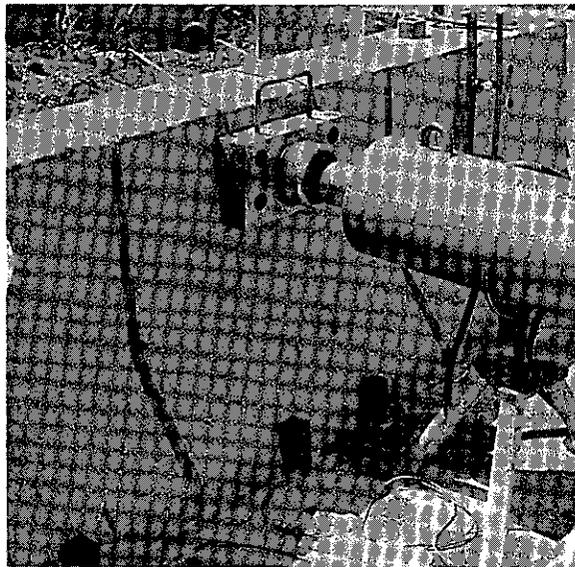
Figure 26. Transducers mounted on angle brackets at base of the 3-foot-long barrier sections in Series I tests.

In each of the three series of full-scale concrete bridge barrier static load tests, deflections of the barriers were measured. In the Series I tests where three 3-foot-long barrier sections were loaded, two transducers were positioned along the bottom front and one foot in from the edge of each barrier section in order to measure the amount of uplift (vertical deflection) of each section (see Figure 26).

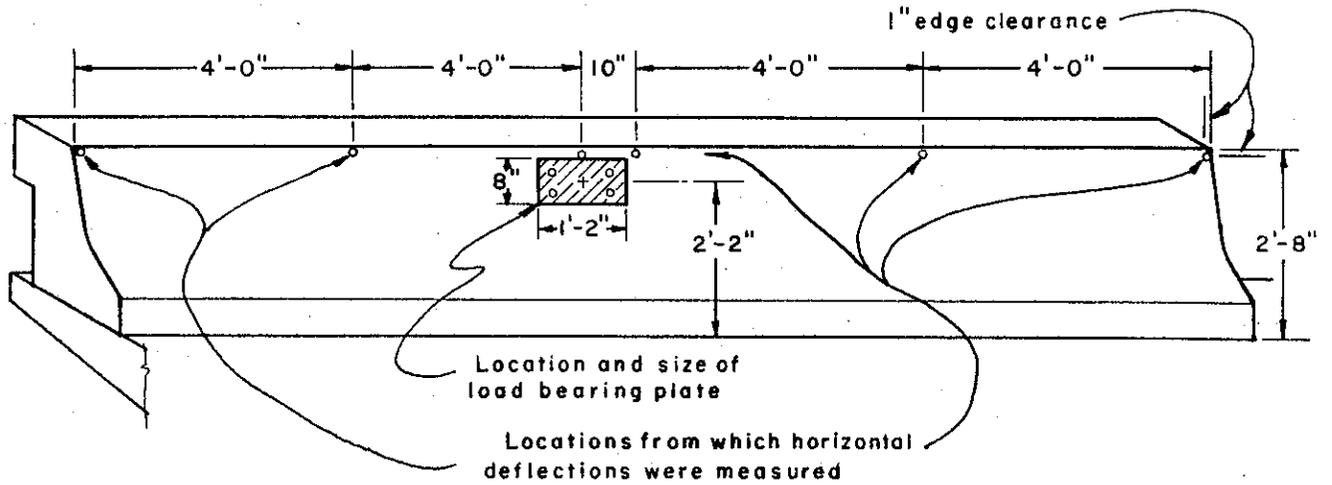
A. Six locations from which horizontal deflections were measured during Series II test.

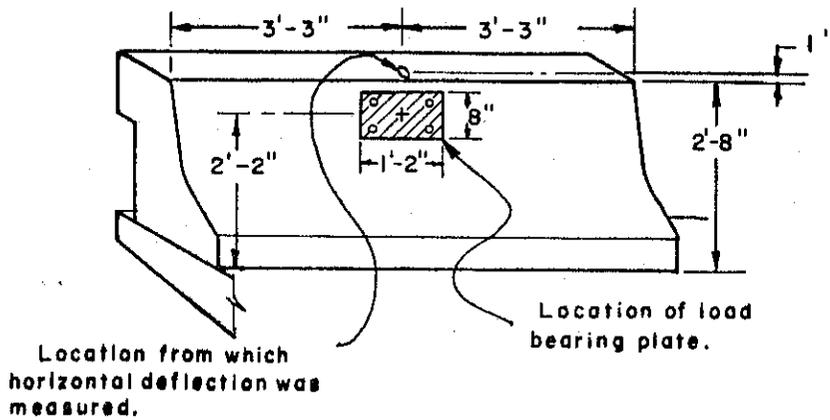
B. Single location from which horizontal deflection was measured for both barriers loaded in Series III tests.

An XYY recorder was used in the Series III tests to monitor the horizontal load, time, and the horizontal deflection of a single point at the top edge of each barrier face.

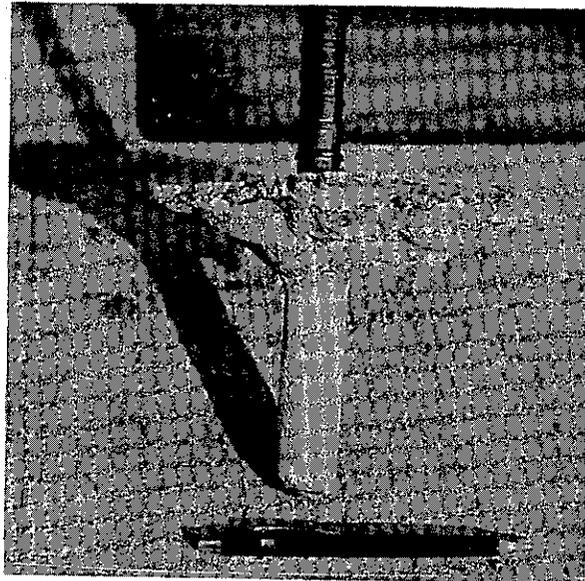
Figure 28. Rebar dowel bonded with epoxy mortar following pullout test, showing typical mode of failure.

When loaded, all specimens embedded 5 inches failed as a result of a combination of concrete tensile failure and bond failure at the grouting material/concrete interface in the drilled hole. A typical rebar dowel which was bonded with epoxy mortar is shown in Figure 28 following a pullout test.

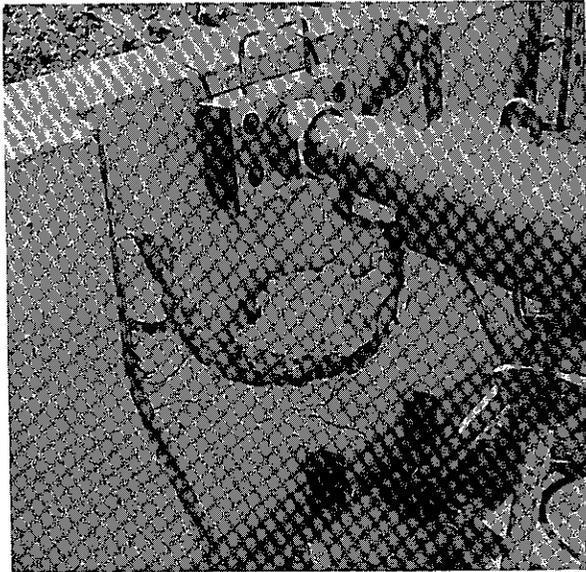
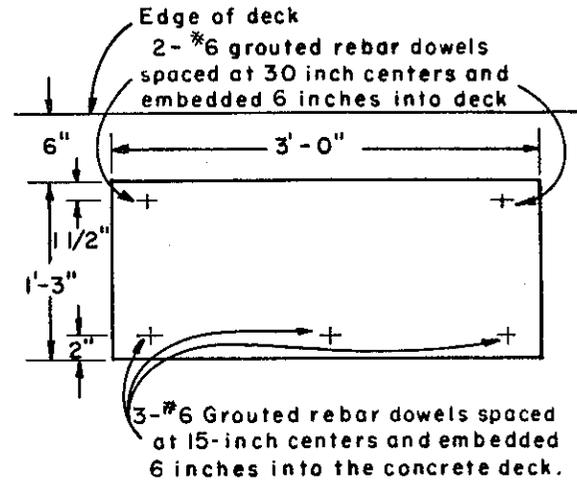
A. Failed section of Type 25 Replacement Barrier shown after horizontal load test.

Figure 29. Results of the static load test on the 3-foot-long section of Type 25 Replacement Barrier - Series I, Test Number 1.

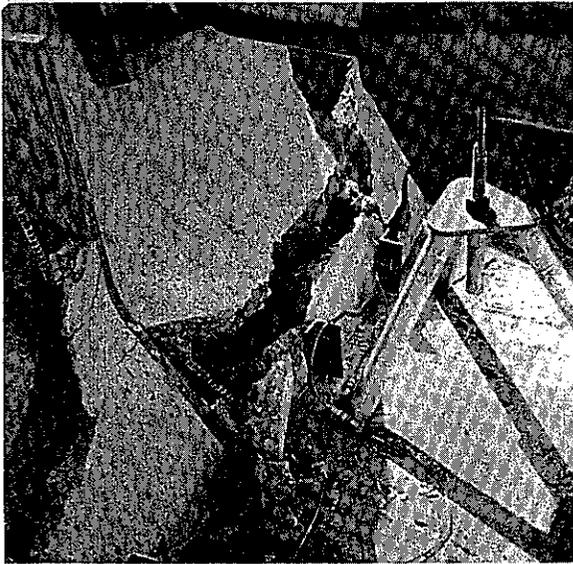
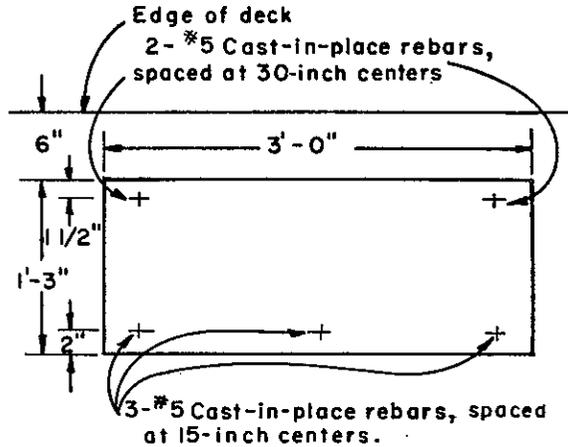
A. Failed section of standard Type 25 Concrete Barrier shown after horizontal load test.

Figure 30. Results of the static load test on the 3-foot-long section of standard Type 25 Concrete Bridge Barrier - Series I, Test Number 2.

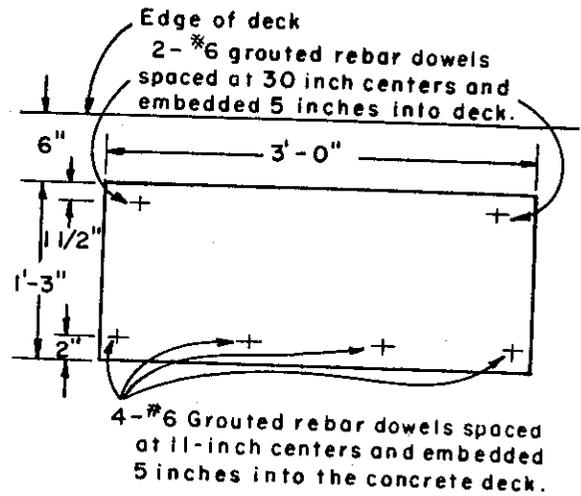
A. Failed section of Type 25 Replacement Barrier shown after horizontal load test.

Figure 31. Results of the static load test on the 3-foot-long section of Type 25 Replacement Barrier - Series I, Test Number 3.

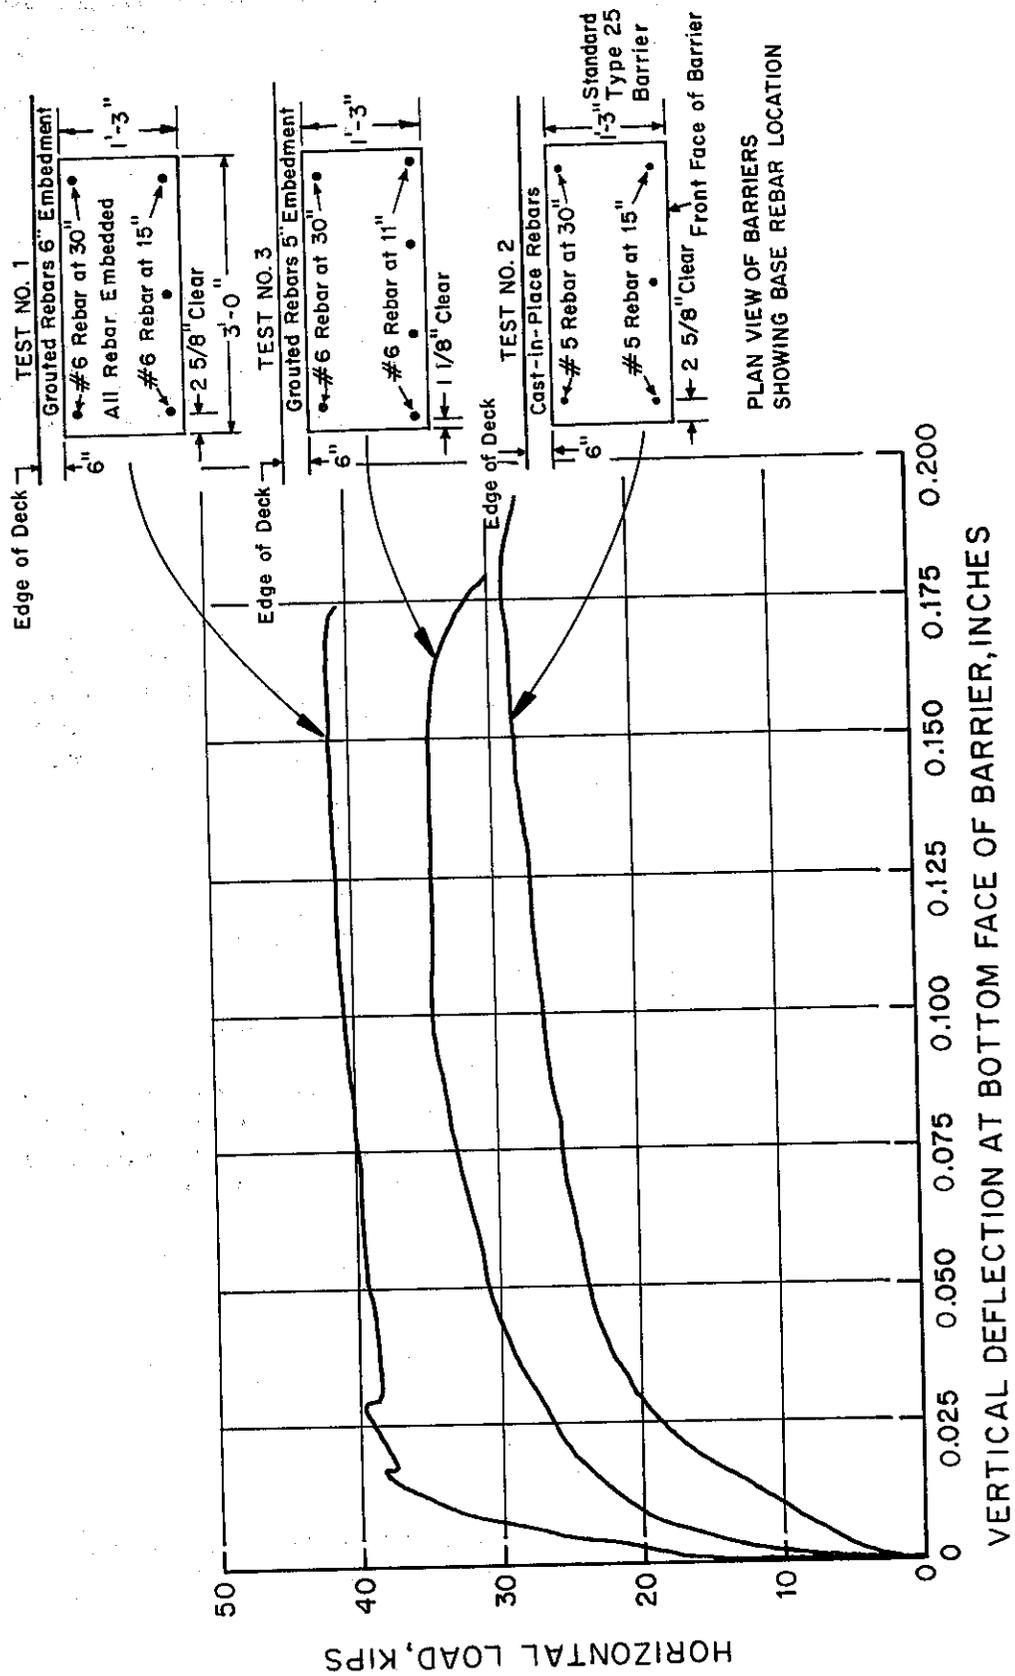
Figure 32. Plots of load versus deflection for the three, 3-foot-long barrier sections tested in Series I.

In general, fairly high overturning resistance to the externally applied horizontal forces resulted in all three tests. Load-deflection curves for each of the three short barrier tests conducted in Series I are shown in Figure 32. Maximum horizontal loads externally applied to the two replacement concrete bridge barrier sections were 41.2 kips and 34.3 kips for Test Nos. 1 and 3 respectively. Both of these replacement barrier sections, attached to the bridge deck with #6 grouted rebar dowels, proved to be stronger than the standard Type 25 Concrete Bridge Barrier with cast-in-place #5 rebar dowels which failed at an external load of 28.7 kips. Because of severe cracking of concrete along the bottom of the front edge of each of the three barrier sections tested, any deflections measured during these tests and reported here are at best approximate.

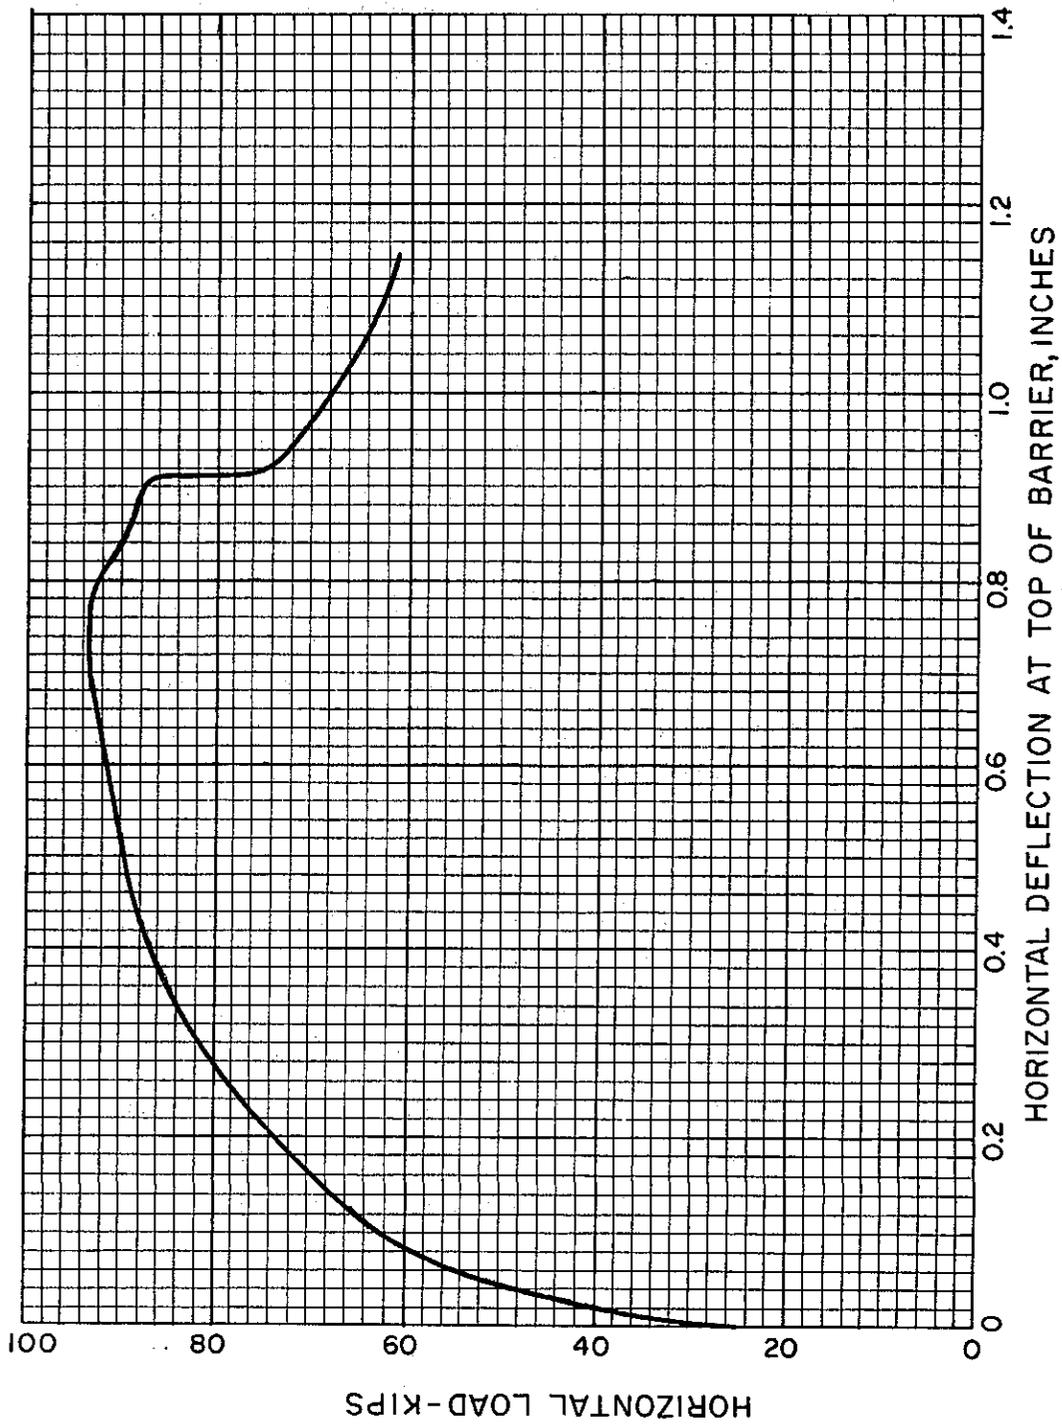
Figure 33. Plot of load versus deflection for the 16-foot-long replacement barrier tested in Series II test.

Discussion of results: The peak load, 93.0 kips, was reached approximately 20 seconds after initial loading had begun. A load-deflection curve for the 16-foot-long replacement barrier section is shown in Figure 33. As the horizontal load was applied, the first visible effect of load on the barrier was the appearance of a horizontal crack along the base of the front edge of the barrier (see Figure 34).

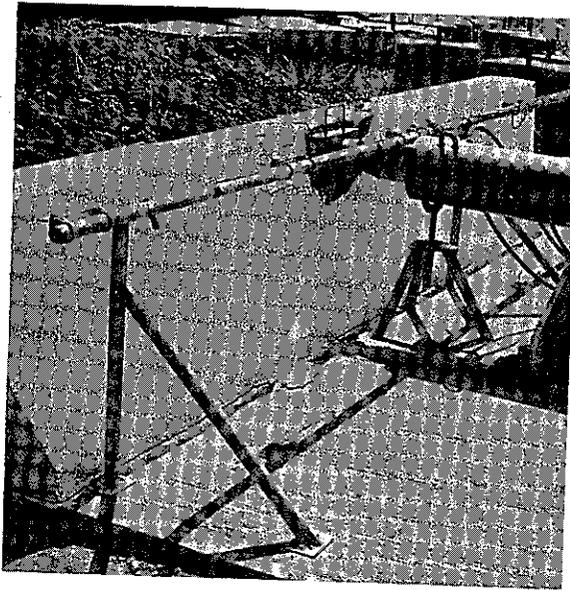
Figure 34. Front face of barrier during Series II test showing crack along bottom edge of barrier face and cracks around loading plate.

As the width of the crack along the front base of the barrier began to increase, radial cracks formed around the loading plate. These cracks passed diagonally through the beam section of the barrier and were indicative of a punching shear failure. As the horizontal load was increased, the size of the shear cracks continued to grow around the loading plate, and many more small cracks running diagonally across the face of the barrier appeared as seen in Figure 35. Once the deep diagonal cracks directly adjacent to and on both sides of the loading plate had propagated and appeared on the back or edge-of-deck side of the barrier (see Figure 36), the horizontal load applied to the loading plate began to decrease. The width of the crack along the bottom of the barrier face reached a maximum size of about 1/4 inch near the left end of the barrier

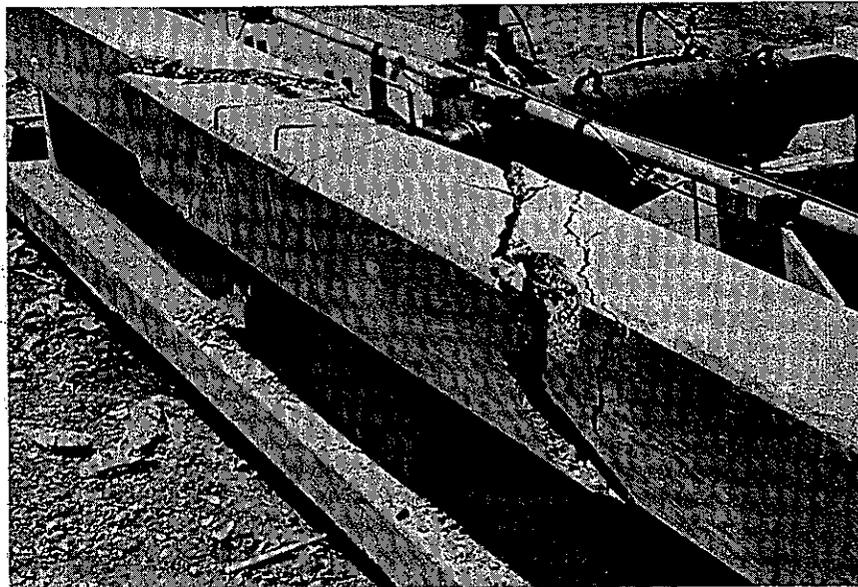
Figure 36. Oblique view of edge-of-deck side of barrier showing diagonal cracking through top beam section in Series II test.

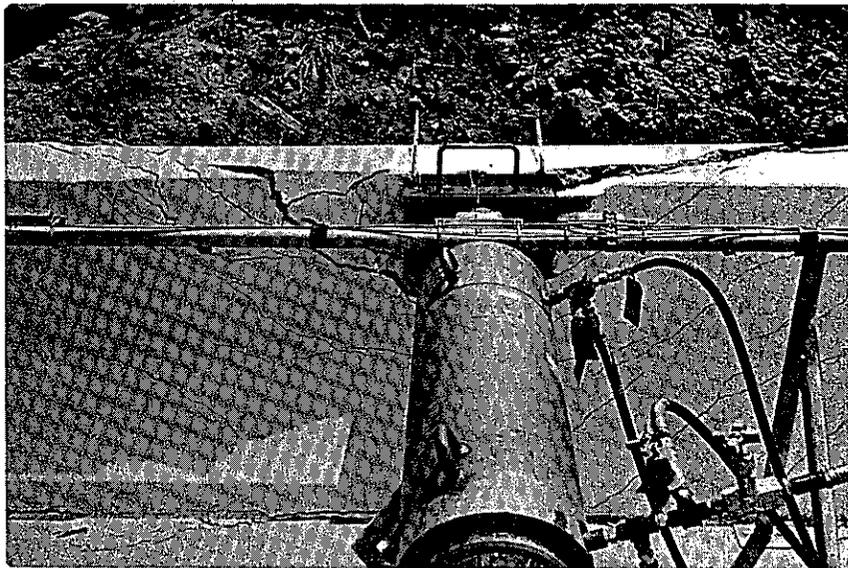
Figure 37. Close-up view of barrier face in Series II test showing crack pattern around bearing plate.

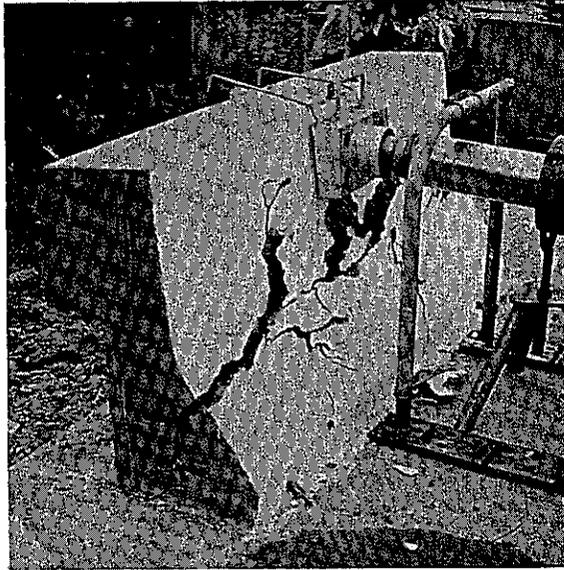
Figure 38. Oblique view of the 6 1/2-foot long standard Type 25 Concrete Bridge Barrier section after horizontal load test in Series III, Test Number 2.

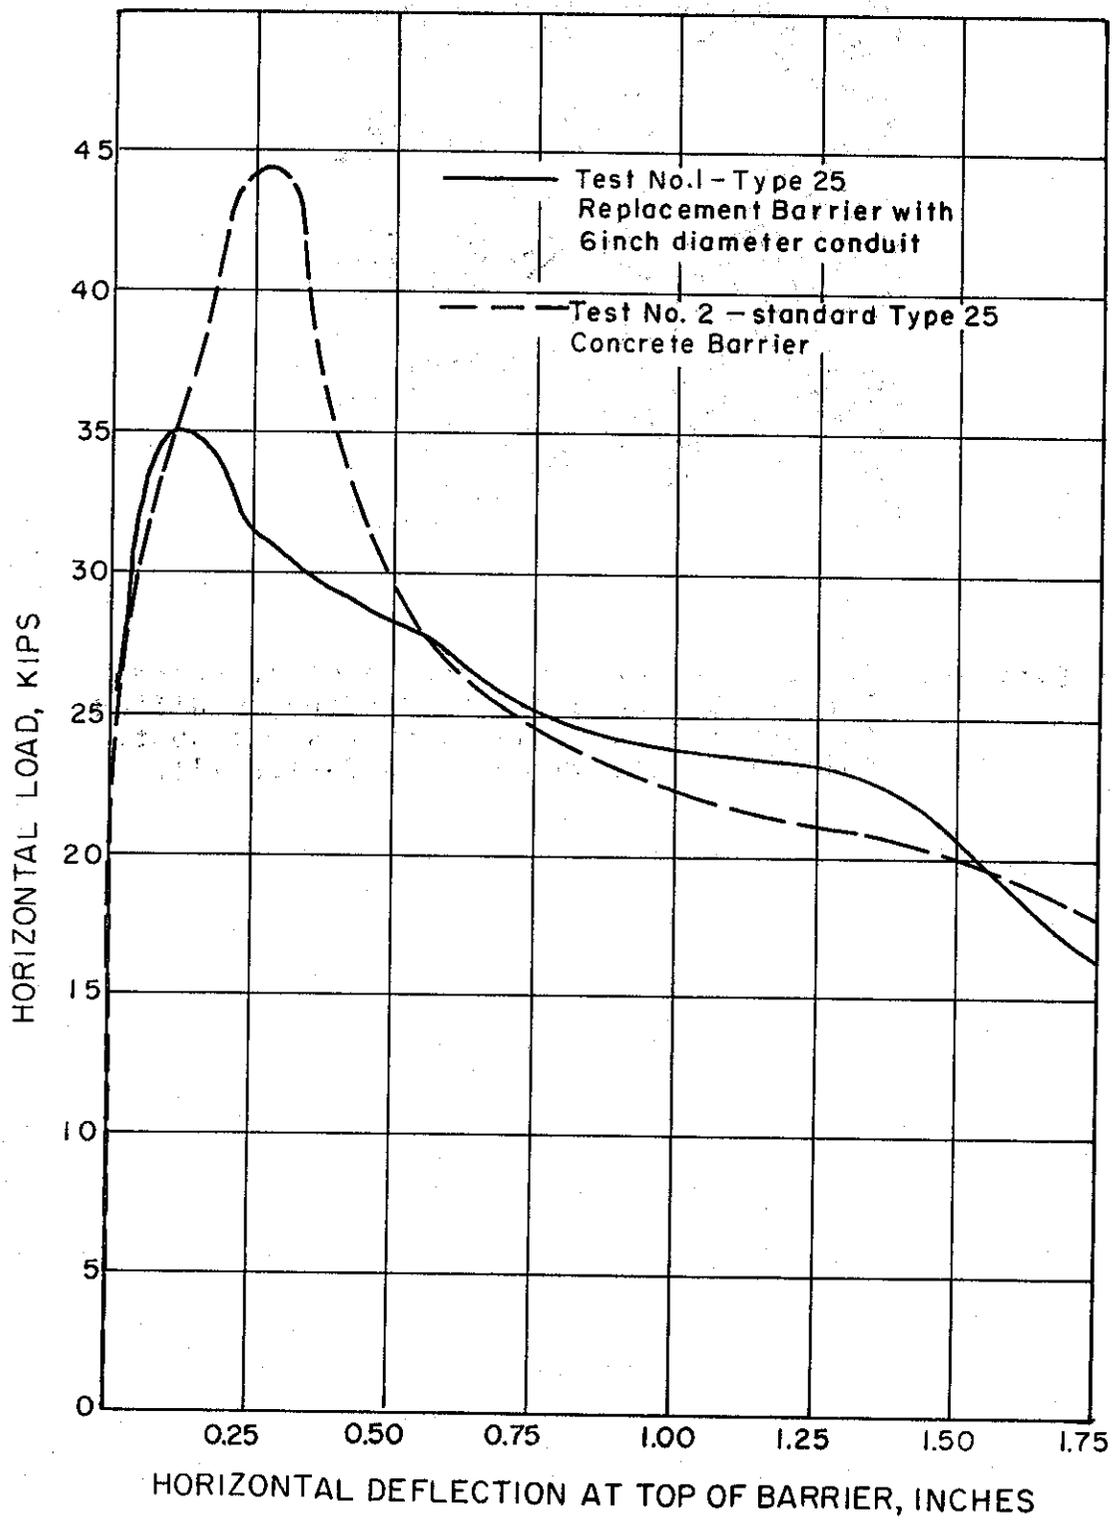
Figure 39. Plots of load versus deflection for the 6 1/2-foot-long barrier sections in Series III tests.

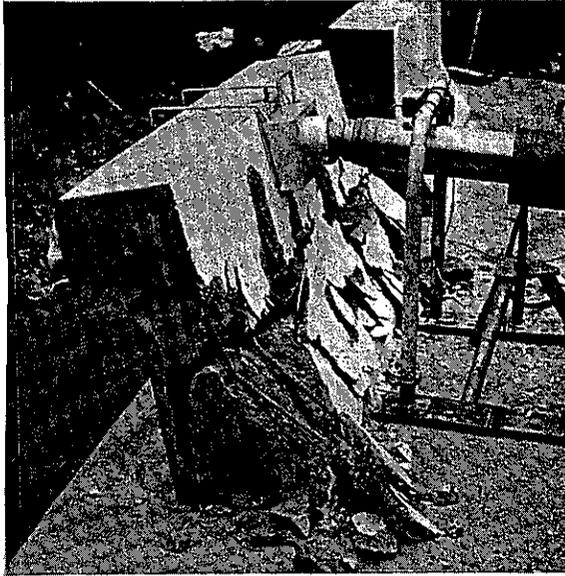
Figure 40. The 6 1/2-foot-long section of standard Type 25 Concrete Bridge Barrier, modified to contain a 6-inch-diameter steel duct, following Test Number 1 in Series III.

Discussion of Results: The barrier section containing a 6-inch-diameter conduit failed in a similar manner as did the standard section, but at a lower load of 34.9 kips. A picture of the failed barrier with conduit is shown in Figure 40. The apparent reason for the lower load failure level of the barrier containing the conduit is because of a loss of bond around stirrup legs along the front of the barrier face. It was necessary to bend legs of the front

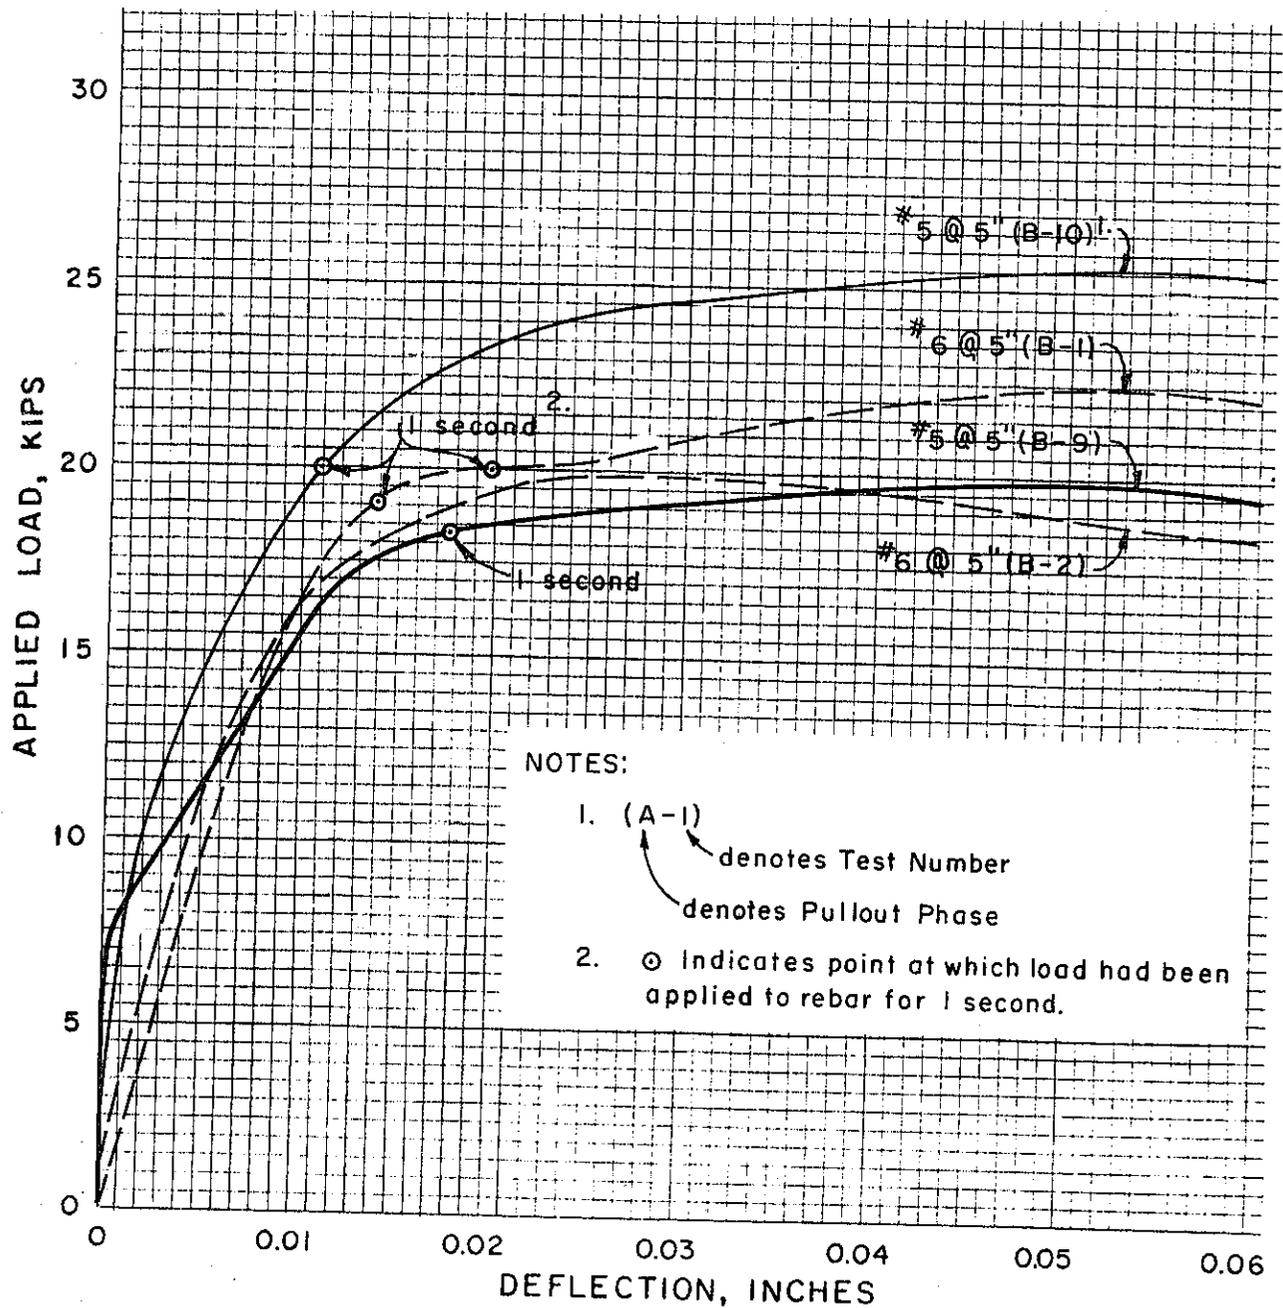
Appendix B-1. Graphs of load versus deflection from individual pullout tests on rebar dowels bonded with Type II Modified portland cement grout and embedded five inches into a reinforced concrete slab.

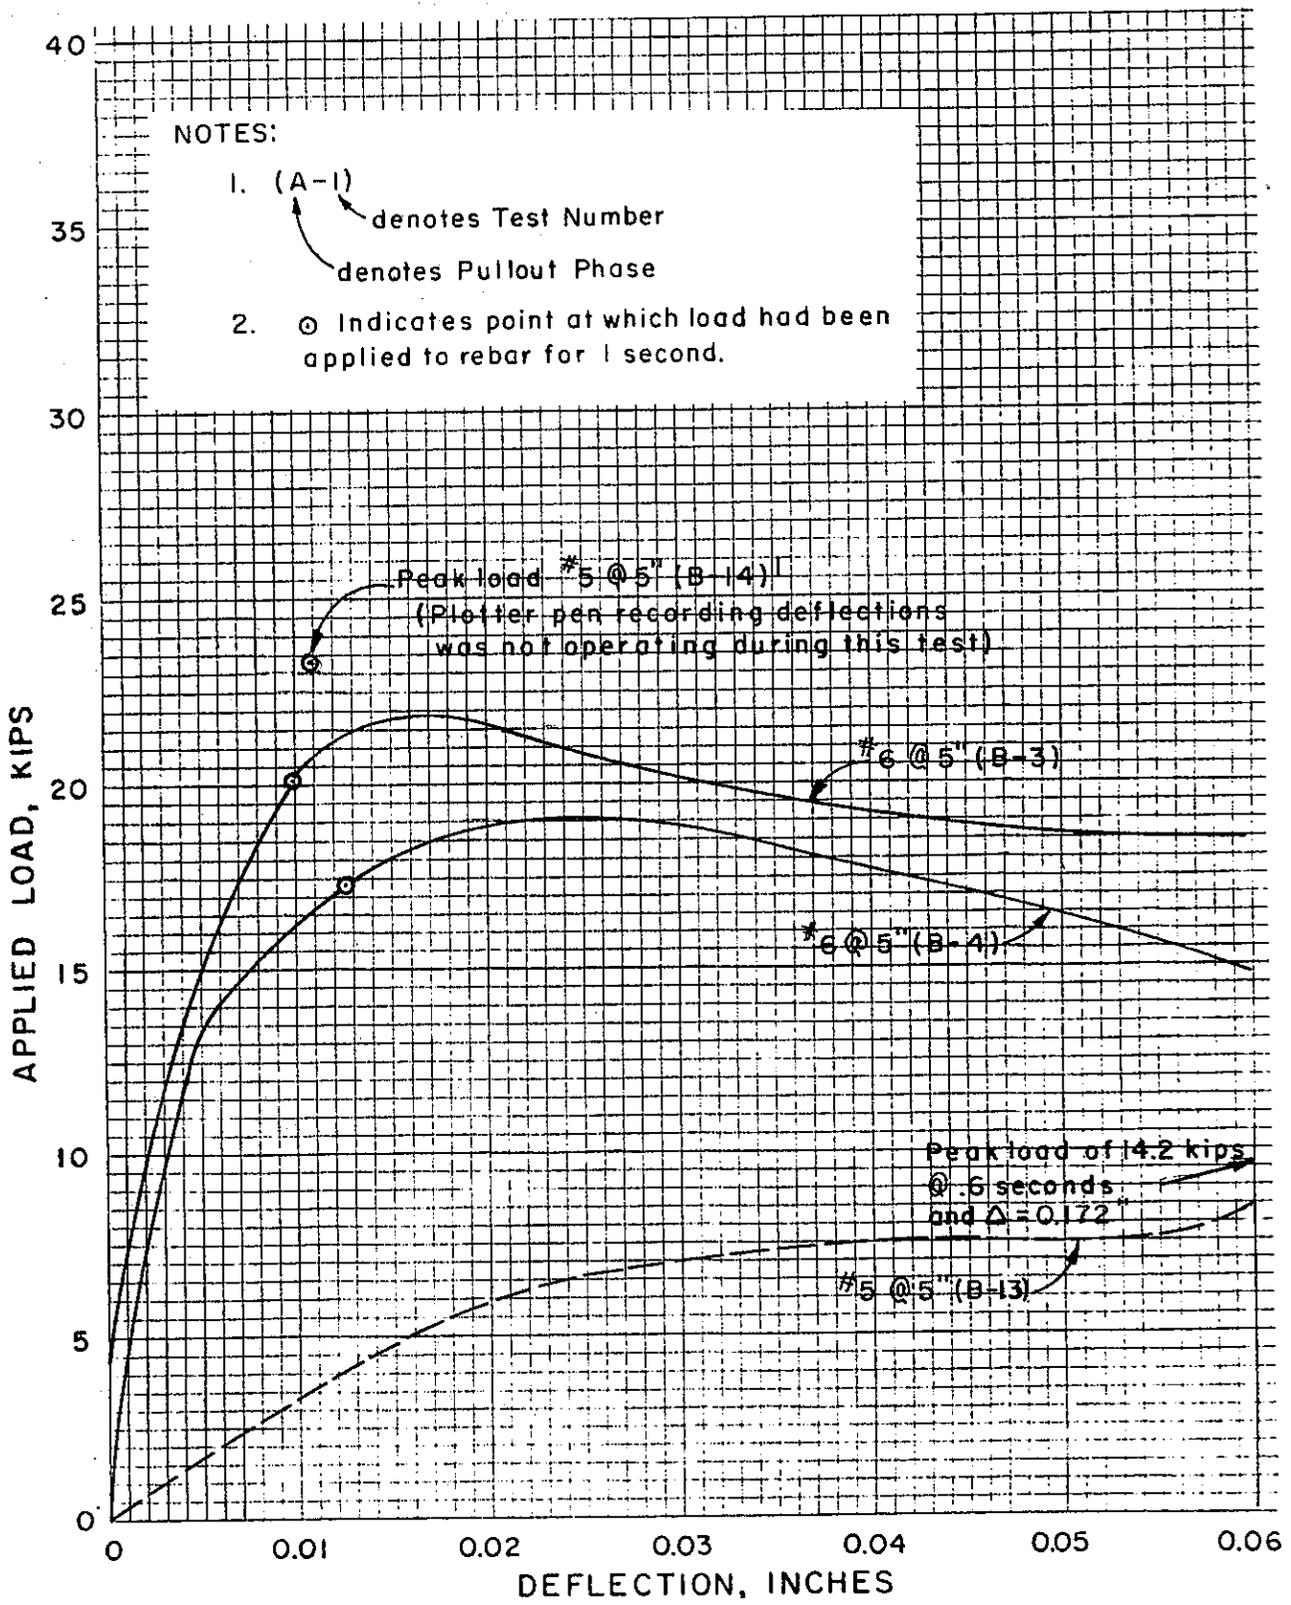
Appendix B-2. Graphs of load versus deflection from individual pullout tests on rebar dowels bonded with epoxy mortar and embedded five inches into a reinforced concrete slab.

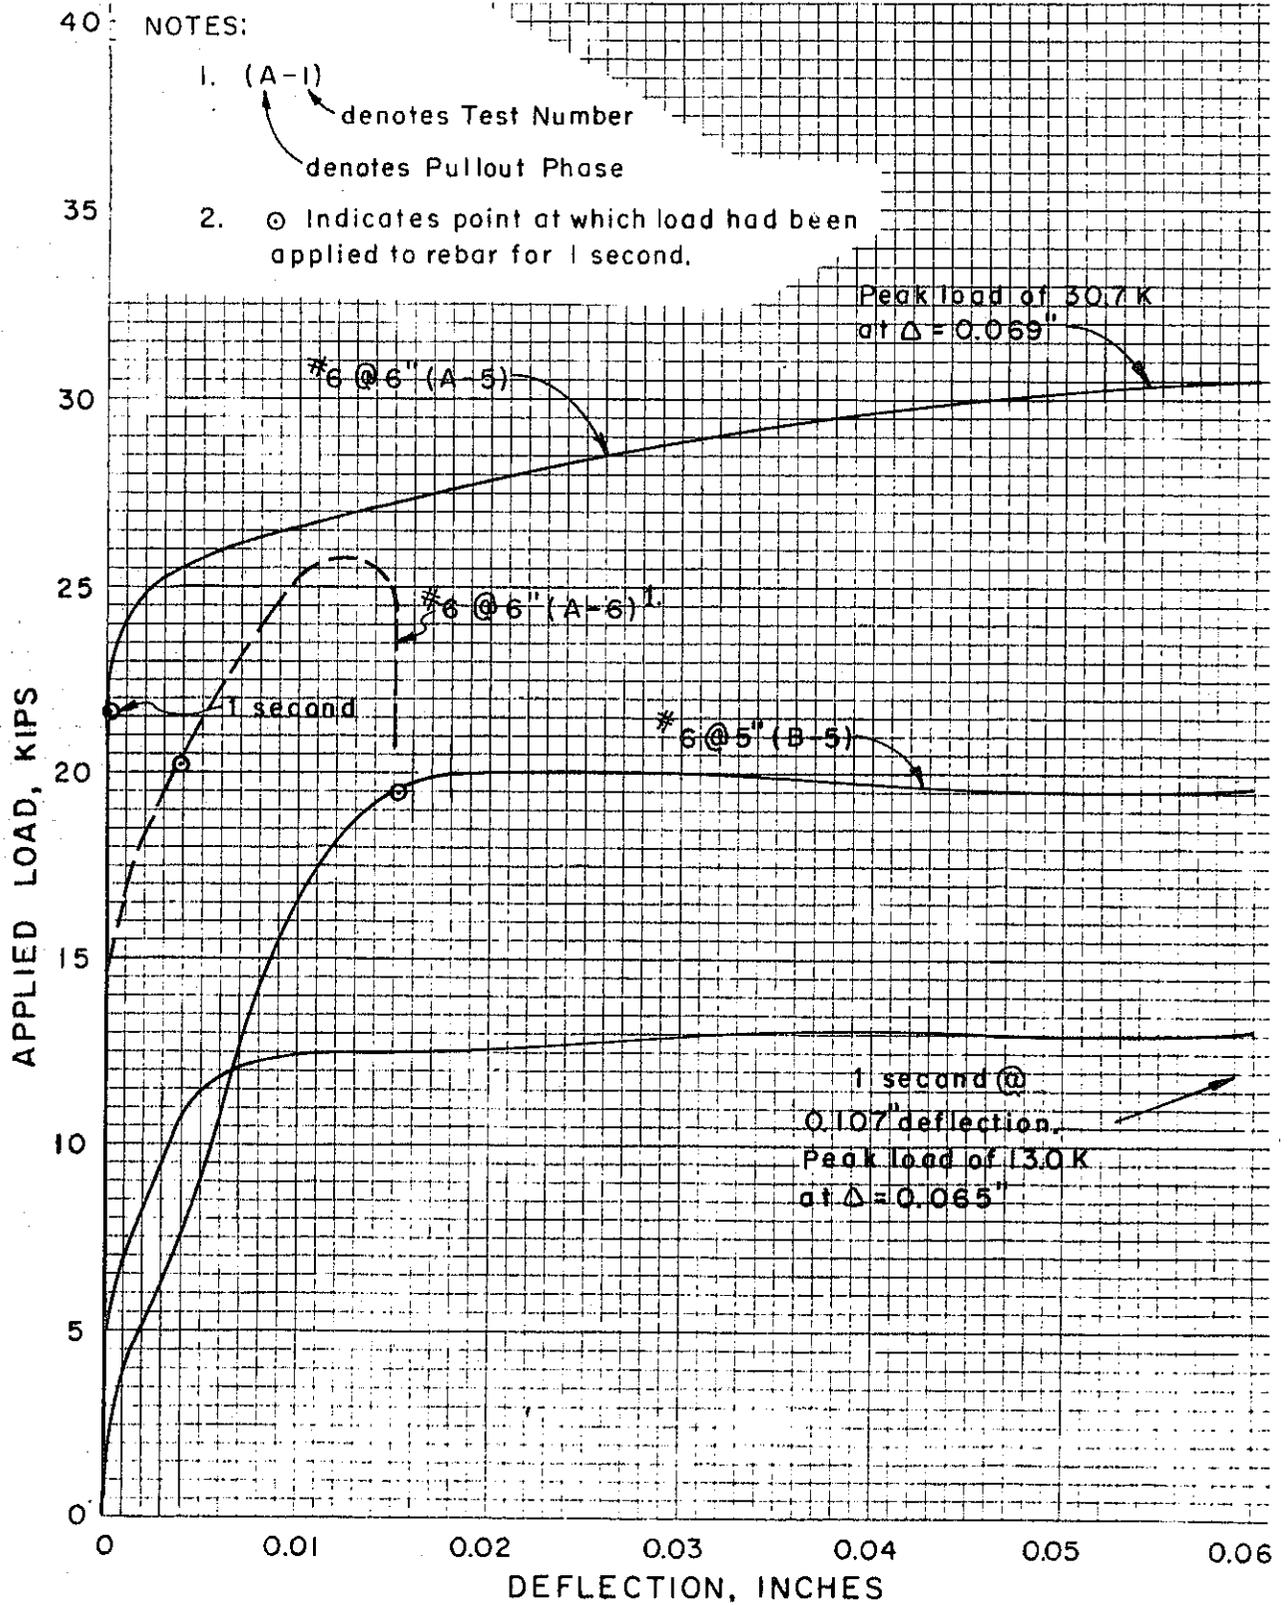
Appendix B-3. Graphs of load versus deflection from individual pullout tests on rebar dowels bonded with Wil-X cement grout and embedded five and six inches into a reinforced concrete slab.

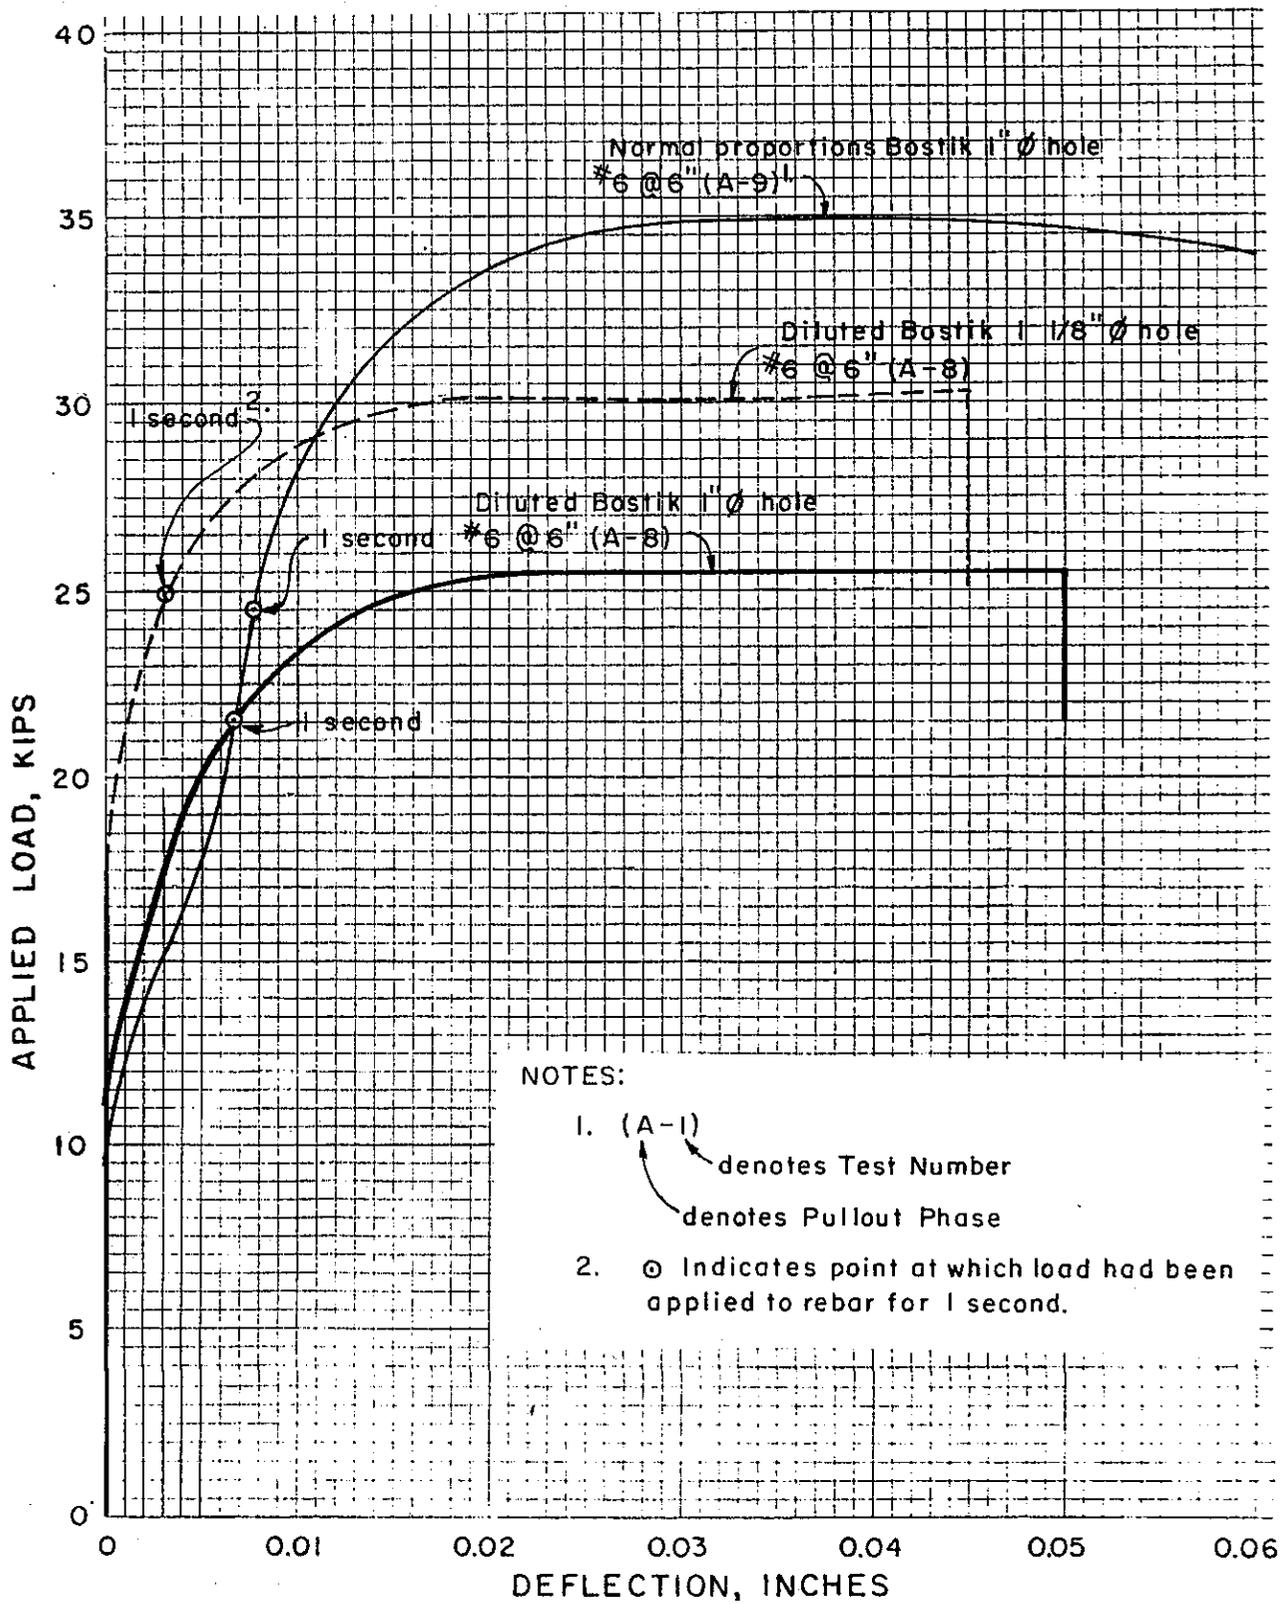
Appendix B-4. Graphs of load versus deflection from individual pullout tests on #6 rebar dowels bonded with Bostik-275 cement grout and embedded six inches into a reinforced concrete slab.
