Development Of A Rebar Dowel Anchorage System For Attaching The California Type 25 Concrete Barrier To Existing Bridges

June 1979

Office of Transportation Laboratory
California Department of Transportation
Sacramento, California 95819

Final Report

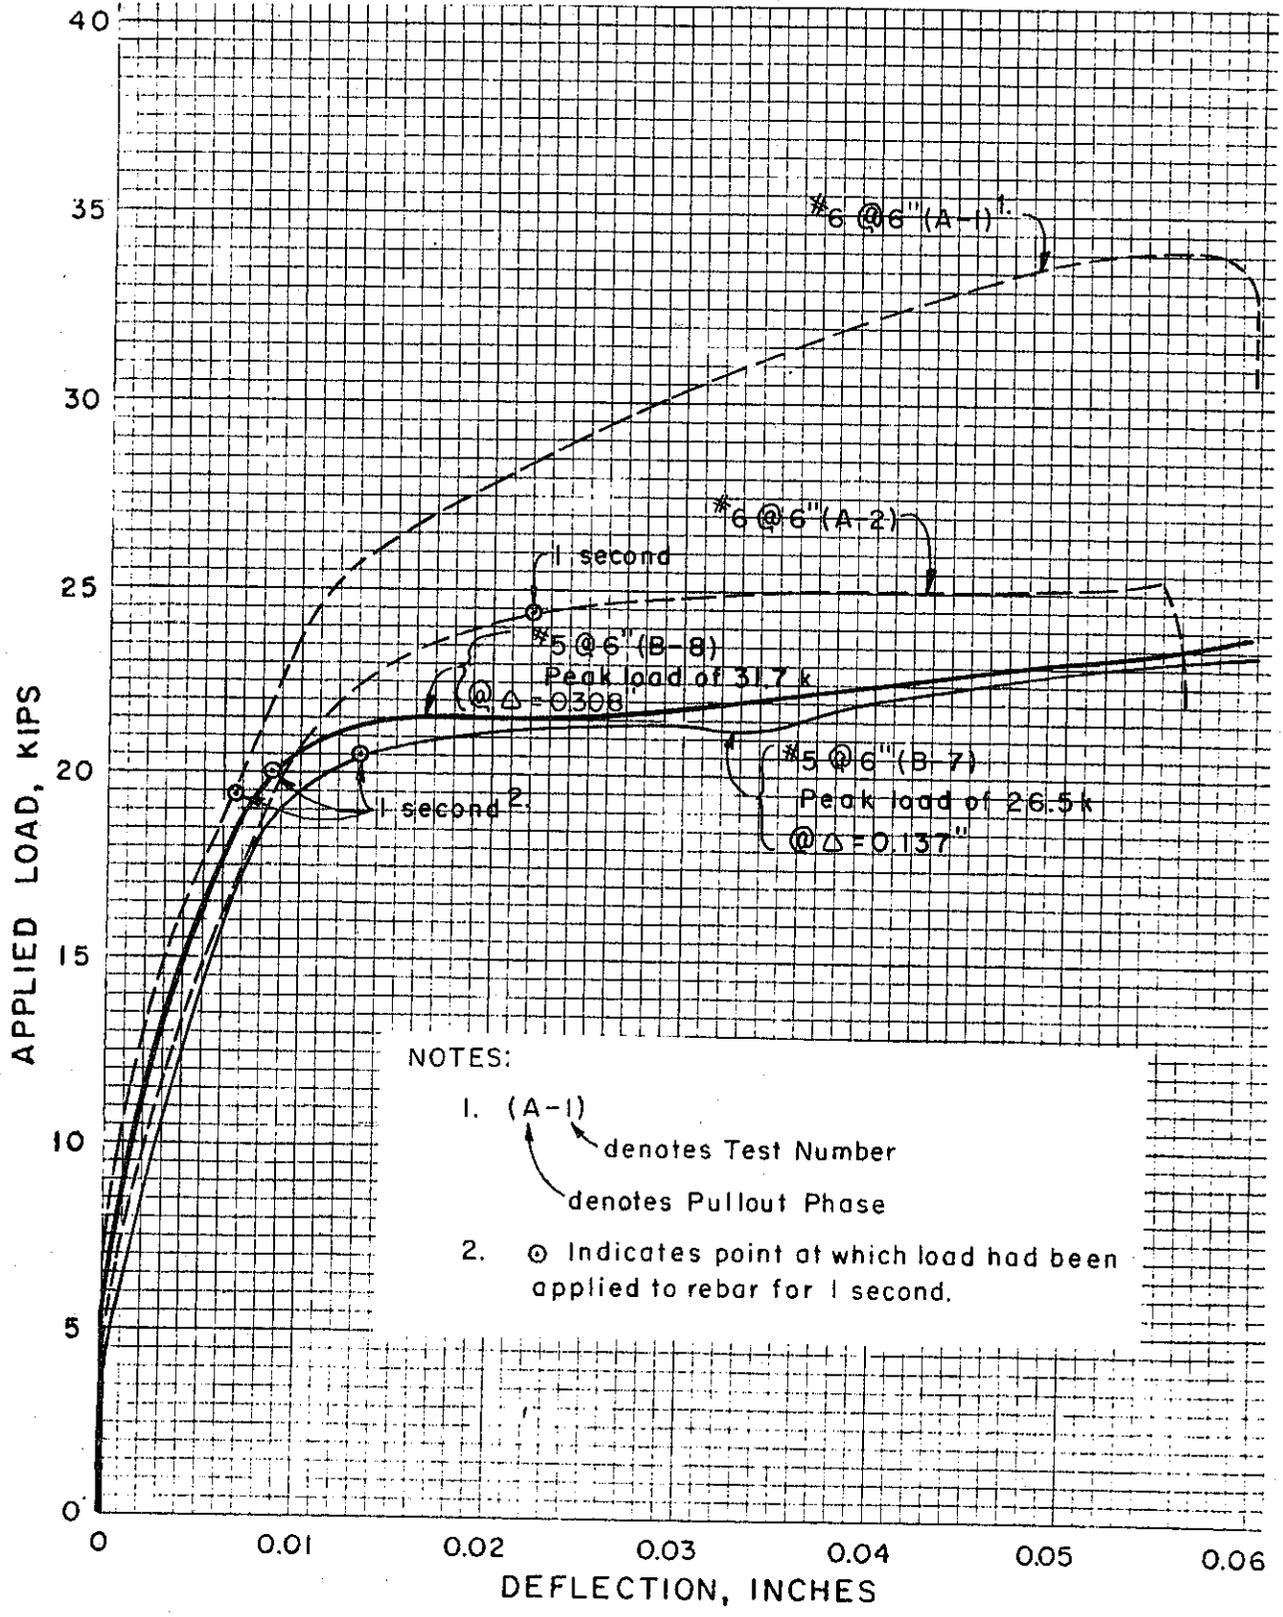
Appendix B-5. Graphs of load versus deflection from individual pullout tests on rebar dowels bonded with Type II Modified portland cement grout and embedded six inches into a reinforced concrete slab.

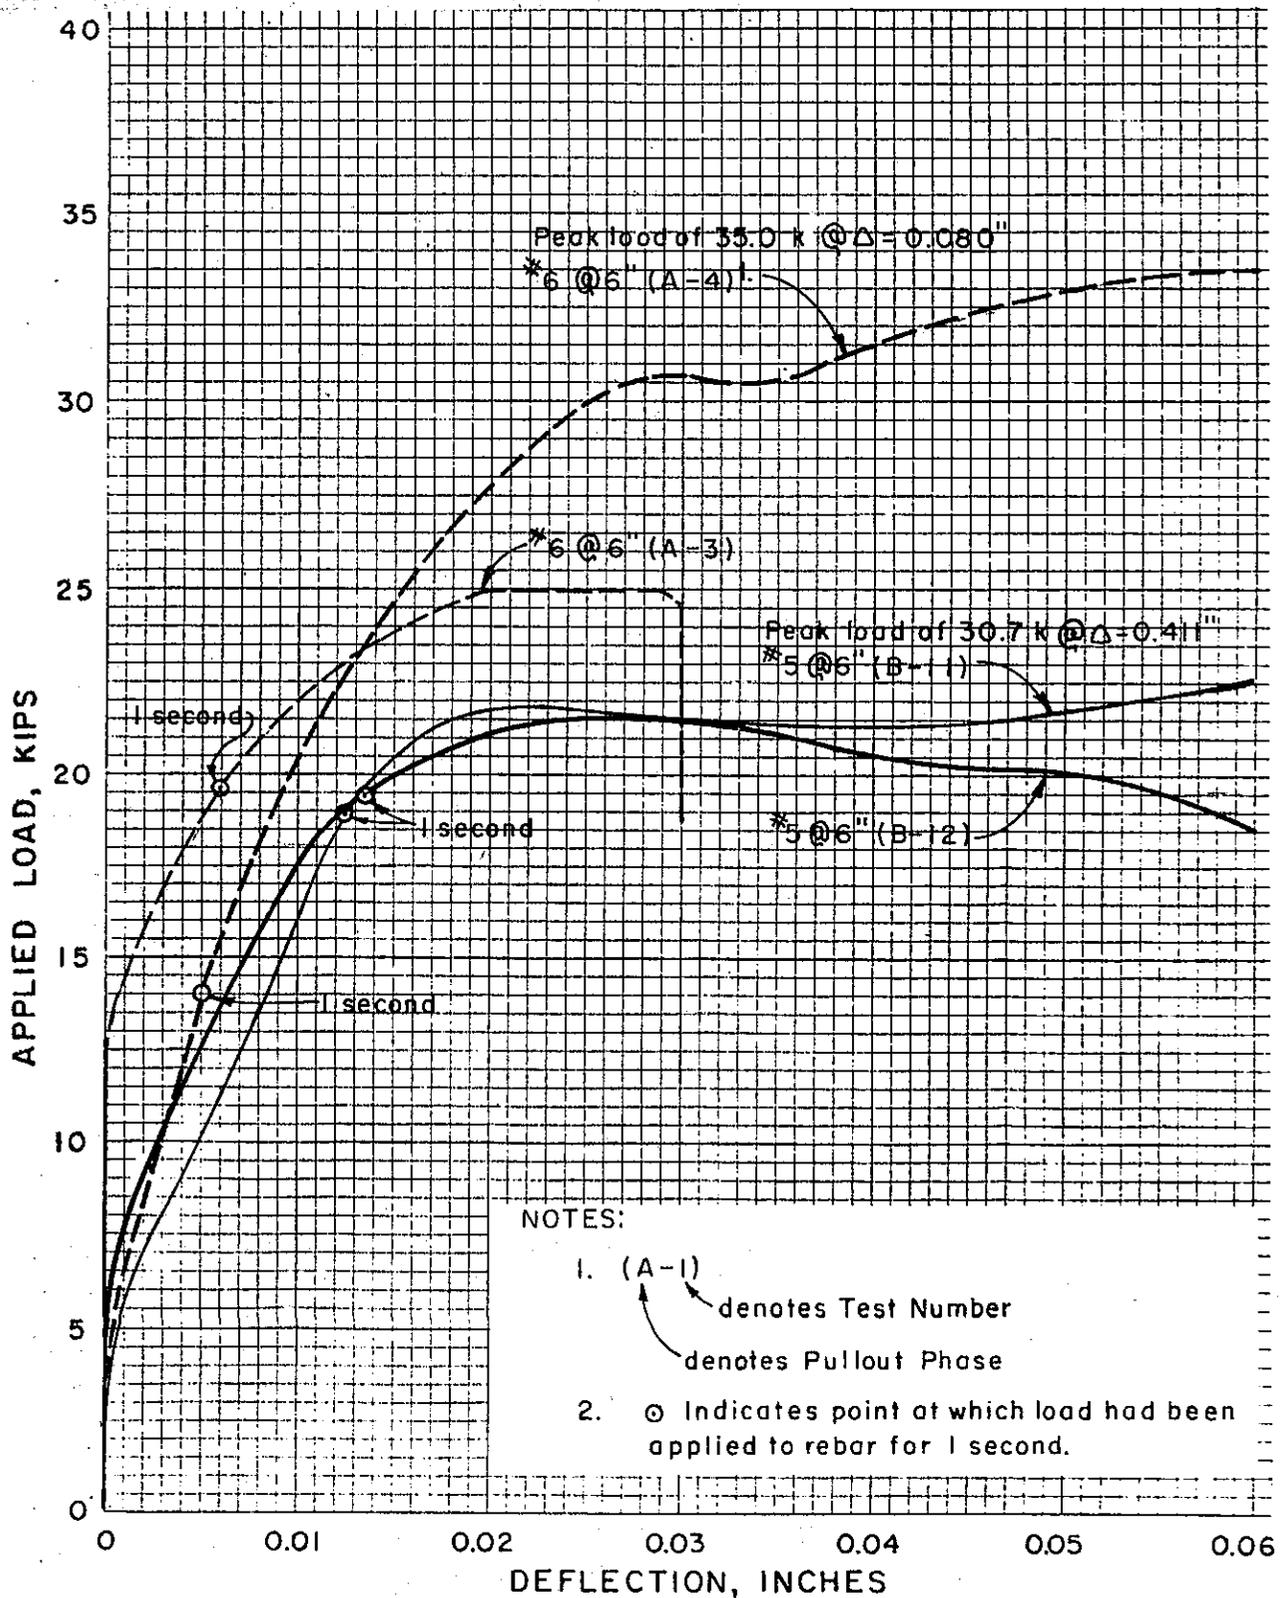
Appendix B-6. Graphs of load versus deflection from individual pullout tests on rebar dowels bonded with epoxy mortar and embedded six inches into a reinforced concrete slab.
