1. REPORT NUMBER FHWA/CA/SD-81/82	2. GOVERNMENT ASSOCIATION NUMBER	3. RECIPIENT'S CATALOG NUMBER
4. TITLE AND SUBTITLE Fatigue Behavior of Steel Light Poles		5. REPORT DATE December 1981
		6. PERFORMING ORGANIZATION CODE 13-625101
7. AUTHOR John W. Fisher, Roger G. Slutter, Chitoshi Miki		8. PERFORMING ORGANIZATION REPORT NO.
9. PERFORMING ORGANIZATION NAME AND ADDRESS Fritz Engineering Laboratory Lehigh University Bethlehem, Pennsylvania 18015		10. WORK UNIT NUMBER
		11. CONTRACT OR GRANT NUMBER F81RC06
12. SPONSORING AGENCY AND ADDRESS California Department of Transportation P.O. Box 1499 Sacramento, California 95807		13. TYPE OF REPORT AND PERIOD COVERED Final July 1, 1981 to December 31, 1981
		14. SPONSORING AGENCY CODE

FATIGUE BEHAVIOR OF STEEL LIGHT POLES

Fritz Engineering Laboratory Report No. 200.81.714.1

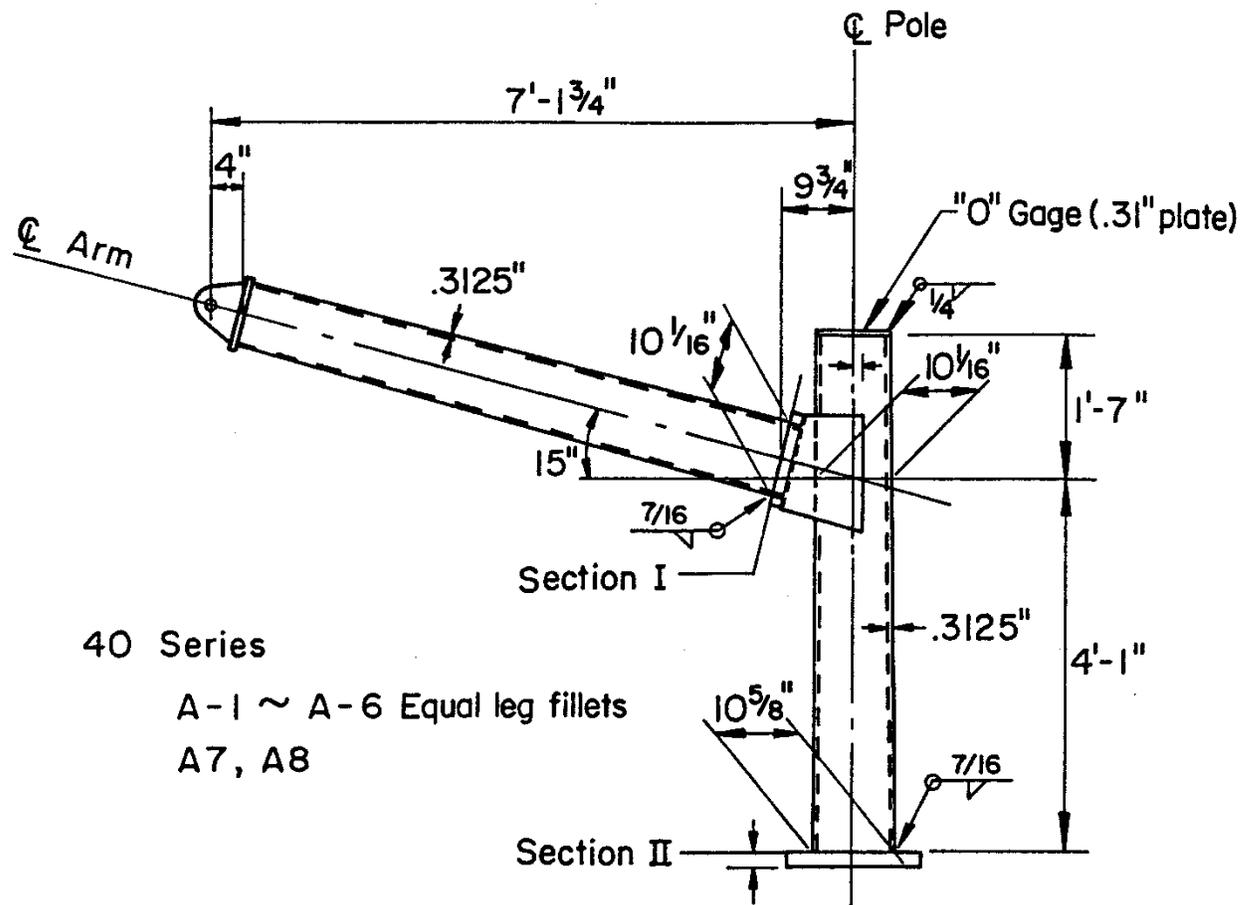
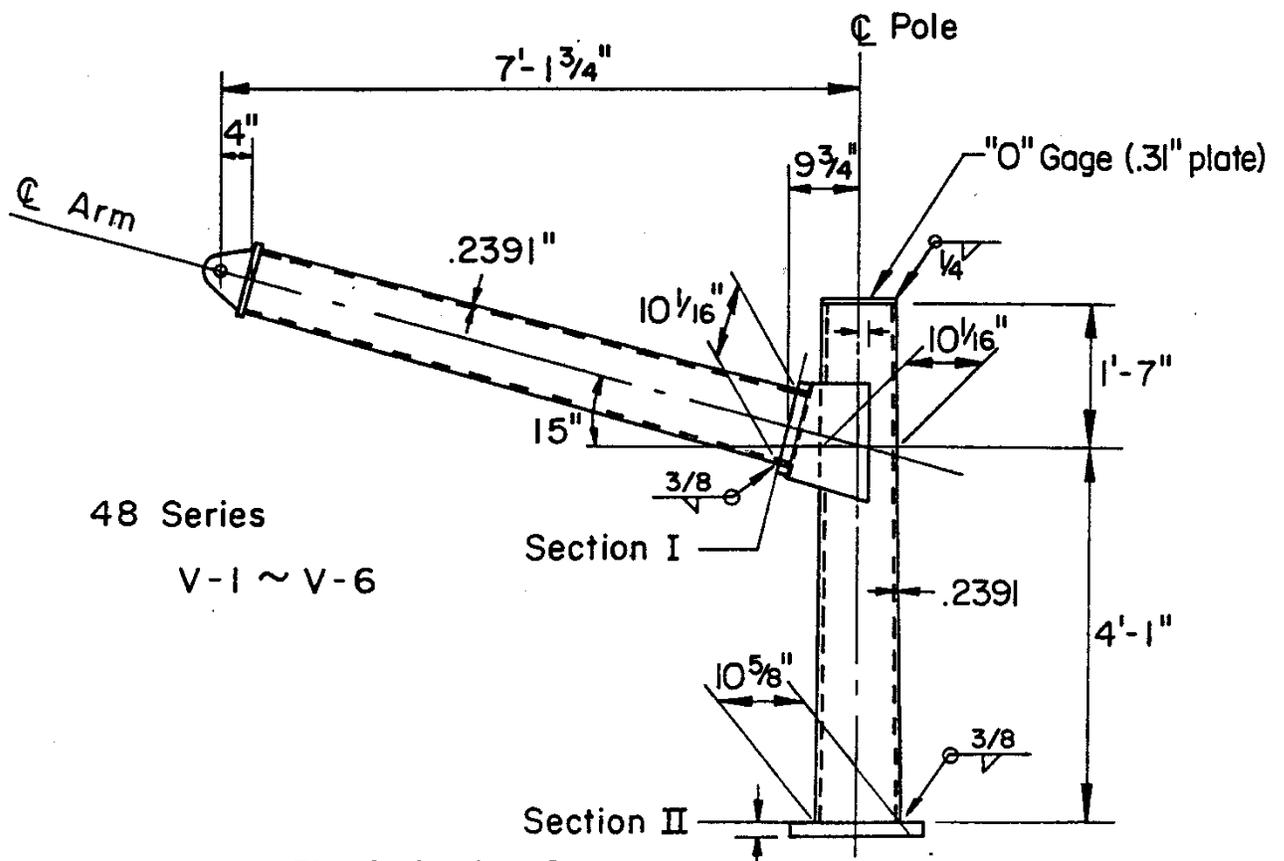
Fig. 1 Specimen Geometry

Figure 1 shows the elevation of the two types of test specimens for the initial test series. The geometric proportions of the 40 and 48 series specimens were the same except for the wall thickness of the tubes and the size of the fillet welds connecting the tubes to the arm connection plates and to the base plates. Appendix I shows the design drawings for the two test series. The fillet weld details that were furnished are shown in Fig. 1b.

The bending stress at the arm connection (identified as Sect. I in Fig. 1) and at the column base connection (identified as Sect. II in Fig. 1) were nearly equal for each series of test specimens. The axial stresses introduced into the pipe arm and column were small in comparison with the bending stress. Appendix II provides details of the stress analysis.

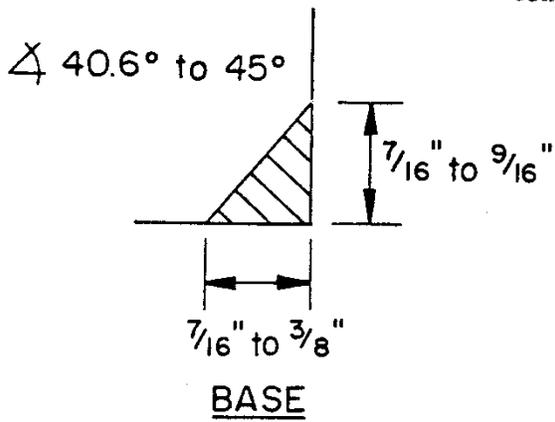
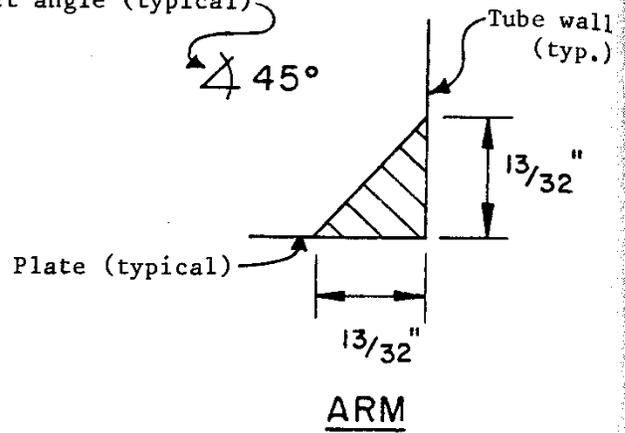
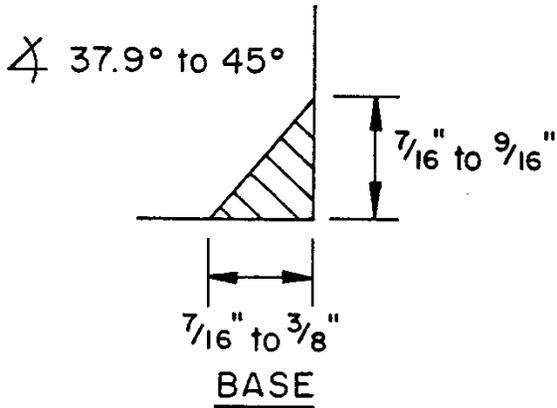
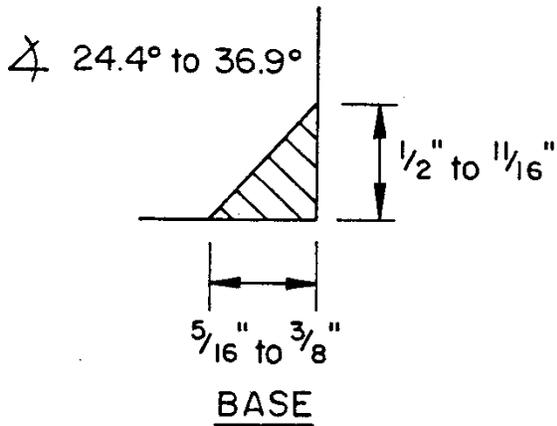
Fig. 1b Summary of Weld Details

Specimens A1 to A6

Weld-to-pole
Contact angle (typical)

Specimens A7 & A8

Specimens V1 to V6

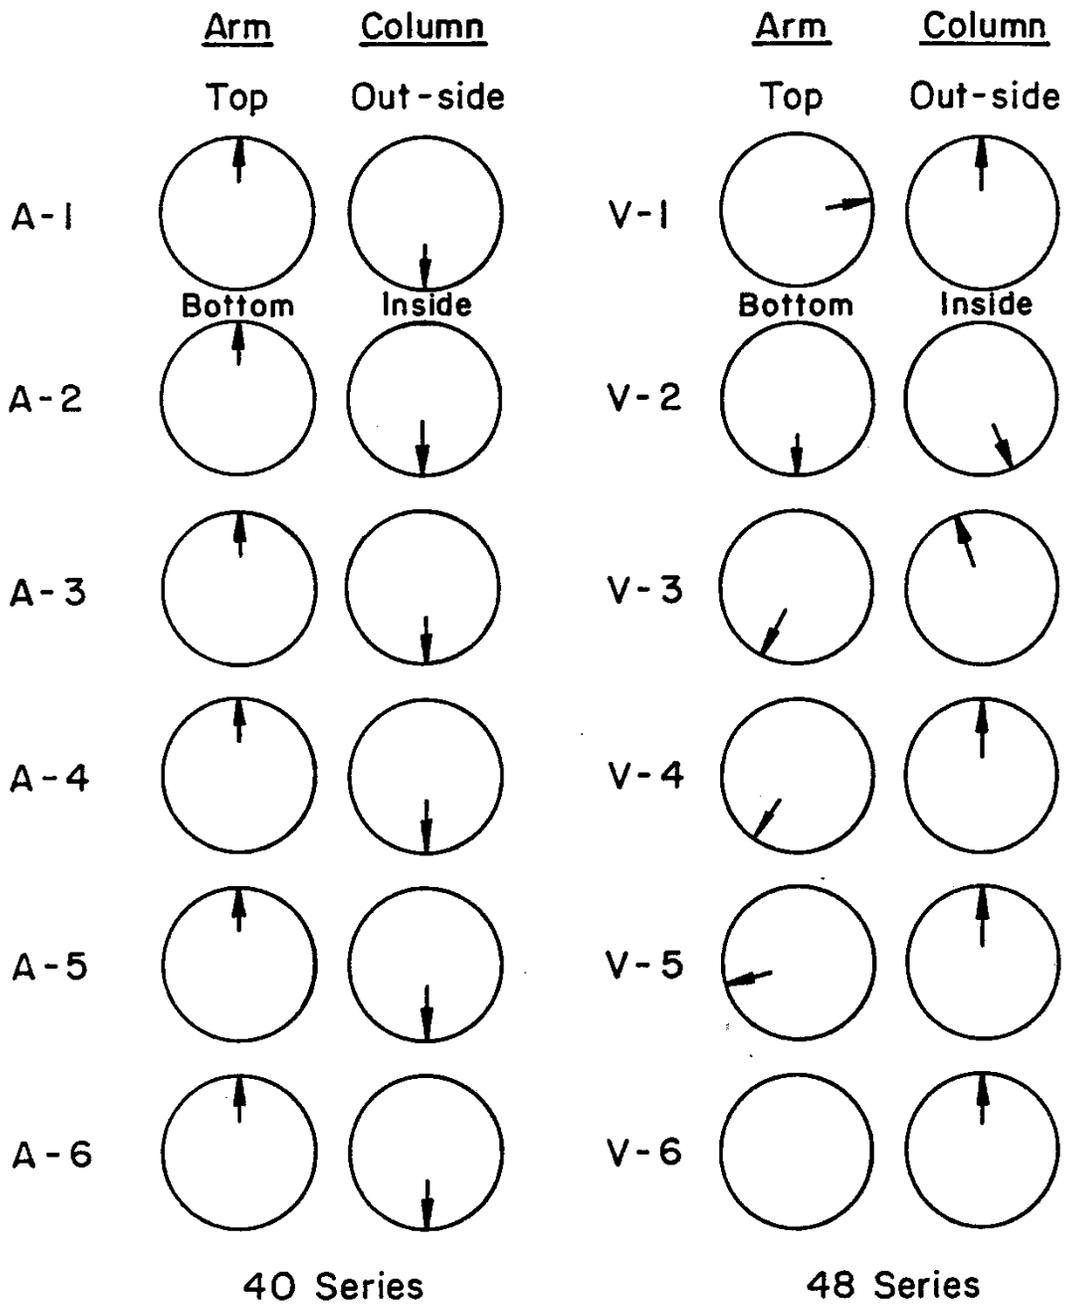
Fig. 2 Location of Seam Welds on Pipe Arm and Column

The 40 series specimens were designated for identification as Specimens A1 to A6. All six of these specimens were fabricated with the longitudinal pipe seams positioned in the manner shown in Fig. 2. This placed the seam for the pipe arms at the top of the connection and for the pipe columns at the inside edge.

The 48 series specimens were designated as V1 to V6. The pipe weld seams appeared to be randomly placed and their locations at the arm connection plates and base plates are also shown in Fig. 2.

↑ Seam Welding

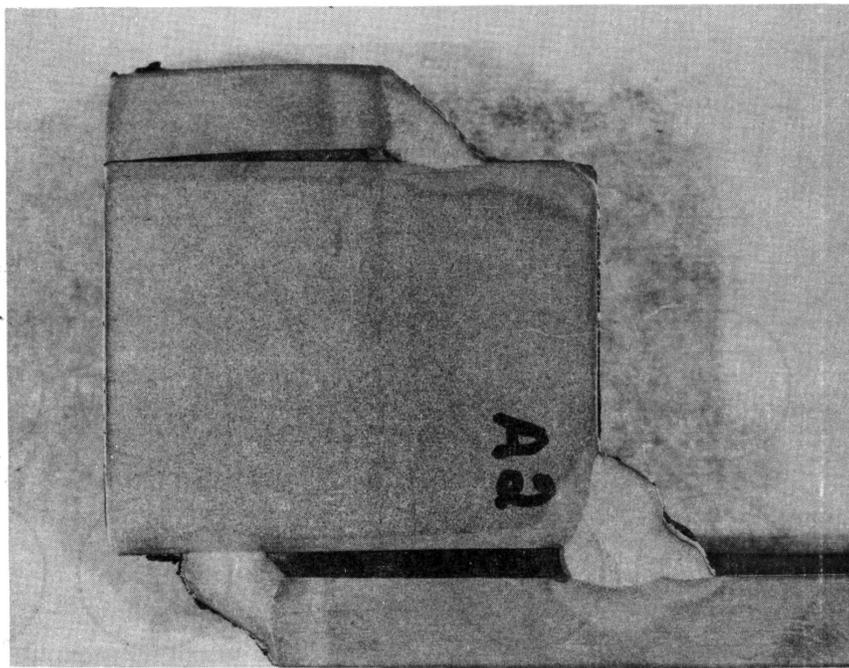
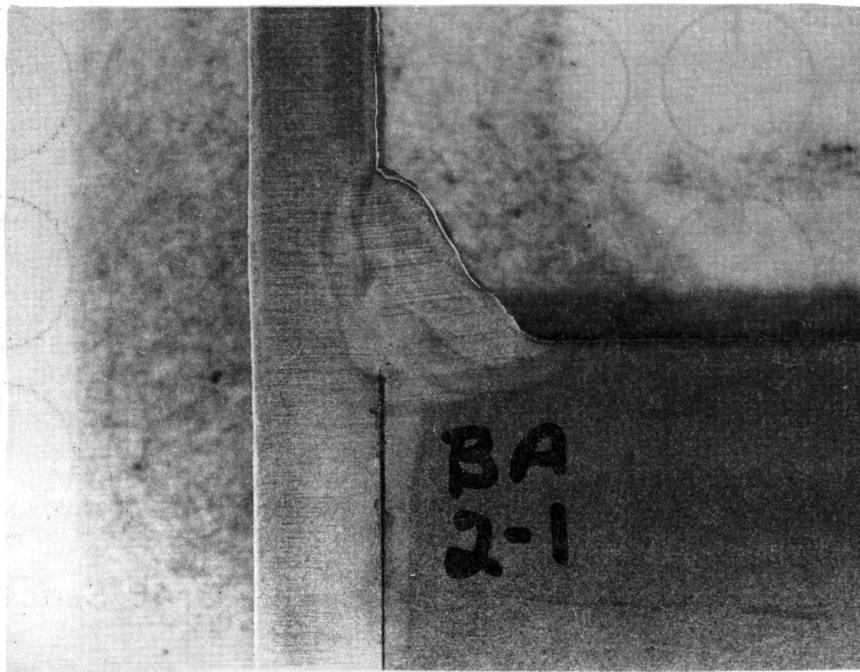
Fig. 3 Typical Fillet Weld Profiles for Pipe Arm and Column Base of A Series Specimens (A1 to A6)

After testing was completed, the connections were cut from the assembly in order to expose the fatigue cracks and to provide cross sections of the weld profiles. Figure 3 shows typical fillet weld profiles of the arm and base connections that were furnished for the 40 series specimens (A1 to A6). These weldments were all equal legs as indicated on the design drawings (see Fig. 1). Figure 4 shows typical fillet weld profiles of the arm and base connections for the 48 series specimens (V1 to V6). These weldments were all unequal leg fillet welds with the long leg on the pipe arm or column.

(a) Fillet Weld Profiles for Pipe Arm - Specimen A2

(b) Fillet Weld Profile at Column Base - Specimen A2

Measurement of the contact angle of the fillet welds shown in Figs. 3, 4 and 5 indicate that the 40 series (A) specimens had a 45°

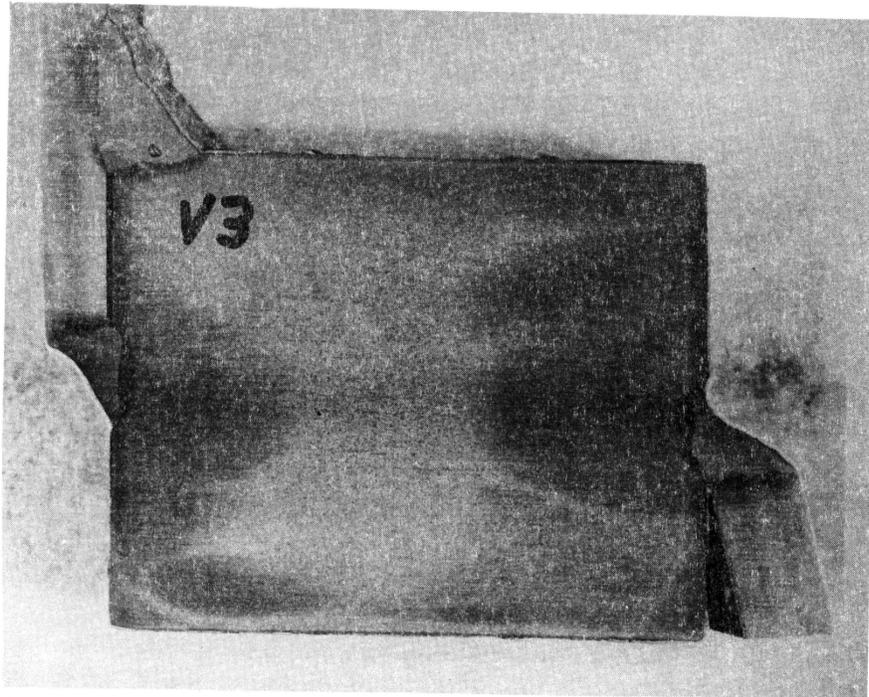
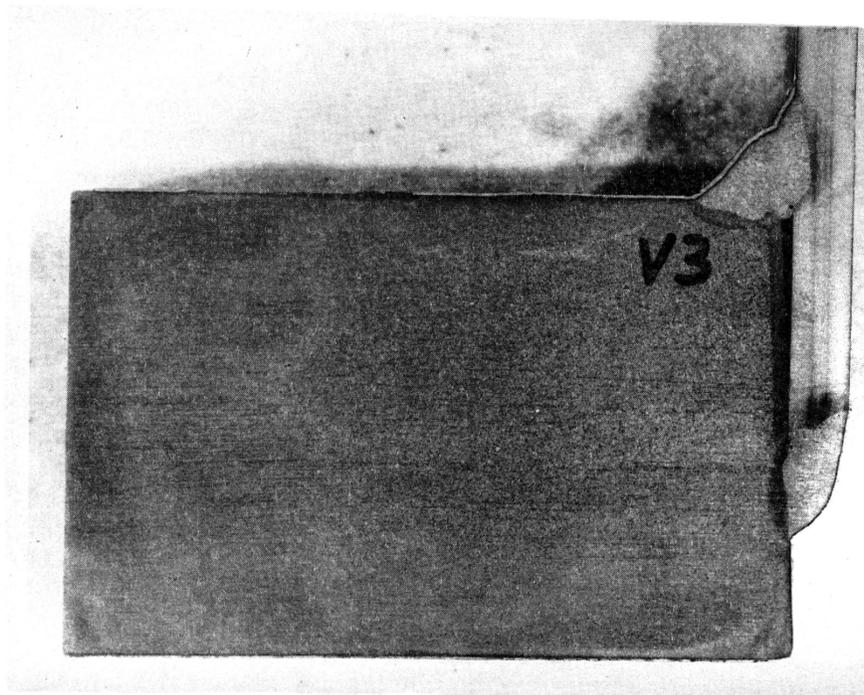
Fig. 4 Typical Fillet Weld Profiles for Pipe Arm and Column Base of V Series Specimens

It is readily apparent that the weld profile provided on the V series test specimens (see Fig. 4) decreased the stress concentration and increased the fatigue resistance of the 48 series test specimens. Fatigue studies of the fillet weld profile have provided similar increases in fatigue resistance.⁽²⁾ At 2×10^6 cycles, the difference in stress range for a 30° contact angle was 1.5 times as great as a 45° contact angle.

(a) Fillet Weld Profiles for Pipe Arm - Specimen V3

(b) Fillet Weld Profiles at Column Base - Specimen V3

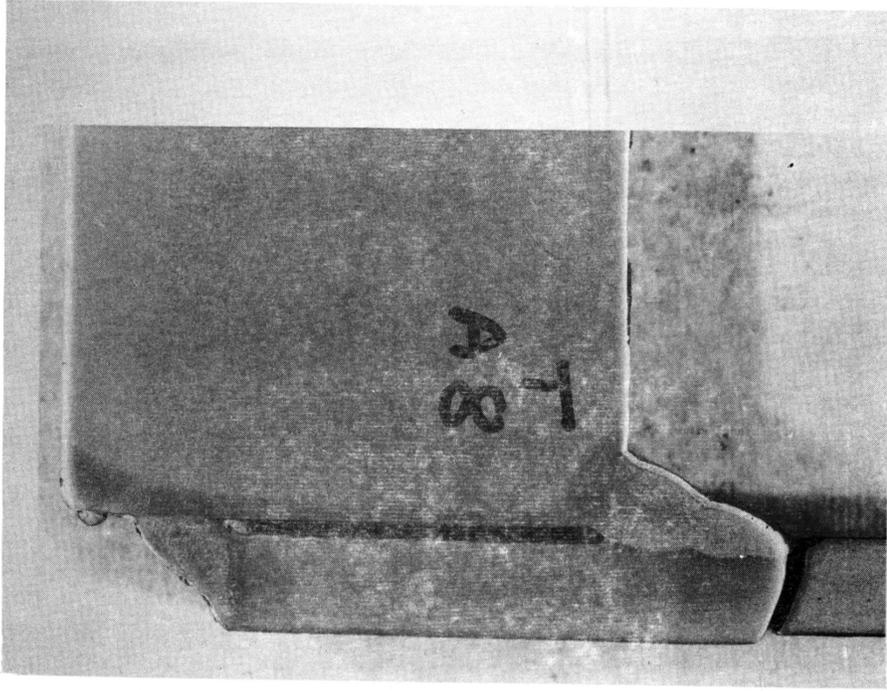
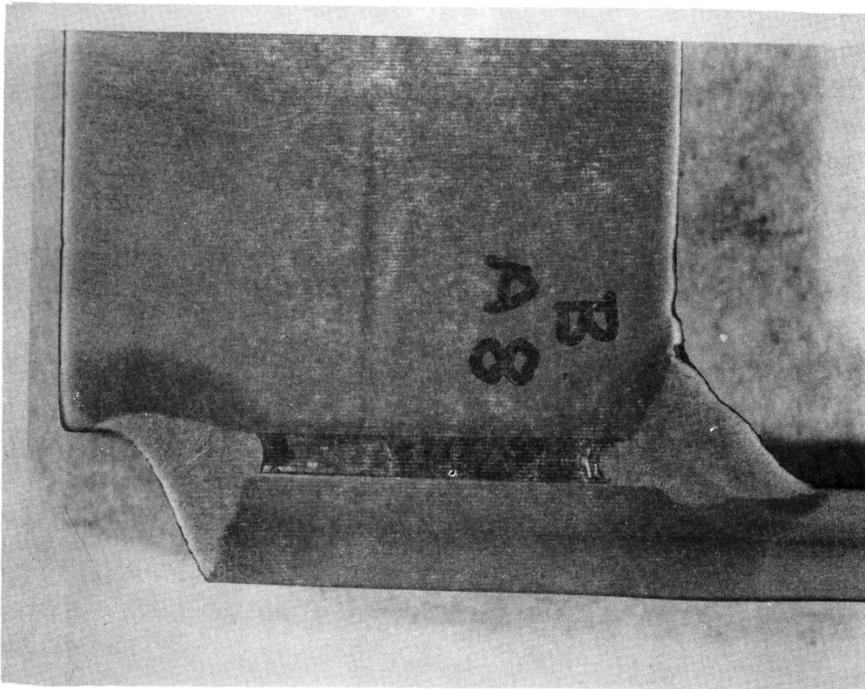
Fig. 5 Typical Fillet Weld Profiles for Pipe Arm and Column Base of Specimens A7 and A8

The two supplemental test specimens A7 and A8 were also furnished with unequal leg fillet welds. These weld profiles are shown in Fig. 5 and are similar to the 48 series test specimens.

As a result of these observations, two additional 40 series specimens (A7 and A8) were fabricated with a comparable weld contact angle. As was illustrated in Fig. 5, the contact angle on the pipe arm where failure occurred was 34°. The column base was 30°.

(a) Fillet Weld Profiles for Pipe Arm - Specimen A8

(b) Fillet Weld Profiles for Column Base - Specimen A8

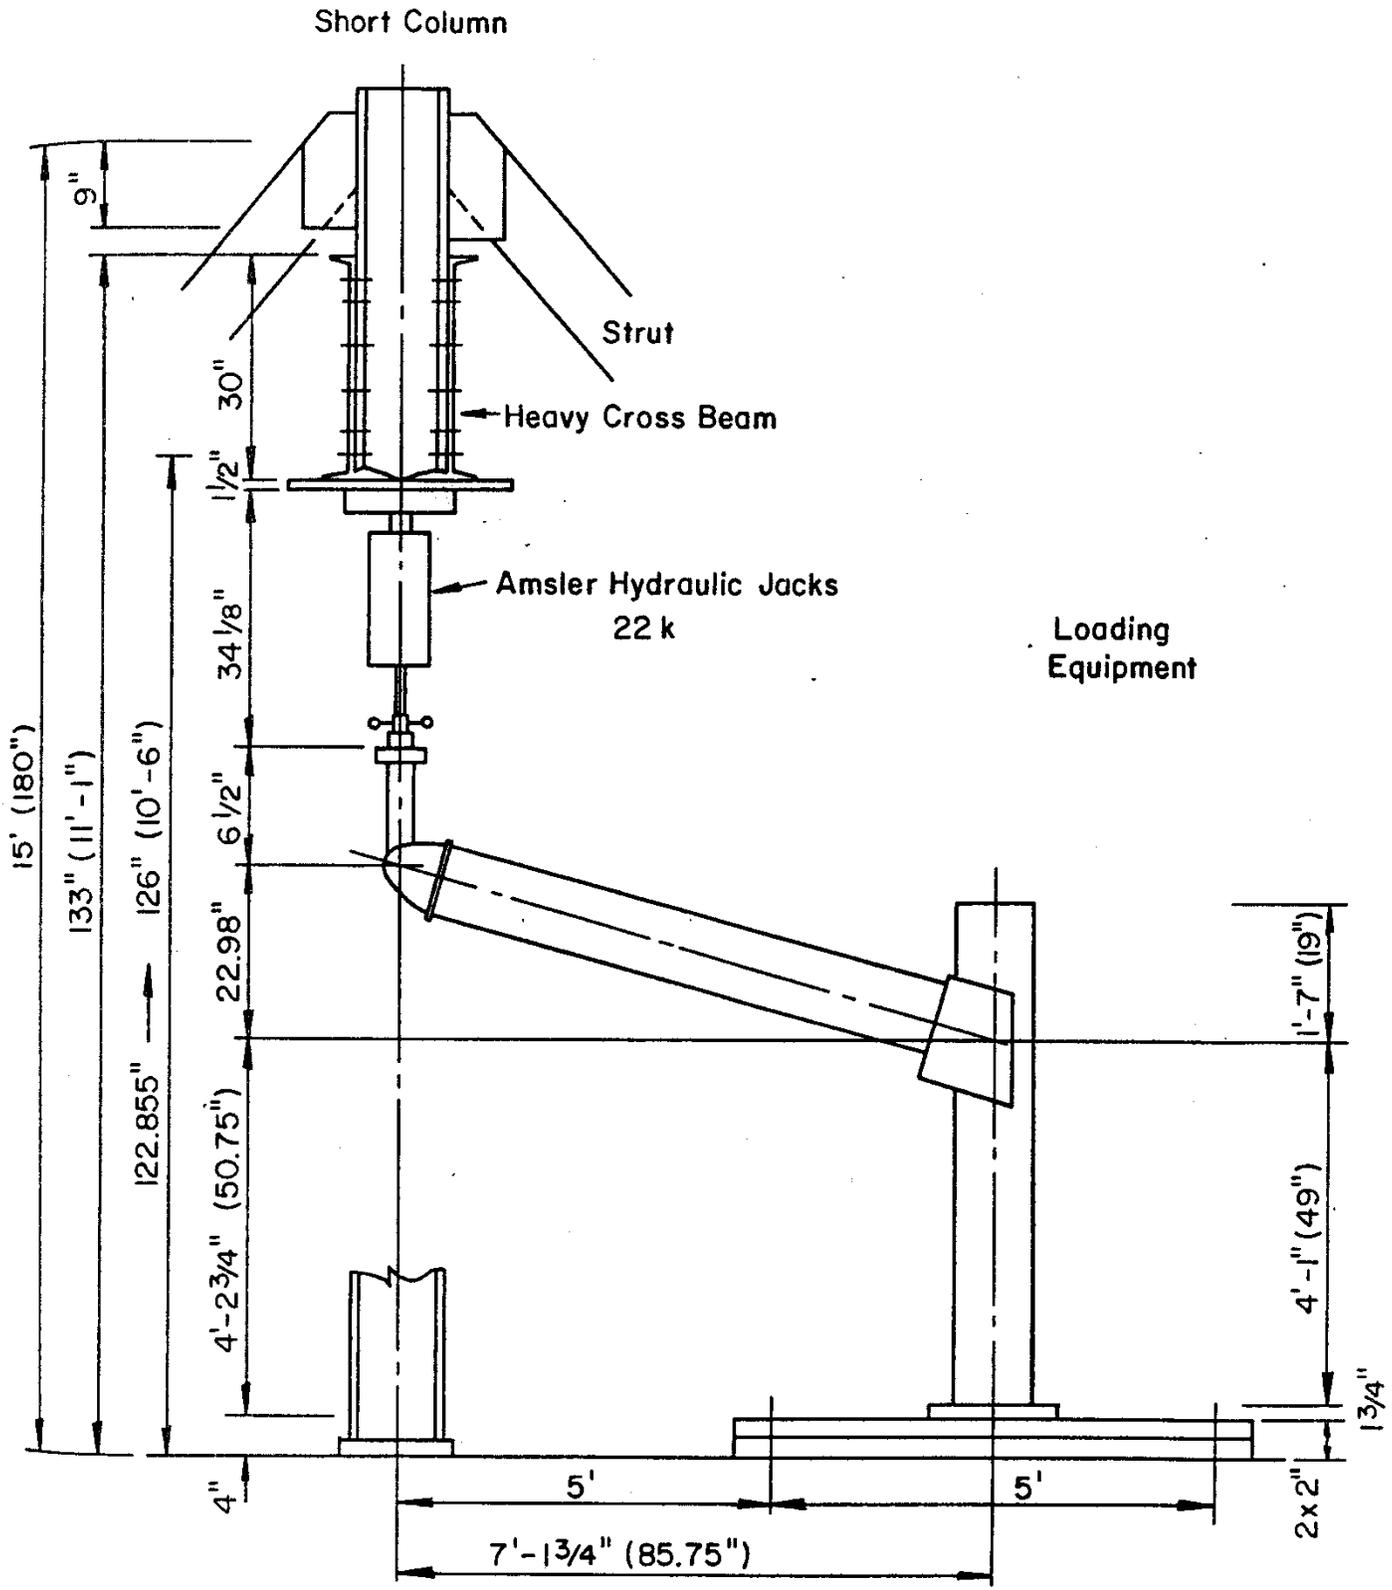
Fig. 6 Test Set-Up

All specimens were tested on the dynamic test bed as shown schematically in Fig. 6. The test specimens were all bolted to steel plates that were bolted directly to the dynamic test bed floor. A test frame was erected and a 22 kip Amsler hydraulic jack was suspended from the cross beam. Figure 7 shows a photograph of the specimen mounted for testing. The anchor bolts attaching the plates to the test floor and the bolts attaching the base plates to the larger plates can be seen together with the test frame.

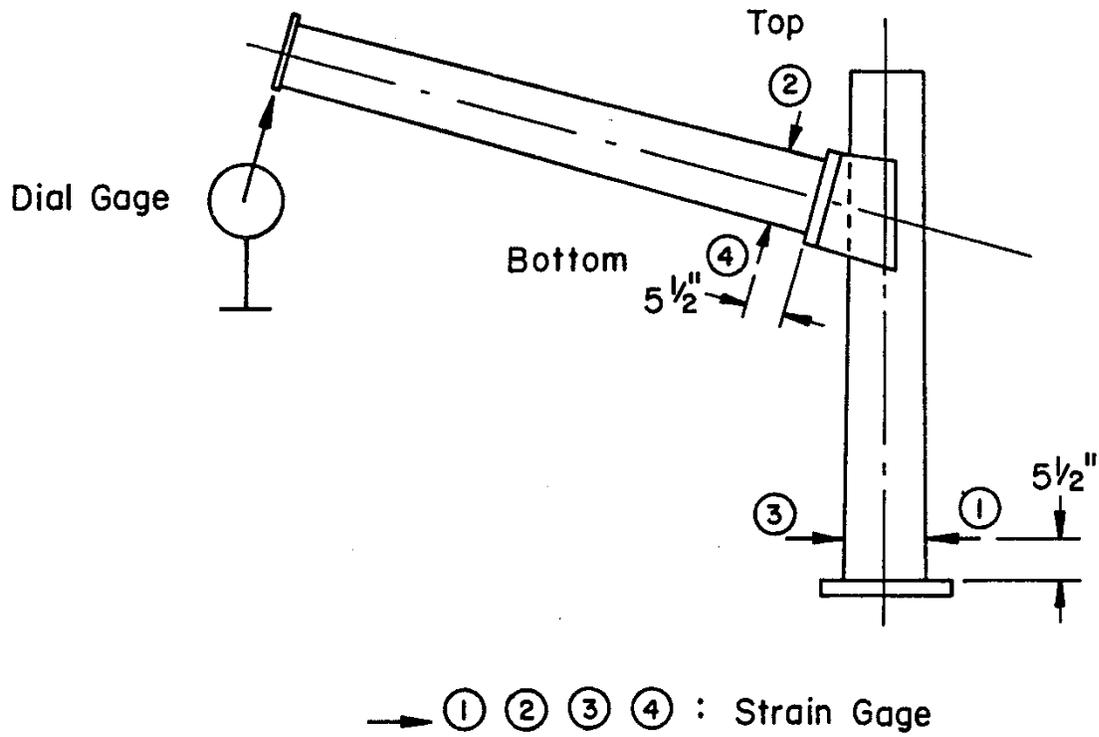
Fig. 8 Location of Strain Gage and Dial Gages

Electrical resistance strain gages were attached to each test specimen as shown schematically in Fig. 8. A dial gage was also used to measure the deflection of the arm under the test load. Several of these gages can be seen in Fig. 7. Prior to commencing the fatigue test, a static load test was carried out on each test specimen. The increments of strain at the arm and base sections and the arm deflection were recorded at 1 kip intervals during the static load test.

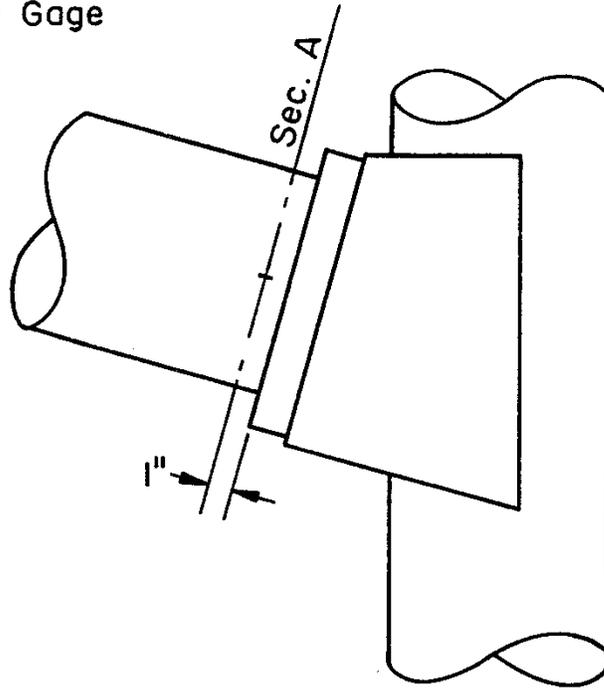
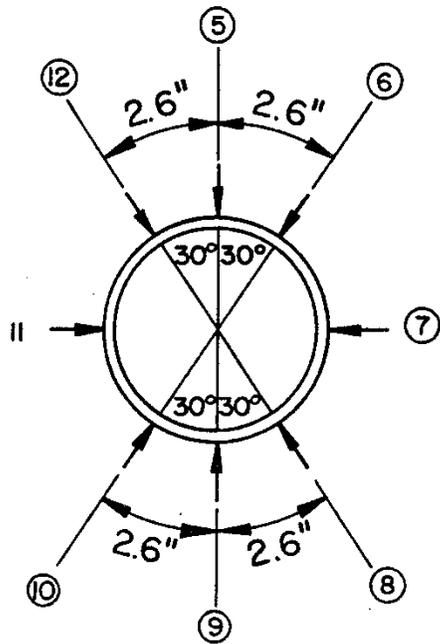
Fig. 26 Location of Strain Gages on Pipe Arm of Specimen V4

One test specimen from the 48 series (specimen V4), was supplied with additional electrical resistance strain gages in order to establish and verify the strain distribution across the pipe section. Figure 26 shows the location of the additional strain gages that were added to the arm.

↓ Strain Gage

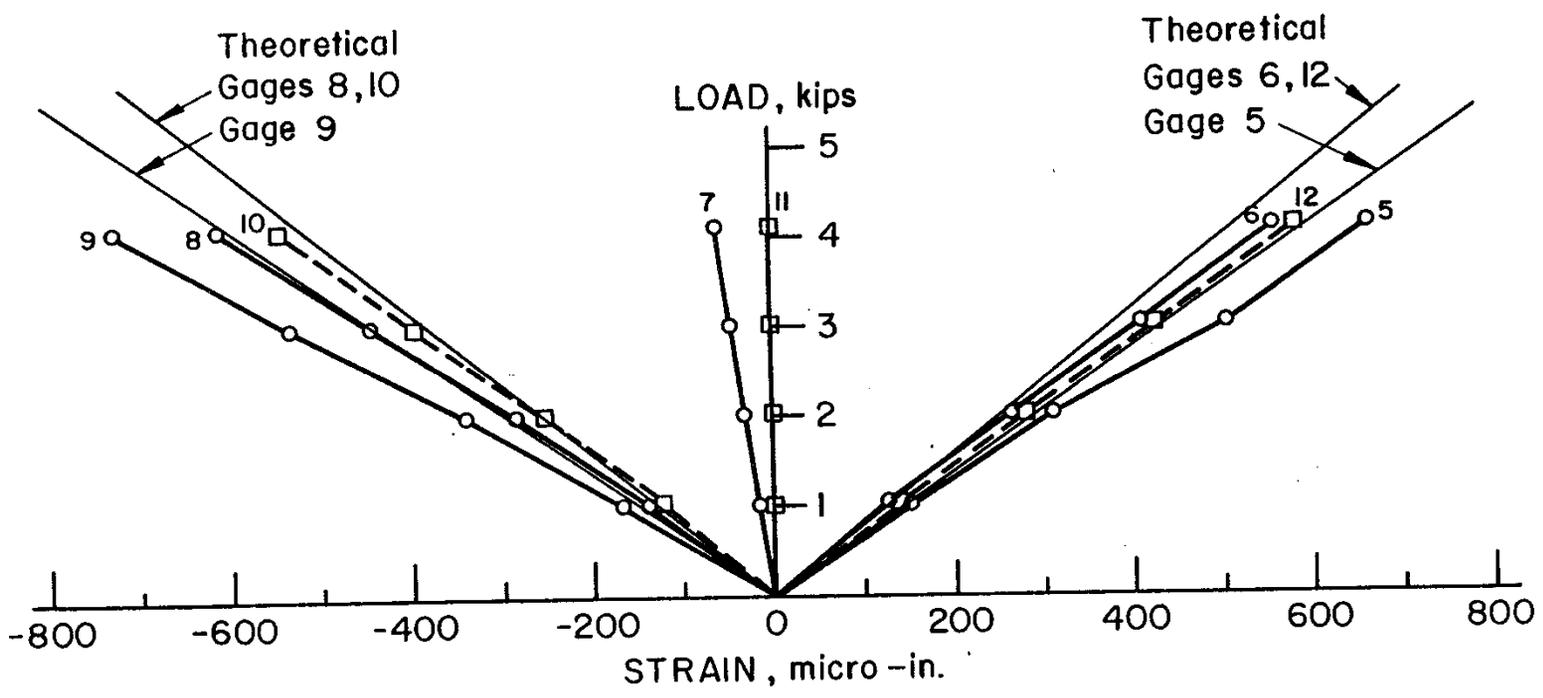
Fig. 27 Load Strain Response Around Pipe Arm - Specimen V4

The results of this special test are summarized in Table 1 and in Fig. 27. Figure 27 shows the load-strain relationship for each strain gage location. Since the strain gaged section was only 1 inch from the weld termination, the calculated strain was based on the properties at Section I.

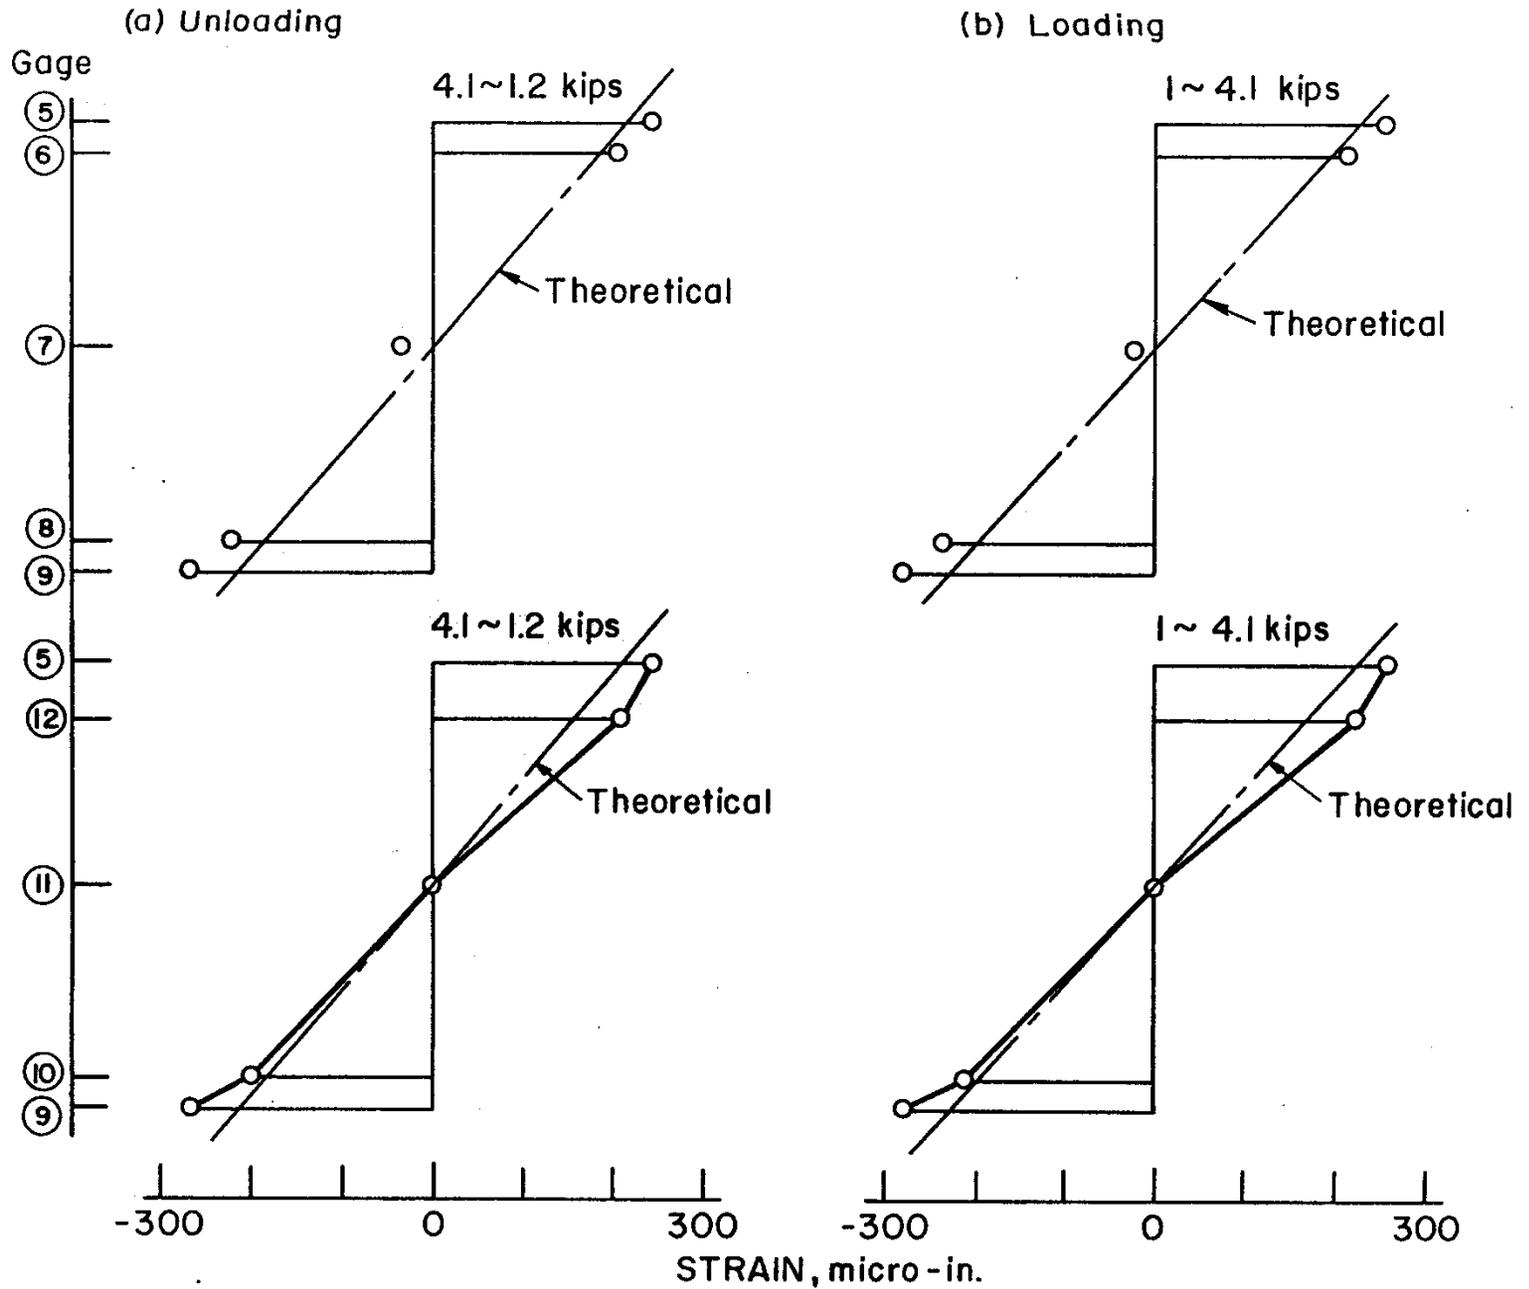
Fig. 28 Comparison of Measured Strain Distribution with Theoretical Distribution, Specimen V4

The strain distribution around each half of the pipe arm is plotted in Fig. 28. The change in strain for a load increase from 1.0 to 4.1 kips and for a load decrease from 4.1 to 1.2 kips show comparable changes for each segment of the pipe arm. The results demonstrate that very little axial stress existed from the applied loads. The theoretical and measured strain gradients were in good agreement.

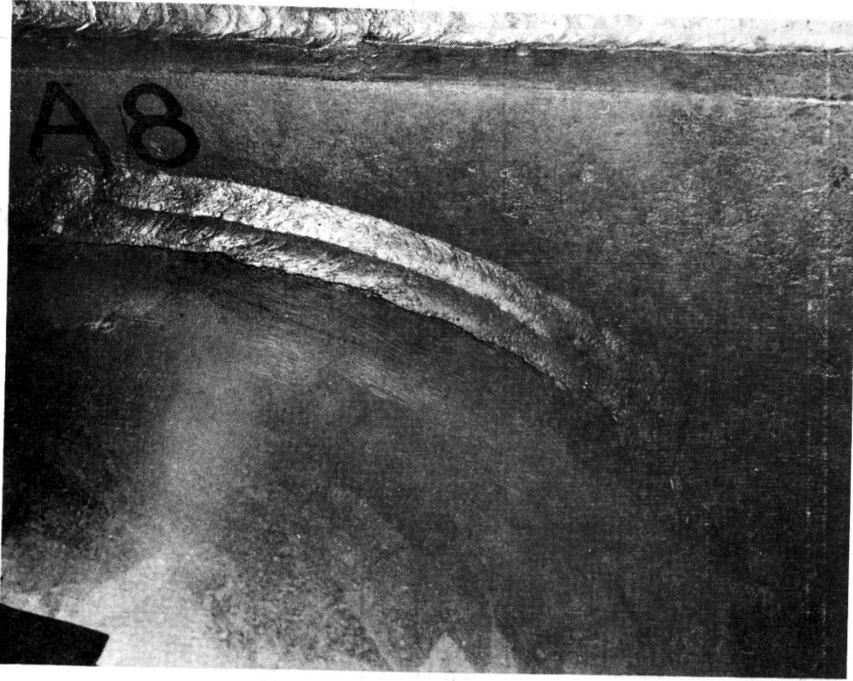
Fig. 29 Typical Crack at Weld Toe on Pipe Arm

As is apparent from an examination of Table 2, most failures were at the arm connection. Only two 48 series test specimens failed at the base location (Section II). However, two specimens that did not fail at the base connection still had relatively large fatigue cracks at the time the test was terminated. These base cracks varied in length from 4 to 11 inches along the weld. All cracks were through the pipe thickness so that most if not all of their fatigue resistance was exhausted. The crack lengths were established by liquid penetrant inspection. Figure 29 shows a crack at the fillet weld toe of the pipe arm base connection.

As can be seen in Fig. 29, the fatigue cracks in the pipe arm or column formed at the weld toe. Figures 31 to 35 show typical crack surfaces for several of the fracture locations. Figures 31, 32 and 34 show typical crack surfaces that formed at the pipe arm connection. Figures 33 and 35 show typical crack surfaces that formed at the column base.

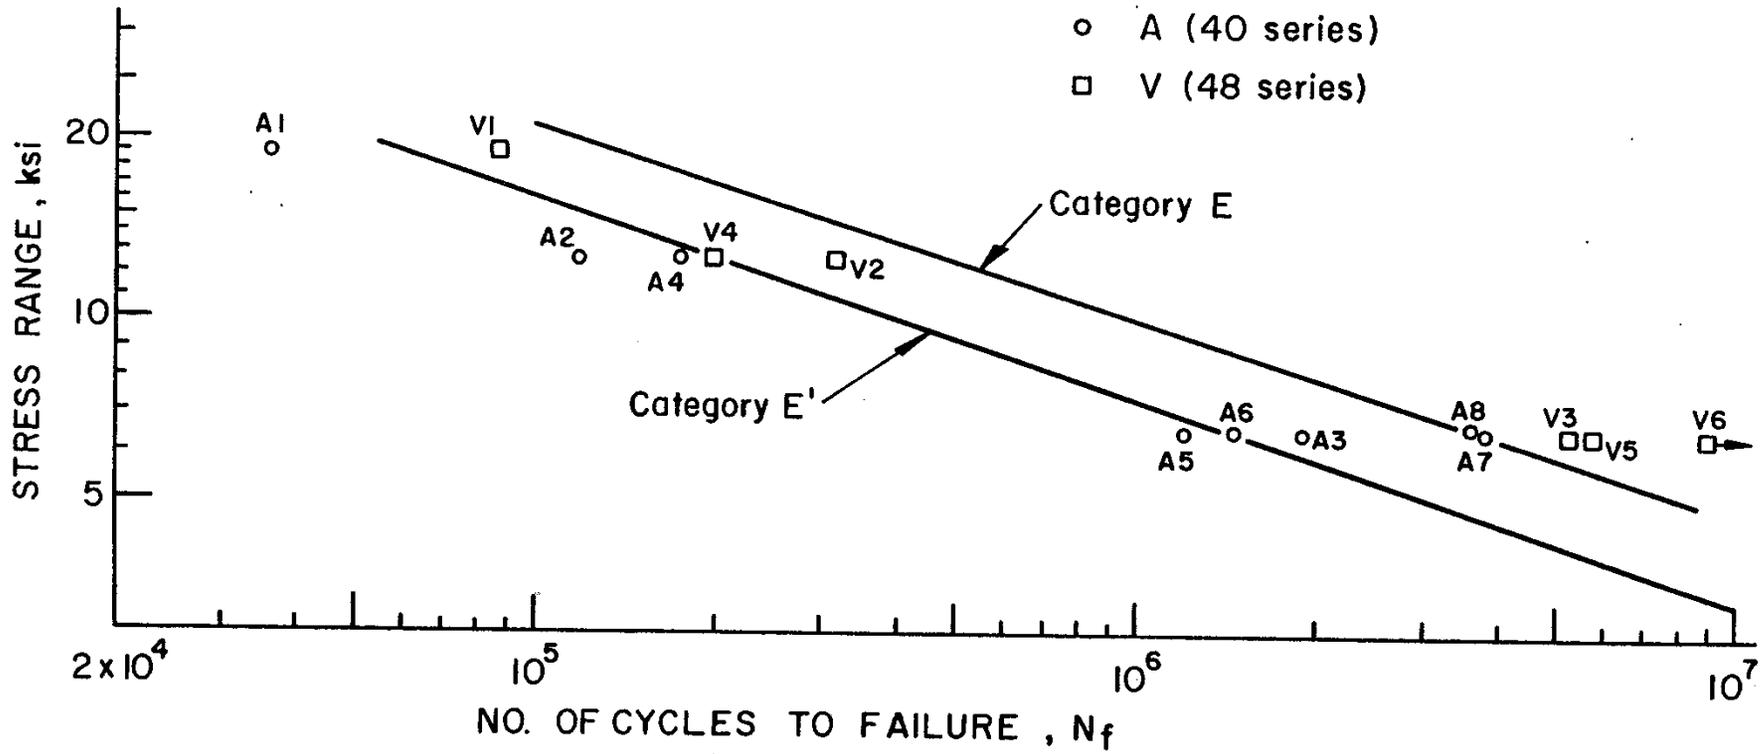
Fig. 30 Summary of Stress Range versus Cycle Life for A and V Series

The test results are also summarized in Fig. 30. Stress range at the weld toe is plotted as a function of cycle life. The 40 series test specimens (A1 to A6) are seen to provide less fatigue resistance than the 48 series test specimens (V1 to V6). Also plotted in Fig. 30 are the fatigue resistance curves for Categories E and E'. At the high stress range levels (12.5 and 19 ksi) the 40 series test specimens were below Category E. The 48 series specimens corresponded to Category E'. At the 6.5 ksi stress range level the 40 series (A) specimens provided a fatigue strength between 1.2 and 1.9 million cycles which was near the Category E' line. The 48 series (V) specimens provided fatigue lives between 5.2 and 9 million cycles.

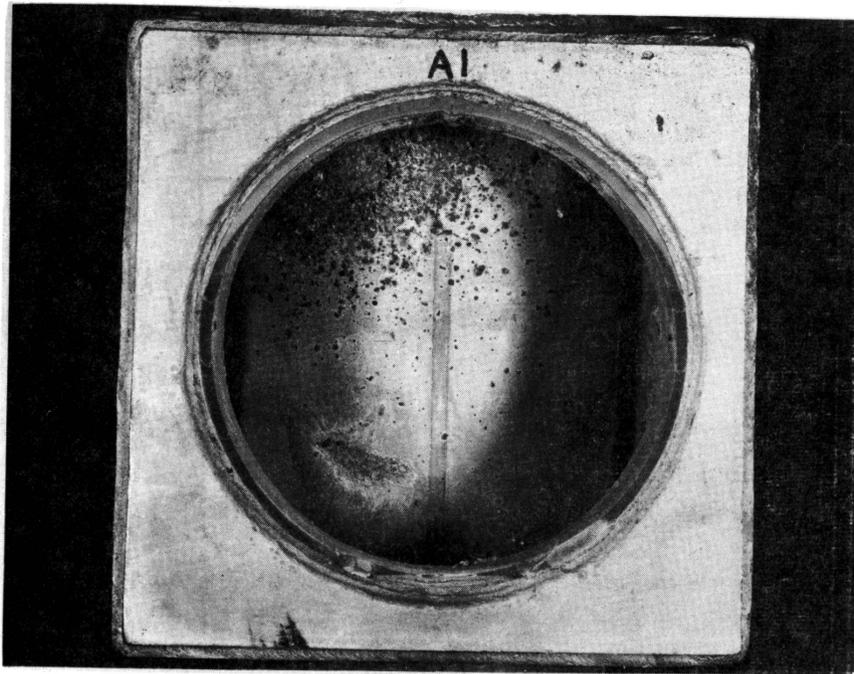
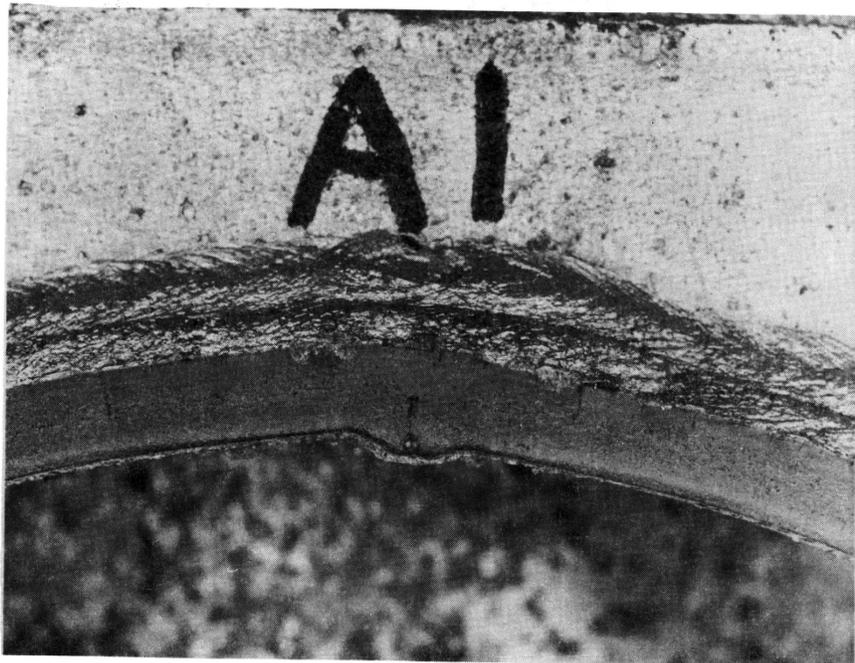
Fig. 31 Crack Surface of Specimen A1

(a) Overview of Fatigue Crack Surface at Arm

(b) Close-up Showing Crack Surface Near Primary Crack Initiation Site

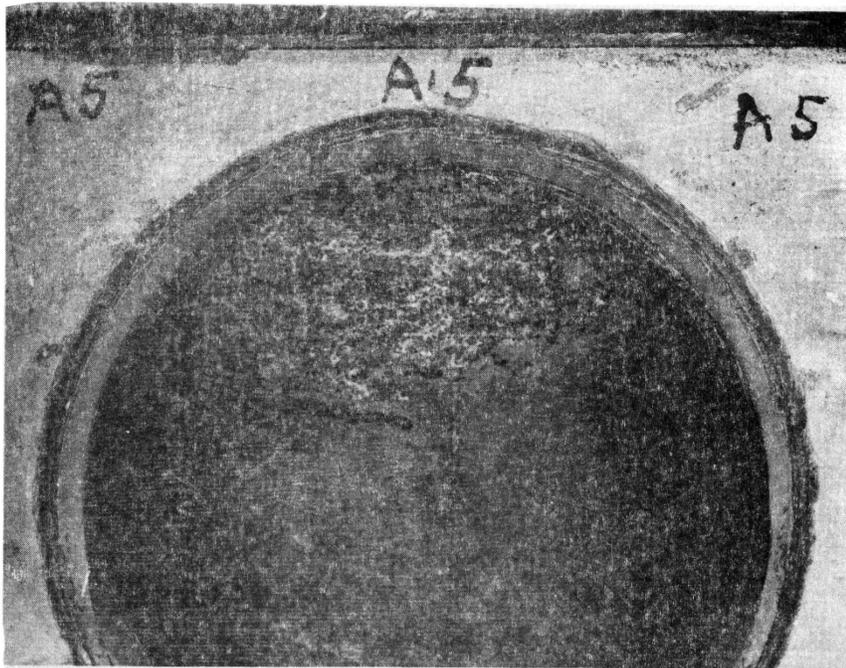
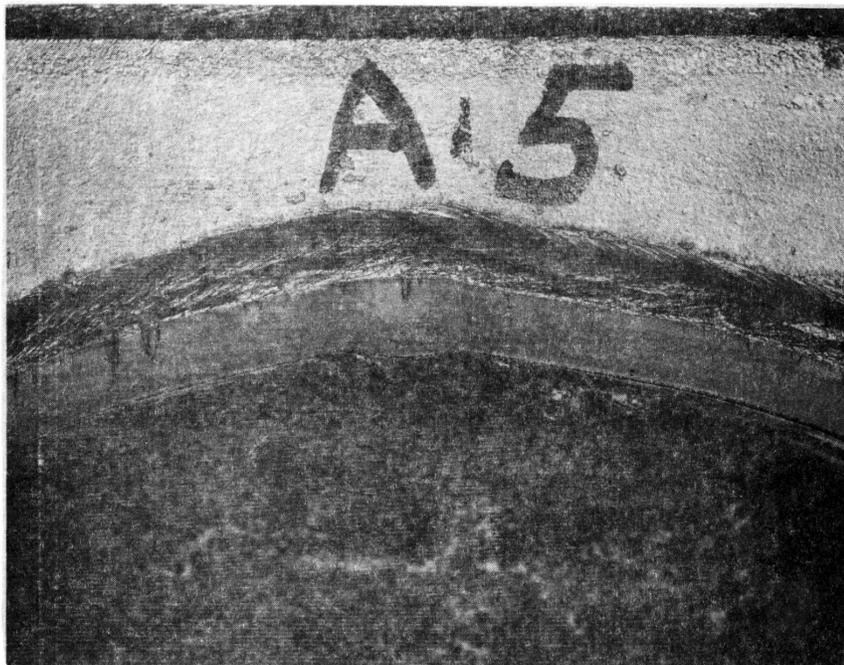
Fig. 32 Crack Surfaces of Specimen A5

Two specimens that had their crack front marked by changing the stress range to create distinctive bench marks are shown in Fig. 32 and 34. Specimen A5 from the 40 series shows failure at the arm as does specimen V4 from the 48 series. Schematic drawings of the crack profile are given in Figs. 36 and 37 for these two specimens. It is apparent that multiple initiation sites occur along the weld toe and coalesce into a wide but shallow surface crack. This condition is comparable to the crack growth conditions observed at other weld toes.⁽⁴⁾ After 45% of the fatigue life was exhausted the semielliptical surface crack was 0.1 in. deep and 2 in. wide in specimen V4. Specimen A5 was found to have a 0.1 in. deep crack 1.1 inches long after 22% of its fatigue life was exhausted. This crack size difference is compatible with the stress these two specimens were subjected to. Specimen A5 had a stress range of 6.4 ksi and specimen V4 was subjected to a stress range of 12.4 ksi. After 75 to 85% of the fatigue life was exhausted the cracks had propagated

(a) Overview of Fatigue Crack Surface at Arm

(b) Close-up of Crack Surface Near Primary Crack Initiation Site
