1. REPORT NUMBER FHWA/CA/SD-81/82	2. GOVERNMENT ASSOCIATION NUMBER	3. RECIPIENT'S CATALOG NUMBER
4. TITLE AND SUBTITLE Fatigue Behavior of Steel Light Poles		5. REPORT DATE December 1981
		6. PERFORMING ORGANIZATION CODE 13-625101
7. AUTHOR John W. Fisher, Roger G. Slutter, Chitoshi Miki		8. PERFORMING ORGANIZATION REPORT NO.
9. PERFORMING ORGANIZATION NAME AND ADDRESS Fritz Engineering Laboratory Lehigh University Bethlehem, Pennsylvania 18015		10. WORK UNIT NUMBER
		11. CONTRACT OR GRANT NUMBER F81RC06
12. SPONSORING AGENCY AND ADDRESS California Department of Transportation P.O. Box 1499 Sacramento, California 95807		13. TYPE OF REPORT AND PERIOD COVERED Final July 1, 1981 to December 31, 1981
		14. SPONSORING AGENCY CODE

FATIGUE BEHAVIOR OF STEEL LIGHT POLES

Fritz Engineering Laboratory Report No. 200.81.714.1

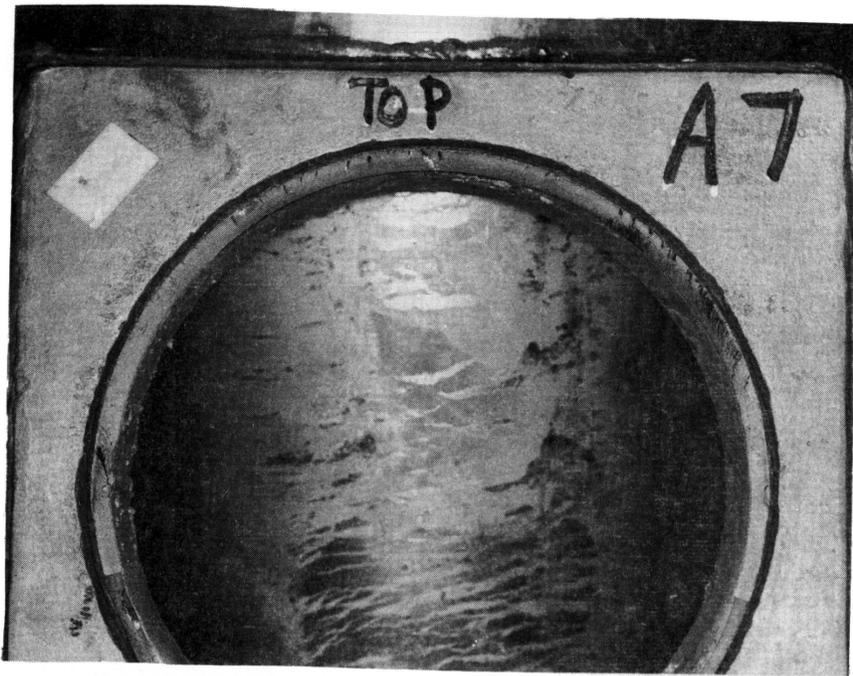
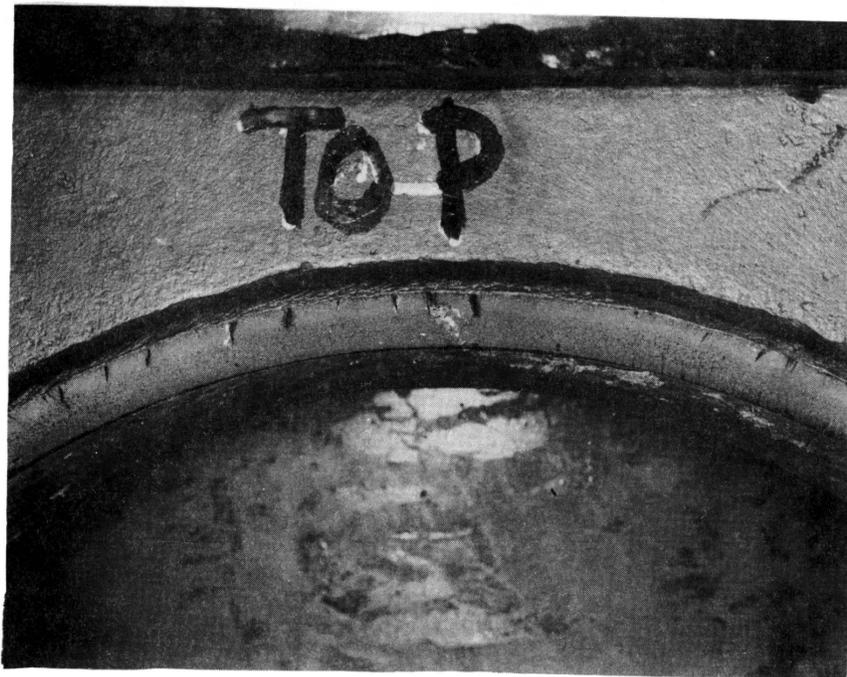
Fig. 33 Crack Surfaces of Specimen A7

(a) Overview of Fatigue Crack Surface at Arm

(b) Close-up View of Crack Surface at Primary Initiation Site

As can be seen in Fig. 29, the fatigue cracks in the pipe arm or column formed at the weld toe. Figures 31 to 35 show typical crack surfaces for several of the fracture locations. Figures 31, 32 and 34 show typical crack surfaces that formed at the pipe arm connection. Figures 33 and 35 show typical crack surfaces that formed at the column base.

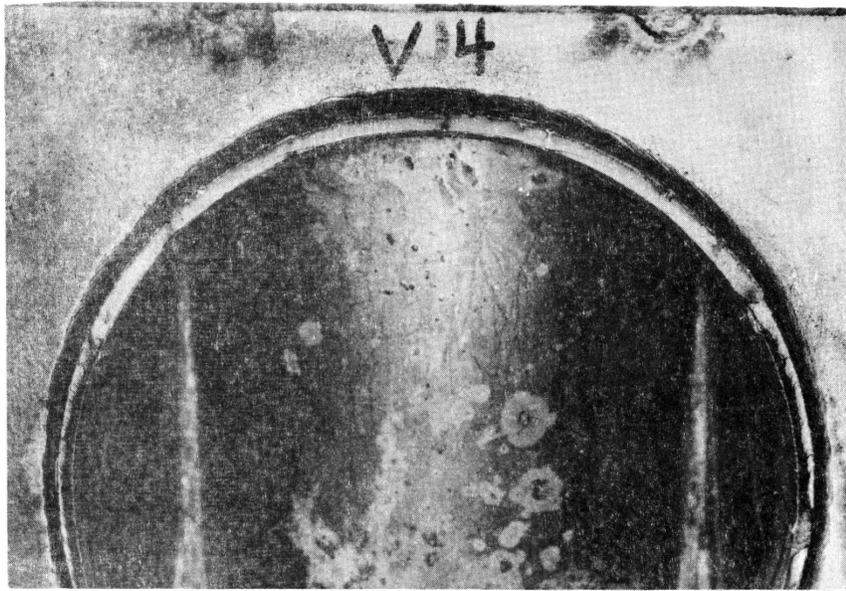
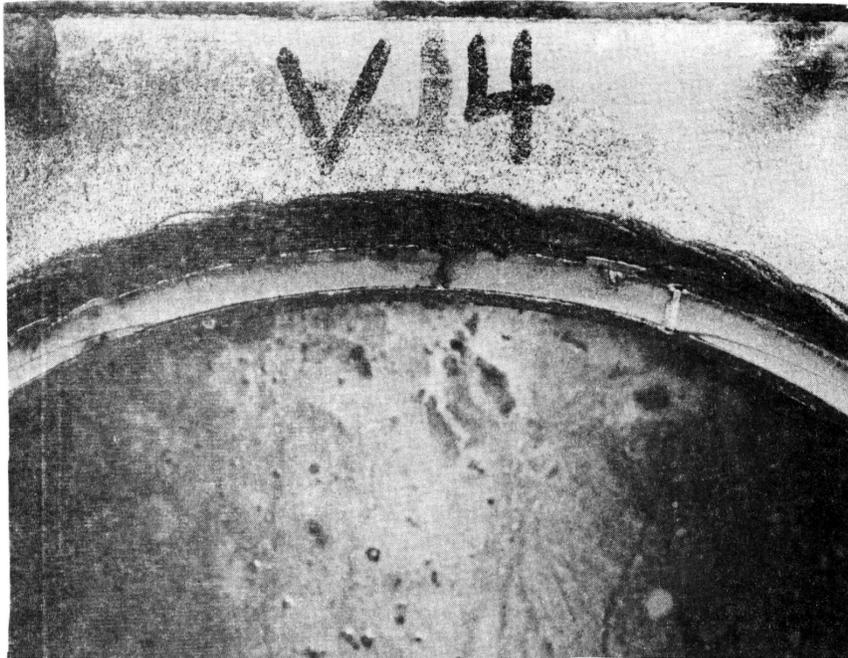
Fig. 34 Crack Surfaces of Specimen V4

Two specimens that had their crack front marked by changing the stress range to create distinctive bench marks are shown in Fig. 32 and 34. Specimen A5 from the 40 series shows failure at the arm as does specimen V4 from the 48 series. Schematic drawings of the crack profile are given in Figs. 36 and 37 for these two specimens. It is apparent that multiple initiation sites occur along the weld toe and coalesce into a wide but shallow surface crack. This condition is comparable to the crack growth conditions observed at other weld toes.⁽⁴⁾ After 45% of the fatigue life was exhausted the semielliptical surface crack was 0.1 in. deep and 2 in. wide in specimen V4. Specimen A5 was found to have a 0.1 in. deep crack 1.1 inches long after 22% of its fatigue life was exhausted. This crack size difference is compatible with the stress these two specimens were subjected to. Specimen A5 had a stress range of 6.4 ksi and specimen V4 was subjected to a stress range of 12.4 ksi. After 75 to 85% of the fatigue life was exhausted the cracks had propagated

(a) Overview of Fatigue Crack Surface at Arm

(b) Close-up View of Crack Surface at Primary Initiation Site

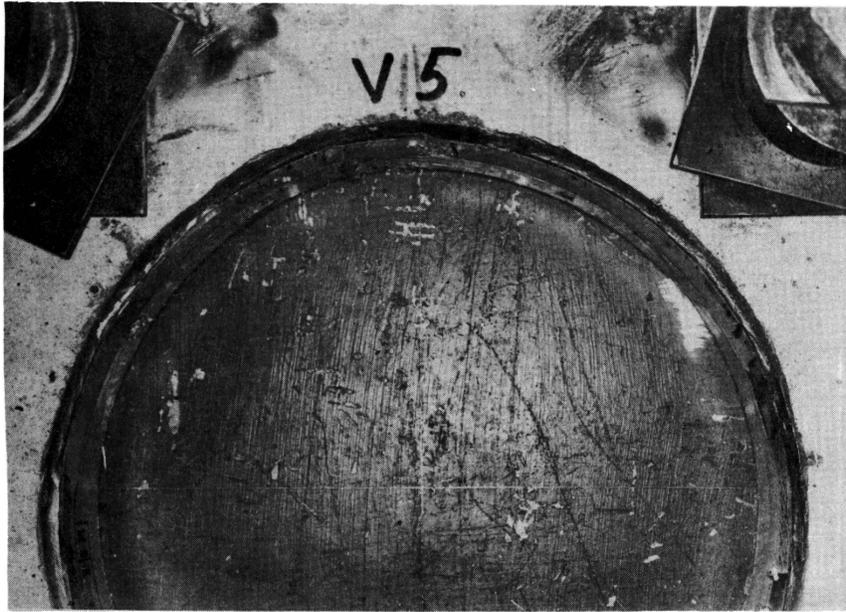
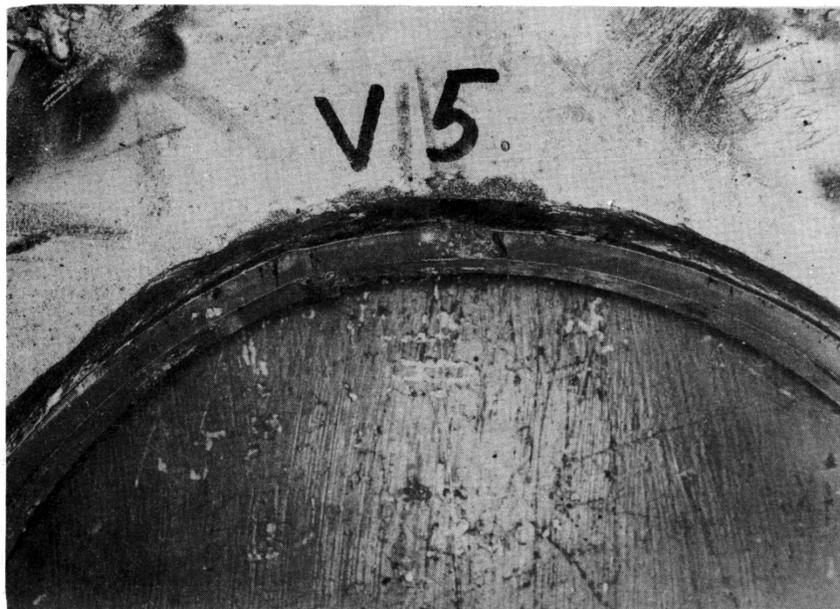
Fig. 35 Crack Surfaces of Specimen V5

(a) Overview of Fatigue Crack Surface at Base

(b) Close-up View of Crack Surface at Primary Initiation Site

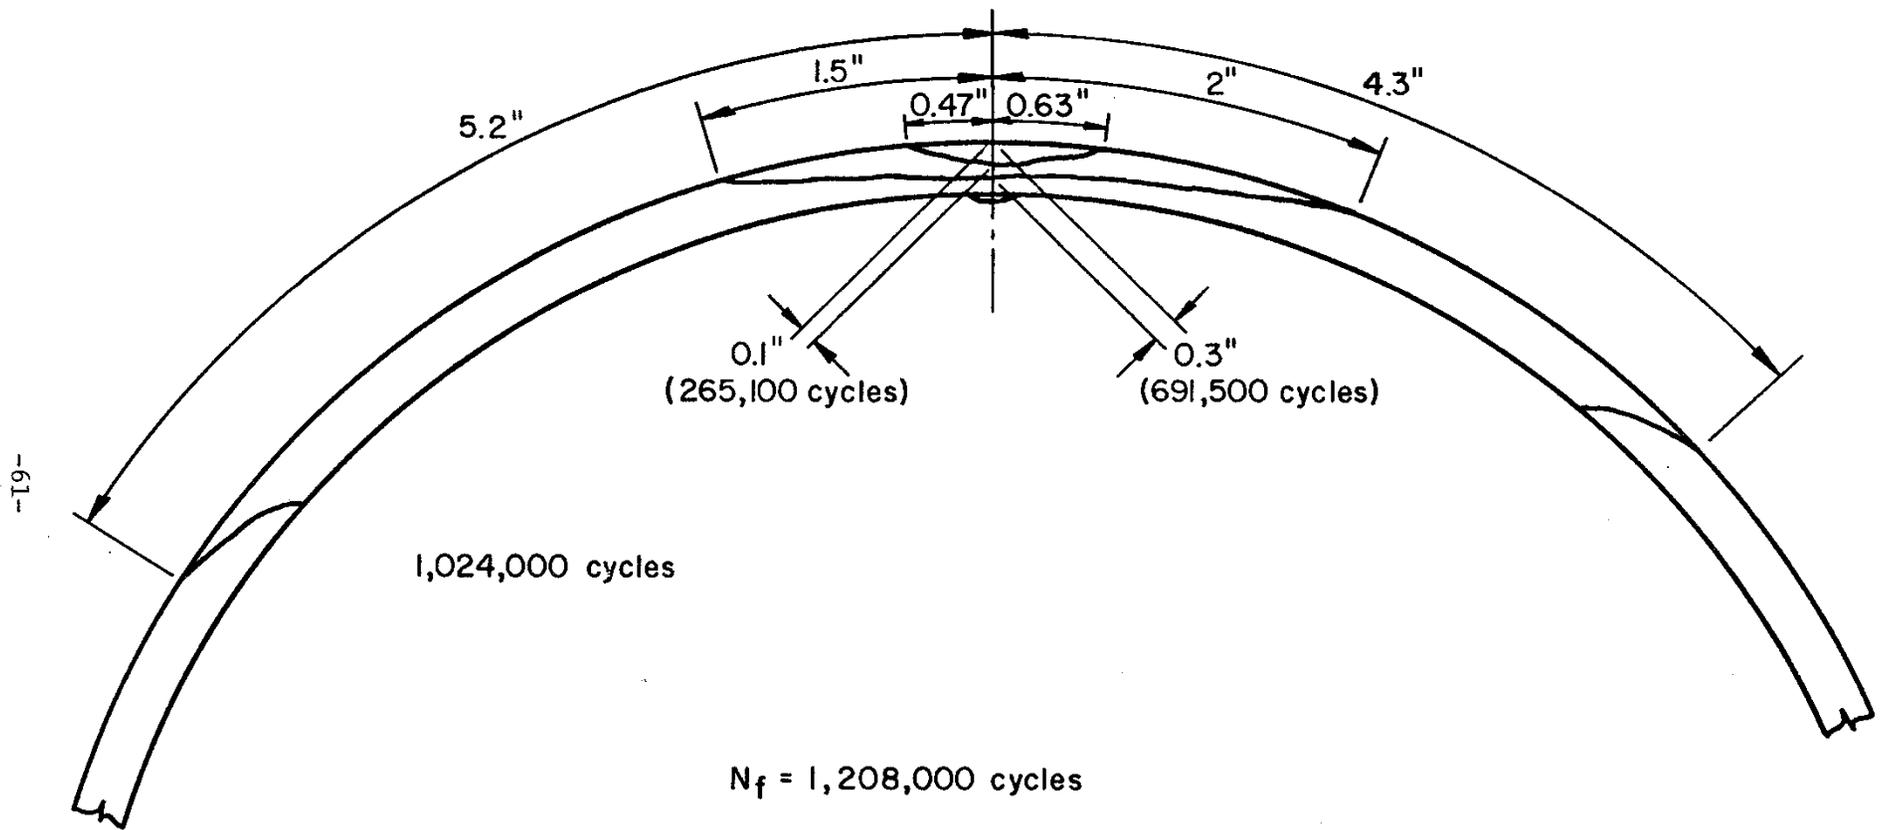
Fig. 36 Crack Shape at Various Cycle Life Intervals - Specimen A5

It quickly became apparent during the course of the experimental work that the galvanized coating made it difficult to detect small cracks. This can be seen in Fig. 36 where the crack front was marked after 265,000 cycles of loading. At that time the small crack sketched in Fig. 36 could not be seen. The galvanized coating did not break and permit the crack to become apparent. Attempts were also made to locate small cracks with a magnetic probe and with an eddy current probe. Neither method was successful. The galvanized coating interfered with both of these methods and it was not possible to detect small cracks.

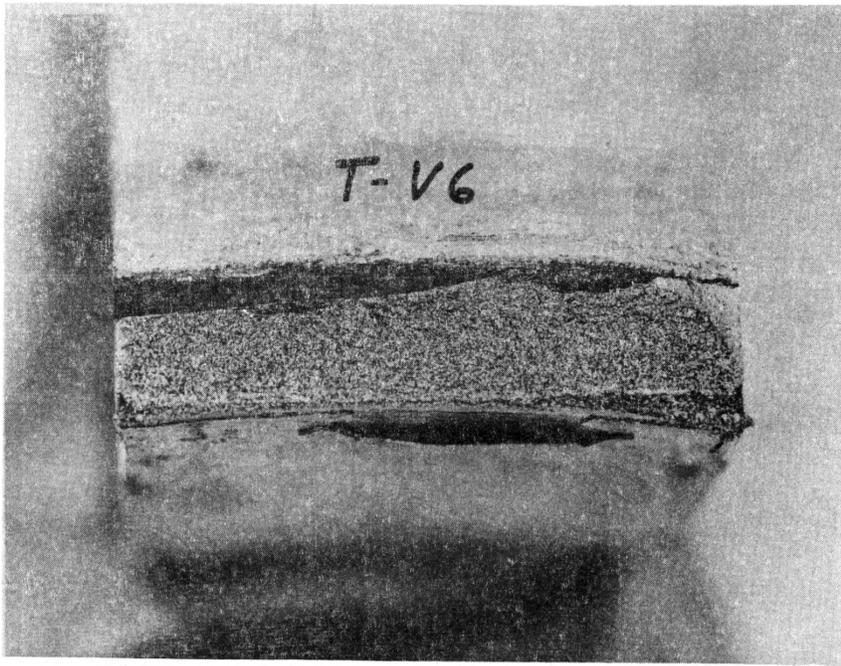
Fig. 38 Fatigue Crack Detected at the Pipe Arm Weld
Toe of Specimen V6

Since small cracks were not visible because of the galvanized coating, several specimens with no visible indication of cracking had segments cut from the pipe arm and column bases. These segments were cooled in liquid nitrogen and then the pipe segment was broken at the weld toe. This exposed several small cracks including a 0.06 in. deep crack in the pipe arm of specimen V6. Figure 38 shows the fatigue crack surface that was exposed in specimen V6.

None of the cracks shown in Figs. 38 to 40 had propagated through the zinc coat. The results suggest that the crack must propagate nearly through the pipe thickness before it can be detected if a single crack as shown in Fig. 40 exists. A longer multiple coalesced crack will likely break the galvanized coating before forming a through thickness crack.

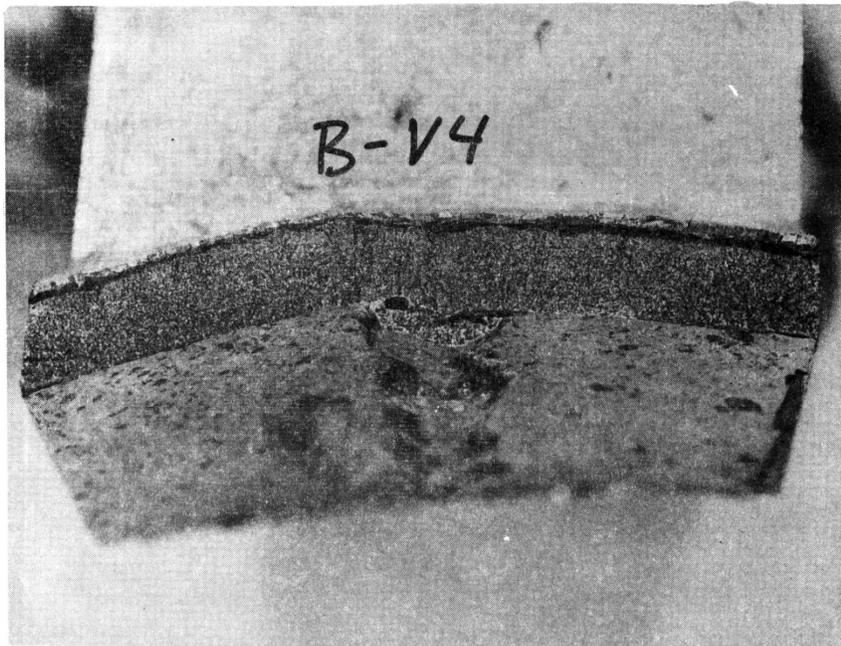
Fig. 39 Small Fatigue Cracks at the Column Base Weld
Toe of Specimen V4

Similar small cracks were found at the column base connections of specimens V4 and A6. These are shown in Fig. 39 and 40. Figure 39 shows the cracks found at the base of specimen V4. These cracks were 0.02 to 0.03 in. deep and varied in width along the weld toe. Their length was between 0.2 and 0.4 in.

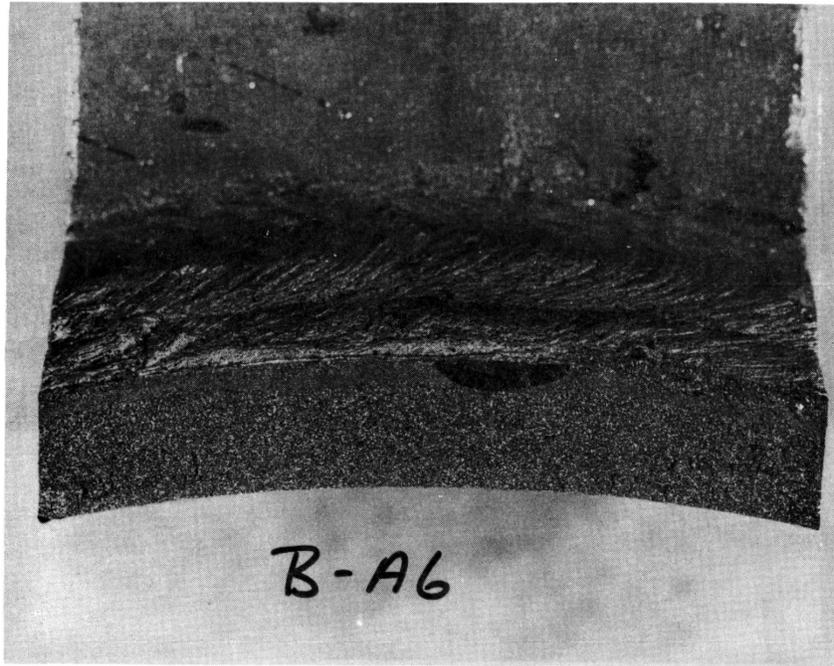
Fig. 40 Small Fatigue Crack at the Column Base Weld
Toe of Specimen A6

Figure 30 shows a crack at the column base of specimen A6. This crack was 0.08 in. deep and was 0.35 in. long.

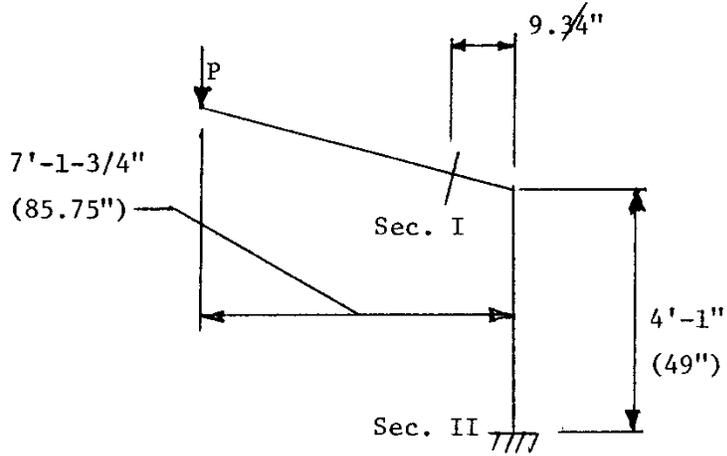
1. Bending Moment

Section I: $M = (85.75'' - 9.75'') \times P$
 $= 76 P$ [kilo-pounds-inch]

Section II: $M = 85.75 P$
