Electrically Powered Conductive Polymer Overlay For Ice Control

**ELECTRICALLY  
POWERED CONDUCTIVE  
POLYMER OVERLAY  
FOR ICE CONTROL**

Final Report # FHWA/CA/TL-93-04  
Caltrans Study # F91TL01-05

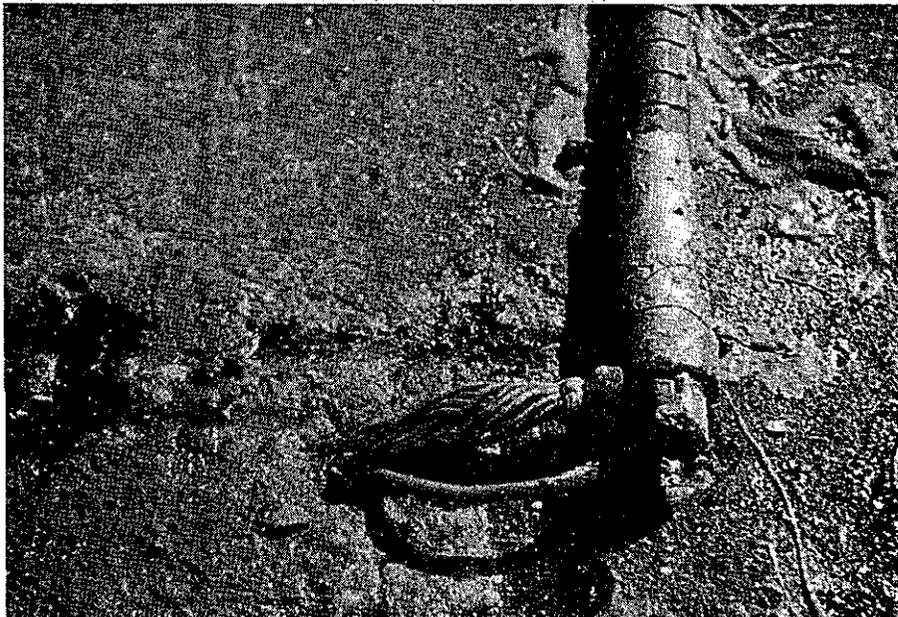
**Photo 4**  
**Power Cable to Rebar Distribution Rod**

The following day, holes for the deck temperature thermocouples outside the test patch were drilled. The power lines and all the sensing wire leads were fed through the holes. The area underneath the bridge was coned off where the wires met the road and the excess wire was coiled up and taped to the column. Bar reinforcing steel (#4), epoxied to the deck was used to deliver the current to the overlay, (Photo 4).

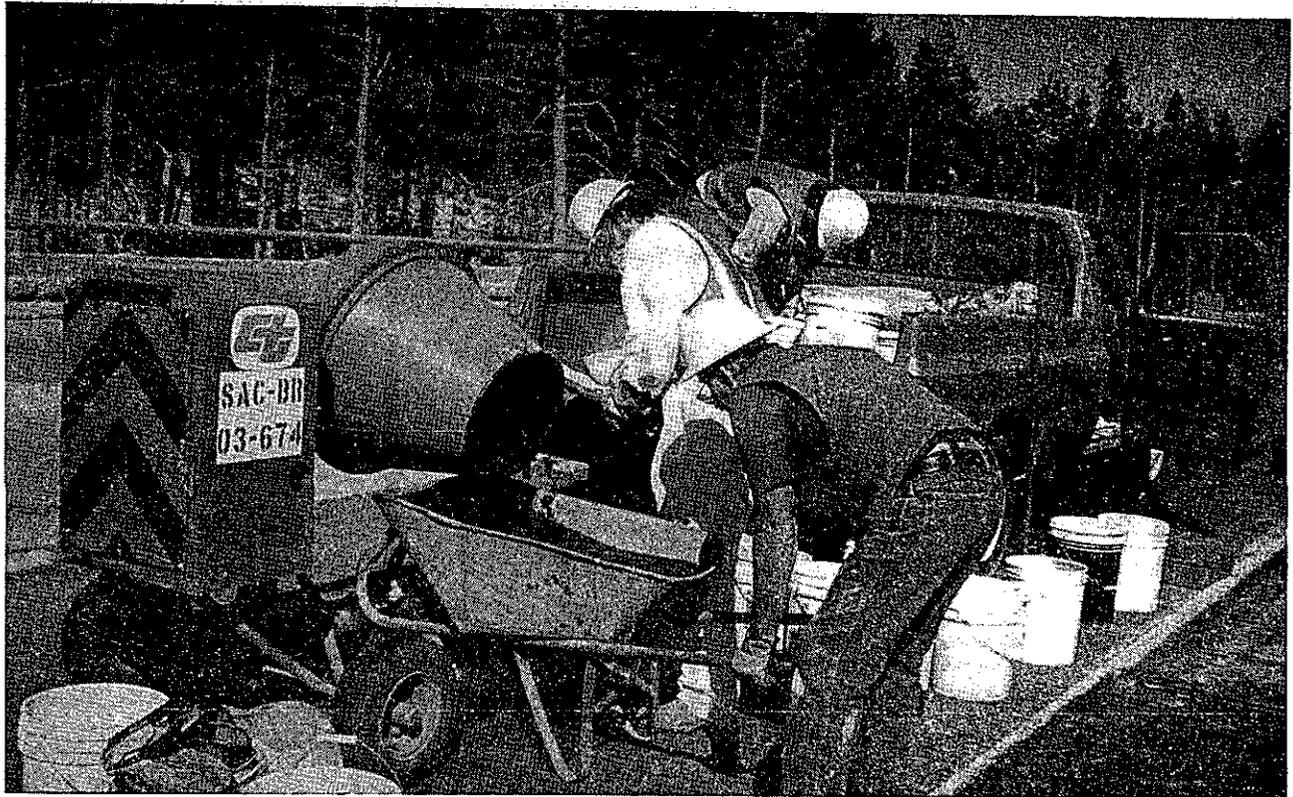
Photo 6  
Batching and Mixing Conductive Polymer Concrete

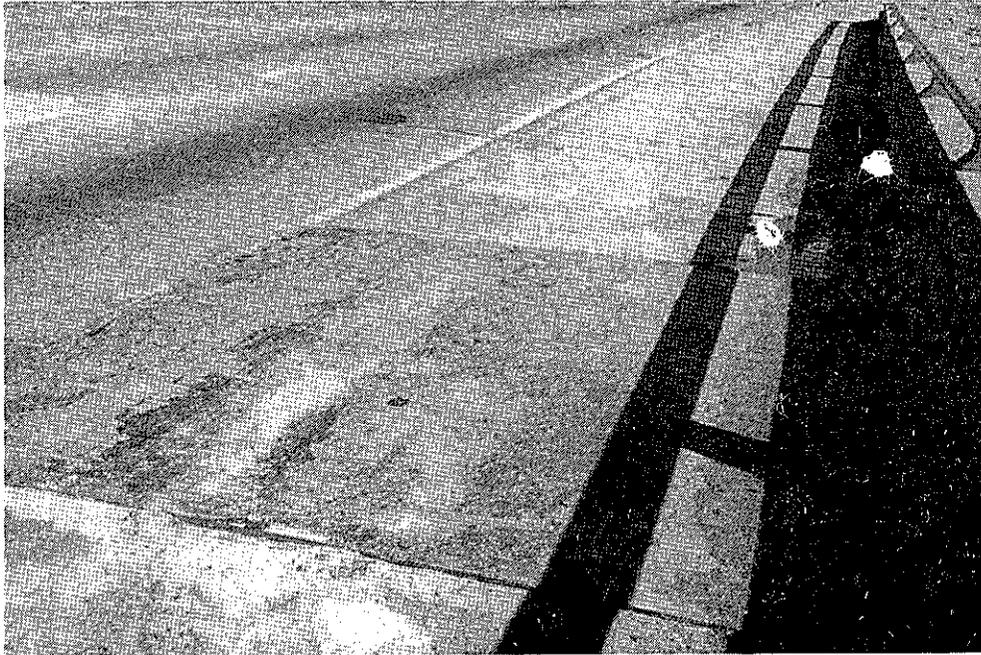
**Photo 7**

**Photo 8**  
**Portion of Deck Shaded by Rail (Photos 7 &8)**

The close proximity of the bridge rail will influence radiative heat transfer rate in two ways. Photos 7 and 8 indicate shade being cast across the edge of the deck due to the low winter sun. This shade moves across the edge of the deck during the day causing an uneven heating effect that is difficult to track. It also causes a residual pattern that influences the deck temperature after the solar radiation is no longer present. The second way the bridge rail influences the deck is by limiting the exposure to the night sky. A large portion of the deck's thermal energy is radiated outward. The rate the energy is lost varies depending on atmospheric conditions. The rail acts to shield part of the deck immediately next to it from the night sky thus decreasing the shape factor by up to 50%, which could decrease thermal radiation loss by 50%.

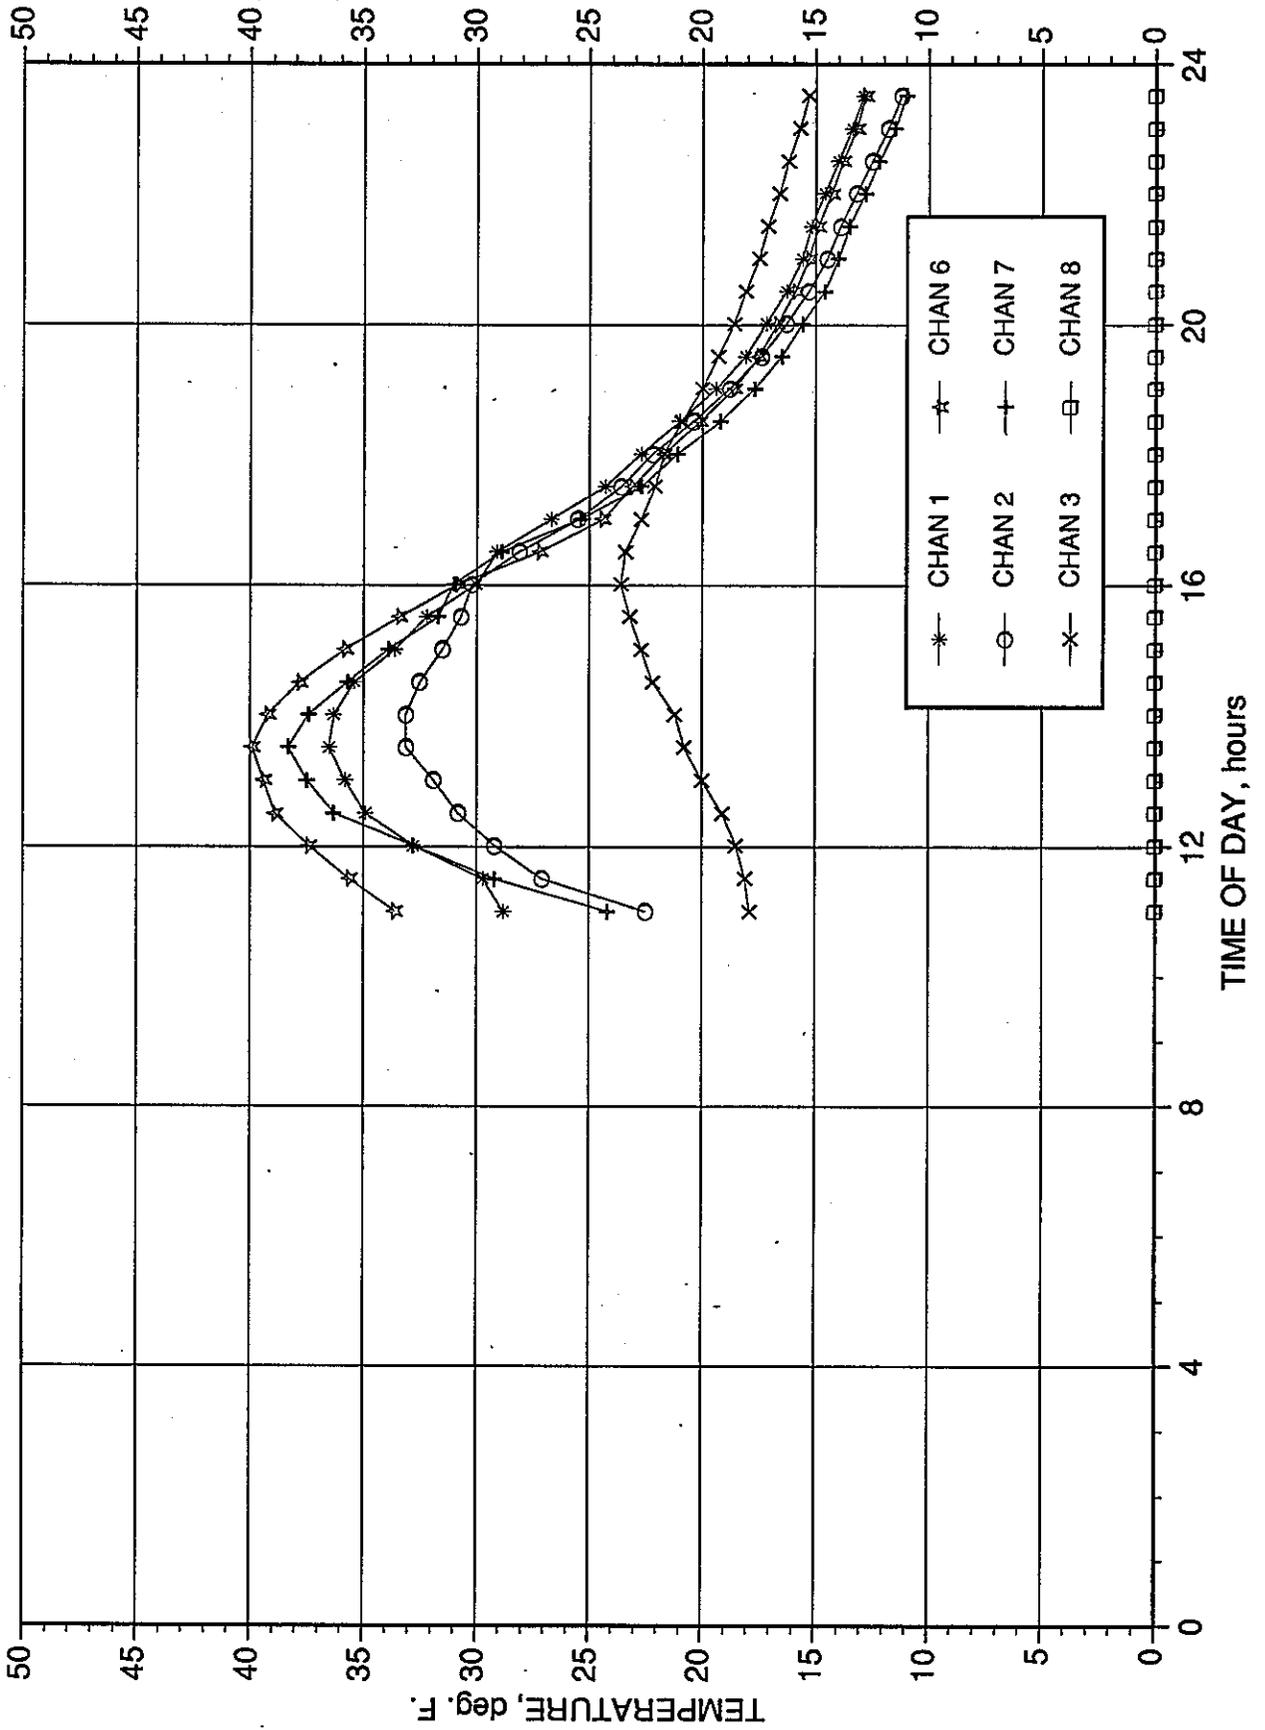
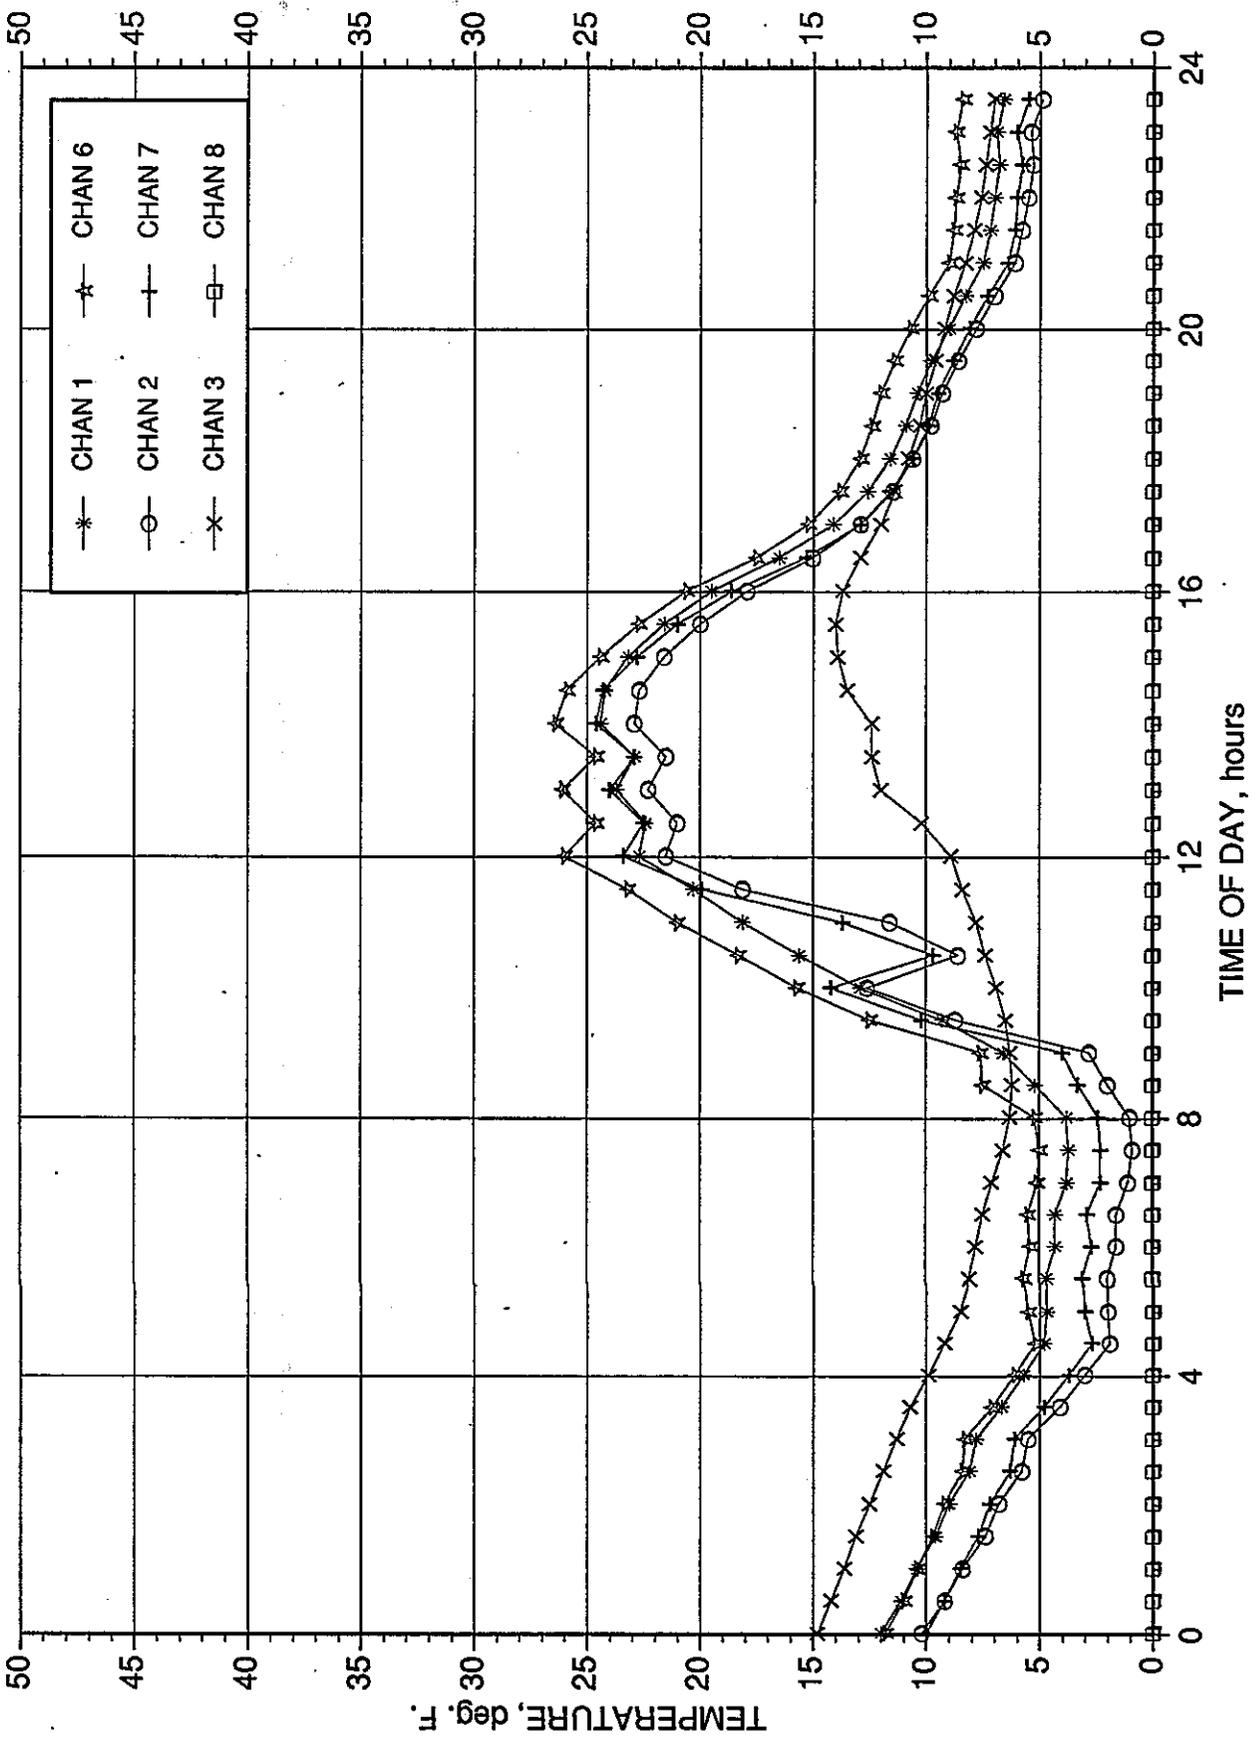
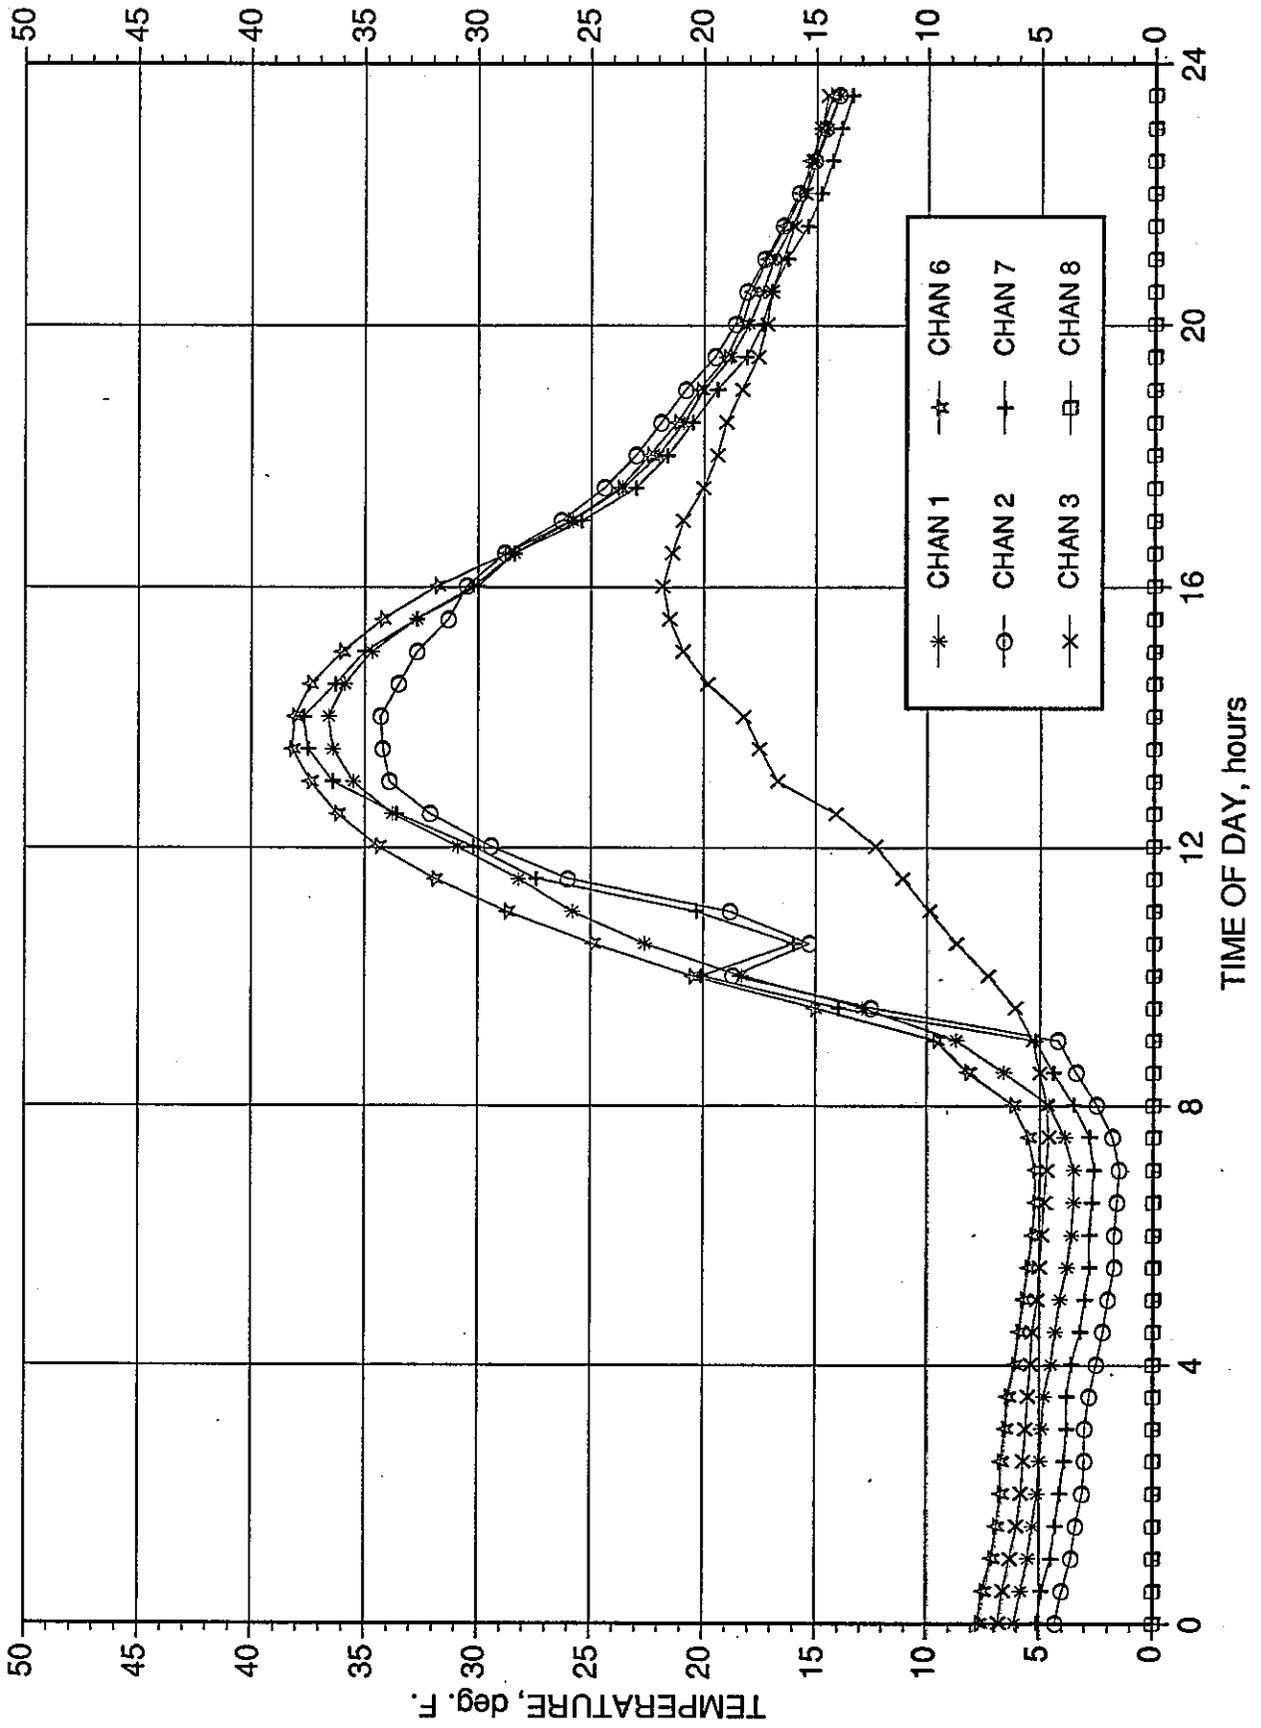
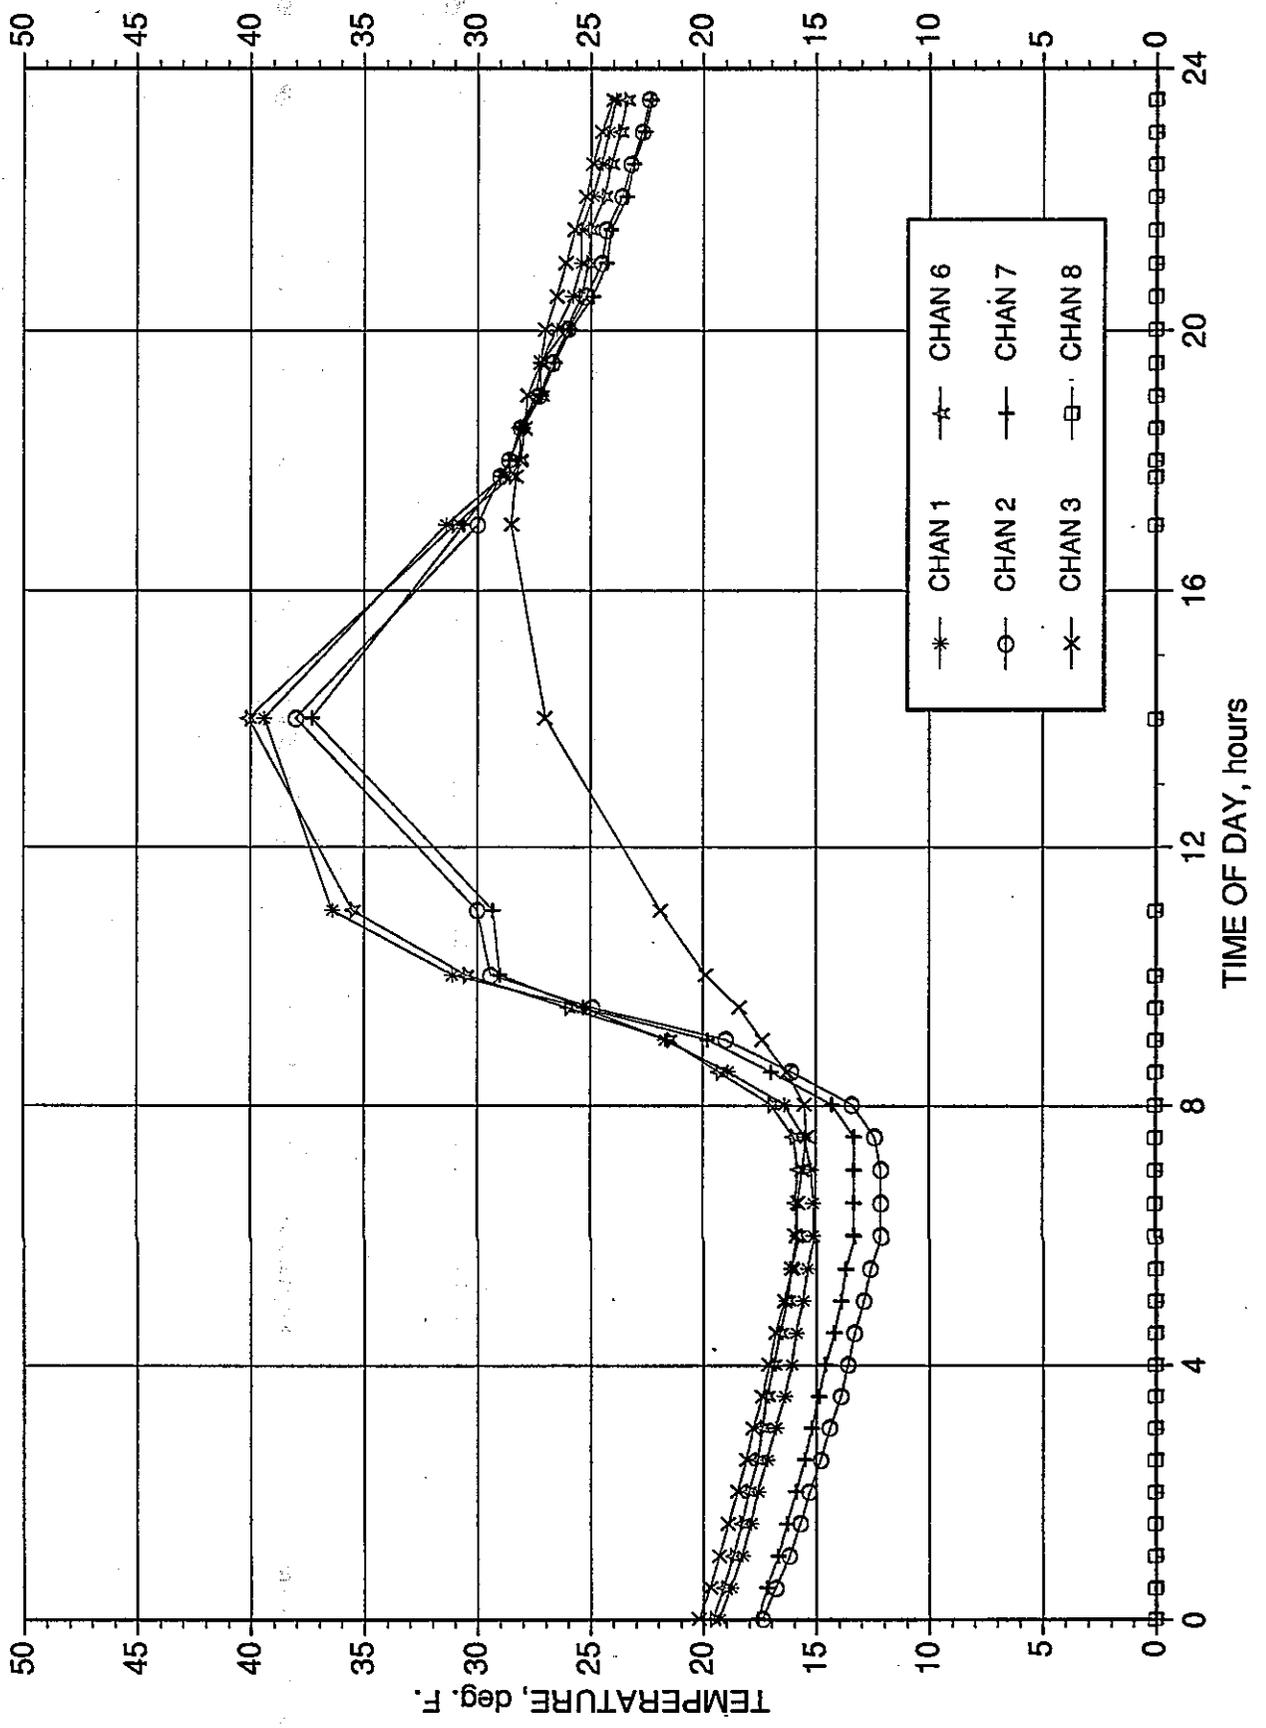
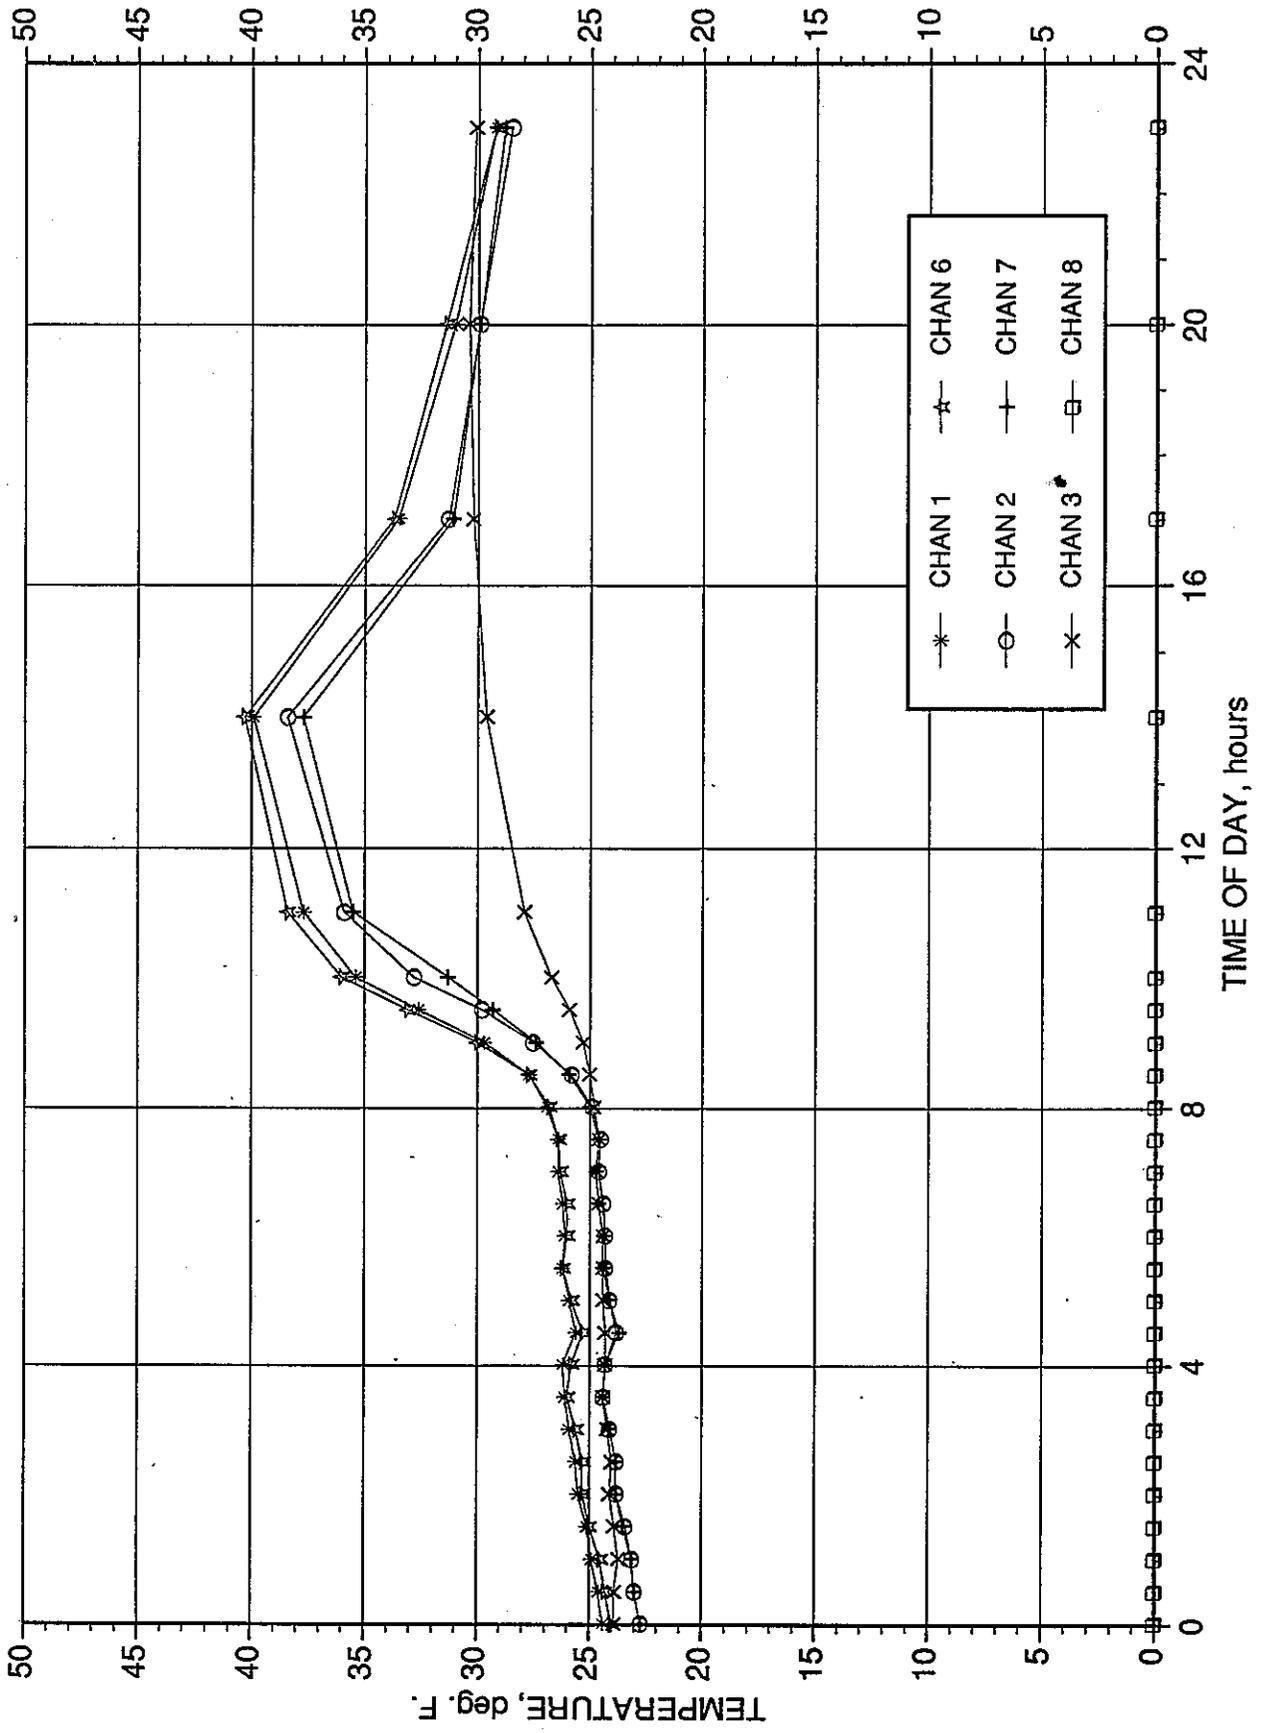
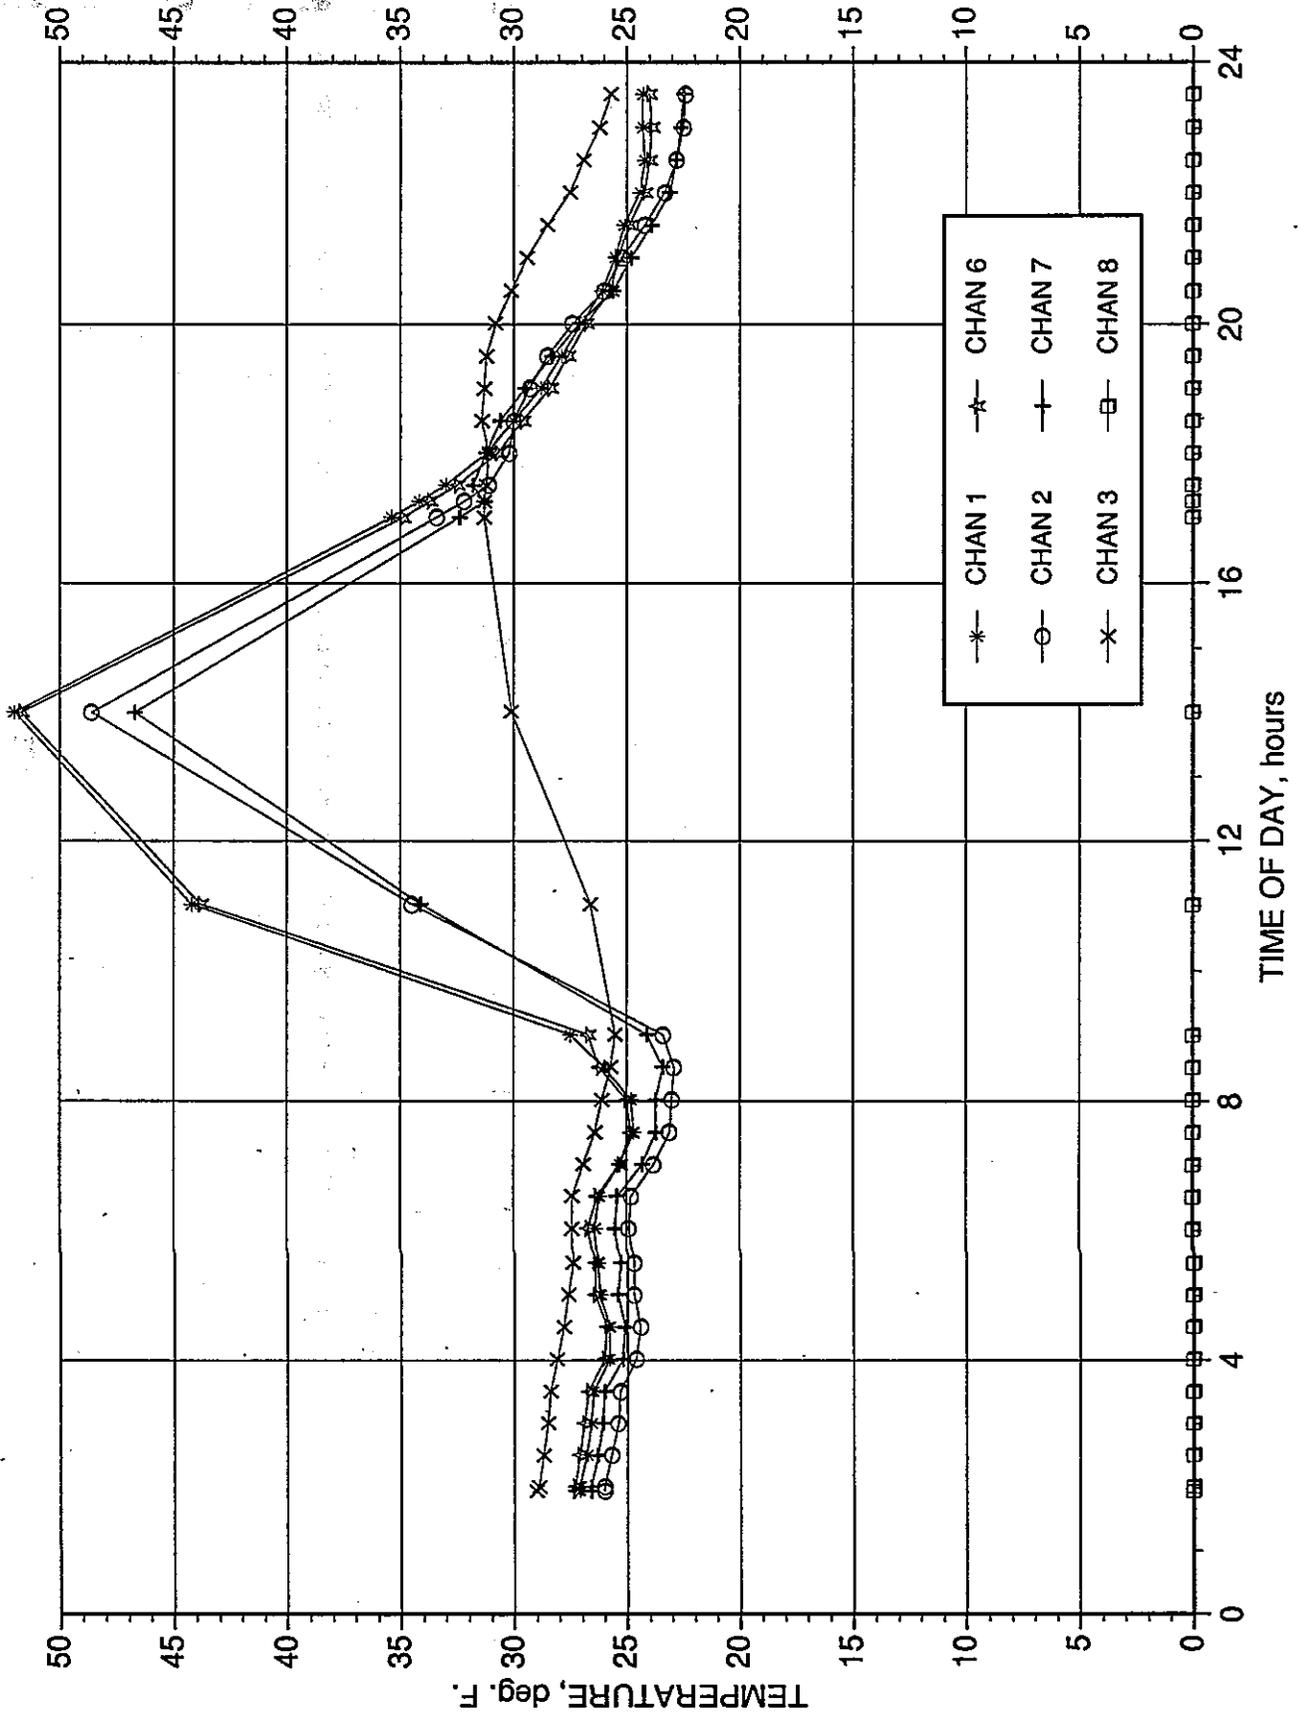
**COMPARISON OF TEMPERATURES OUTSIDE OVERLAY BOUNDARY**

The temperature data from within the conductive overlay showed a consistently higher temperature than the area outside the overlay. The differences increased with an absence of solar radiation on the deck. During a typical day the temperatures generally increased significantly from 0800 hours to a peak at 1400 hours then steadily decreased until the next morning. This pattern is interrupted during severe storm conditions and can be seen in the temperature data taken on December 15, 19, 20 and 21, in Appendices A, B, C, and D. Record cold temperatures were logged in the latter half of December 1990. More typical weather conditions were recorded from December 30 through January 6, (Appendices F, G, and H).

A visual inspection of figures from December 30 to January 6 reveal a distinct differences in temperature inside and outside the overlay. The figures in Appendix H, December 30 through January 2, show clear examples of the heating capability. As mentioned previously, the temperature differences are greatest when solar radiation is not present, due to the elimination of solar heat contribution to the deck. For this reason average temperature data was calculated over specified nighttime hours. Figure 6 and Table 3 show examples of average temperatures calculated.
