Electrically Powered Conductive Polymer Overlay For Ice Control

**ELECTRICALLY  
POWERED CONDUCTIVE  
POLYMER OVERLAY  
FOR ICE CONTROL**

Final Report # FHWA/CA/TL-93-04  
Caltrans Study # F91TL01-05

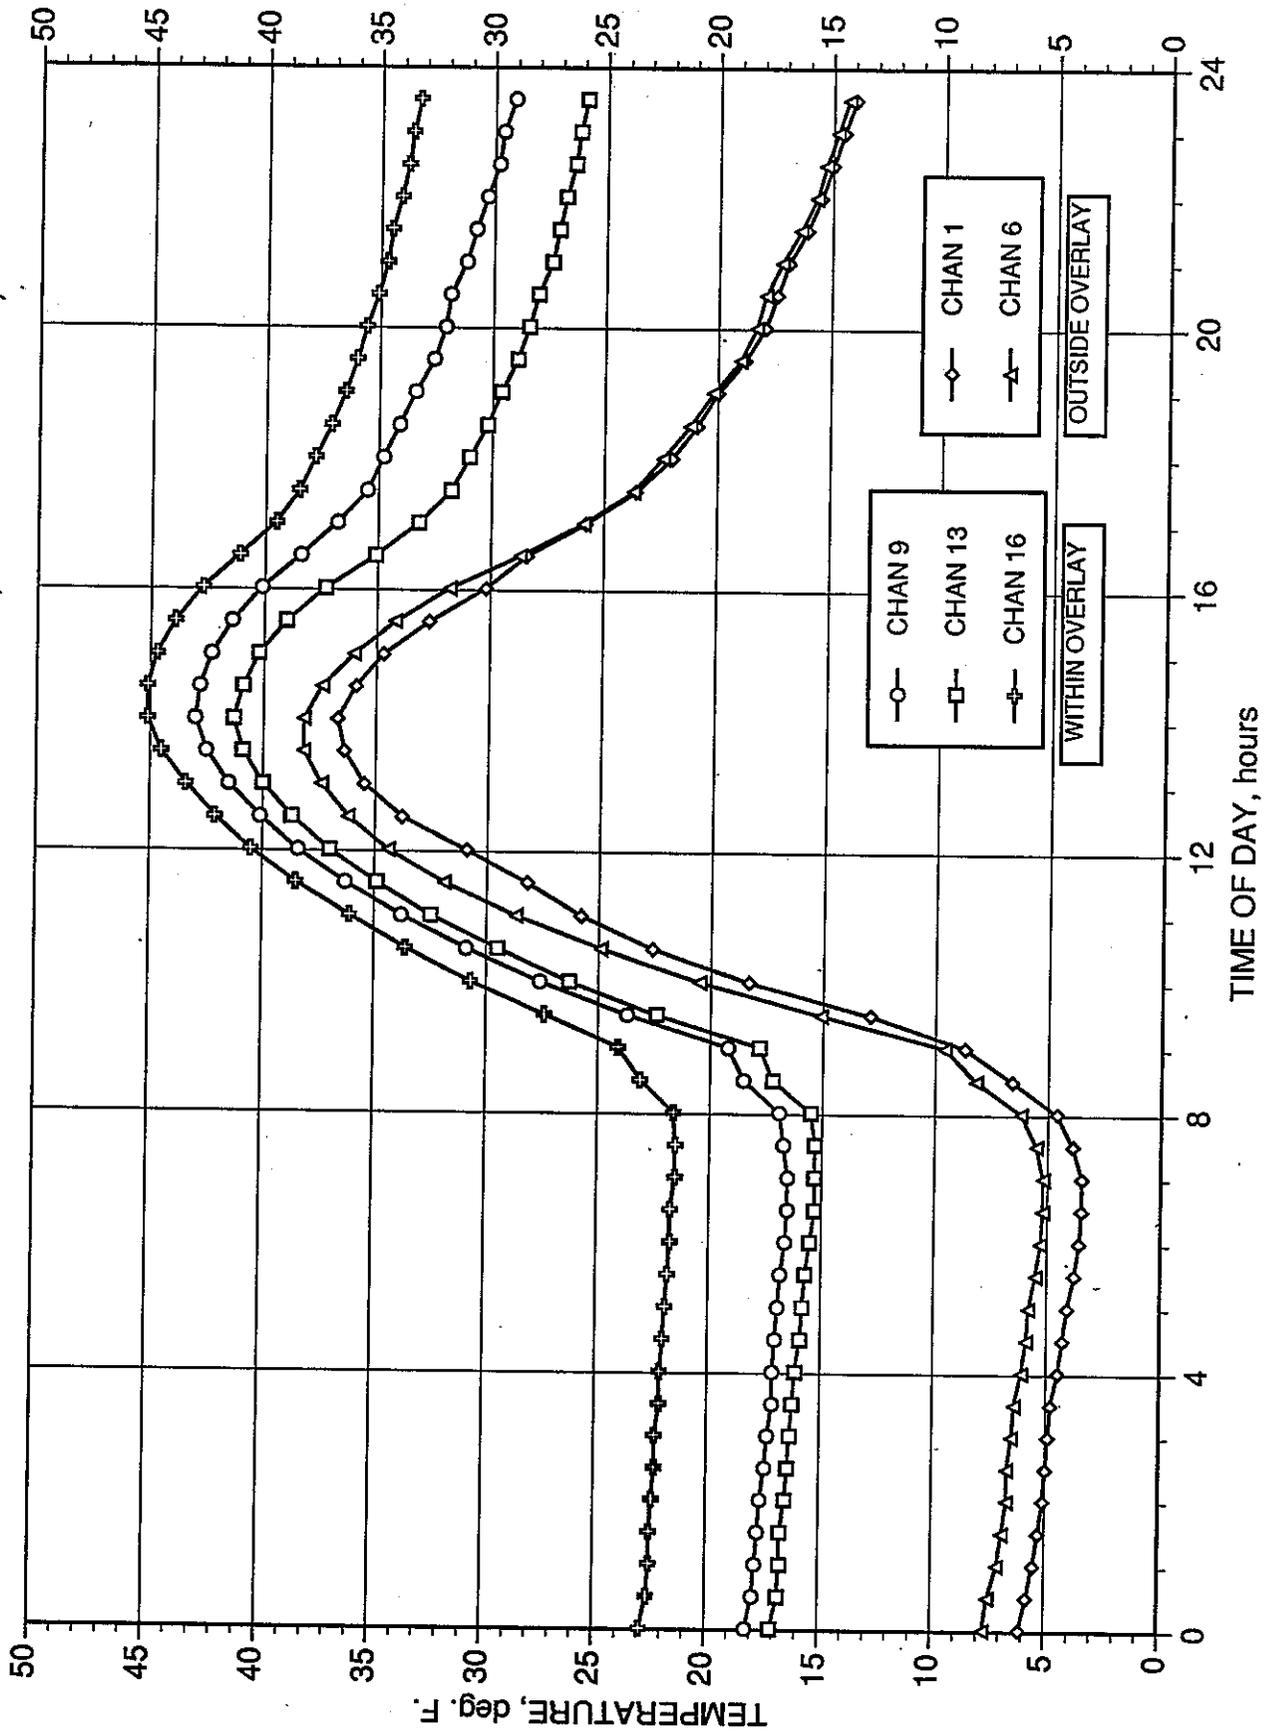
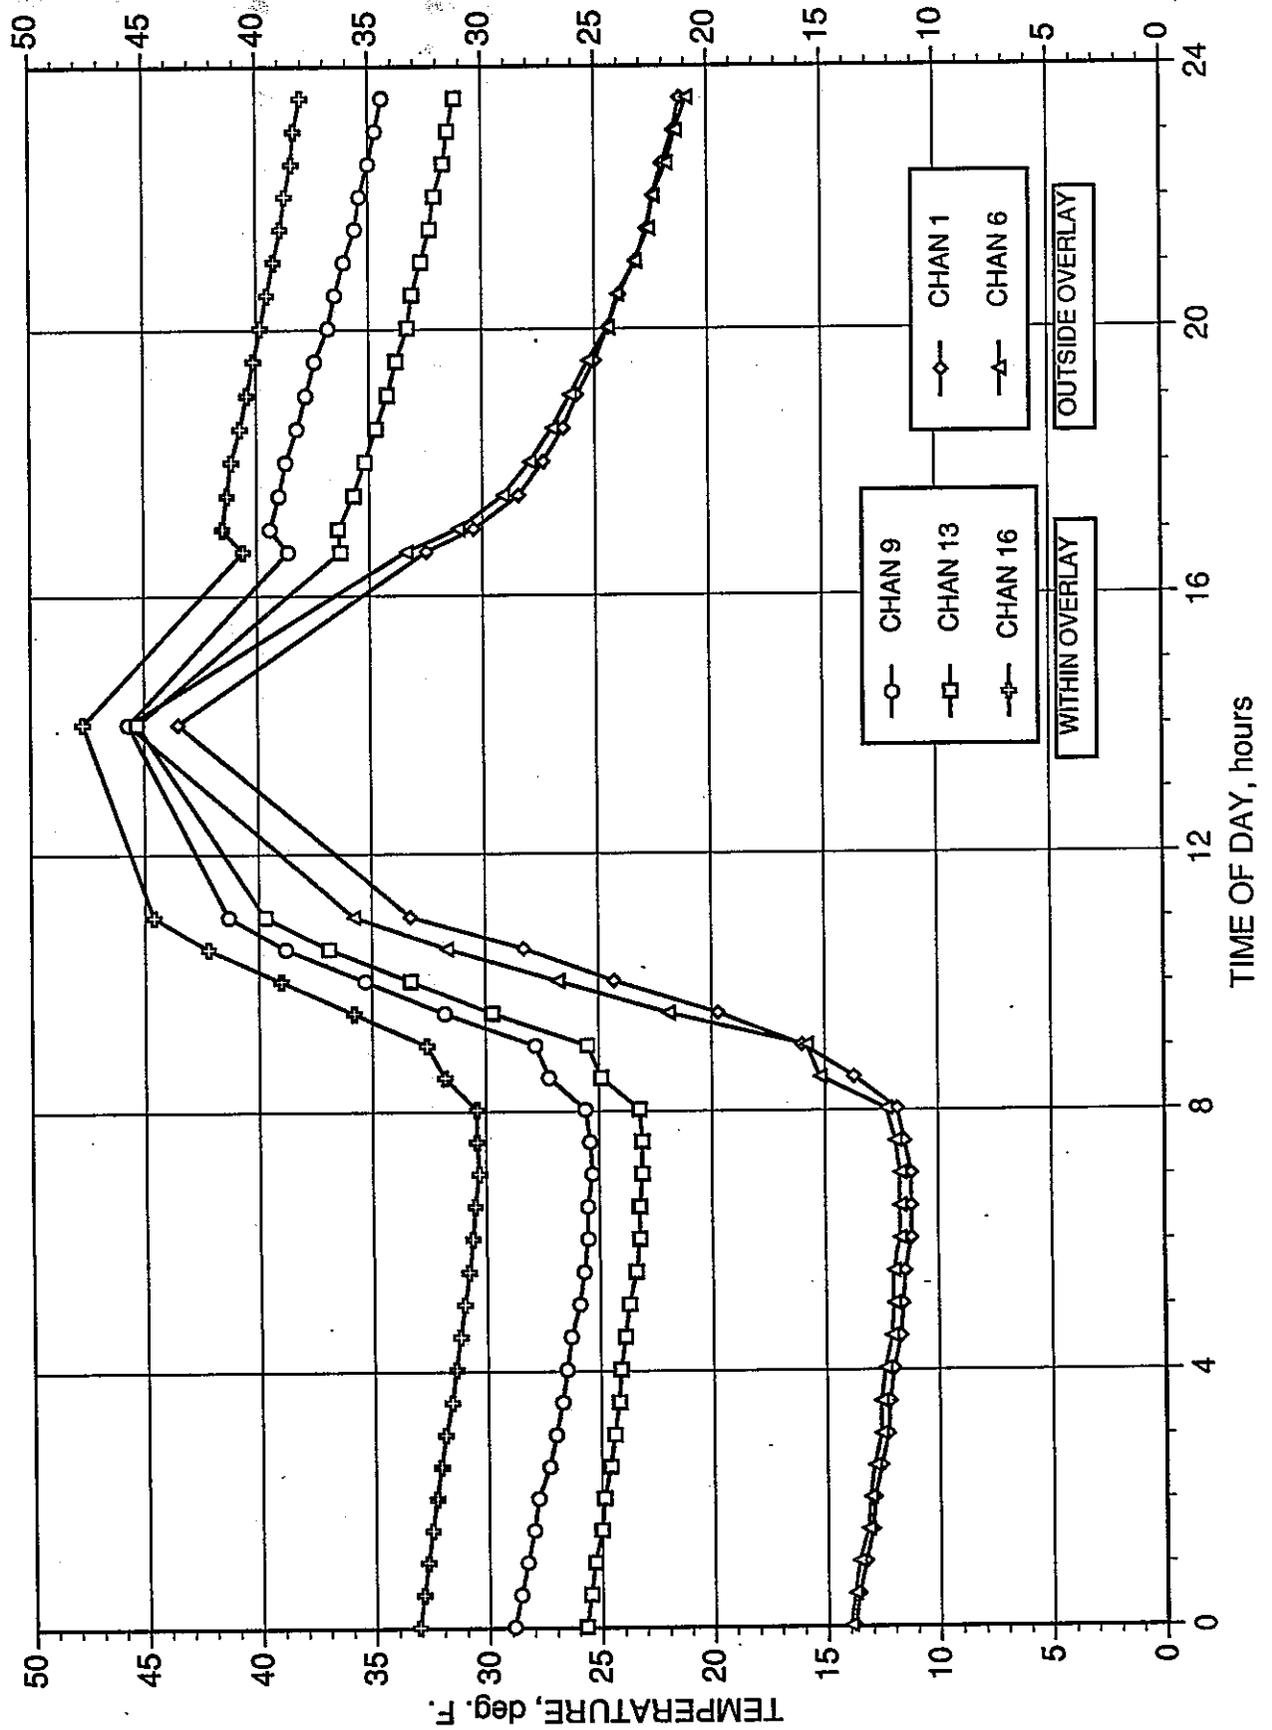
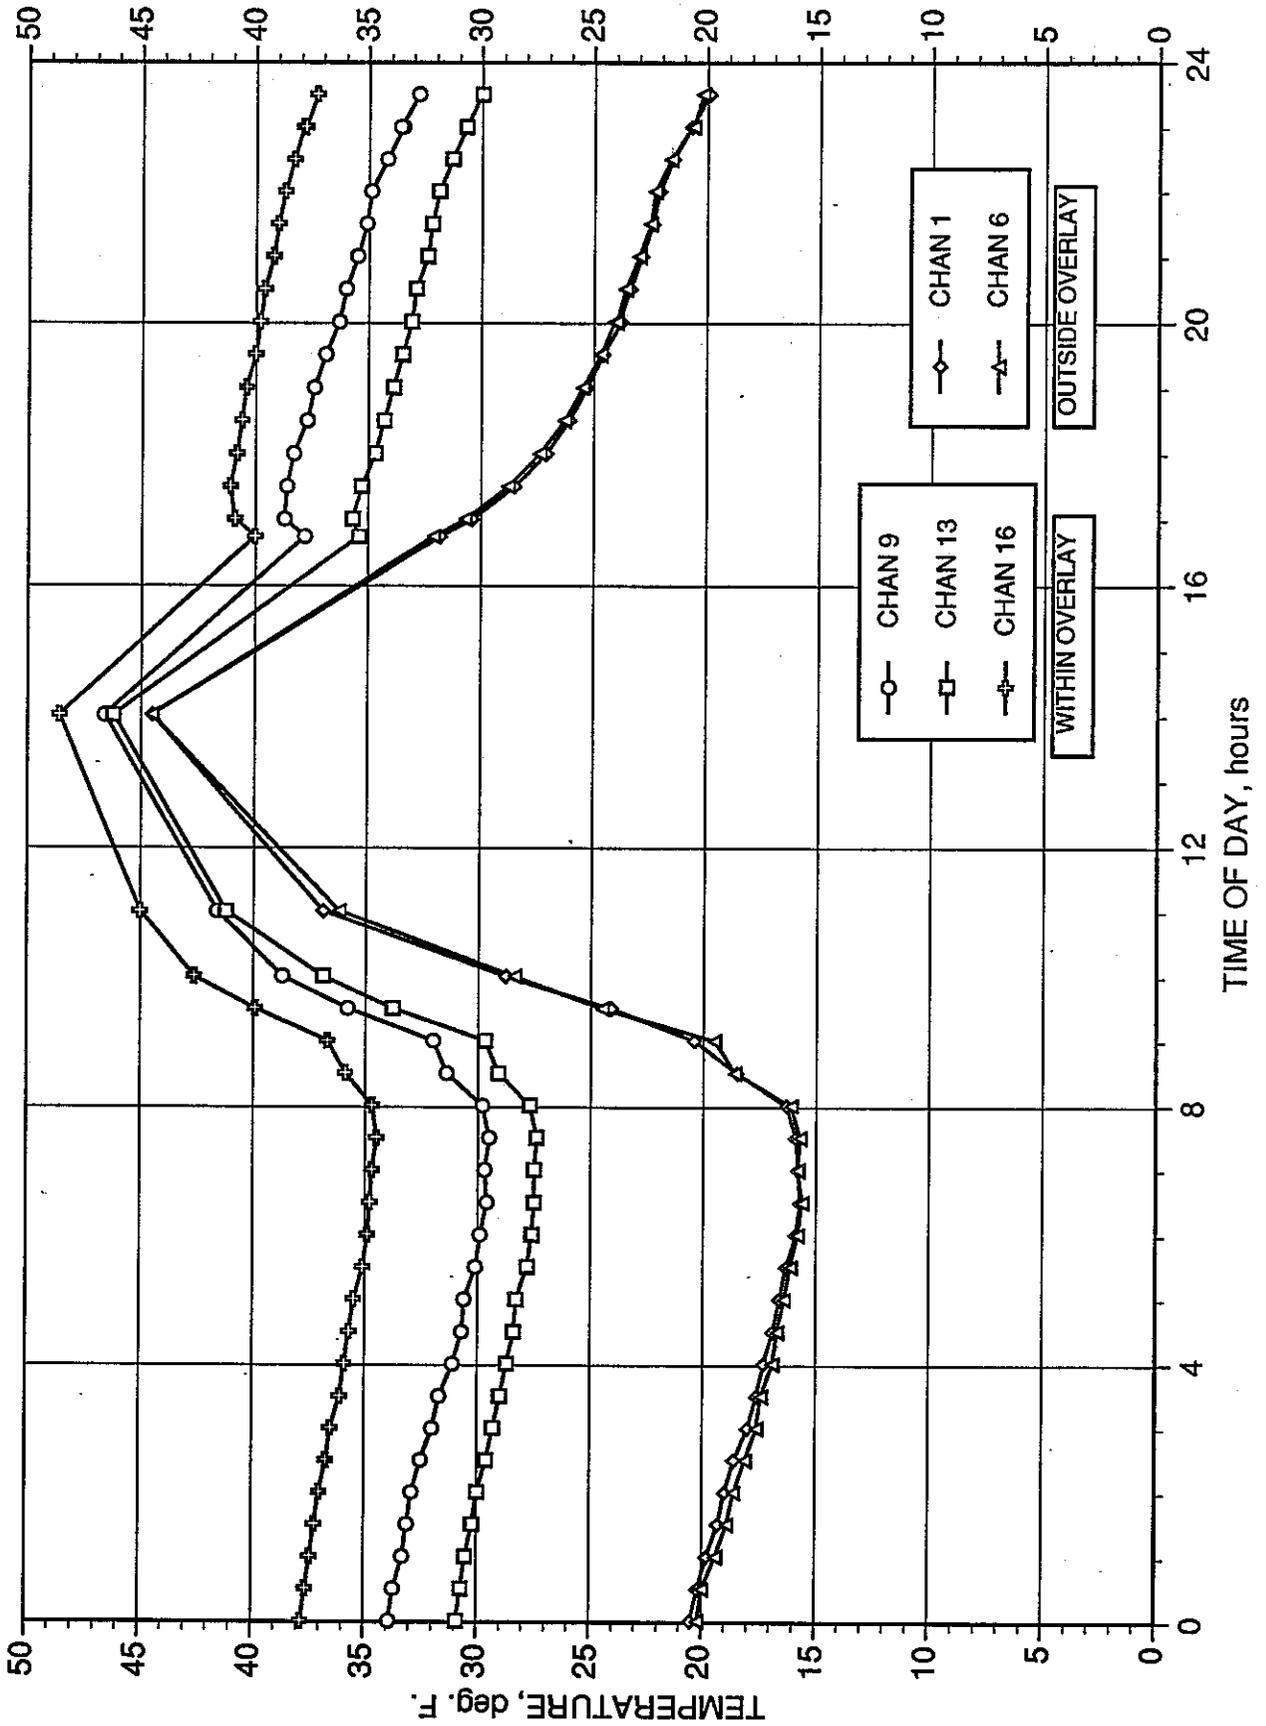
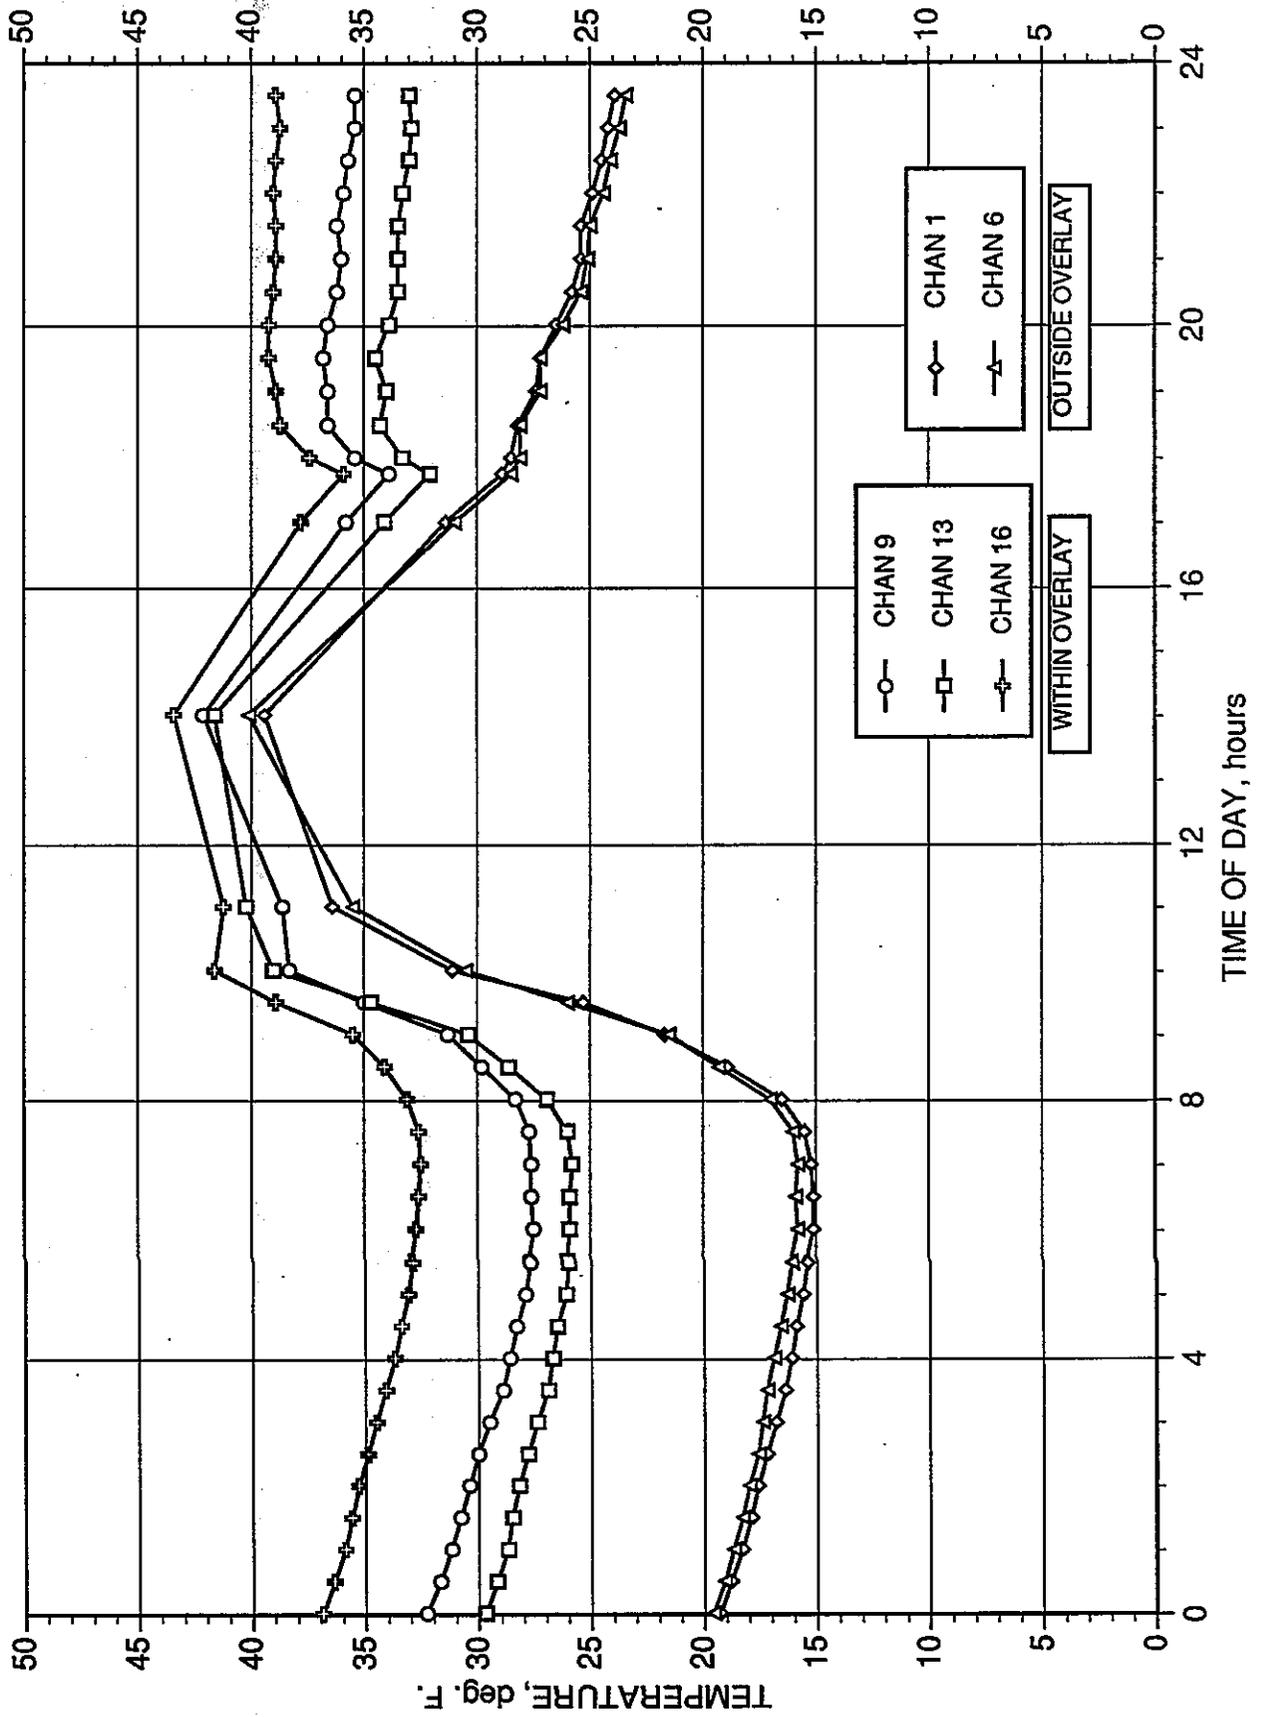
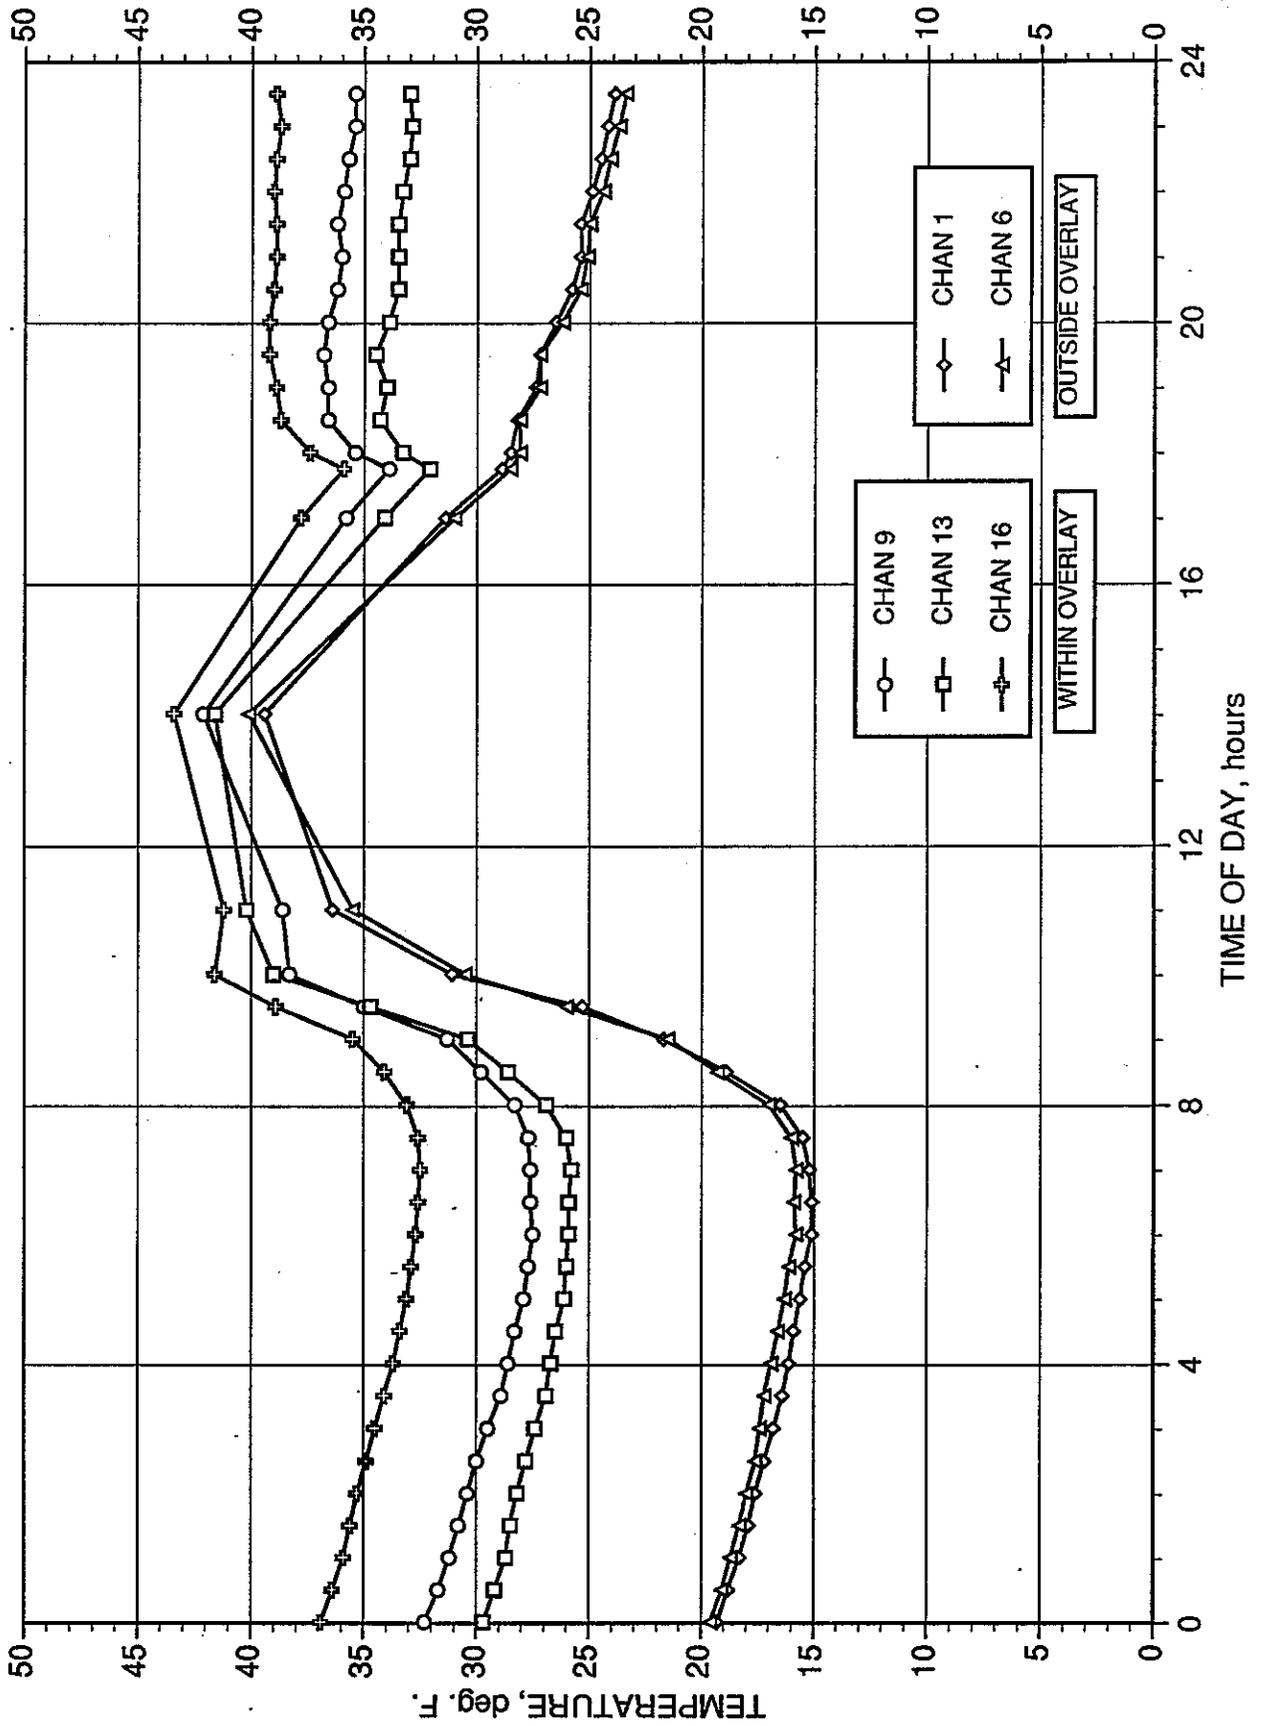
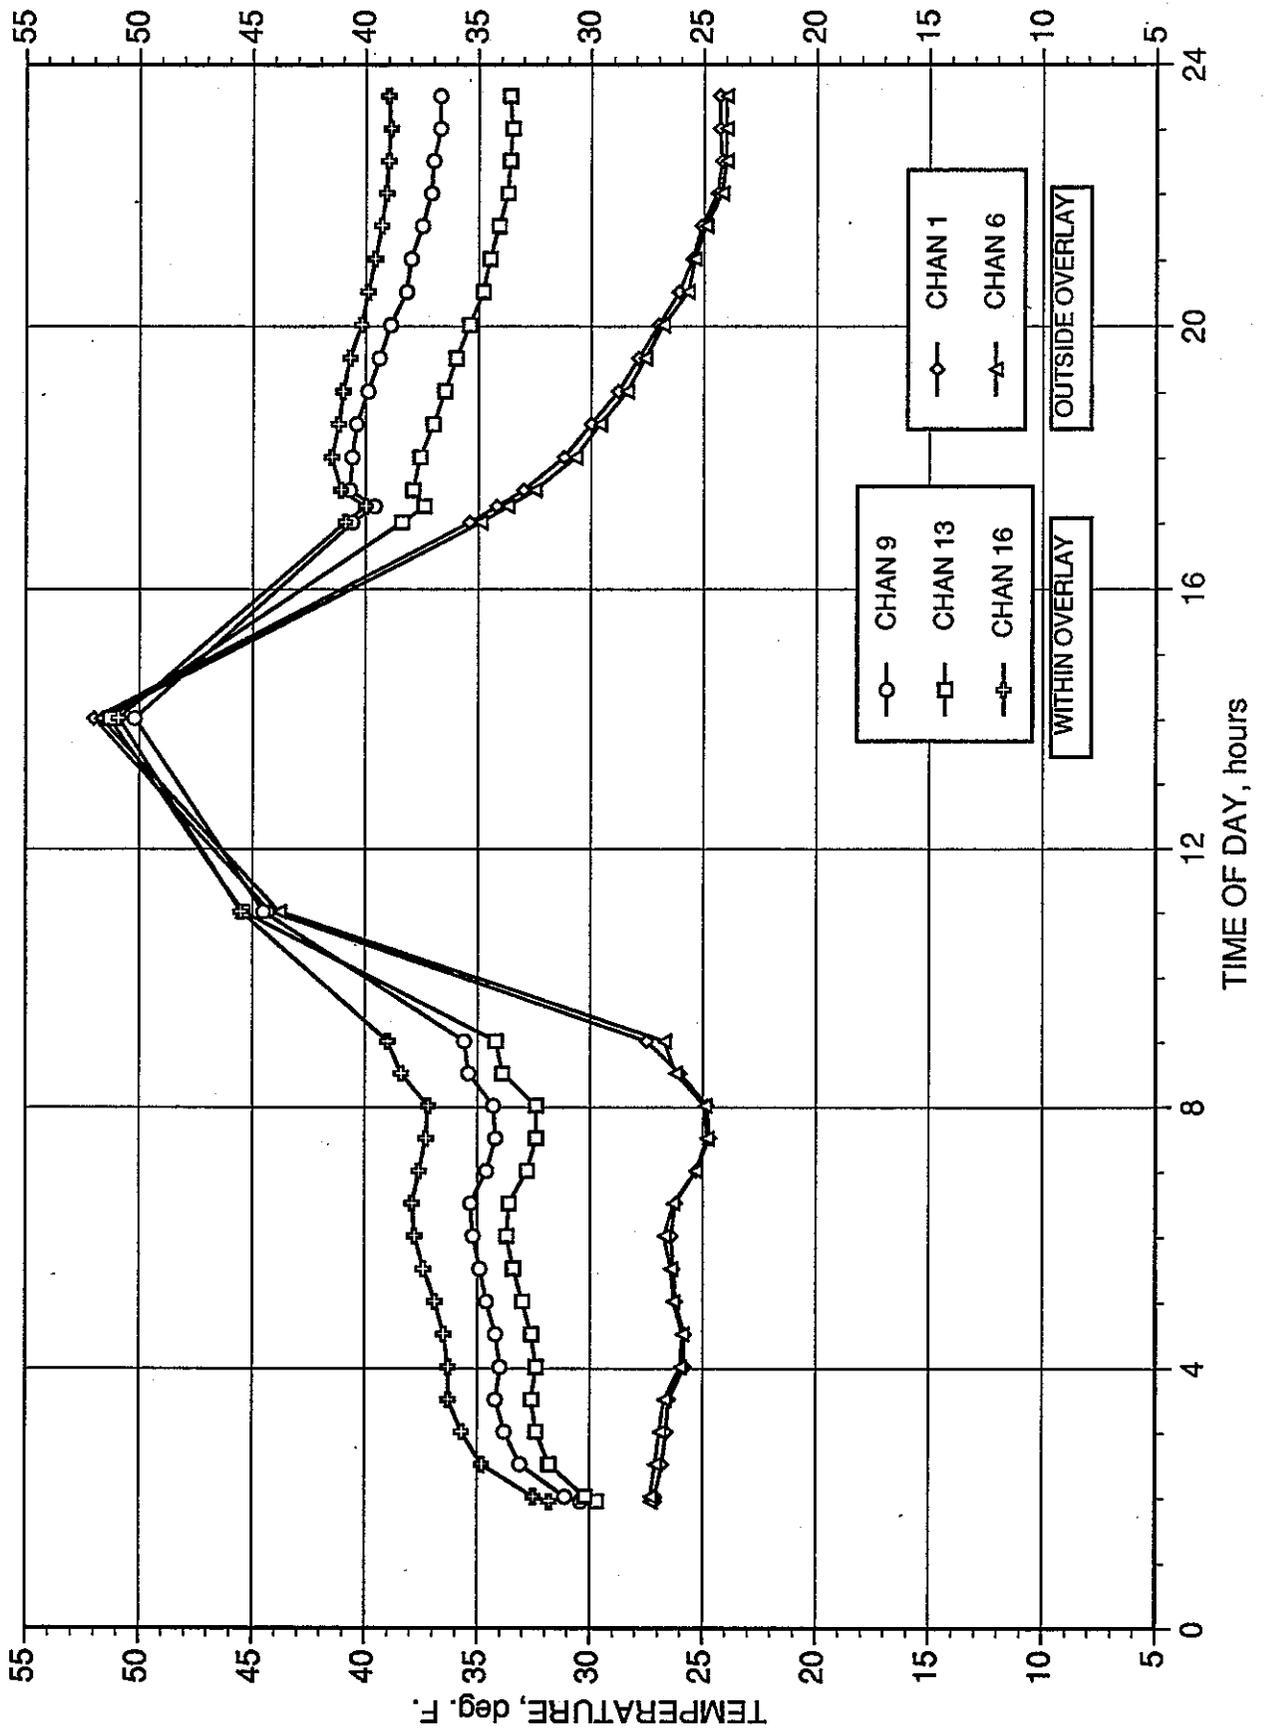
**(CLOSEST TO LANE)**

A visual inspection of figures from December 30 to January 6 reveal a distinct differences in temperature inside and outside the overlay. The figures in Appendix H, December 30 through January 2, show clear examples of the heating capability. As mentioned previously, the temperature differences are greatest when solar radiation is not present, due to the elimination of solar heat contribution to the deck. For this reason average temperature data was calculated over specified nighttime hours. Figure 6 and Table 3 show examples of average temperatures calculated.

closest to the lane are the least likely to be covered by snow, water or sand. For this reason, it was judged that these channels more accurately represented actual lane conditions.
