Construction, Instrumentation, and Testing of Fast-Setting Hydraulic Cement Concrete in Palmdale, California

**Construction, Instrumentation, and Testing of Fast-Setting  
Hydraulic Cement Concrete in Palmdale, California**

Pavement Research Center  
Institute of Transportation Studies  
University of California Berkeley

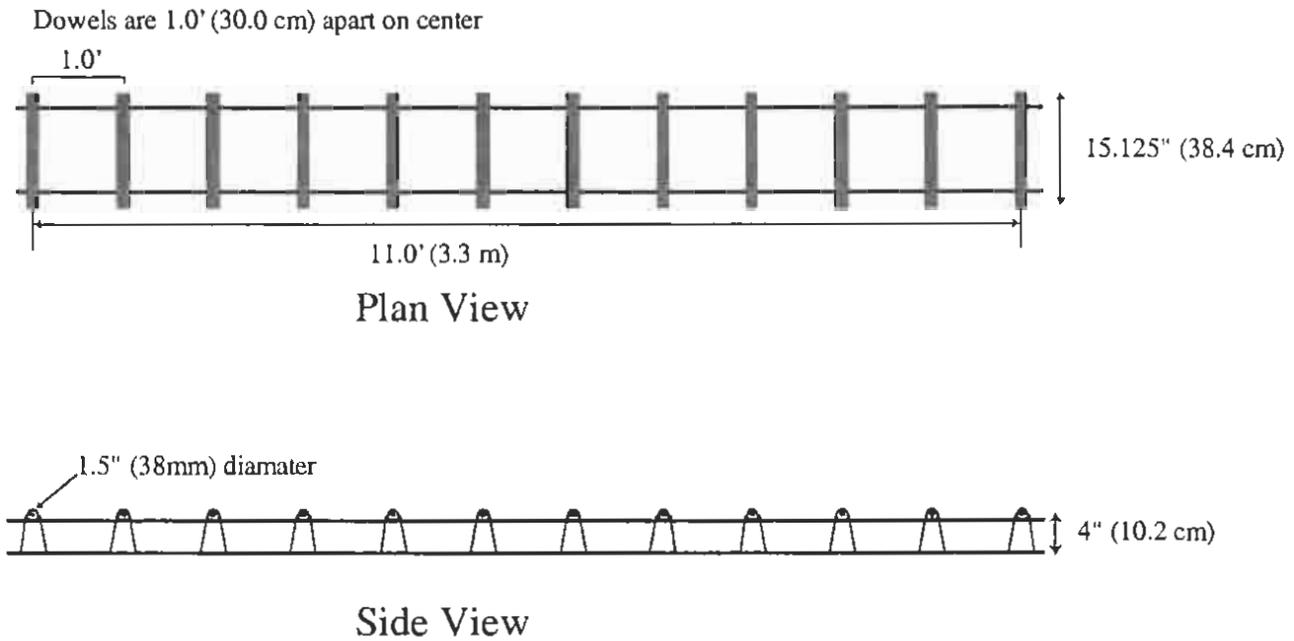
**Figure 4.1. Illustration of Typical Dowel Bars.**

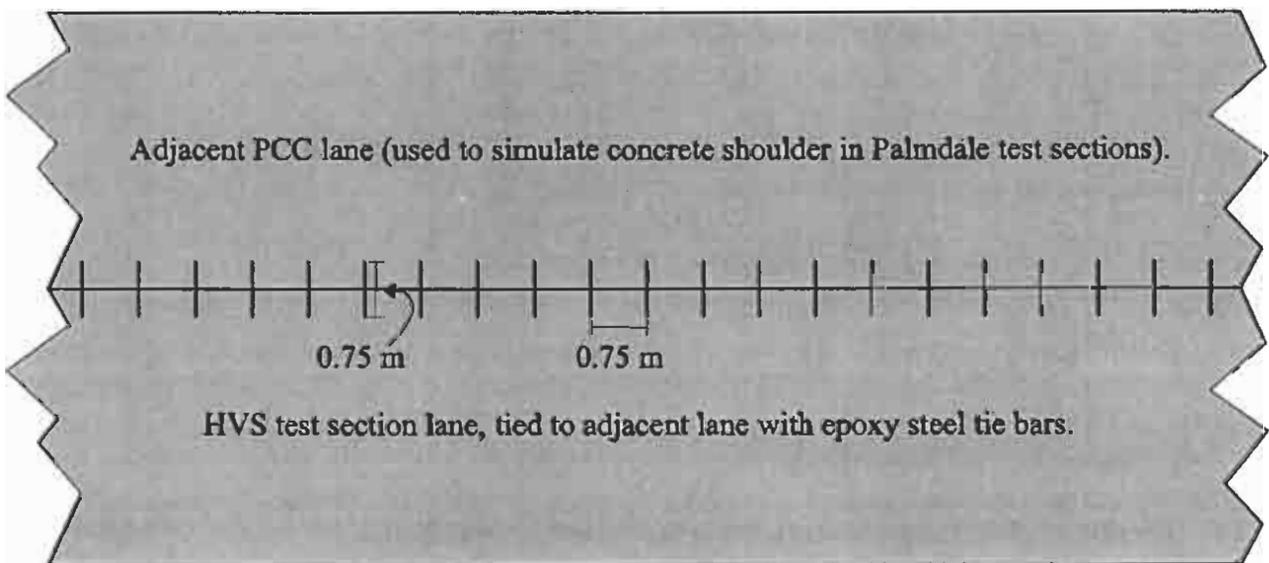
**Figure 4.2. Layout and Dimensions of Dowels Used to Simulate a Tied Concrete Shoulder.**

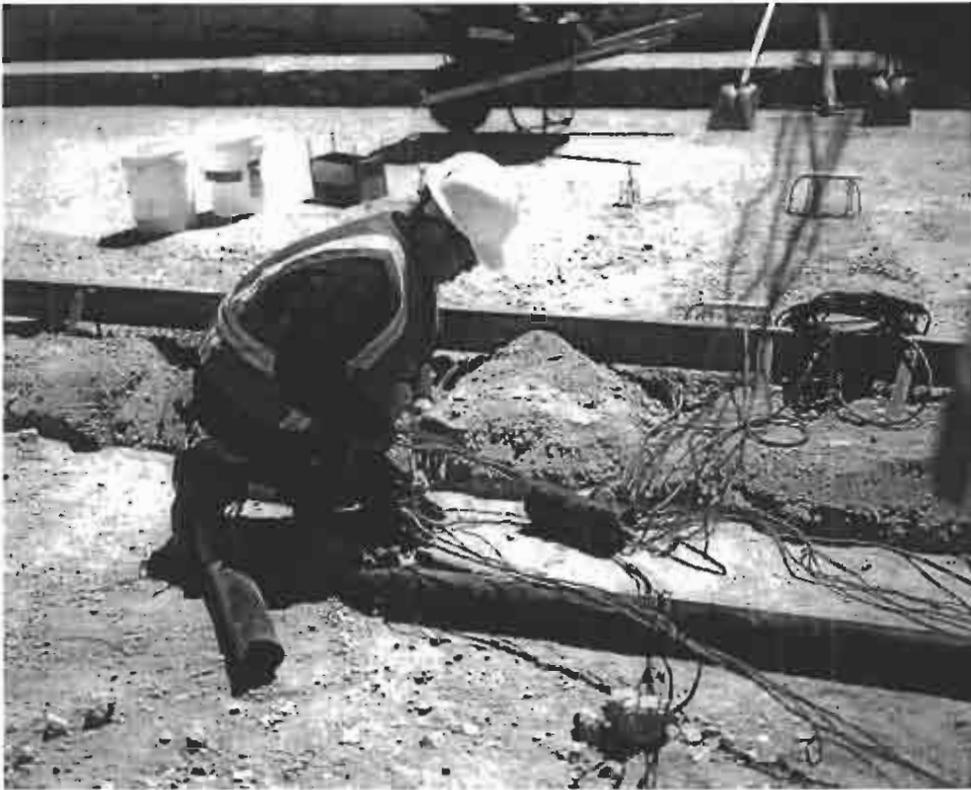
**Figure 6.1. South Tangent Instrument Wiring and Piping Laid in Aggregate Base.**

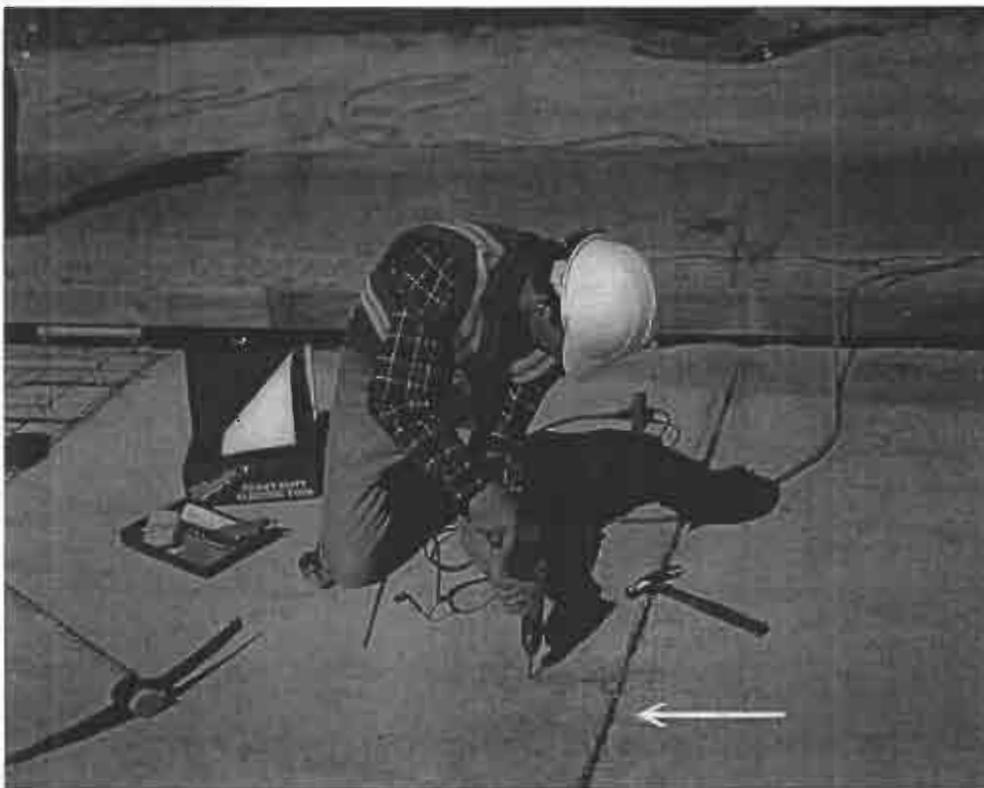
**Figure 6.2. Grooves cut in North Tangent CTB for Instrument Leads.**

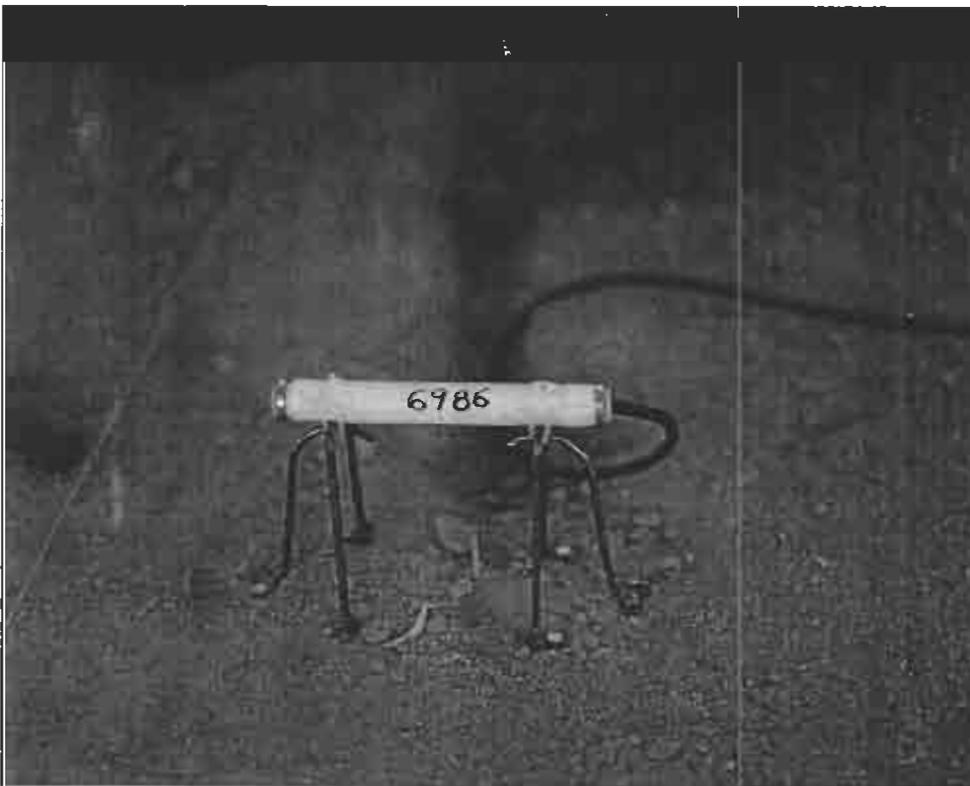
**Figure 6.4. Steel Frame with Carlson A-8 Strain Meter Installed on South Tangent.**

All strain gages were placed and properly oriented on the base material with small steel frames, as shown in Figures 6.4 and 6.5. Each instrument was attached to its steel frame using a plastic zip tie. Each instrument was attached firmly enough so that it wouldn't become dislodged

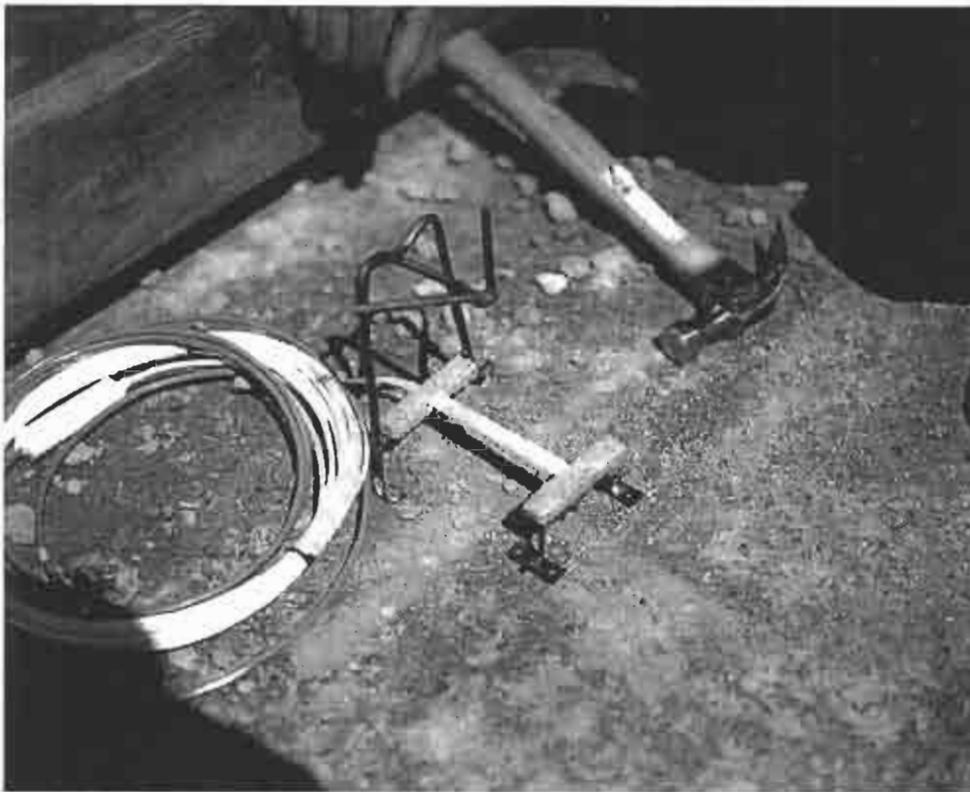
**Figure 6.5. Steel Frames for Collocation of Dynatest PAST-2PCC (shown) and Tokyo-Sokki PMR-60-6L (not shown).**

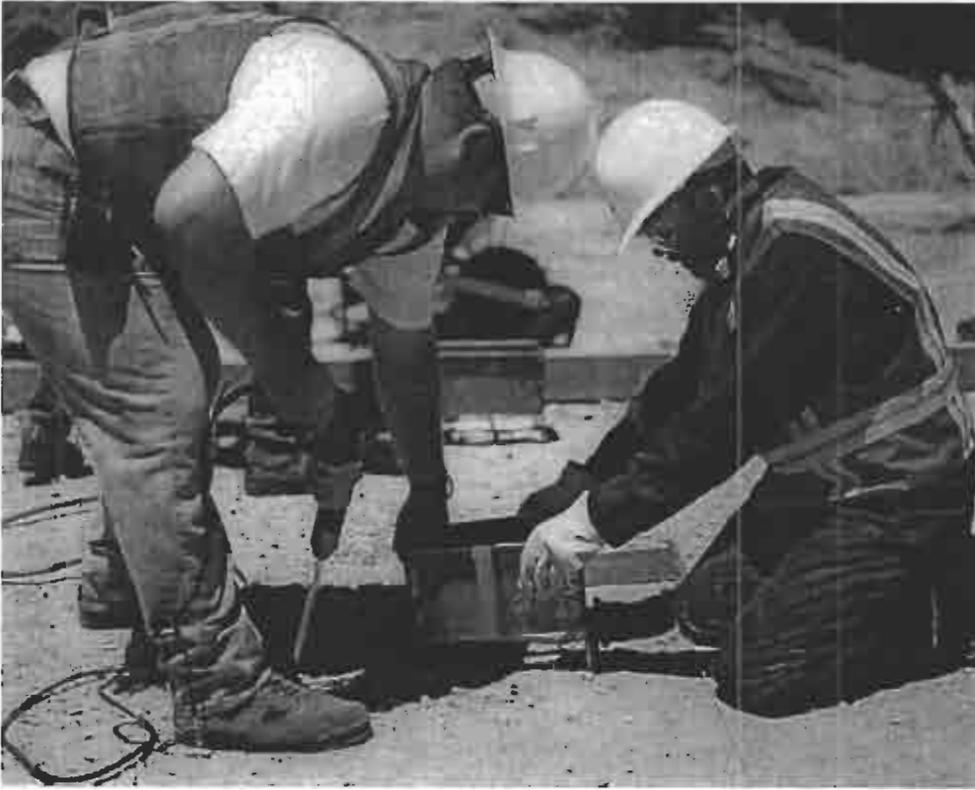
**Figure 6.6. Steel Instrument Box Being Installed on South Tangent.**

As shown in Figures 6.6 and 6.7, four-part sheet metal boxes with five-centimeter spikes at each corner were placed around all gages except for thermocouples. The sheet metal boxes prevented the flow of concrete from pushing any gages out of their intended location and orientation during paving. The spikes were driven into the base material to further stabilize the boxes. These boxes were then marked with “turkey tails” or wire flags affixed with duct tape so that they would be easily visible to the paving crew, as shown in Figure 6.8.

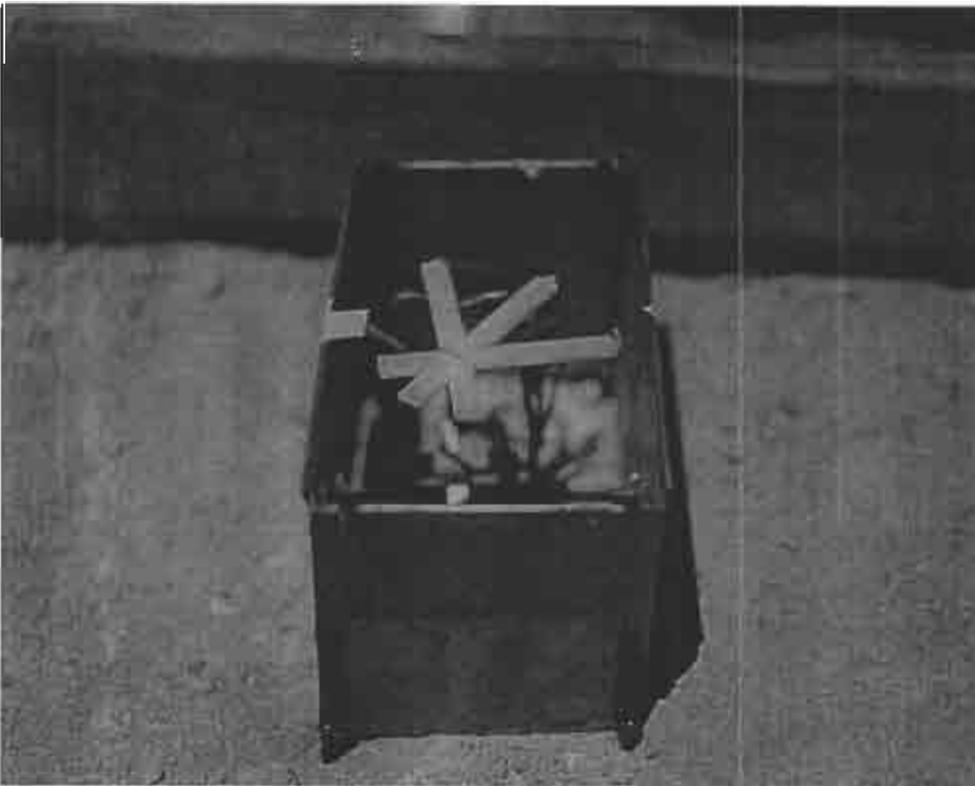
**Figure 6.7. Steel Instrument Box Protecting Strain Gages on South Tangent.**

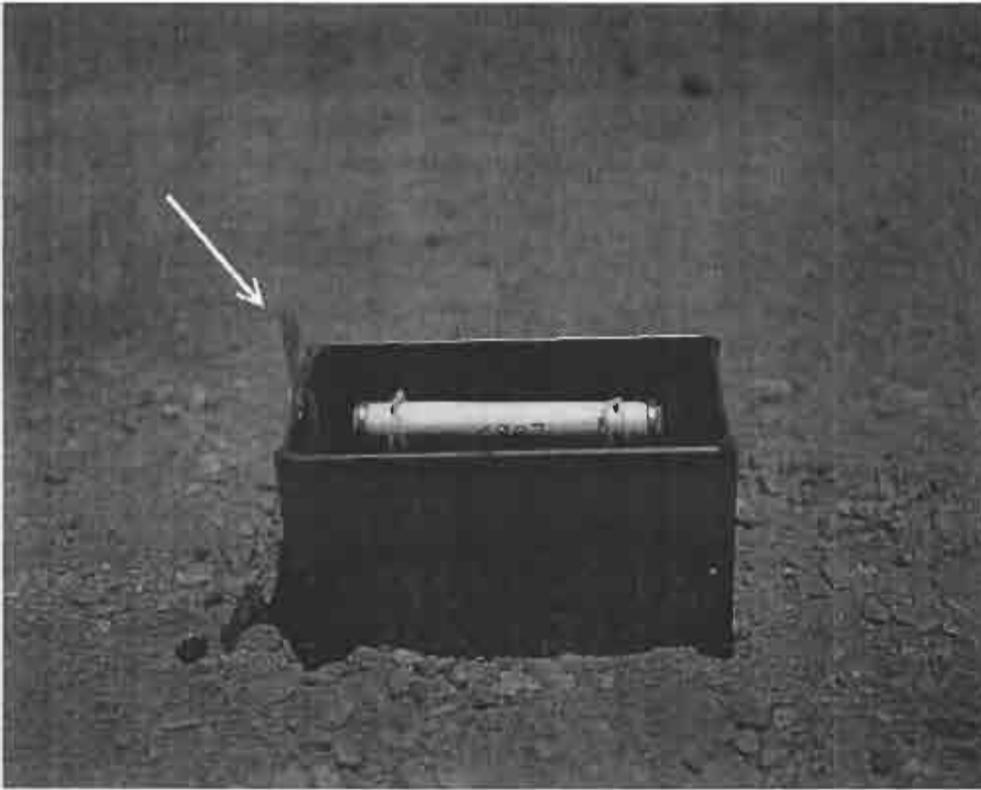
**Figure 6.8. Instrument Box with Turkey Tail Attached.**

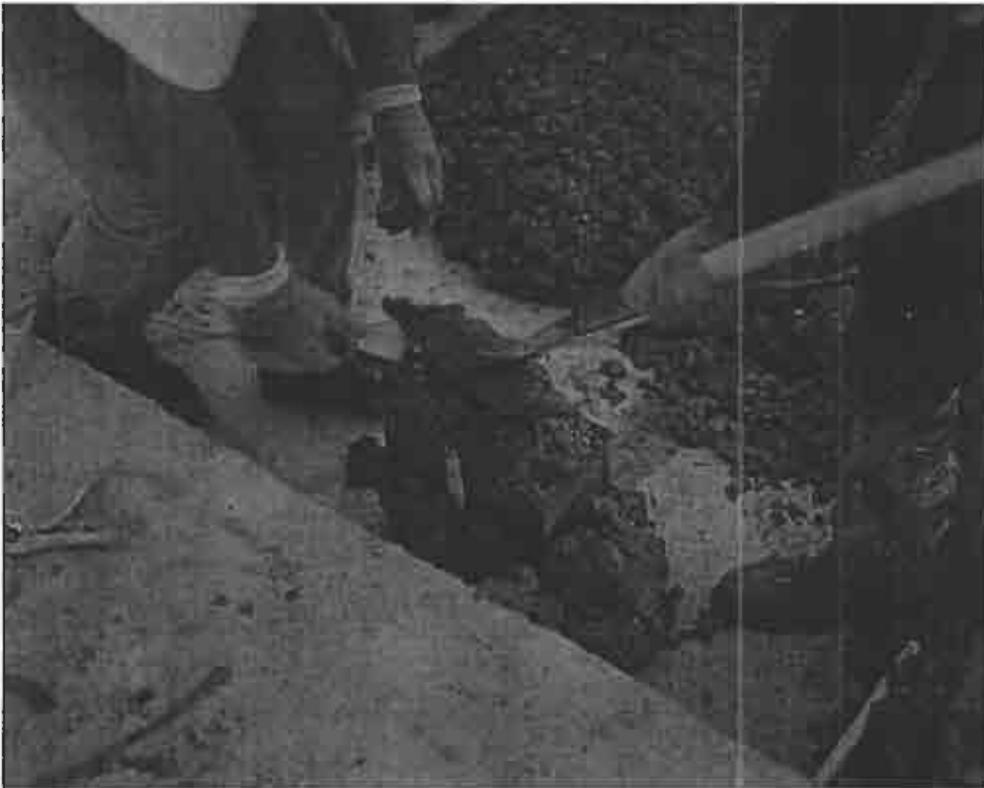
**Figure 6.9. Instrument Box Being Filled by Shovel, North Tangent.**

When the concrete neared one of the instruments in its box, UCB personnel shoveled concrete into the box, as shown in Figure 6.9. Coffman Specialties personnel consolidated the mix inside the sheet metal box by vibrating all four sides of the box, as shown in Figure 6.10. The Coffman Specialties crew then ran a screed over the concrete surface. Both the wire flags

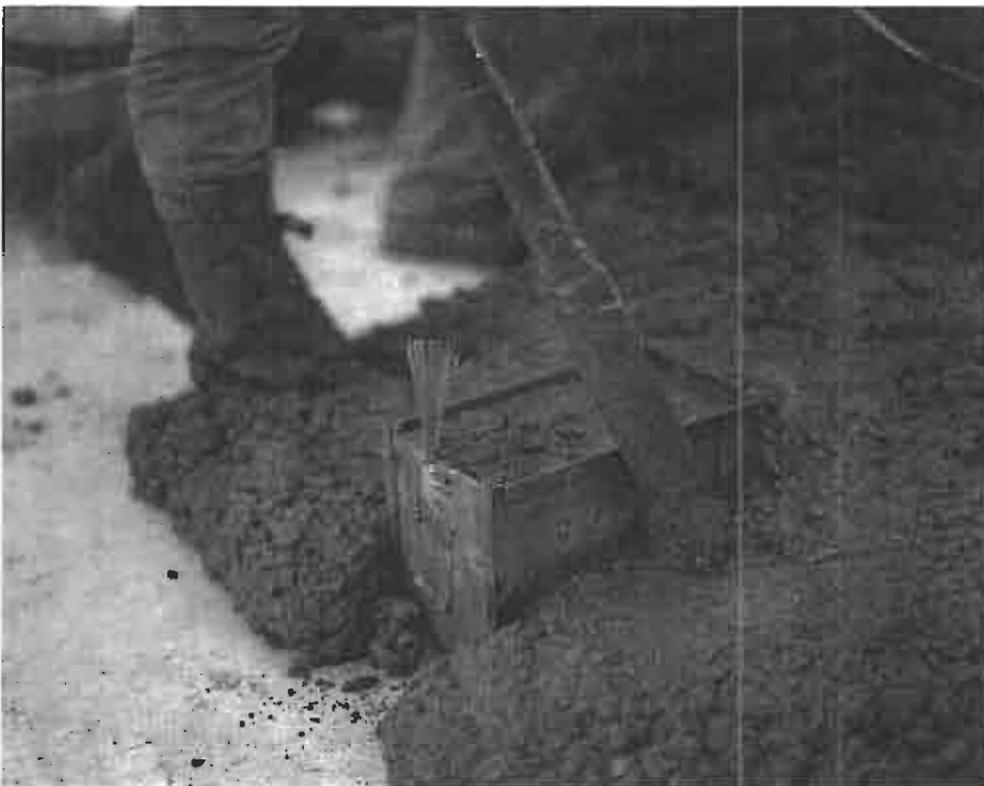
**Figure 6.10. Vibrator Being Applied to Instrument Box to Consolidate Concrete.**

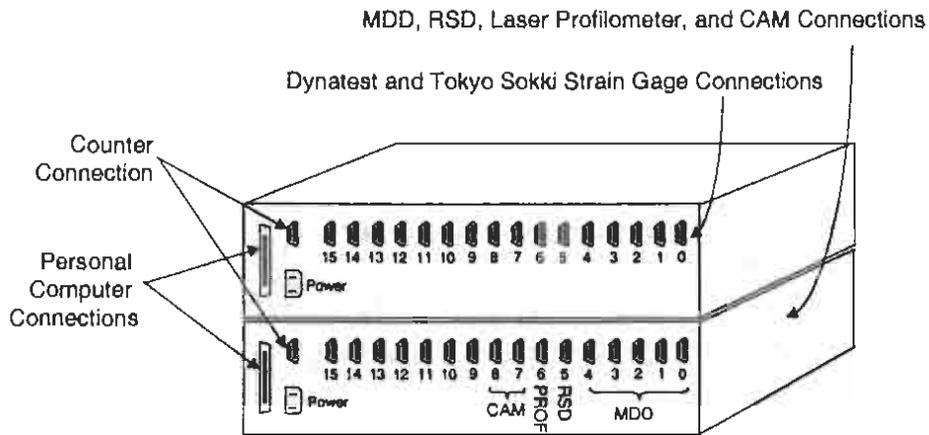
**Figure 6.12. HVS Data Acquisition System Schematic.**

The first data acquisition system and class of gages relies on the HVS data acquisition system built by CSIR. This system consists of a 16-channel analog to digital converter (A/D) board connected to a PC and two rack-mount housings containing signal conditioners. Each rack-

mount housing contains a series of signal conditioner modules specific to each particular instrument. Sixteen separate instruments can be connected at one time. However, data from only one single instrument or single group of MDDs (see Section 6) can be monitored at any given time.

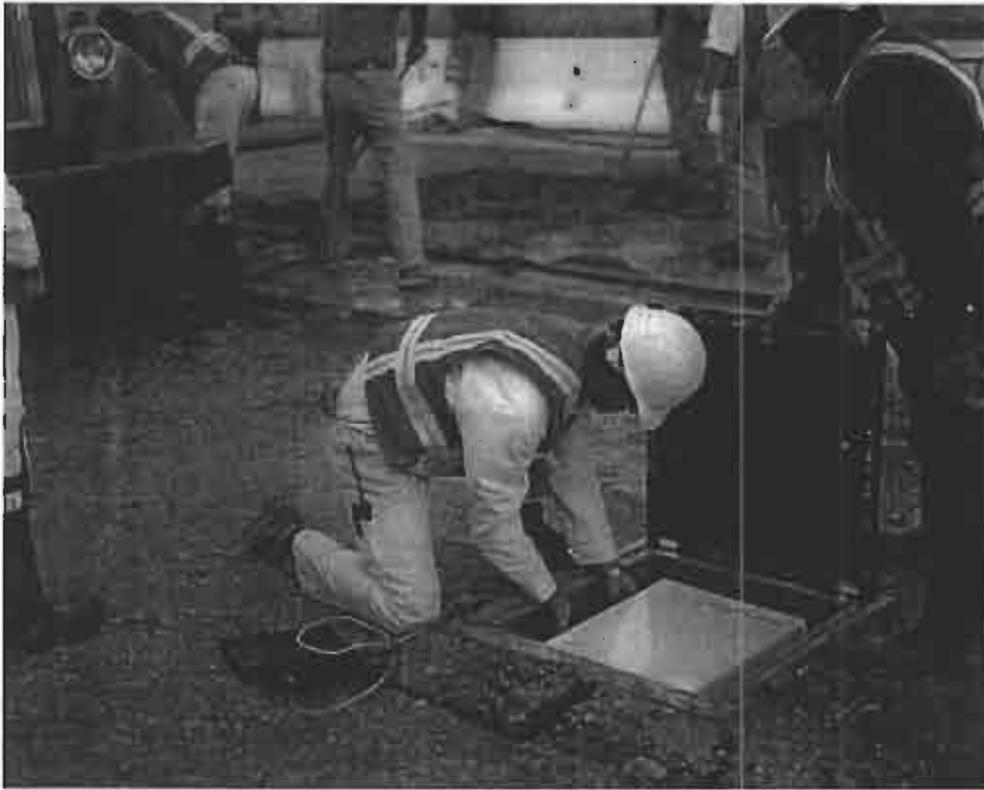
**Figure 6.14. CR10X Acquisition System Being Placed on North Tangent.**

The CR10X systems consist of a CR10X data logger, one AM 416 relay multiplexer, two AM 25 Thermocouple multiplexers, one ASTEC DC/DC converter, one external 12 volt power supply, three signal conditioners, and an alkaline battery pack, all of which are enclosed in a fiberglass box. The system is used to continuously monitor and record data from thermocouples, LVDTs, MDDs, and environmental strain gages embedded in the test sections. The stored data can then be downloaded to a PC. Figure 6.14 shows the CR10X. The following sections detail all instrumentation placed during Palmdale construction.

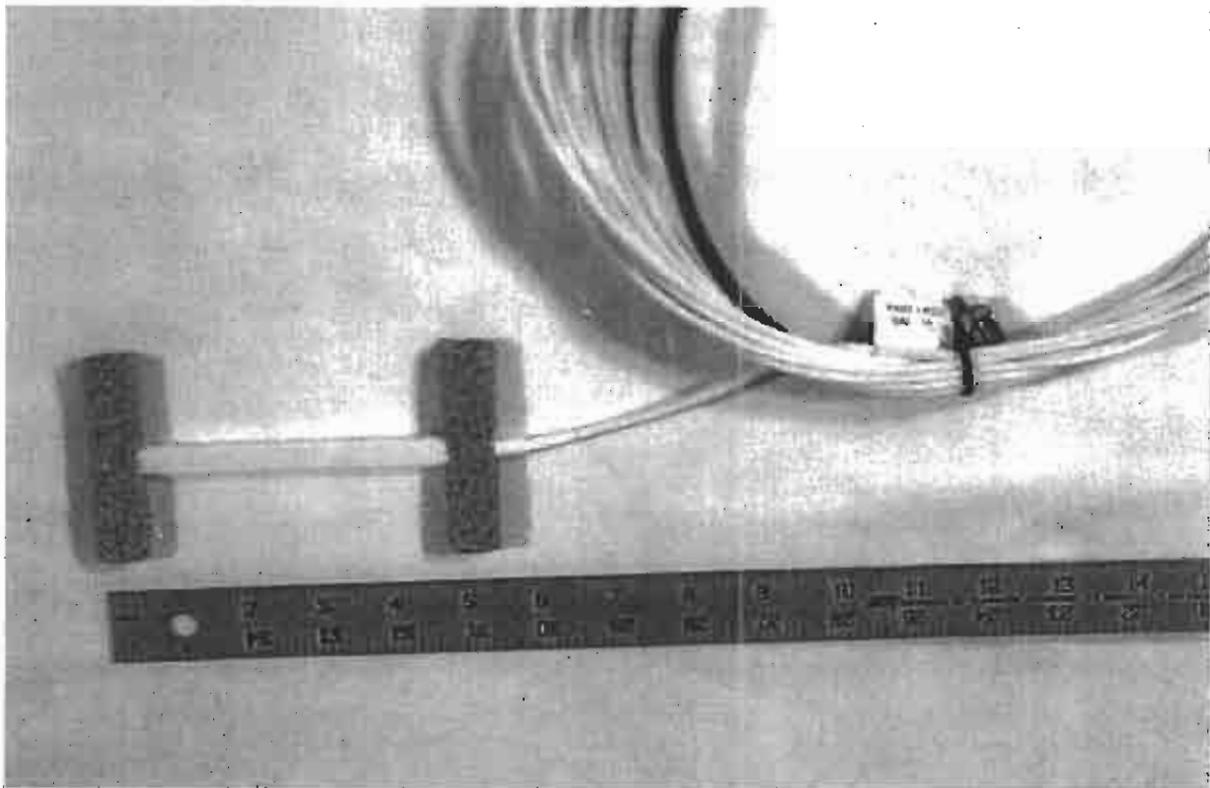
Figure 6.16. Dynatest PAST-2PCC Strain Gage.

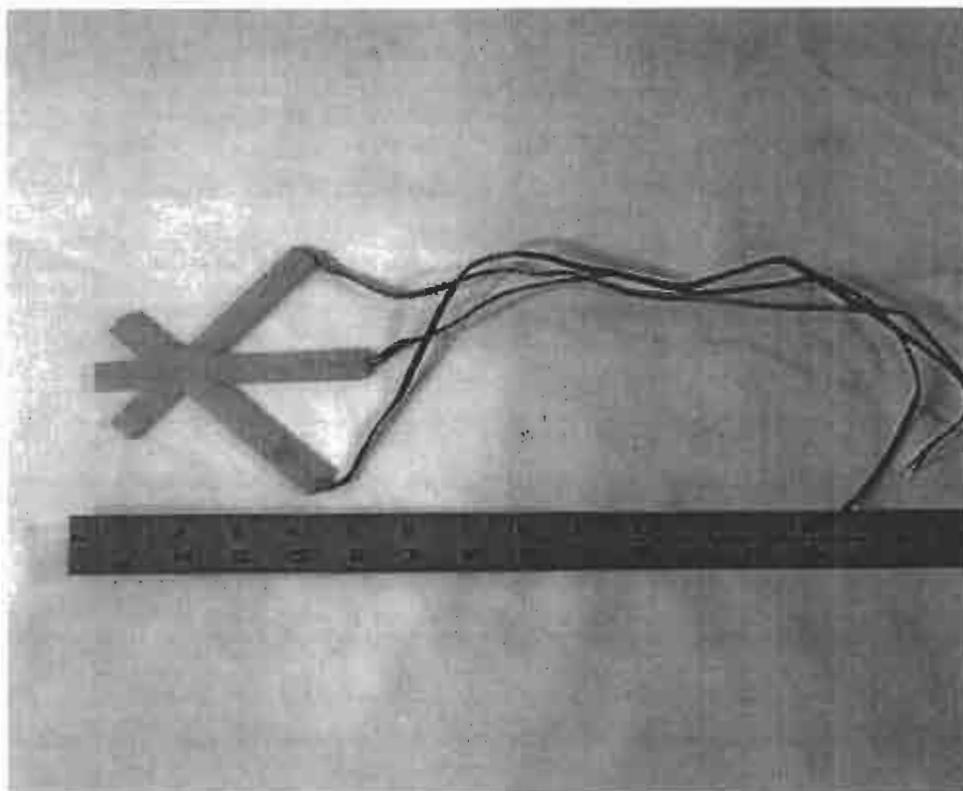
**Figure 6.17. Tokyo-Sokki PMR-60-6L Strain Gage.**

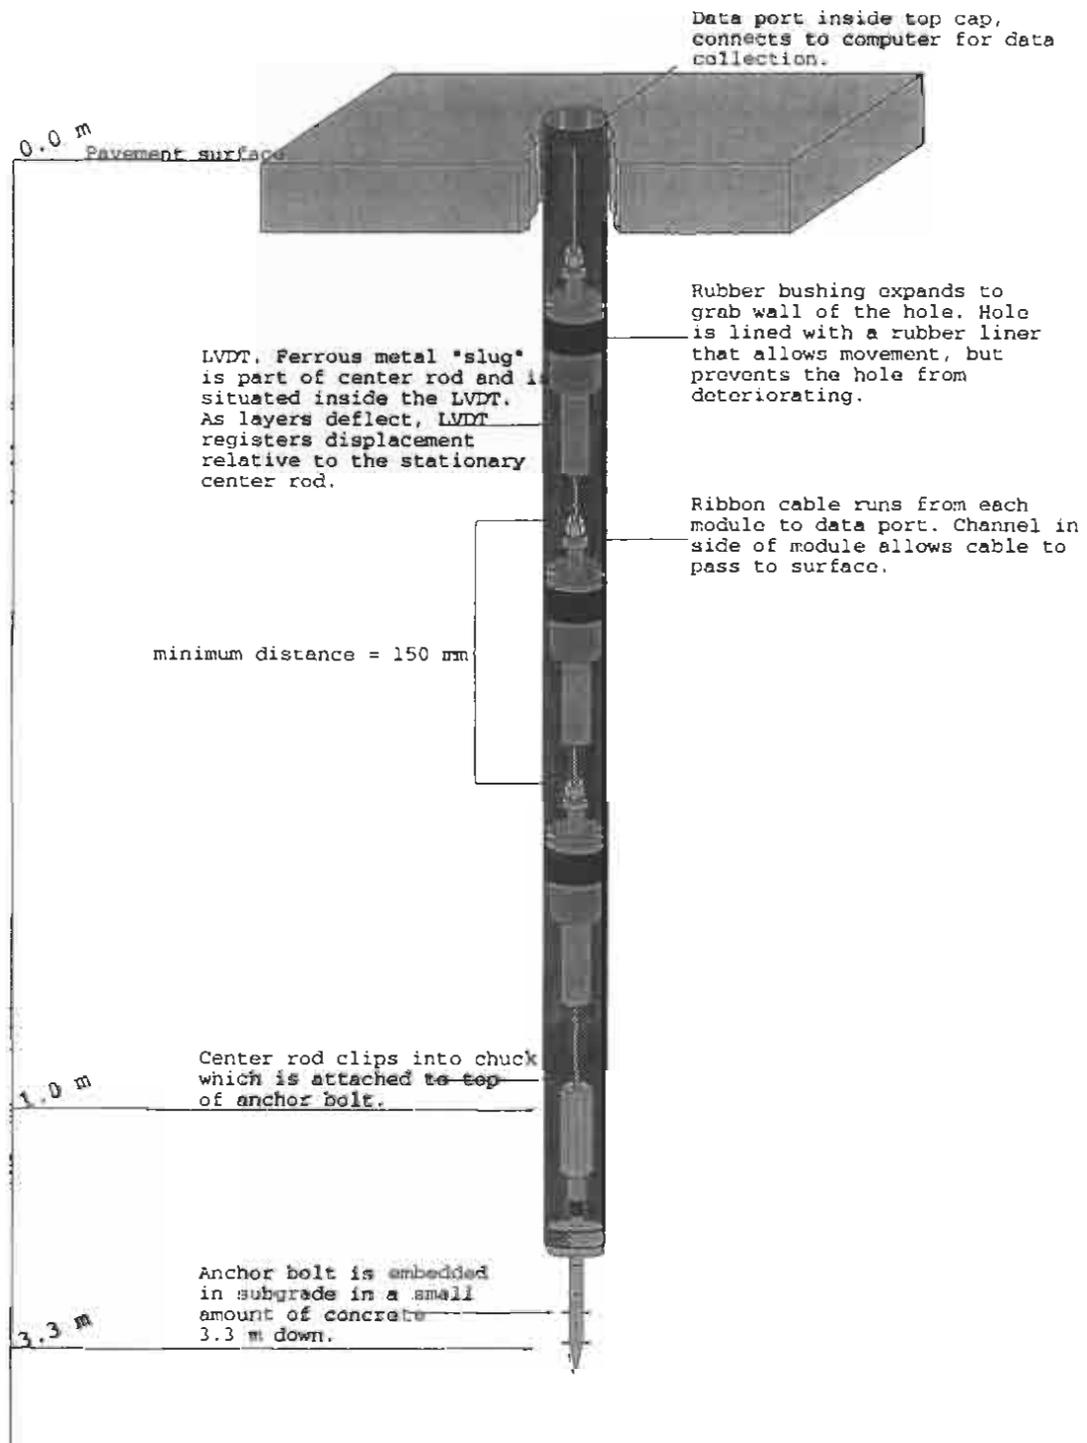
Figure 6.18. Schematic of Multi-Depth Deflectometer (MDD) Array.

The MDDs sites in the South Tangent have three modules installed. The South Tangent MDDs were installed in July and August of 1998. On section 5C, one of the MDD modules is being monitored by the CR10X until HVS trafficking begins on that section. When the HVS is placed on the sections with MDDs, they will be connected to the HVS data acquisition system to monitor pavement deflection under dynamic loading. Appendix A show the MDD locations of the six MDDs on the South Tangent.

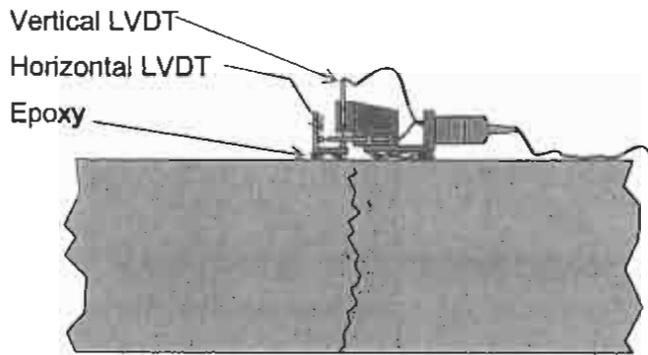
**Figure 6.19. Diagram of Crack Activity Meter (CAM) on Cross-section of Pavement.**

The Crack Activity Meter, manufactured by the Council for Scientific and Industrial Research (CSIR), is used to measure the horizontal and vertical displacement of cracks during dynamic loading. The device consists of two Linear Variable Differential Transformers (LVDT), one oriented horizontally and one oriented vertically, as illustrated in Figures 6.19 and 6.20. CAMs will be placed over joints on HVS loaded sections to measure the relative displacement between two adjacent slabs. The CAM data will be used for determination of the load transfer capacity between two slabs.

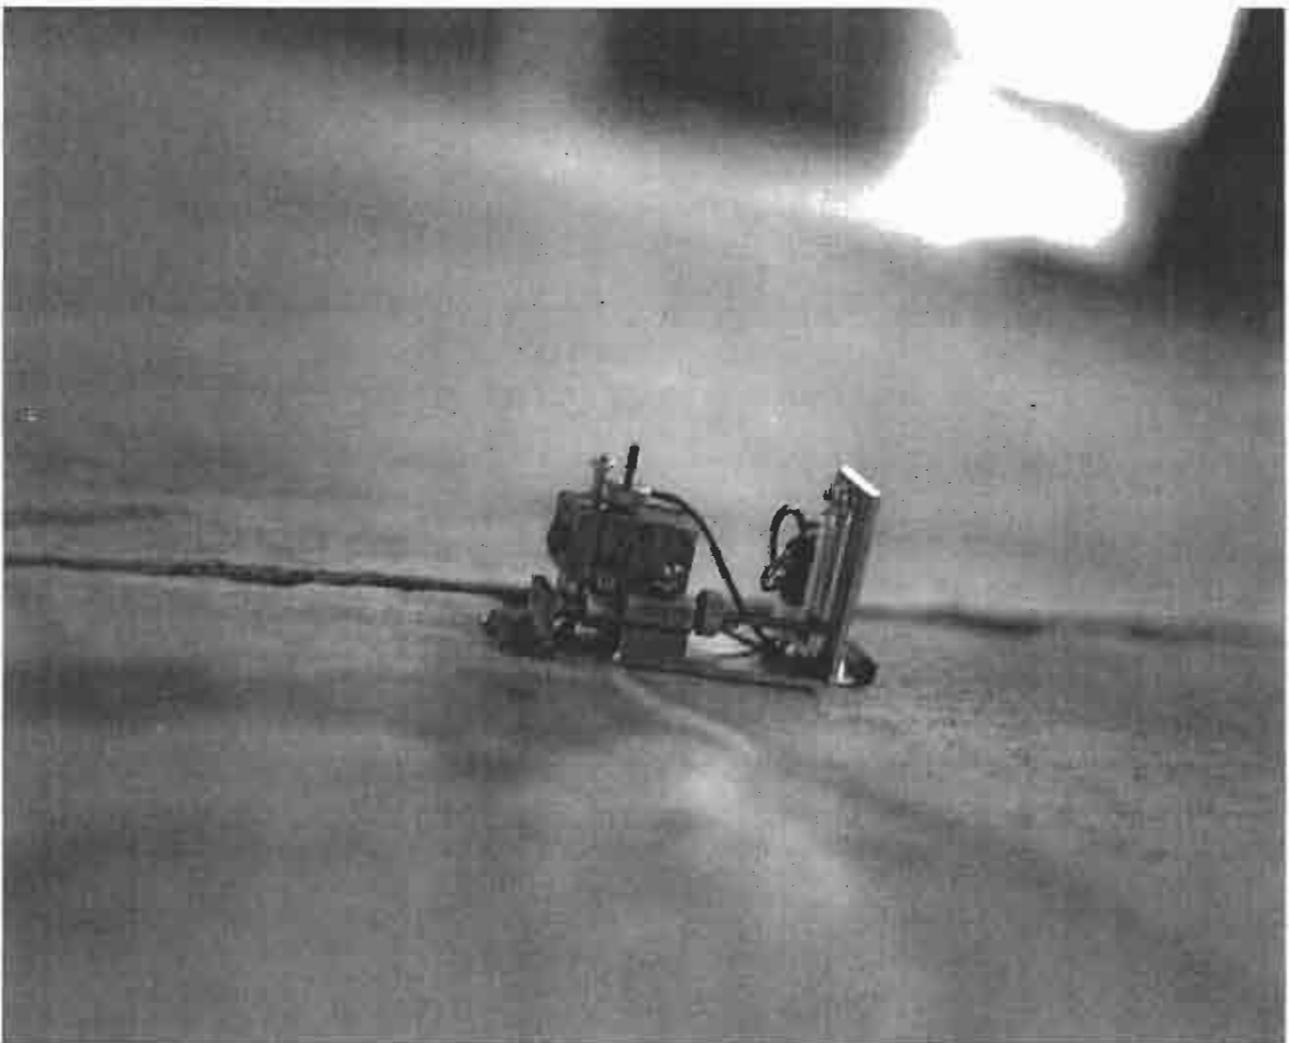
**Figure 6.20. Crack Activity Meter (CAM) in Typical Position over a Crack.**

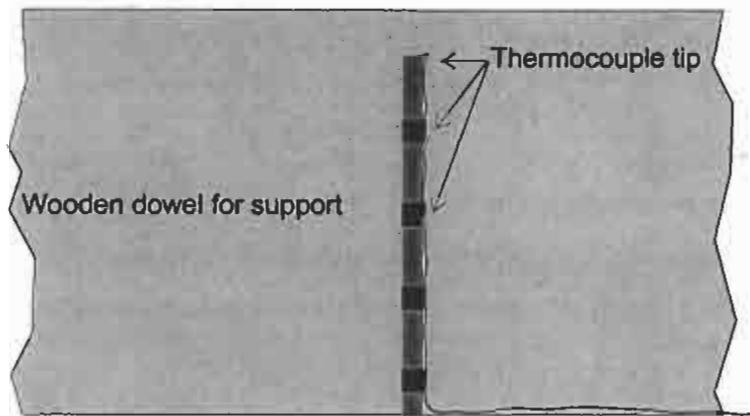
**Figure 6.21. Diagram of Thermocouple as Oriented in Cross-section of Pavement.**

The thermocouples used were assembled by the UCB Pavement Research Center. Type K (nickel-chromium and nickel-aluminum leads) and Number 24 American Wire Gage thermocouple wires were used. The thermocouple wires are manufactured by Omega

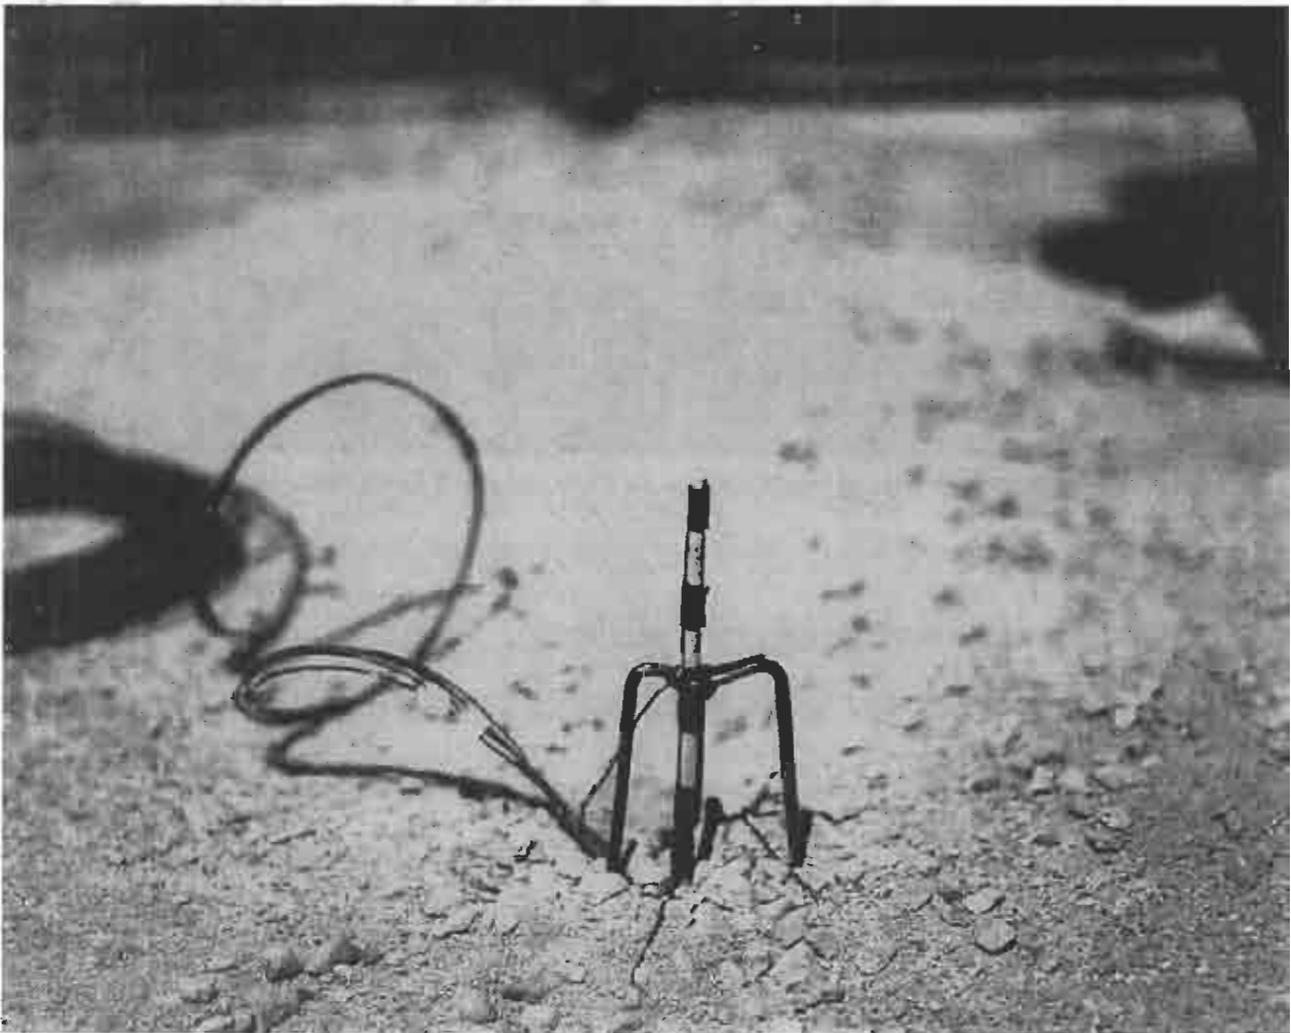
**Figure 6.22. Thermocouple prior to Placement of Concrete, South Tangent.**

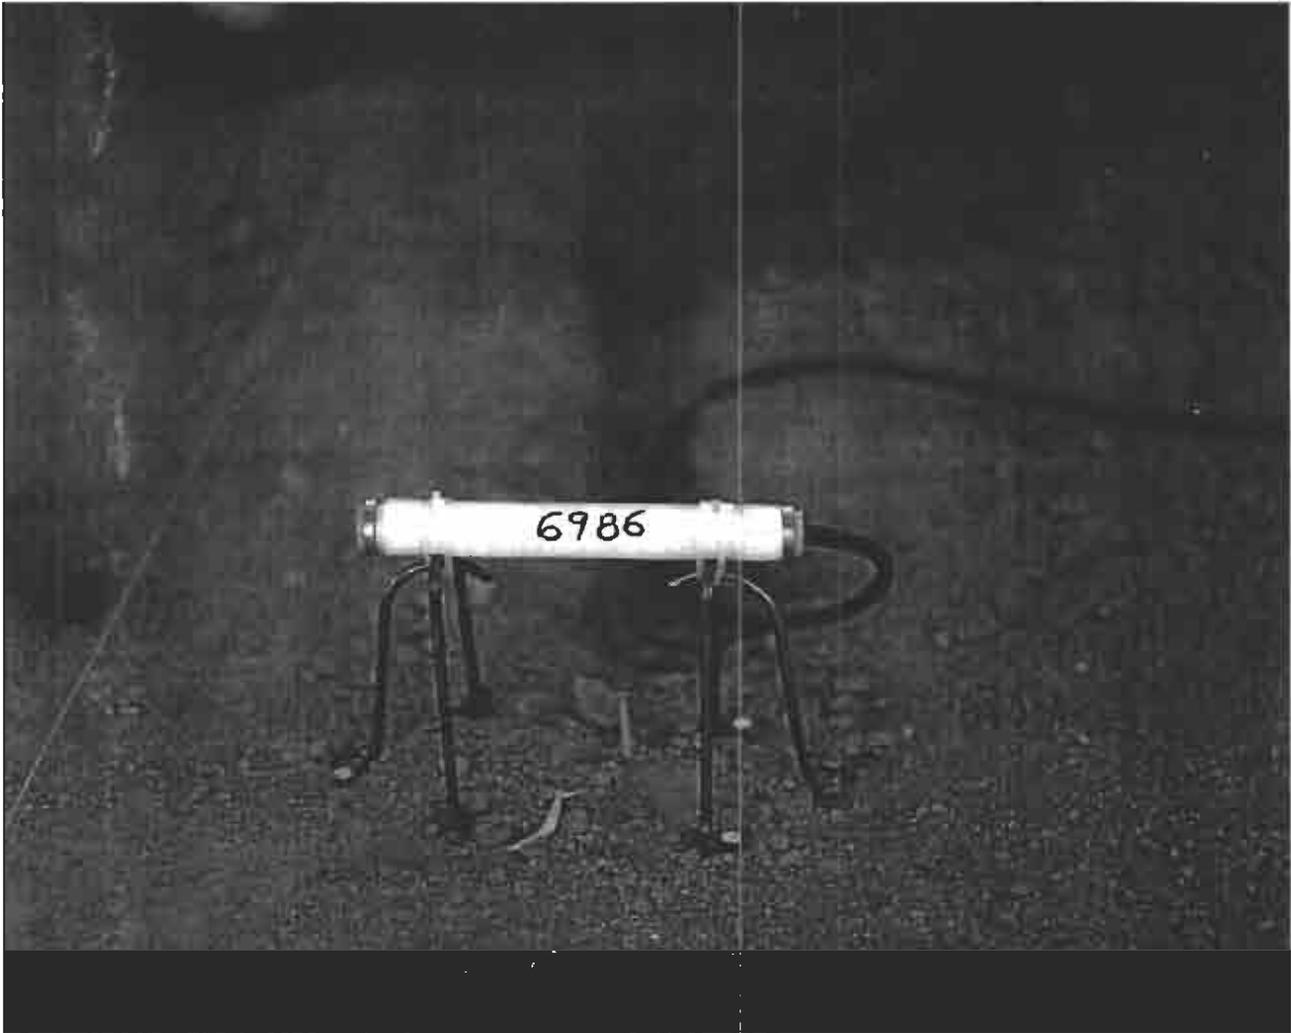
**Figure 6.23. Carlson A-8 Strain Meter prior to Placement of Concrete, South Tangent.**

The environmental strain gages used were the Carlson A-8 strain meter, manufactured by RST Instruments, Inc. Shown in Figures 6.15 and 6.23, the instrument is tubular in construction and contains two coils of highly elastic steel wire. One coil increases in length and electrical resistance when strained, while the other decreases in length when unloaded or compressed. The gages were placed in the concrete pavement at various critical locations near the surface and bottom of the pavement to measure strains caused by length changes in the pavement due to thermal changes and curing. The Carlson A-8 gages are monitored continuously by the online data acquisition system. A total of 24 Carlson A-8 gages have been embedded in the Palmdale test sections. Appendix A shows the locations of the Carlson A-8 gages on the Palmdale test sections.

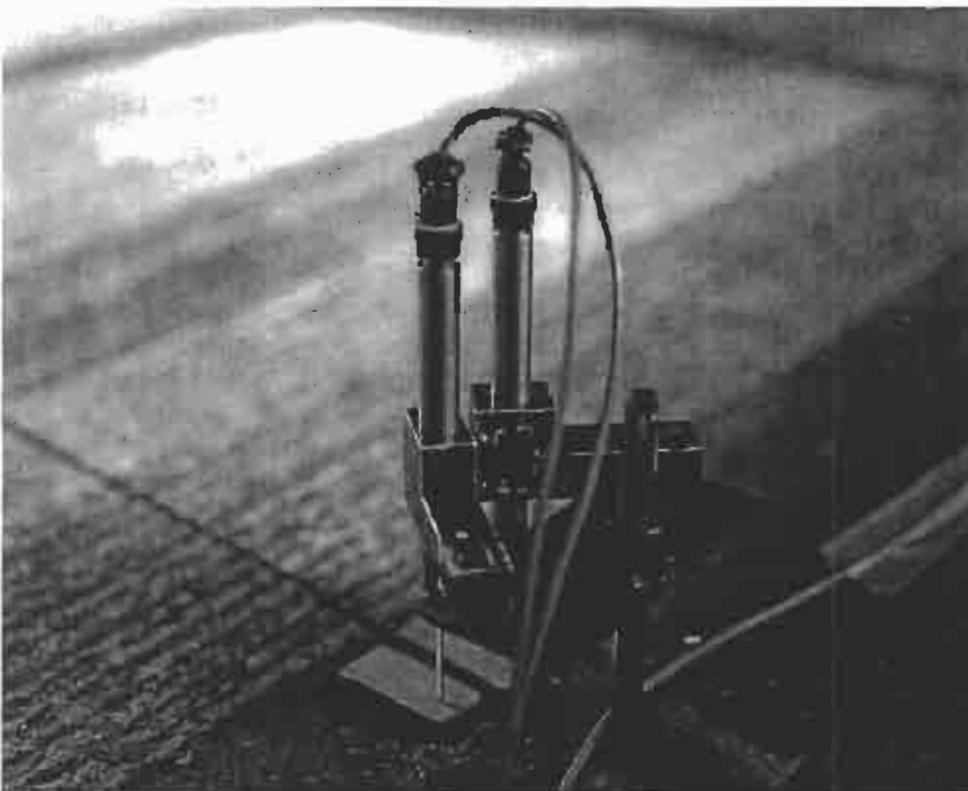
**Figure 6.24. Joint Displacement Measuring Device (JDMD) on South Tangent. (*Edge Displacement Measuring Device is essentially identical except that it is placed in the middle of the slab instead of at the joint.*)**

The JDMDs, manufactured by the UCB Pavement Research Center, are used to measure vertical and horizontal joint displacement under dynamic loads and temperature changes. For environmental changes, the JDMDs can be used in two separate configurations. The first device can measure the relative vertical and horizontal displacement across a joint. Each device consists of one Linear Variable Displacement Transducer (LVDT) for vertical displacement and one LVDT for horizontal displacement, as shown in Figure 6.24. Section 7C on the North Tangent

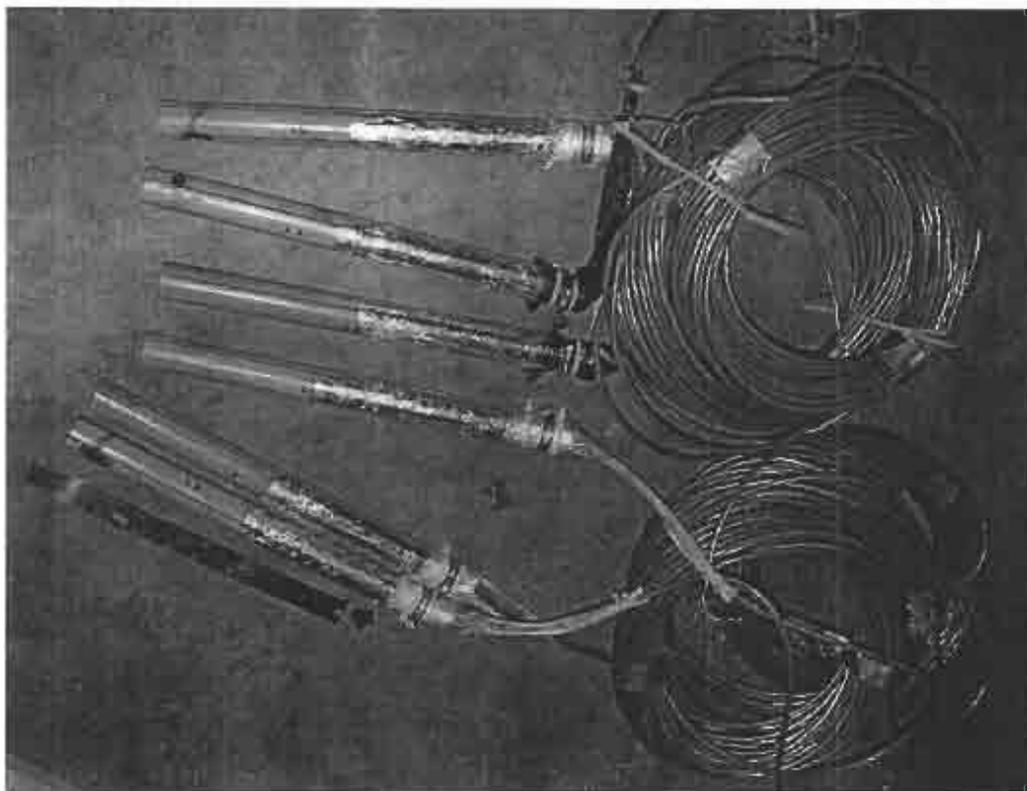
Figure 6.25. Individual Instrumented Dowel Bars Prior to being Welded to Dowel Bar Cage.

The instrumented dowels are 38 mm diameter by 450 mm long steel bars, spot welded to a frame to ensure the dowels were oriented properly in the slab. The dowels were spaced 300 mm center to center and 150 mm from the slab edge. Each instrumented dowel had two axial strain gages to measure bending strain and one strain gage rosette to measure bending and shear strain. Figure 6.25 shows the placement of the strain gages on the individual dowels prior to welding them into the dowel frame. Figures 6.26 and 6.27 show which dowels have strain gages

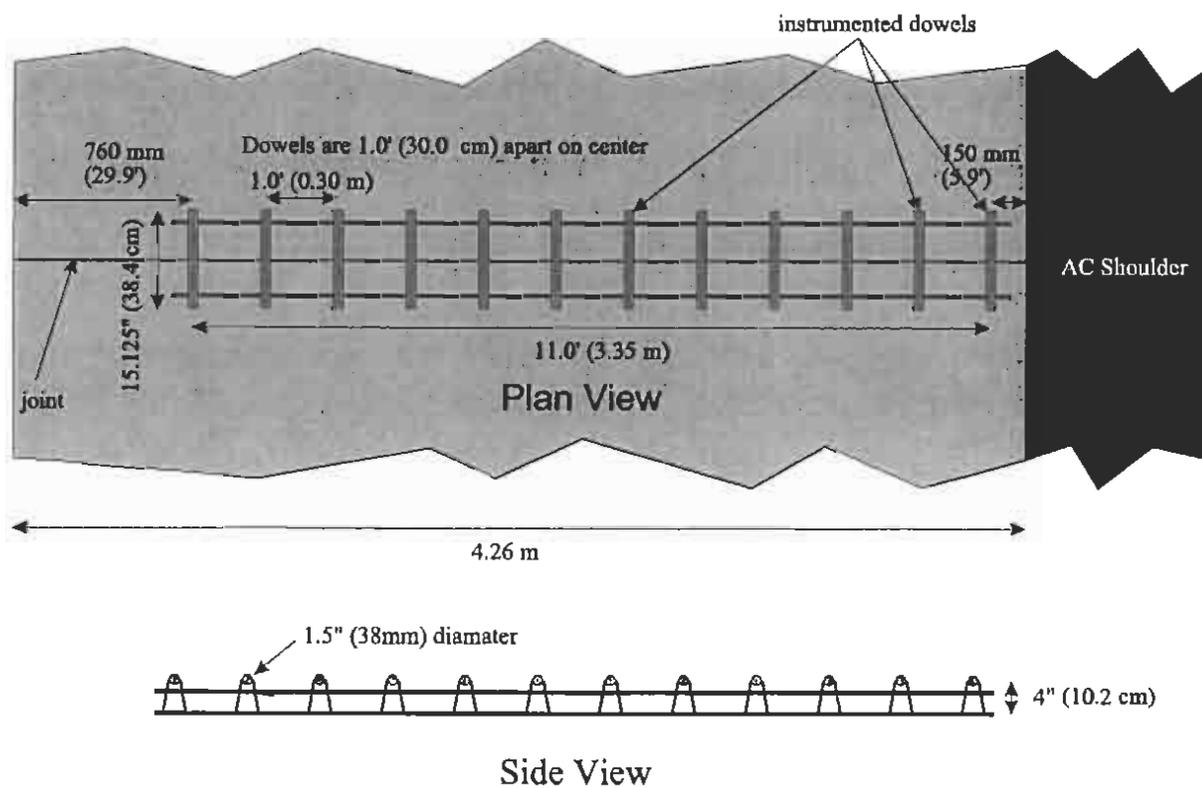
Figure 6.26. Instrumented Dowel Locations and Orientation at Joint 7, North Tangent.
