Construction, Instrumentation, and Testing of Fast-Setting Hydraulic Cement Concrete in Palmdale, California

**Construction, Instrumentation, and Testing of Fast-Setting  
Hydraulic Cement Concrete in Palmdale, California**

Pavement Research Center  
Institute of Transportation Studies  
University of California Berkeley

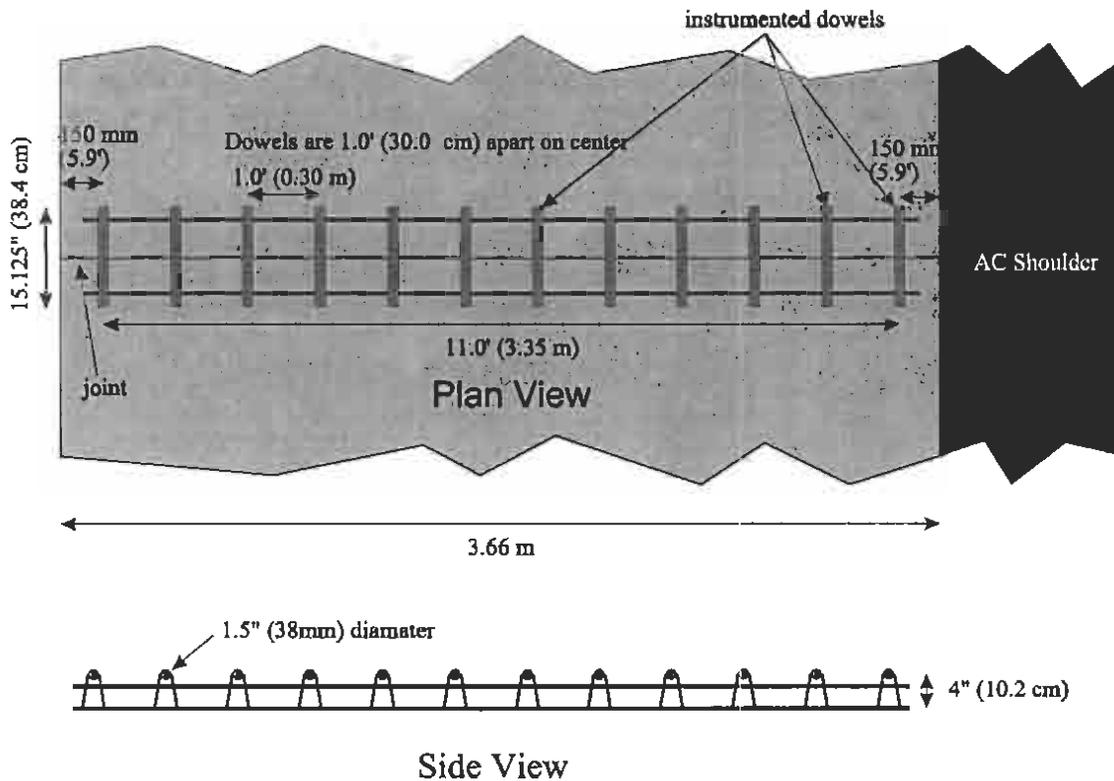
**Figure 6.27. Instrumented Dowel Locations and Orientation at Joint 20, North Tangent.**

The instrumented dowels are 38 mm diameter by 450 mm long steel bars, spot welded to a frame to ensure the dowels were oriented properly in the slab. The dowels were spaced 300 mm center to center and 150 mm from the slab edge. Each instrumented dowel had two axial strain gages to measure bending strain and one strain gage rosette to measure bending and shear strain. Figure 6.25 shows the placement of the strain gages on the individual dowels prior to welding them into the dowel frame. Figures 6.26 and 6.27 show which dowels have strain gages

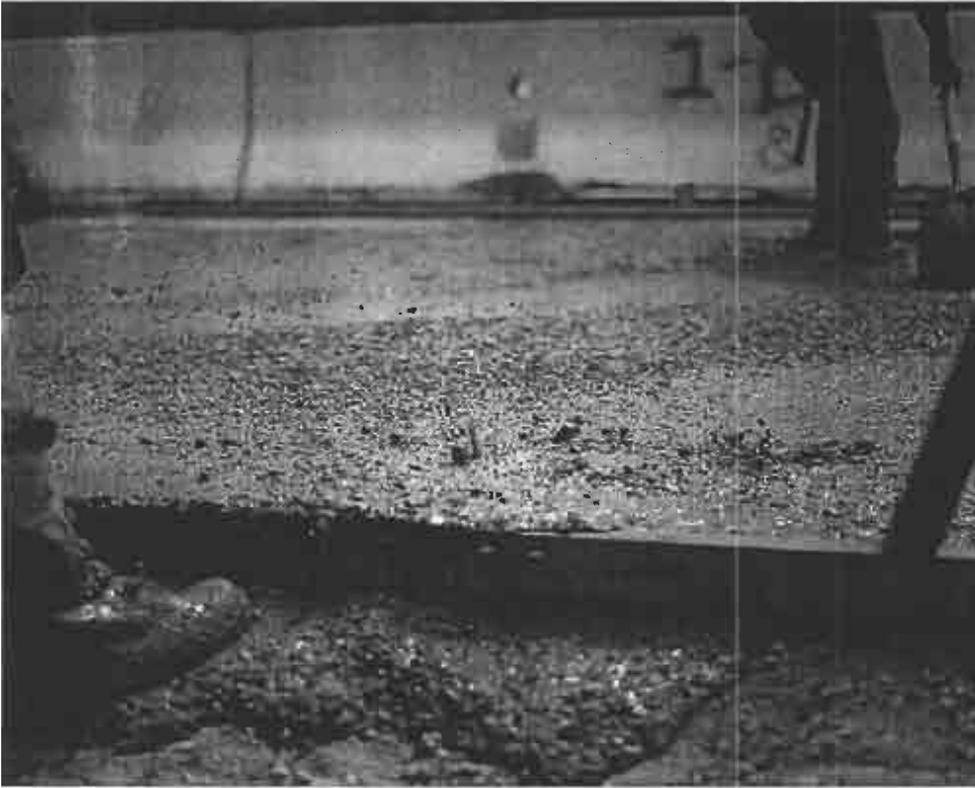
**Figure 8.1. Wet Mix with Bleed Water on South Tangent.**

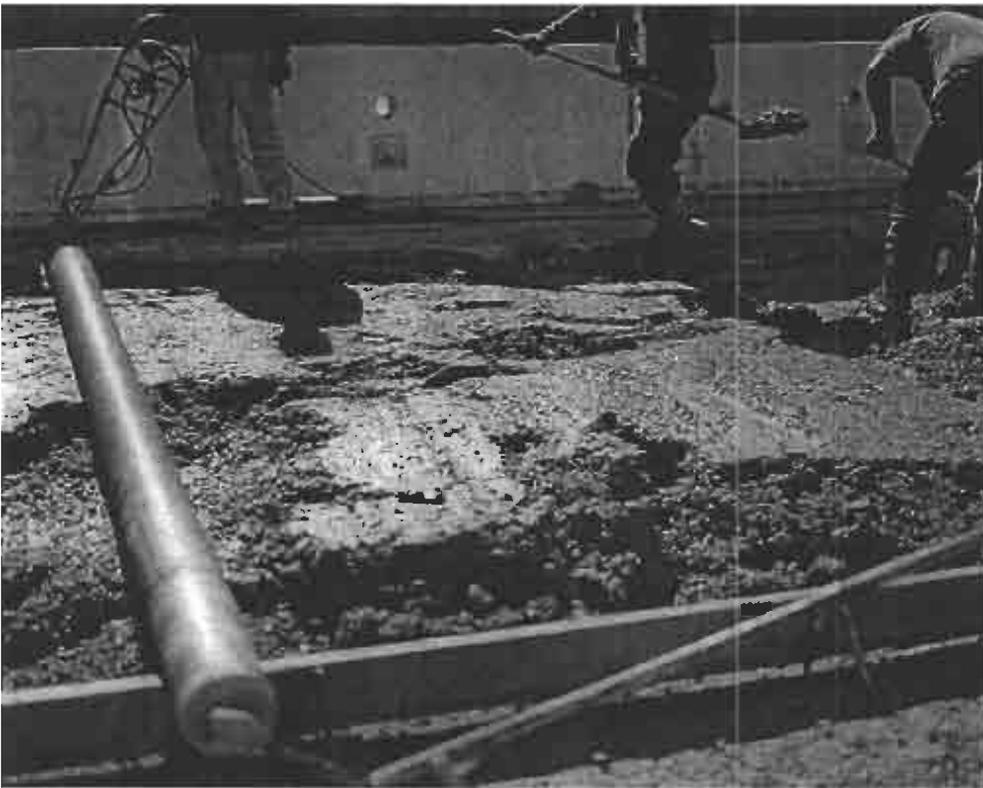
**Figure 8.2. Unworkable Mix on South Tangent.**

The rate of slump loss was also very high. It was frequently observed that a good consistency mix would be coming out of the chute and then within a couple of minutes it began to become difficult to offload from the truck. When this condition occurred, the contractor would add water to the drum to increase workability and help remove the FSHCC from the drum. This resulted in mixes with higher than targeted water-to-cement ratios, as seen in Tables 4.3 and 4.4 in Section 4.3.

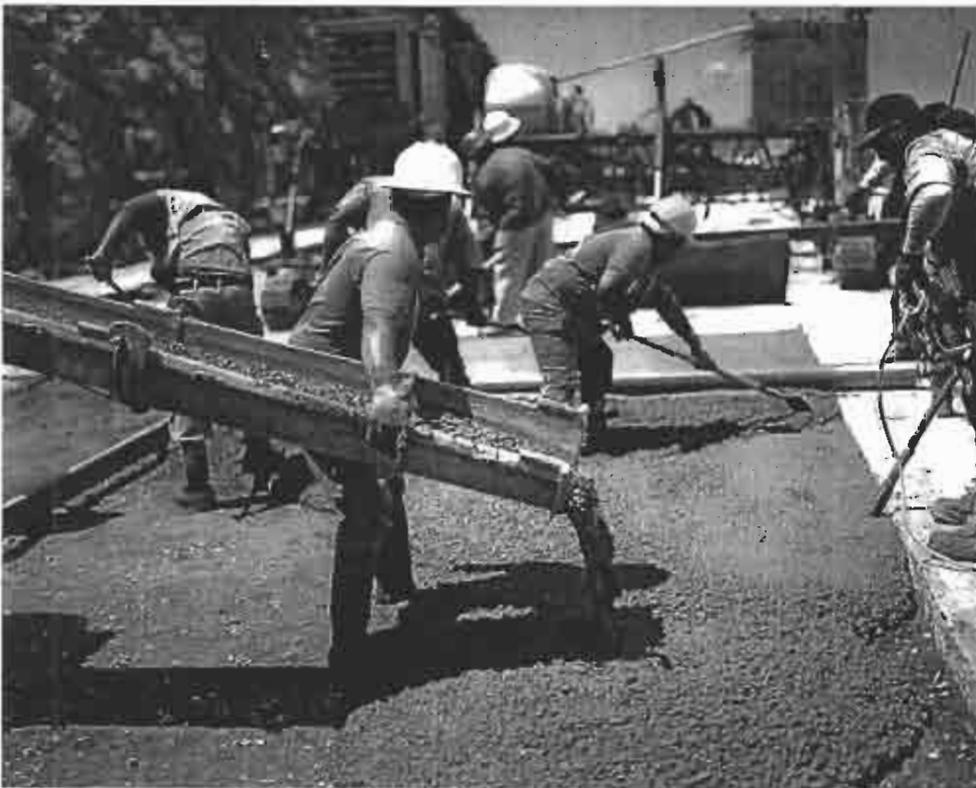
**Figure 8.4. Good Mix Quality and Finish, South Tangent.**

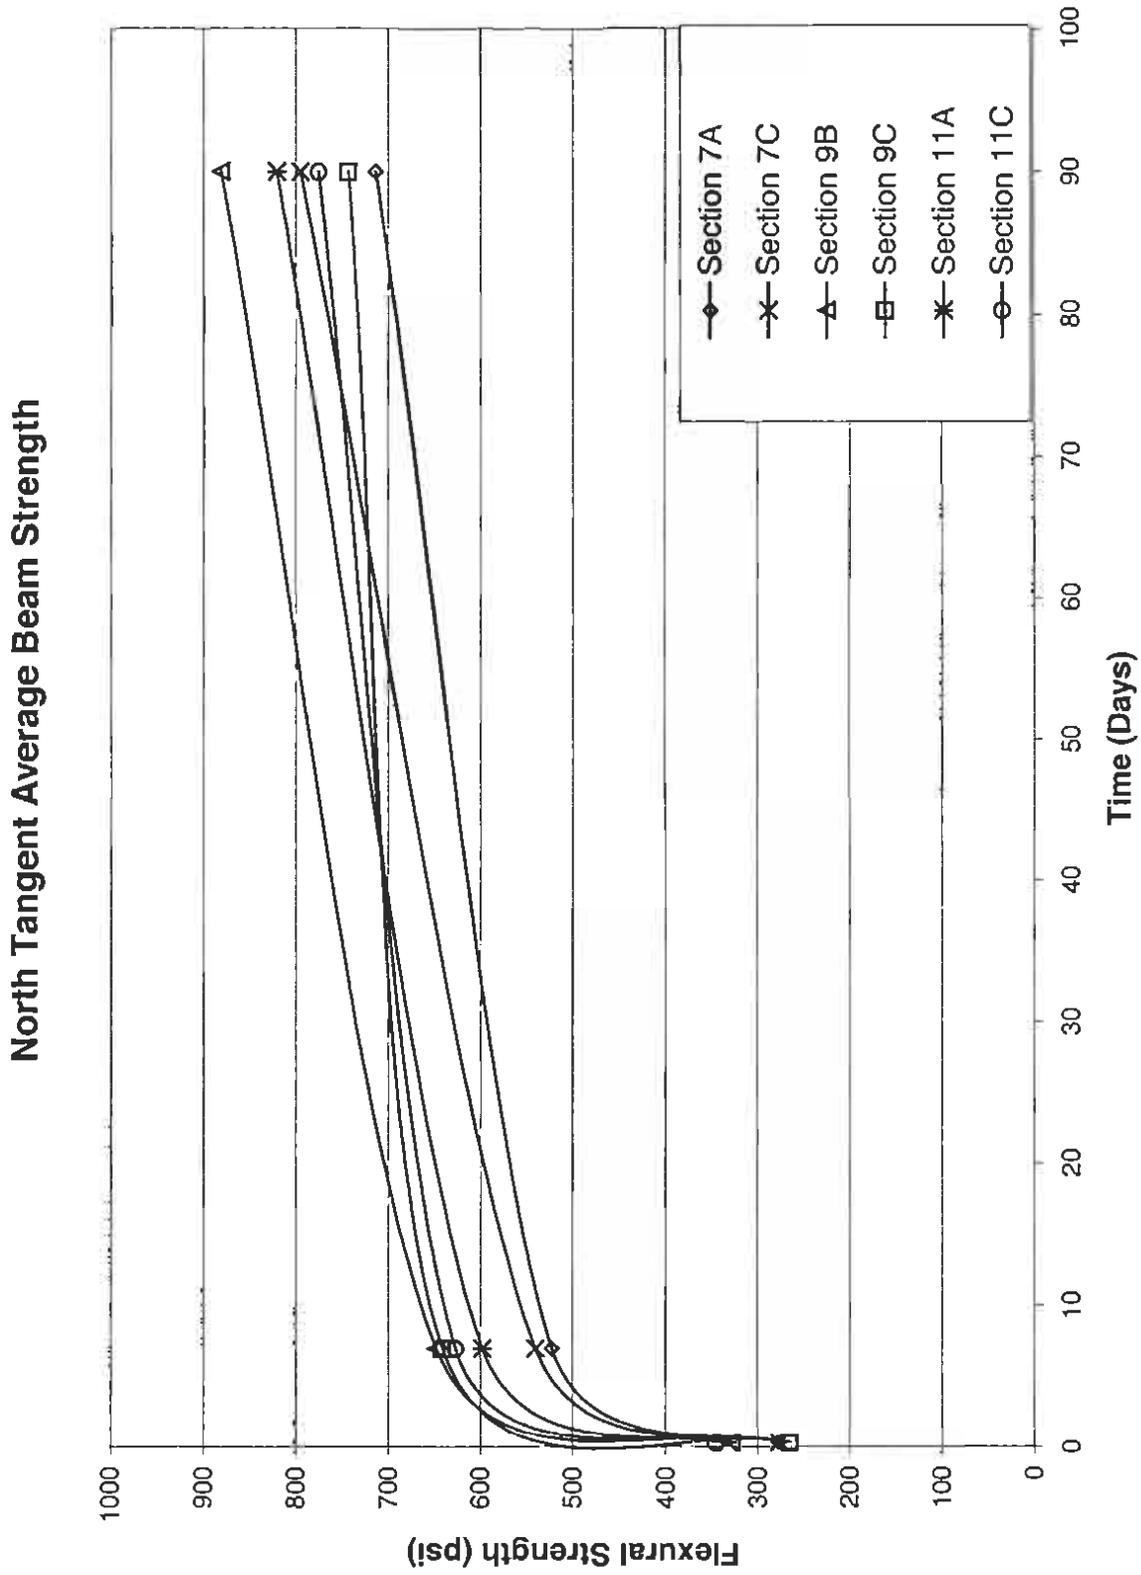
Figure 9.1. Average Beam Flexural Strength, North Tangent

Tables 9.6, 9.1, and 9.2 demonstrate that no section met the 8-hour specification of 400 psi (2.76 MPa) flexural strength and only half of the sections met the 7-day specification of 600 psi (4.14 MPa) flexural strength. This is assuming Caltrans center-point testing and ASTM third-

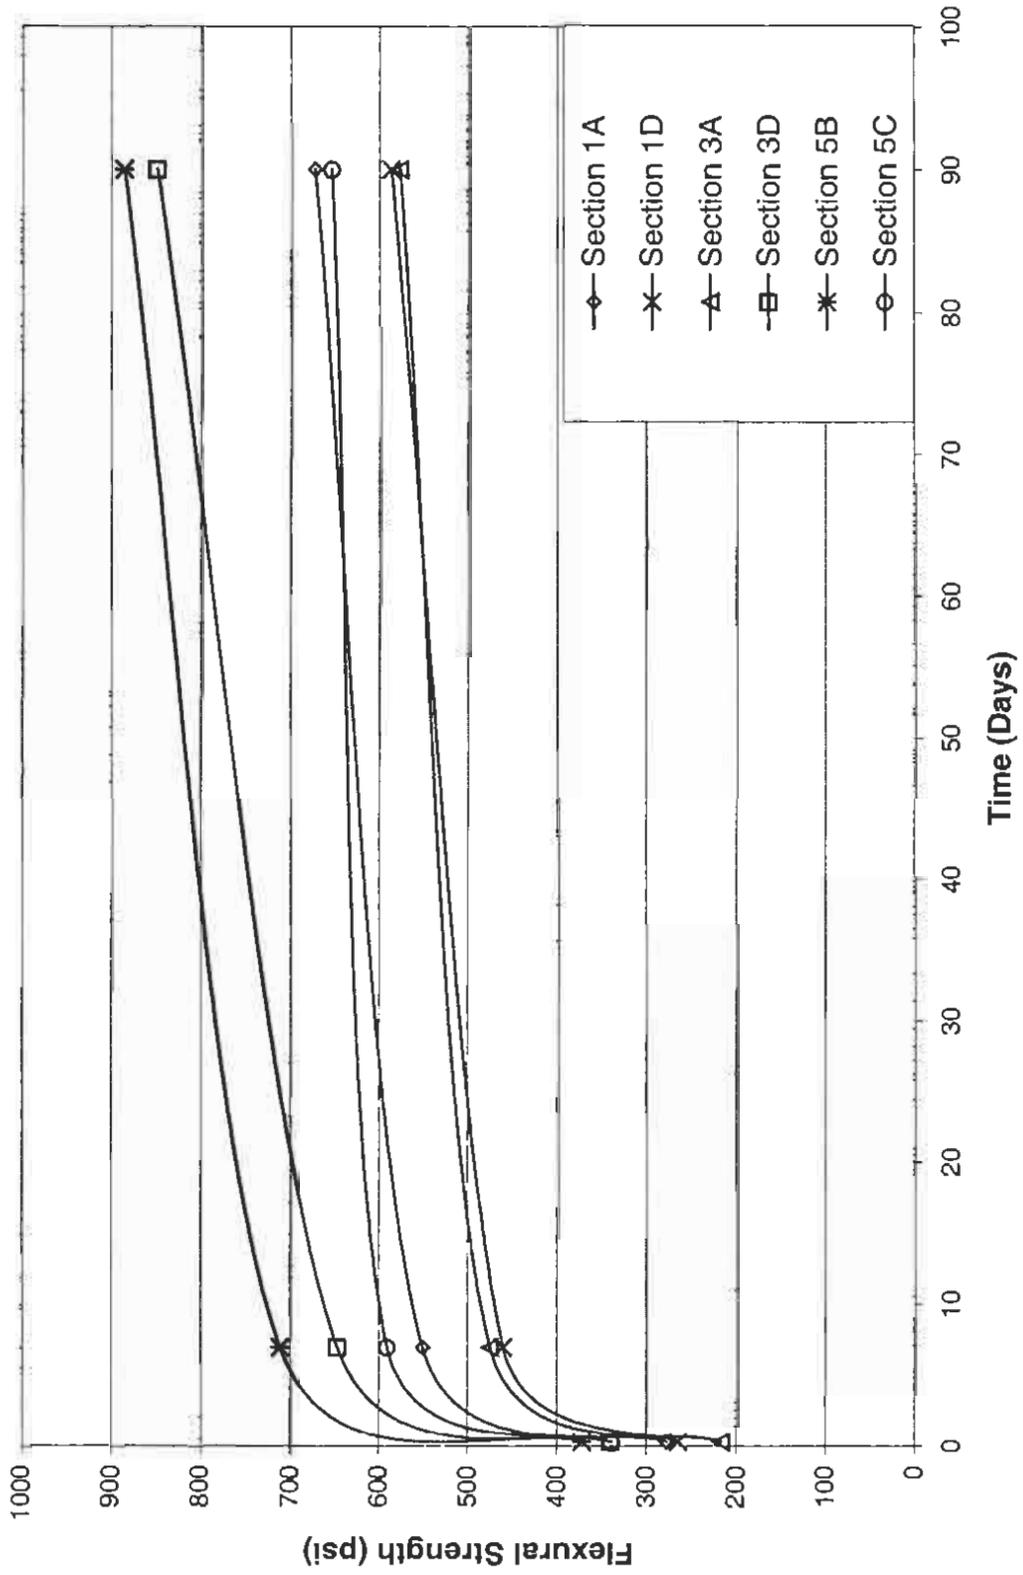
Figure 9.2. Average Beam Flexural Strength, South Tangent.

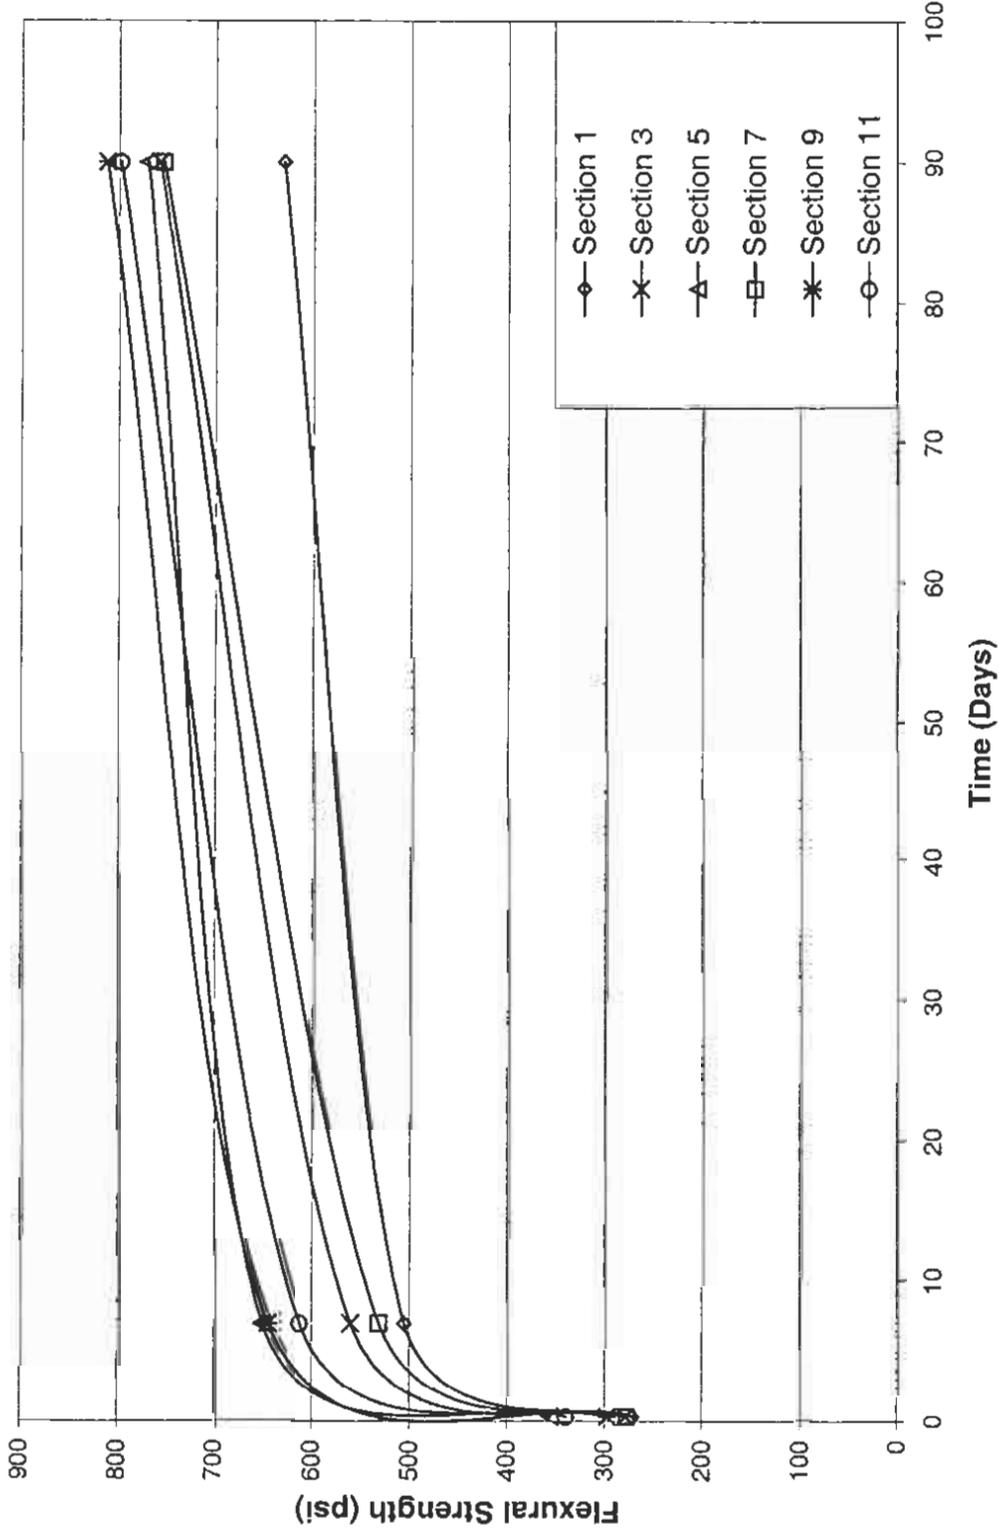
Figure 9.3. Average Beam Strength Gain for Palmdale Test Sections.

Figure 9.3 shows the average beam strength gain for each Palmdale test section. This plot demonstrates again the variability in strength found between test sections. It also shows that the strength gain rate after 7 days is similar for all mixes.

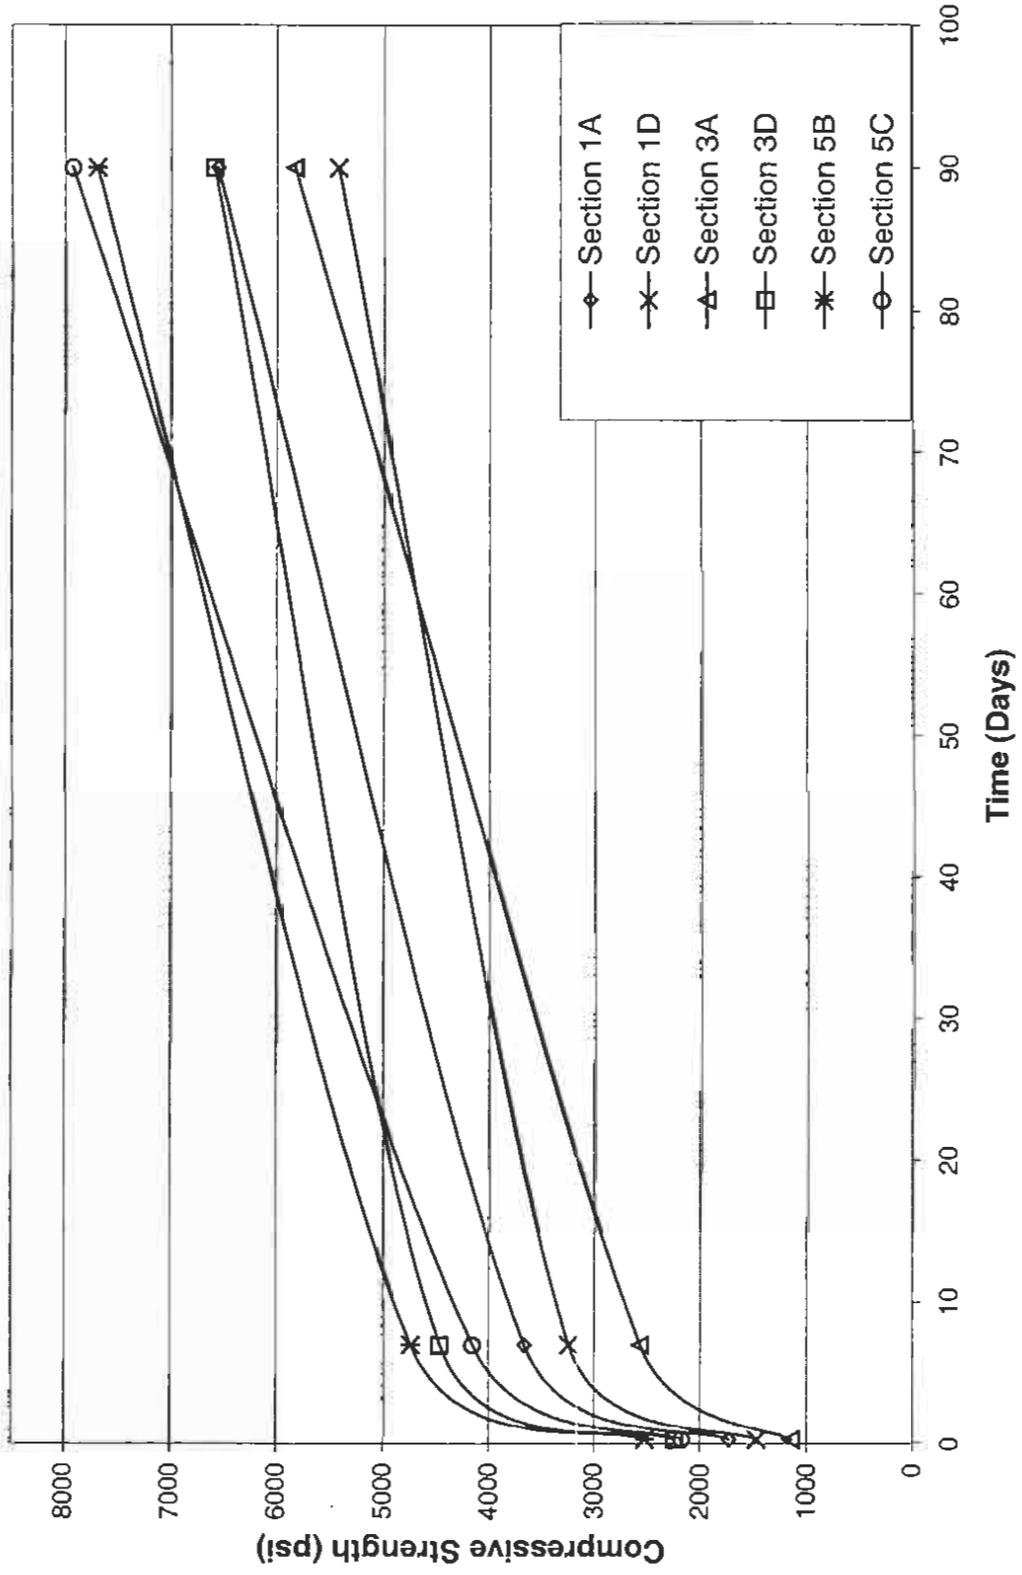
Figure 9.4. Average Cylinder Compressive Strength versus Time (South Tangent).

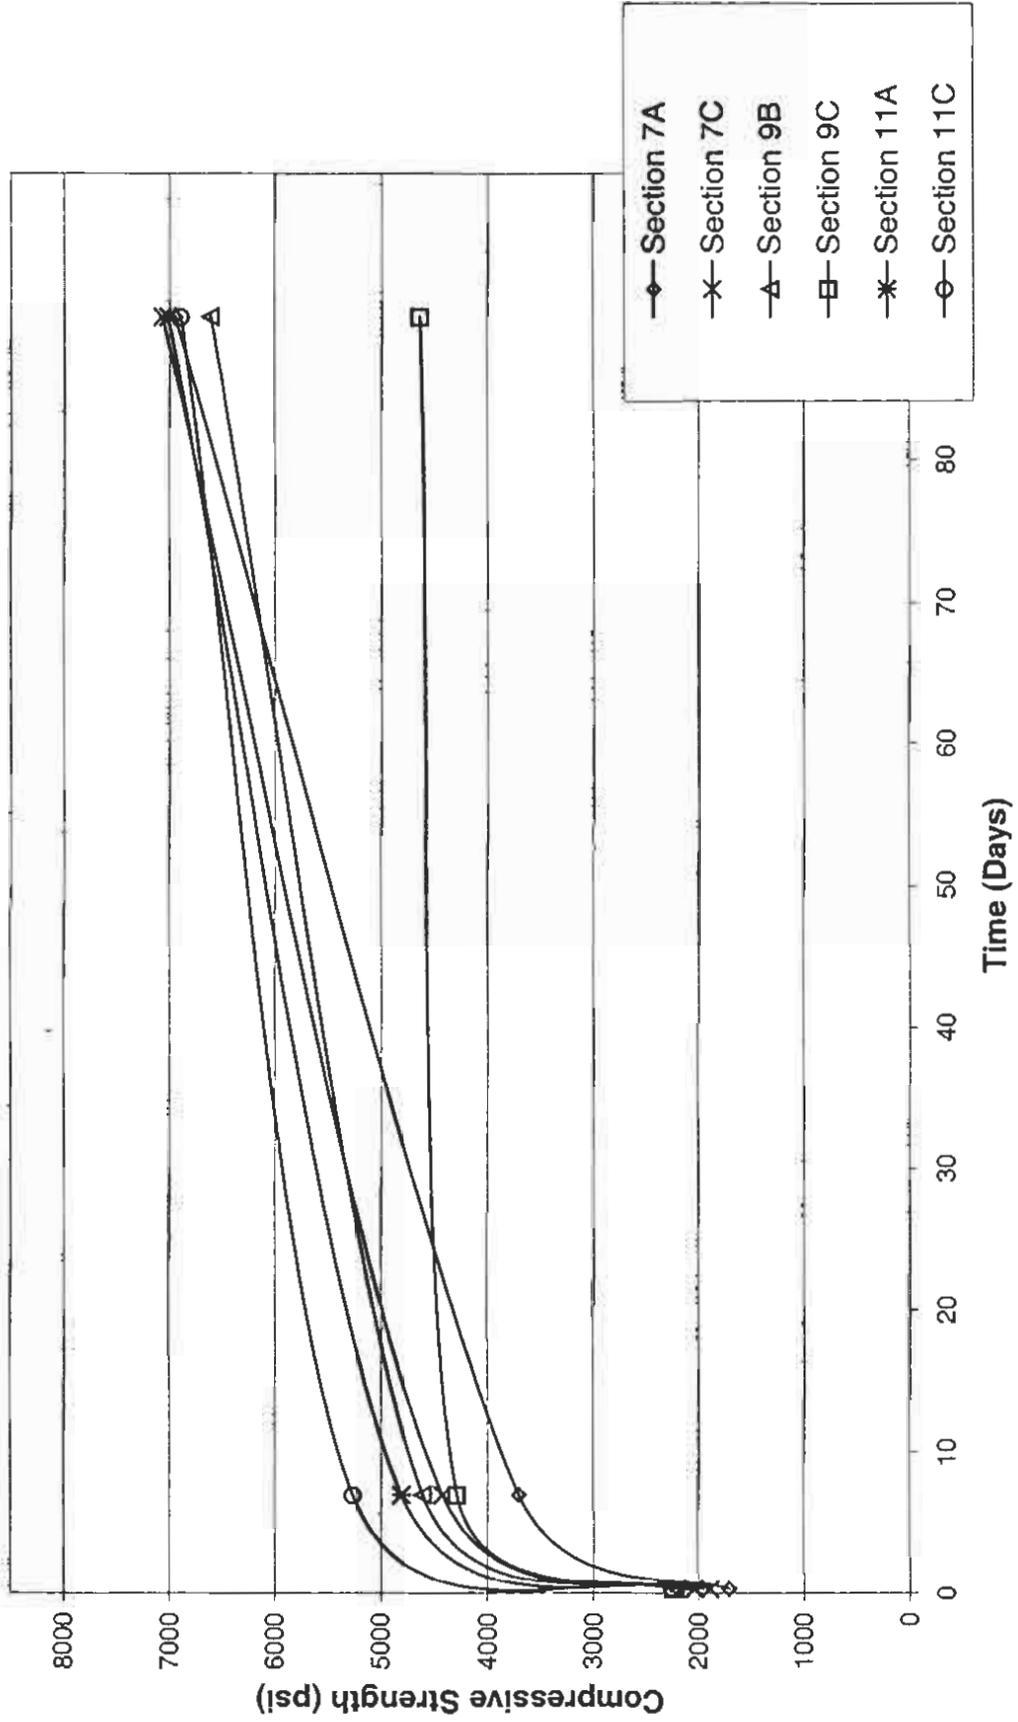
Figure 9.5. Average Cylinder Compressive Strength versus Time (North Tangent).

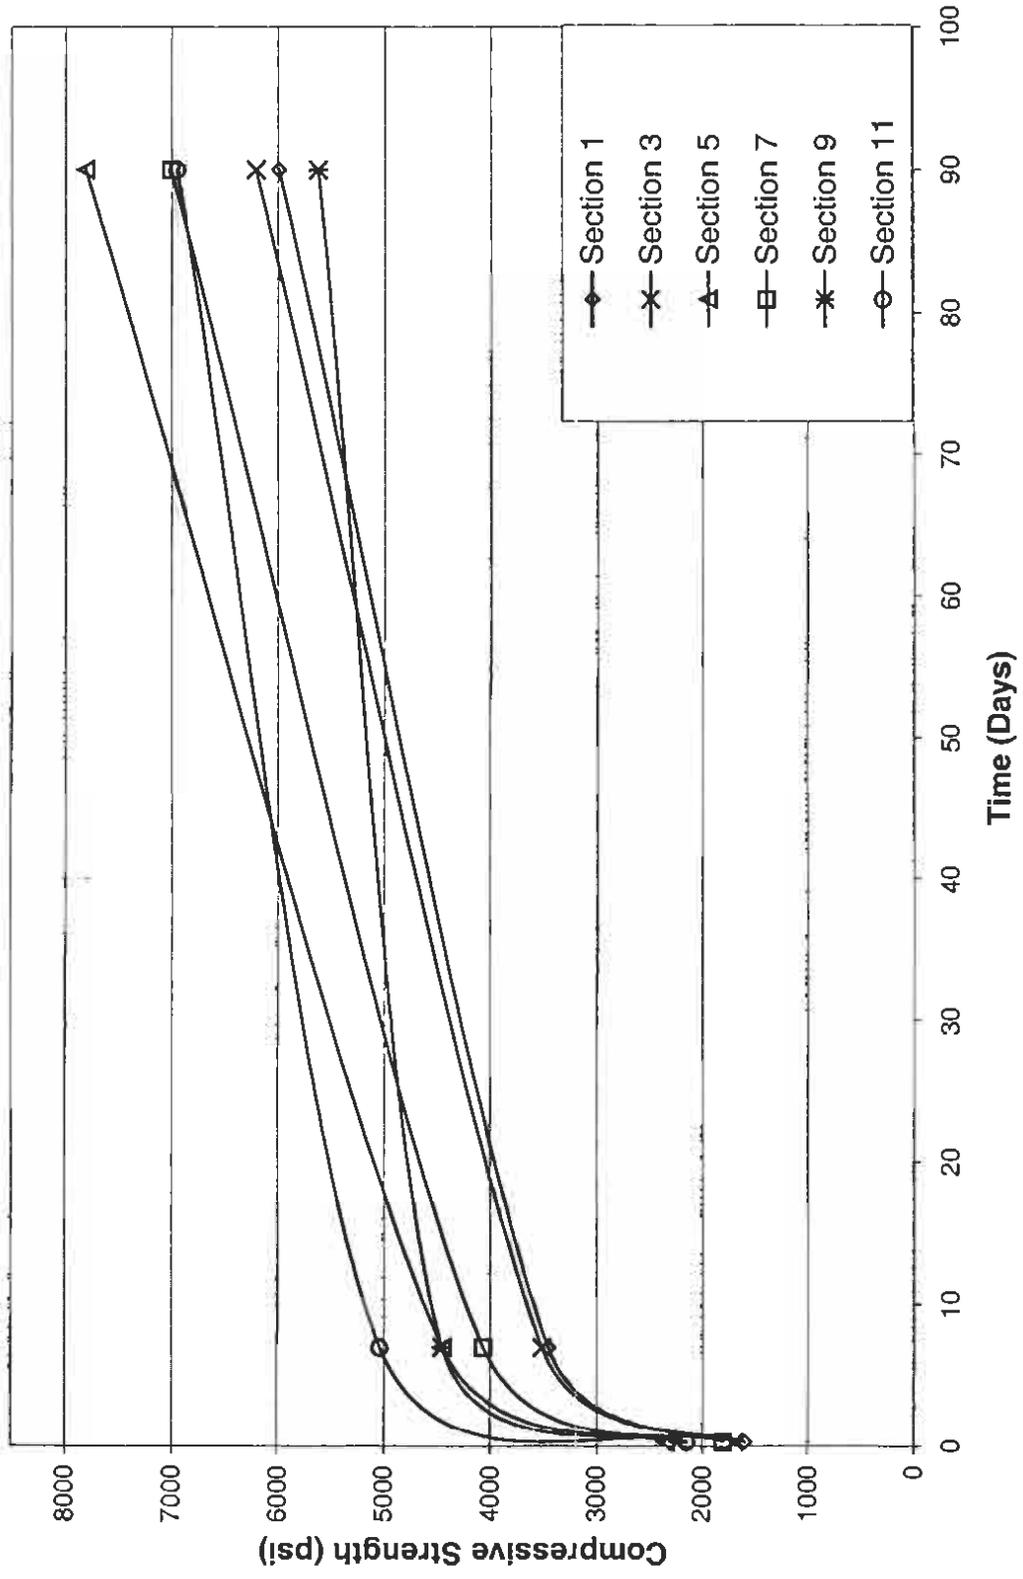
Figure 9.6. Average Cylinder Compressive Strength versus Time (North and South Tangents).

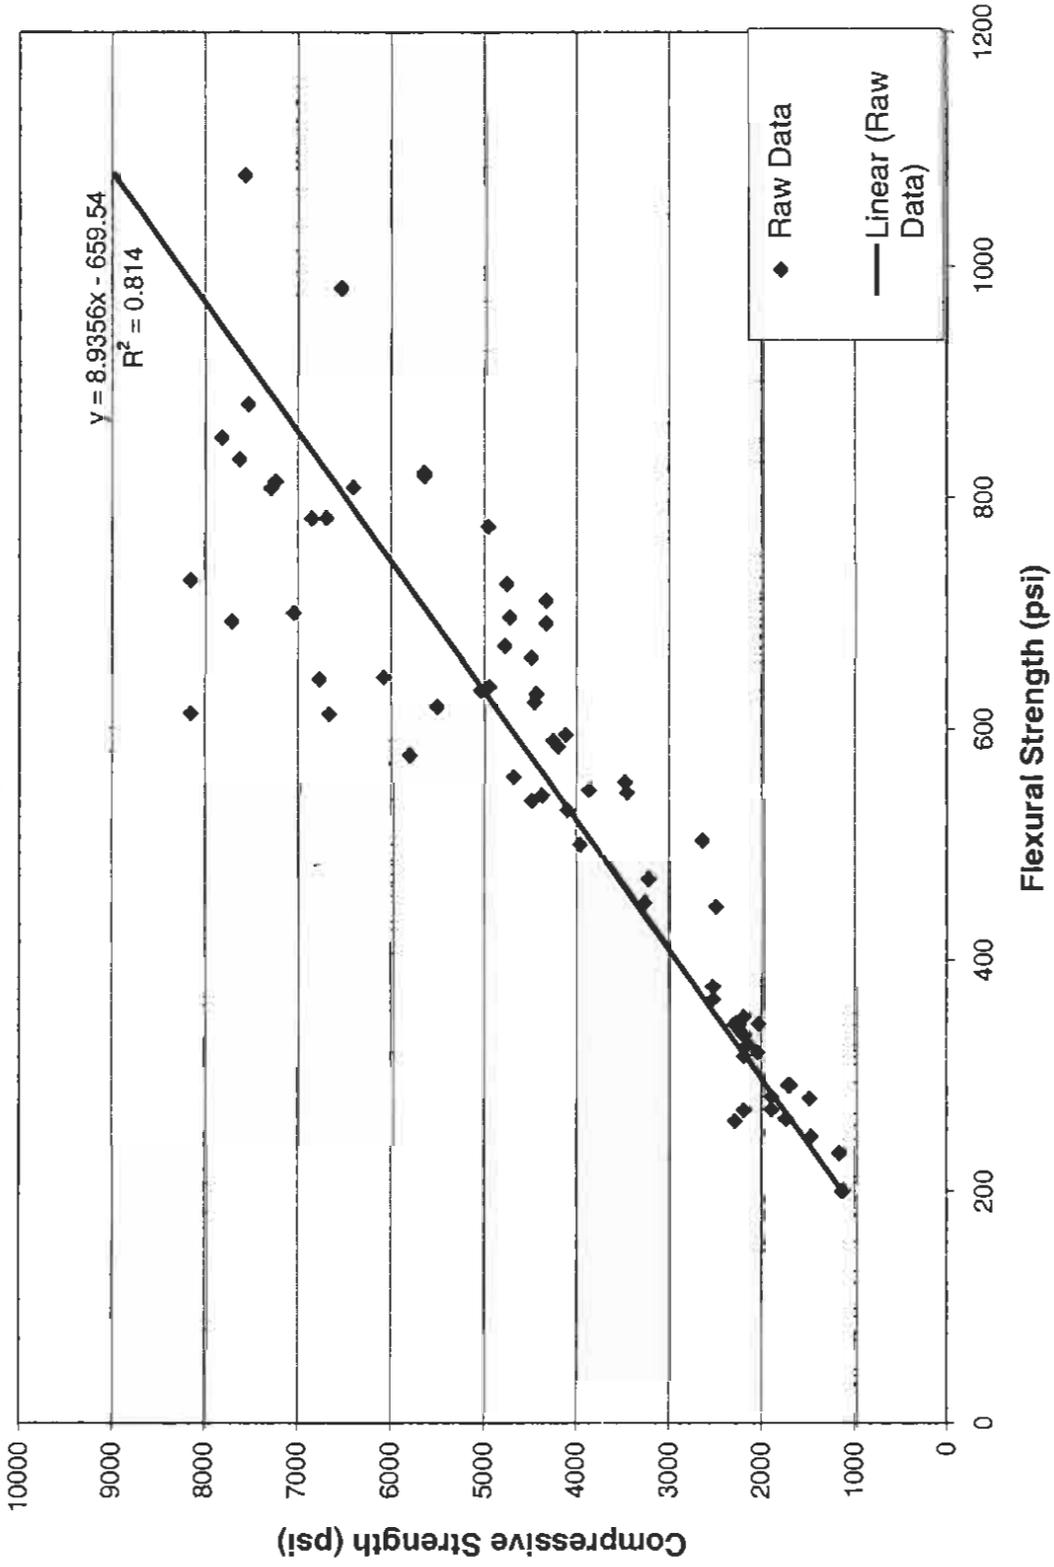
Figure 9.7. Relationship of Compressive Strength and Flexural Strength for Palmdale Test Sections.

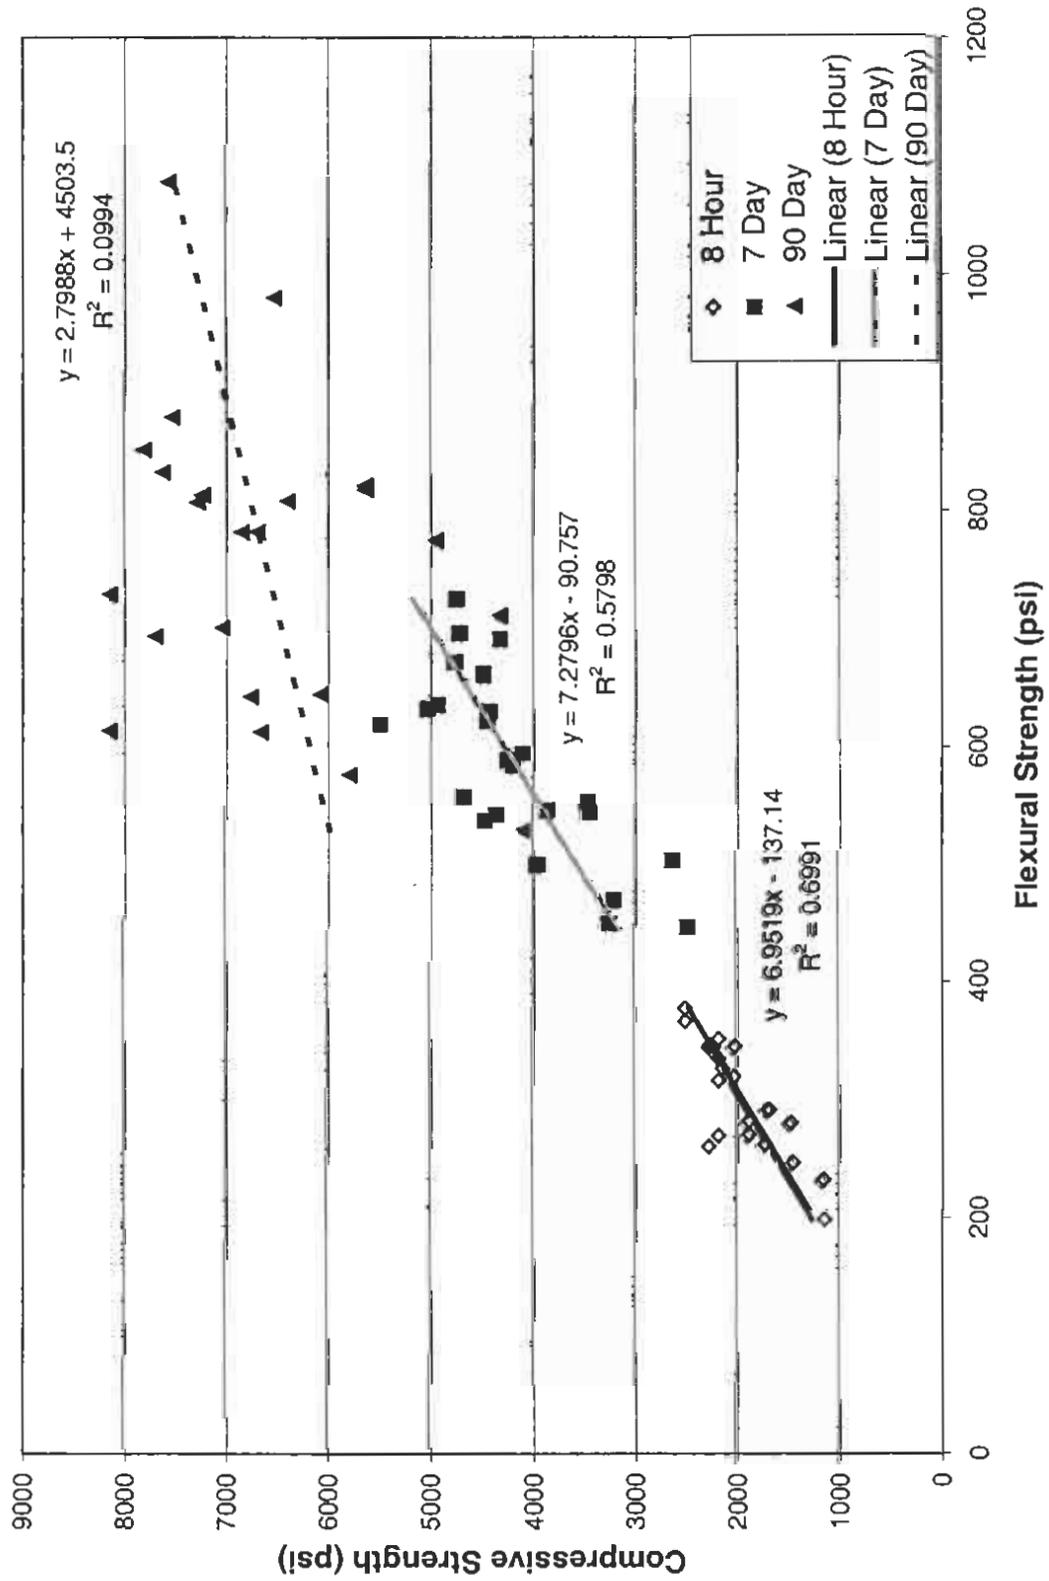
Figure 9.8. Relationship of Compressive Strength and Flexural Strength at Different Specimen Ages.

In order to identify where the most scatter exists in the data, a plot of beam (flexural) and cylinder (compressive) strength at each specimen age was made. Figure 9.8 shows that the scatter for the tests at 8 hours and 7 days is much less than for the tests at 90 days. At 90 days, there appears to be little correlation between flexural and compressive strength. Further laboratory testing needs to be completed to verify or dismiss the trend observed for the tests at 90 days.

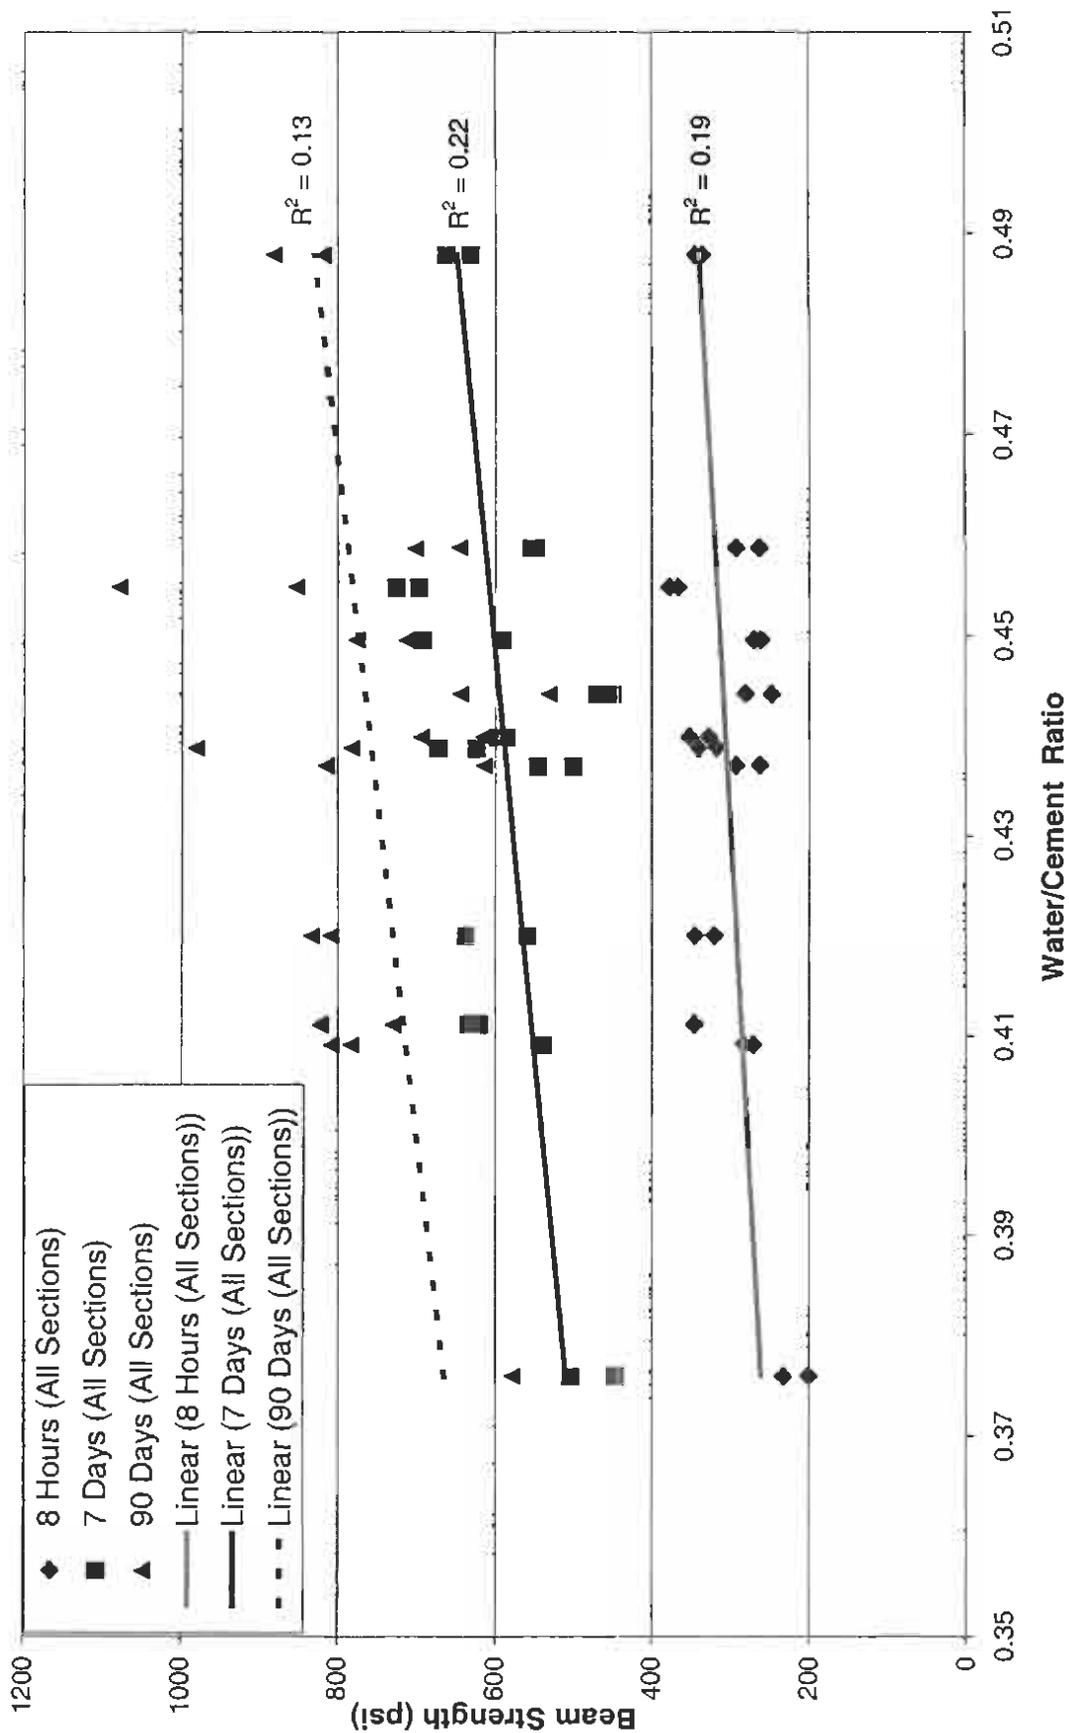
Figure 9.9. Water-to-Cement Ratio versus Beam Strength at 8 hours, 7 days, and 90 days.

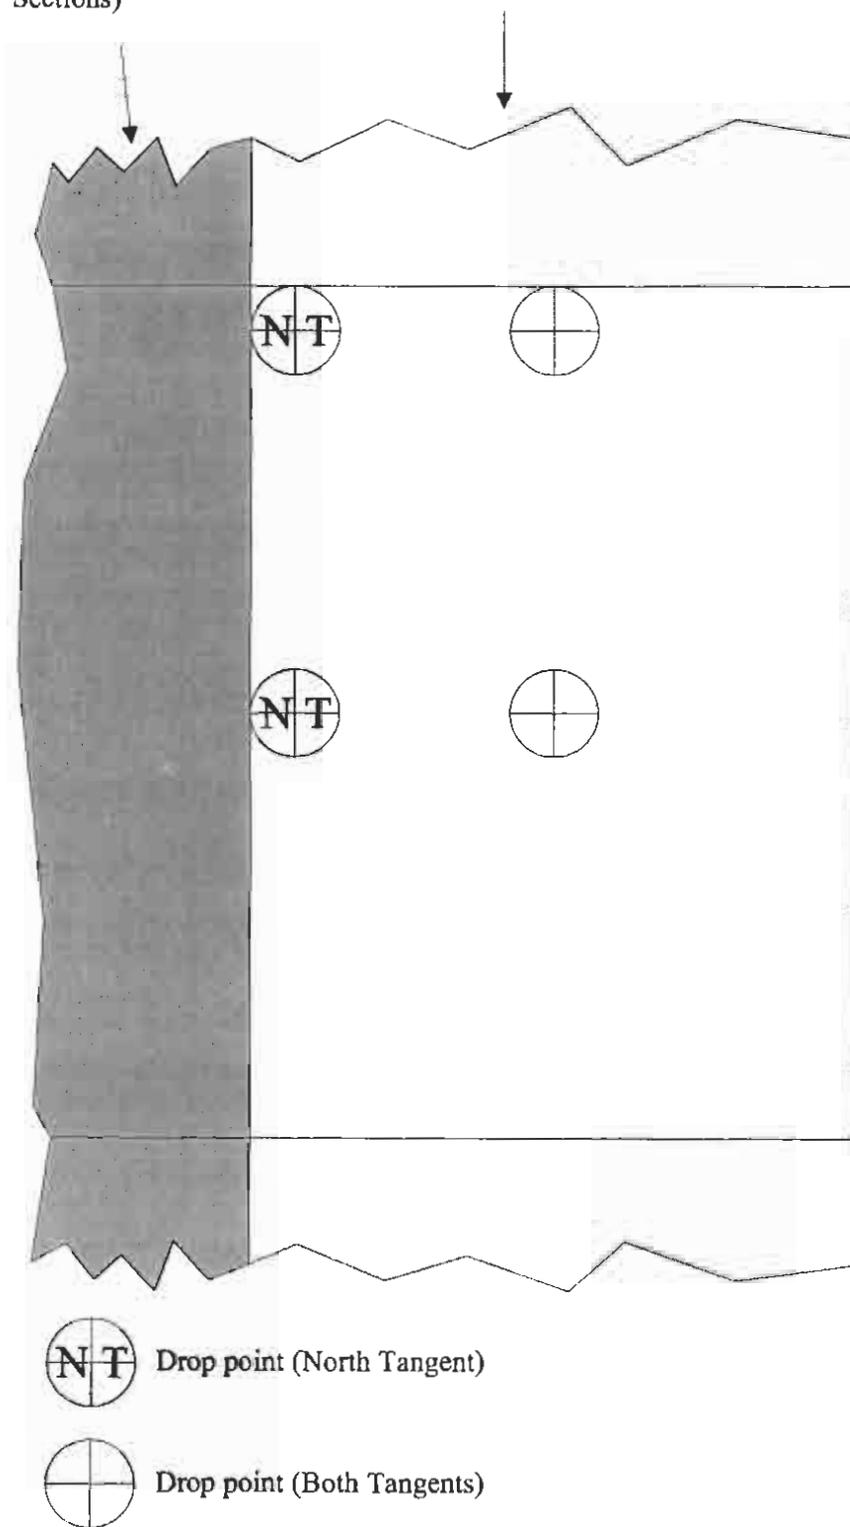
Figure 9.10. HWD Drop Locations, North and South Tangents.

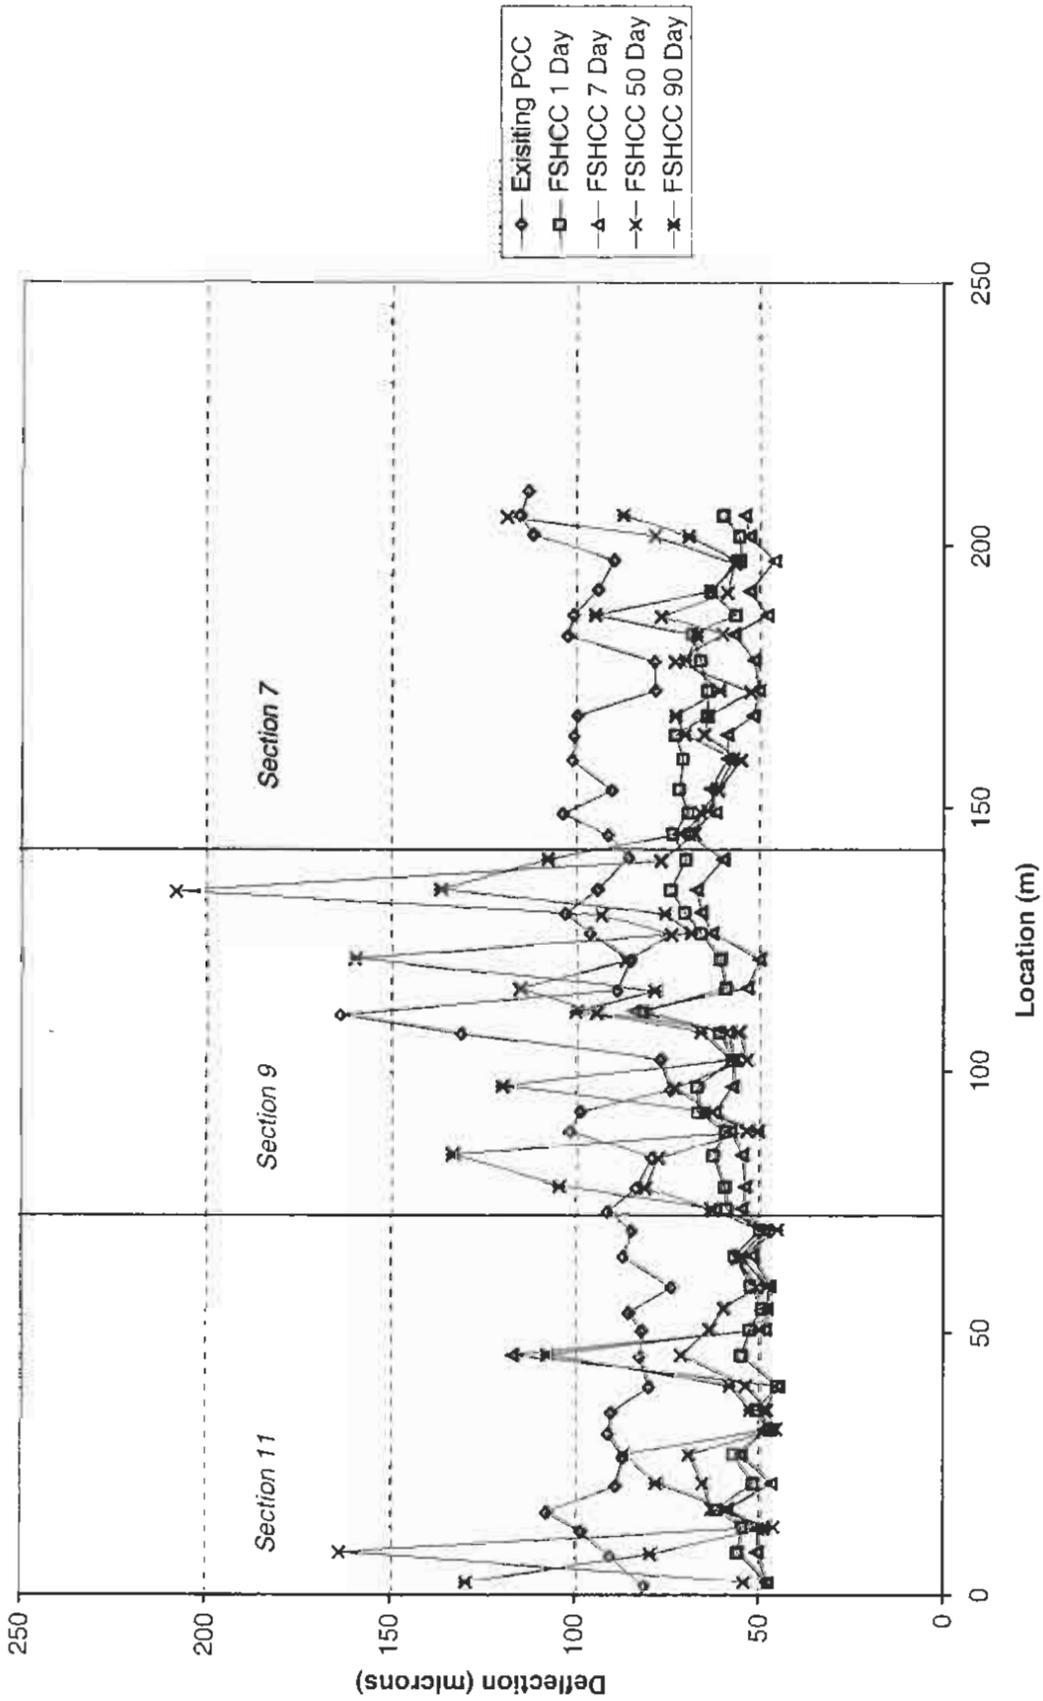
Figure 9.1.1. HWD Deflections, 40kN Load, North Tangent.
