Construction, Instrumentation, and Testing of Fast-Setting Hydraulic Cement Concrete in Palmdale, California

**Construction, Instrumentation, and Testing of Fast-Setting  
Hydraulic Cement Concrete in Palmdale, California**

Pavement Research Center  
Institute of Transportation Studies  
University of California Berkeley

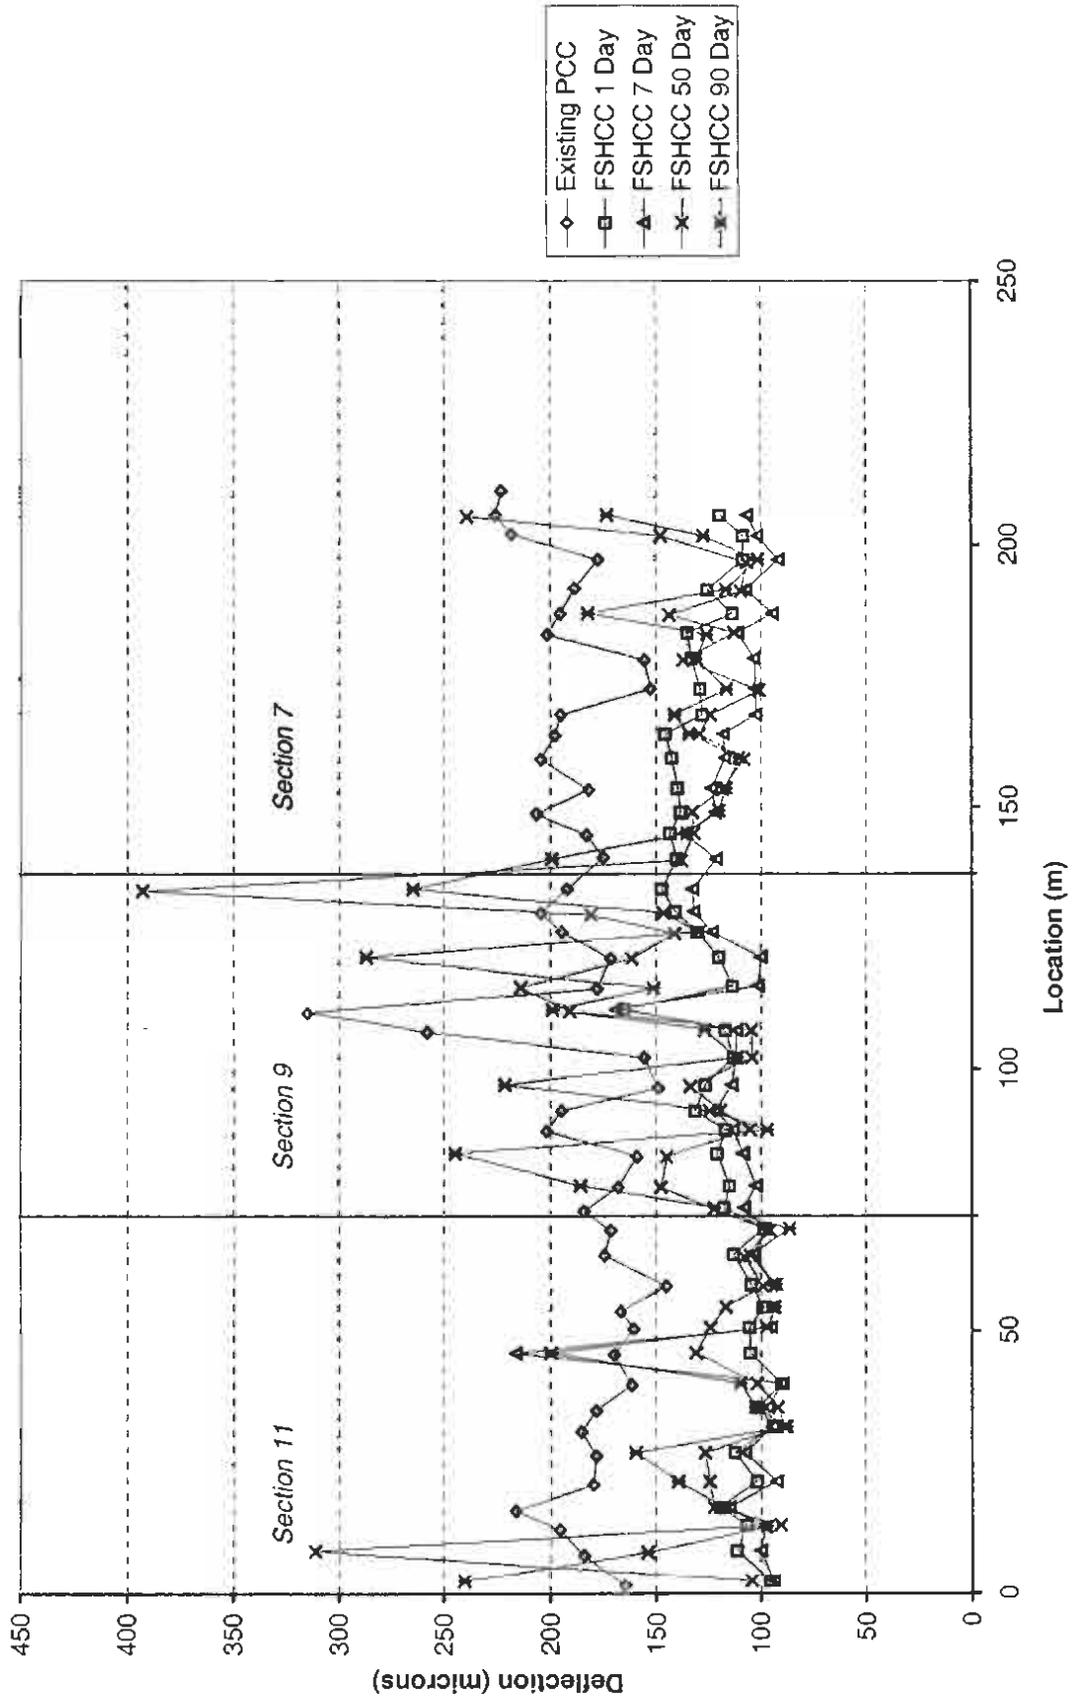
Figure 9.12. HWD Deflections, 80kN Load, North Tangent.

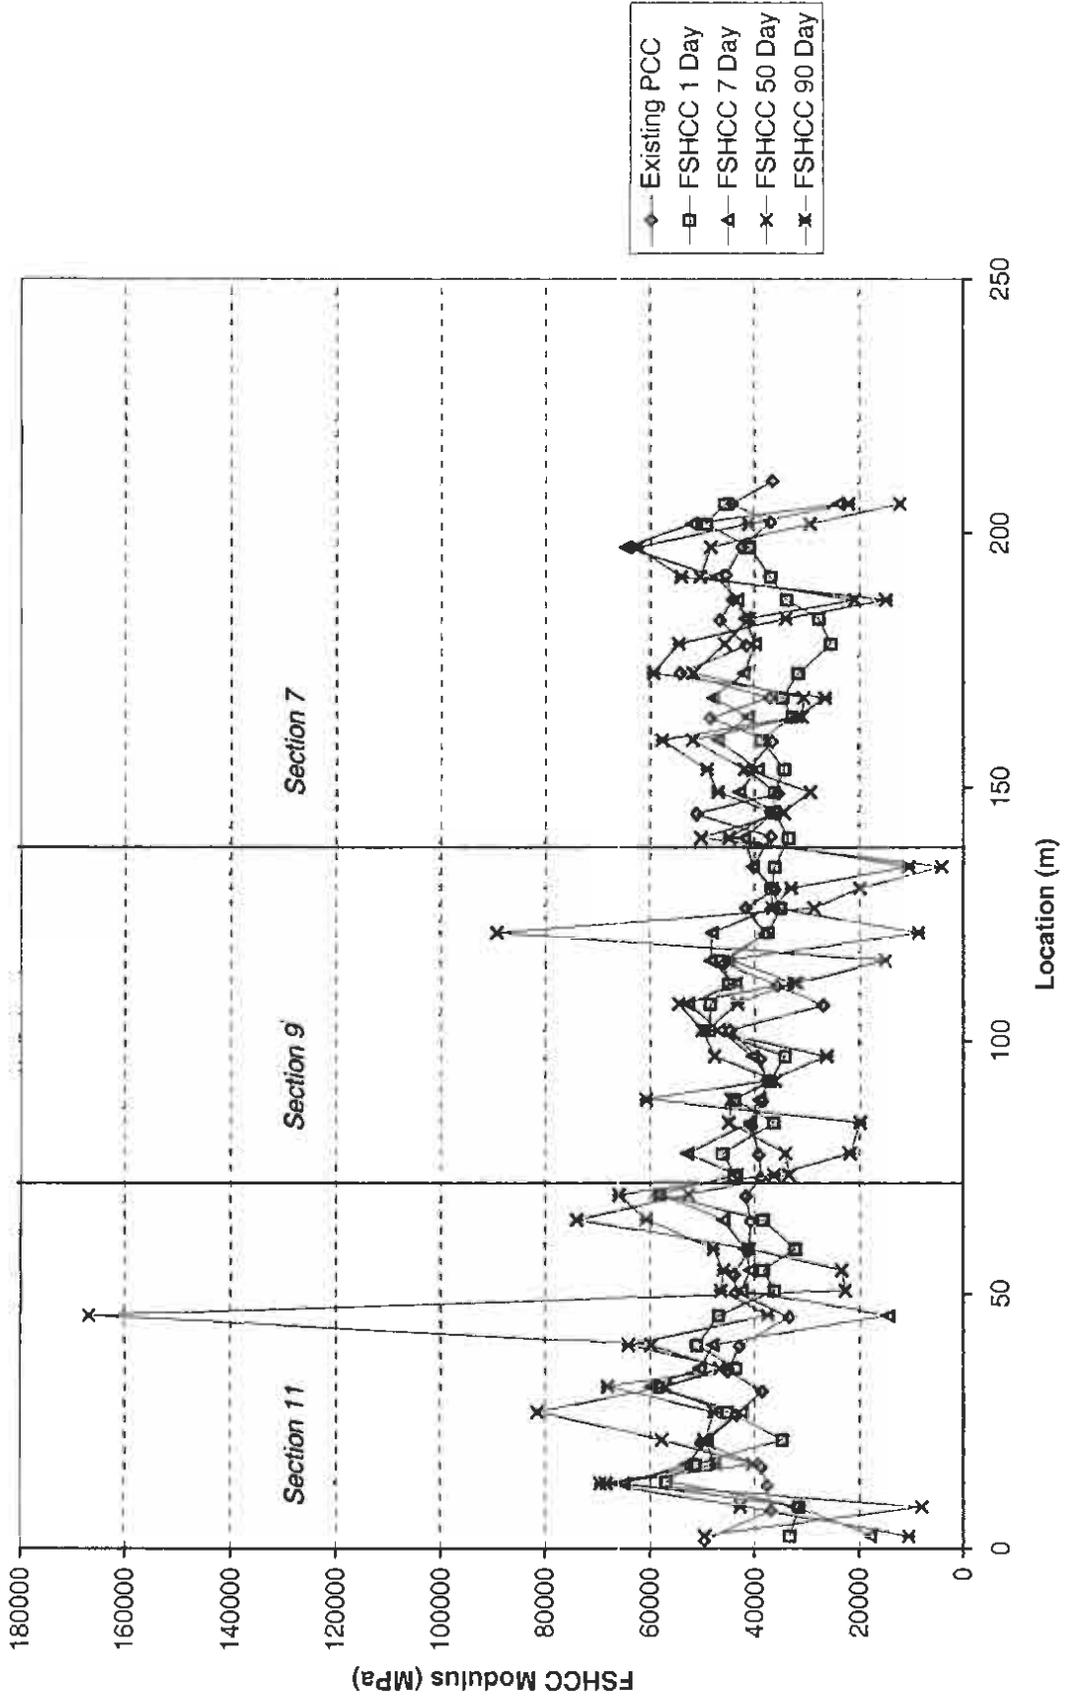
Figure 9.13. Surface Moduli (Backcalculated) for North Tangent.

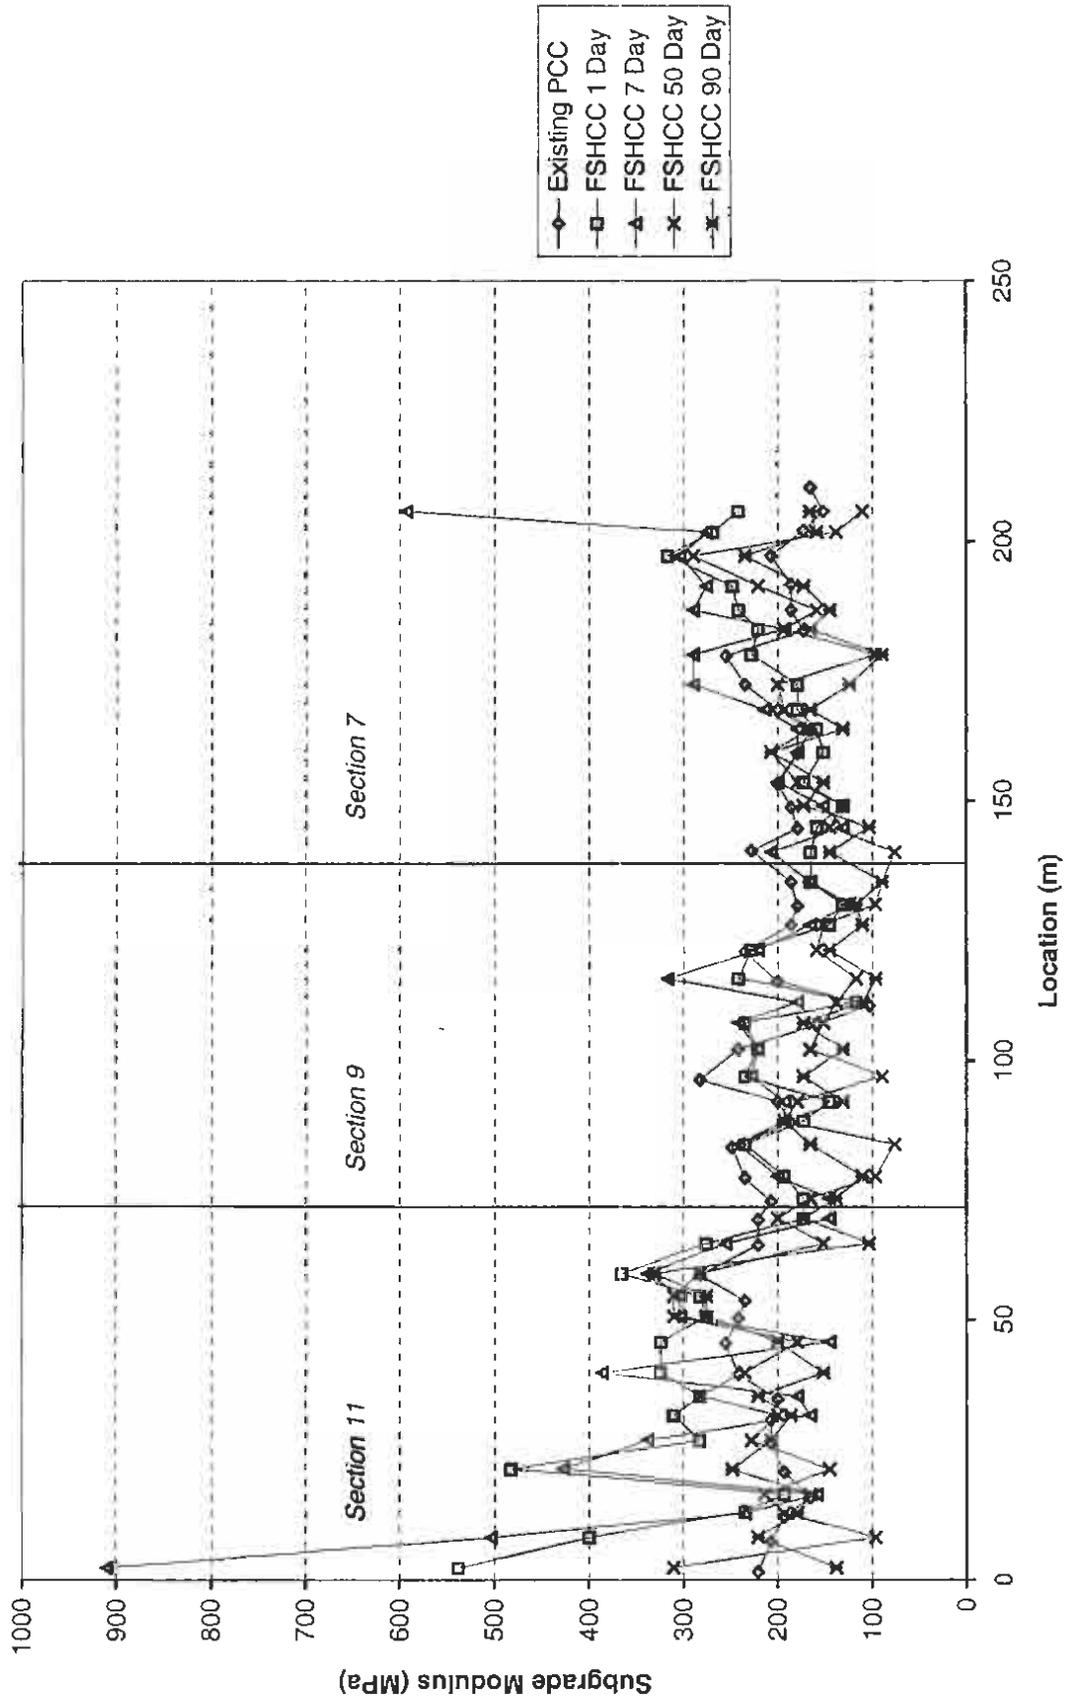
Figure 9.14. Subgrade Moduli (Backcalculated), North Tangent.

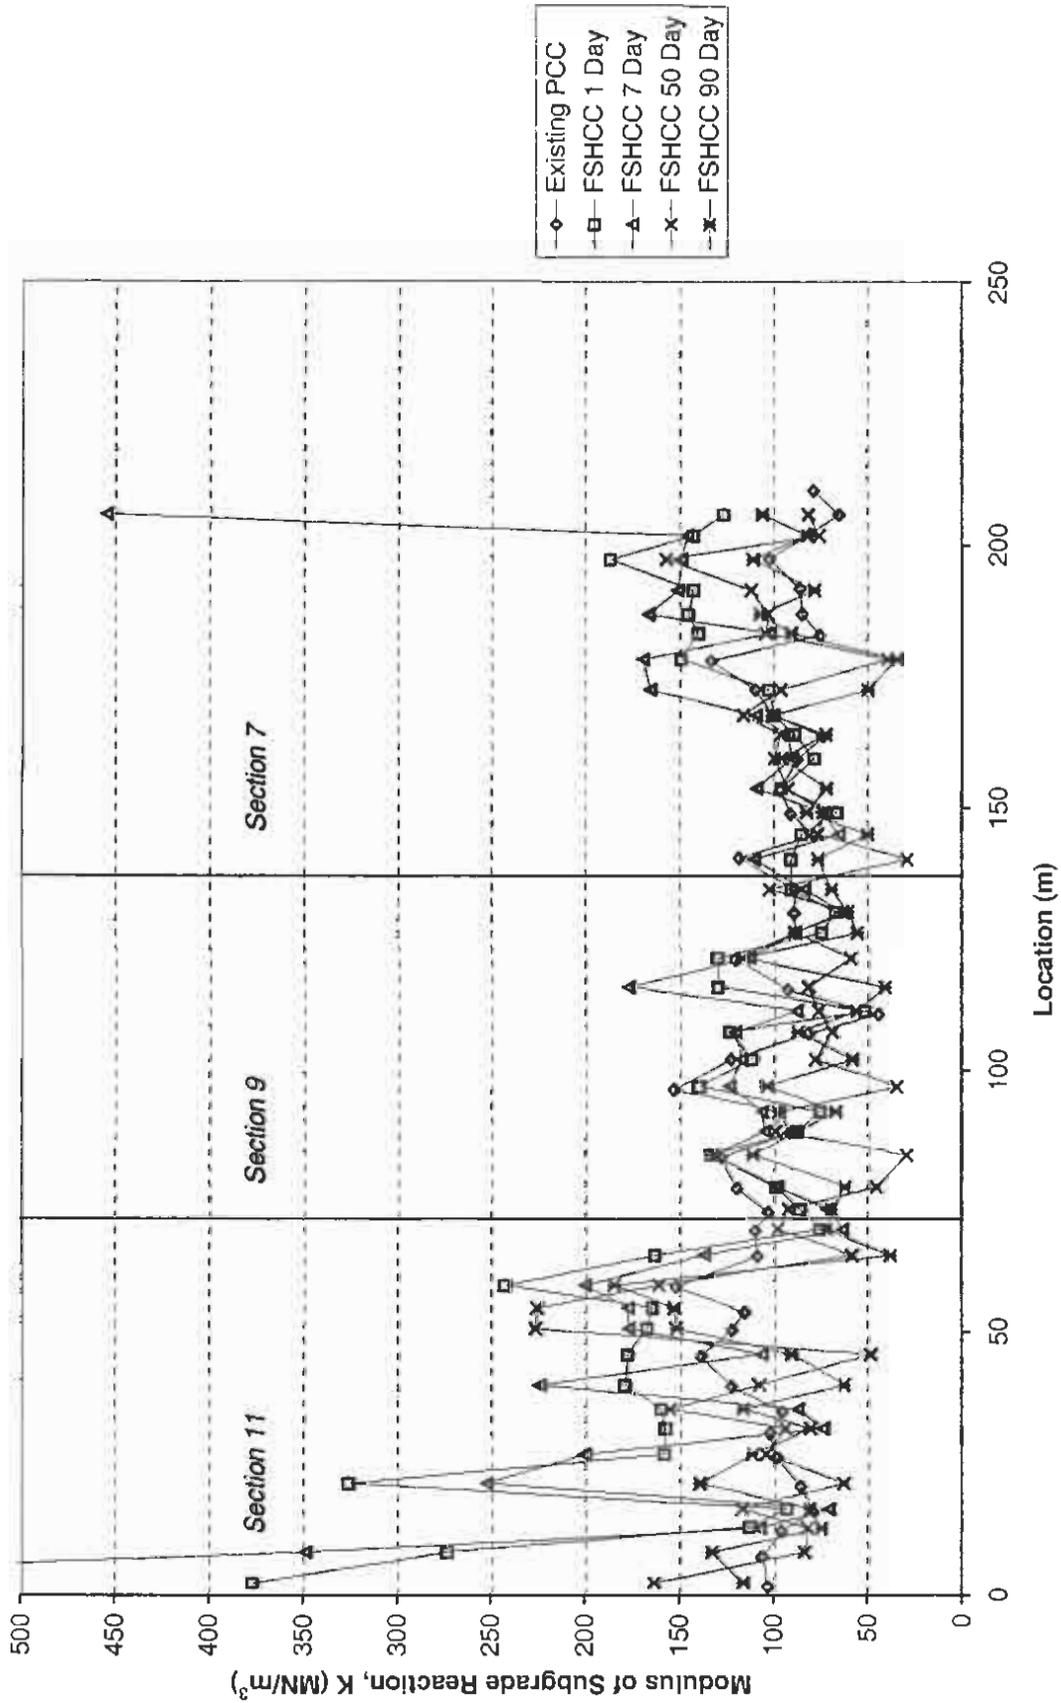
Figure 9.15. North Tangent Modulus of Subgrade Reaction.

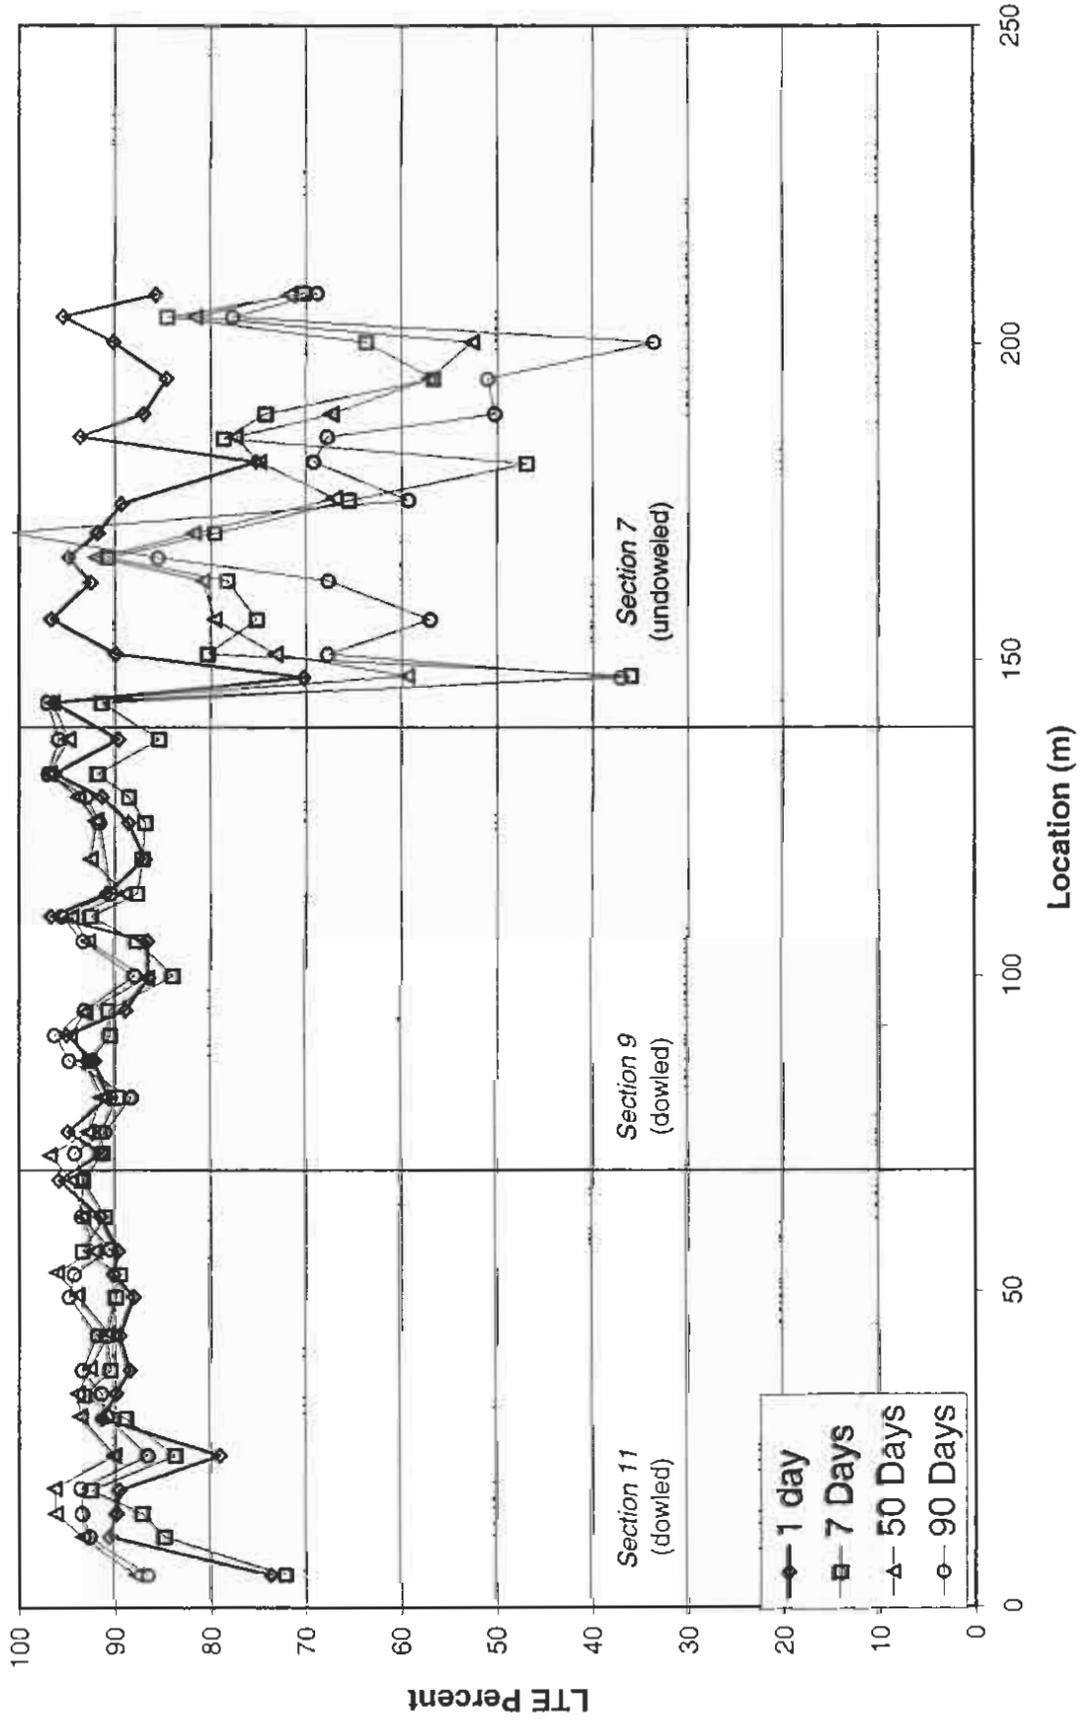
Figure 9.16. Transverse Joint Load Transfer Efficiency, North Tangent.

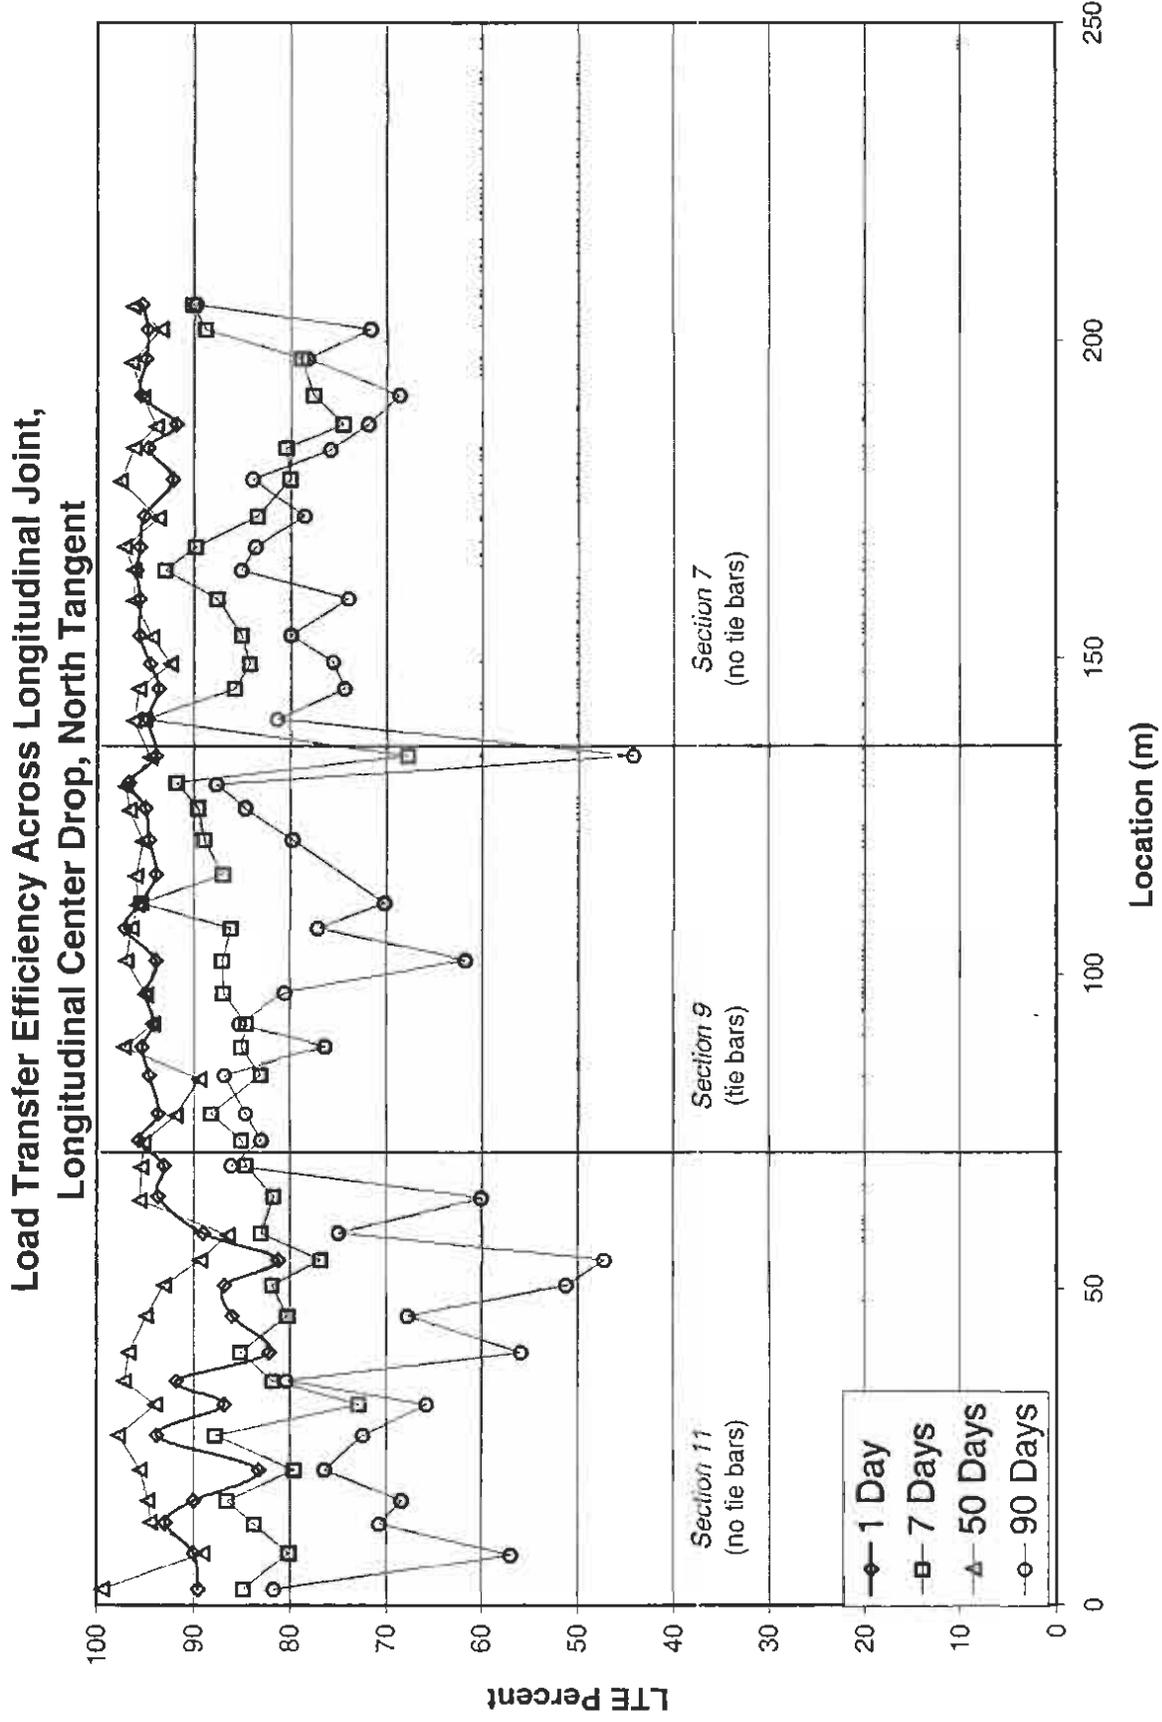
Figure 9.17. Longitudinal Joint Load Transfer Efficiency, Longitudinal Center Drop, North Tangent.

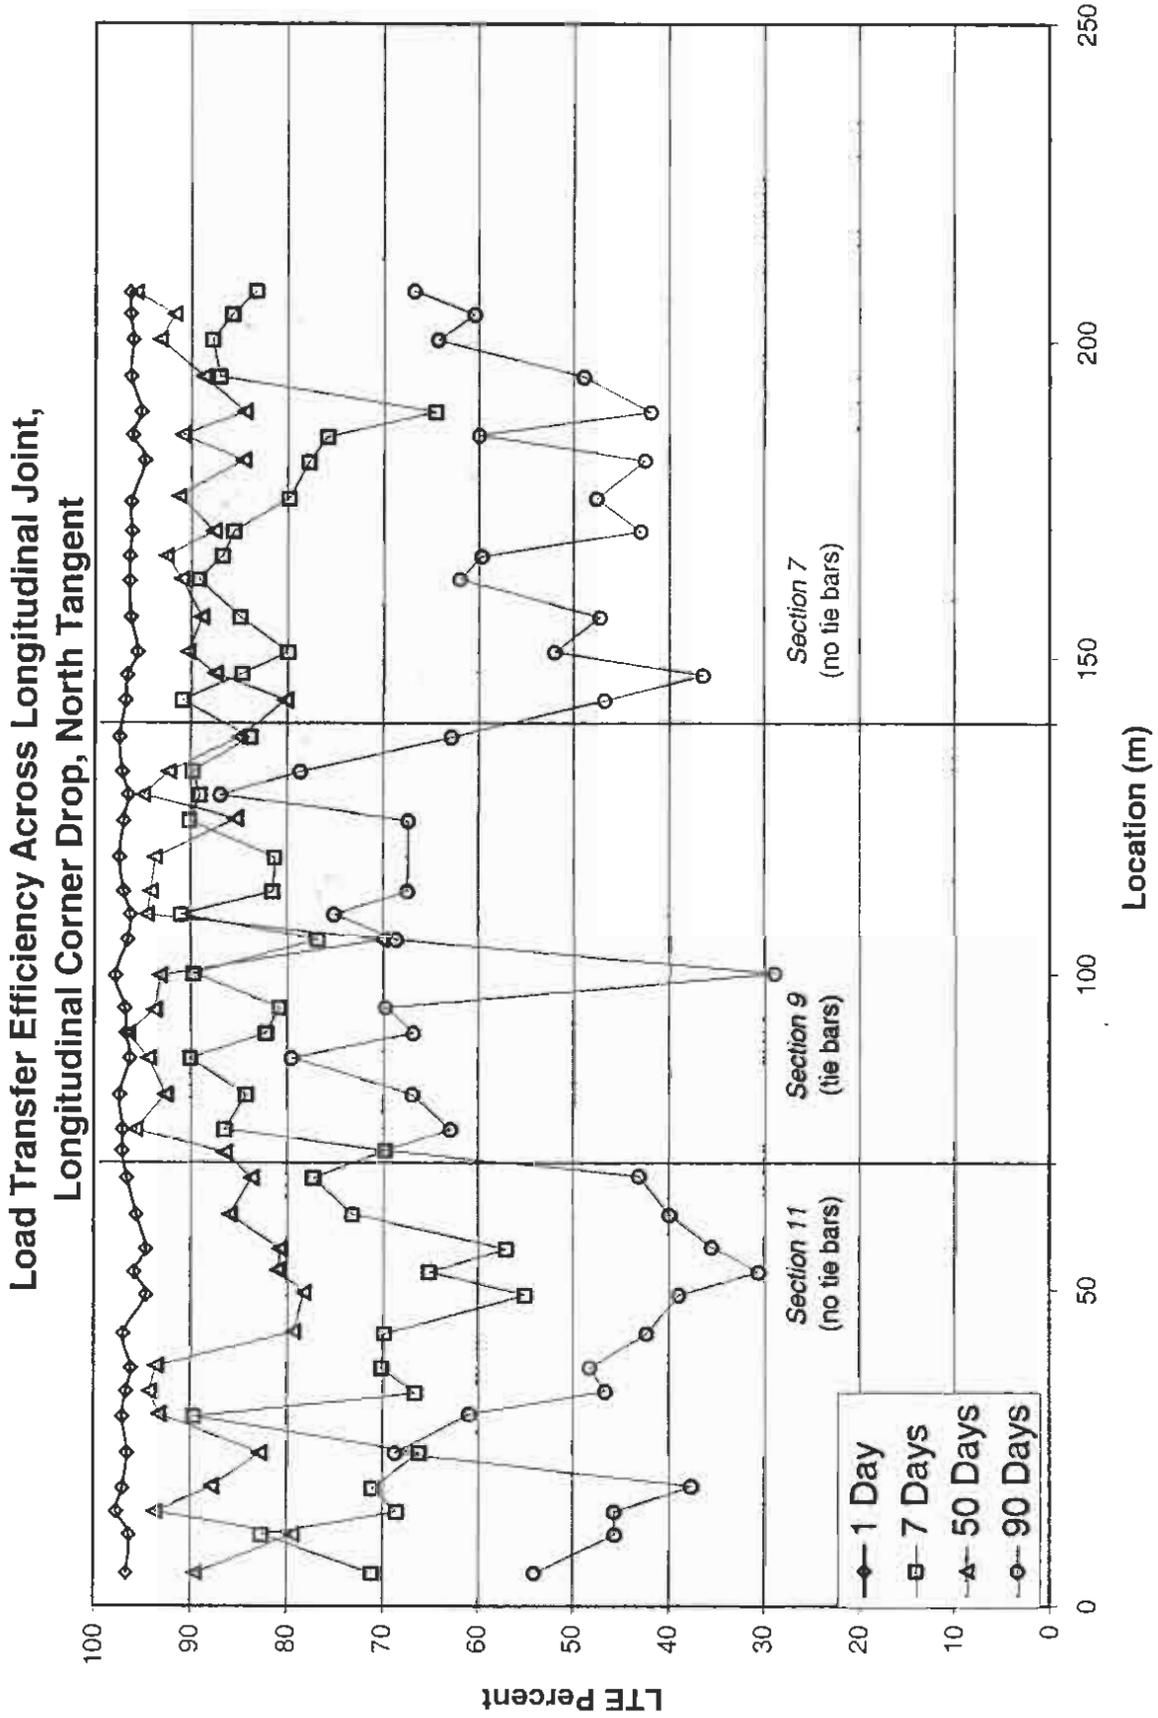
Figure 9.18. Longitudinal Joint Load Transfer Efficiency, Longitudinal Corner Drop, North Tangent.

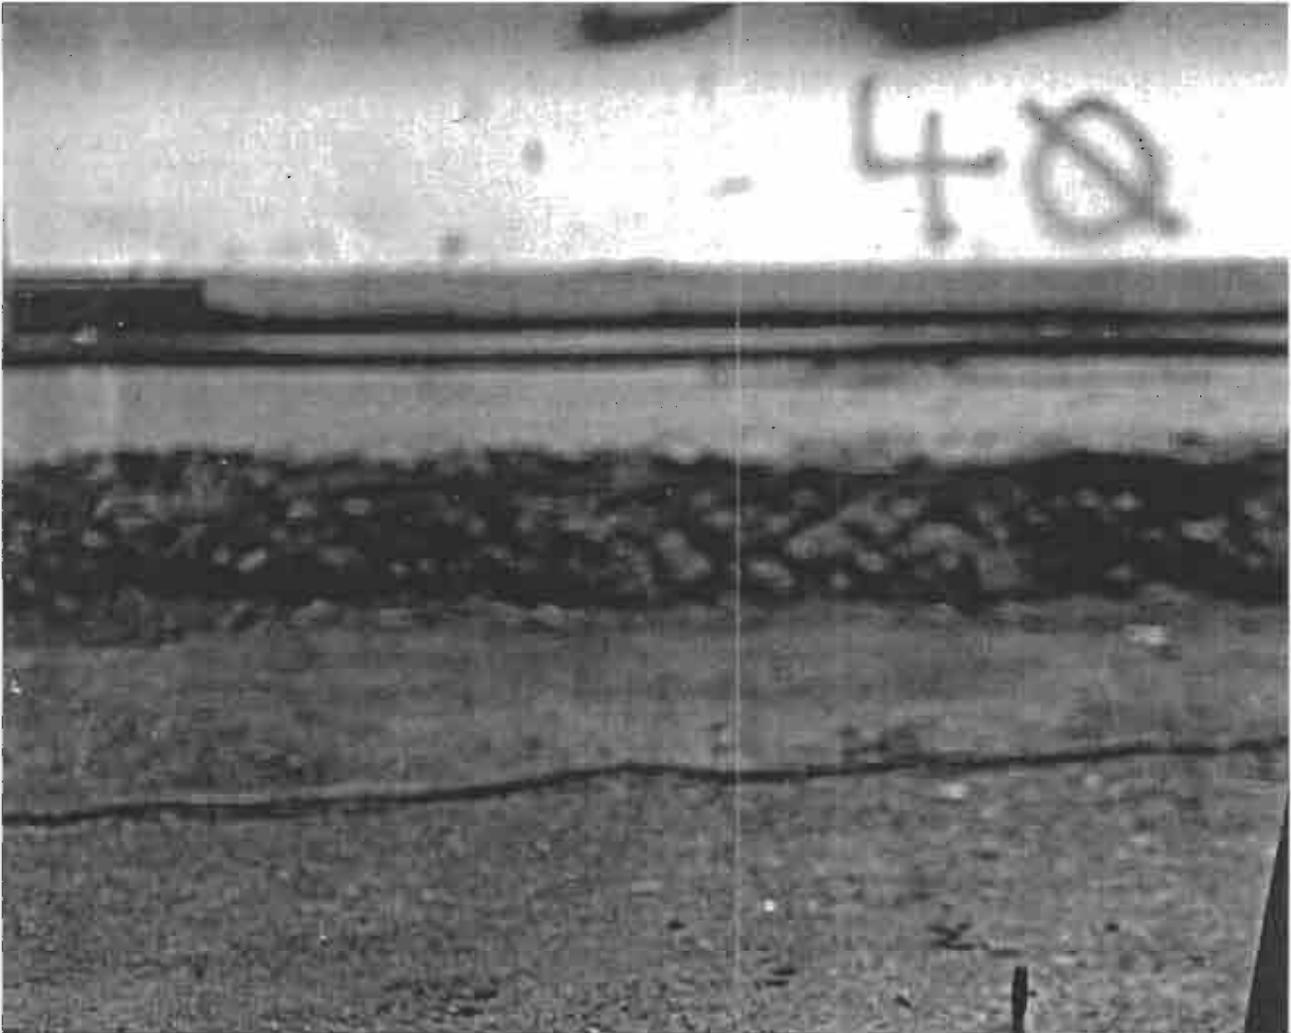
**Figure 9.19. Detail photo of Rough Longitudinal Surface of Existing PCC Slabs, South Tangent.**

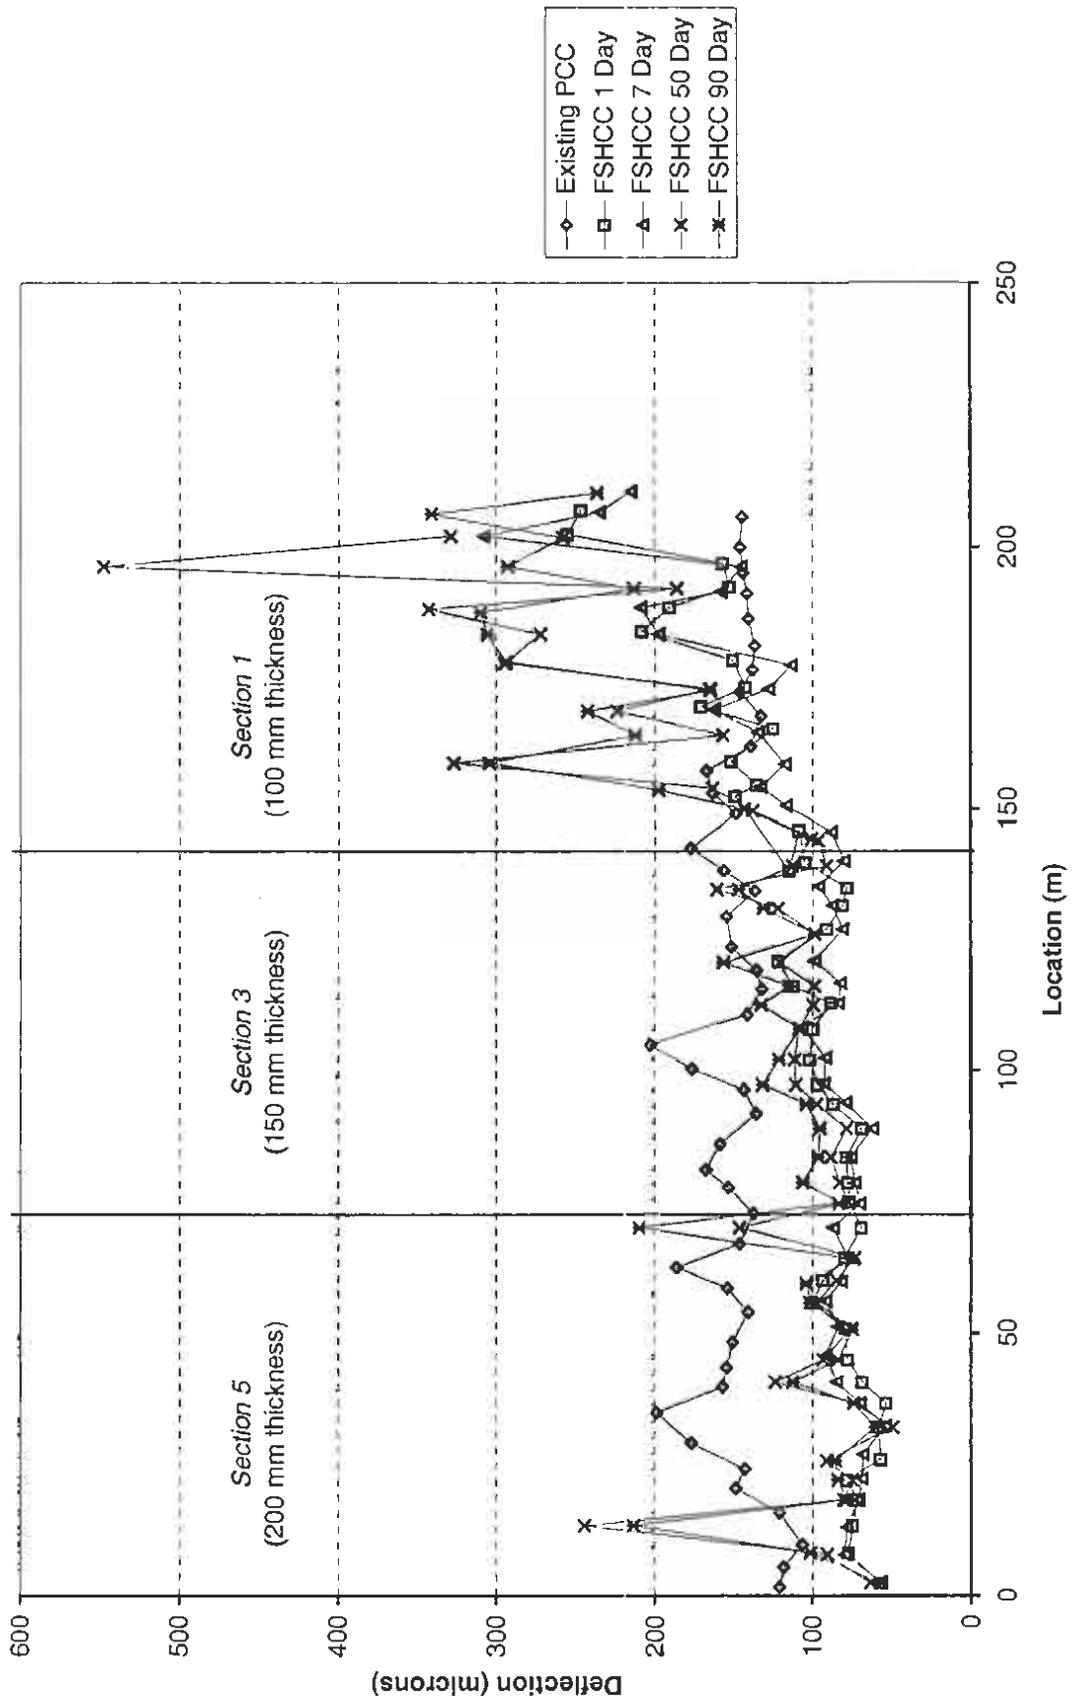
Figure 9.20. HWD Deflections, 40kN Load, South Tangent.

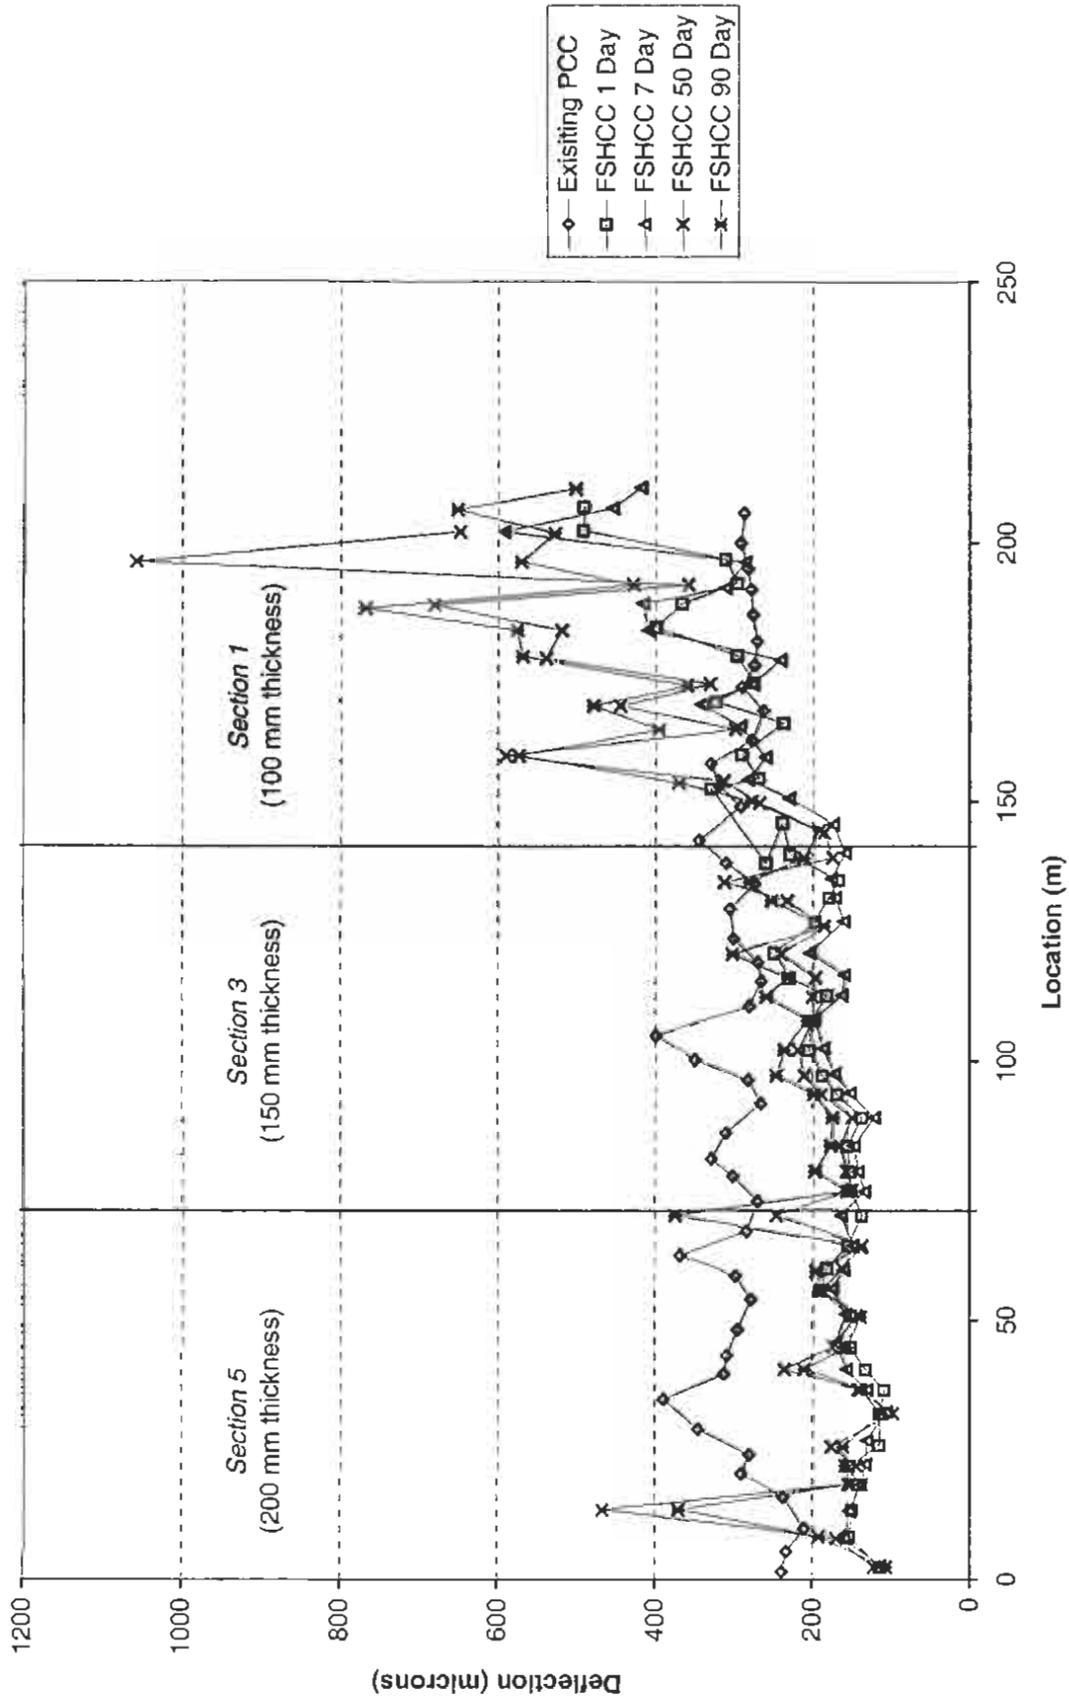
Figure 9.21. HWD Deflections, 80kN Load, South Tangent.

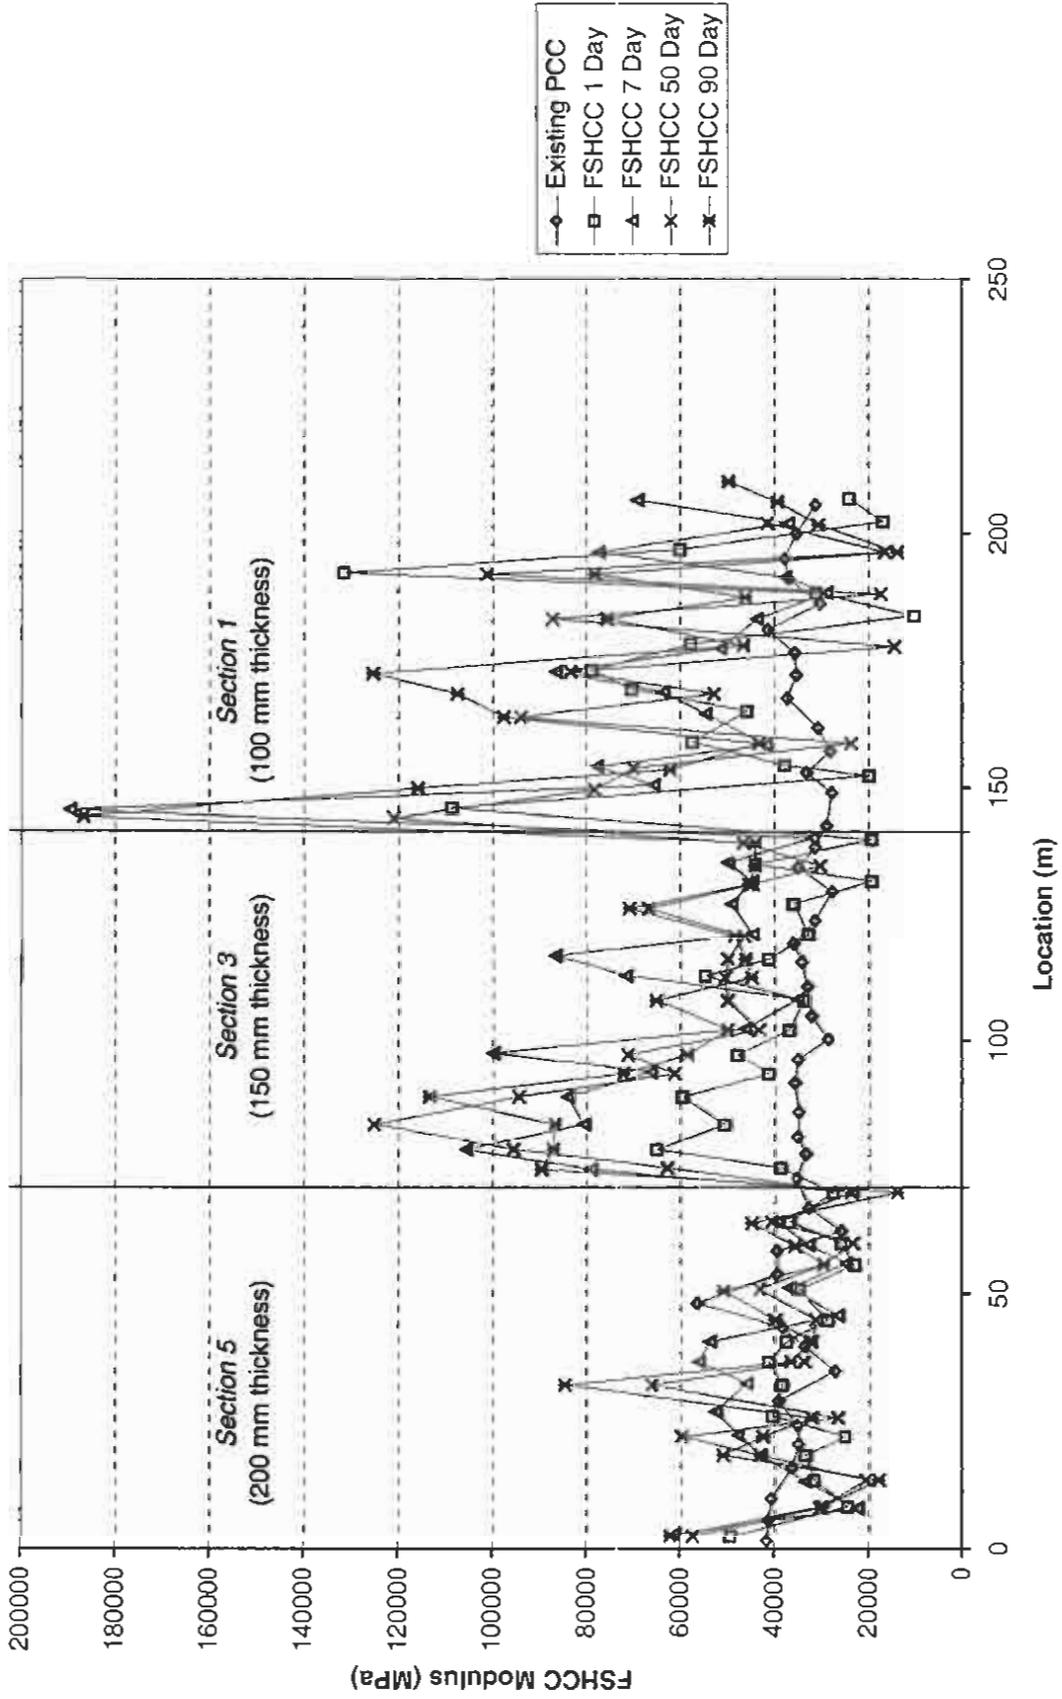
Figure 9.22. Surface Moduli (Backcalculated) for South Tangent.

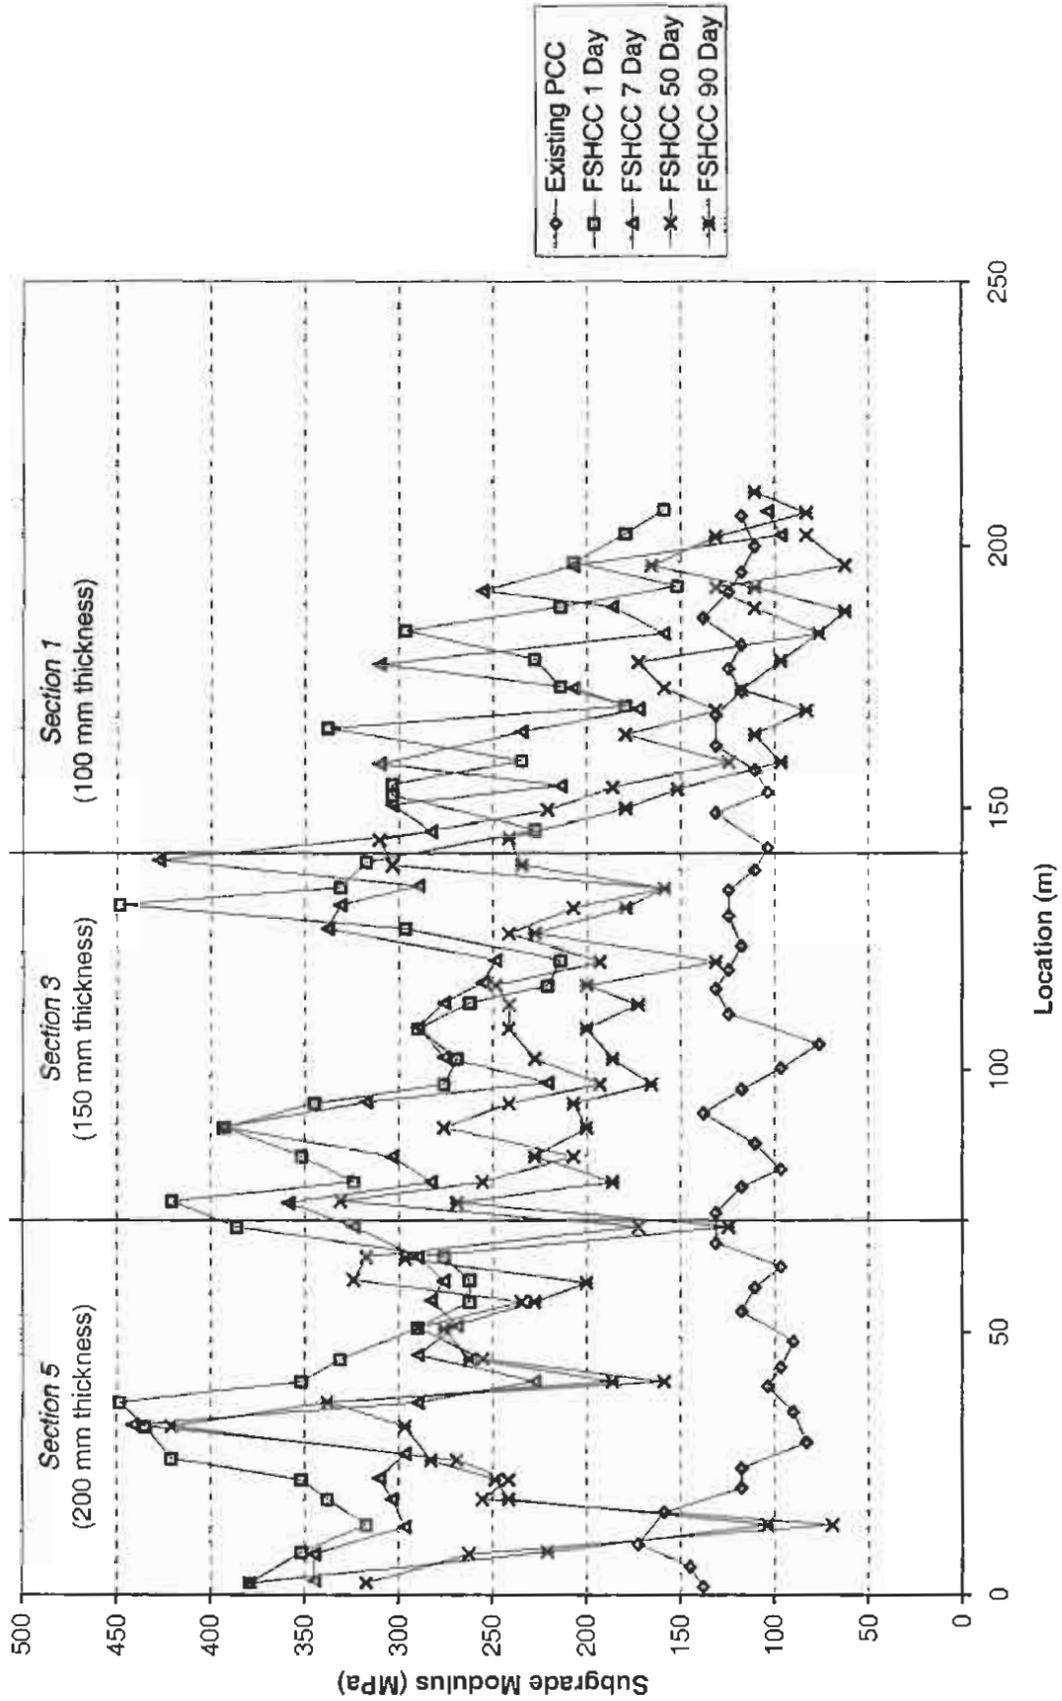
Figure 9.23. Subgrade Moduli (Backcalculated), South Tangent.
