Construction, Instrumentation, and Testing of Fast-Setting Hydraulic Cement Concrete in Palmdale, California

**Construction, Instrumentation, and Testing of Fast-Setting  
Hydraulic Cement Concrete in Palmdale, California**

Pavement Research Center  
Institute of Transportation Studies  
University of California Berkeley

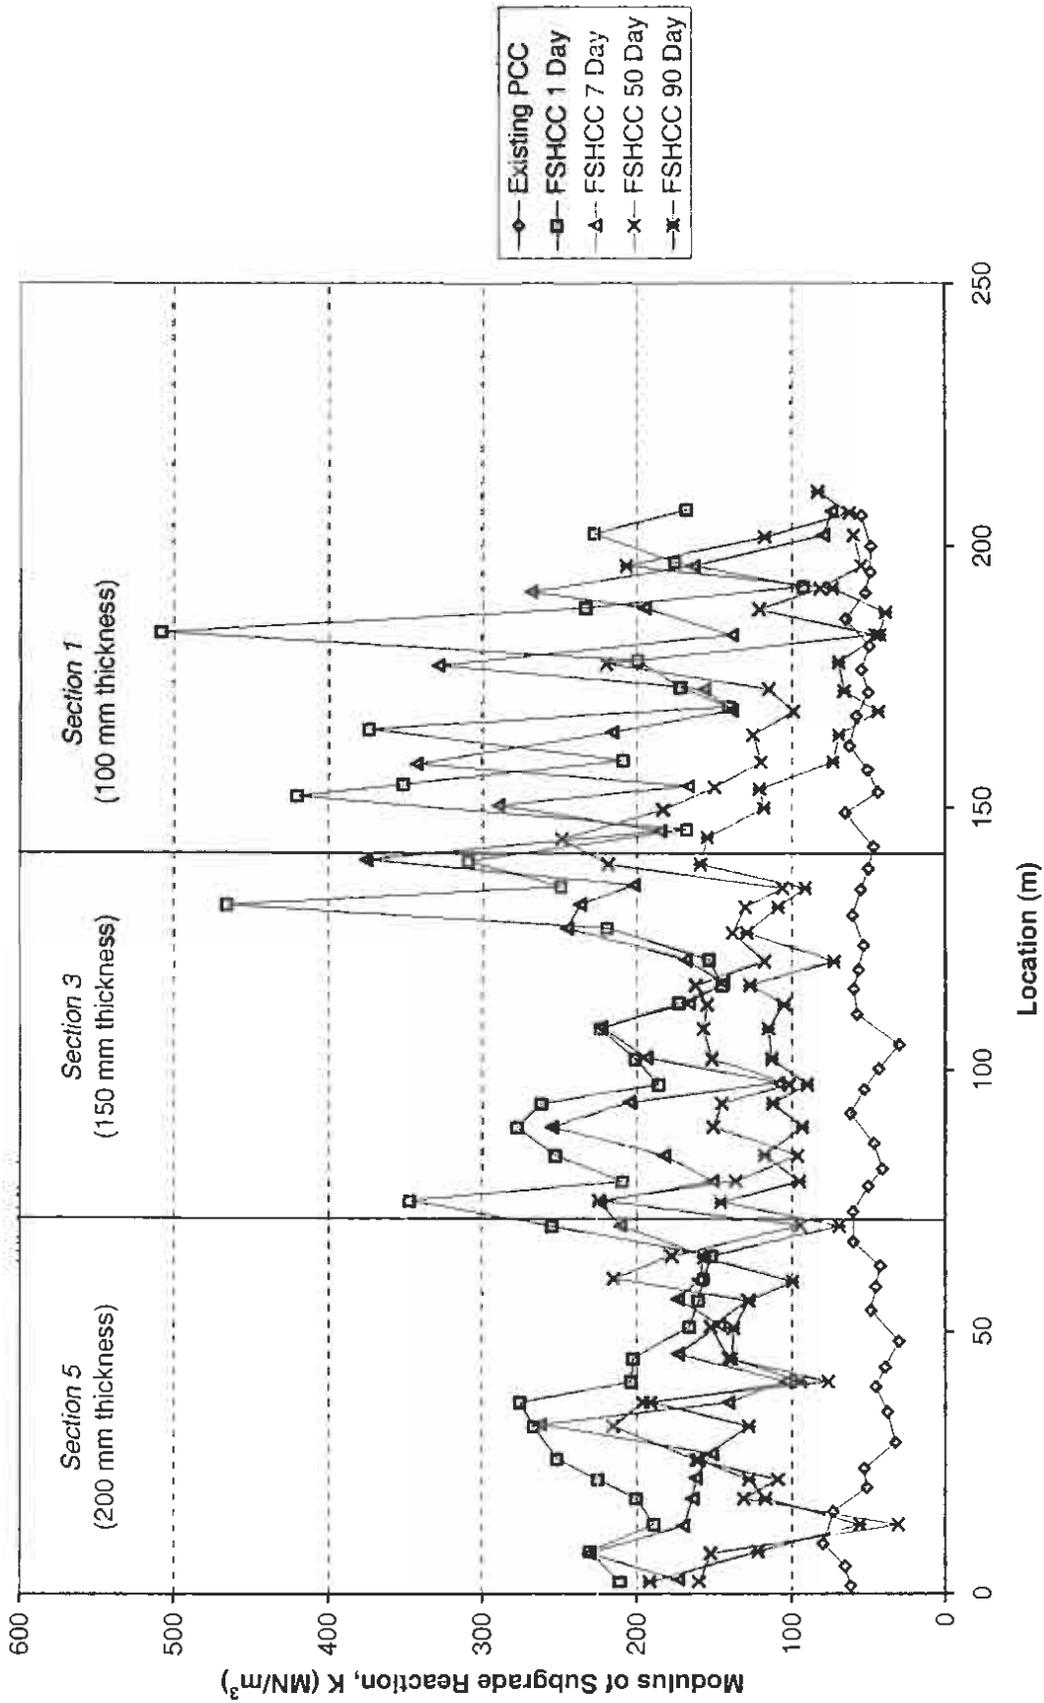
Figure 9.24. South Tangent Modulus of Subgrade Reaction.

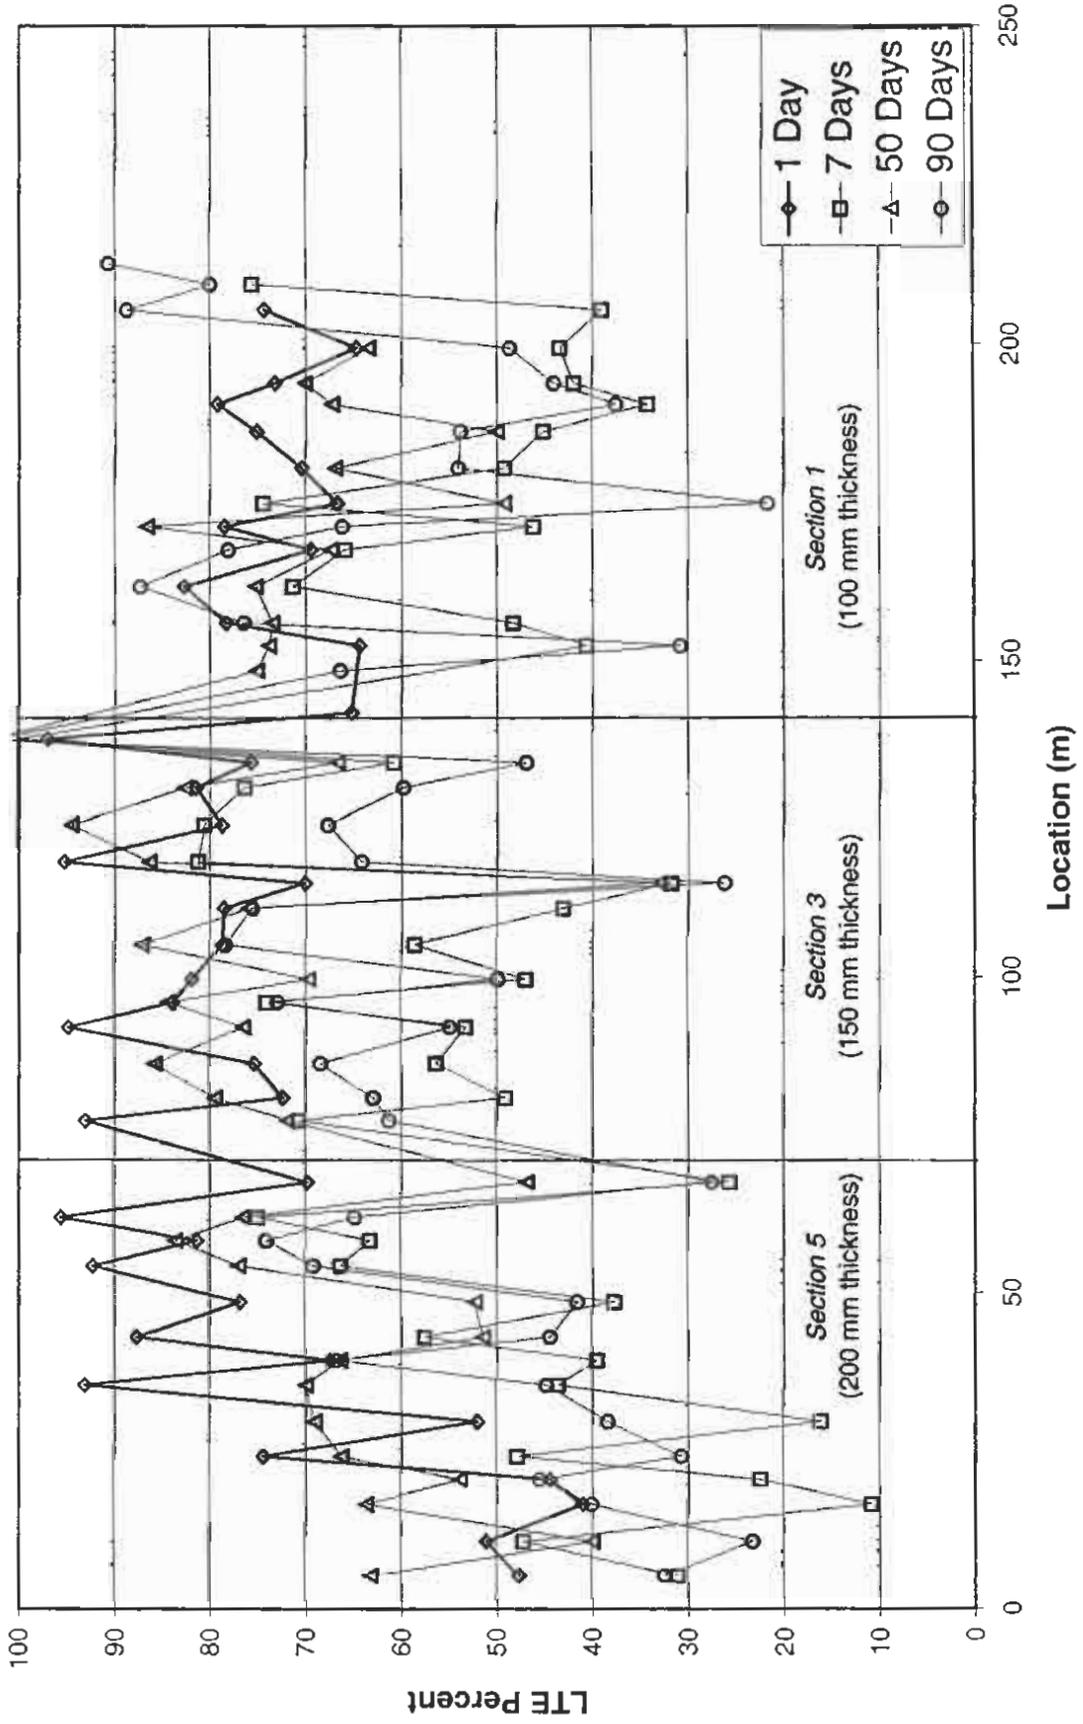
Figure 9.25. South Tangent Transverse Joint Load Transfer Efficiency.

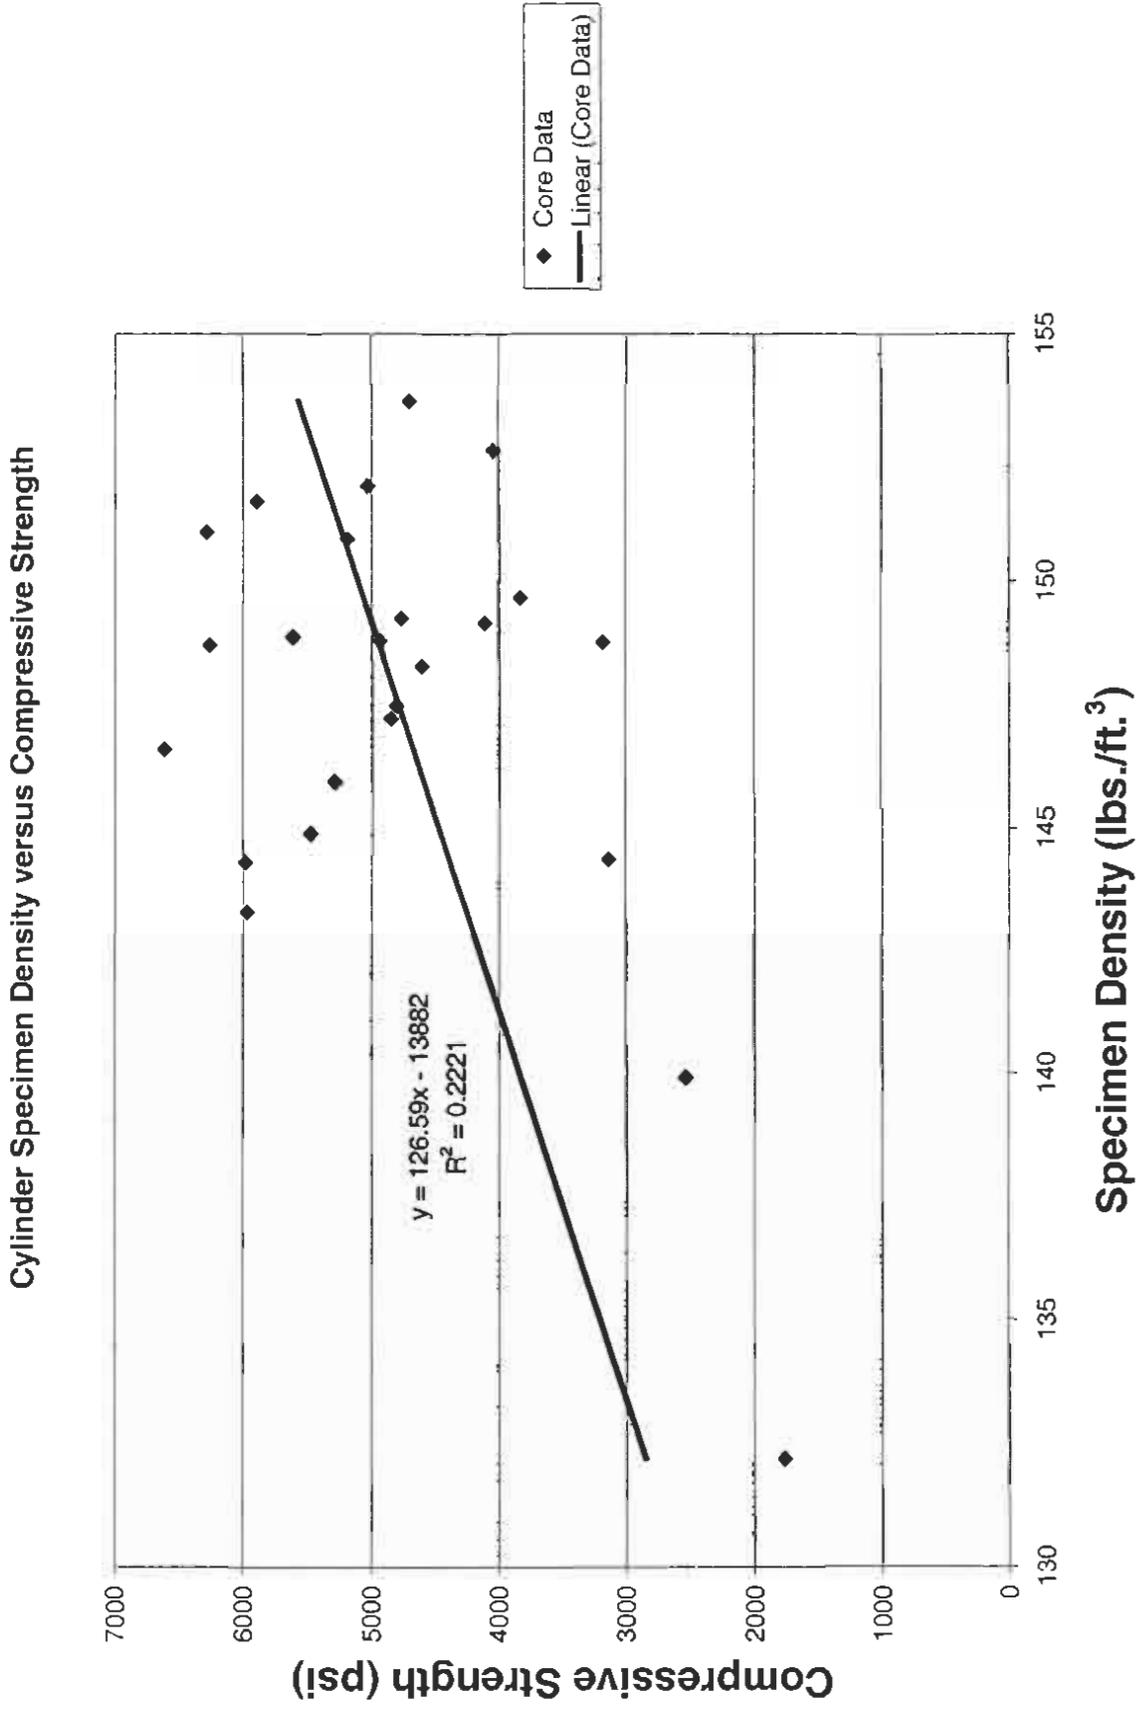
Figure 9.26. Cylinder Specimen Density versus Compressive Strength.

In order to verify the thickness and strength of all HVS test sections, coring and compressive strength testing was conducted. As shown in Appendix A, there are 4 HVS test sites in each test section, for a total of 24 potential HVS tests. A core was taken from each slab on which an HVS test was planned. The core was taken about 1 m from the non-loaded slab edge. The core diameters were nominally 100 mm for all test sections. Table 9.29 shows the location of each core and the measured core thickness. Note that the measured core thicknesses varied greatly from the target thicknesses. The average core thickness was 8 percent greater than the design thickness. This average thickness had a 10.5 percent standard deviation and a 137 percent coefficient of variation. This large variation indicates that the thickness of the constructed slabs could vary as much as 30 percent from the design thickness. This variation in core thickness was most likely the reason for the high variability found in all the HWD results.
