# Use of Fiber Reinforced Concrete in Bridge Approach Slabs

## Final Report

**Report No. CA09-0632**

Civil and Environmental Engineering Department  
University of California, Berkeley  
Berkeley, CA 94720

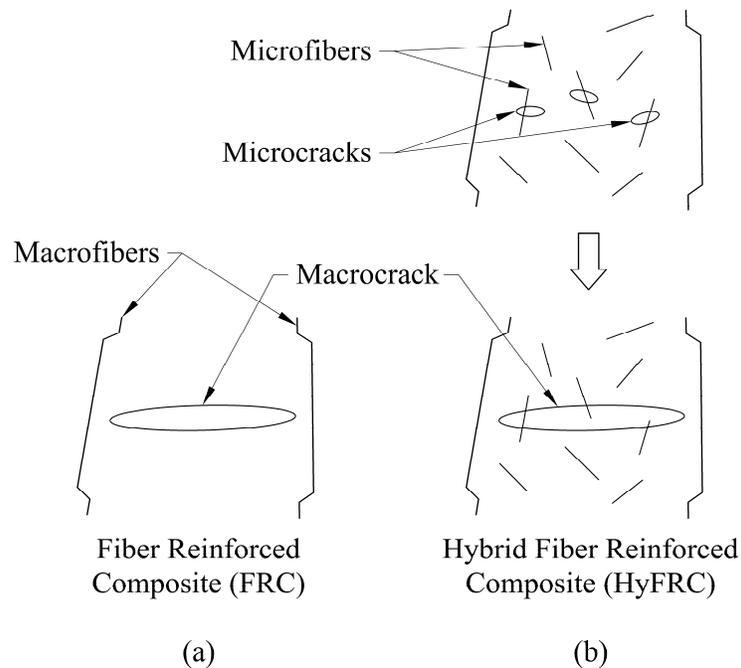
Fig. 1. – Schematic representation of fiber spacing and characteristic cracking in (a) FRC and (b) HyFRC

Since cracks initiate as microcracks, they need to be influenced at this stage, prior to becoming macrocracks. One effective way to enhance the resistance to crack propagation is through fiber reinforcements. However, conventional fibers are not well suited to bridge and influence these small microcracks at onset because their diameters are too large and the fibers are spaced too far apart in conventional FRCs (Fig. 1a). To influence these microcracks, microfibers were utilized. Not only are their diameters much smaller ( $10\text{-}40\mu\text{m}$  compared to  $500\mu\text{m}$  of conventional macrofibers), their numerical density (number of fibers per area of any cross section) will be much higher for microfibers than it is for macrofibers for identical fiber volume fractions (Fig. 1b)). Once microcracks become macrocracks, they need to be bridged by macro fibers to resist further propagation and crack opening. Hence, a HyFRC based matrix appears to be an effective means to resist crack propagation.

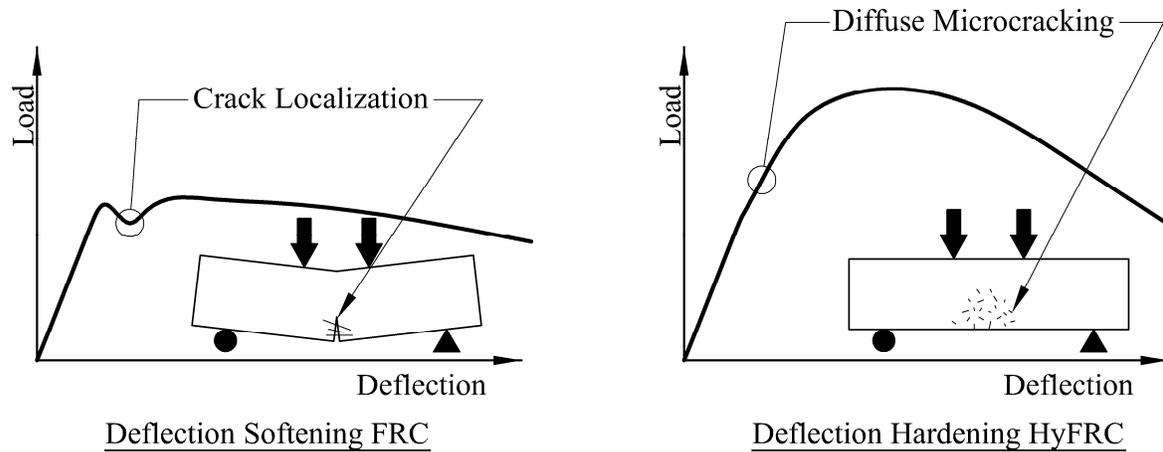
Fig. 2 – Comparison between deflection softening and deflection hardening

*ii) Post crack flexural stiffness* is necessary to prevent excessive deflection of bridge approach slabs after soil erosion. In order to retain stiffness, the HyFRC composite needs to delay macrocrack formation and exhibit deflection hardening. However, the enhanced matrix strength due to the low w/c ratio of 0.4 at a low fiber volume fraction, typically used in conventional FRC's, is more likely to promote the formation of a localized crack system which is characterized by a lower toughness, fiber pull-out and a single, large width crack (Li and Wu 1992, Tjiptobroto and Hansen 1993). Banthia and Trottier (1995) showed that in terms of flexural response, this is most commonly characterized by load instability immediately following macrocrack formation in the matrix. It is also apparent that for any load demands in excess of the matrix cracking strength, the onset of crack localization results in reduced stiffness. This is schematically shown in Fig. 2. In this case, given a conventional fiber reinforced matrix of one type of fiber and a HyFRC at the same total fiber volume fraction  $V_f$ , a load demand  $P$  in excess of the first crack strength will produce a deflection  $\Delta_{\text{FRC}}$  and  $\Delta_{\text{HyFRC}}$  in the FRC and the HyFRC composite respectively. Elimination of the load instability results in a condition where  $\Delta_{\text{HyFRC}}$  will always be less than  $\Delta_{\text{FRC}}$ . The HyFRC composite needs to be designed such that it eliminates the instability and increases the composite strength following the matrix first crack strength. It is important to note that hardening is anticipated only under a flexural stress distribution. This behavior does not imply a hardening response in direct tension.

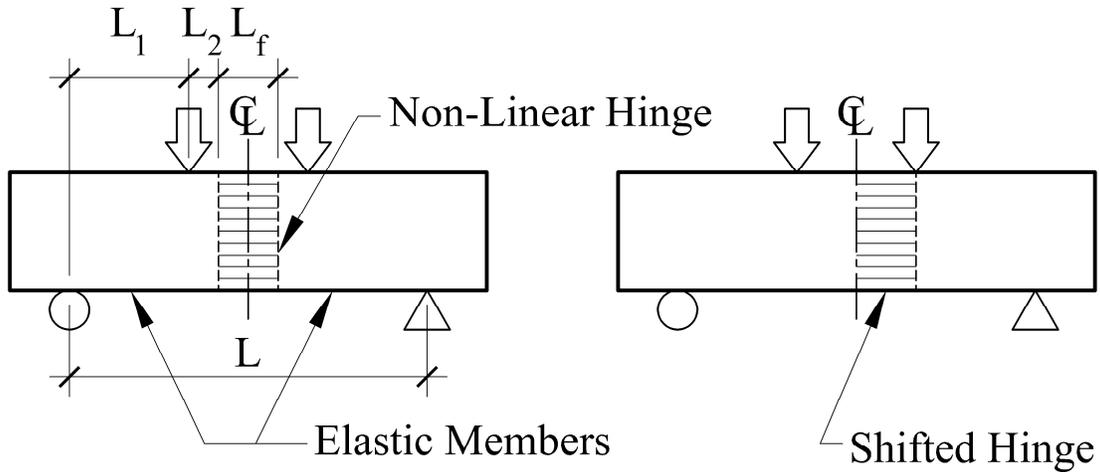
Fig 3: Modeling Method

A performance criteria associated with the yield strain of rebar is an effective benchmark for the design of a HyFRC composite. However, it is very difficult to use strain alone as a performance criterion. This arises from the fact that the discrete nature of crack formation and resulting failure in plain concrete makes experimentally determined values of strain heavily dependent on the specimen size and monitoring method. Hence, a numerically based computational approach was employed to determine the expected flexural performance of the HyFRC composite in four point bending. The modeling method consisted of combining elastic beam flexure with a layered non-linear hinge based on fictitious crack propagation. The model was robust enough so that the width of the nonlinear hinge  $L_f$  could be varied as well as the position of the hinge relative to the centerline of the beam. This is shown in Fig. 3.

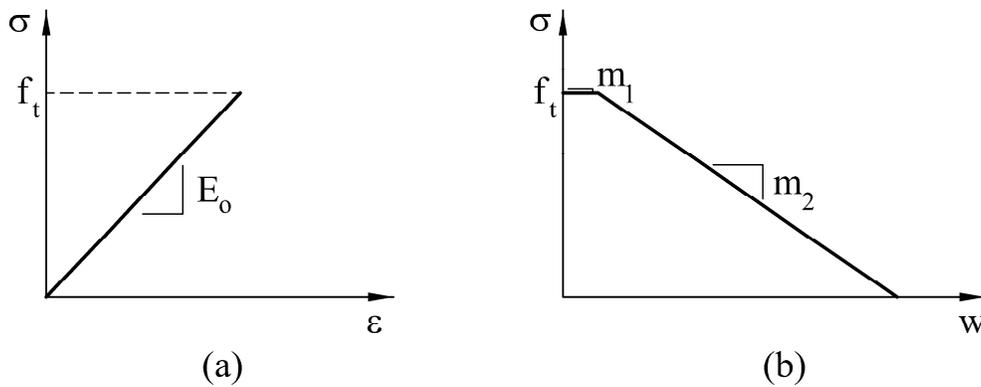
Fig. 4: Proposed Constitutive Parameters for (a) Elastic Tensile  $\sigma-\epsilon$  Behavior and (b) Cracked Tensile  $\sigma-w$  Behavior

Flexure load-deformation behavior was determined by incrementing the hinge rotation and then numerically solving for a compatible stress distribution. In the hinge region an Euler-Bernoulli compatibility assumption was used while a Timoshenko type shear deformation relationship was incorporated in the elastic regions to account for the deep beam proportions. The cracked portion of the hinge was approximated with a bilinear stress-crack width  $\sigma-w$  relationship with slopes  $m_1$  and  $m_2$ . Parameters for defining the nonlinear constitutive behavior are shown in Figs. 4 & 5.

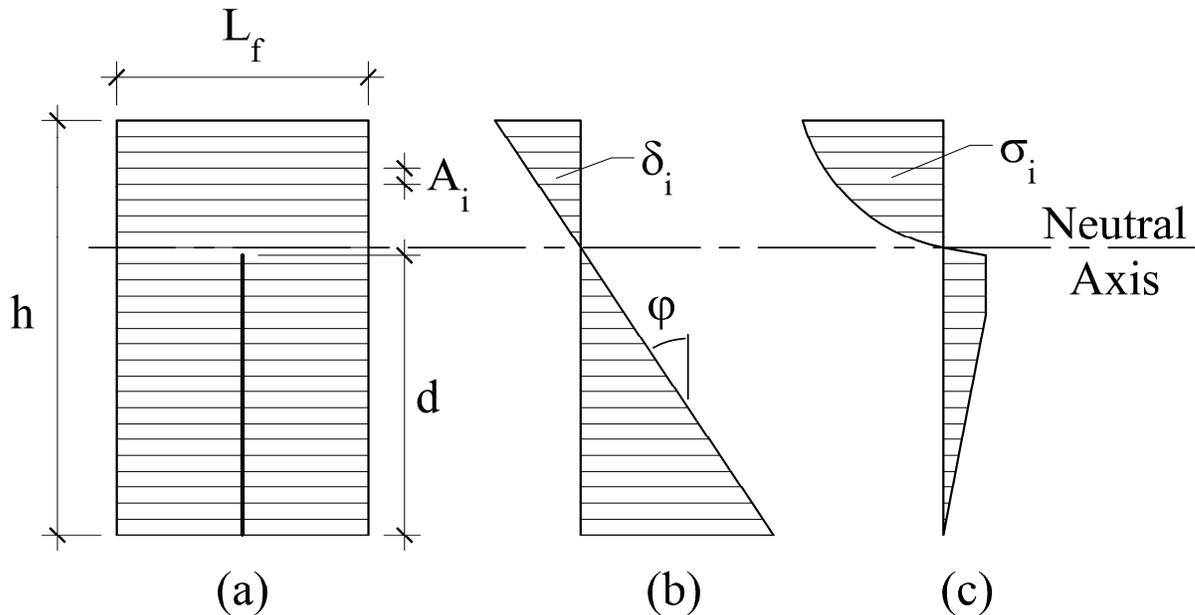
Fig. 5: Schematic Representation of (a) Hinge Discretization, (b) Assumed Section Rotational Displacement and (c) Stress Distributions

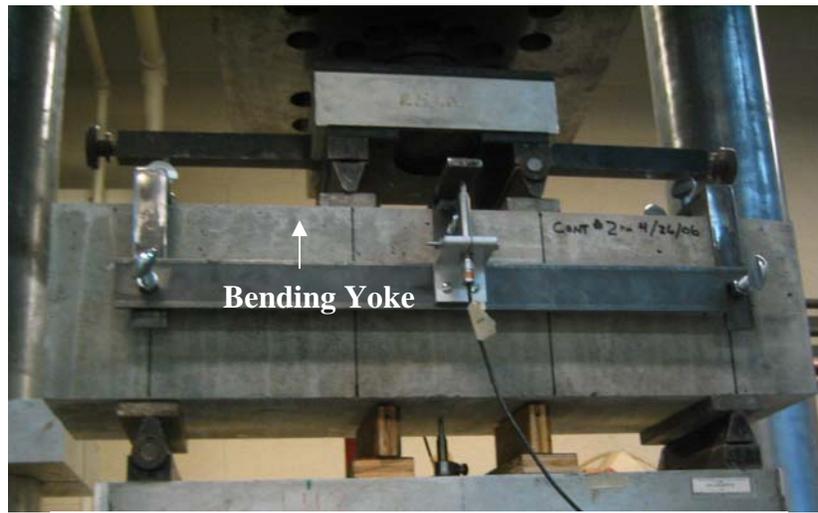
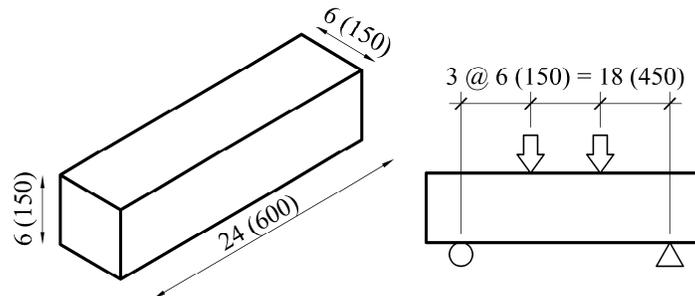
Fig. 6 – Four point flexure test setup [in. (mm)]

extraneous displacements associated with support settlement and stiffness of the test apparatus. The bending yoke was anchored at the support points along the beam neutral axis. A Linear Variable Differential Transformer (LVDT) was attached to the yoke on both sides of the beam. The average displacement between the two LVDT's was used as the measure of the beam centerline displacement.

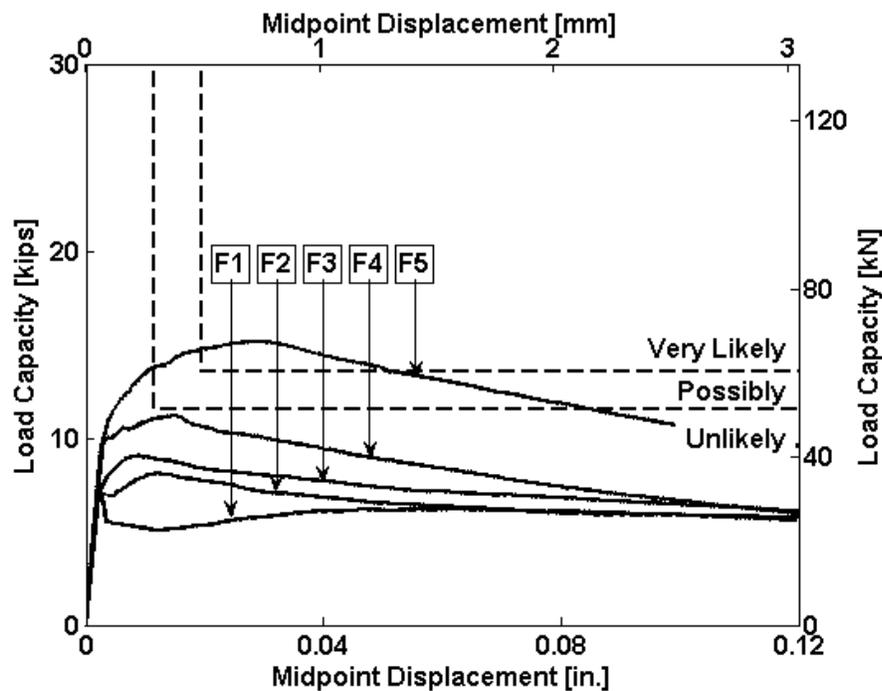
Fig. 7 – Trial batch flexural behavior plotted against the strain based deflection hardening performance goals (CONC1 matrix w/ air = 5-8%)

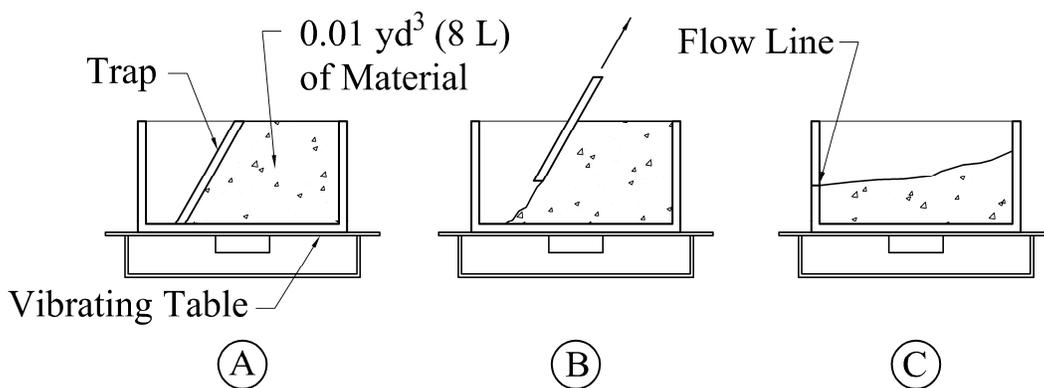
Fig. 8 – Proposed consistency measuring method

assume fibers affect the consistency of the concrete on the same level as the aggregate and that the most workable mix is the one that has the densest packing of the sand, gravel and fiber phases. Once the fiber proportions were determined the fine aggregate to coarse aggregate (sand to gravel) weight ratio could be varied and consistency measured through the use of a workabilimeter. The workabilimeter used by Rossi and Harrouche used an external vibrating apparatus which was attached to a box and could vibrate 0.04 yd<sup>3</sup> (30 L) of concrete. It is noted that this is a particularly robust means to measure the consistency of fiber reinforced and other stiff concrete based mixes. The use of an electric or pneumatic based external vibrator allows it to be easily adapted for field use. Due to constraints associated batch sizes, a 0.01 yd<sup>3</sup> (8 L) workabilimeter was constructed and vibrated in a manner similar to that used by Massicotte et al. (2000). This process of using the workabilimeter is outlined in Fig. 8.

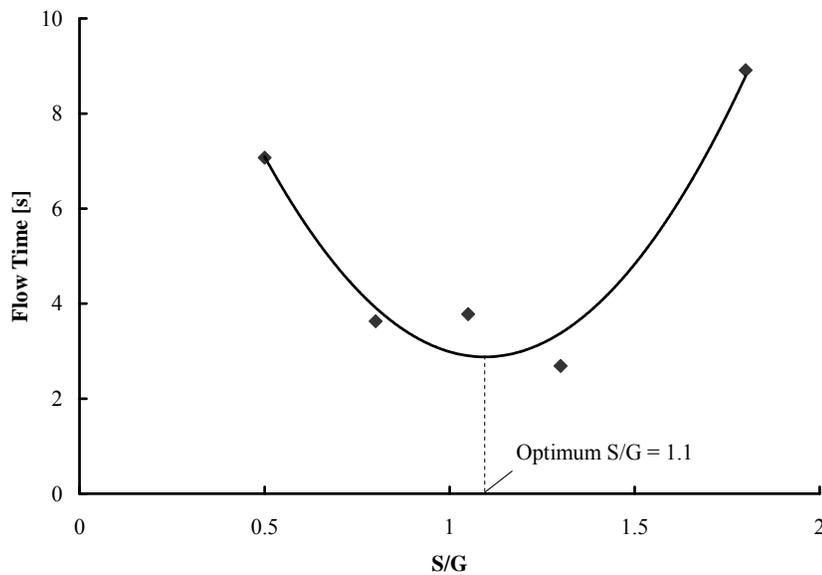
Fig. 9 – Consistency variation with sand to gravel weight ratio (S/G)

material to flow across the box and up to a pre-determined flow line. The process is repeated for different sand-to-gravel weight ratios (S/G) and the optimum mix is chosen from the mix that produces the minimum flow time. This process was carried out for the hybrid fiber gradation under consideration and the data is provided in Fig. 9. The optimum S/G was determined from a best-fit parabolic regression. A practical difference between the mix consistencies was not discernable in the range of 1.0 – 1.3. A S/G = 1.1 was chosen as an acceptable intermediate value that weighted more heavily toward the coarse aggregate side to promote a stiffer, more abrasion resistant material.

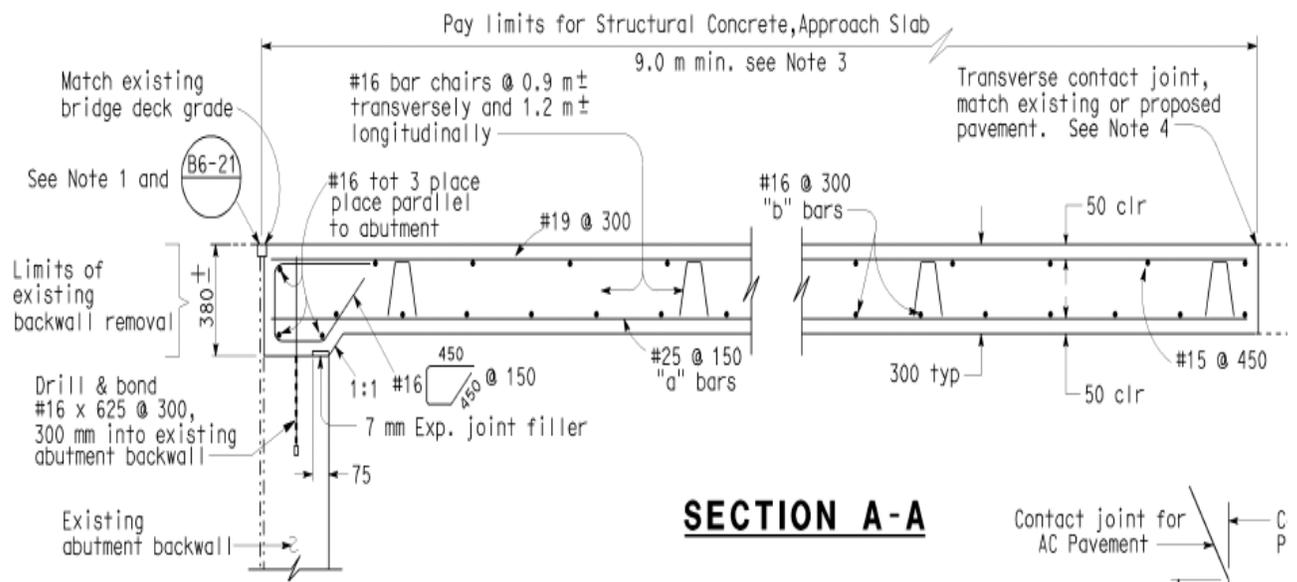
Fig. 10. CalTrans existing Bridge Approach slab design.

The existing CalTrans bridge approach slab design was used as the basis for element sizing and reinforcement ratios (Fig. 10). A longitudinal section (parallel to the flow of traffic) of the existing slab design is shown in Fig. 11a. It is anticipated that surface cracking in the bridge approach slab can accelerate durability related problems such as corrosion and spalling. Mechanisms for such cracking include restrained contraction due to drying and thermal mechanisms where sufficient tensile stresses develop that cause cracking. In order to approximate this behavior, 1/2 scale beam specimens were prepared (Fig. 11b).

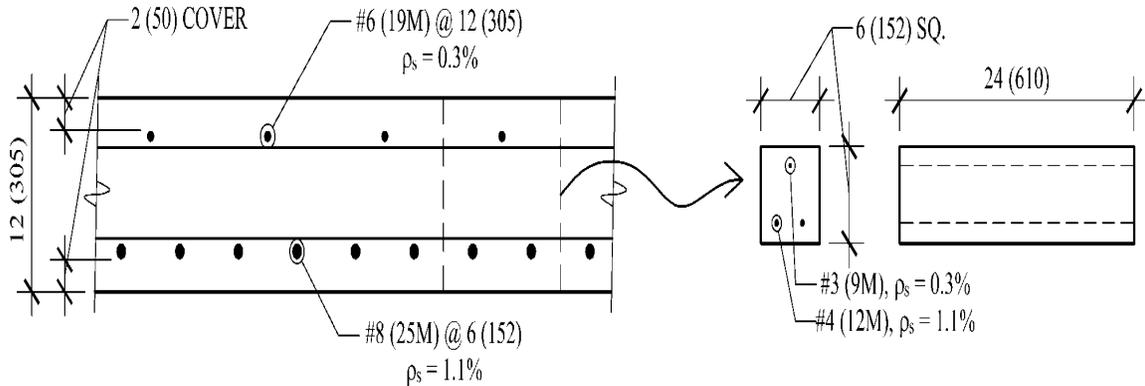
Fig .11. a) Longitudinal Section of Existing Bridge Approach Slab (BAS); b)  $\frac{1}{2}$  scale model of BAS

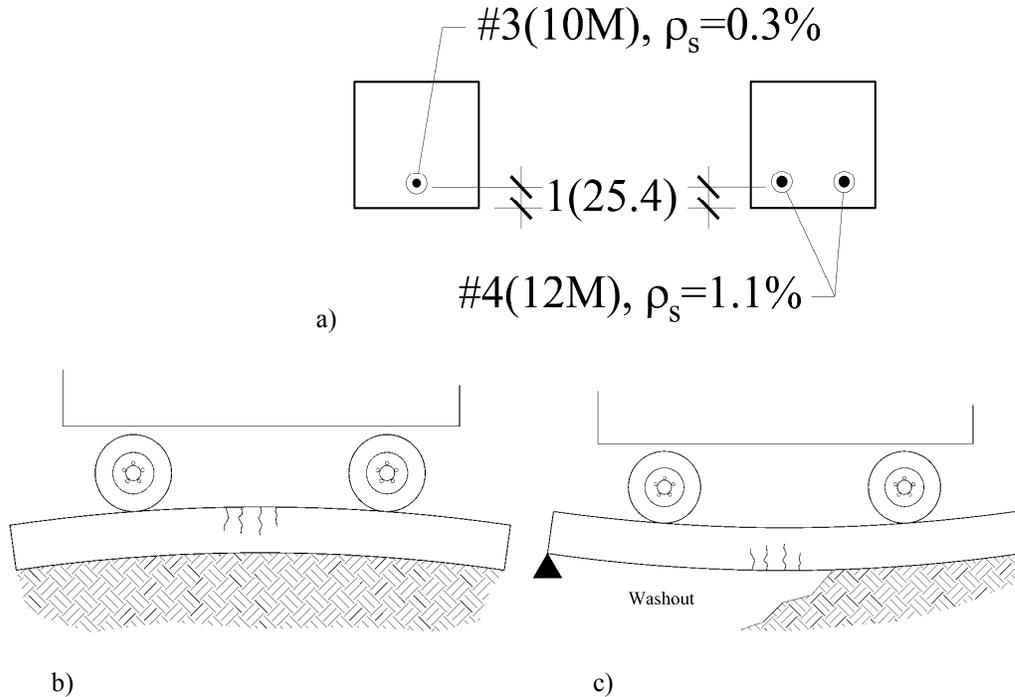
Fig. 12 – a) Rebar layout for reinforced beam element tests; b) rebar ratio of 0.3% in the tensile surface of the flexure specimens represents the top surface of the BAS and cracking associated with truck loading, drying shrinkage etc. prior to soil wash-out; c) rebar ratio of 1.1% in the tensile surface of the flexure specimens represents the bottom surface of the BAS and the cracking associated with soil wash-out.

Beam specimens maintained the same dimensions shown in Fig. 6 and rebar was included in the manner shown in Fig. 12. Monotonic load-displacement tests were carried out for both un-reinforced and reinforced specimens consisting of plain concrete and the HyFRC in order to provide information regarding relative contributions of the constitutive materials to the element performance. Four conditions were tested; plain concrete, reinforced plain concrete, plain HyFRC and reinforced HyFRC. In terms of description and labeling for the remainder of this study, the use of “plain concrete” or “HyFRC” as a descriptor refers to the matrix composition only. Incorporation of the term “reinforced” refers to the use of rebar. Therefore a reinforced plain concrete specimen is an element composed of the plain concrete matrix and contains rebar.

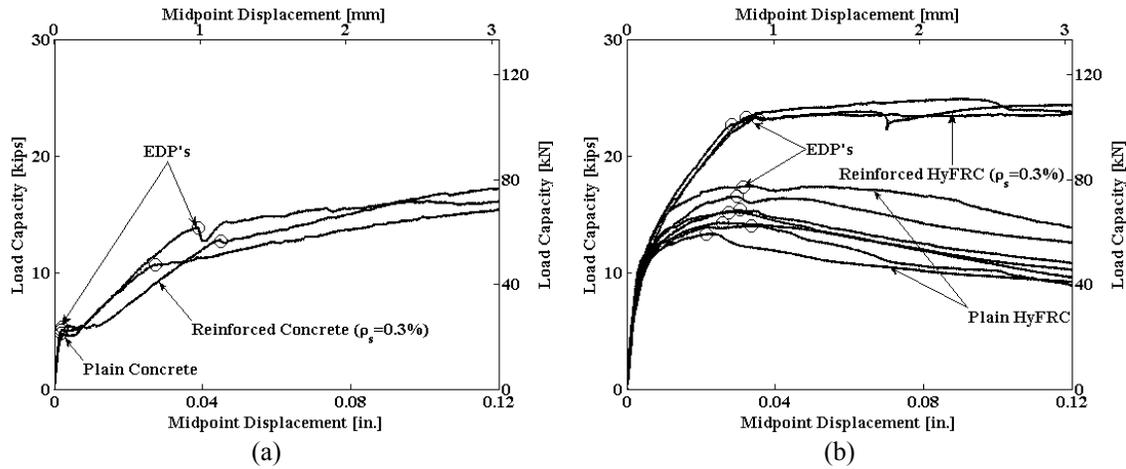
Fig. 13 – Flexure test results for (a) plain concrete and (b) HyFRC specimens

conventional bar steel yield. A summary of the average EDP's for the results shown in Fig. 13 are provided in Table 4.

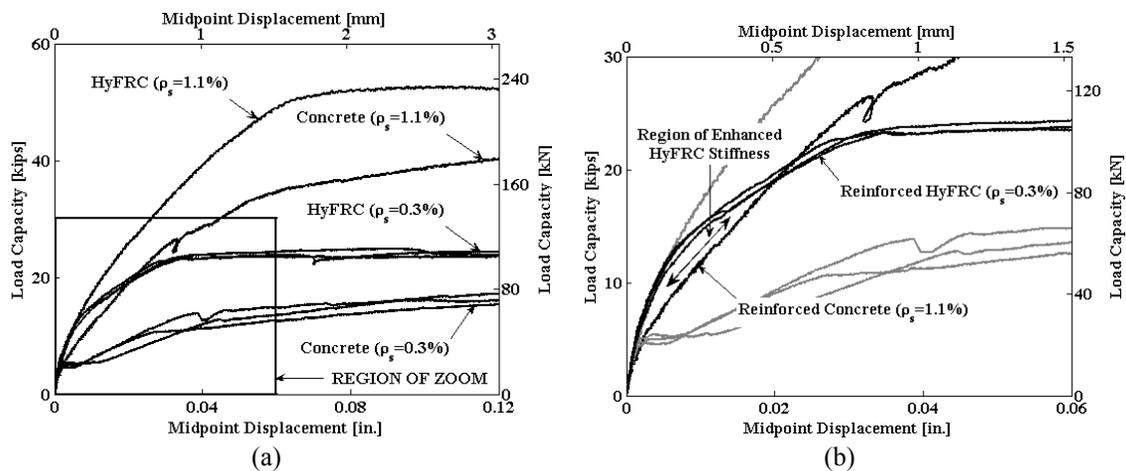
Fig. 14 – (a) Flexural performance of reinforced specimens with different reinforcing ratios  $\rho_s$  and (b) zoomed region highlighting enhanced HyFRC flexural stiffness

The flexural results of the beam specimens with the higher reinforcing ratio ( $\rho_s=1.1\%$ ) is shown Fig. 14. The flexural yield strength and stiffness of the heavily reinforced HyFRC element was greater than its reinforced plain concrete counterpart, however the difference was reduced to a 67% increase in strength. An interesting phenomena is highlighted when the minimally reinforced HyFRC element ( $\rho_s=0.3\%$ ) is compared against the heavily reinforced plain concrete element ( $\rho_s=1.1\%$ ). It is evident that the reinforced concrete element is much stronger; however in the region immediately following concrete cracking the HyFRC shows a significantly stiffer behavior (Fig 14b). This response has implications for crack control that were utilized during the corrosion characterization portion of this study.

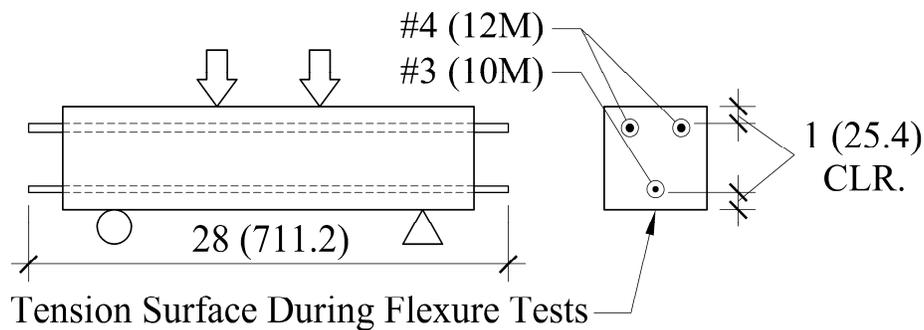
Fig. 15 – Beam specimen rebar layout and orientation during casting and testing [in. (mm)]

those specified in Fig. 6 and ASTM A615 Gr. 60 rebar was added in the configuration shown in Fig. 15. The rebar configuration and specimen size were chosen to represent  $\frac{1}{2}$  scale strip element from a CalTrans Type R(9S) (metric designation) bridge approach slab. The matrix type varied between the CONC1 and the CONC2 (Table 2) and the beam elements were subjected to varying degrees of cyclic load based flexural demands in order to induce surface cracking. Specimens were oriented during flexural cycling such that the top surface during casting became the flexural tension surface during testing.

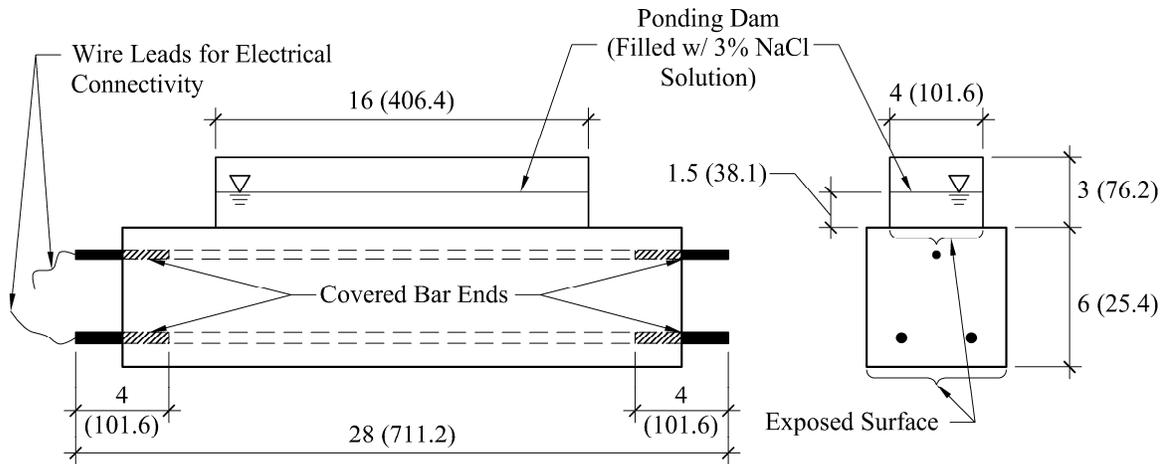
Fig. 16 – Beam specimen configuration for salt water ponding [in. (mm)]

by Ardex). The intent behind the sealing method was to increase the driving force behind the solution's intrusion into the beam matrix. The exposed bottom surface provided the only evaporation sink, which would effectively pull the solution through the matrix and create a vertical moisture gradient.

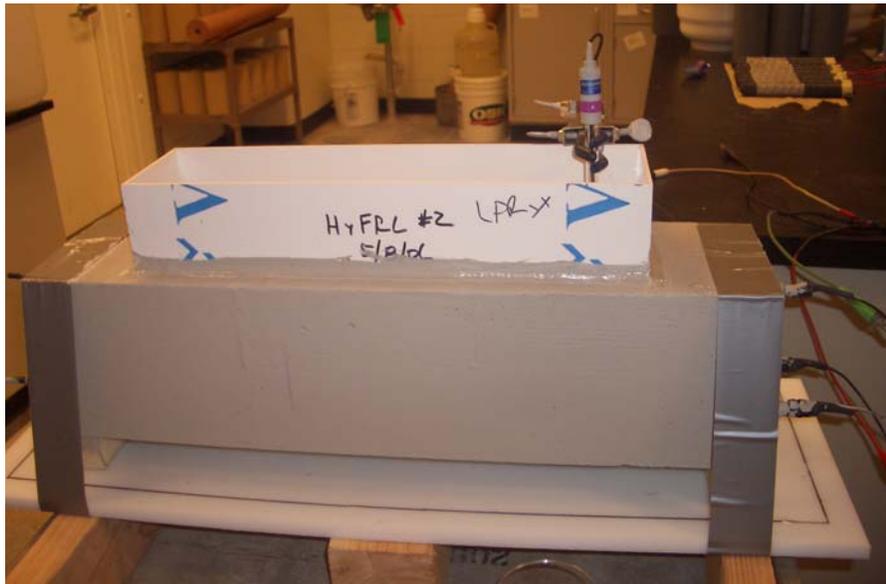
Fig. 17 – Picture of beam specimen prepared for corrosion monitoring

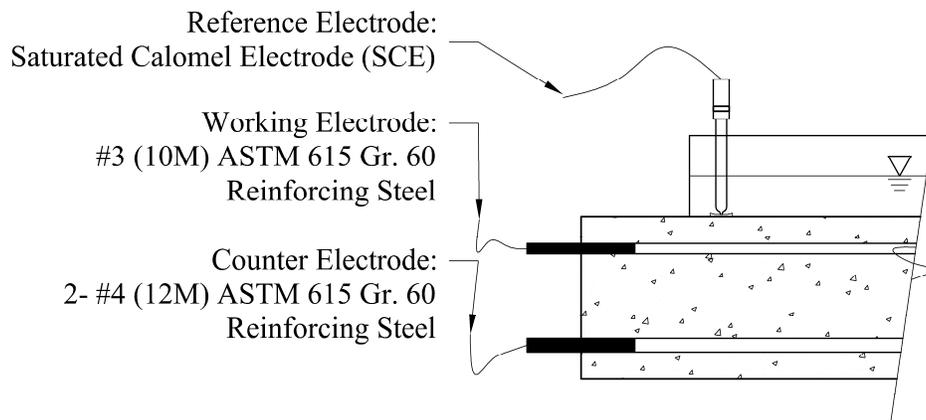
Fig. 18 – Embedded cell for corrosion monitoring experiments

For corrosion monitoring, the electrochemical cell was created by placing a saturated calomel electrode (SCE) directly into the ponding dam (Fig. 18). The SCE was used as the reference electrode. The top most #3 (9M) rebar was used as the working electrode (WE) and the two #4 (12M) bottom bars were connected and used jointly as a counter electrode (CE). The beam elements were stored in a hot chamber at 122°F (50°C) at 50% RH in between corrosion monitoring periods. Evaporation of the ponded solution was mitigated by covering the ponding dams with an acrylic sheet, however it was necessary to replace the solution on a weekly basis. The old solution was completely removed by vacuuming the exposed surface and a new sodium chloride solution with the specified concentration was added.

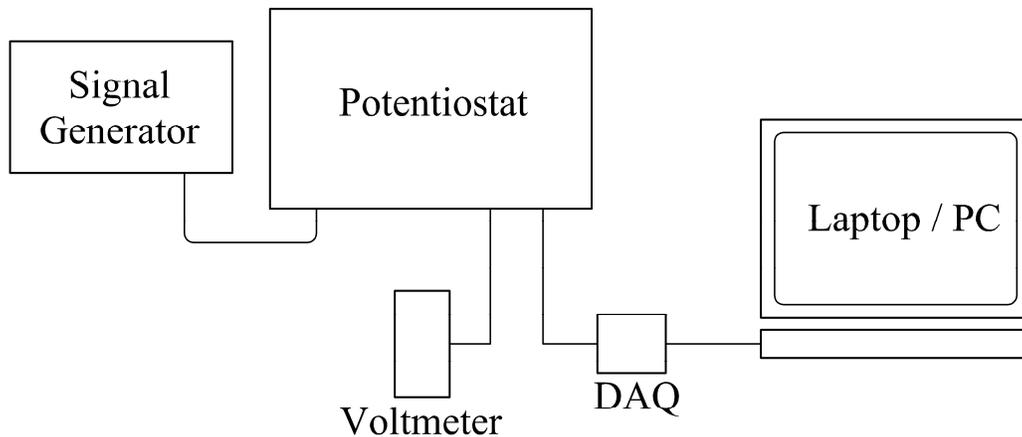
Fig. 19 – Schematic of corrosion monitoring setup

Corrosion monitoring was carried out through a series a direct current (DC), potentiodynamic measurements. An EG&G Princeton Applied Research model 363 potentiostat was used for this purpose. The experimental set-up also consisted of a custom built ramp signal generator which was used to control the rate of potentiodynamic sweeps and a Measurement and Computing USB-1208LS data acquisition (DAQ) module for automated data recording. The DAQ interfaced directly via USB with a personal computer (PC), where data was stored. This monitoring setup is illustrated schematically in Fig. 19.

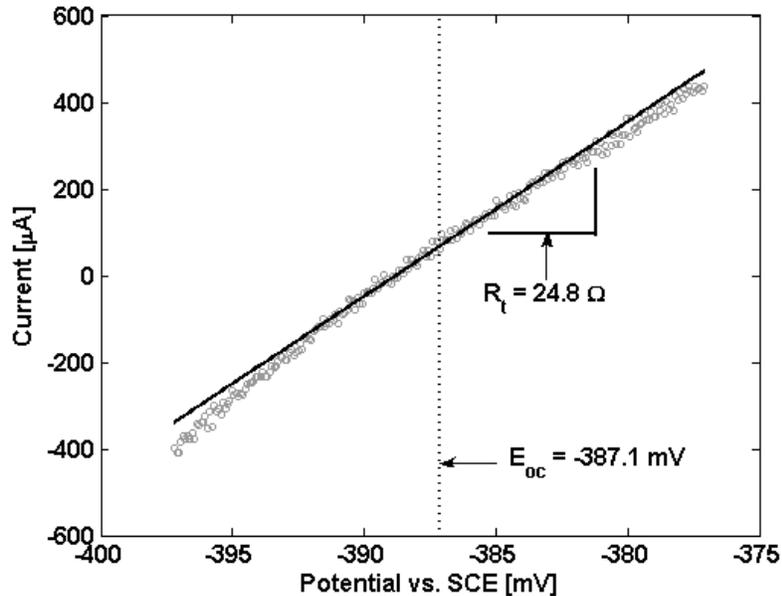
Fig. 20 – Example polarization resistance measurement

of the start of monitoring). Scans were carried out in the anodic direction with a span of  $\pm 10$  mV relative to the  $E_{oc}$  at a rate of 10 mV/min. Specimens were cathodically conditioned at  $E_{oc} - 10$  mV for 30 seconds prior to initiation of the PR scan. An example of the measurement results with data regression is provided in Fig. 20.

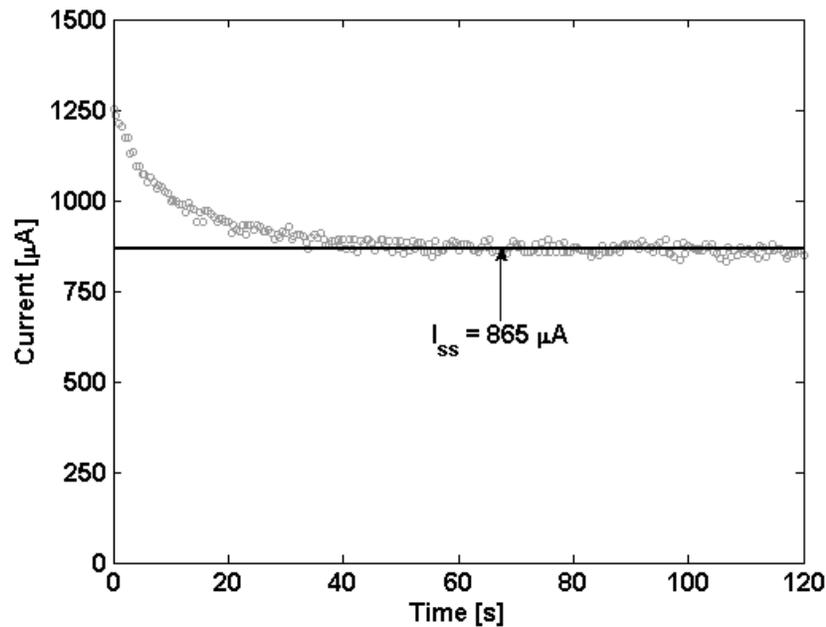
Fig. 21 – Example macrocell (galvanic current) measurement

removed from the hot storage chamber and immediately coupled in to the ZRA. The current was sampled at a rate of 2 Hz for 2 minutes. It was noted that a relatively steady state current flow  $I_{ss}$  was attained within 30-40 seconds of monitoring, so the galvanic current was determined by averaging over the data taken from 60 to 120 seconds within in the monitoring interval. This is shown in Fig. 21.

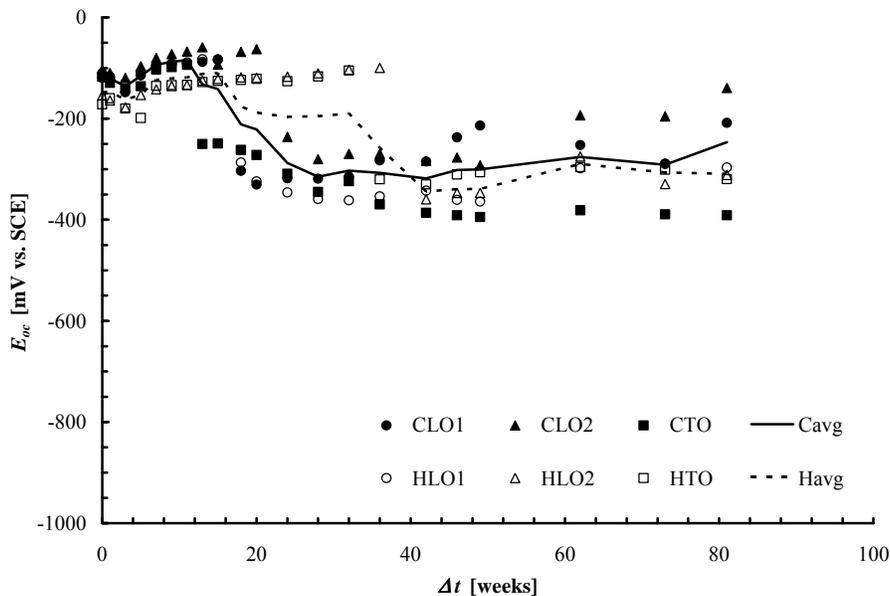
Fig. 22 – Uncracked beam specimen corrosion potentials

The first series of beam specimens were prepared with a CONC1 matrix and cast and cured (7 day wet, 21 day dry) as described previously. At the conclusion of the curing period, ponding dams were immediately adhered to the top surface during casting and the outer surfaces were coated with sealant. Ponding started 1 week following application of the sealant. The corrosion potential  $E_{oc}$  and the estimated corrosion current density  $i_{corr}$  based on the polarization resistance  $R_p$  measurements were measured periodically through an 80 week monitoring period. These results are provided in Figs. 22 and 23.

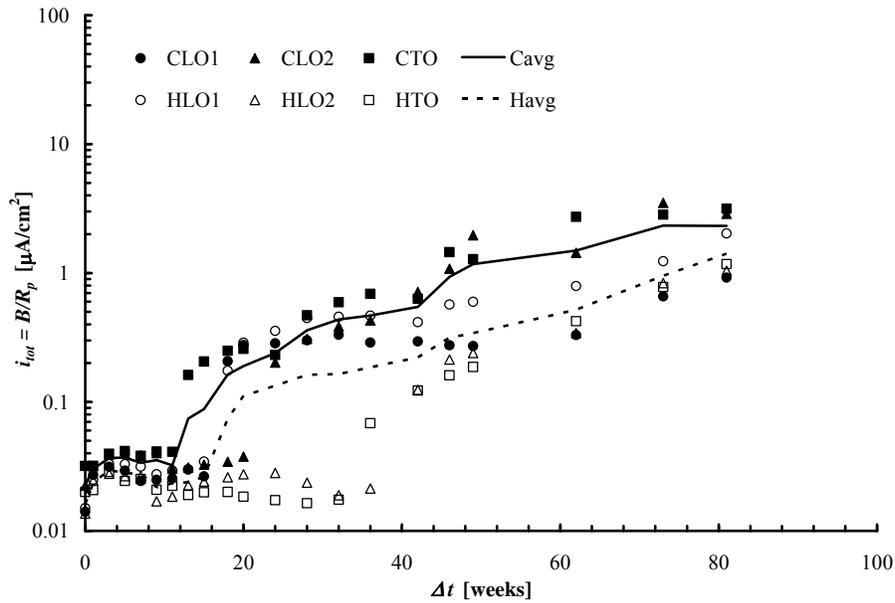
Fig. 23 – Estimated uncracked beam specimen corrosion current densities

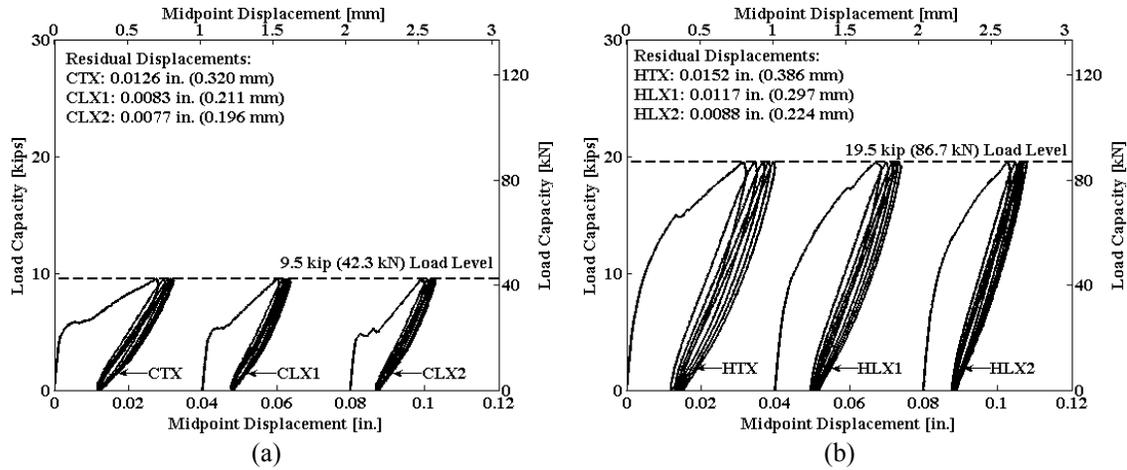
Fig. 24 – Cyclic flexure behavior for (a) reinforced plain concrete and (b) reinforced HyFRC

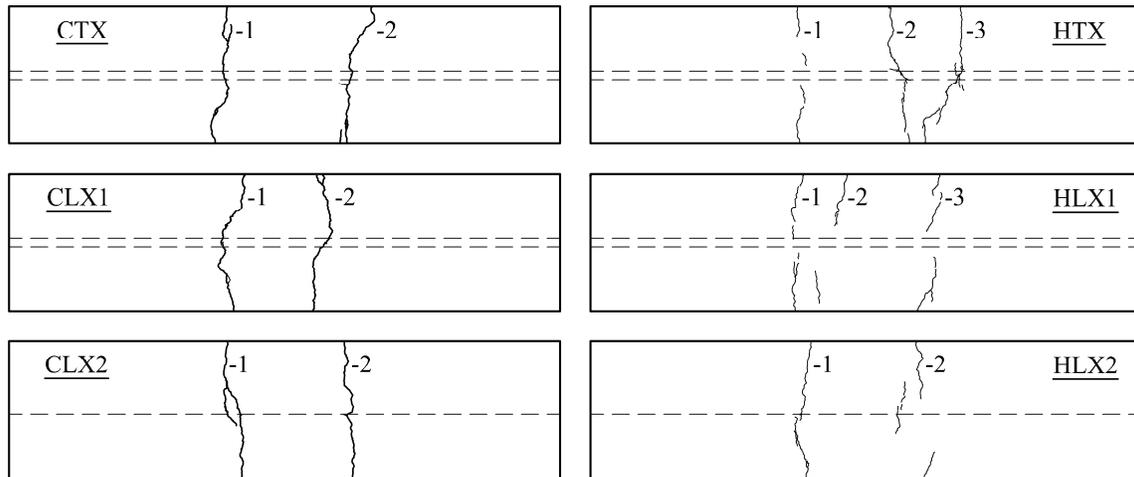
Fig. 25 – Cracked beam (similar displacement demand) tensile surfaces after cyclic flexure tests (dashed line represents position of the tensile rebar)

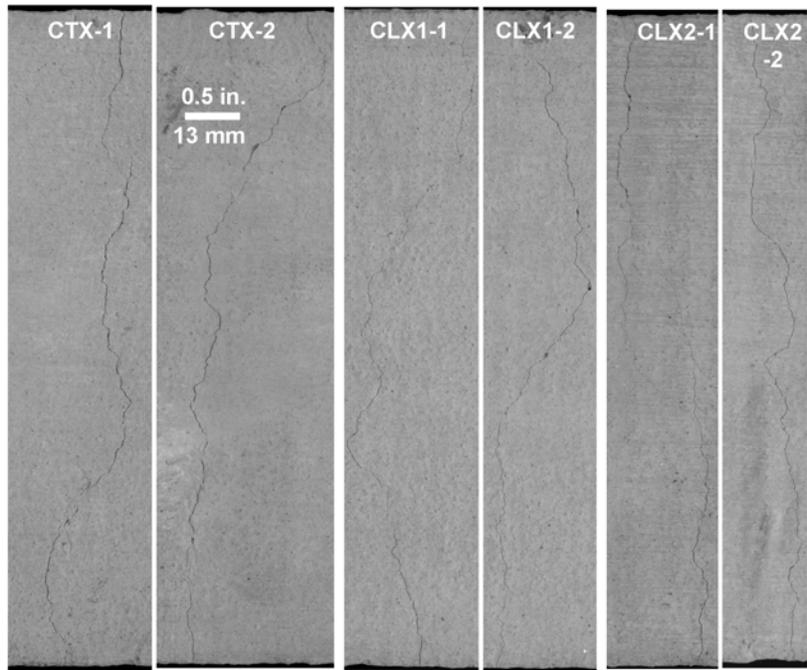
Fig. 26 – High resolution digital surface scans of reinforced plain concrete surfaces after cyclic flexure tests

also provided in Figs. 26 and 27 in order for a more accurate visualization of the surface cracking behavior.

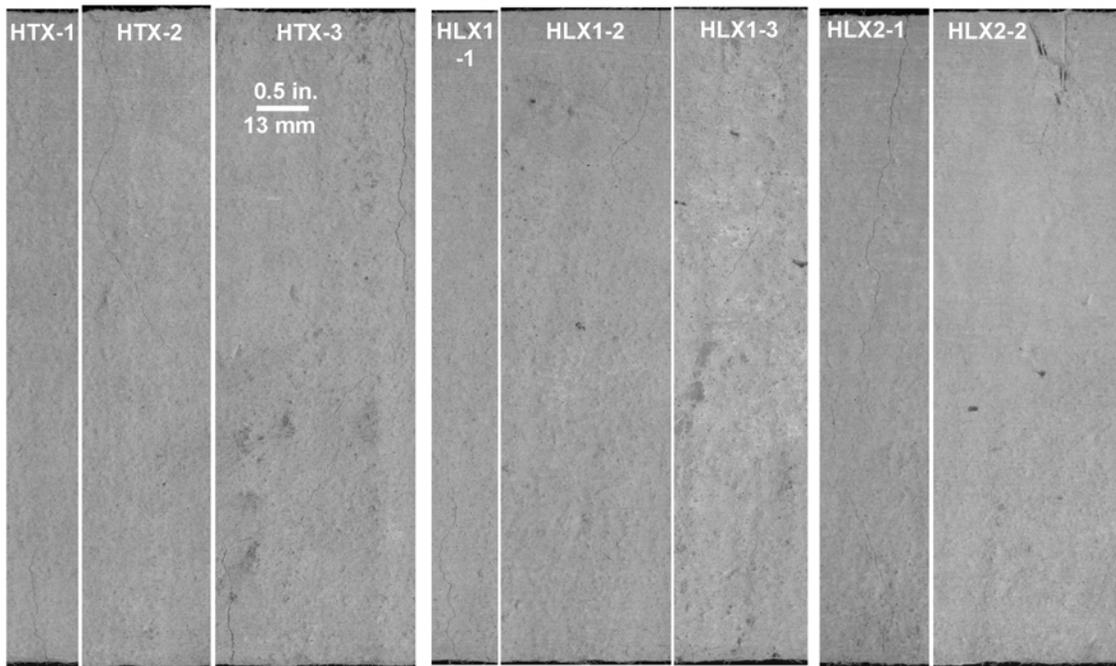
Fig. 27 –High resolution digital surface scans of the reinforced HyFRC surfaces after cyclic flexure tests

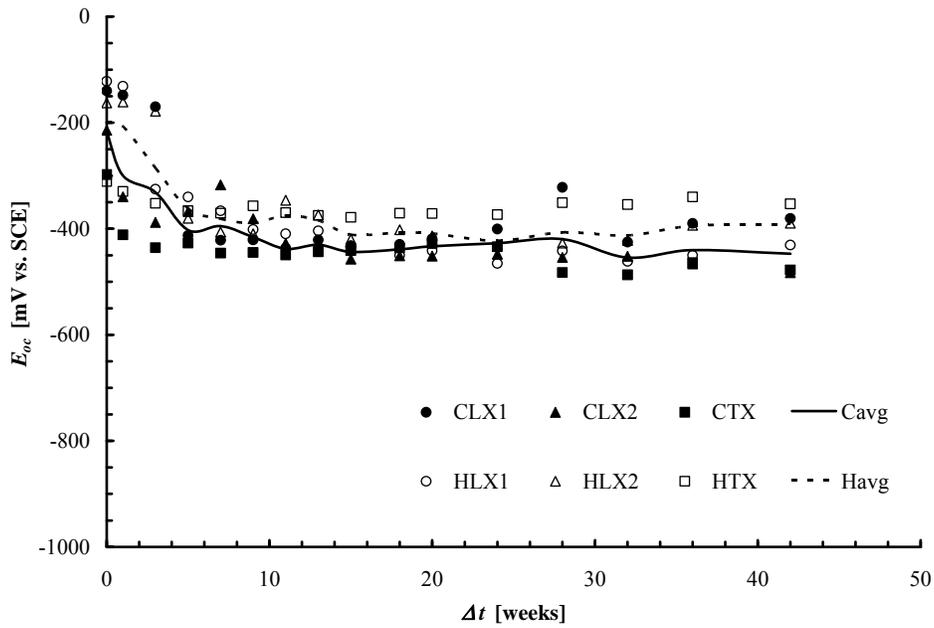
Fig. 28 – Cracked beam (similar displacement demand) specimen corrosion potentials

Following cyclic testing, the ponding dams were adhered to the cracked surface of the beam and the sides were coated with sealant. Salt water ponding began 1 week following the application of the sealant and corrosion monitoring commenced. The data for the corrosion potential  $E_{oc}$  and the estimated corrosion current density  $i_{corr}$  are provided in Figs. 28 and 29.

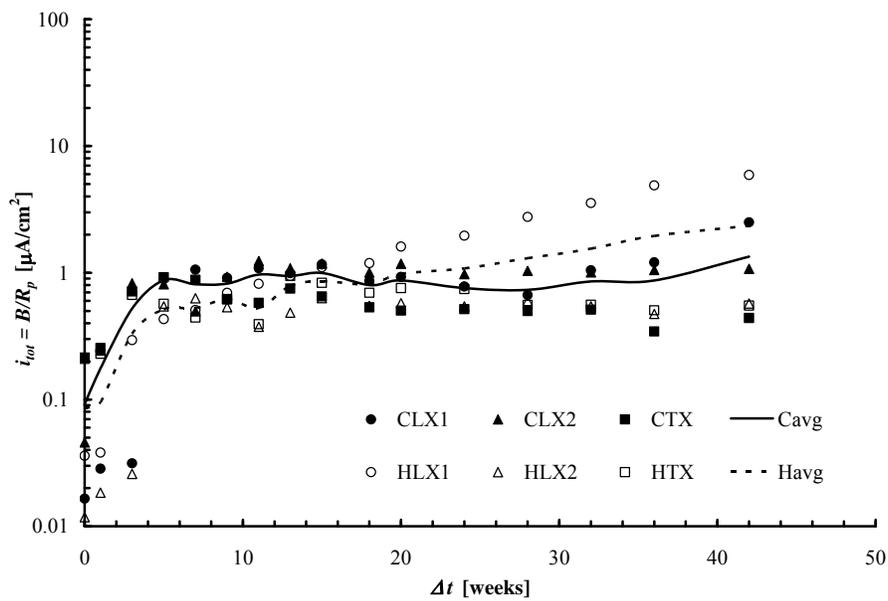
Fig. 29 – Estimated cracked beam (similar displacement demands) specimen corrosion current densities

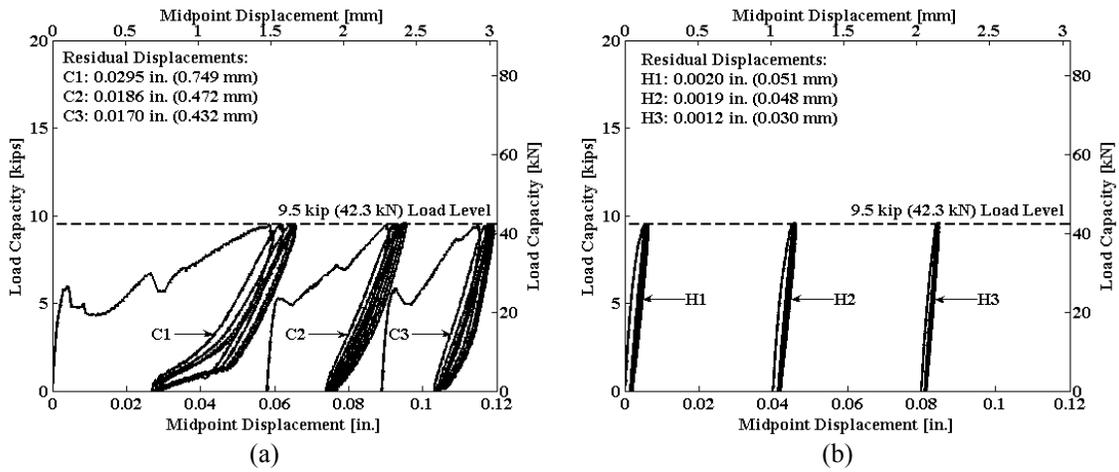
Fig. 30 – Cyclic flexure behavior for (a) reinforced plain concrete and (b) reinforced HyFRC

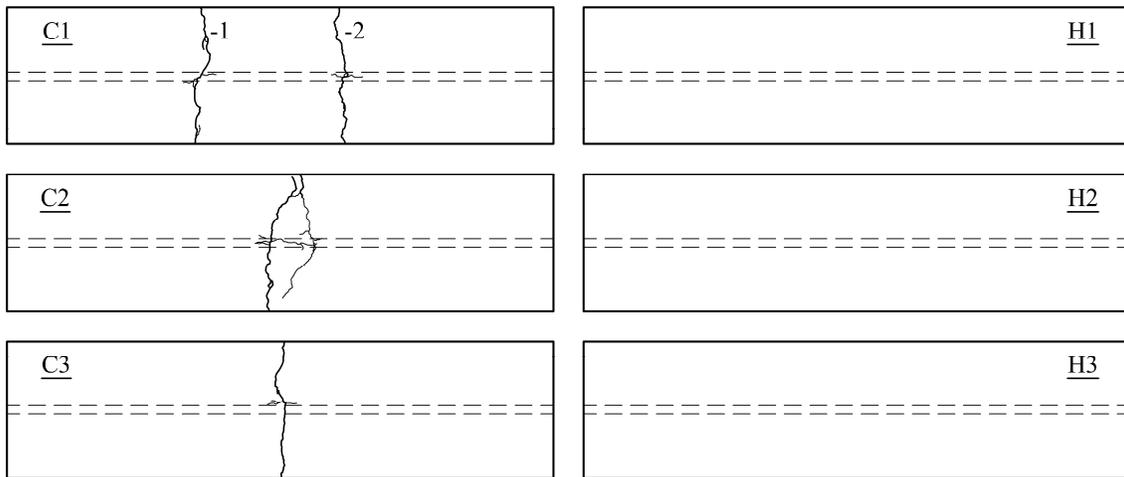
Fig. 31 – Beam tensile surfaces after cyclic flexure tests (dashed line represents position of the tensile rebar)

Another beam series was prepared for equivalent load based cyclic flexural demands. A CONC2 matrix was used for this beam series and the specimens were prepared, cast and cured in the same manner described previously (sections 4.1.1 and 4.1.2). Four point cyclic bend tests were carried out in the manner shown in Fig. 15 and these results are provided in Fig. 30. Schematics and high resolution scans of the tensile surface cracking follow in Figs. 31 and 32.

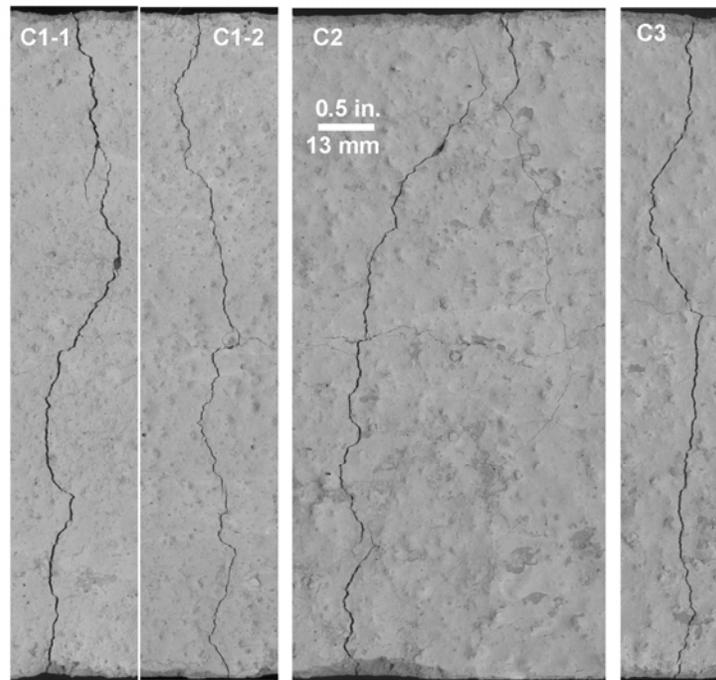
Fig. 32 – High resolution digital surface scans of the reinforced plain concrete after cyclic load testing

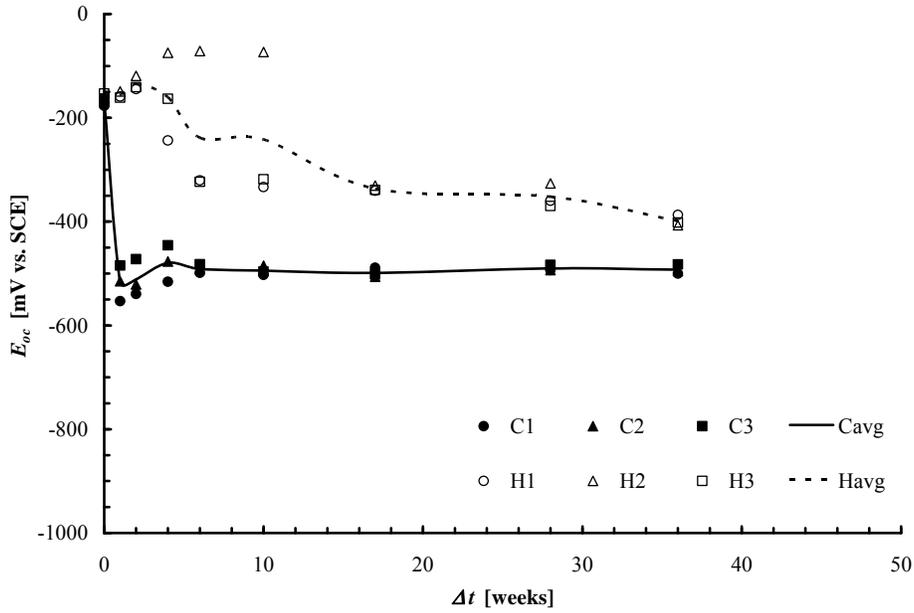
Fig. 33 – Cracked beam (similar load demand) specimen corrosion potentials

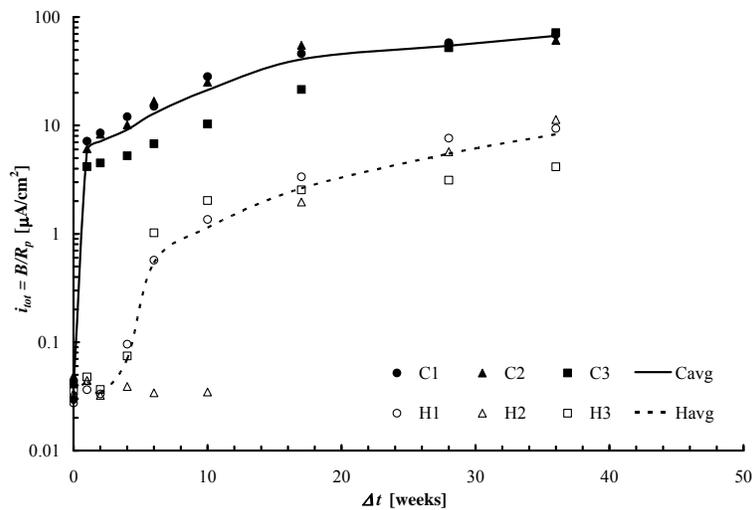
Fig. 34 – Estimated cracked beam (similar load demands) specimen corrosion current densities
