# Use of Fiber Reinforced Concrete in Bridge Approach Slabs

## Final Report

**Report No. CA09-0632**

Civil and Environmental Engineering Department  
University of California, Berkeley  
Berkeley, CA 94720

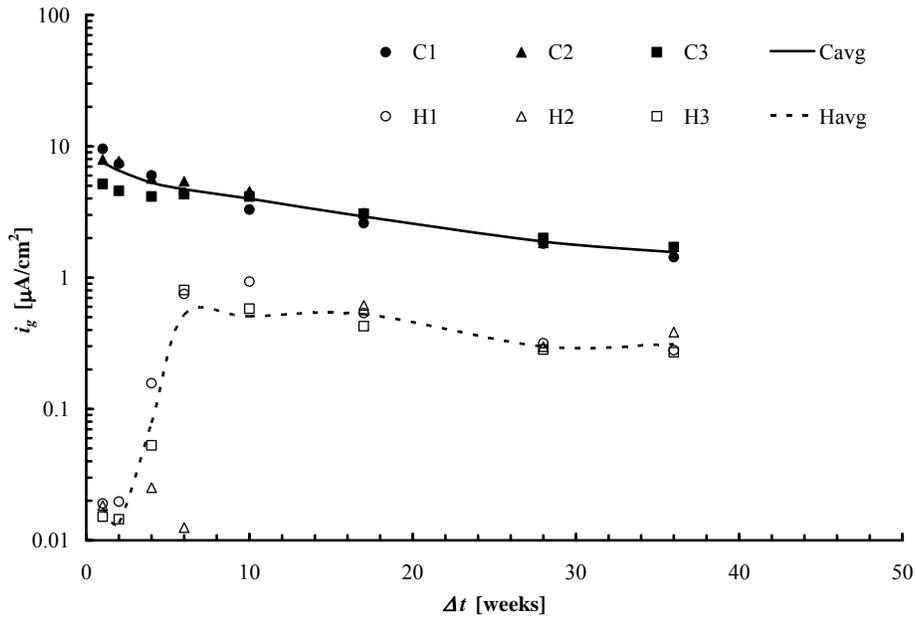
Fig. 35 – Cracked beam (similar load demands) specimen macrocell corrosion current densities

the bottom bars (CE) were electrically connected to the top (WE) so a macrocell was formed. The macrocell (galvanic) current density  $i_g$  is provided in Fig. 35.

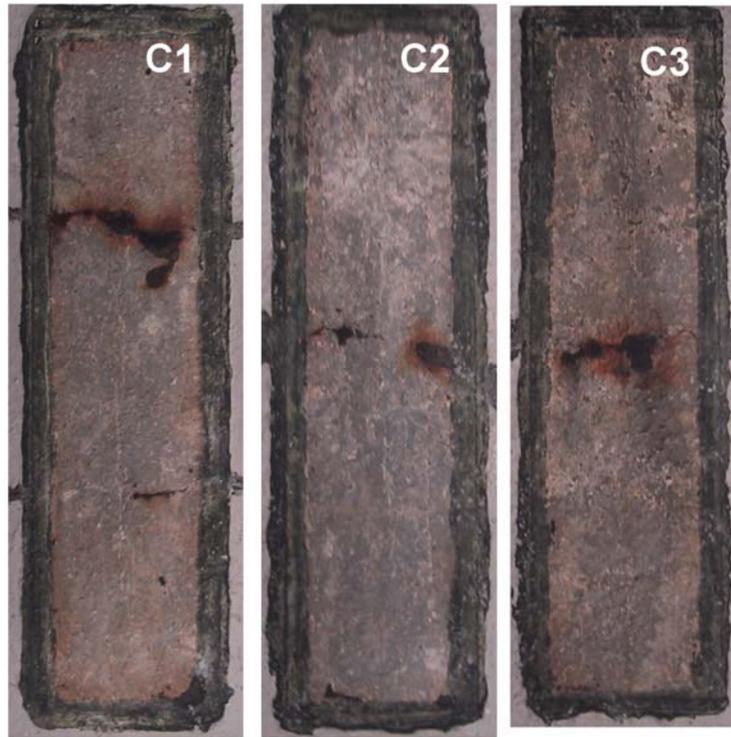
Fig. 36 – Reinforced plain concrete surface condition following salt water ponding (the black rectangular shape at the periphery of each specimen is the residue from the mastic caulk used to adhere the ponding dams to the concrete surface)

The electrochemical data shows a significant difference between the specimen types, with the reinforced HyFRC specimens having lower corrosion rates (both  $i_{tot}$  and  $i_g$ ). The average difference ranges between a factor of 8-10 along the corrosion monitoring interval, which is well outside the range of the anticipated 2x error. Corrosion in the reinforced plain concrete specimens was significant enough such that corrosion products were visible at the crack surface. This is shown in Fig. 36.

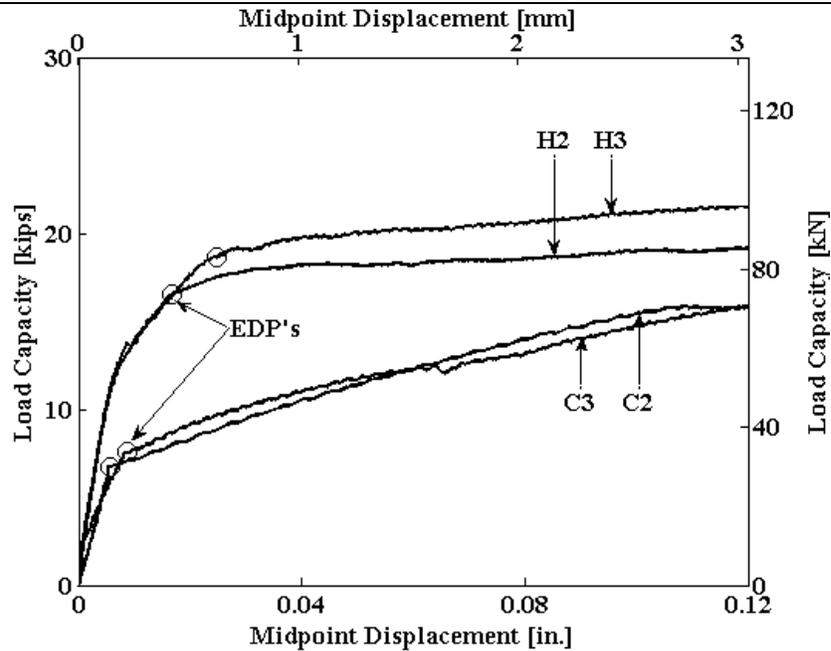
Fig. 37 – Monotonic flexure tests following 9 months of salt solution ponding

The significant difference in the specimen behavior warranted further study. A series of destructive tests were conducted to characterize the material post corrosion behavior. Monotonic, 4 point flexure tests were performed on 2 of the 3 samples for each material type and these results are presented in Fig. 37.

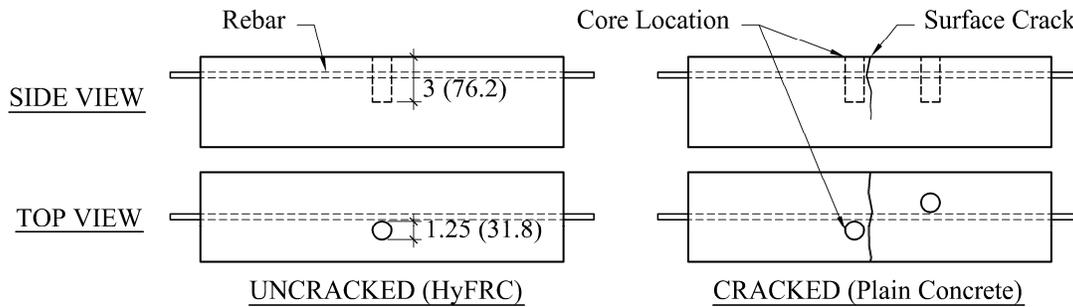
Fig. 38 – Schematic of core extraction location in beam specimens [in. (mm)]

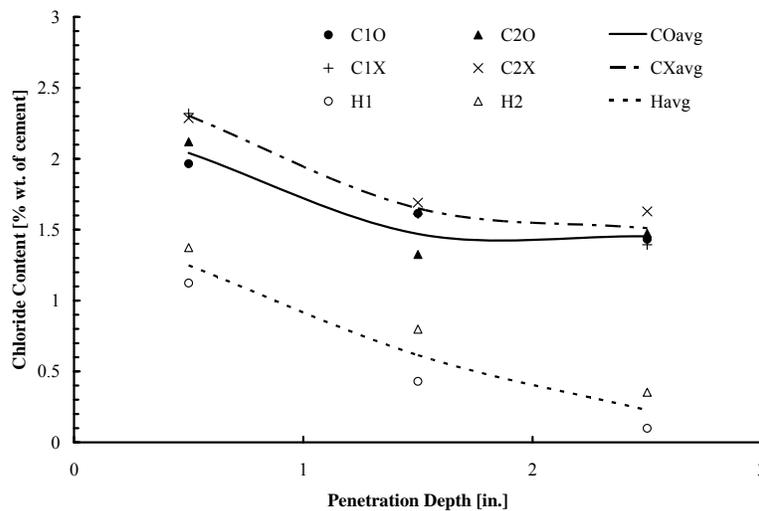
Fig. 39 – Chloride concentration profiles

extract the corroded rebar for visual and gravimetric assessment. In order to conduct the  $\text{Cl}^-$  concentration measurements 1.25 $\phi$  x 3 in. (31.8 $\phi$  x 76.2 mm) cores were taken through the top surface of beam element adjacent to the WE. One core was taken from the central region of the beam, however for the case where visible surface cracks were present during corrosion monitoring (plain concrete specimens) two cores were taken; one adjacent to the crack and another relatively far {3-4in. (76.2-101.6mm)} from the crack (Fig. 38). Core samples were dry cut in to 1 in. (25.4 mm) long segments to characterize the  $\text{Cl}^-$  concentration with depth. They were then prepared and tested per ASTM C1152 for acid soluble chloride content. These results are provided in Fig. 39.

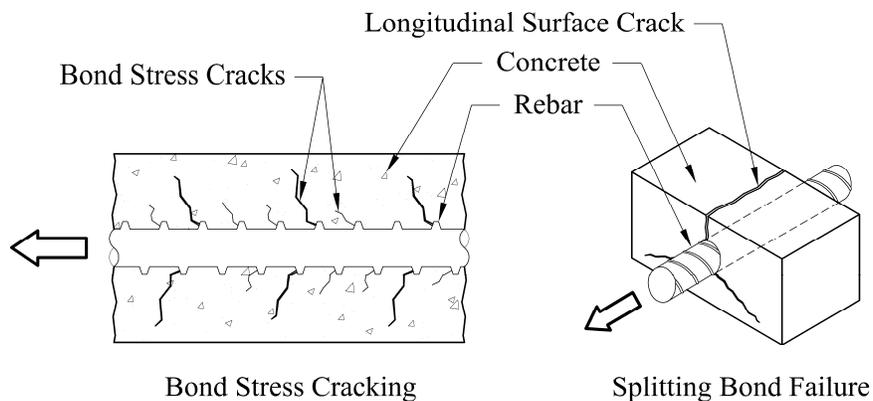
Fig. 40 – Cracking mechanisms from rebar/matrix bond interaction

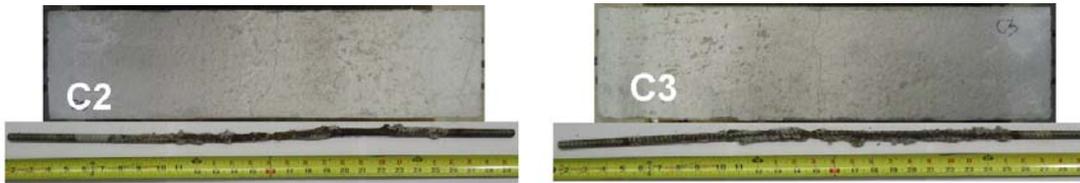
Fig. 41 – Corroded rebar in plain concrete beam specimens

section loss (see Fig. 43). Note that the pictures and scans (Figs. 41 – 43) can be adequately examined in detail in the original digital word document under a magnification of 500%.

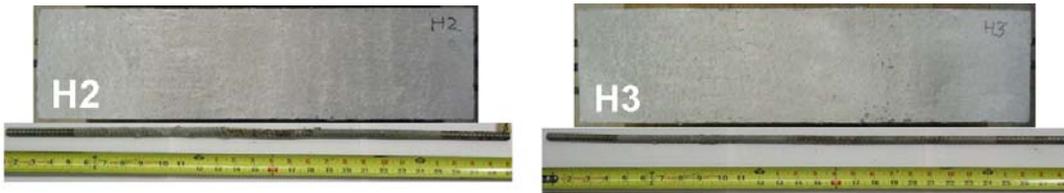
Fig. 42 – Corroded rebar in HyFRC beam specimens

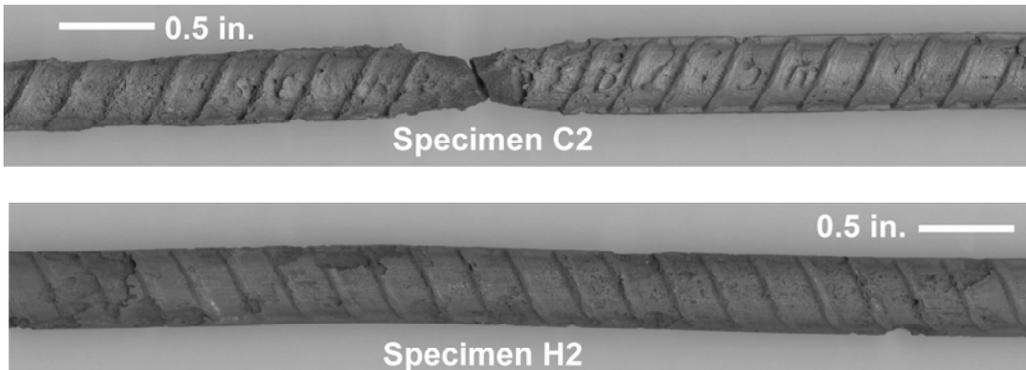
Fig. 43 – High resolution digital scans of the region of greatest section loss

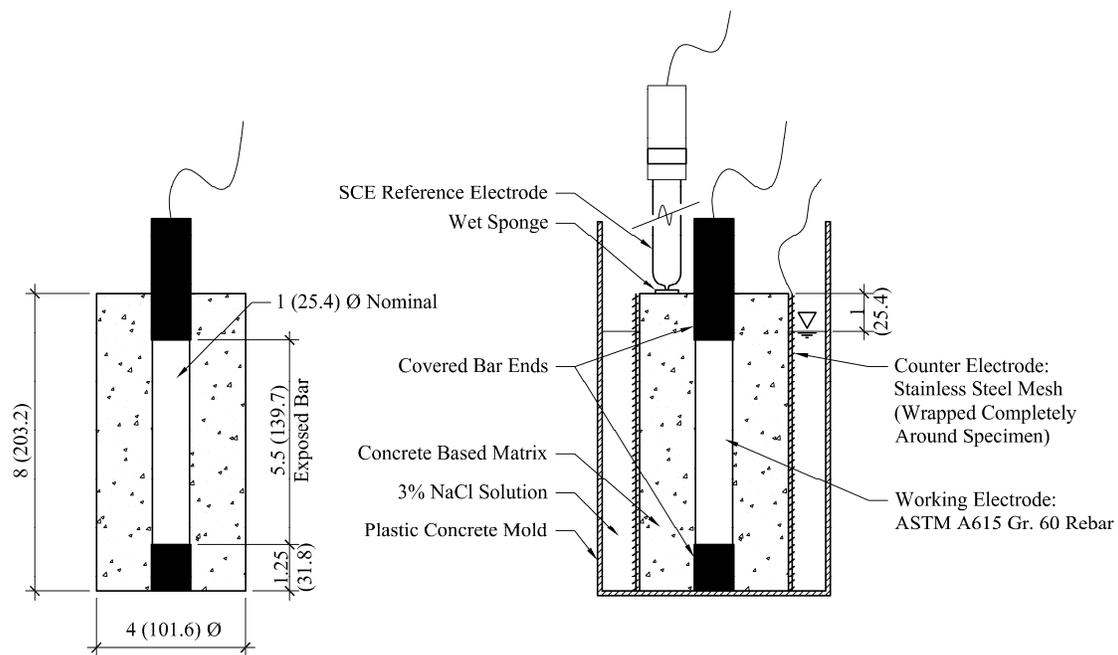
Fig. 44 – Dimensions and corrosion cell for corrosion propagation specimens [inch (mm)]

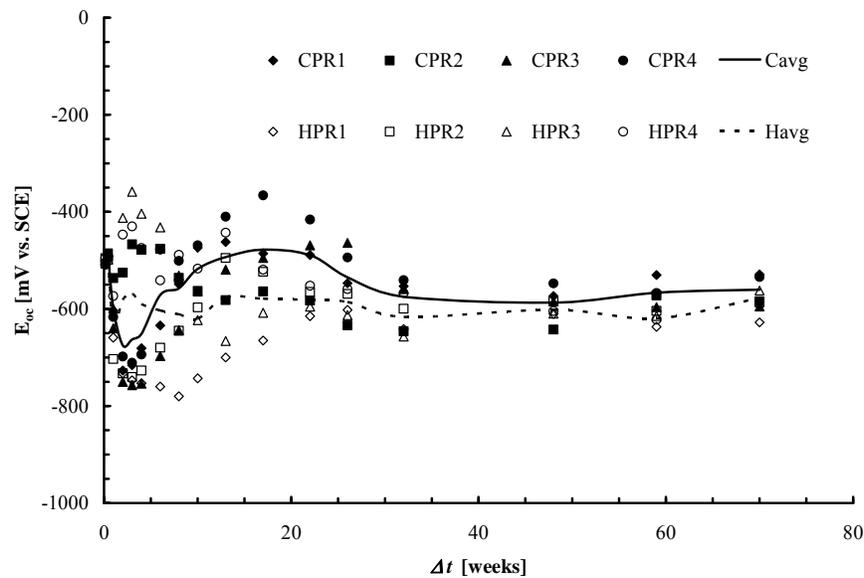
Fig. 45 – Cylindrical specimen corrosion potentials

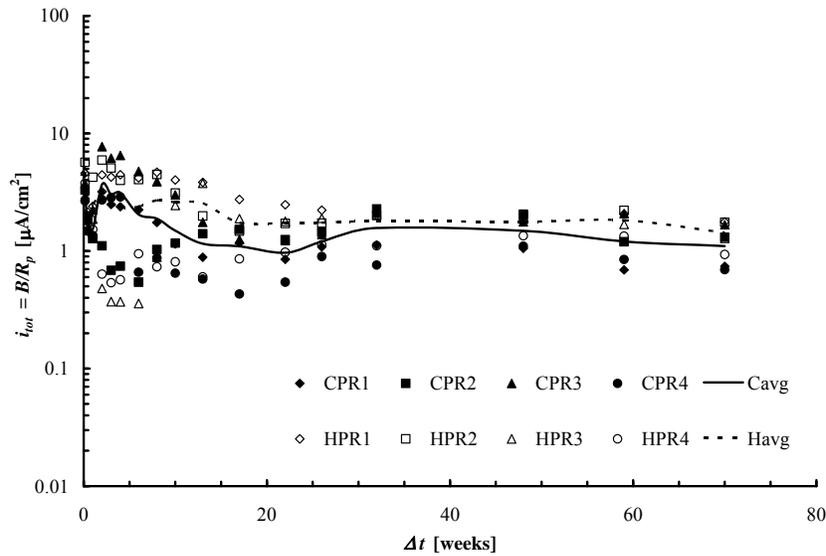
Fig. 46 – Estimated cylindrical specimen corrosion current densities

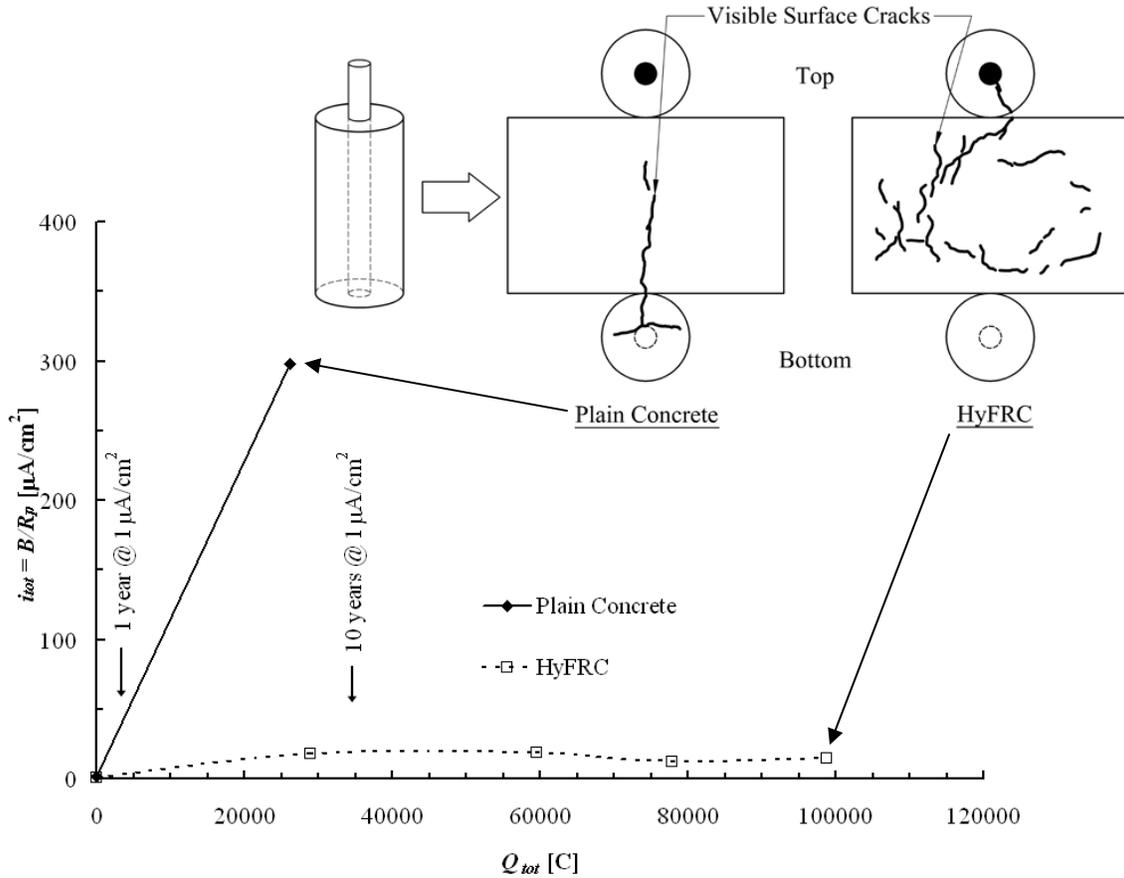
Fig. 47 – Accelerated test results of cylindrical specimens ( $B = 26$  mV)

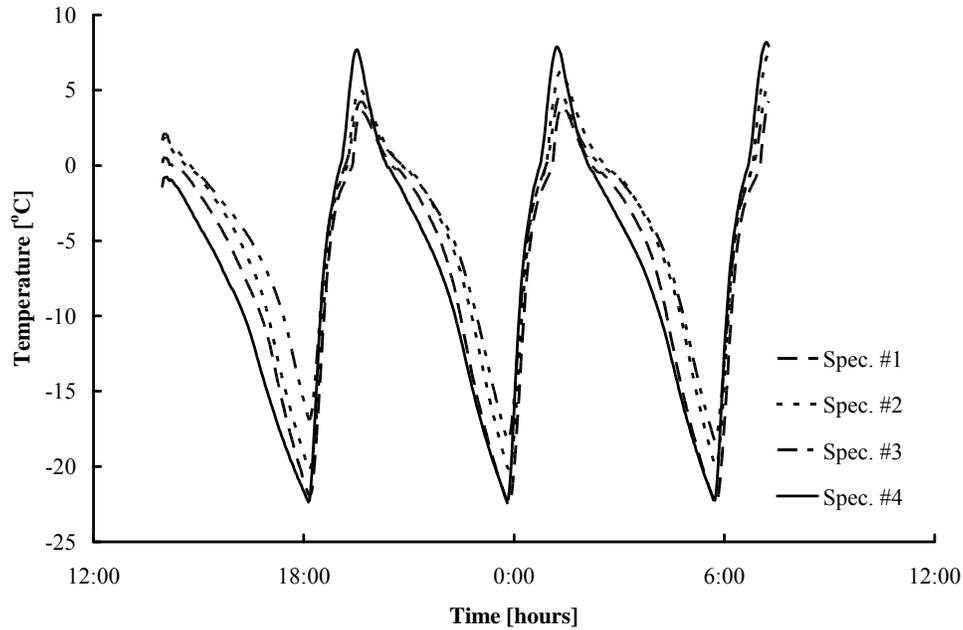
Fig. 48 – Example temperature variation within the freeze-thaw specimens

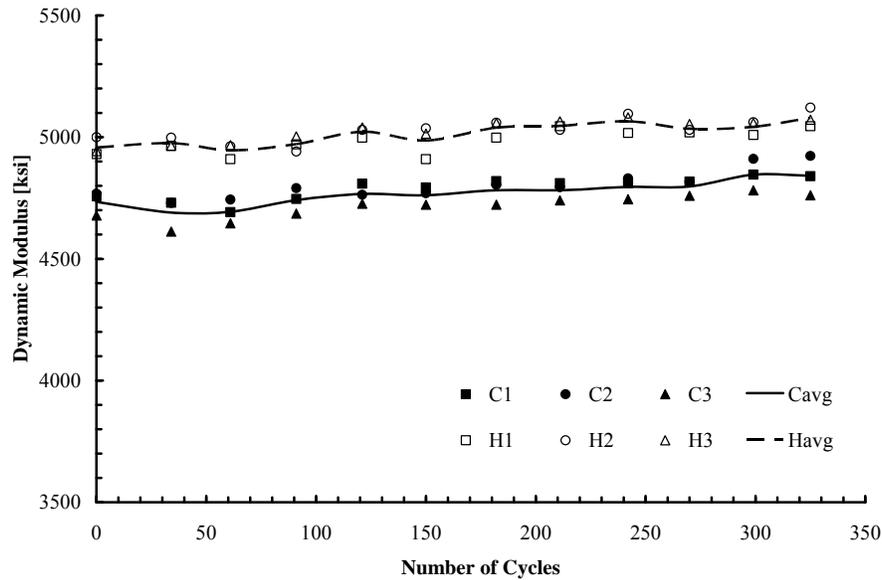
Fig. 49 – Dynamic modulus  $E_D$  variation with freeze-thaw cycling [multiply by  $6.89 \times 10^{-3}$  for GPa]

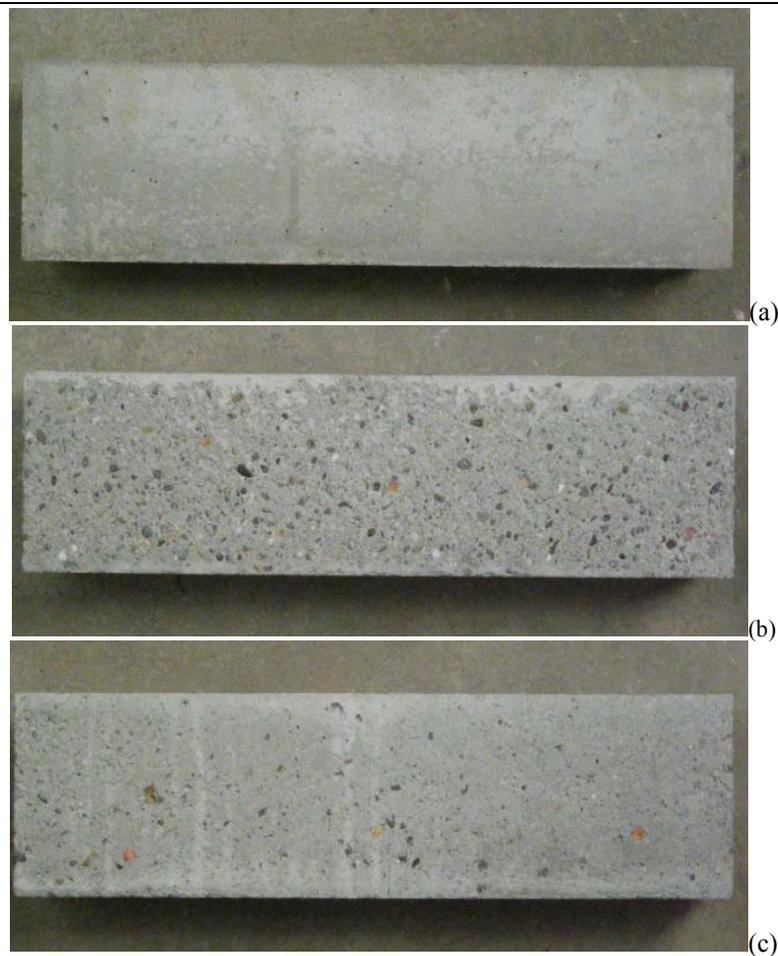
Fig. 50 – Freeze-thaw specimen surface (a) before, (b) plain concrete after and (c) HyFRC after freeze-thaw cycling

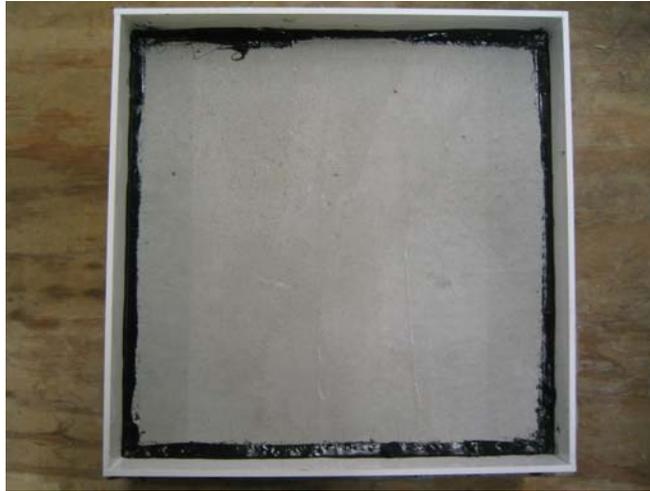
Fig. 51 – Surface condition before salt scaling (specimen C1)

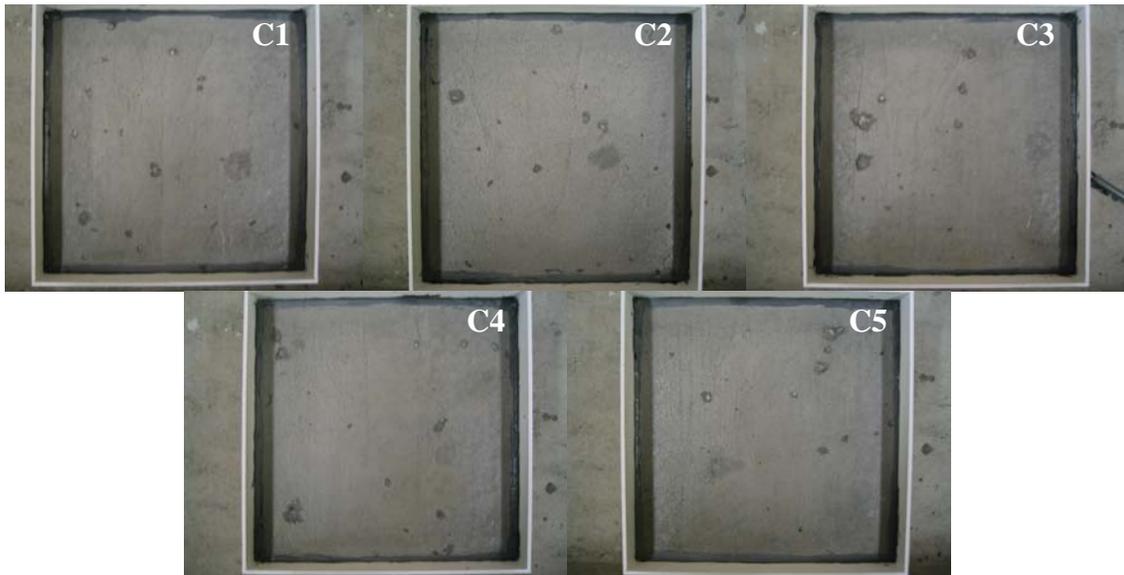
Fig. 52 – Surface condition of plain concrete specimens following 50 cycles of salt scaling

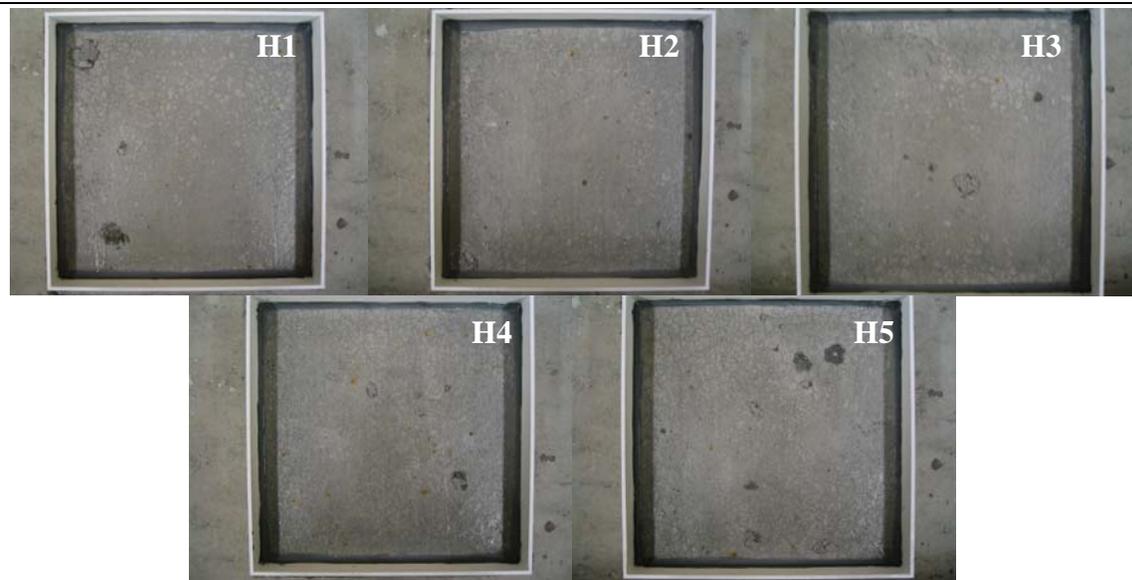
Fig. 53 – Surface condition of HyFRC specimens following 50 cycles of salt scaling

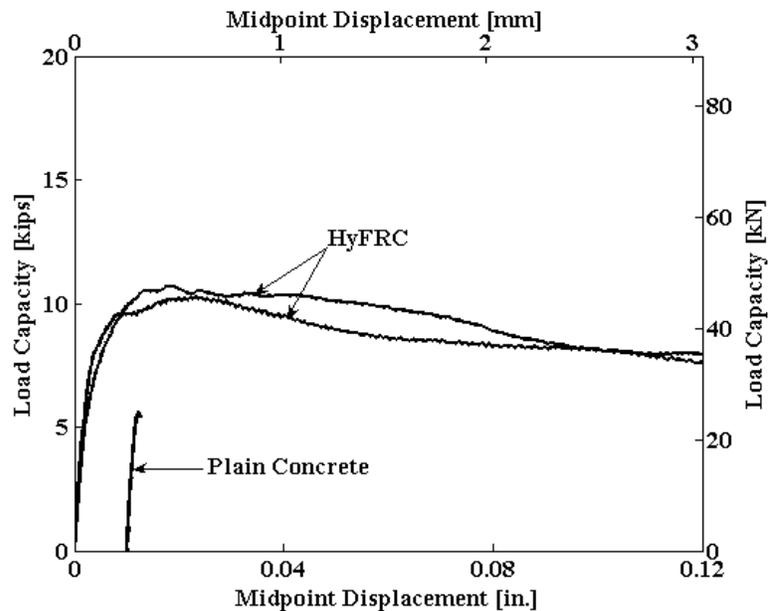
Fig. 54 – SCC flexure tests (plain concrete shifted from origin for clarity)

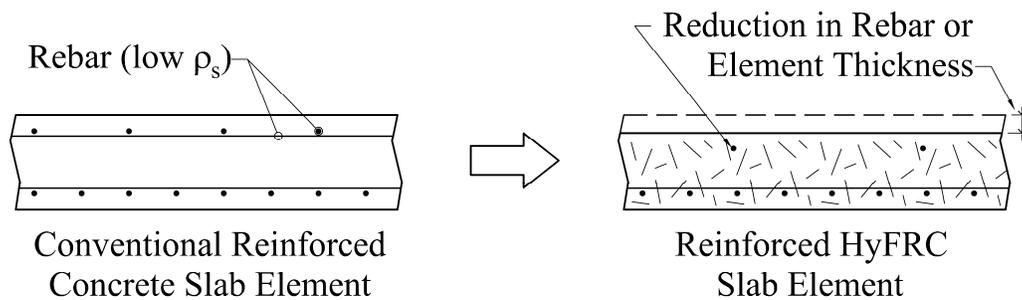
Fig. 55 – Proposed methods for optimum element design using HyFRC flexure properties
