Dynamic Full Scale Impact Tests of Cable Type Median Barriers Test Series IX

June 1965

Project W.O. 6302

State of California
Highway Transportation Agency
Department of Public Works
Division of Highways
Materials and Research Department

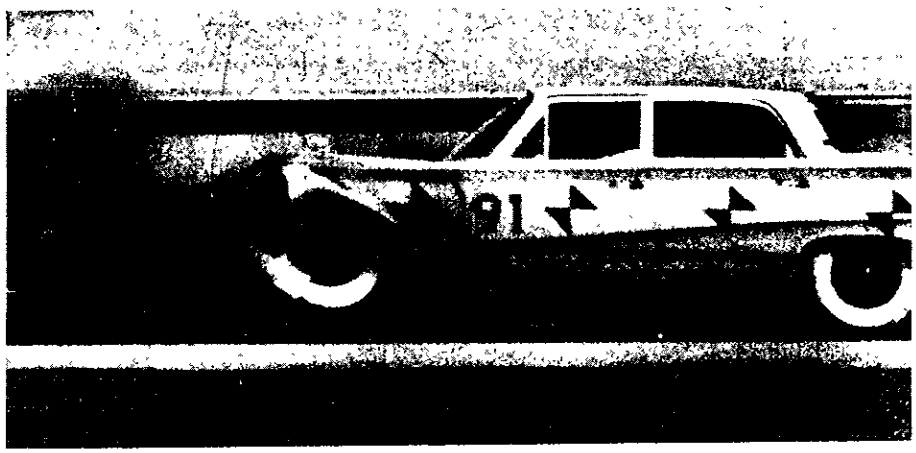
Fig. 2

Note in Figure 2 above that the cable is at the mid-point of the wheel. Had the vehicle continued to rise above this point, it is probable that the wheel would have rolled over the cable and vaulted the barrier. It was concluded from the results of this first test that the 26 inch cable height was marginal and would probably have to be raised to a height of from 27 to 28 inches above the paved median surface.

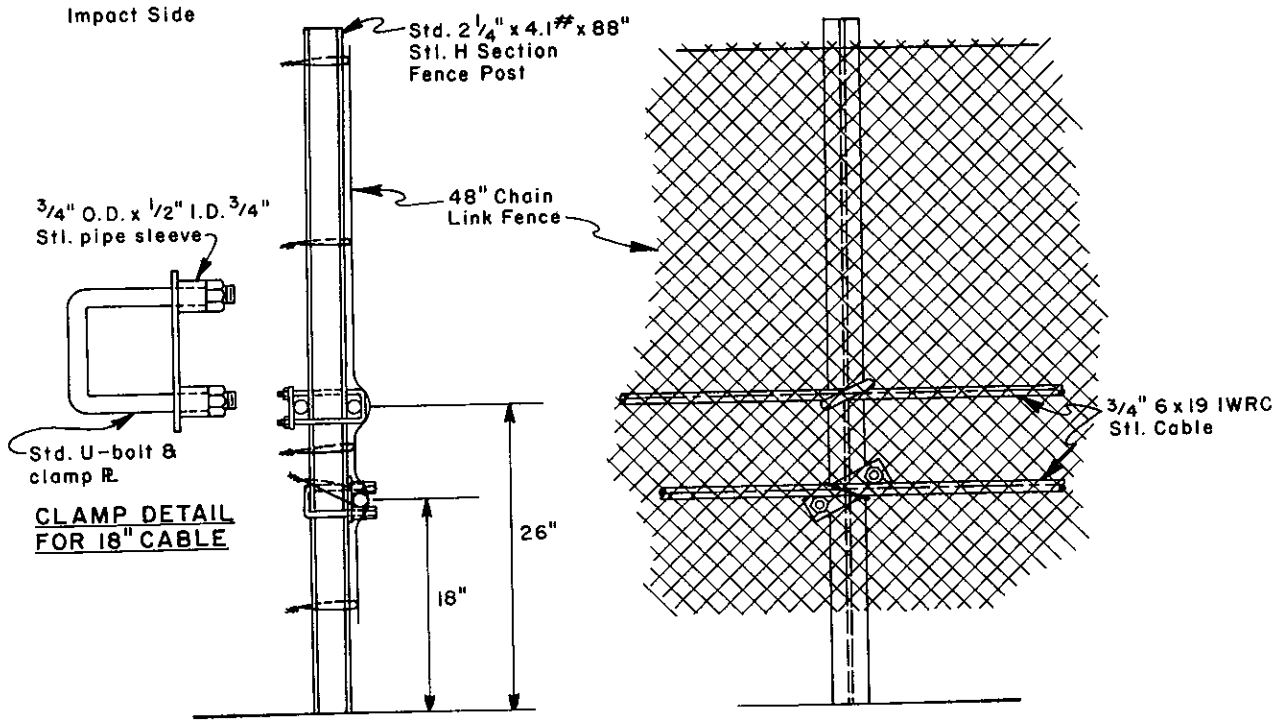
Fig. 4

BREAK-AWAY CABLE MOUNTING DETAIL
FOR RUN NO. 93

A complete performance for Test No. 93 is outlined on Plates 93-A, B, and C. In this test the lower cable did not break away as expected. The U-clamps twisted as the posts deflected and locked the lower cable in place (see Plate 93-C). The failure of the break-away cable to function as planned produced a rapid deceleration to a violent nose stand. The trapped vehicle then rolled on its side as it made a 180 deg. spin-out, which almost resulted in a complete roll over. There was a tendency for the vehicle to climb the barrier in this test.

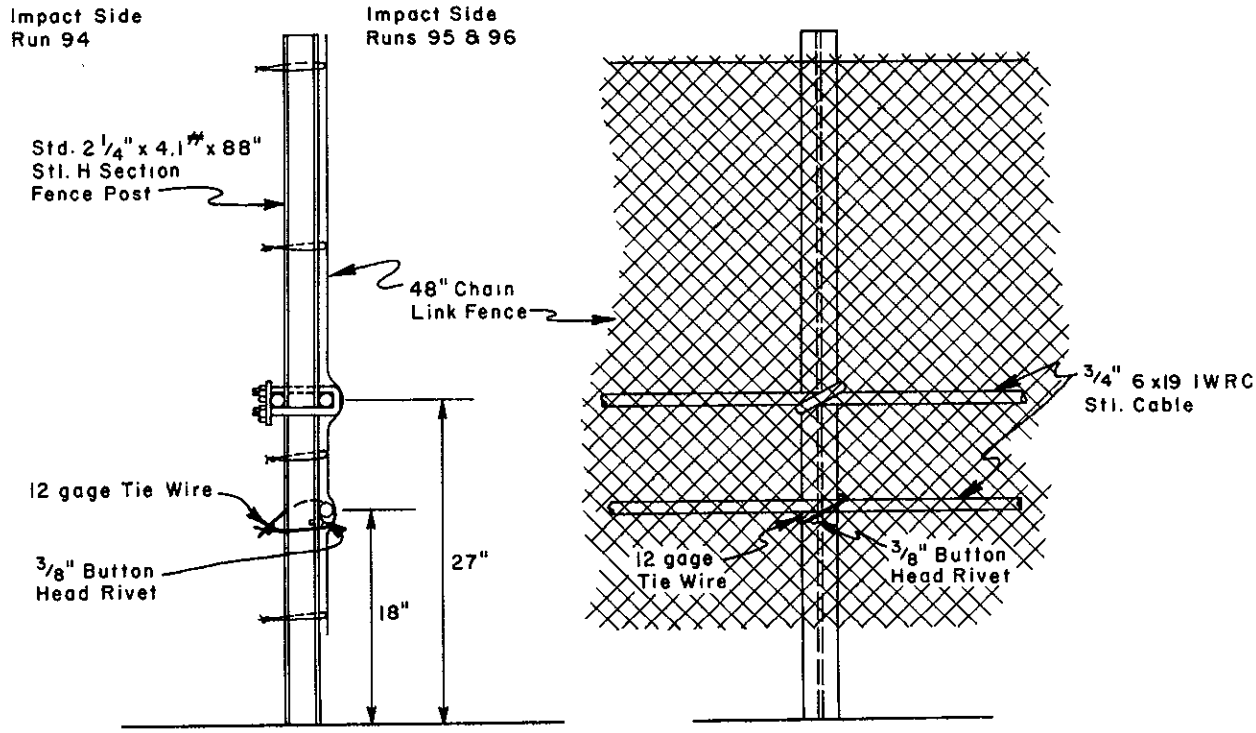
Fig. 5

The next impact test, Test No. 94, was performed on the cable-type barrier with the lower break-away cable design revised. For the new design, the lower cable was tied to the post with 12 ga. steel tie wire. The vertical position was maintained by resting the cable on a 3/8" button head rivet driven into the flange of the post (see Figure 5). The top cable height was raised 1" from the critical 26" height used for the previous test to 27". All other parameters remained the same as for Test No. 93.

BREAK-AWAY CABLE MOUNTING DETAIL FOR RUNS 94, 95 & 96

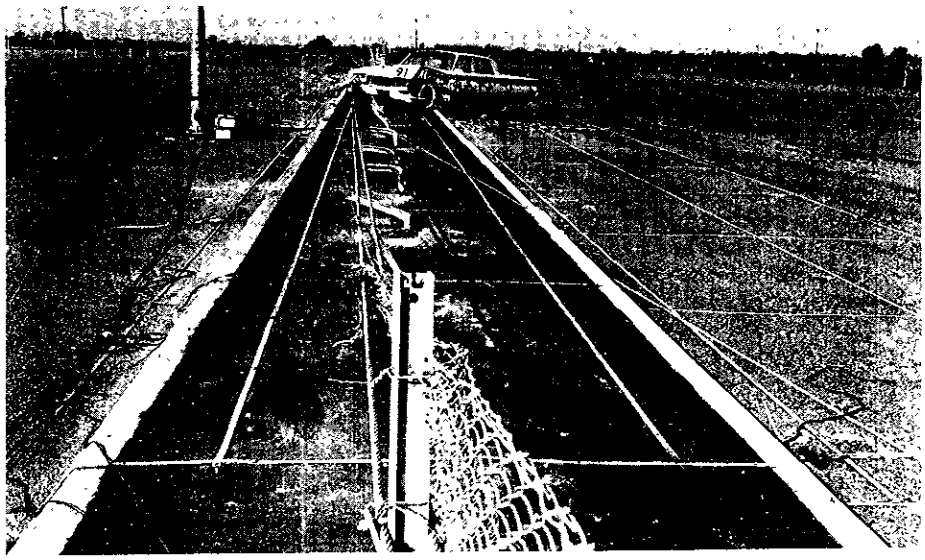
PLATE 91-A

PERFORMANCE: The test vehicle struck the curb and jumped, presenting a front end profile height 2 in. higher than normal on impact with the barrier. This additional height caused the left front tire to partially climb the cables, nearly resulting in the test vehicle vaulting the barrier. The test vehicle was entrapped by the cables and decelerated smoothly to a stop after a 130 deg. spin to the right at 94 ft. beyond impact. The test vehicle was rolling slightly to the right and yawing to the left when it started its spin and was never redirected by the barrier.

BARRIER DAMAGE: Approximately 96 ft. of mesh was damaged. The mesh separated and approximately 75 ft. gathered up between the cables at point of entrapment. Twelve posts were bent, eleven beyond repair. No posts were pulled out of footings. Two footings were cracked. There was no cable fitting damage or failure. The cables were frayed slightly.

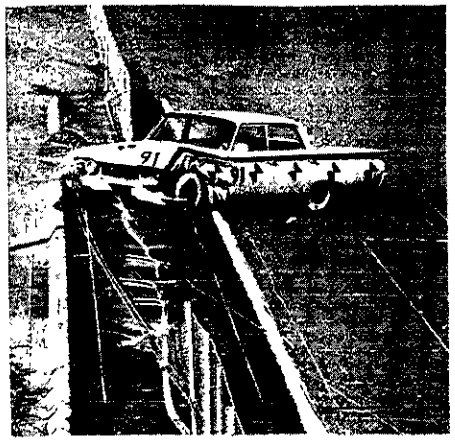
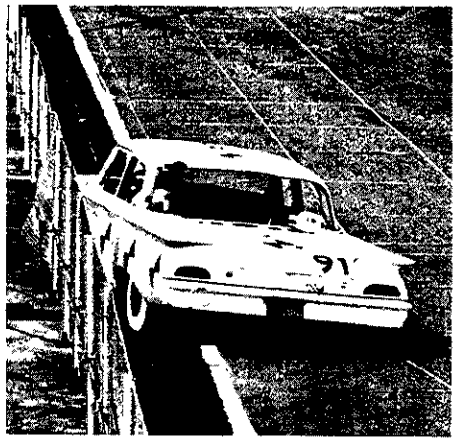
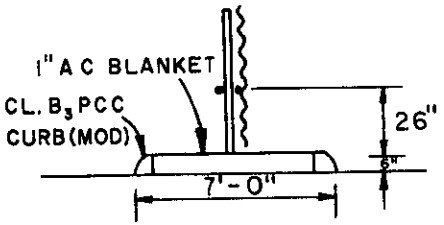
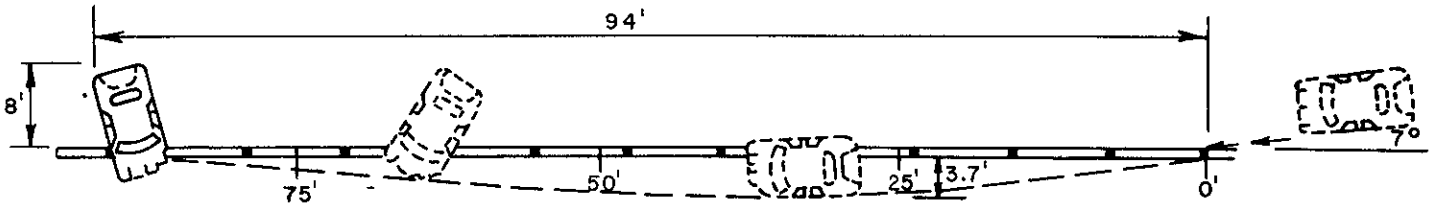
FENCE.....48" Cable Chain link at 9" above pvmt.
CABLE.....3/4" - 6 x 19 IWRC (2 at 26" above pvmt.)
POST....2-1/4" x 4.1# x 88" Stl. H Post
POST FOOTING.....Conc.
POST SPACING.....8' o.c.
LENGTH OF INSTALLATION.....225'
GROUND CONDITION.....Dry
FENCE DAMAGE.....96'

CABLE FITTING DAMAGE.....None
CABLE DAMAGE.....Slight fraying
POST DAMAGE.....12 bent, 11 beyond repair
POST FOOTING DAMAGE.....2 cracked
MAX. DEFLECTION OF CABLES.....3.7'
DUMMY DECELERATION (PEAK LONG).....3.7 g's
(PEAK LAT.).....3.5 g's
(PEAK VERT.)....2.5 g's
VEHICLE DAMAGE.....$ 450

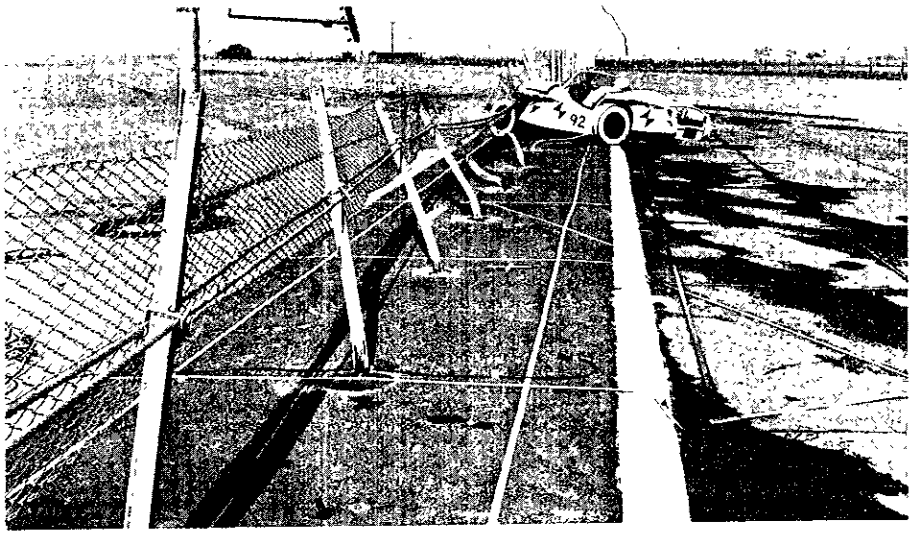
PLATE 92-A

BARRIER DAMAGE: Approximately 80 ft. of mesh was damaged. No mesh separated. Ten posts were bent, seven beyond repair. No posts were pulled out of footings. Two footings were cracked. There was no cable fitting damage or failure. The cables were frayed slightly.

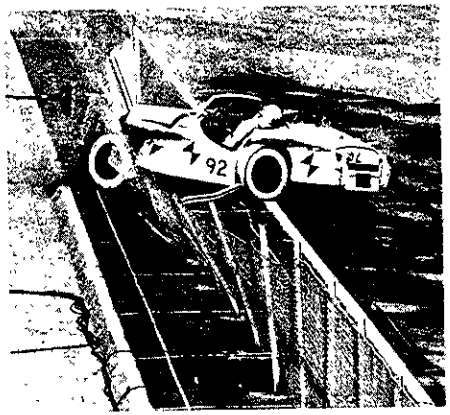
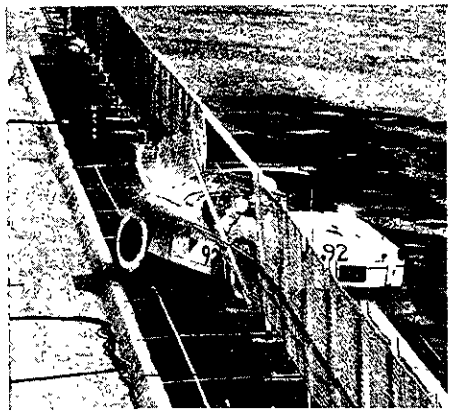
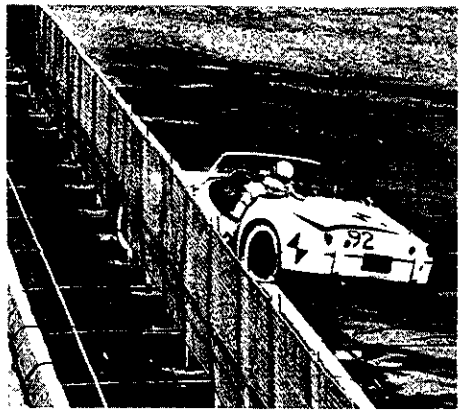
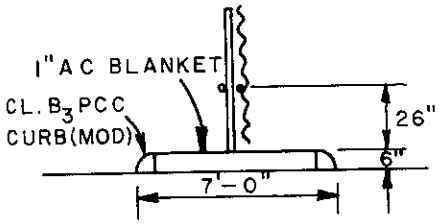
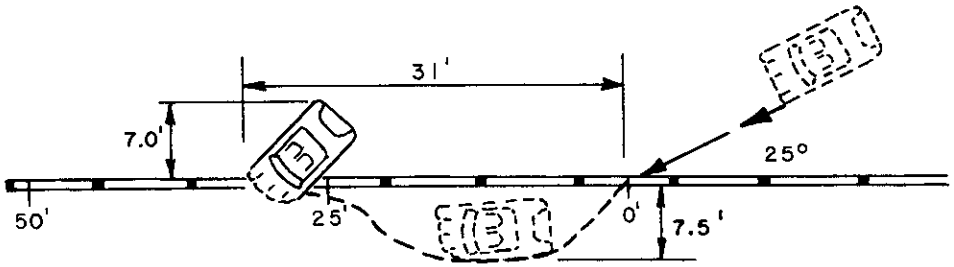
FENCE.....48" Cable Chain link at 9" above pvmt.
CABLE.....3/4" – 6 x 19 IWRC (2 at 26" above pvmt.)
POST...2-1/4" x 4.1 x 88" Stl H Post
POST FOOTING.....Conc.
POST SPACING.....8' o.c.
LENGTH OF INSTALLATION.....200'
GROUND CONDITION.....Dry
FENCE DAMAGE.....80'

CABLE FITTING DAMAGE.....None
CABLE DAMAGE.....Slight fraying
POST DAMAGE.....10 bent, 7 beyond repair
POST FOOTING DAMAGE.....2 cracked
MAX. DEFLECTION OF CABLES.....7.5'
DUMMY DECELERATION (PEAK LONG)....7.5 g's
(PEAK LAT.)....7.0 g's
(PEAK VERT.)..6.5 g's
VEHICLE DAMAGE.....TOTAL

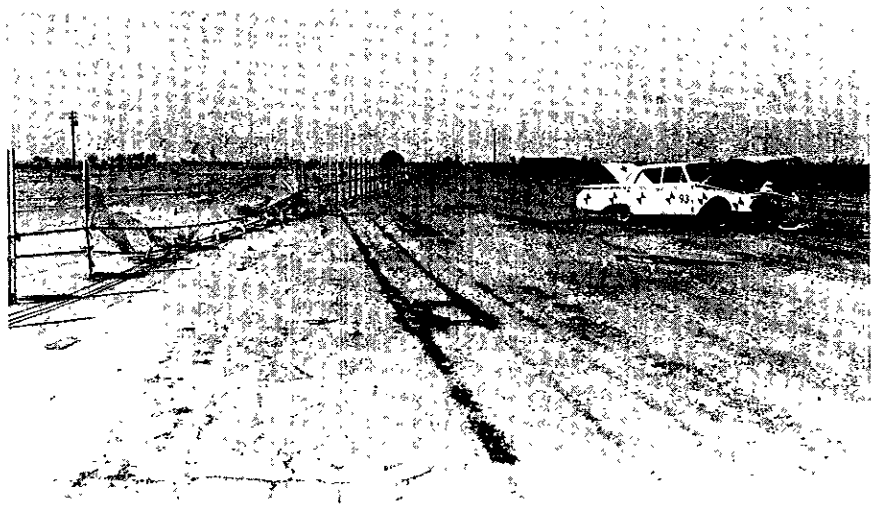
PLATE 93-A

PERFORMANCE: The test vehicle struck the barrier and wedged between the upper and lower cables due to failure of the break-away cable to function as planned. This resulted in rapid deceleration to a violent nose stand and 180 deg. spin-out at 56 ft. beyond impact. As the test vehicle spun out, it rolled onto its right side, skidded to the left, and rolled back into an upright position coming to a stop clear of the barrier at 32 ft. beyond impact. The test vehicle was never redirected by the barrier.

BARRIER DAMAGE: Approximately 80 ft. of mesh separated and approximately 48 ft. gathered up between the cables at point of spin-out. Nine posts were bent, seven beyond repair. No posts were pulled out of footings. Four footings were cracked. Three U-bolts on the lower cable sheared. The cables were frayed slightly.

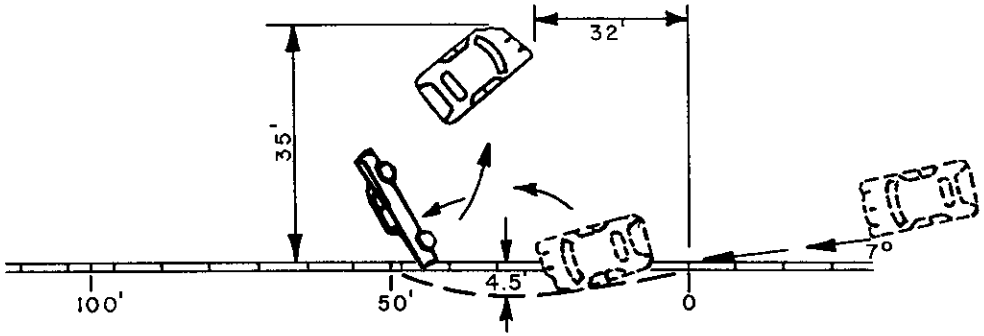
FENCE.....48" Cable Chain link at 8" above pvmt.
CABLE.....3/4" – 6 x 19 IWRC (2 at 26" & 1 at 18" above pvmt.
POST....2-1/4" x 4.1# x 88" Stl. H Post
POST FOOTING.....Conc.
POST SPACING.....8' o. c.
LENGTH OF INSTALLATION.....600'
GROUND CONDITION.....Dry
FENCE DAMAGE.....80'

CABLE FITTING DAMAGE.....3 U bolts sheared
CABLE DAMAGE.....Slight fraying
POST DAMAGE.....9 bent, 7 beyond repair
POST FOOTING DAMAGE.....4 cracked
MAX DEFLECTION OF CABLES.....4.5'
DUMMY DECELERATION (PEAK LONG) 4.5 g's
(PEAK LAT.) 3.0 g's
(PEAK VERT.) 4.0 g's
VEHICLE DAMAGE.....TOTAL

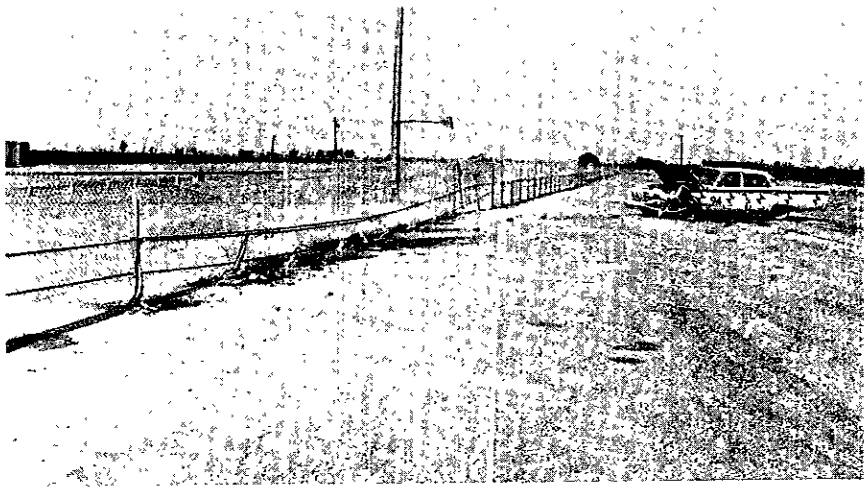
PLATE 94-A

BARRIER DAMAGE: Approximately 80 ft. of mesh was damaged. No mesh separated. Sixteen posts were bent, nine beyond repair. No posts were pulled out of footings. Six footings were broken and six were cracked. There was no cable fitting damage or failure. The cables were slightly frayed.

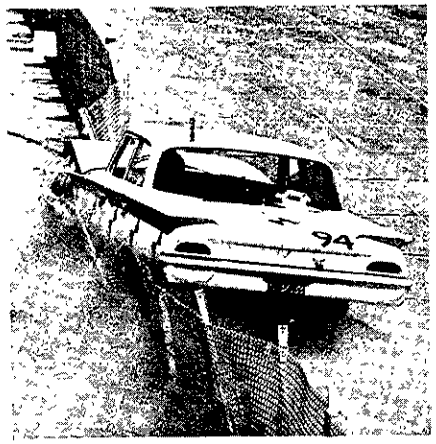
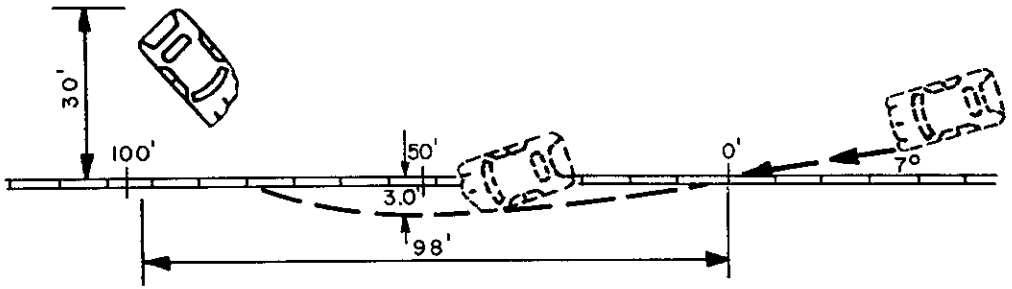
FENCE.....48" Cable chain link at 9" above pvmt.
CABLE.....3/4" – 6 x 19 IWRC (2 at 27" & 1 at 18")
POST.....2-1/4" 4.1# x 88" Stl. H Post
POST FOOTING.....Conc.
POST SPACING.....8' o.c.
LENGTH OF INSTALLATION.....600'
GROUND CONDITION.....Dry
FENCE DAMAGE.....80'

CABLE FITTING DAMAGE.....None
CABLE DAMAGE.....Slight fraying
POST DAMAGE.....16 bent, 9 beyond repair
POST FOOTING DAMAGE.....6 broken 6 cracked
MAX. DEFLECTION OF CABLES.....3.5'
DUMMY DECELERATION (PEAK LONG).....3.5g's
(PEAK LAT.).....3.7g's
(PEAK VERT) 2.0g's
VEHICLE DAMAGE.....TOTAL

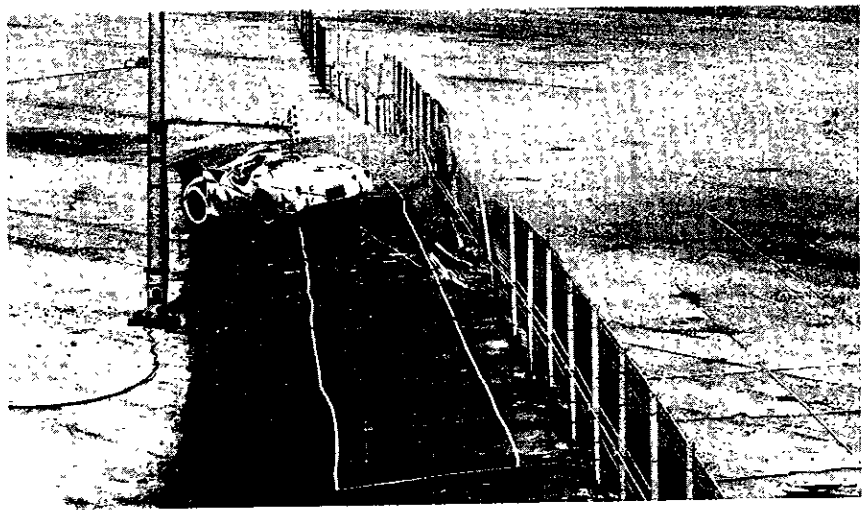
PERFORMANCE: The test vehicle was depressed approximately 6 in. by action of the 2:1 slope on the face of the sawtooth. This reduction in front end profile height permitted the test vehicle to nose under the lower cable, forcing it up and allowing the test vehicle to pass under the top cables and penetrate the barrier. The cable clips installed on the lower break-away cable failed to hold under impact loading, permitting the cable to slip as the test vehicle penetrated the barrier. As it progressed through the barrier, the vehicle was violently snubbed to a stop by the lower cable 46 ft. beyond impact.

BARRIER DAMAGE: Approximately 35 ft. of mesh was damaged. The mesh separated and approximately 15 ft. gathered up between the top cables at point of penetration. Five posts were bent, two beyond repair. No posts were pulled out of footings. One footing was broken and two were cracked. Four cable clips failed to secure the lower cable. The cables were slightly frayed.

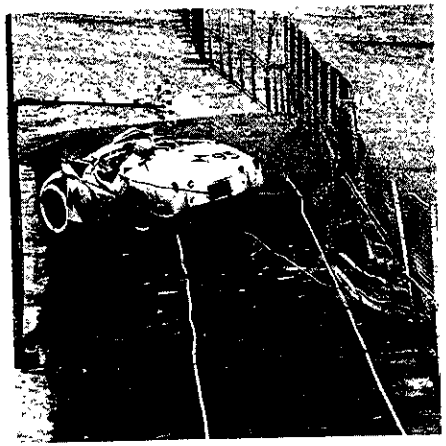
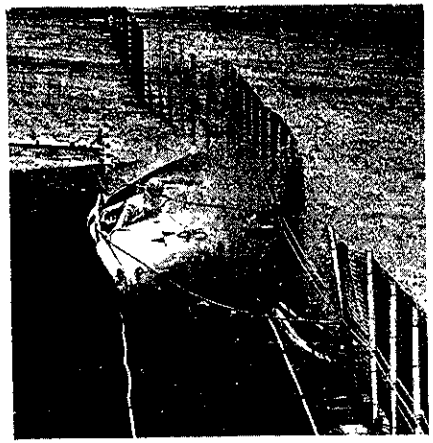
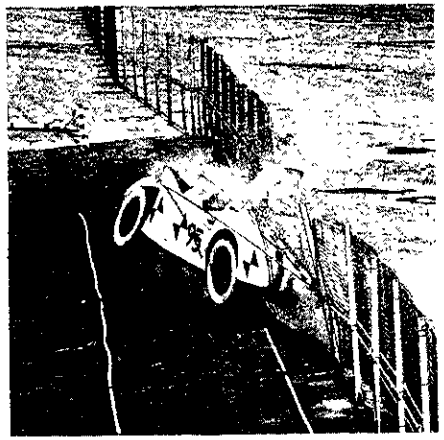
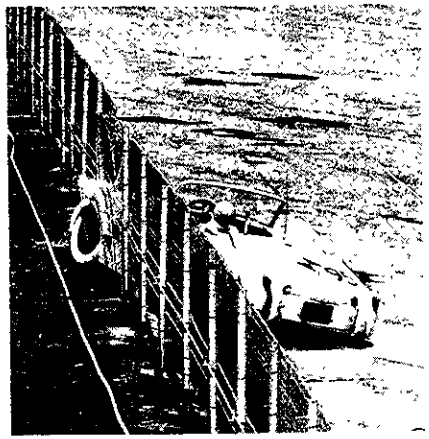
DUMMY INJURIES: Severe upper arm wounds resulting from the bottom cable dragging across the exposed side of the dummy.

FENCE.....48" Cable Chain link at 9" above pvmt.
CABLE.....3/4" - 6 x 19 IWRC (2 at 27" & 1 at 18")
POST.... 2-1/4" x 4.1# x 88" Stl. H Post
POST FOOTING .... Conc.
POST SPACING..... .....8' o.c.
LENGTH OF INSTALLATION..... ..175'
GROUND CONDITION ..... Dry
FENCE DAMAGE... .... 35'

CABLE FITTING DAMAGE.....None
CABLE DAMAGE.....Slight fraying
POST DAMAGE.....5 bent, 2 beyond repair
POST FOOTING DAMAGE.....1 broken, 2 cracked
MAX. DEFLECTION OF CABLES..... 2.5'
DUMMY DECELERATION (PEAK LONG) 38.0 g's
(PEAK LAT.) 16.5 g's
(PEAK VERT.) 8.5 g's
VEHICLE DAMAGE.....TOTAL

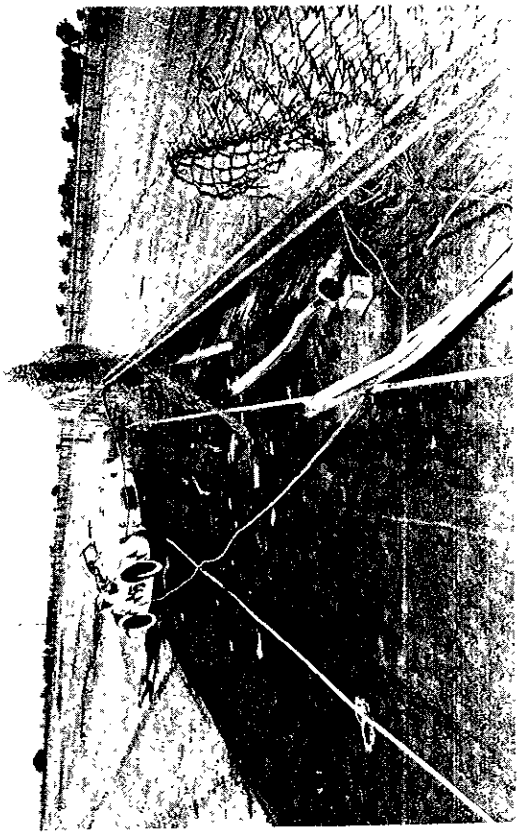
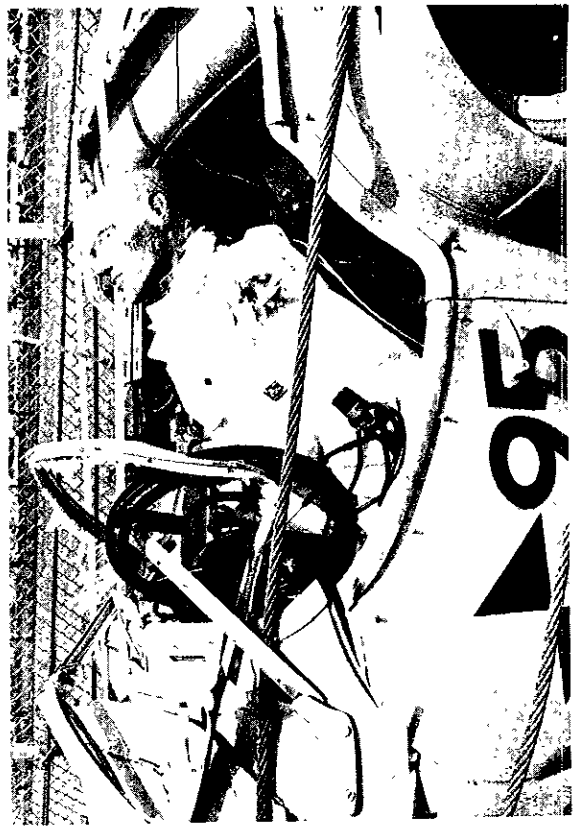
PLATE 96-A

PURPOSE: Same as Test No. 95. Re-run of previous test due to failure of cable clips to secure lower cable.

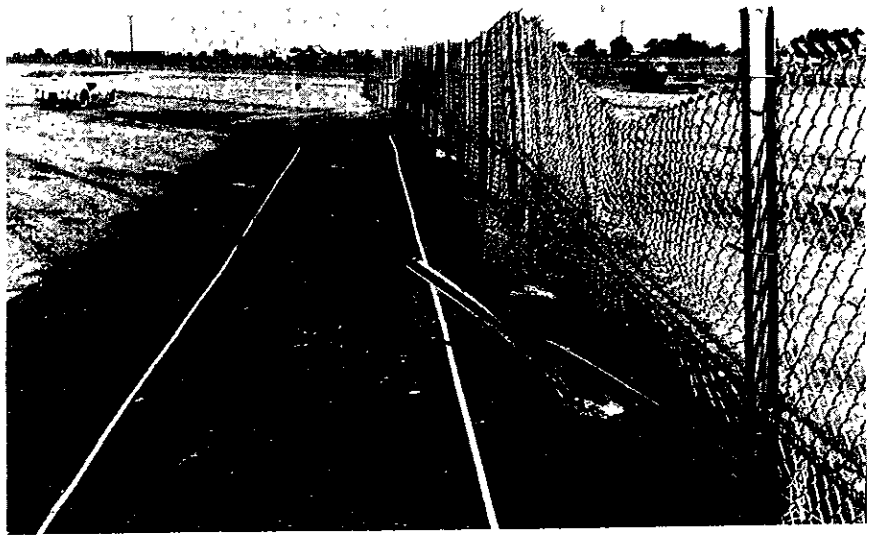
BARRIER DAMAGE: Approximately 16 ft. of mesh was damaged. There was no mesh separation. Four posts were bent, one beyond repair. No posts were pulled out of footings. Two footings were cracked. There was no cable fitting damage or failure. The cables were slightly frayed.

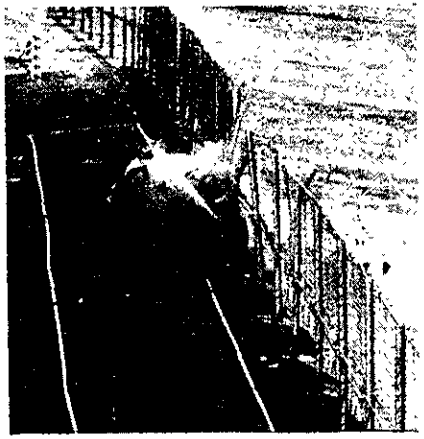
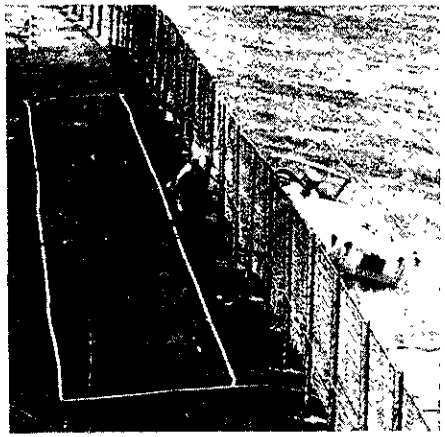
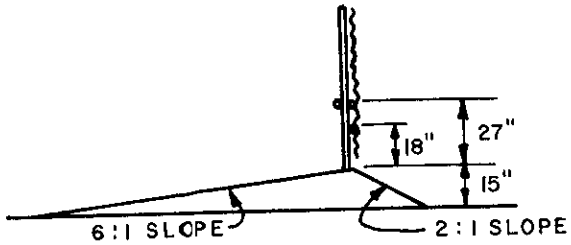
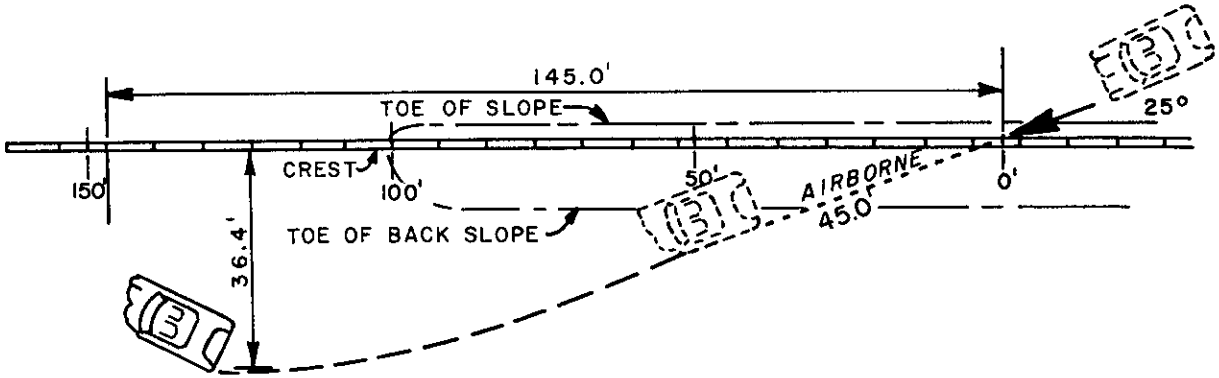
BARRIER CROSS SECTION

DUMMY INJURIES: Severe neck wound -- possibly resulting in a decapitation of a human driver. The dummy struck the cables with such force that a portion of the cloth was torn from the coveralls and jammed two inches into the lower portion of the neck.

FENCE..... 48" Cable Chain. link 9" above pvmt.
CABLE ..... 3/4"-6 x 19 IWRC (2 at 27" & 1 at 18")
POST.....2-1/4" 4.1# x 88" Stl. H Post
POST FOOTING..... Conc.
POST SPACING..... 8' o. c.
LENGTH OF INSTALLATION.....175'
GROUND CONDITION.....Dry
FENCE DAMAGE..... 16'

CABLE FITTING DAMAGE.....None
CABLE DAMAGE.....Slight fraying
POST DAMAGE.....4 bent, 1 beyond repair
POST FOOTING DAMAGE.....2 cracked
MAX. DEFLECTION OF CABLES..... 2.0
DUMMY DECELERATION (PEAK LONG)...58.0 g's
(PEAK LAT.)....29.5 g's
(PEAK VERT.)..25.0 g's
VEHICLE DAMAGE.....TOTAL

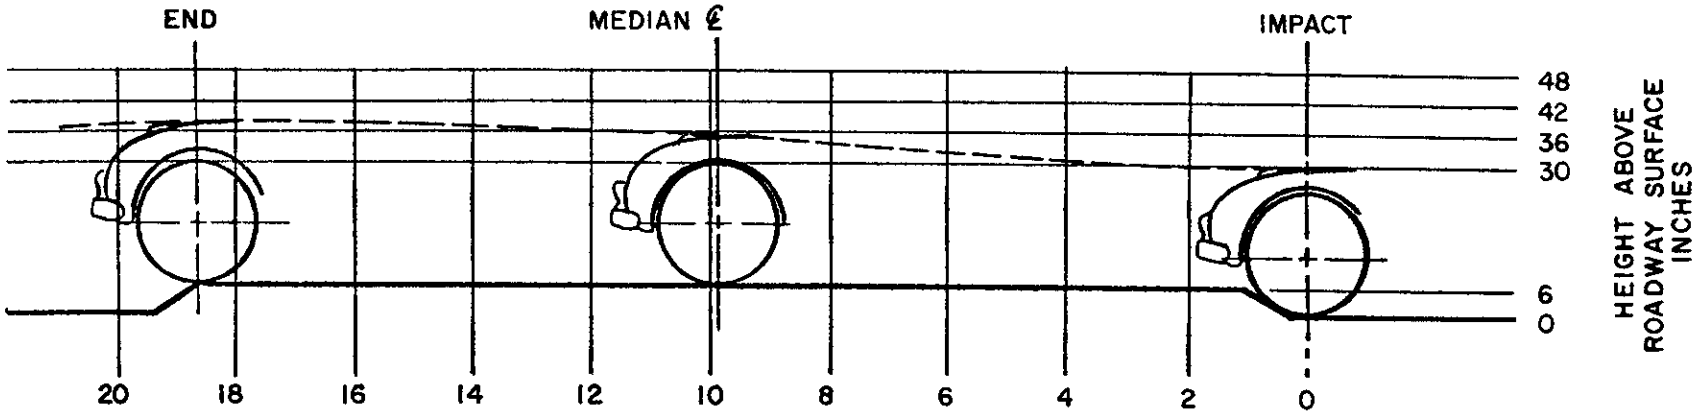
EXHIBIT 6

HEIGHT OF CURB. . . . . 6" Class B Curb
VEHICLE TIRE SIZE & DIA. . . . . 5.50-15 24"OD
TOTAL VEHICLE HEIGHT AT AXLE ℄ . . 30"
RISE AT MEDIAN ℄ . . . . . .5" Ref. from roadway surface
LENGTH & WIDTH OF INSTALLATION. . 200' long x 7' wide
GROUND CONDITION. . . . . Dry
VEHICLE DAMAGE. . . . . 3 Rims bent - 3 tires blown
MAX. RISE. . . . . .8" Ref. from roadway surface

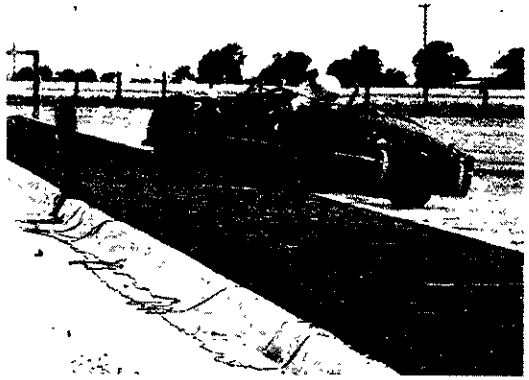
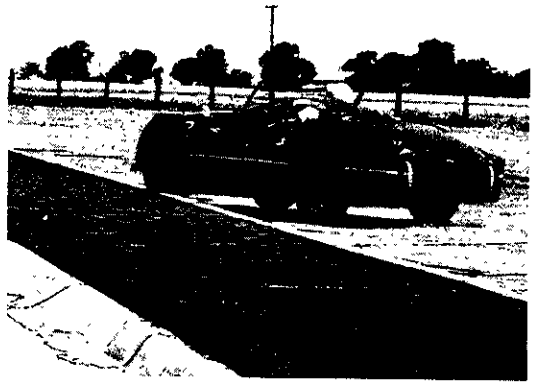
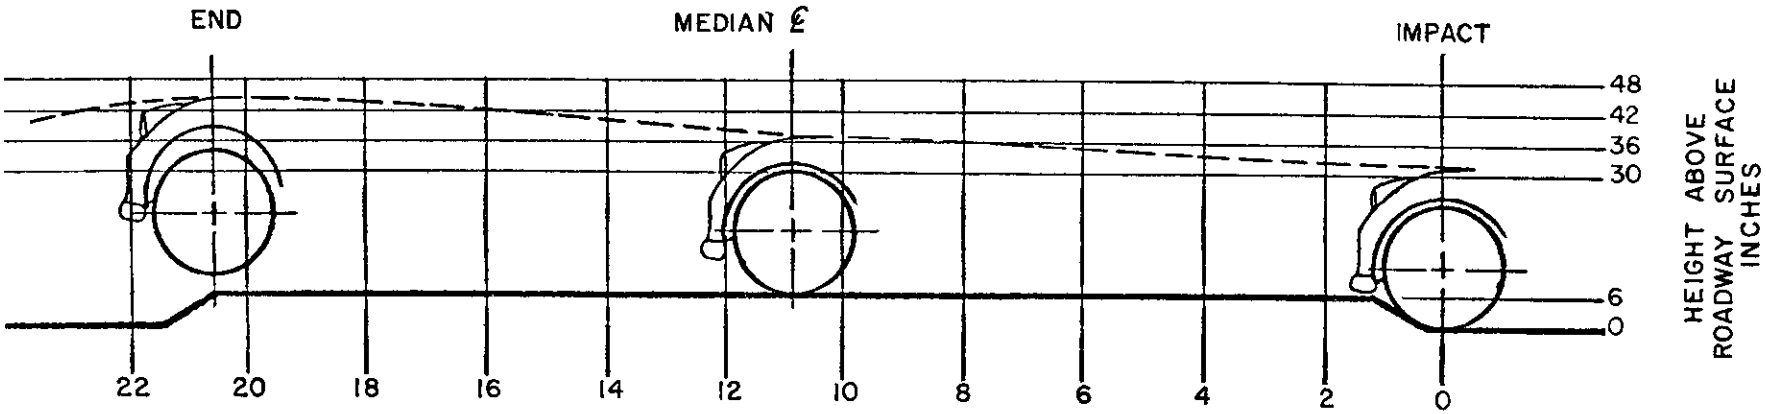
EXHIBIT 7

HEIGHT OF CURB . . . . . 6" Class B Curb
VEHICLE TIRE SIZE & DIA. . . . . 5.50-15 26" OD
TOTAL VEHICLE HEIGHT AT AXLE ℄ . . 33"
RISE AT MEDIAN ℄ . . . . . 5 3/4" Ref. from roadway surface.
LENGTH & WIDTH OF INSTALLATION. . 200' long x 7' wide
GROUND CONDITION. . . . . Dry
VEHICLE DAMAGE. . . . . 2 Rims bent
MAX. RISE. . . . . 13" Ref. from roadway surface

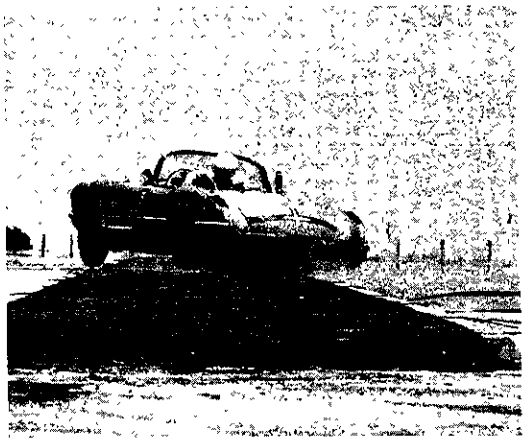
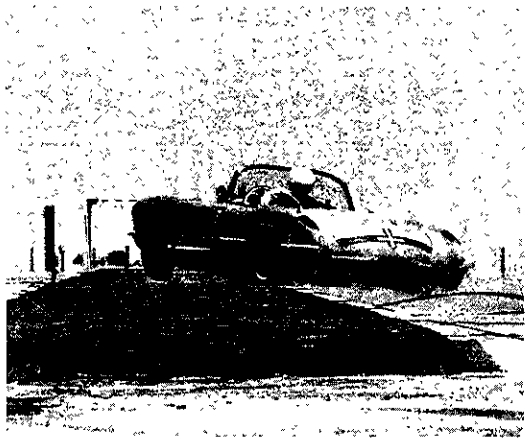
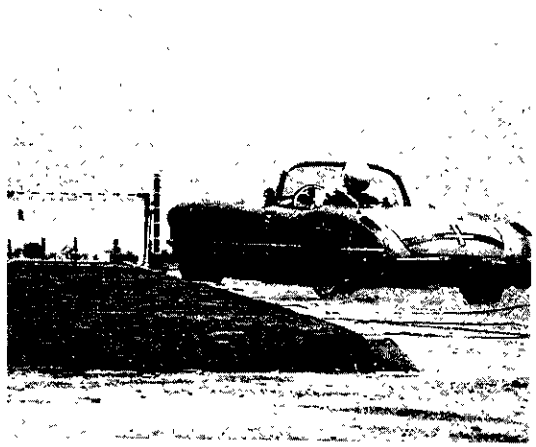
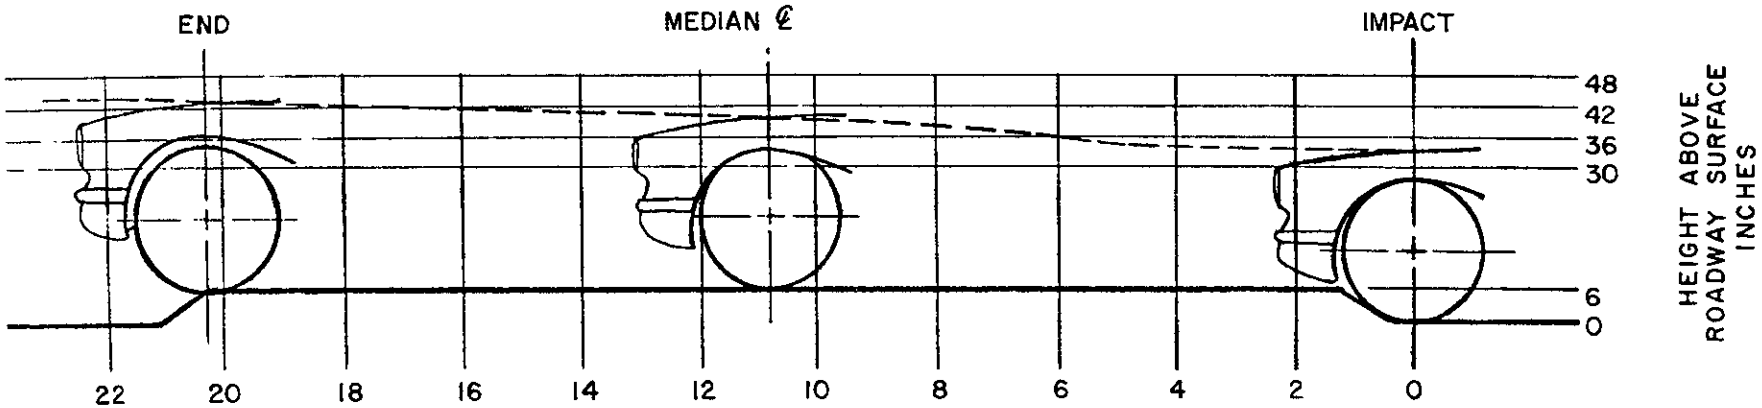
EXHIBIT 8

HEIGHT OF CURB..... 6" Class B Curb
VEHICLE TIRE SIZE & DIA..... 6.70-15 27" OD
TOTAL VEHICLE HEIGHT AT AXLE ℄.... 34"
RISE AT MEDIAN ℄..... 5" Ref. from roadway surface
LENGTH & WIDTH OF INSTALLATION... 200' long x 7' wide
GROUND CONDITION..... Dry
VEHICLE DAMAGE..... 2 Rims bent - tire blown
MAX. RISE..... 9" Ref. from roadway surface

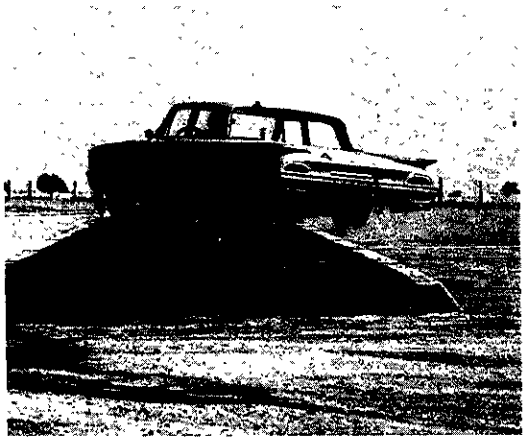
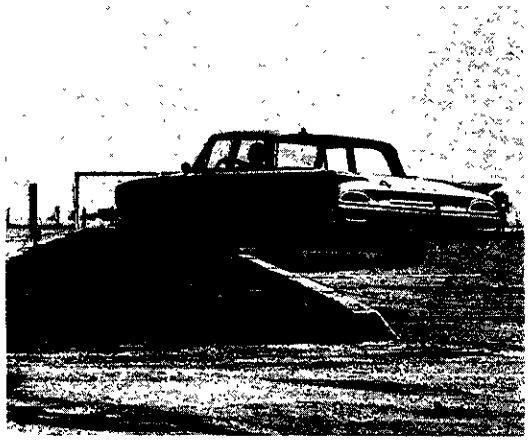
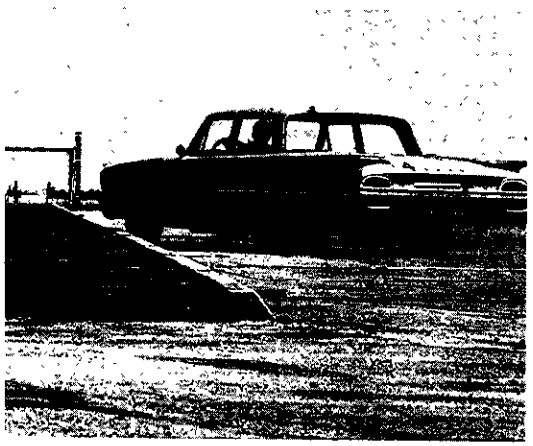
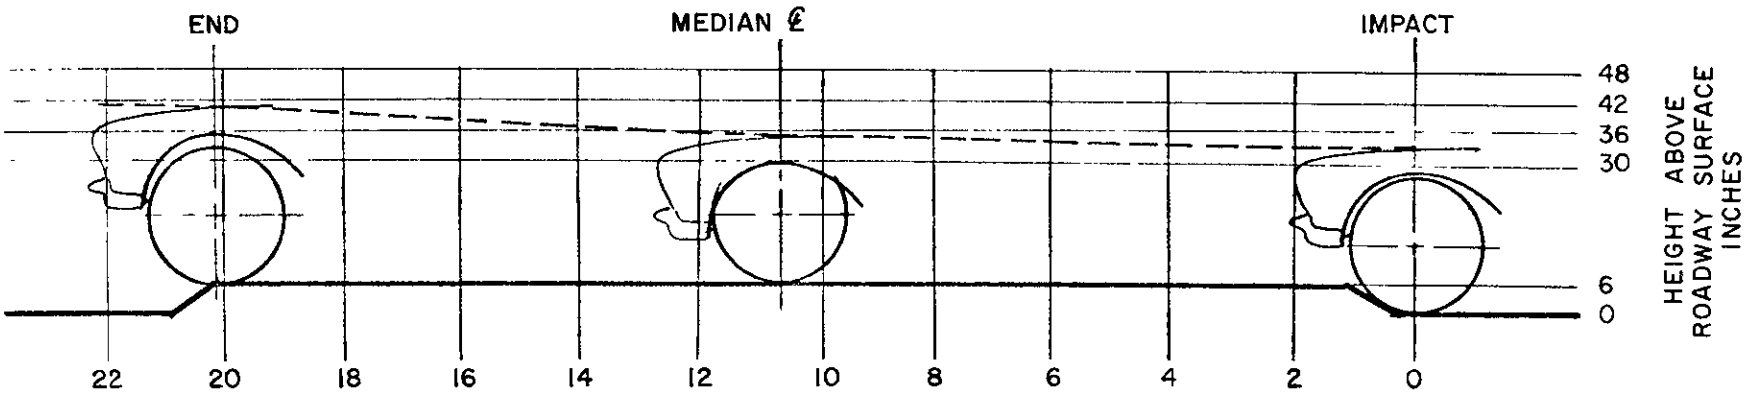
EXHIBIT 9

HEIGHT OF CURB	6" Class B Curb
VEHICLE TIRE SIZE & DIA	7.50-14 26"OD
TOTAL VEHICLE HEIGHT AT AXLE ℄	34"
RISE AT MEDIAN ℄	2" Ref. from roadway surface.
LENGTH & WIDTH OF INSTALLATION	200' long x 7' wide
GROUND CONDITION	Dry
VEHICLE DAMAGE	2 Rims bent – 1 tire blown
MAX. RISE	8" Ref. from roadway surface

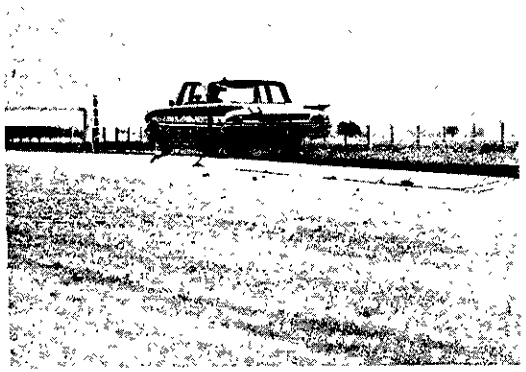
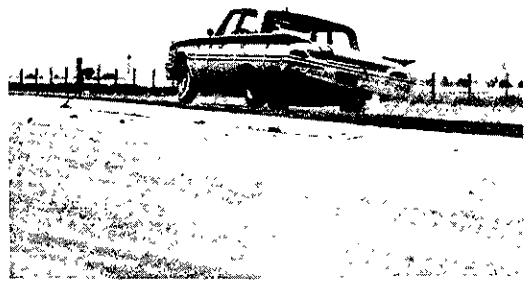
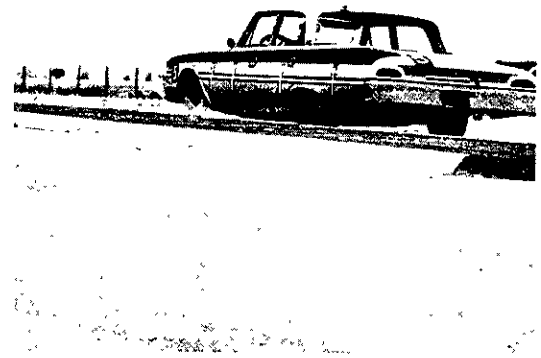
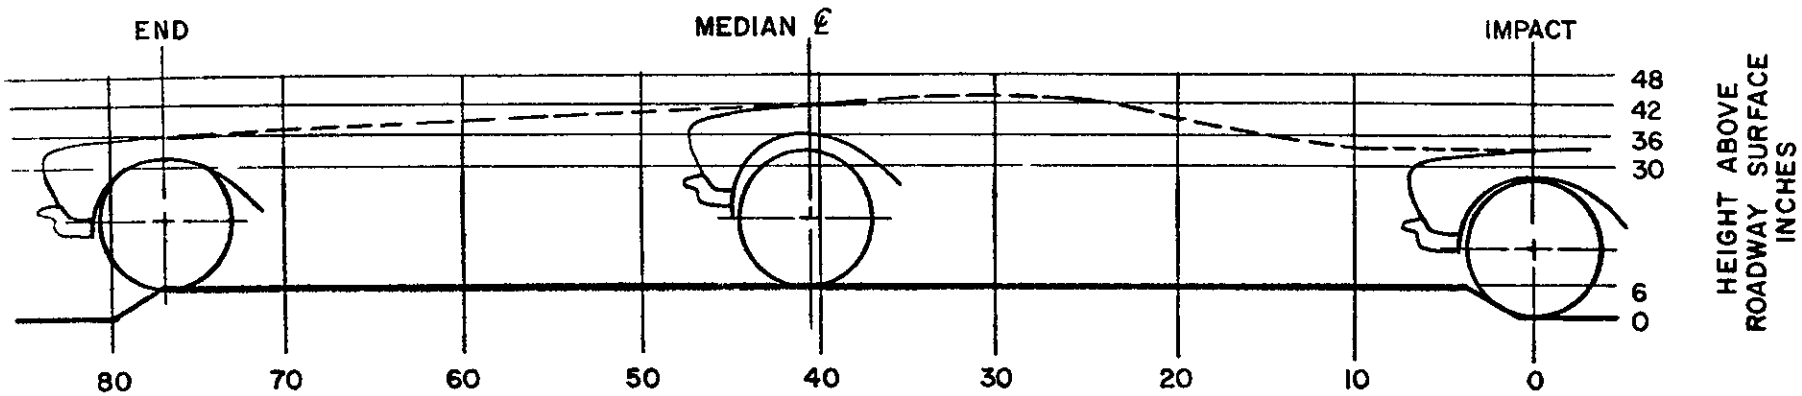
EXHIBIT 10

HEIGHT OF CURB . . . . . 6" Class B Curb
VEHICLE TIRE SIZE & DIA. . . . . 7.50-14 26" OD
TOTAL VEHICLE HEIGHT AT AXLE ℄ . . 34
RISE AT MEDIAN ℄ . . . . . 9" Ref. from roadway surface
LENGTH & WIDTH OF INSTALLATION . . 200' long x 7' wide
GROUND CONDITION . . . . . Dry
VEHICLE DAMAGE . . . . . None
MAX. RISE . . . . . 10" Ref. from roadway surface

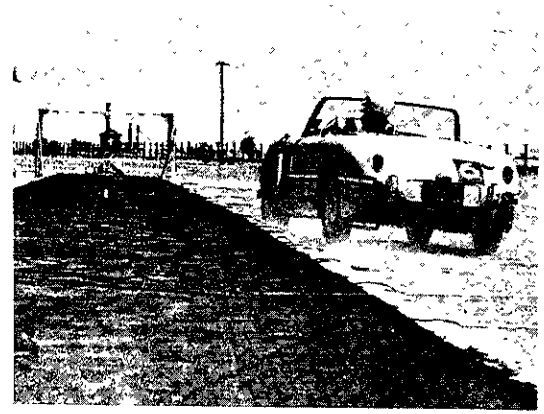
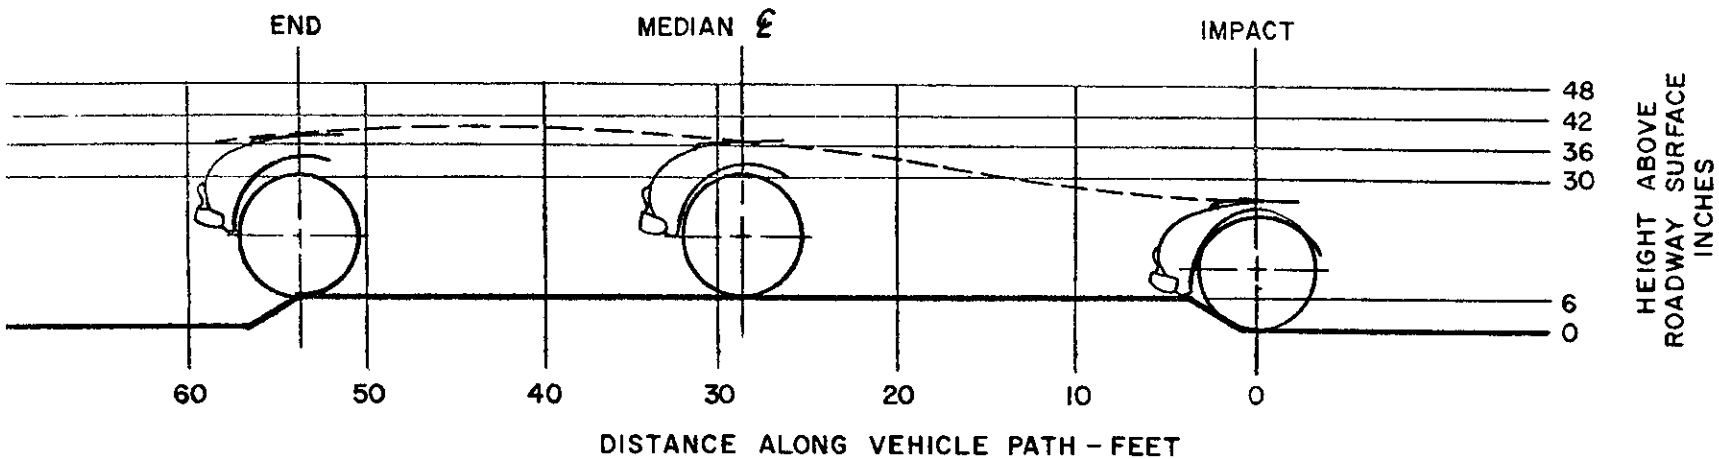
EXHIBIT 11

HEIGHT OF CURB	6" Class B Curb
VEHICLE TIRE SIZE & DIA.	5.20-13 30" OD
TOTAL VEHICLE HEIGHT AT AXLE ℄	30"
RISE AT MEDIAN ℄	7" Ref. from roadway surface
LENGTH & WIDTH OF INSTALLATION	200' long x 7' wide
GROUND CONDITION	Dry
VEHICLE DAMAGE	None
MAX. RISE	9" Ref. from roadway surface

TEST NO.	J6
DATE	7-26-63
VEHICLE	61 AH SPRITE
SPEED	56 mph
IMPACT ANGLE	7°
VEHICLE WEIGHT (W/DUMMY & INSTRUMENTATION)	1900 #

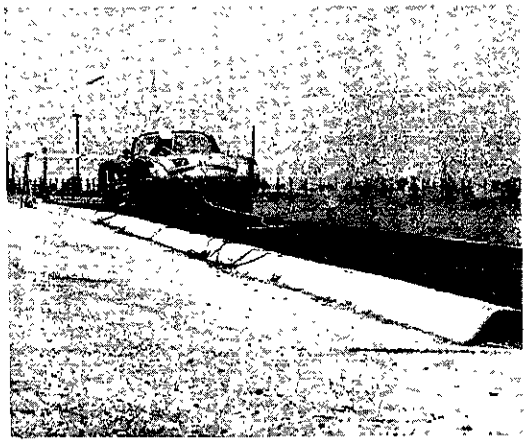
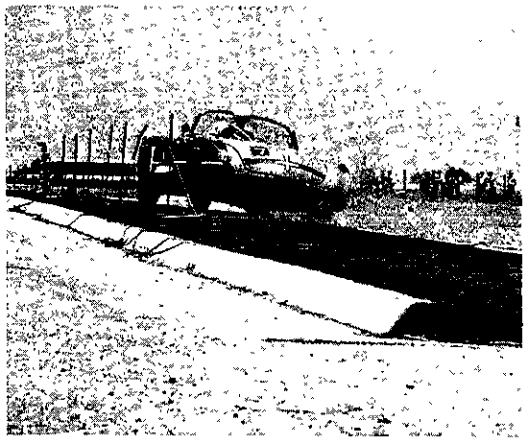
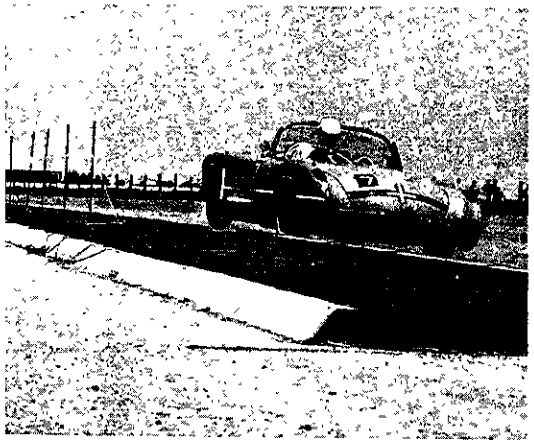
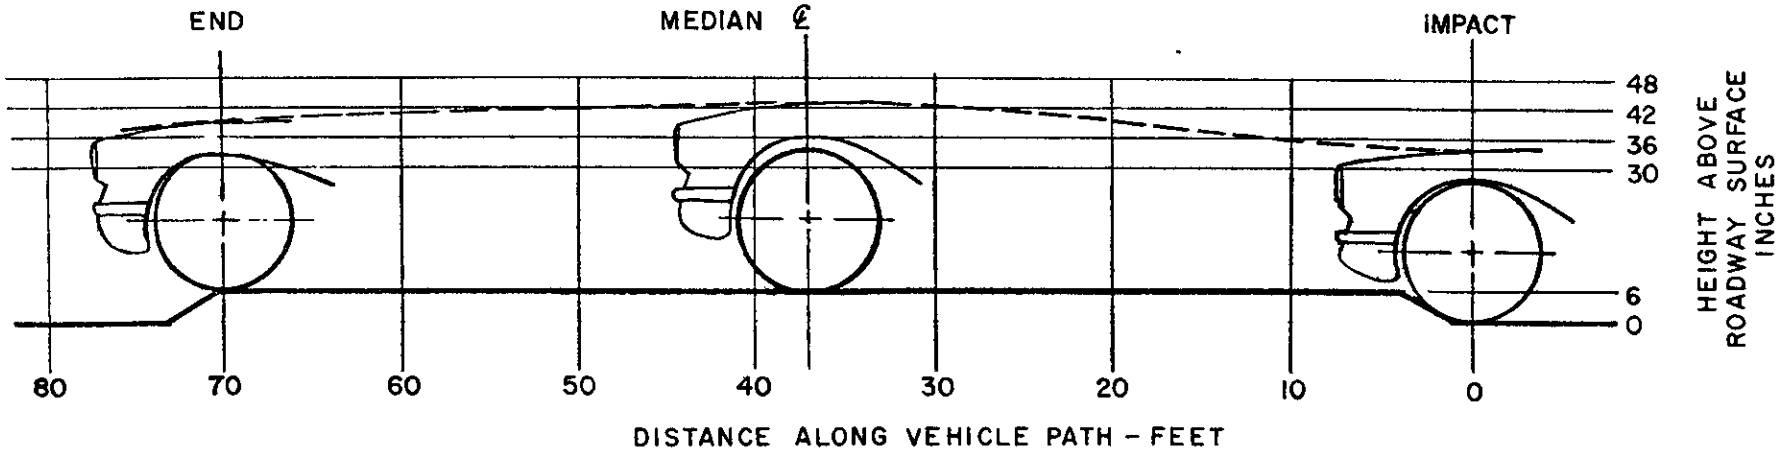
EXHIBIT 12

HEIGHT OF CURB..... 6" Class B Curb
VEHICLE TIRE SIZE & DIA..... 6.70-15 27" OD
TOTAL VEHICLE HEIGHT AT AXLE ℄.... 34"
RISE AT MEDIAN ℄..... 9" Ref. from roadway surface
LENGTH & WIDTH OF INSTALLATION.... 200' long x 7' wide
GROUND CONDITION..... Dry
VEHICLE DAMAGE..... 2 Rims bent - 1 tire blown
MAX. RISE..... 10" Ref. from roadway surface

TEST NO..... J7a
DATE..... 7-30-63
VEHICLE..... 57 CHEV. CORVETTE
SPEED..... 62 mph
IMPACT ANGLE..... 7°
VEHICLE WEIGHT.. 3300#
(W/DUMMY & INSTRUMENTATION)
