Dynamic Full Scale Impact Tests of Cable Type Median Barriers Test Series IX

June 1965

Project W.O. 6302

State of California
Highway Transportation Agency
Department of Public Works
Division of Highways
Materials and Research Department

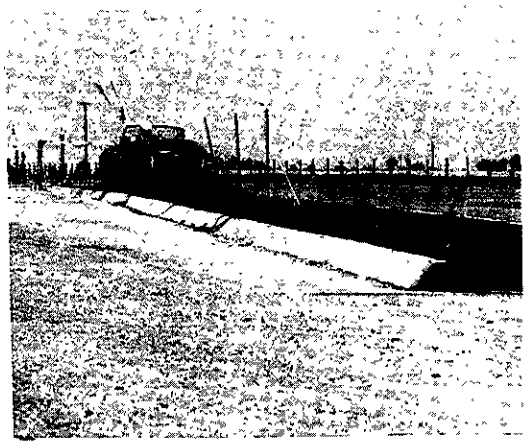
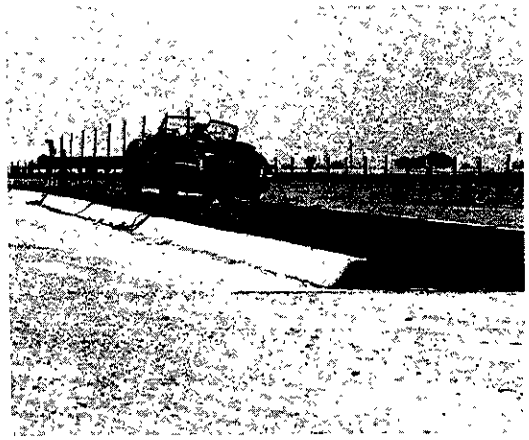
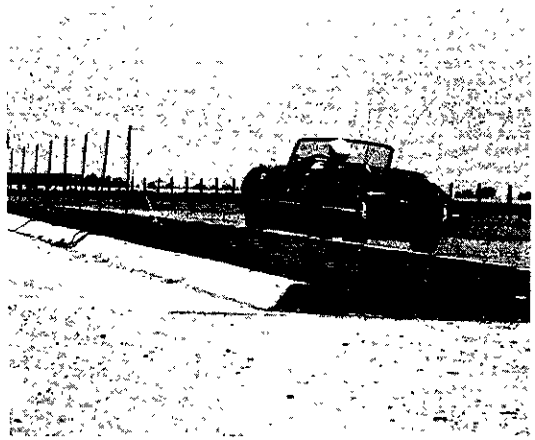
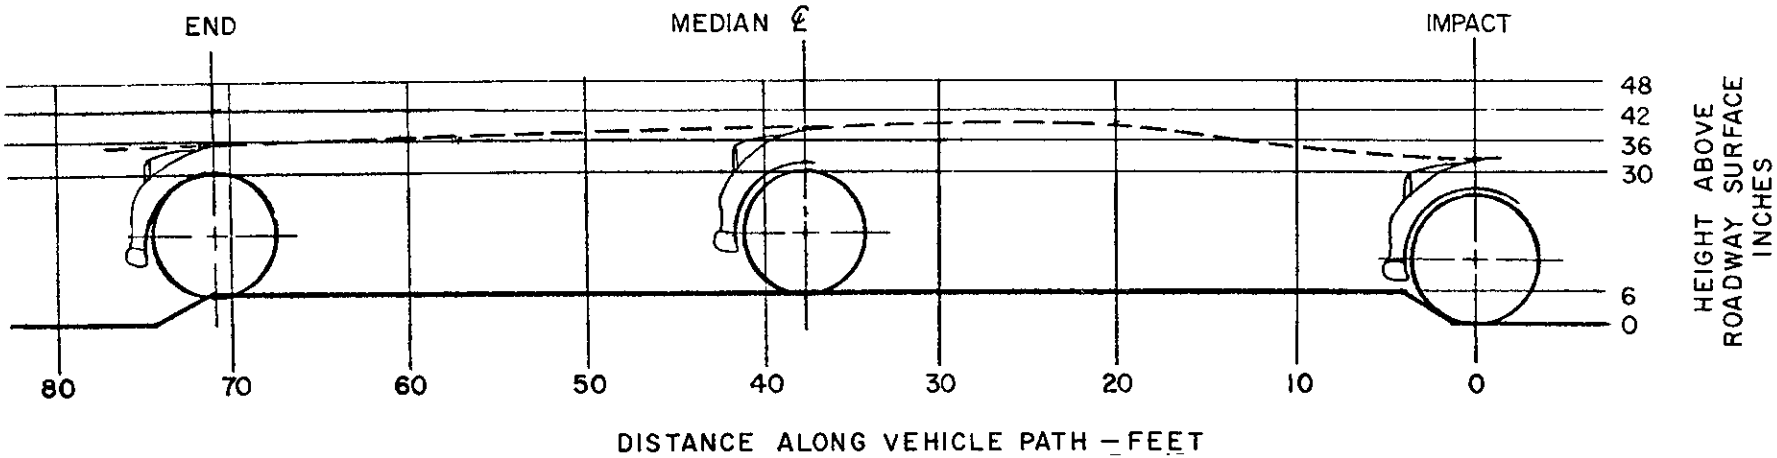
EXHIBIT 13

HEIGHT OF CURB.....6" Class B Curb
VEHICLE TIRE SIZE & DIA.....5.50-15 26" OD
TOTAL VEHICLE HEIGHT AT AXLE ℄.....33"
RISE AT MEDIAN ℄.....7" Ref. from roadway surface
LENGTH & WIDTH OF INSTALLATION....200' long x 7' wide
GROUND CONDITION.....Dry
VEHICLE DAMAGE.....1 Rim bent
MAX. RISE.....8" Ref. from roadway surface

TEST NO J8a
DATE.....7-31-63
VEHICLE.....58 TRIUMPH TR-3
SPEED.....57 mph
IMPACT ANGLE.....7°
VEHICLE WEIGHT....2540#
(W/DUMMY & INSTRUMENTATION)

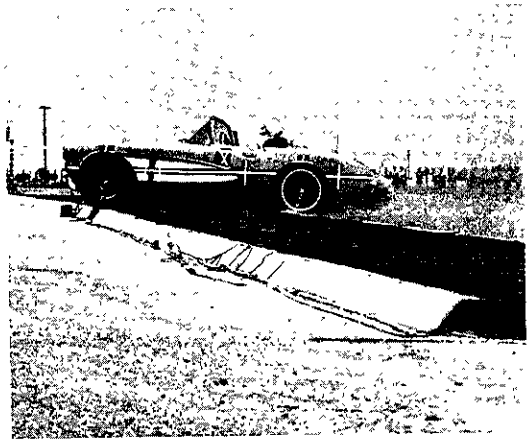
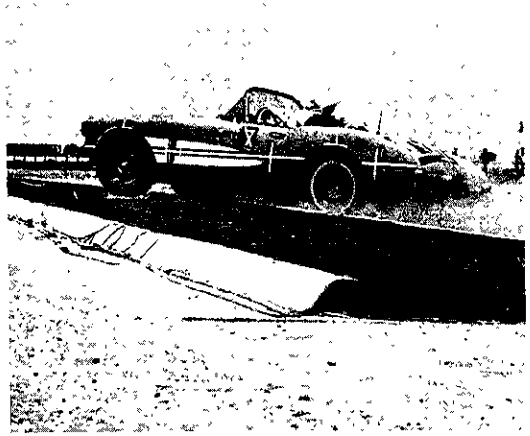
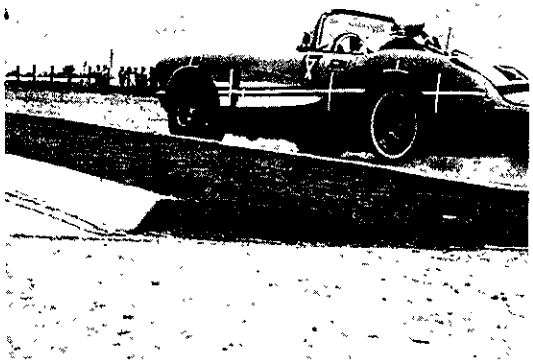
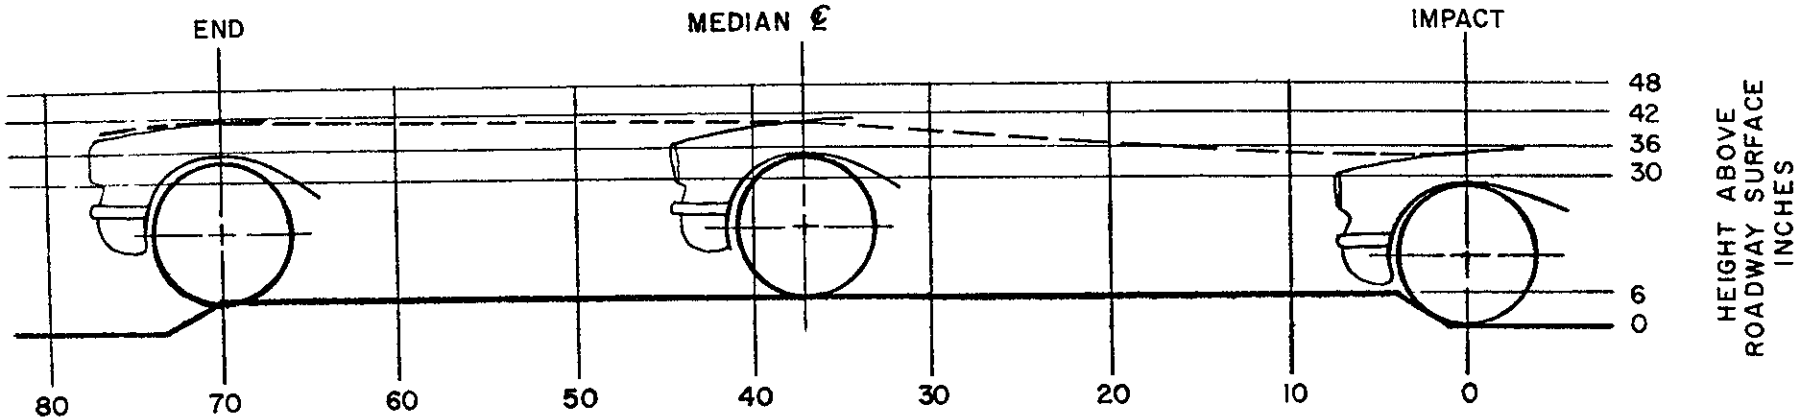
EXHIBIT 14

HEIGHT OF CURB.....6" Class B Curb
VEHICLE TIRE SIZE & DIA.....6.70-15 27" OD
TOTAL VEHICLE HEIGHT AT AXLE ℄....34"
RISE AT MEDIAN ℄.....6" Ref. from roadway surface
LENGTH & WIDTH OF INSTALLATION....200' long x 7' wide
GROUND CONDITION.....Dry
VEHICLE DAMAGE.....2 Rims bent - 1 tire blown
MAX. RISE.....8" Ref from roadway surface

TEST NO.....J7b
DATE.....7-30-63
VEHICLE.....57 CHEV. CORVETTE
SPEED.....Brakes at impact
IMPACT ANGLE.....7°
VEHICLE WEIGHT...3300#
(W/DUMMY & INSTRUMENTATION)

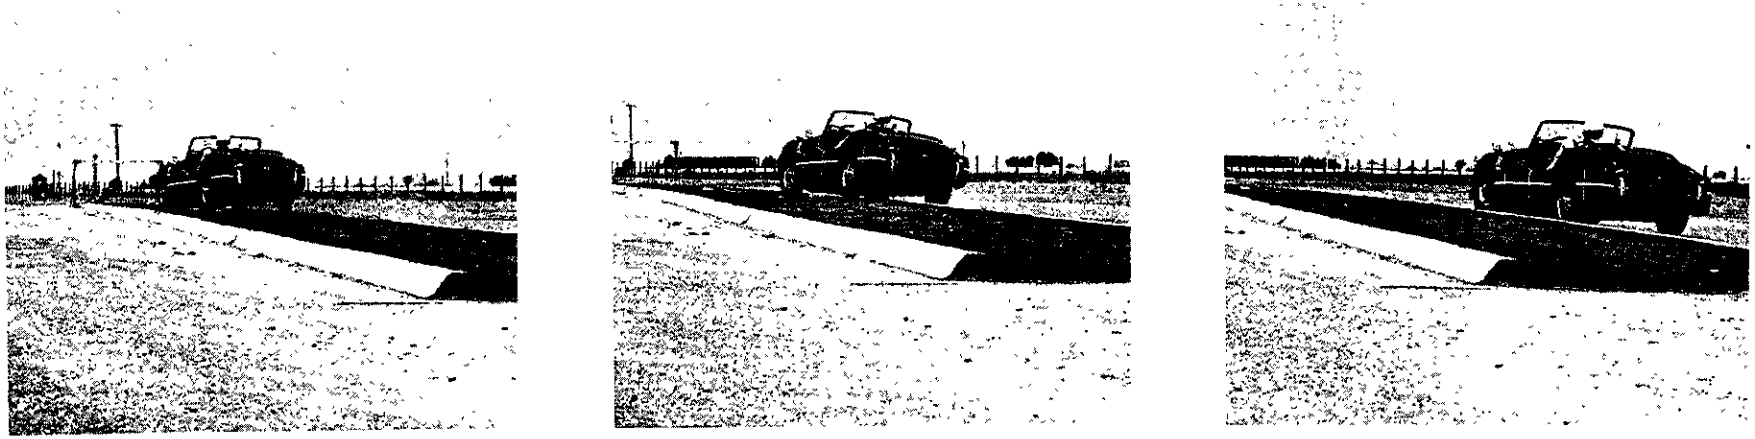
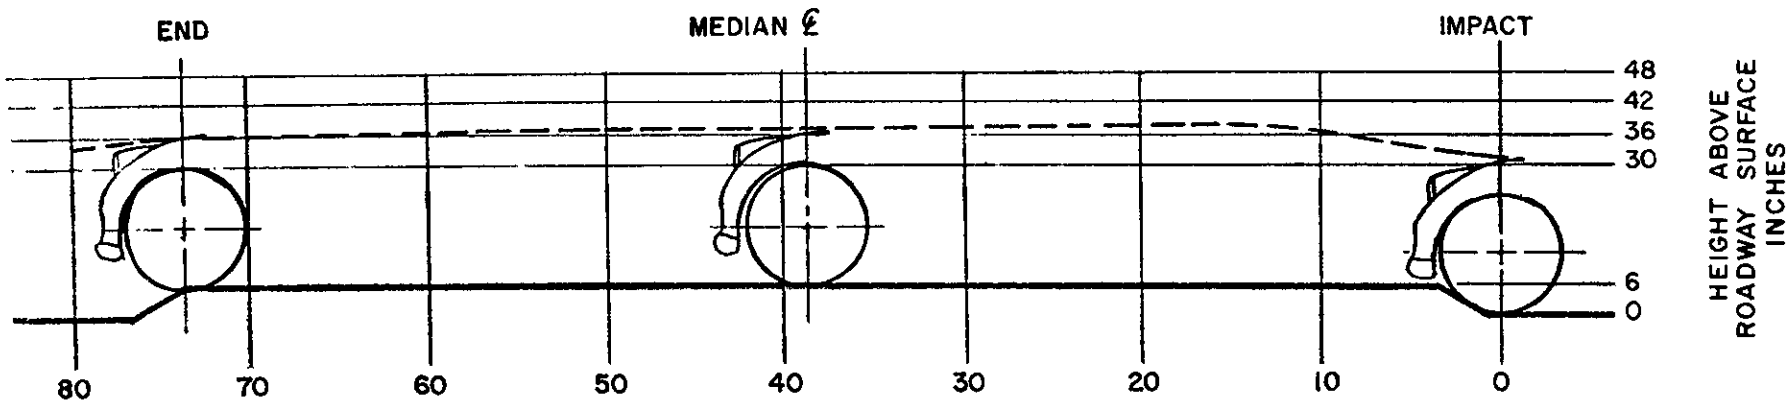
HEIGHT OF CURB. . . . . .6" Class B Curb
VEHICLE TIRE SIZE & DIA. . . . . .5.50-15 26" OD
TOTAL VEHICLE HEIGHT AT AXLE ℄ . . 33"
RISE AT MEDIAN ℄ . . . . . .6" Ref. from roadway surface
LENGTH & WIDTH OF INSTALLATION. . 200' long x 7' wide
GROUND CONDITION. . . . . Dry
VEHICLE DAMAGE. . . . . 2 Rims bent
MAX. RISE. . . . . .7" Ref. from roadway surface

TEST NO. J8b
DATE 7-31-63
VEHICLE . . . . . .58 TRIUMPH TR-3
SPEED. . . . . .Brakes at impact
IMPACT ANGLE. . . .7°
VEHICLE WEIGHT. .2540#
(W/DUMMY & INSTRUMENTATION)
