4. TITLE AND SUBTITLE
Investigation of Rock Slope Protection Material

9. PERFORMING ORGANIZATION NAME AND ADDRESS
State of California
Department of Public Works
Division of Highways
Materials and Research Department

HIGHWAY RESEARCH REPORT

INVESTIGATION OF ROCK SLOPE PROTECTION MATERIAL

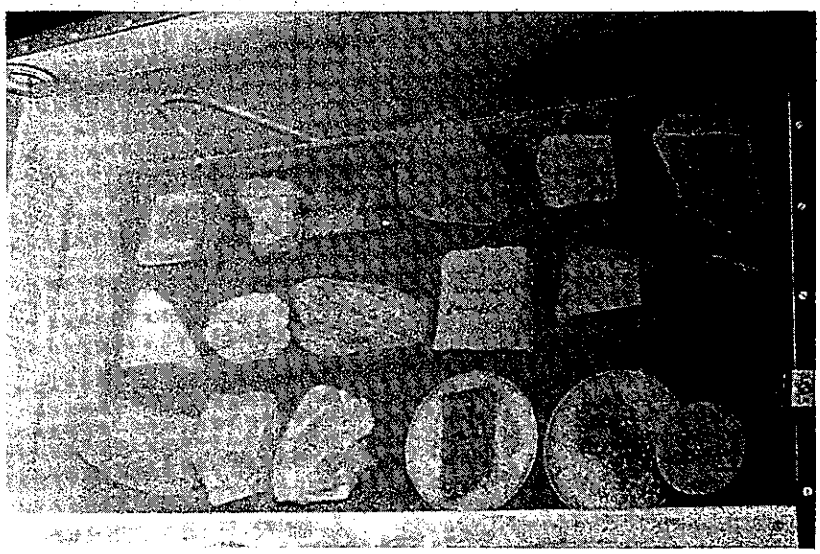
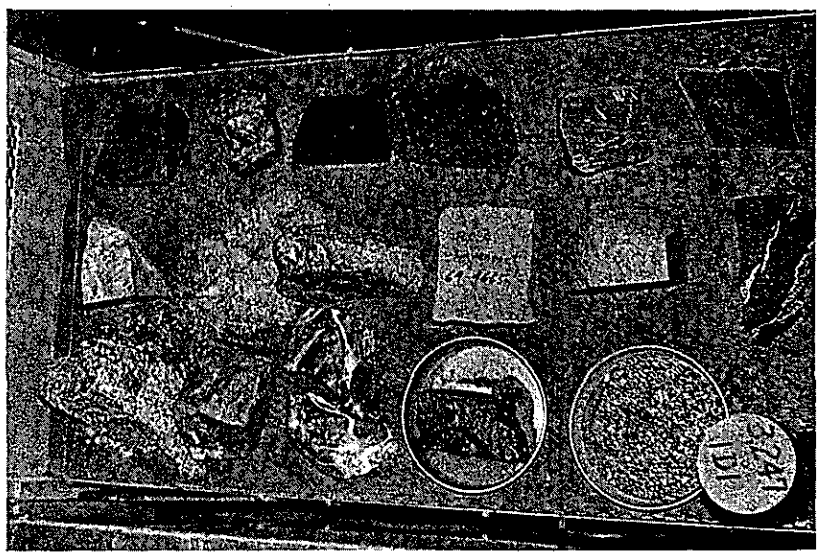
Figure 7.-Samples in freeze-thaw chamber

A. In frozen condition

B. After 200 cycles

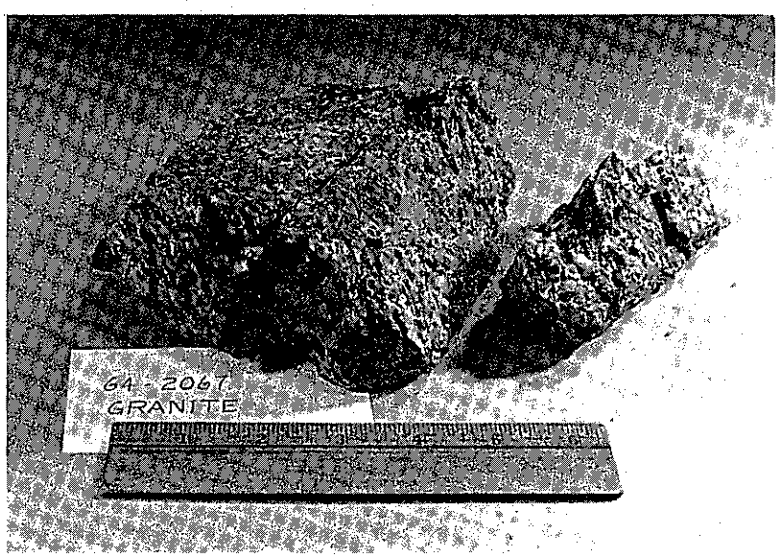
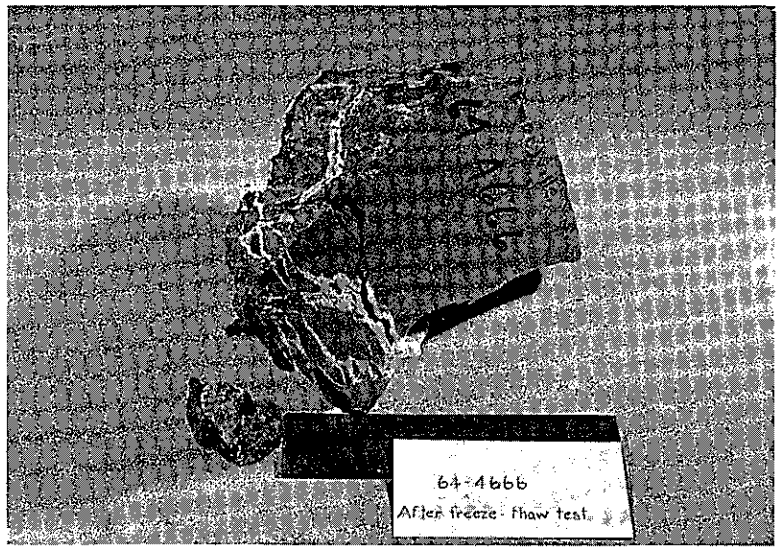
Figure 8.-Freeze-thaw samples with fractures

The Freeze-Thaw test appears to be most effective in attacking rocks with zones of structural weakness such as foliation, fractures, veins, and seams. These features are destroyed in the process of crushing and screening and, therefore, crushed rock should perform well in this test whether submerged or not. This was true in the above described series of tests for evaluating the relative severity of intermittent submersion and continuous submersion.

A. Granite (foliated)

B. Andesite

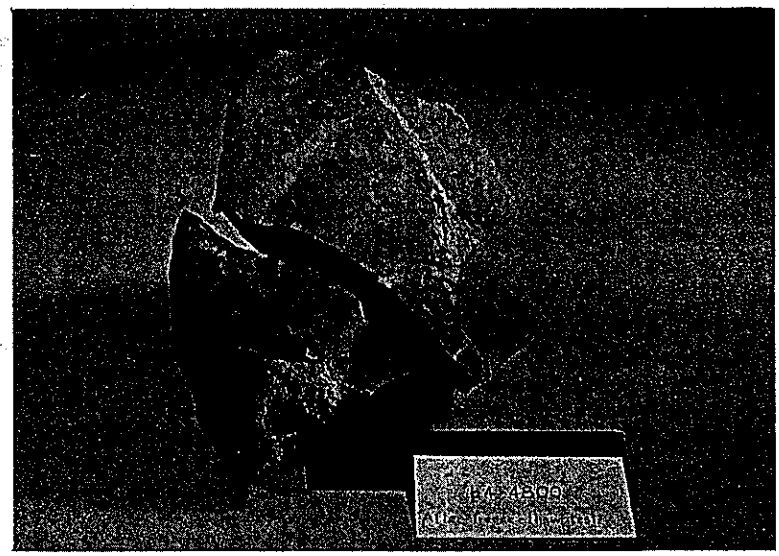
In the Freeze-Thaw test only fractured or foliated rocks, or those with expansive minerals had significant losses; all of these rocks would have failed one or more of the Specification tests. Also, the results obtained from this test do not correlate with the results of any of the present Specification tests. An inherent disadvantage of the Freeze-Thaw test as performed in this study is that 33.3 days are required to complete 200 cycles. This is considered to be the minimum number of cycles necessary to adequately test the rock.

Figure 9.-Freeze-thaw sample with expansive minerals

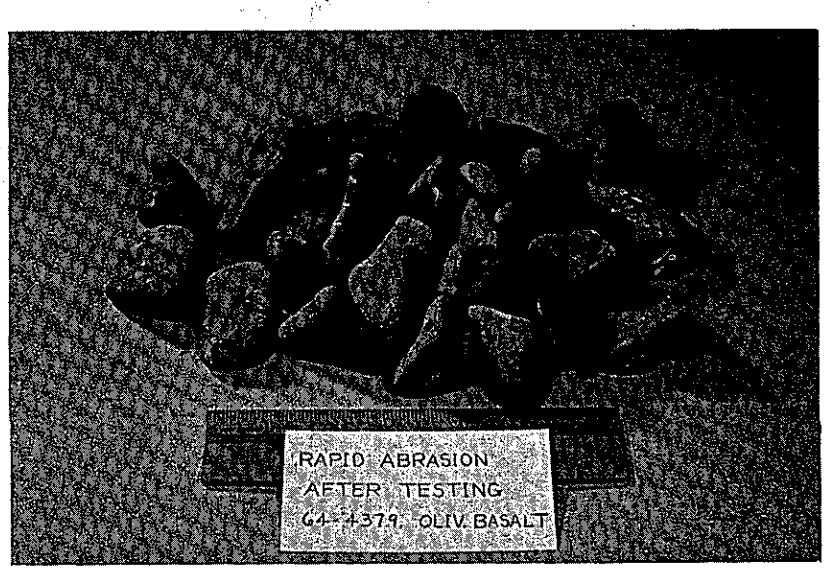
The "before" and "after" appearance of samples of two types of rock used in this study are shown in Figure 12 and Figure 13. This appearance is typical of all samples tested and shows very clearly the extreme rounding and smoothing which occurs in this test.

Figure 12.-Rapid abrasion sample

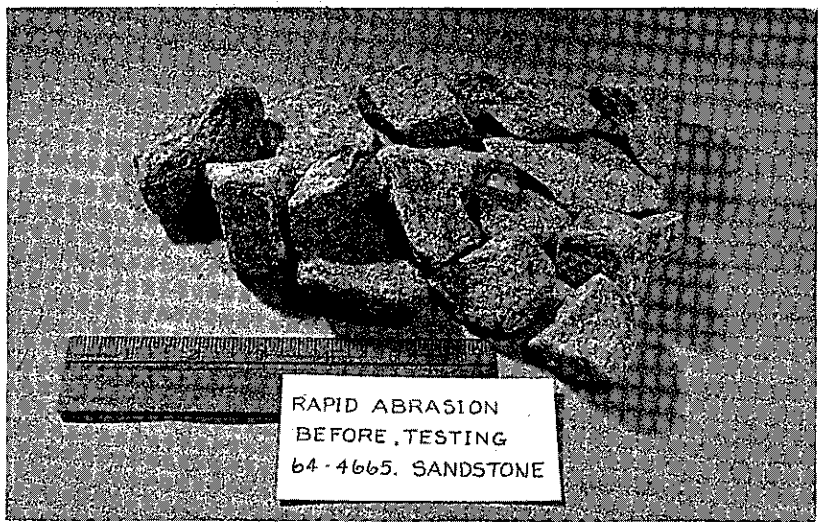
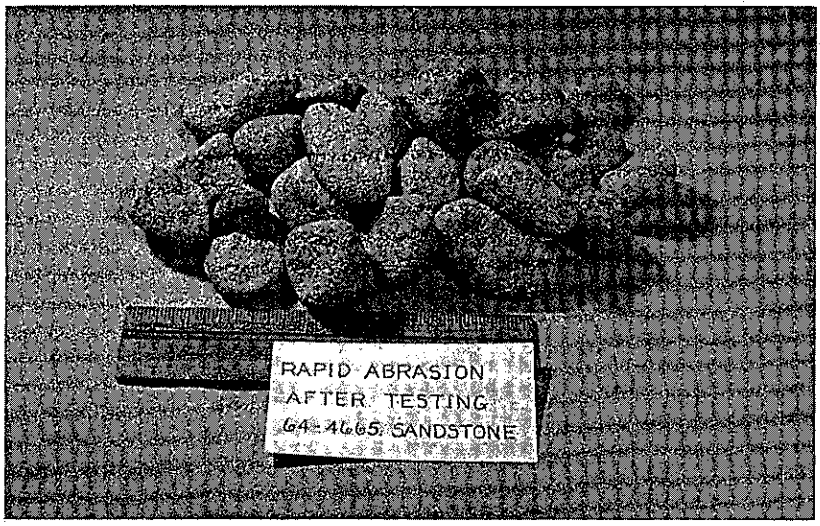
Figure 13.-Rapid abrasion sample
