4. TITLE AND SUBTITLE
Long Term Performance Of The First Reinforced Earth Wall In California

7. AUTHOR(S)
Joseph B. Hannon

9. PERFORMING ORGANIZATION NAME AND ADDRESS
Office of Transportation Laboratory
California Department of Transportation
Sacramento, California 95819

13. TYPE OF REPORT & PERIOD COVERED
Final

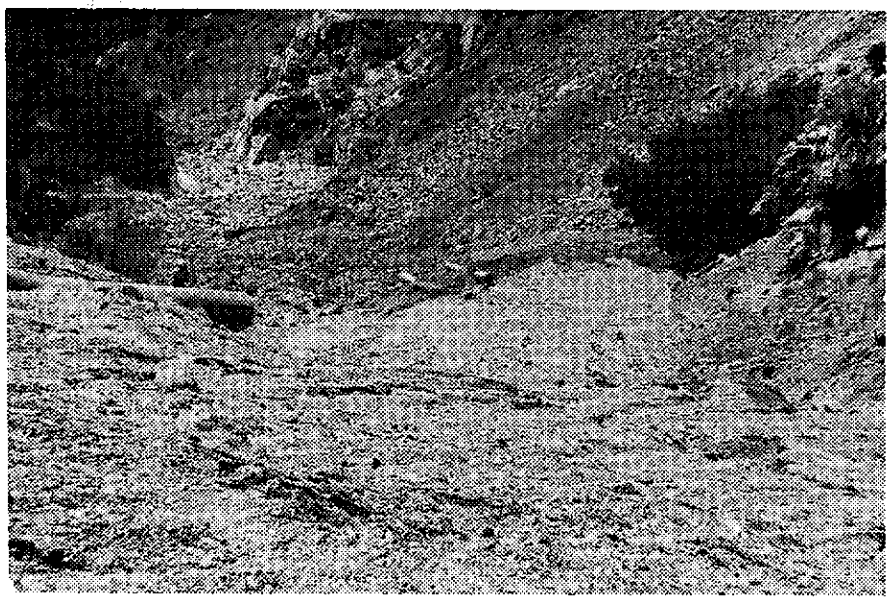
Photo 31 - Catchment Basin at Toe of Slope with Retained Eroded Material, After One Rainy Season (May 1980)

The fill slope below the wall is in generally good condition with some surface erosion (Photos 29 through 31), most of which has occurred at the south end of the wall below a rock outcrop. Erosion is concentrated in this area due to surface water runoff over the rock face.

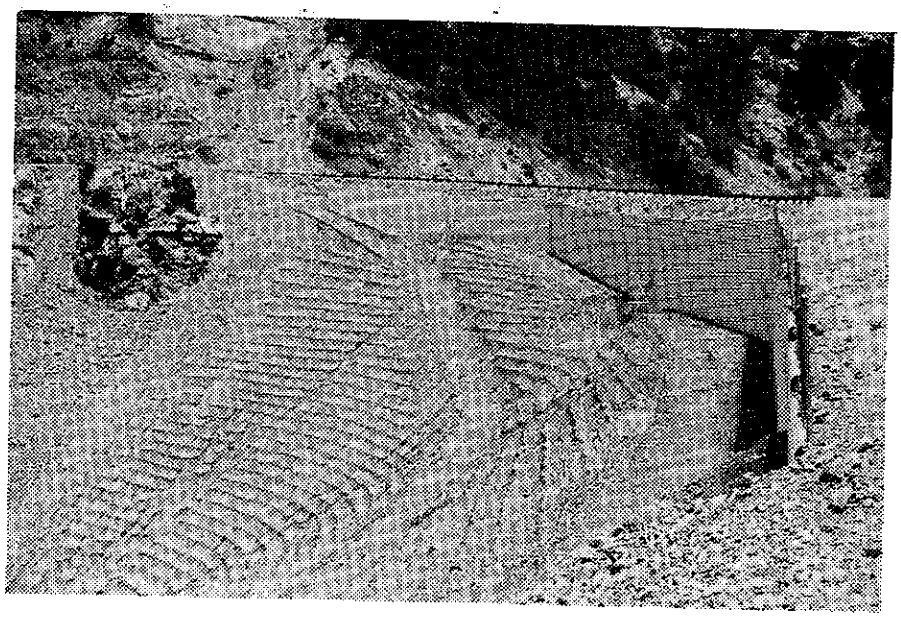
Photo 29 - Side View of Wall Looking North at Access Road on Slope, After One Rainy Season (May 1980)

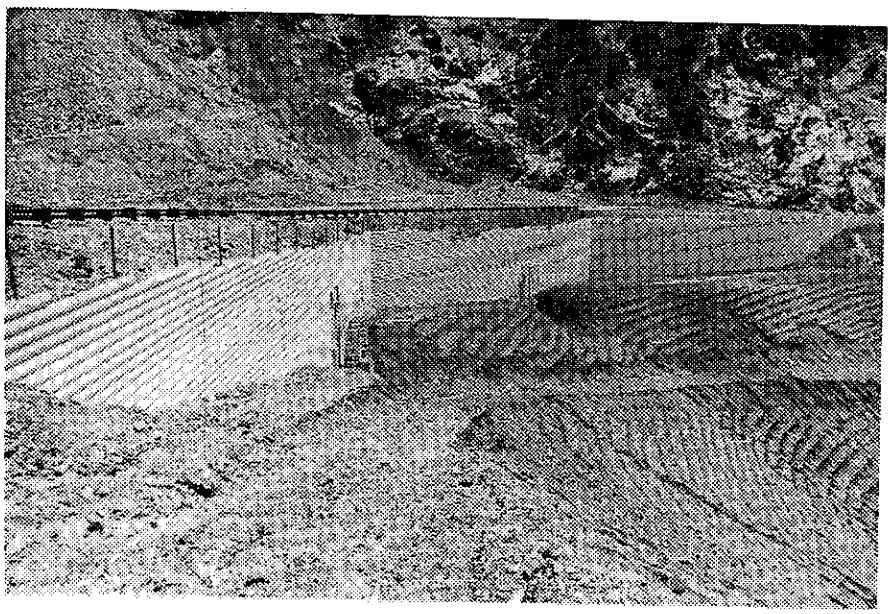
Photo 30 - Side View of Wall Looking South at Access Road on Slope, After One Rainy Season (May 1980)

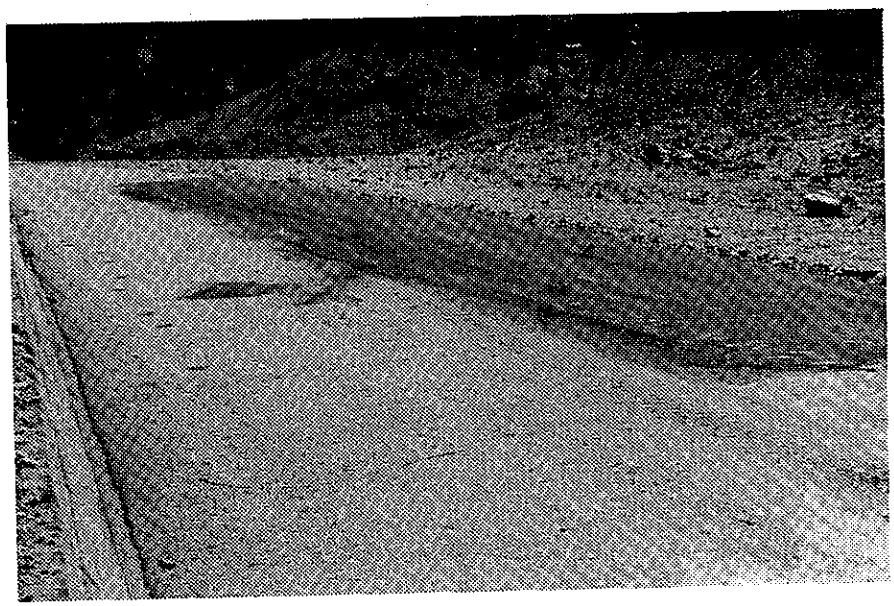
Photo 28 - Patched Pavement Behind South Flank of Wall (June 1980)

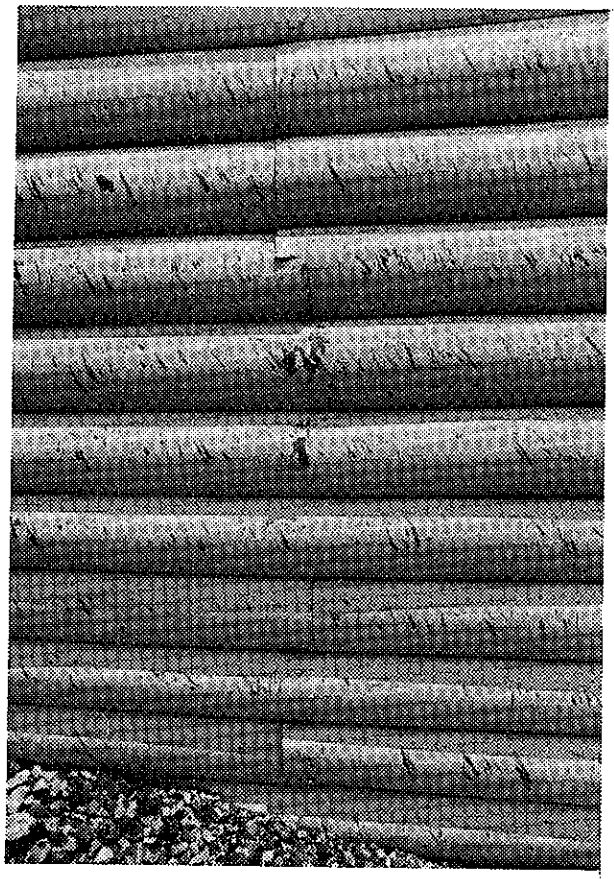
Photo 25 - Close-up of Skin Plate Joint Compression in Center Chord (May 1980)

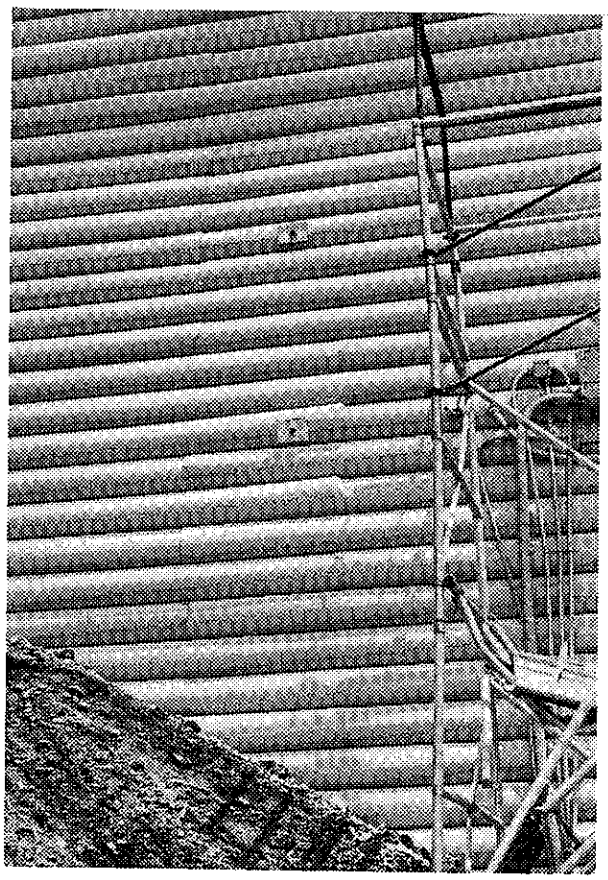
Photo 26 - Evidence of Skin Plate End Gouging and Distortion Near Instrumentation Station 551+75, Center Chord (May 1980)

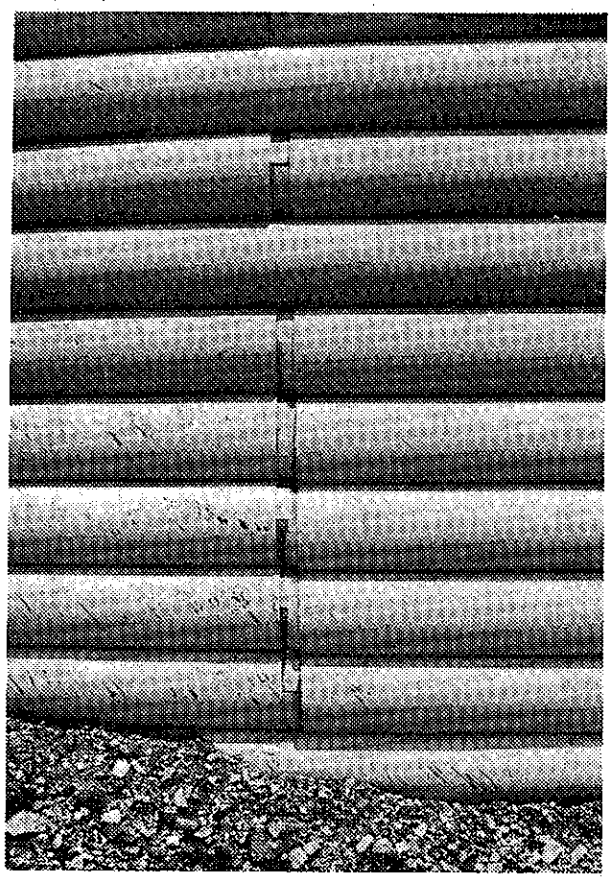
Photo 23 - Close-up of Skin Plate Joint Separation on North Flank (May 1980)

The relative magnitude and direction of movement of the wall has been manifested in the steel face elements as shown by photographs taken June 28, 1980. Photos 22, 23 and 24 show the extension and separation at the joints between skin plates on the north flank due to axial tensile stresses in the face. (Refer to skin element numbers 46, 57 and 69 in Tables 7 and 8.) This condition also occurs but to a lesser extent at the end of the south flank.

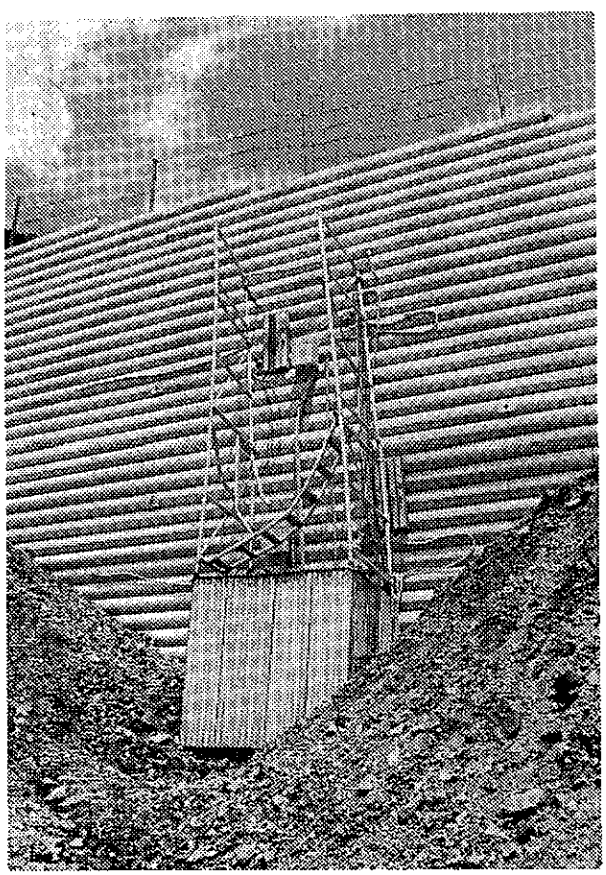
Photo 24 - Skin Plate Joint Separation Near Instrumentation Station 550+25, North Flank (May 1980)

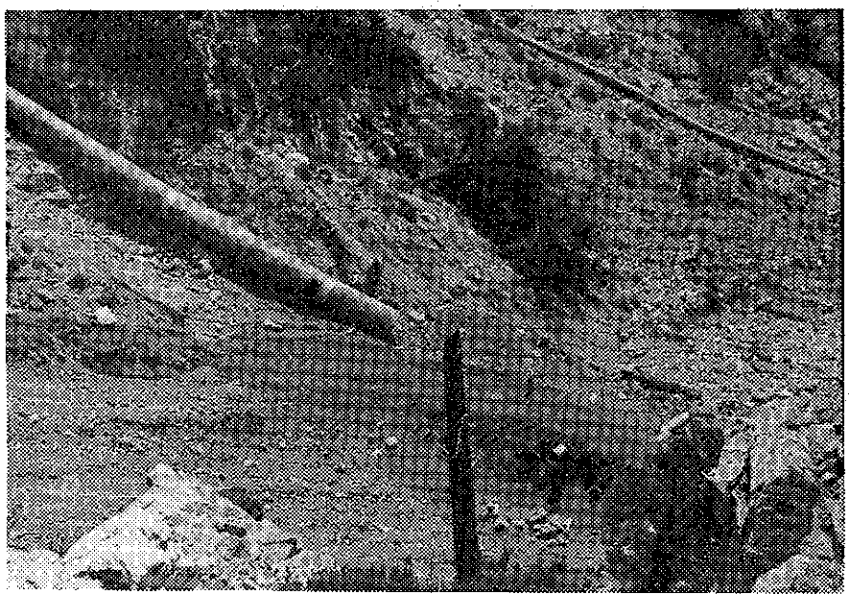
Photo 21 - Catchment Berm at Toe of Slope to Retain Eroded Material (August 1979)

The earthwork resloping operation below the wall was completed on August 7, 1979 by the Foothill Maintenance Station using Day Labor. This work involved: removing the temporary buttress and raising the berm in front of the wall toe by 10 feet as recommended (Photo 17); resloping the embankment (Photo 18); restoring the 84-inch drain pipe (Photo 19); constructing the access road from the top of the embankment to the toe of the slope (Photo 20); and building a catchment berm at the toe of the slope (Photo 21). The completed slope was terraced to minimize future erosion.

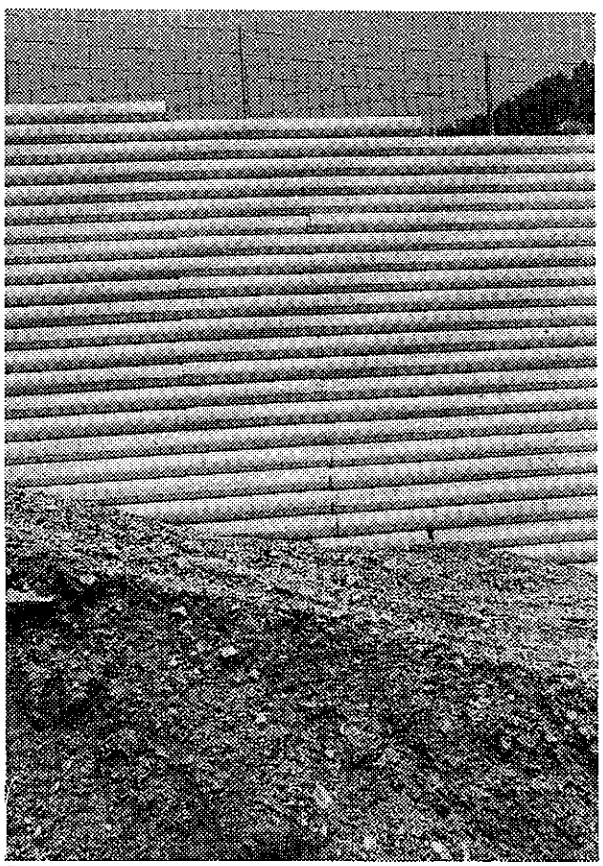
Photo 22 - Extension and Separation of Skin Plate Joints on North Flank (May 1980)

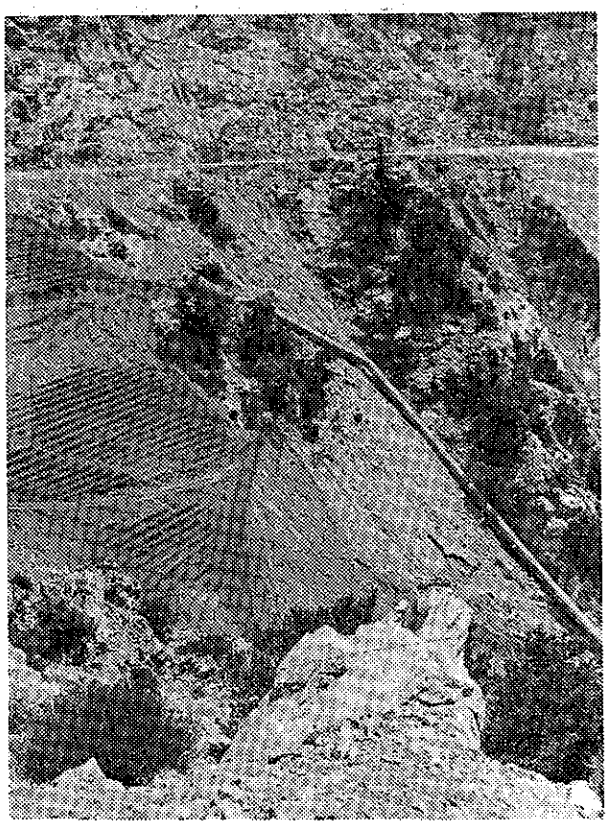
Photo 19 - View of Lower Portion of Slope and Restored 84-Inch Culvert (August 1979)

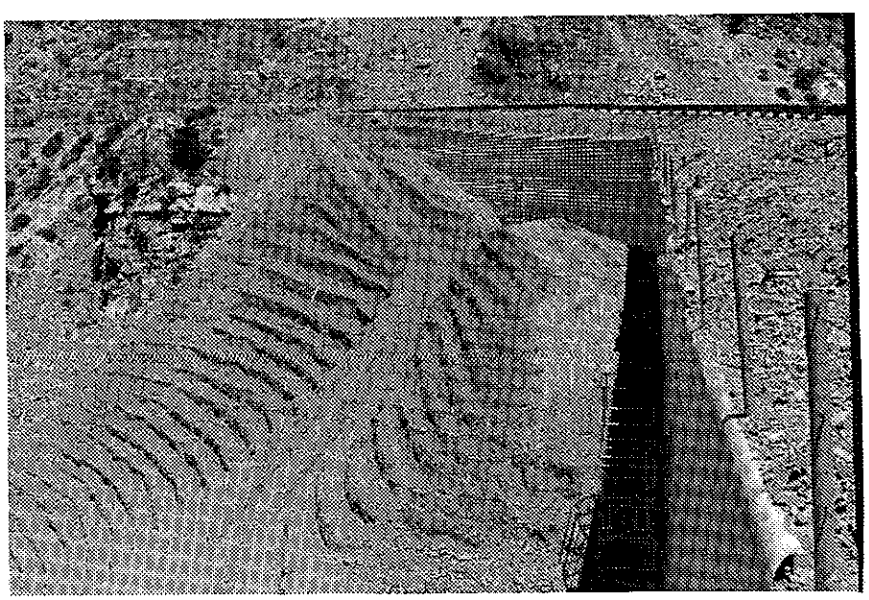
Photo 20 - Side View of Wall Looking North at Access Road on Slope (August 1979)

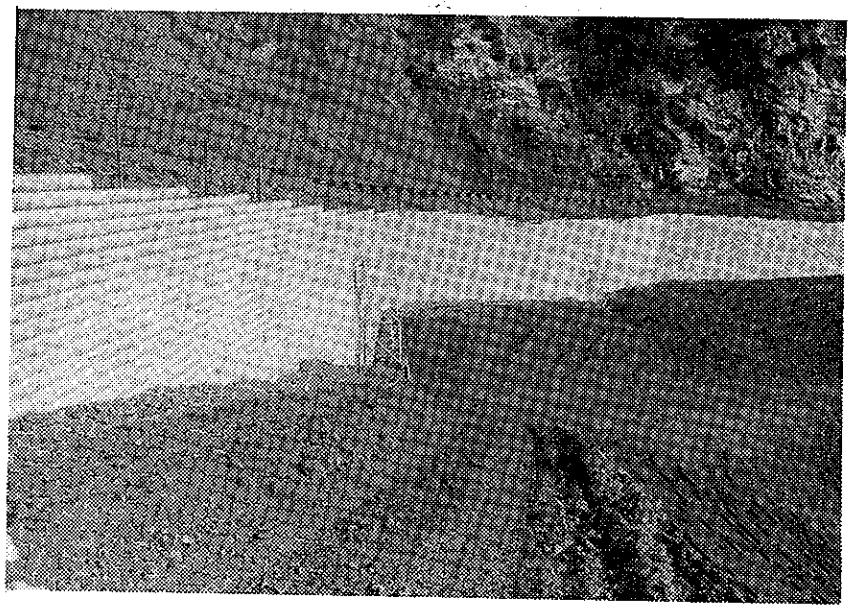
Photo 17 - Resloping and Construction of 10 ft of Additional Toe Buttress (July-August 1979, note stain on wall face of south flank from temporary buttress.)

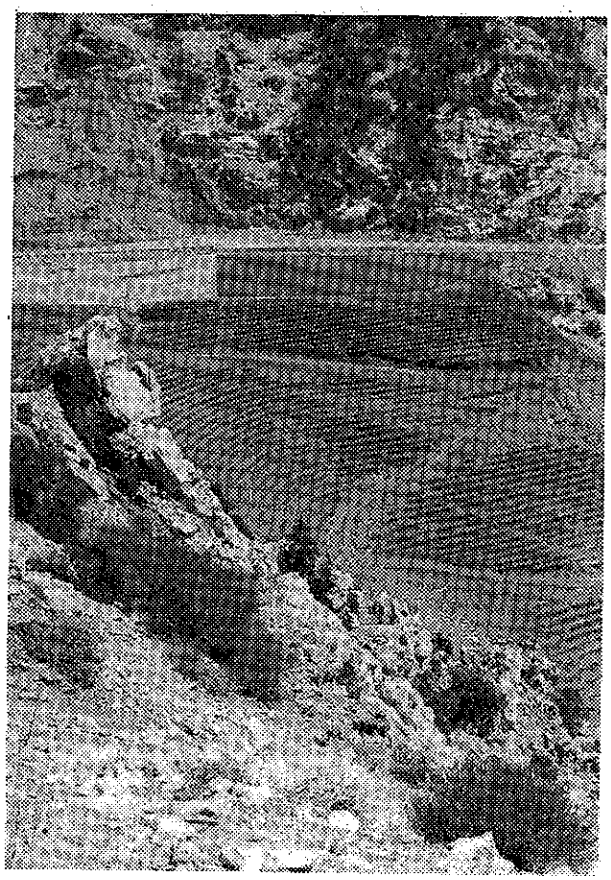
Photo 18 - Distant View of Slope Terracing and Access Road (August 1979)

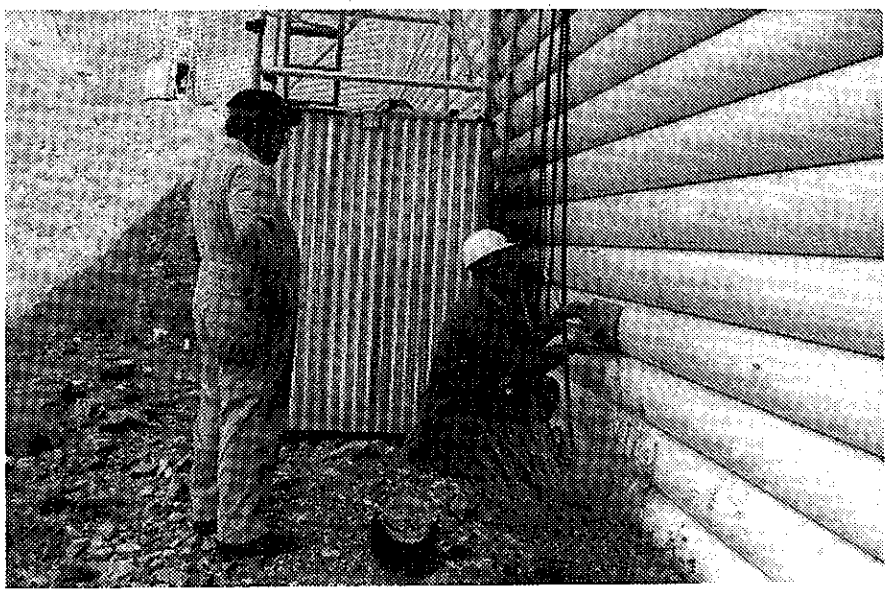
Photo 15 - Replacement of Skin Plate
Following Strain Gage Removal

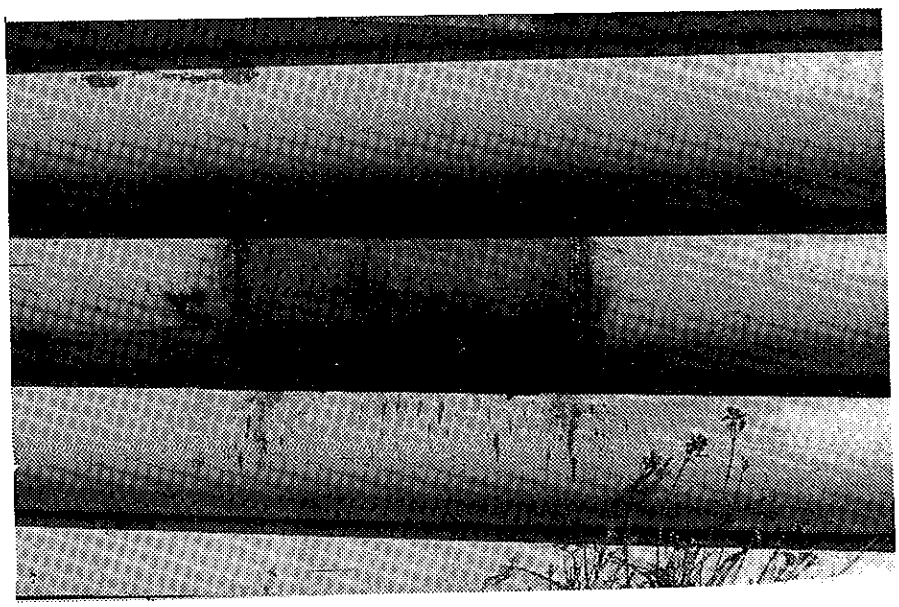
Photo 16 - Replacement of Skin Plate
Following Strain Gage Removal

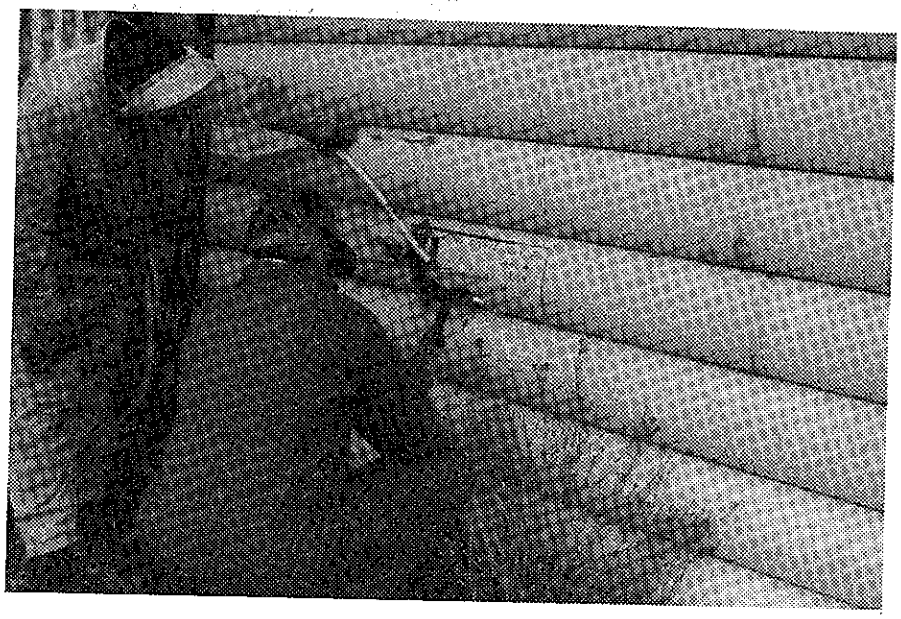
Photo 13 - Cutting Operation to Remove Strain Gage (October 1978)

Since the strain measurements on the reinforcing strips continued to suggest stresses beyond or near their proportional limit, the long term reliability of the strain gages was questioned. It was thus decided to retrieve several buried strain gages to verify that they were still functioning properly. The most accessable gages were those on the back of the skin plate. These gages were located at Station 551+75, Level B (See Photo 11 and refer to Figure 8.) The retrival was accomplished as shown in Photos 12 through 16 by removal of a small section of face plate. Tensile tests up to 6,000 lbs performed on samples of the retrieved skin plate with the gages attached indicated that these strain gages were functioning properly. This, in turn, indicated the probable validity of data developed from the buried strain gages on the reinforcing strips.

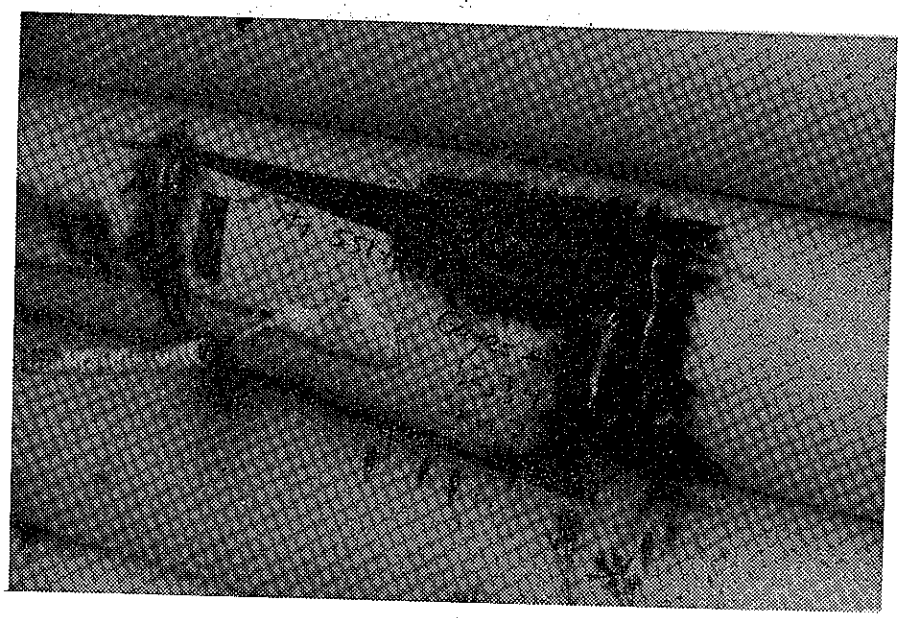
Photo 14 - Strain Gage Removal

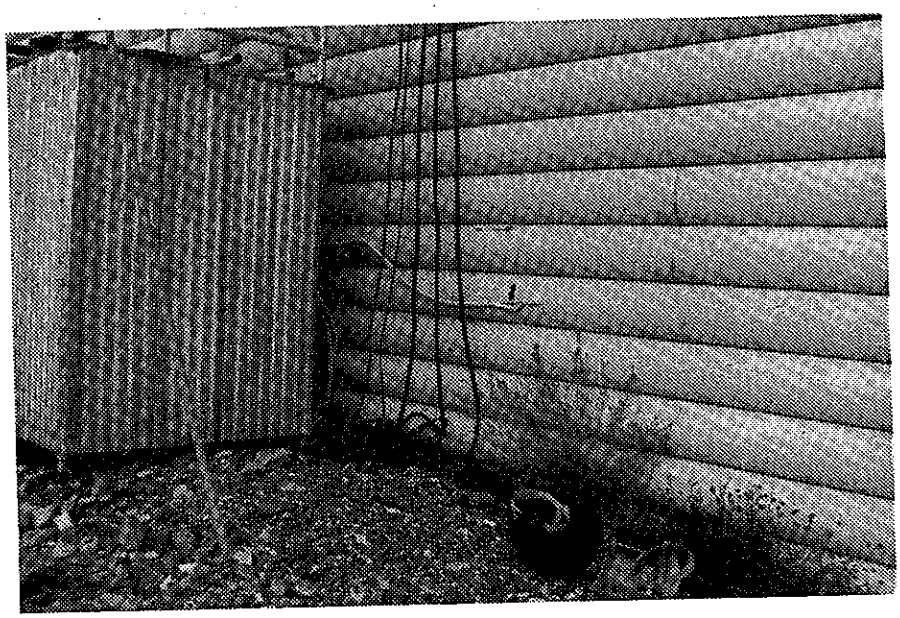
Photo 11 - Strain Gage Location at Level B, Station 551+75 Prior to Removal

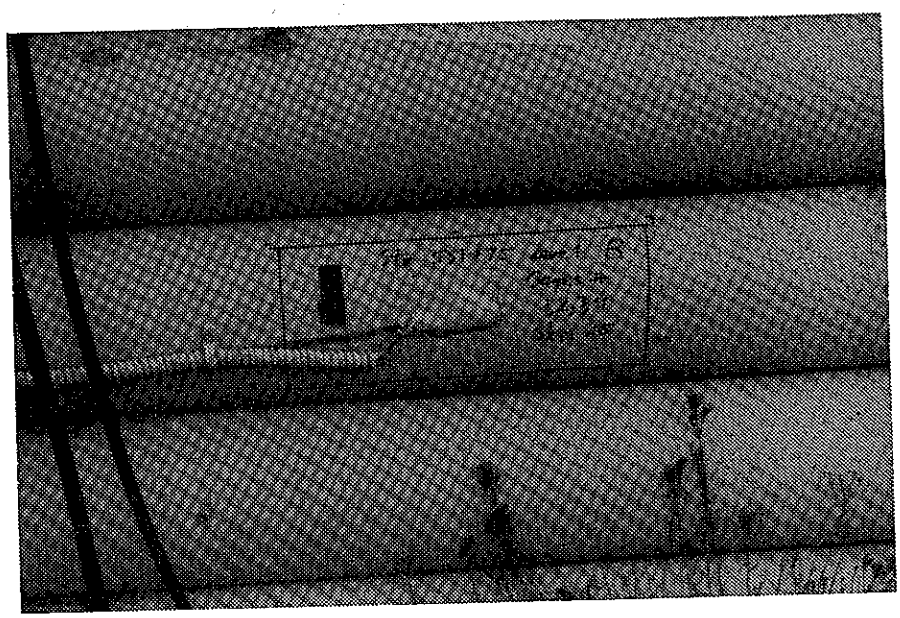
Photo 12 - Strain Gage Location at Level B, Station 551+75 Prior to Removal

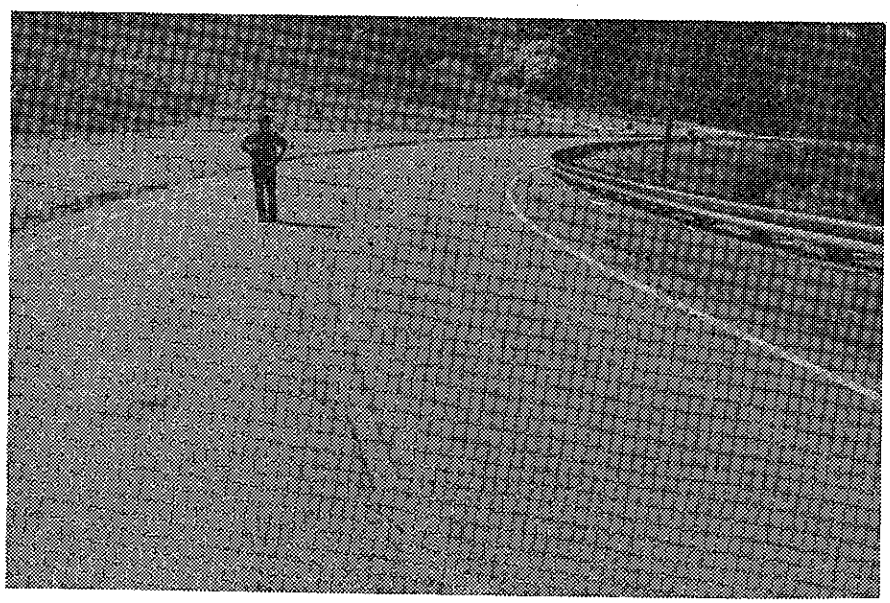
Photo 10 - Cracks in Pavement at North Flank of Wall Near Centerline (June 1978)

centerline for a distance of about 40 feet (Photo 10). It was apparent that reshaping of the slope below the wall would be mandatory prior to the next winter season. Recommended remedial measures by the Transportation Laboratory to improve wall stability were submitted to District 07 in October 1978. These measures included flatting the embankment slope, interception and diversion of surface runoff and removal of additional slide debris behind the wall plus repair of the drain system below the wall.

During this period, a series of cracks appeared in the pavement on top of the north flank of the wall near roadway

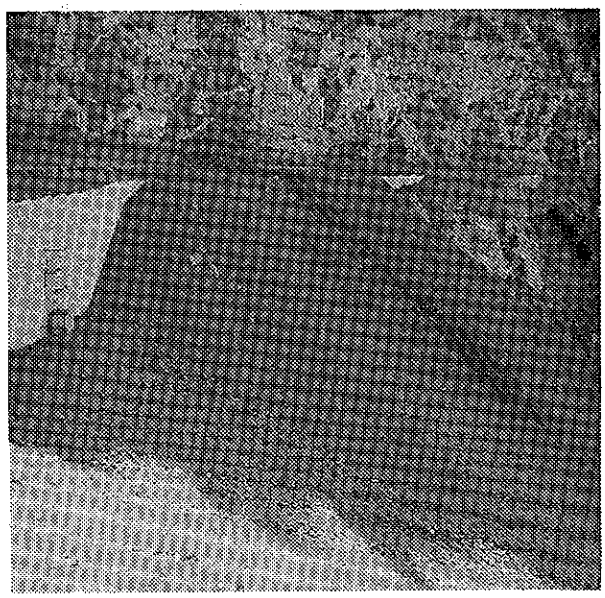
Photo 7 - Slide Material Being Pushed Over Wall Face to Form Temporary Buttress (November-December 1977)

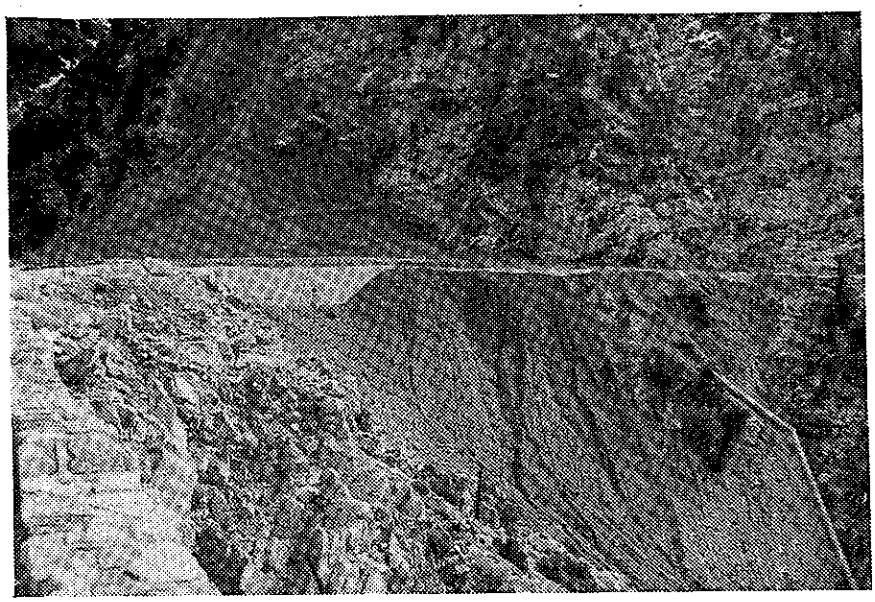
Photo 8 - Erosion on Temporary Buttress (Winter of 1977)

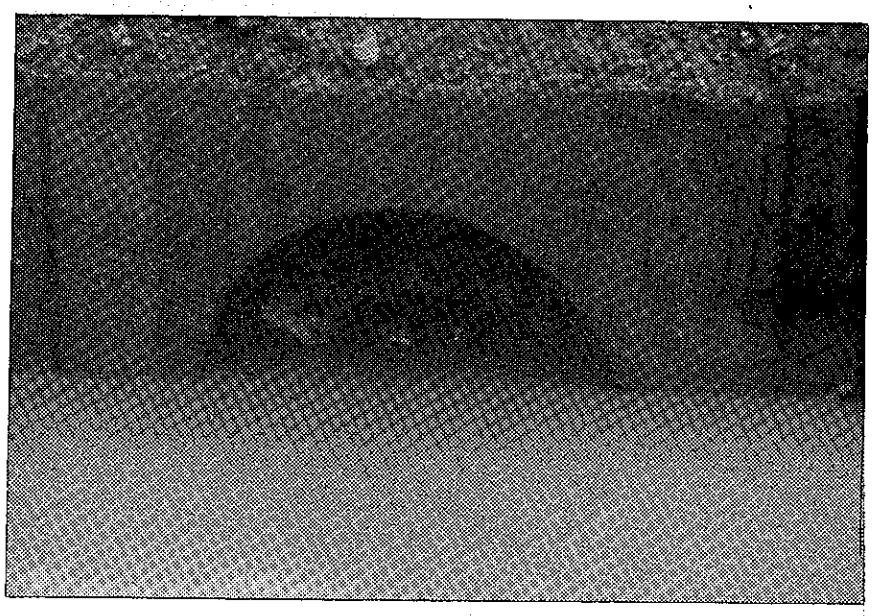
Photo 5 - Plugged Culvert Inlet During Winter Storm

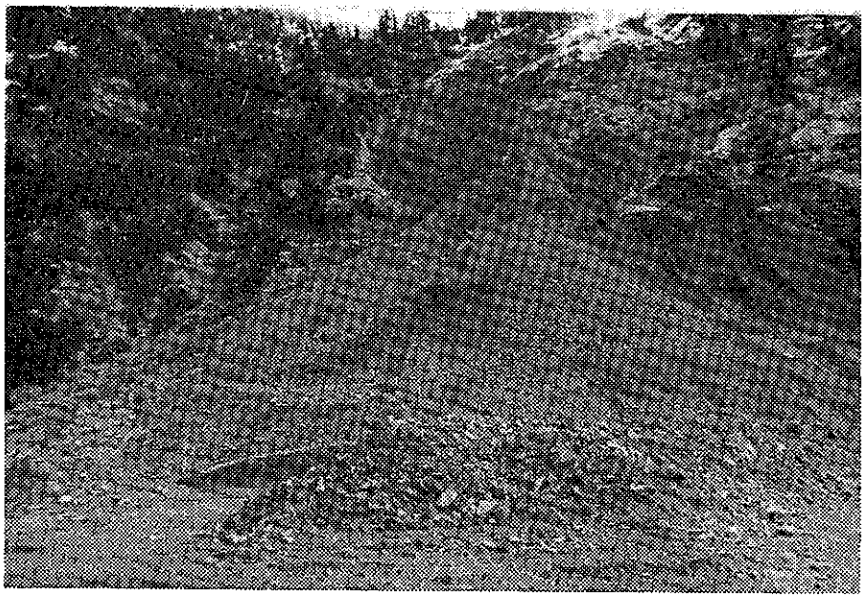
Photo 6 - Slide Debris Prior to Removal Behind Wall

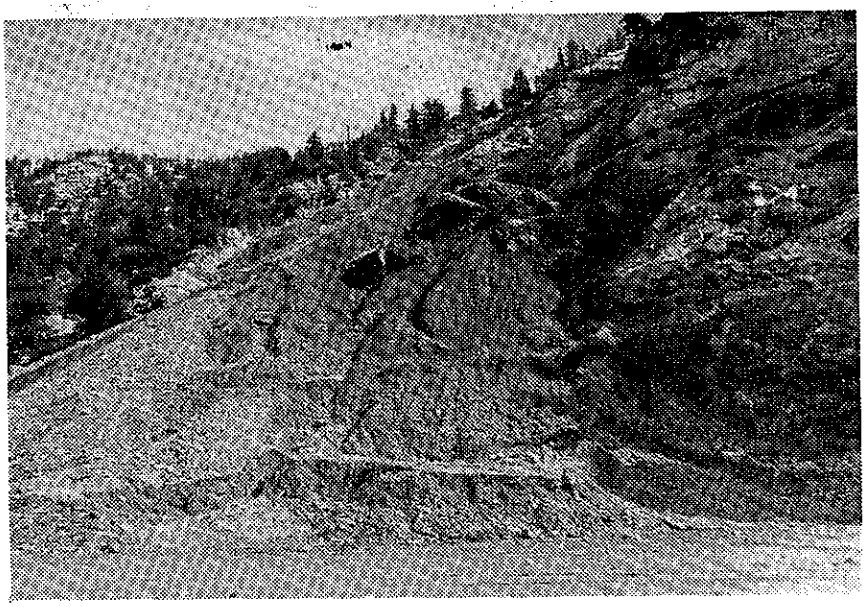
Photo 3 - Continuous Accumulation of Slide Debris Behind Wall

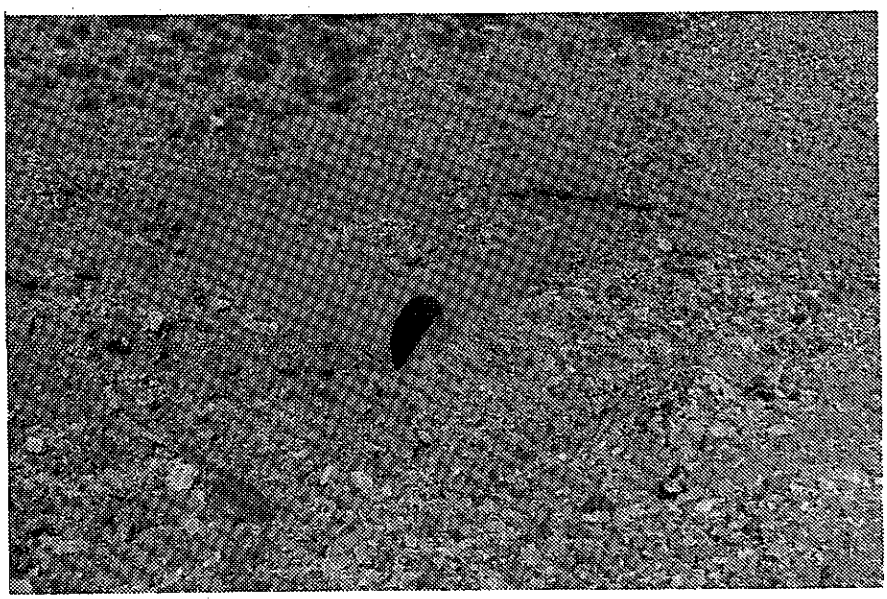
Photo 4 - Culvert Inlet Behind Wall (Note pervious nature of channel entrance.) - June 1978

to surface water moving directly into the highly permeable embankment from natural drainage swales in back of the wall, when these flows were unable to reach the culvert inlet (Photo 4) or due to a plugged inlet structure (Photo 5).

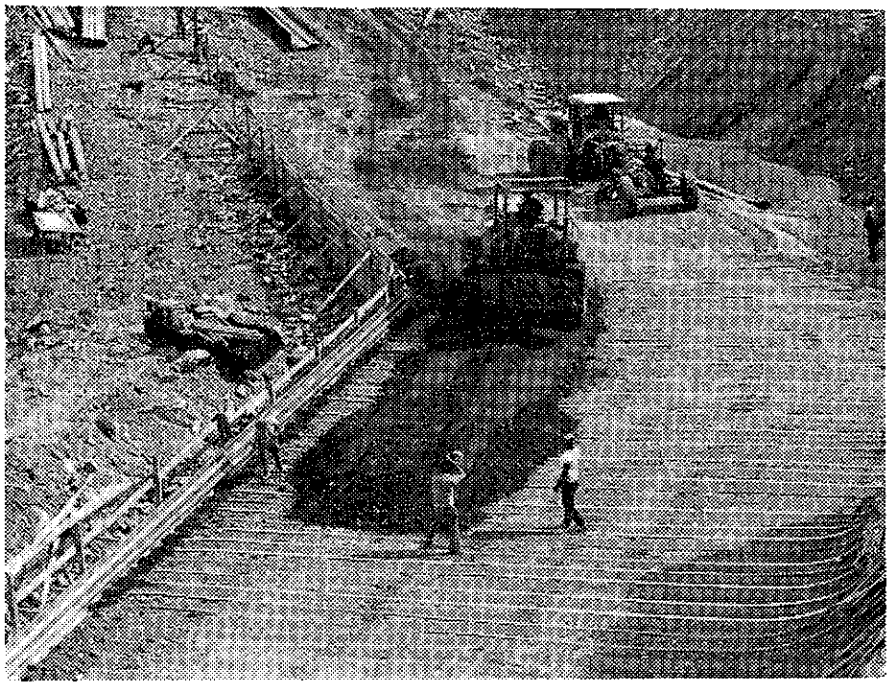
Photo 1 - Reinforced Earth Construction in 1972
(07-LA-39)

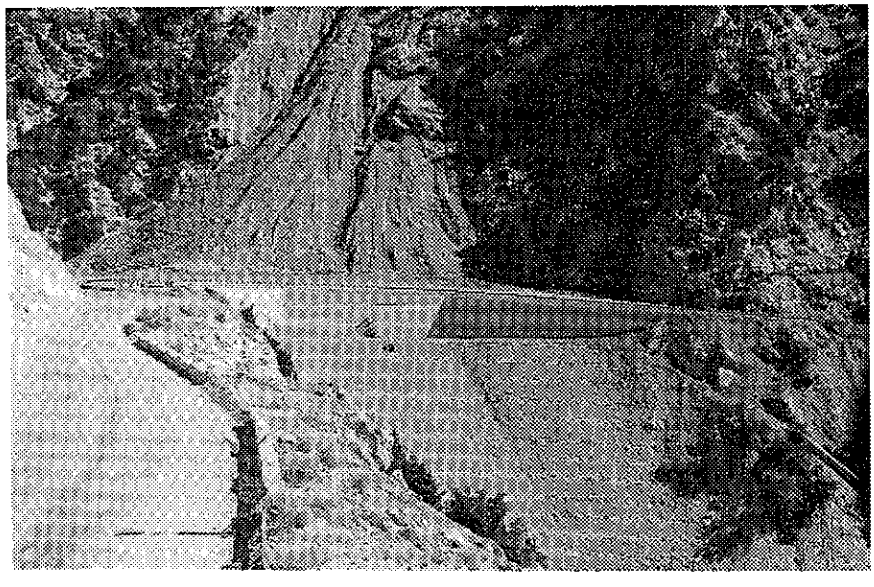
Photo 2 - Completed Facility in 1972
(07-LA-39)

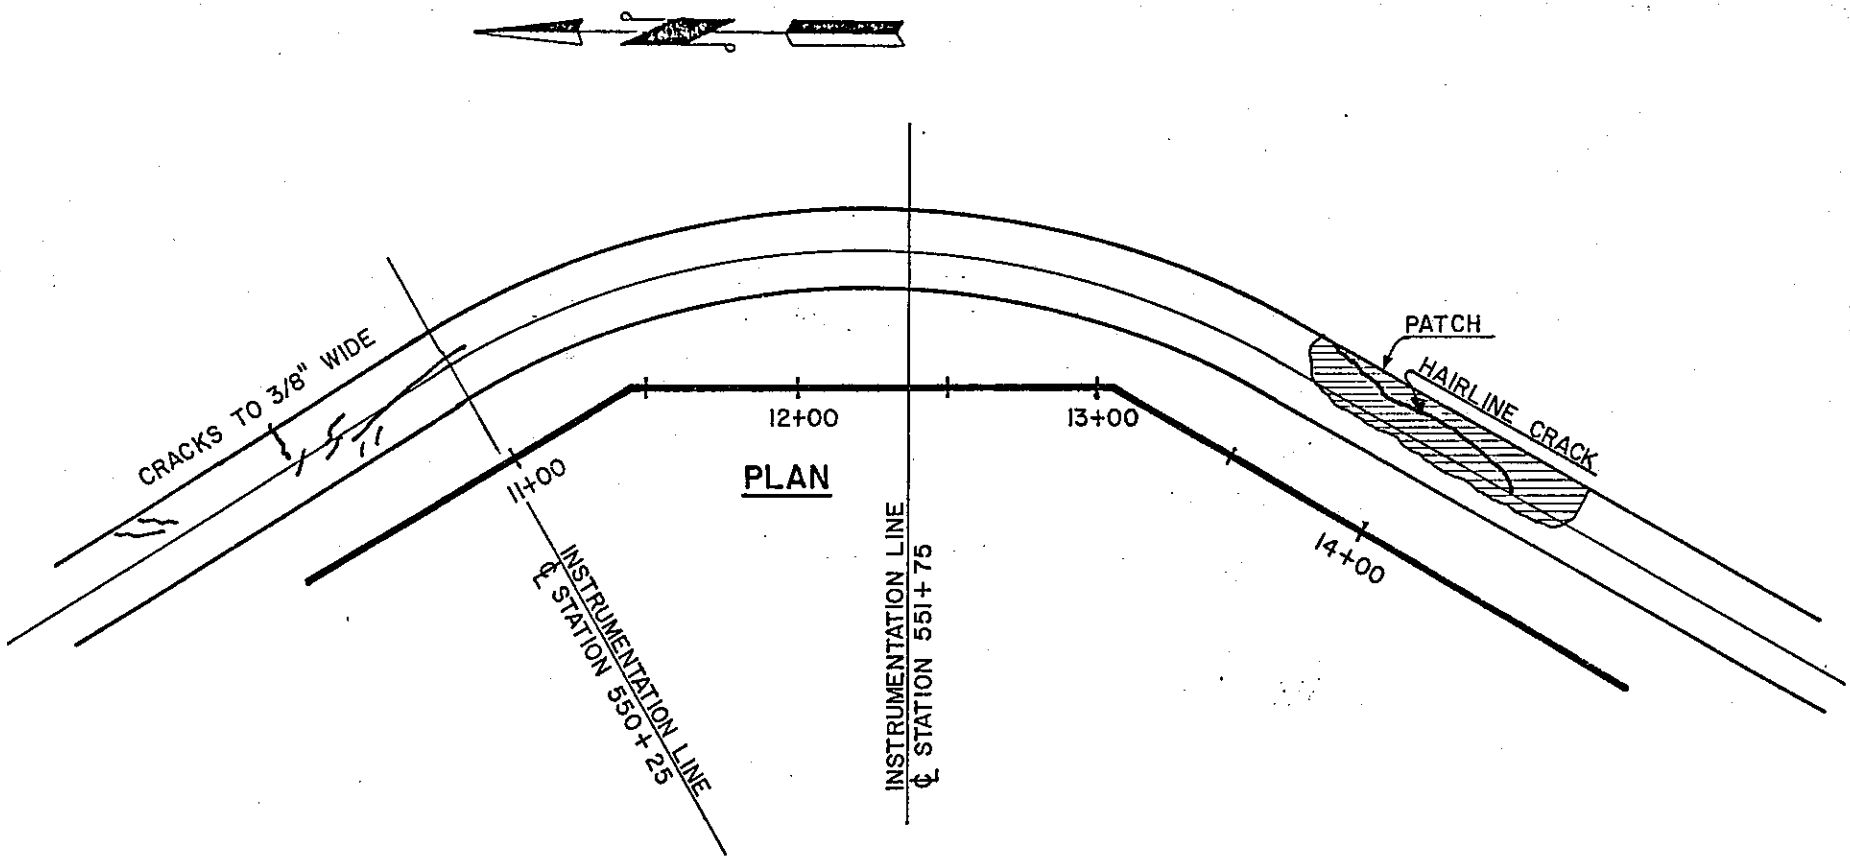
FIGURE 14

PAVEMENT CONDITION STUDY, JUNE 1980

A crack count made during the final condition survey indicated several 1/4 to 3/8 inch wide cracks in the pavement behind the north flank of the wall. These are shown in Figure 14 and are the same cracks observed in 1978 (Photo 10). Hairline cracks were also observed in the patched pavement area behind the wall's south flank (Photo 28). These cracks were reflecting up from the interface between the patch and the old pavement. The pavement and roadway above the wall are otherwise in excellent condition.

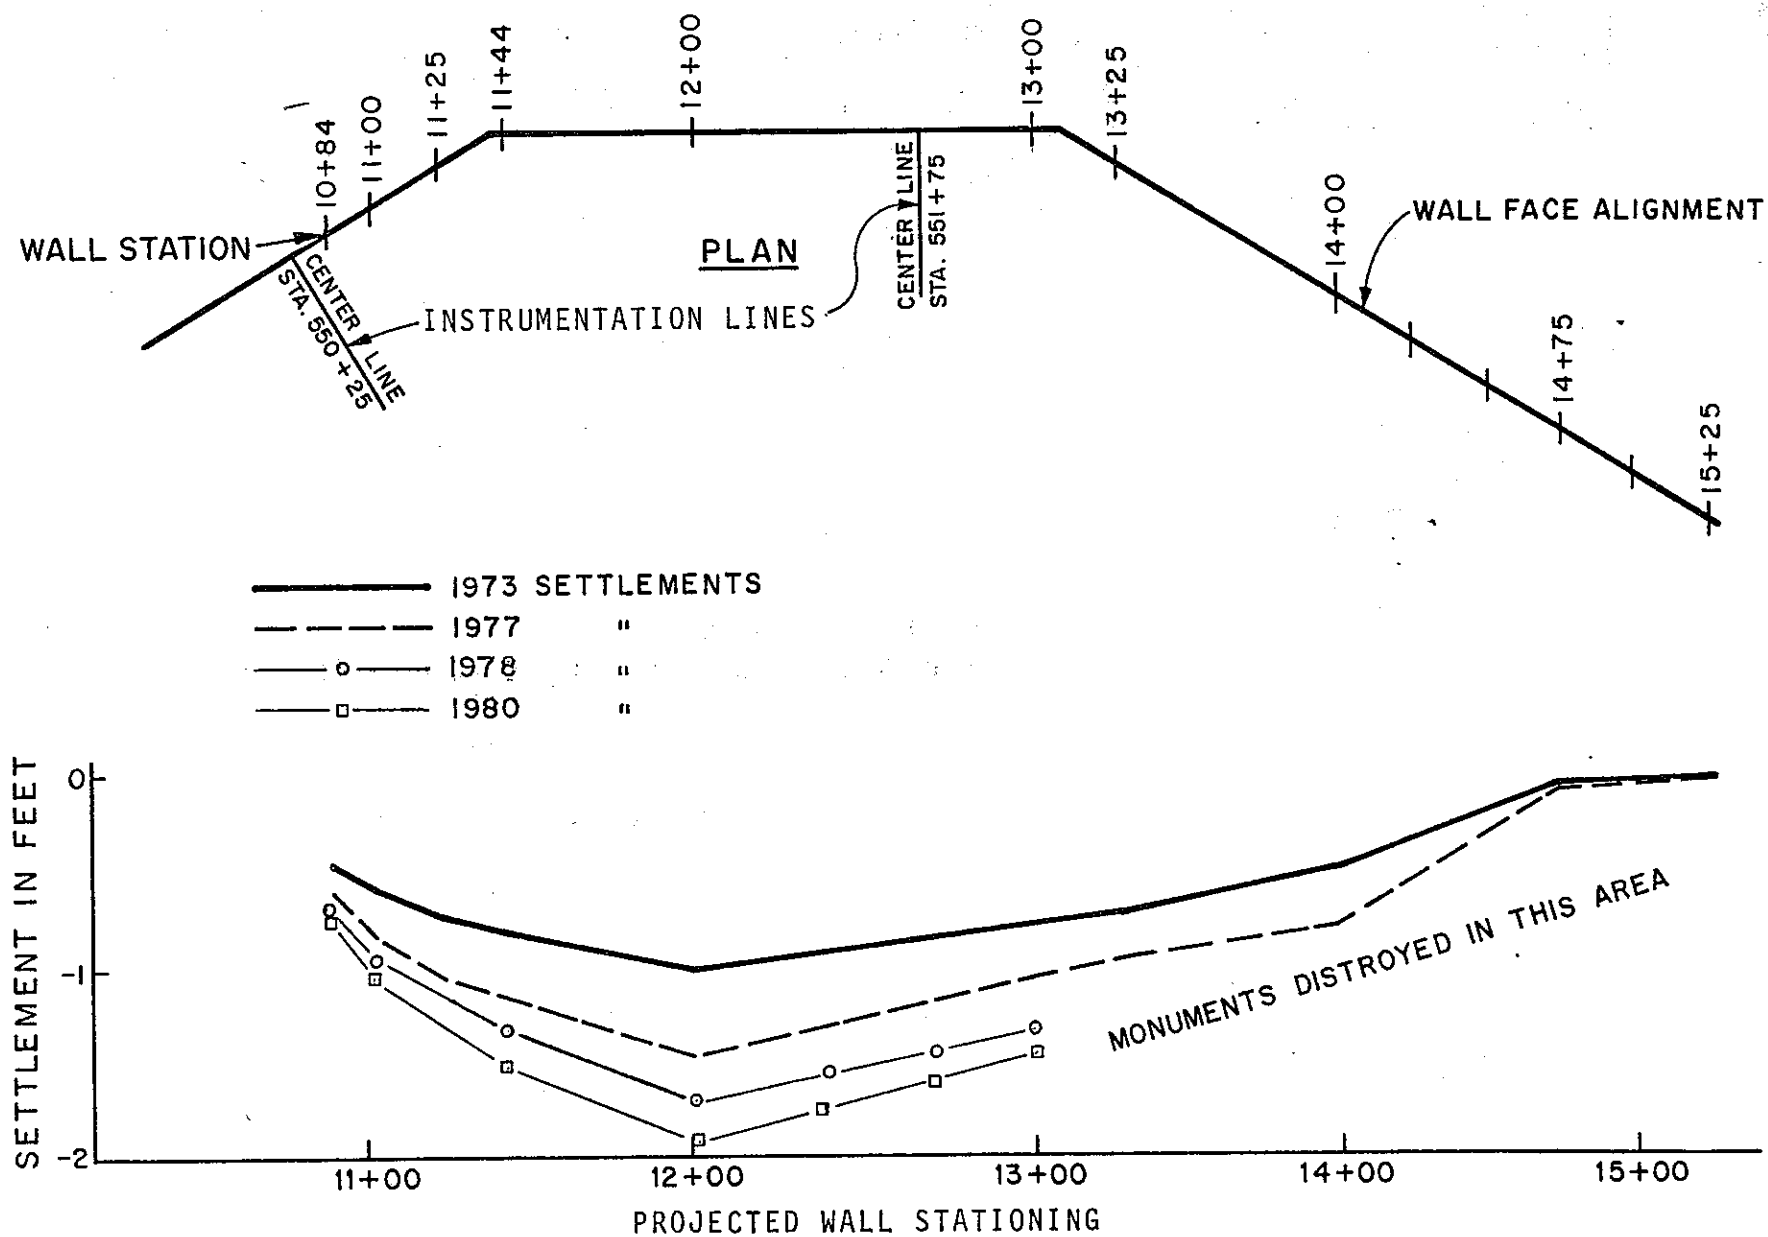
FIGURE 13

SETTLEMENTS AT SERIES "C" MONUMENTS

Settlement of the wall has continued since construction. A total settlement of 3.5 ft was recorded on settlement platforms SP1 through SP4 at Sta. 551+75, Level A, through December 1973. (Refer to Figure 8.) The readout at this level was destroyed after that date. Measurements on Series "A" and "C" monuments have provided a continuation of the settlement record. Based on these measurements, about 1.0 ft of additional settlement has occurred through May 1980. Measurements on Series "A" monuments show a maximum of 0.5 ft of settlement between 1973 and 1978 (Figure 12). No settlement measurements are available for Series "A" monuments after 1978 since they were buried by the correctional work. Series "C" monuments at the top of the wall suggest a maximum of 1.0 ft of settlement between 1973 and May 1980 (Figure 13). About 20% of that occurred since 1978.

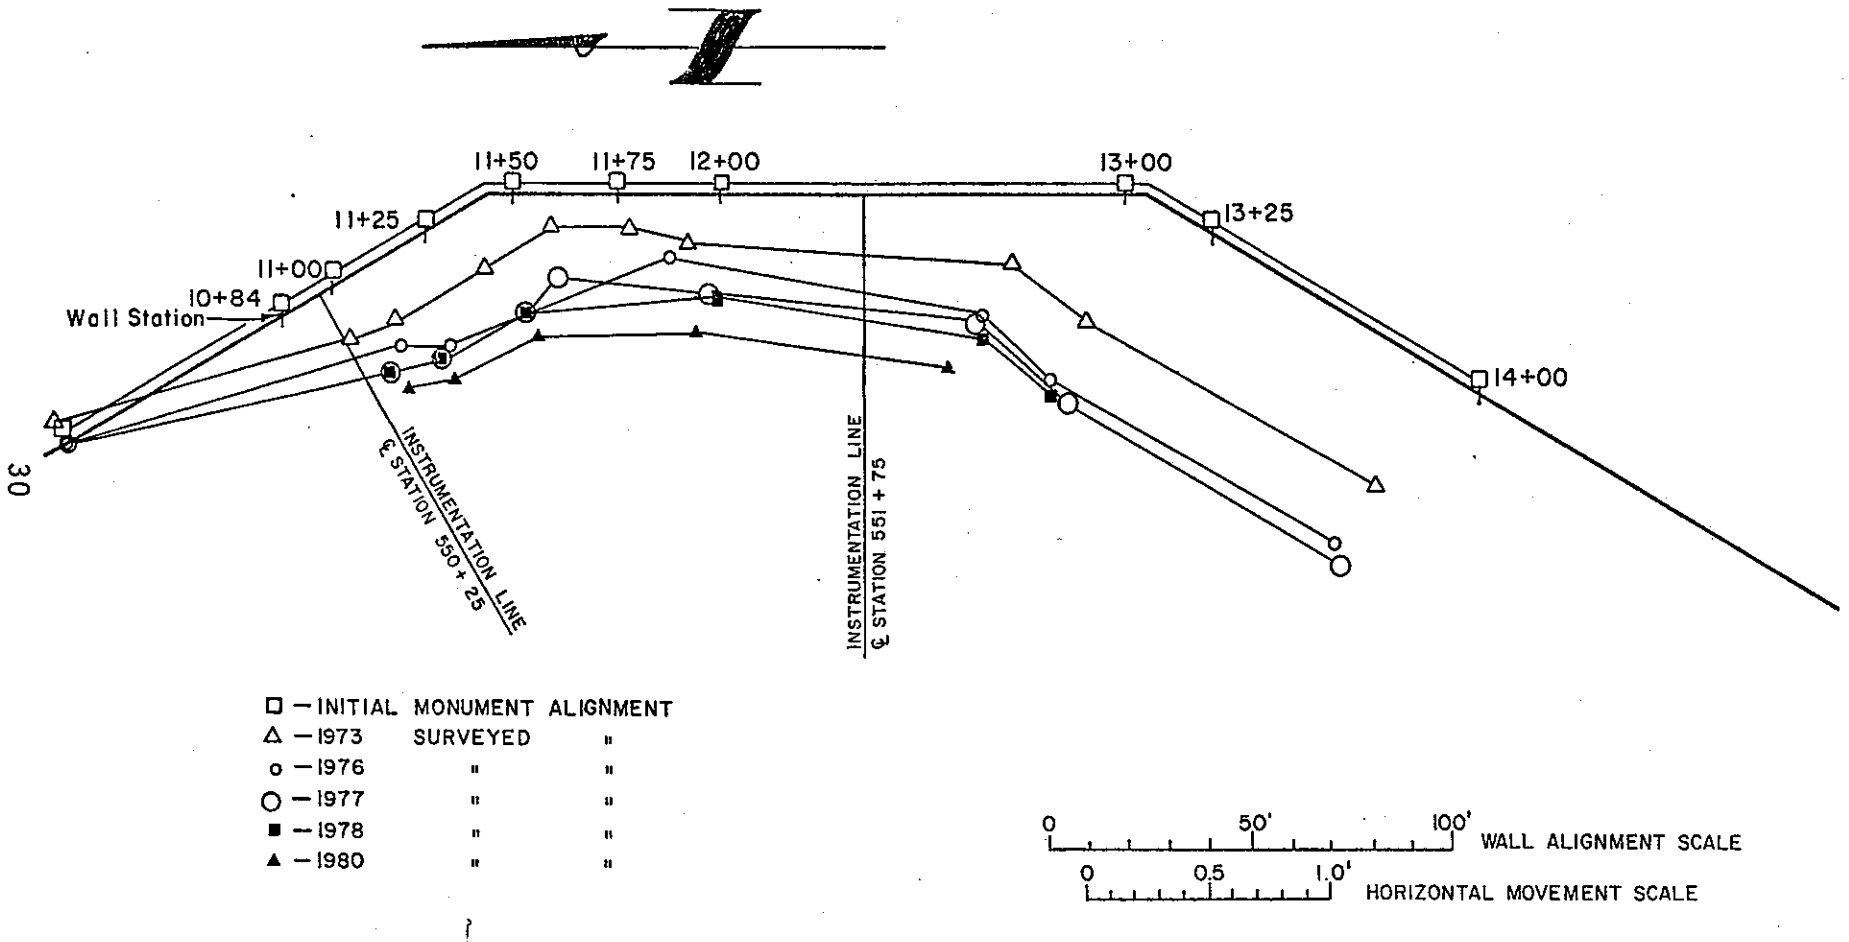
FIGURE 11

HORIZONTAL MOVEMENTS AT SERIES "C" MONUMENTS

Measurements made on Series "C" monuments on top of the wall suggest 1.5 to 1.9 inches of additional horizontal movement since 1978 for the north flank and center chord sections of the wall. (Refer to Figure 11 and Table 6.) These measurements represent horizontal movement since 1978, the majority of which probably occurred prior to the correctional work in 1979. The measurements, therefore, do not provide a good assessment of the effectiveness in correcting the overall stability of the wall.
