4. TITLE AND SUBTITLE
Long Term Performance Of The First Reinforced Earth Wall In California

7. AUTHOR(S)
Joseph B. Hannon

9. PERFORMING ORGANIZATION NAME AND ADDRESS
Office of Transportation Laboratory
California Department of Transportation
Sacramento, California 95819

13. TYPE OF REPORT & PERIOD COVERED
Final

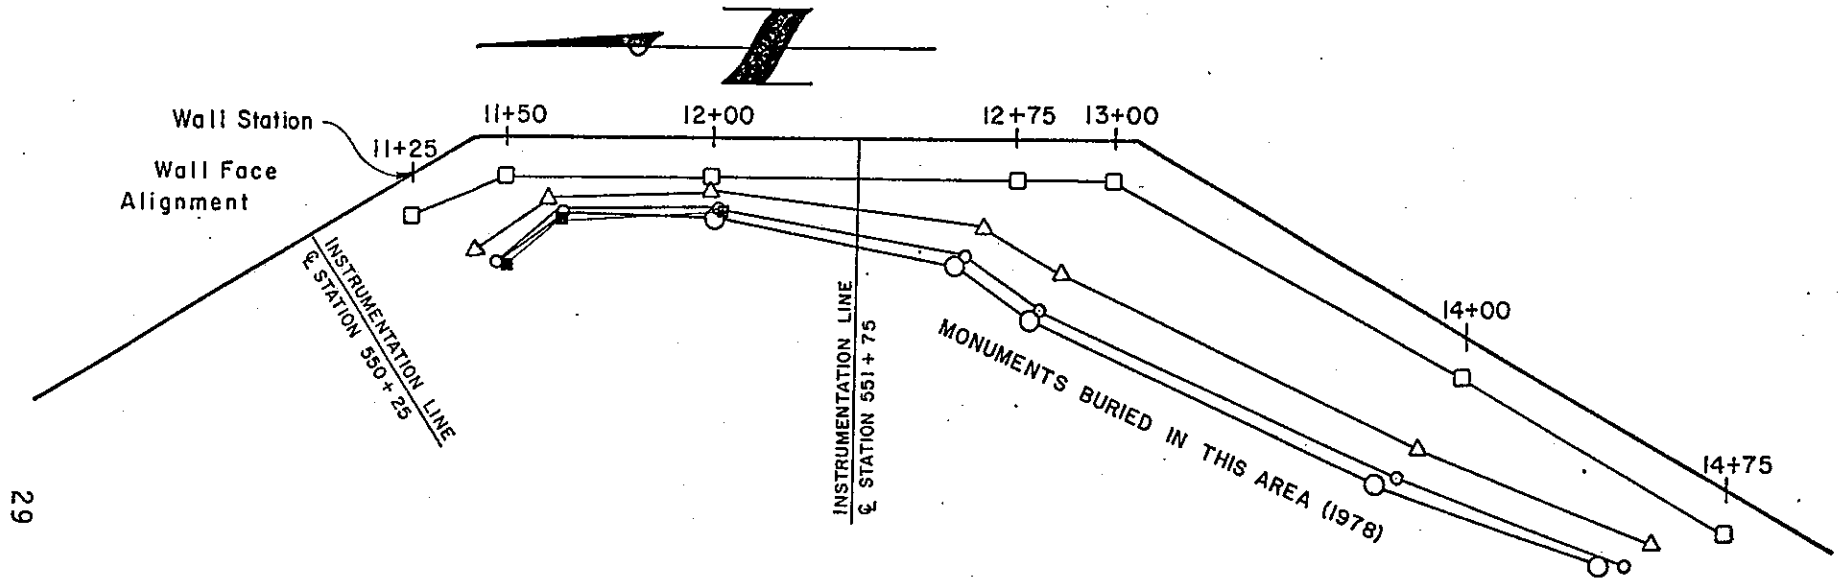
FIGURE 10

HORIZONTAL MOVEMENTS AT SERIES "A" MONUMENTS

recorded horizontal movement was 7.80 inches at Sta. 13+00 on July 1, 1977. (Refer to Figure 10 and Table 5 for measurements through 1978.)

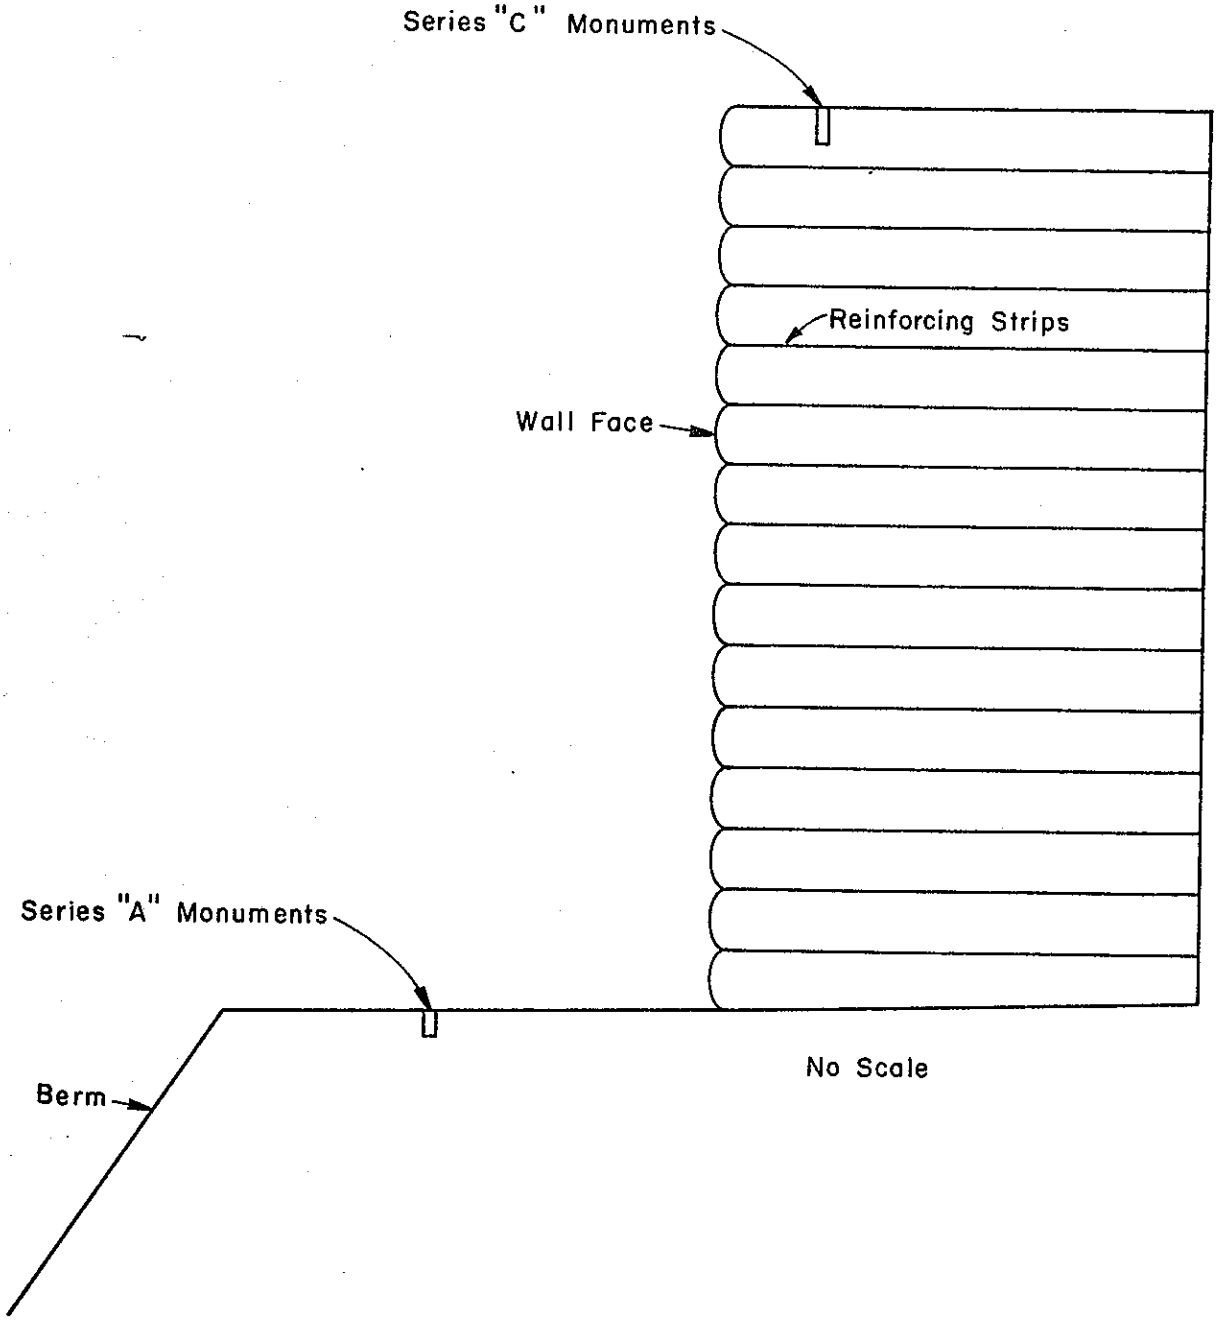
FIGURE 9

CROSS SECTION OF REINFORCED EARTH WALL

Most of the surface monuments on top of the wall were located and surveyed by District 07 Survey personnel. Destroyed monuments on top of the wall and on the new toe buttress at the base of the wall require reestablishment to monitor long term performance. The approximate location of these monuments are shown in Figure 9.

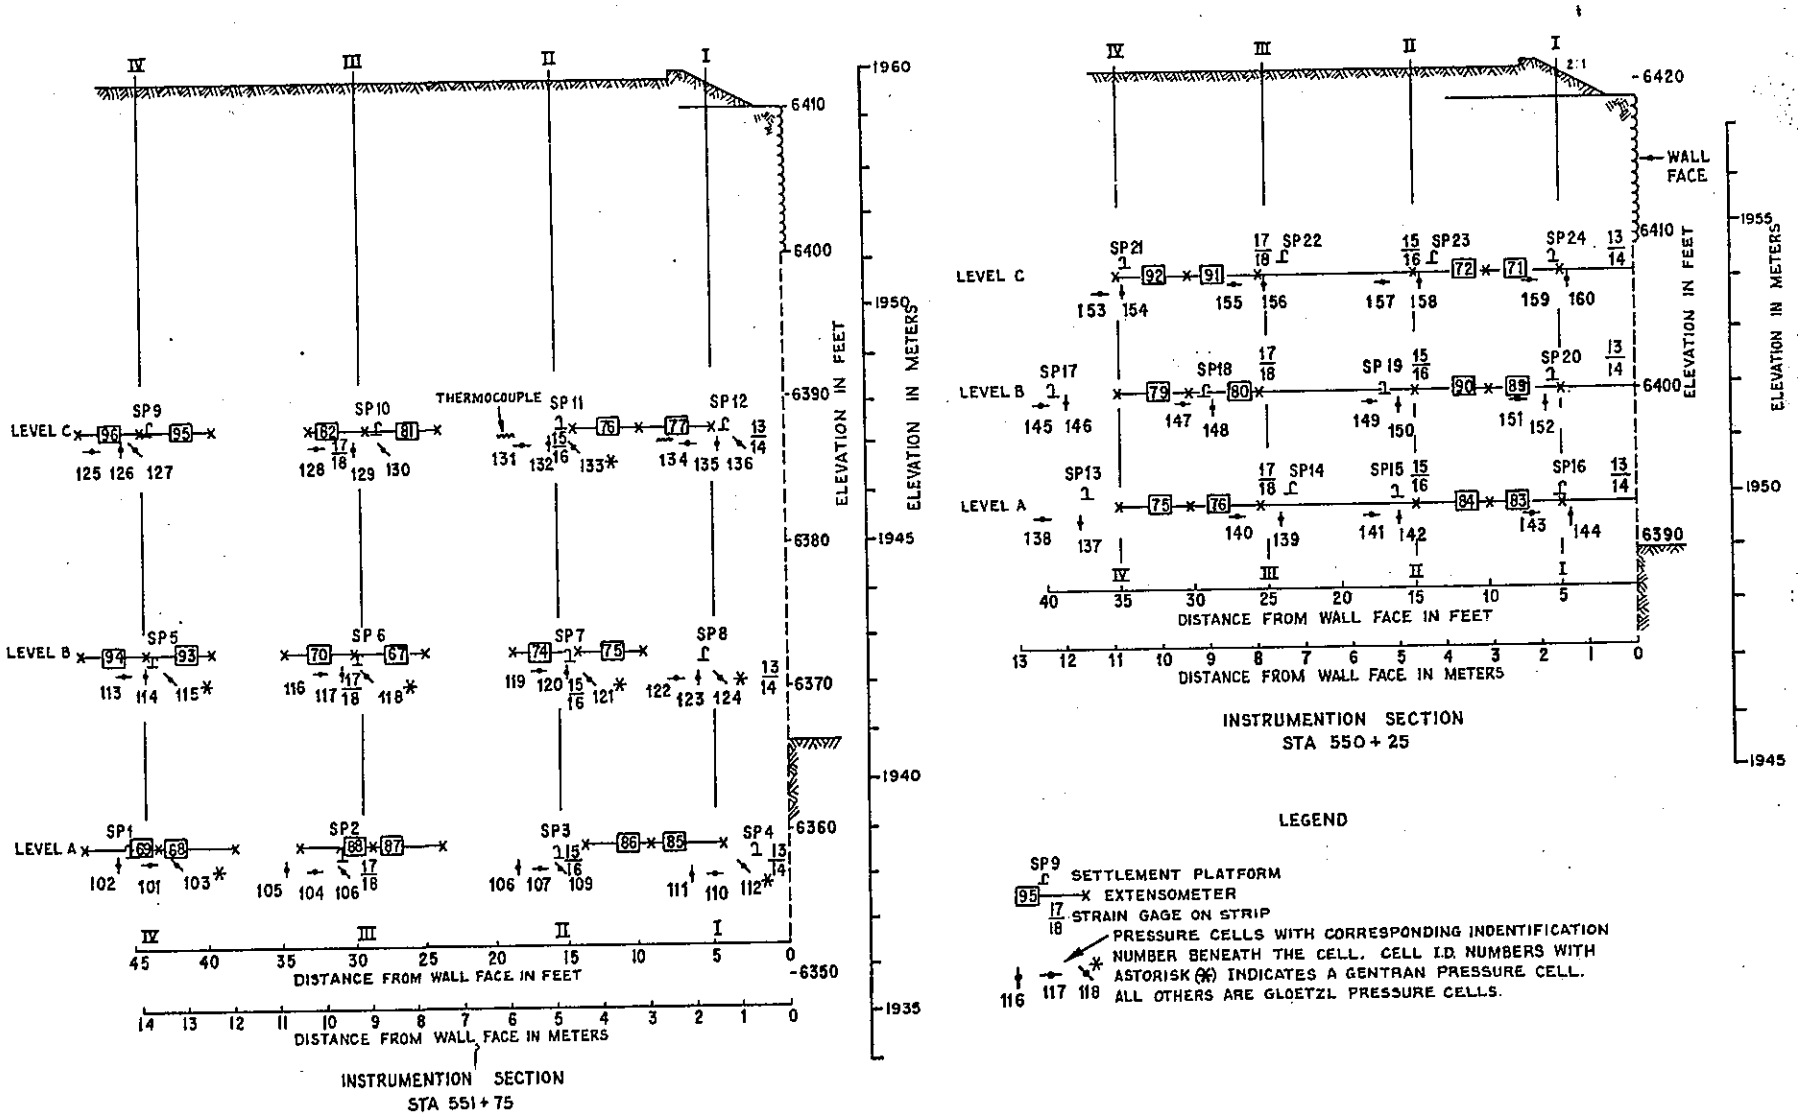
FIGURE 8

INSTRUMENTATION SECTIONS

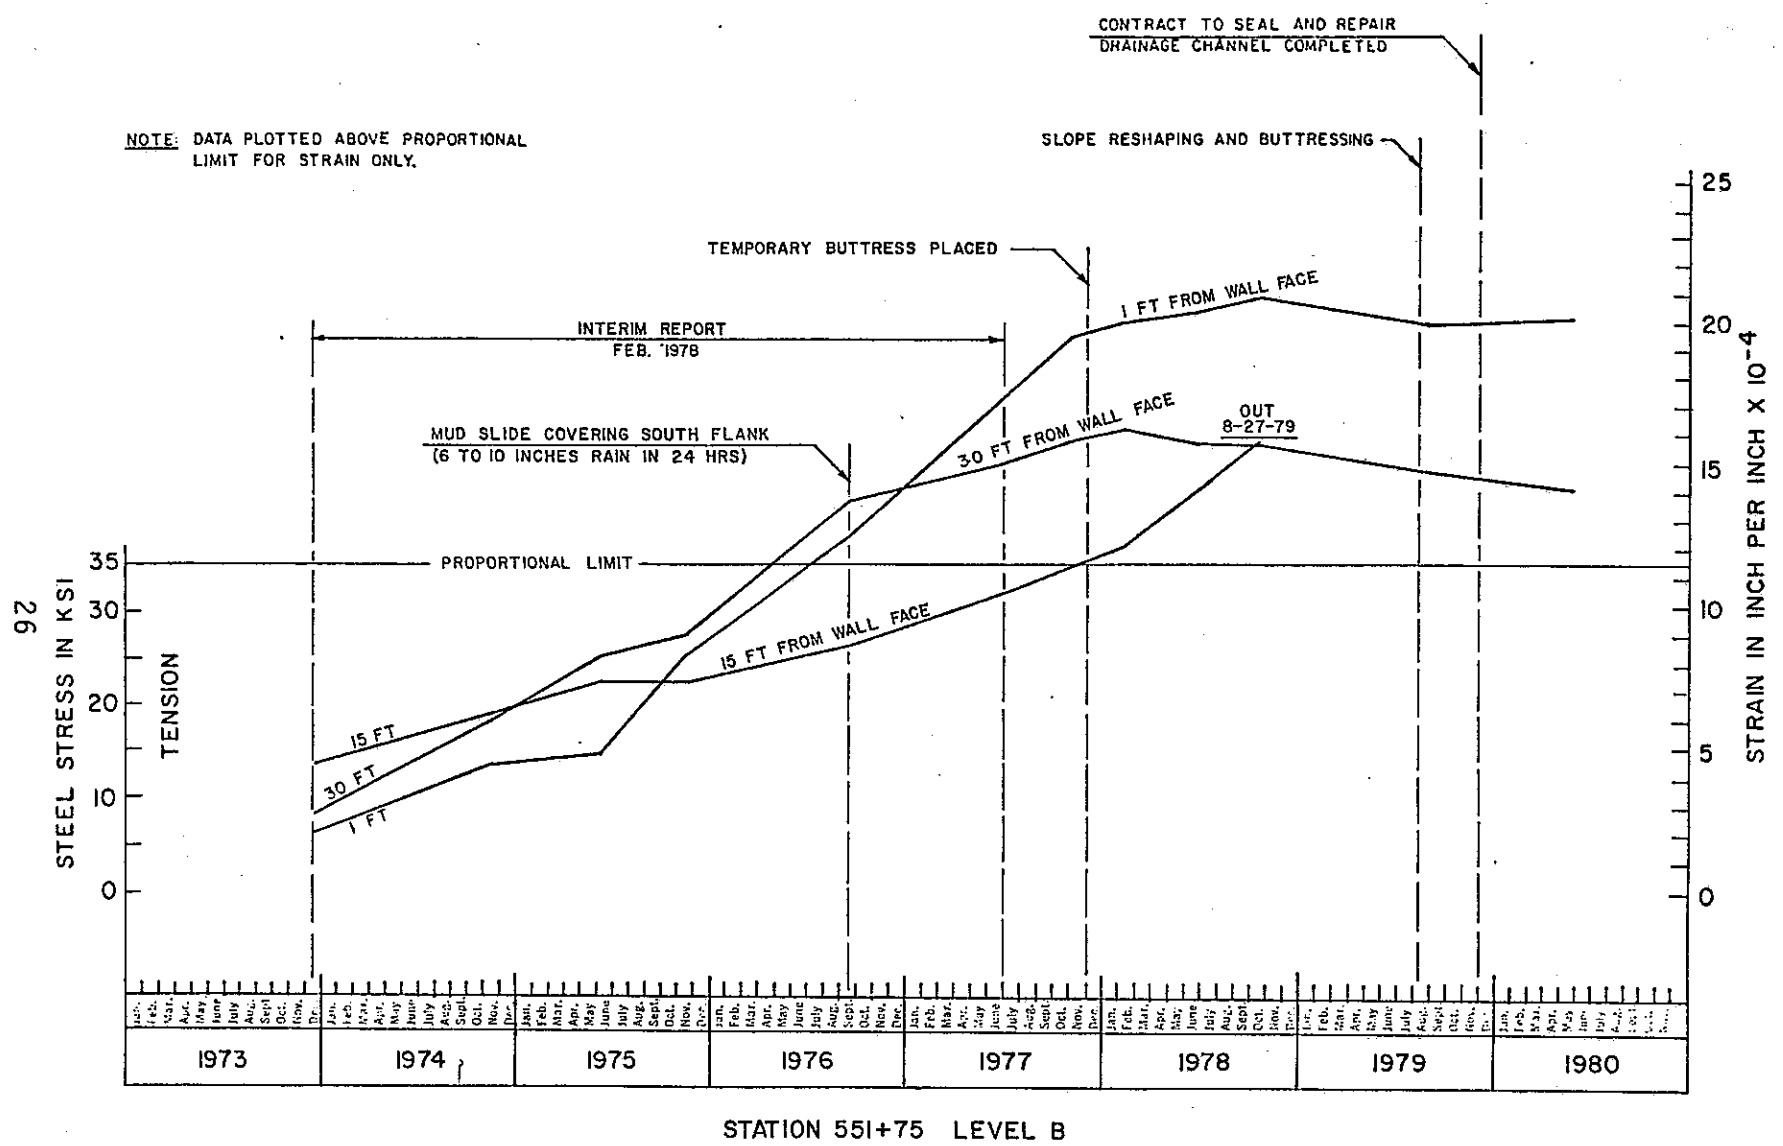
FIGURE 7

STATION 551+75 LEVEL B

HISTORY OF STRESSES & STRAINS IN STEEL STRIPS

The strain gage data observed on June 28, 1978, indicated that the stresses in the steel strips embedded in the center chord and the south flank were continuing to increase (Figures 2 through 7). However, the increases in steel stresses in the south flank were more significant than those in the center chord of the wall. These continual increases in steel stresses along with newly discovered cracks on the pavement of the north flank indicated that the south flank was still moving outward.

Field data obtained from 1973 through 1976 indicated continuous increases in steel stresses in some cases exceeding the proportional limit of 35,000 pounds per square inch for the steel strips. (Refer to Figures 2 through 7.) The location of the various strain gages and other instruments are shown on Figure 8. Horizontal movements have continued at the top and bottom of the wall along the south flank. These movements have been recorded on the monuments shown on Figure 9 and are presented on Figures 10 and 11. The increases in steel stresses and horizontal movements may have been caused by additional earth pressure from the continuous deposit of debris from the slide behind the wall (Photo 3). Several other conditions not anticipated in the original design have also developed since construction. A mud slide in September 1976 deposited several feet of debris on the roadway subsequent to an intense 6 to 10 inch rain storm during a 24 hour period. A maximum settlement in excess of 4 feet has also been experienced since the beginning of construction which may have sheared drainage collector pipes on the back slope behind the wall. Seepage pressures may have also developed due

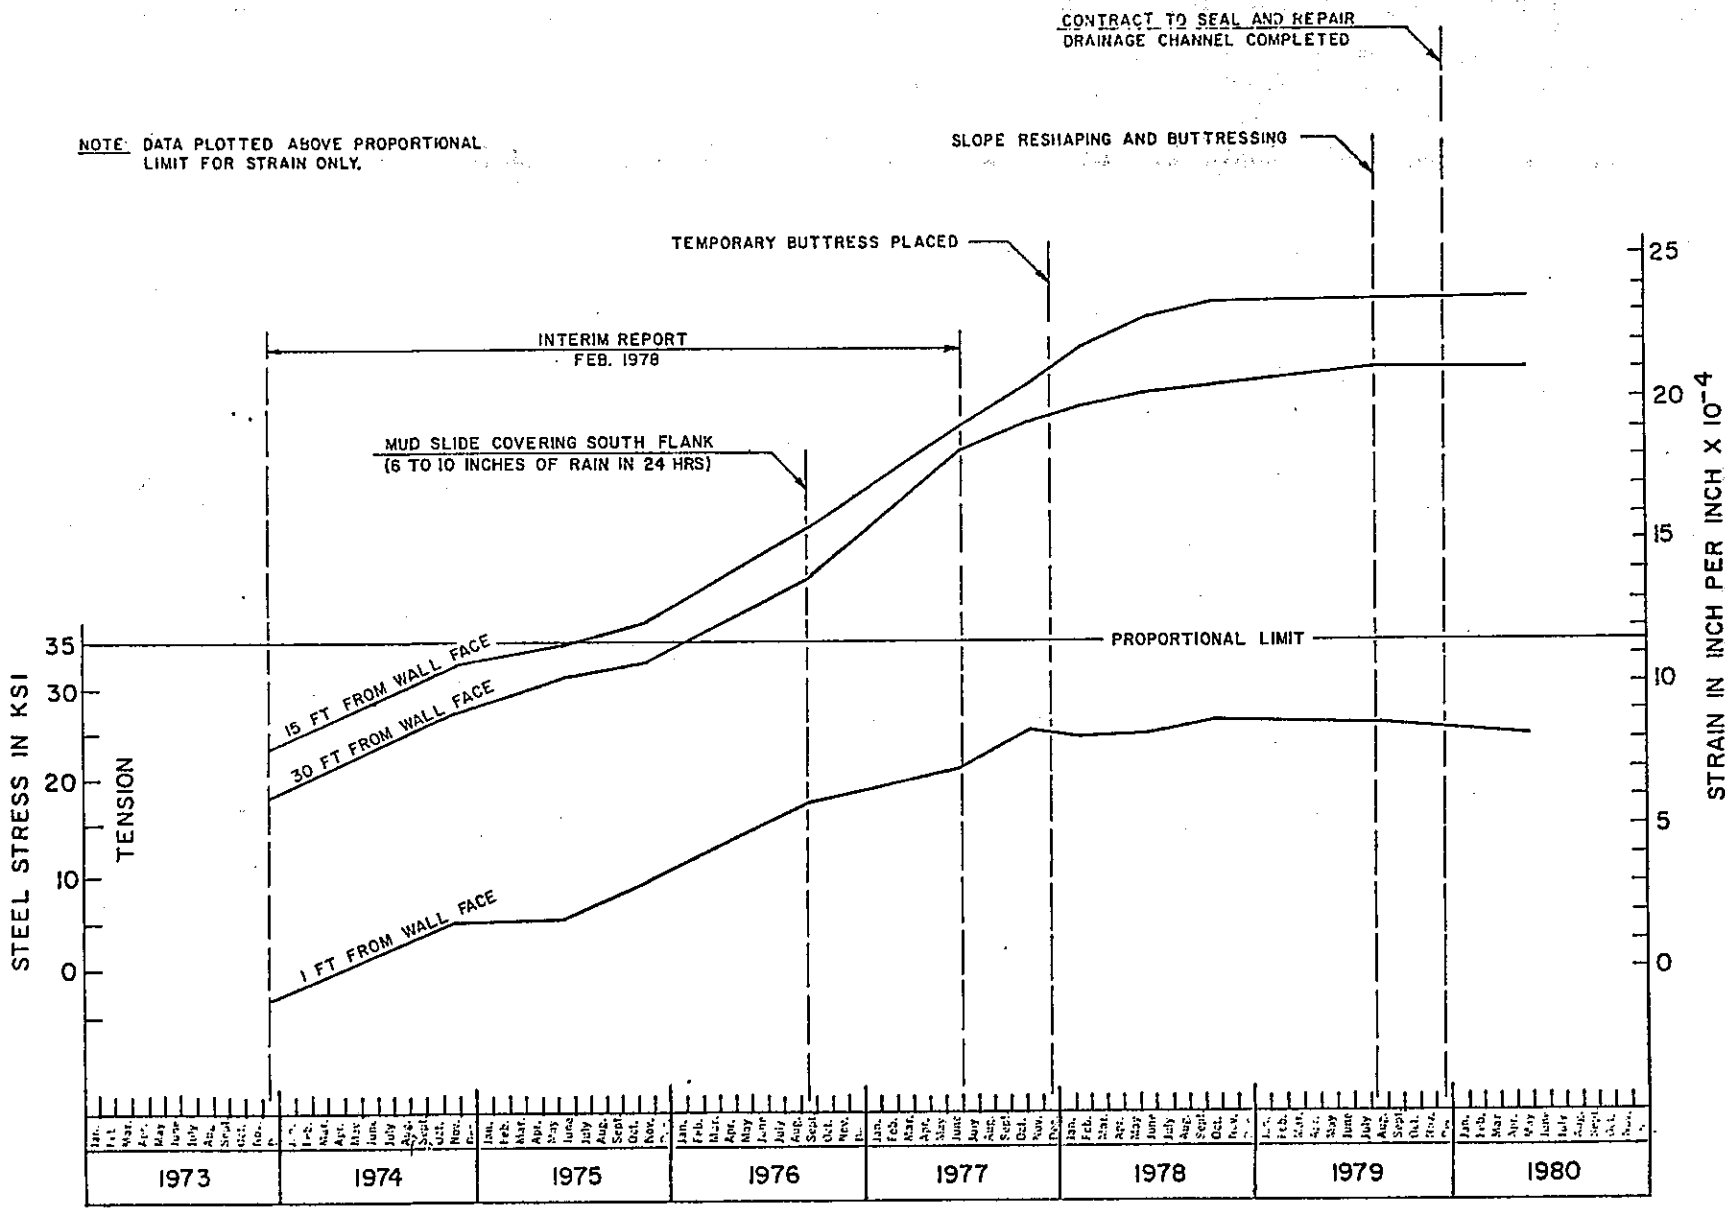
FIGURE 6

STATION 551+75 LEVEL C

HISTORY OF STRESSES & STRAINS IN STEEL STRIPS

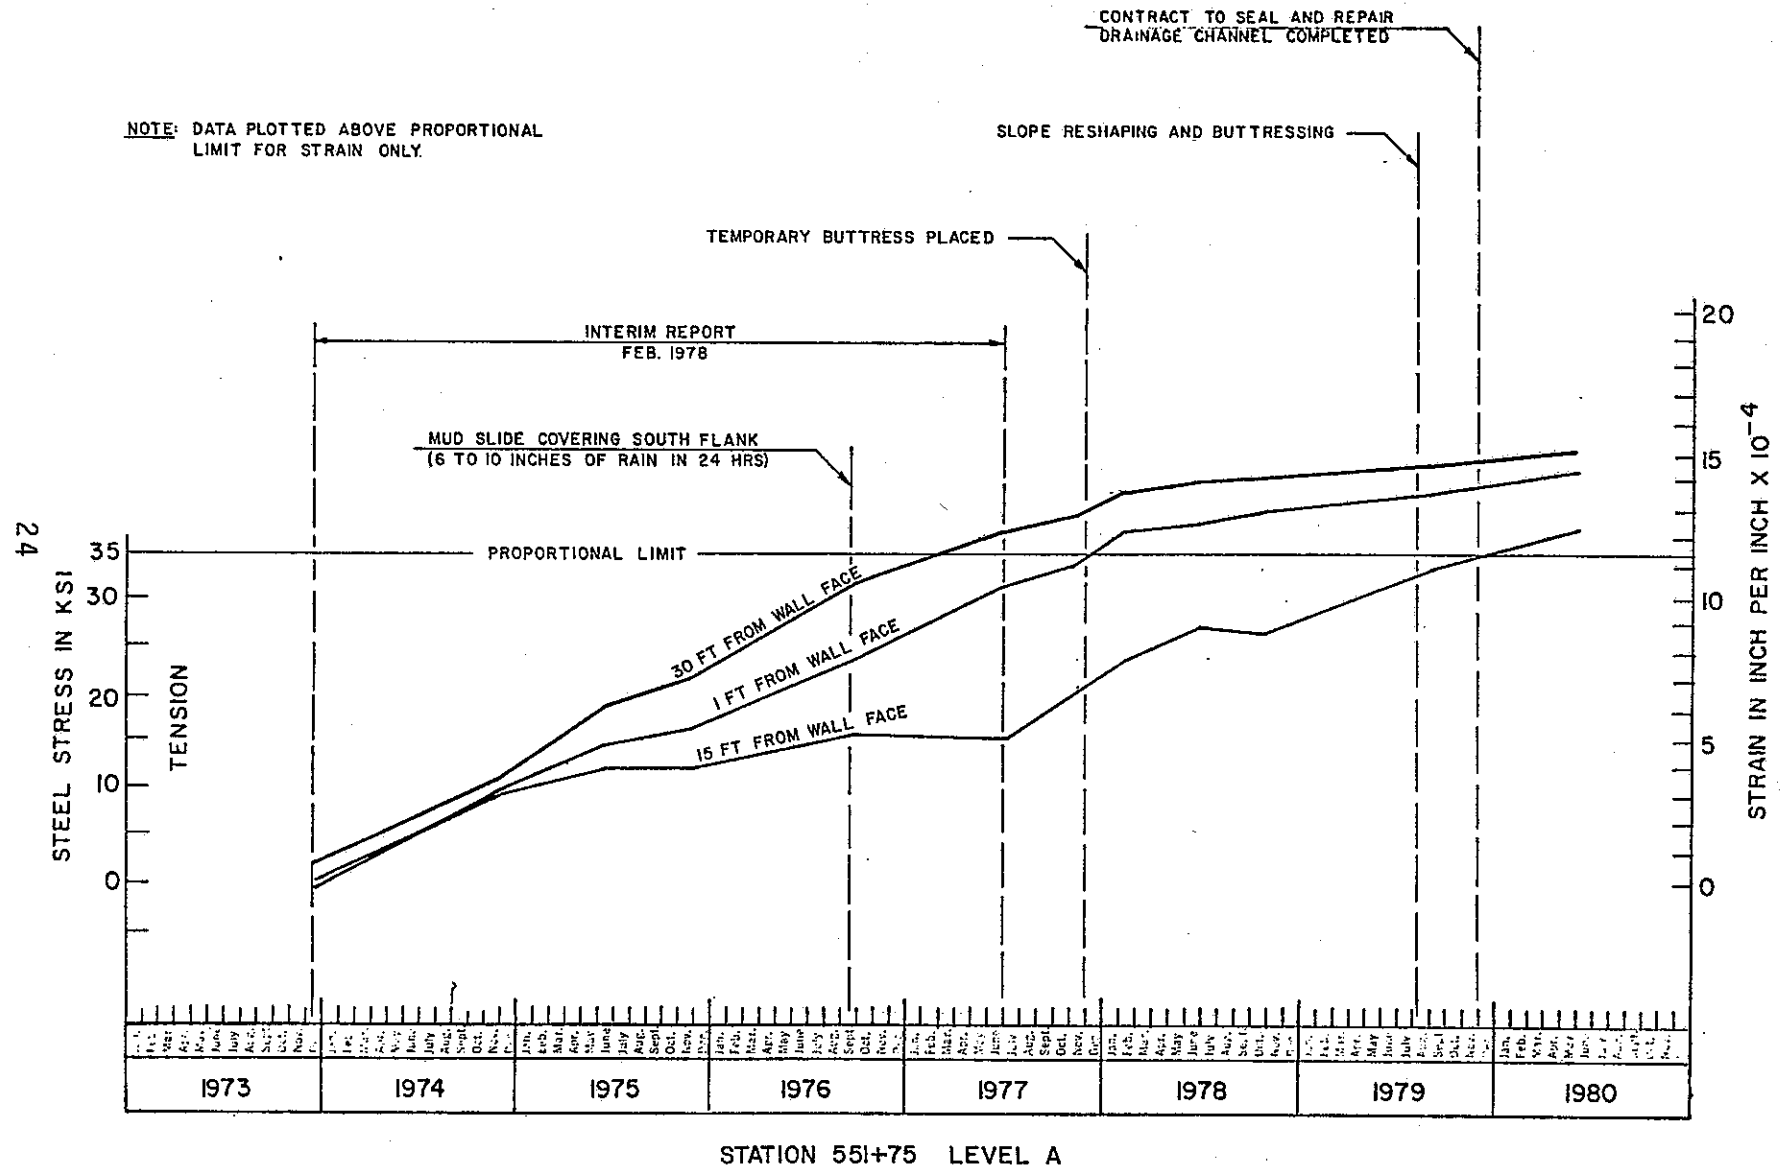
FIGURE 5

STATION 551+75 LEVEL A

HISTORY OF STRESSES & STRAINS IN STEEL STRIPS

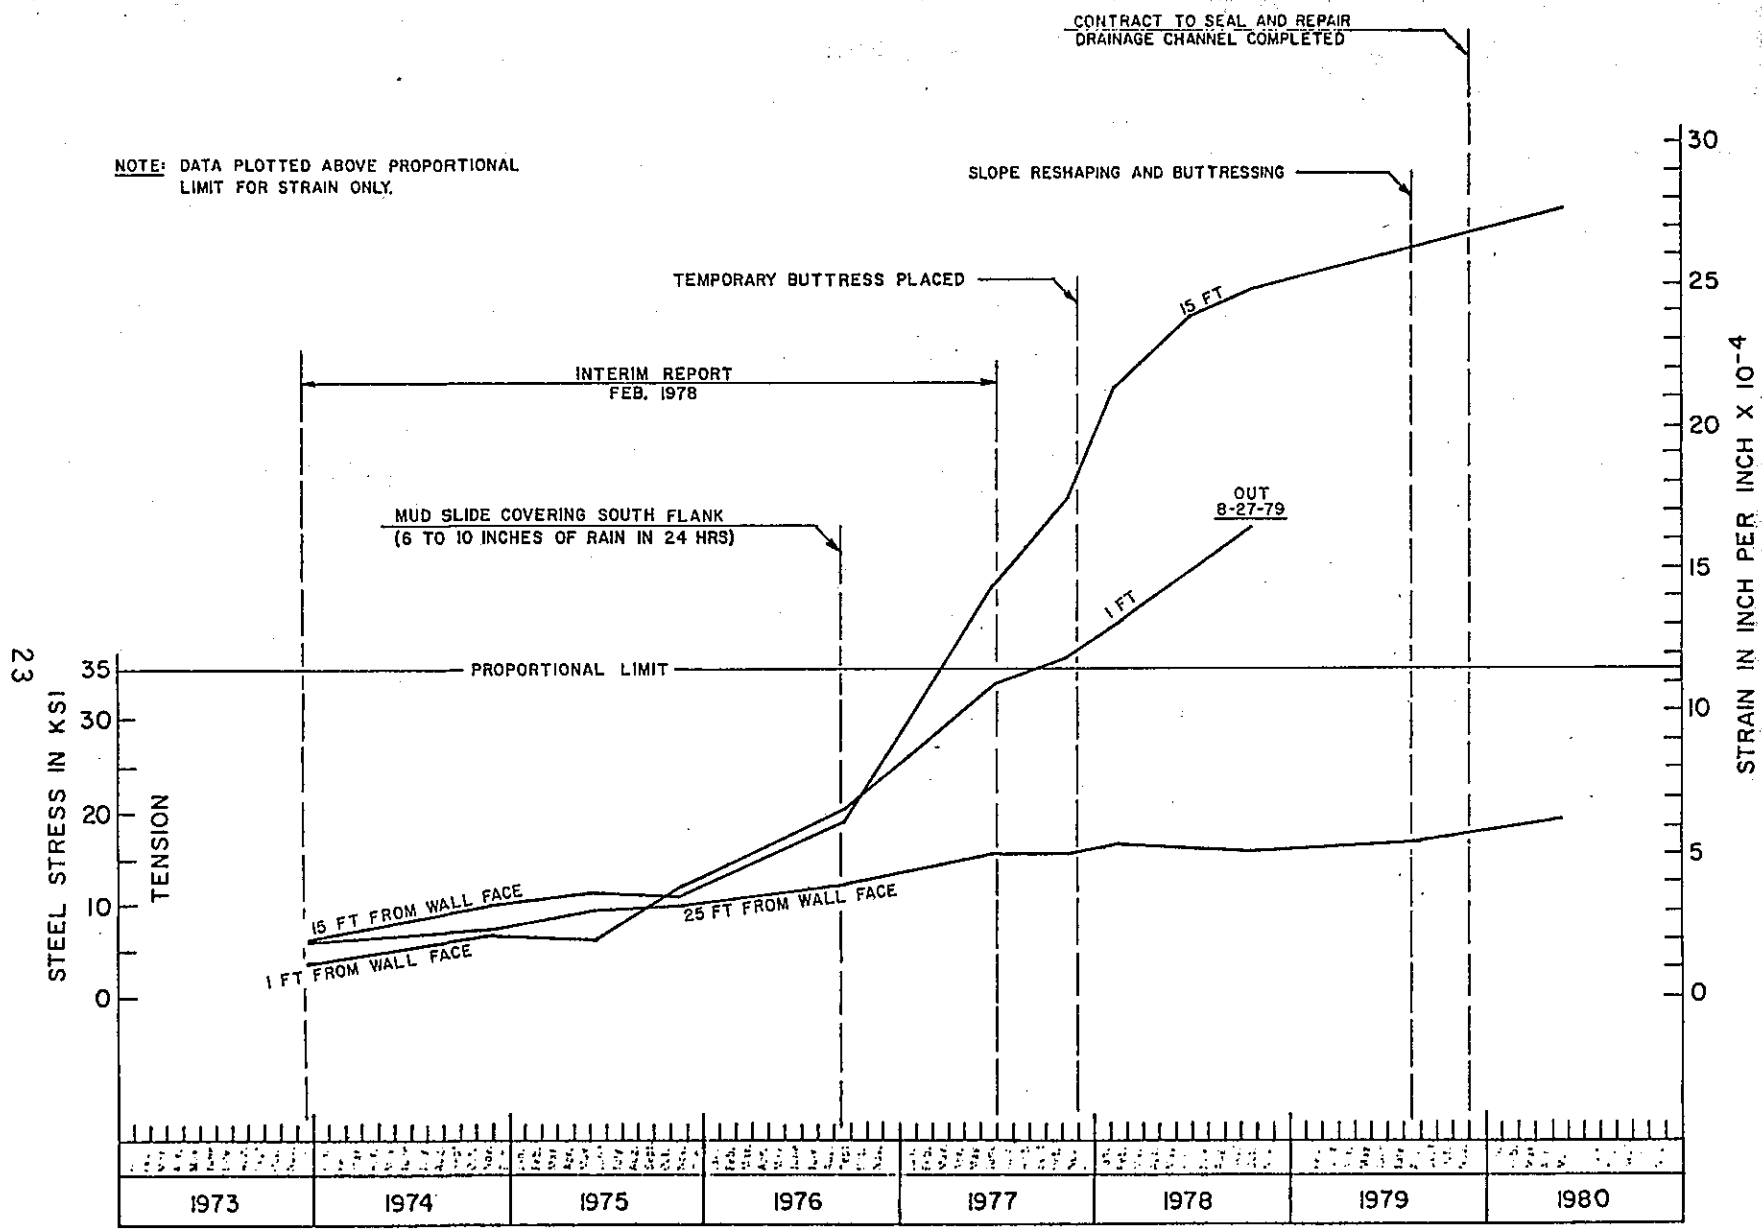
FIGURE 4

STATION 550+25 LEVEL C

HISTORY OF STRESSES & STRAINS IN STEEL STRIPS

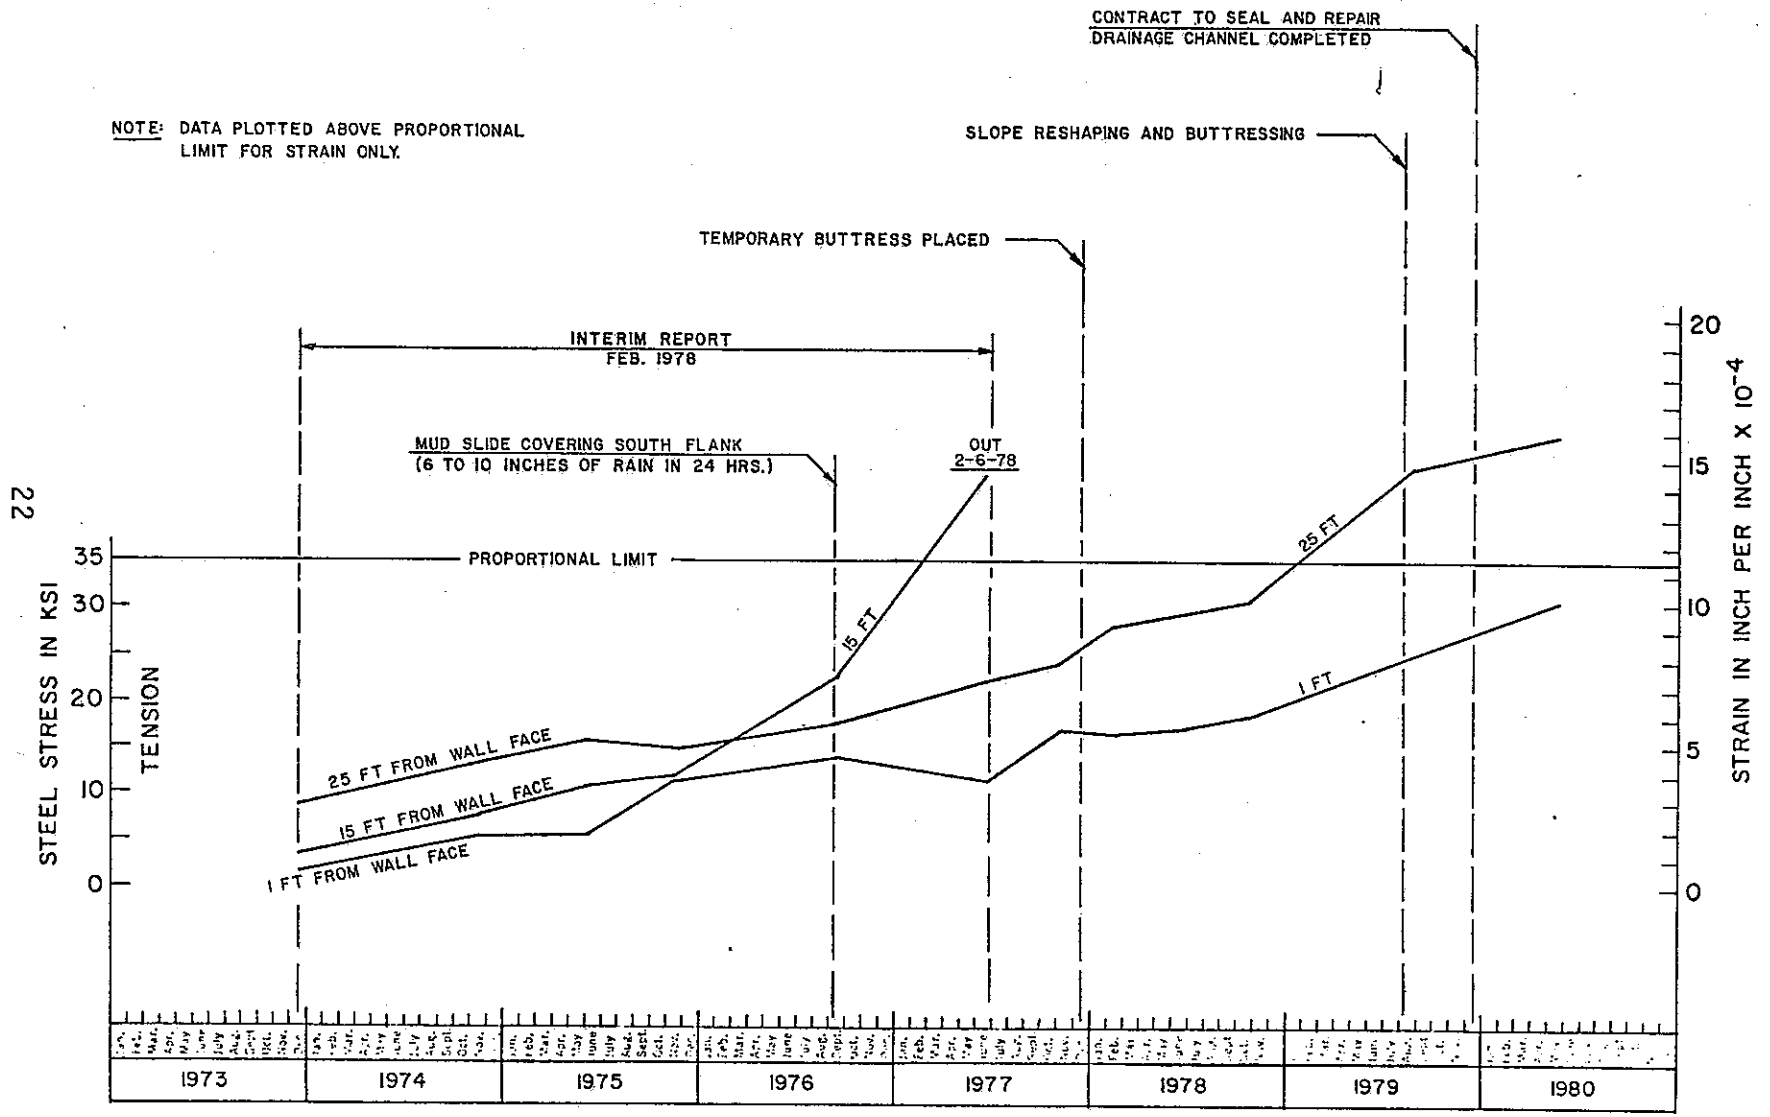
FIGURE 3

STATION 550+25 LEVEL B

HISTORY OF STRESSES & STRAINS IN STEEL STRIPS

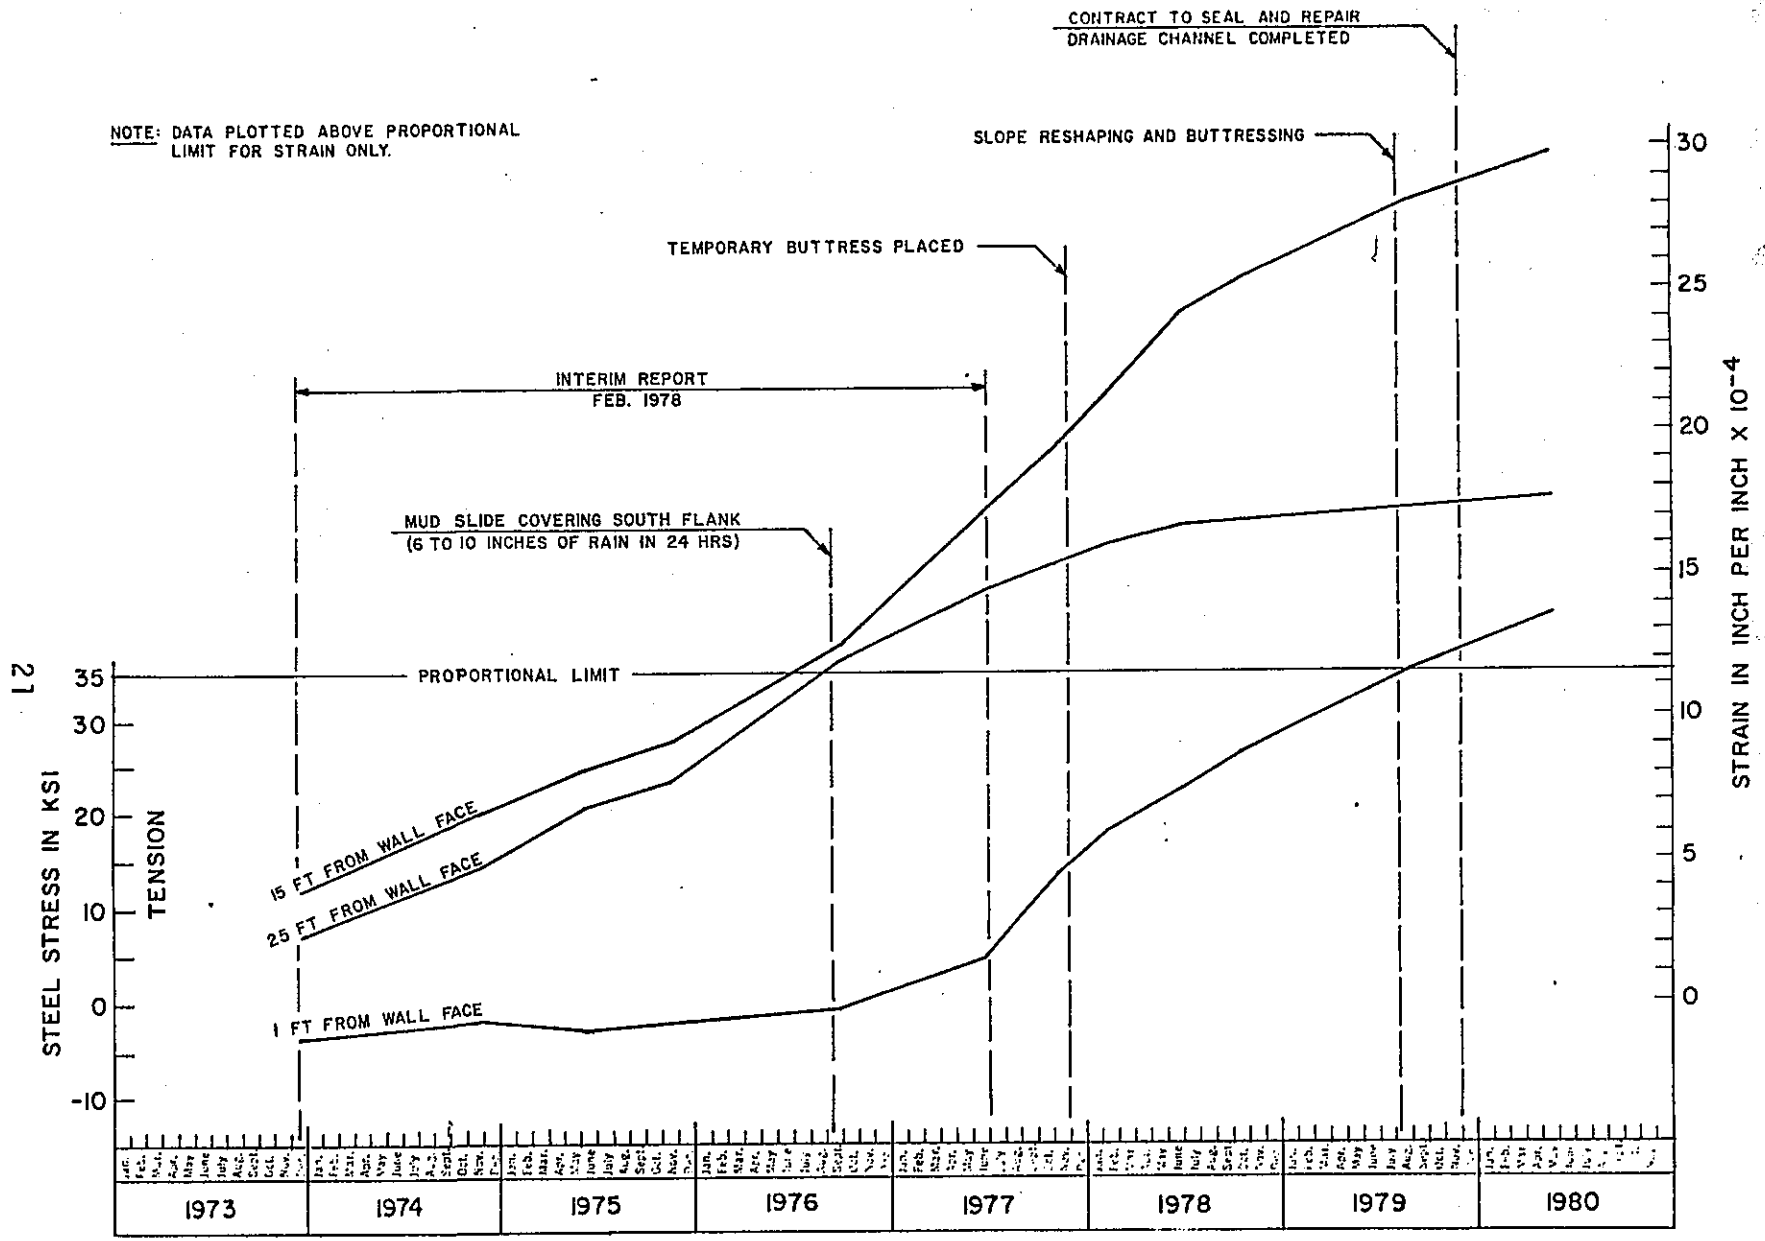
FIGURE 2

STATION 550+25 LEVEL A

HISTORY OF STRESSES & STRAINS IN STEEL STRIPS

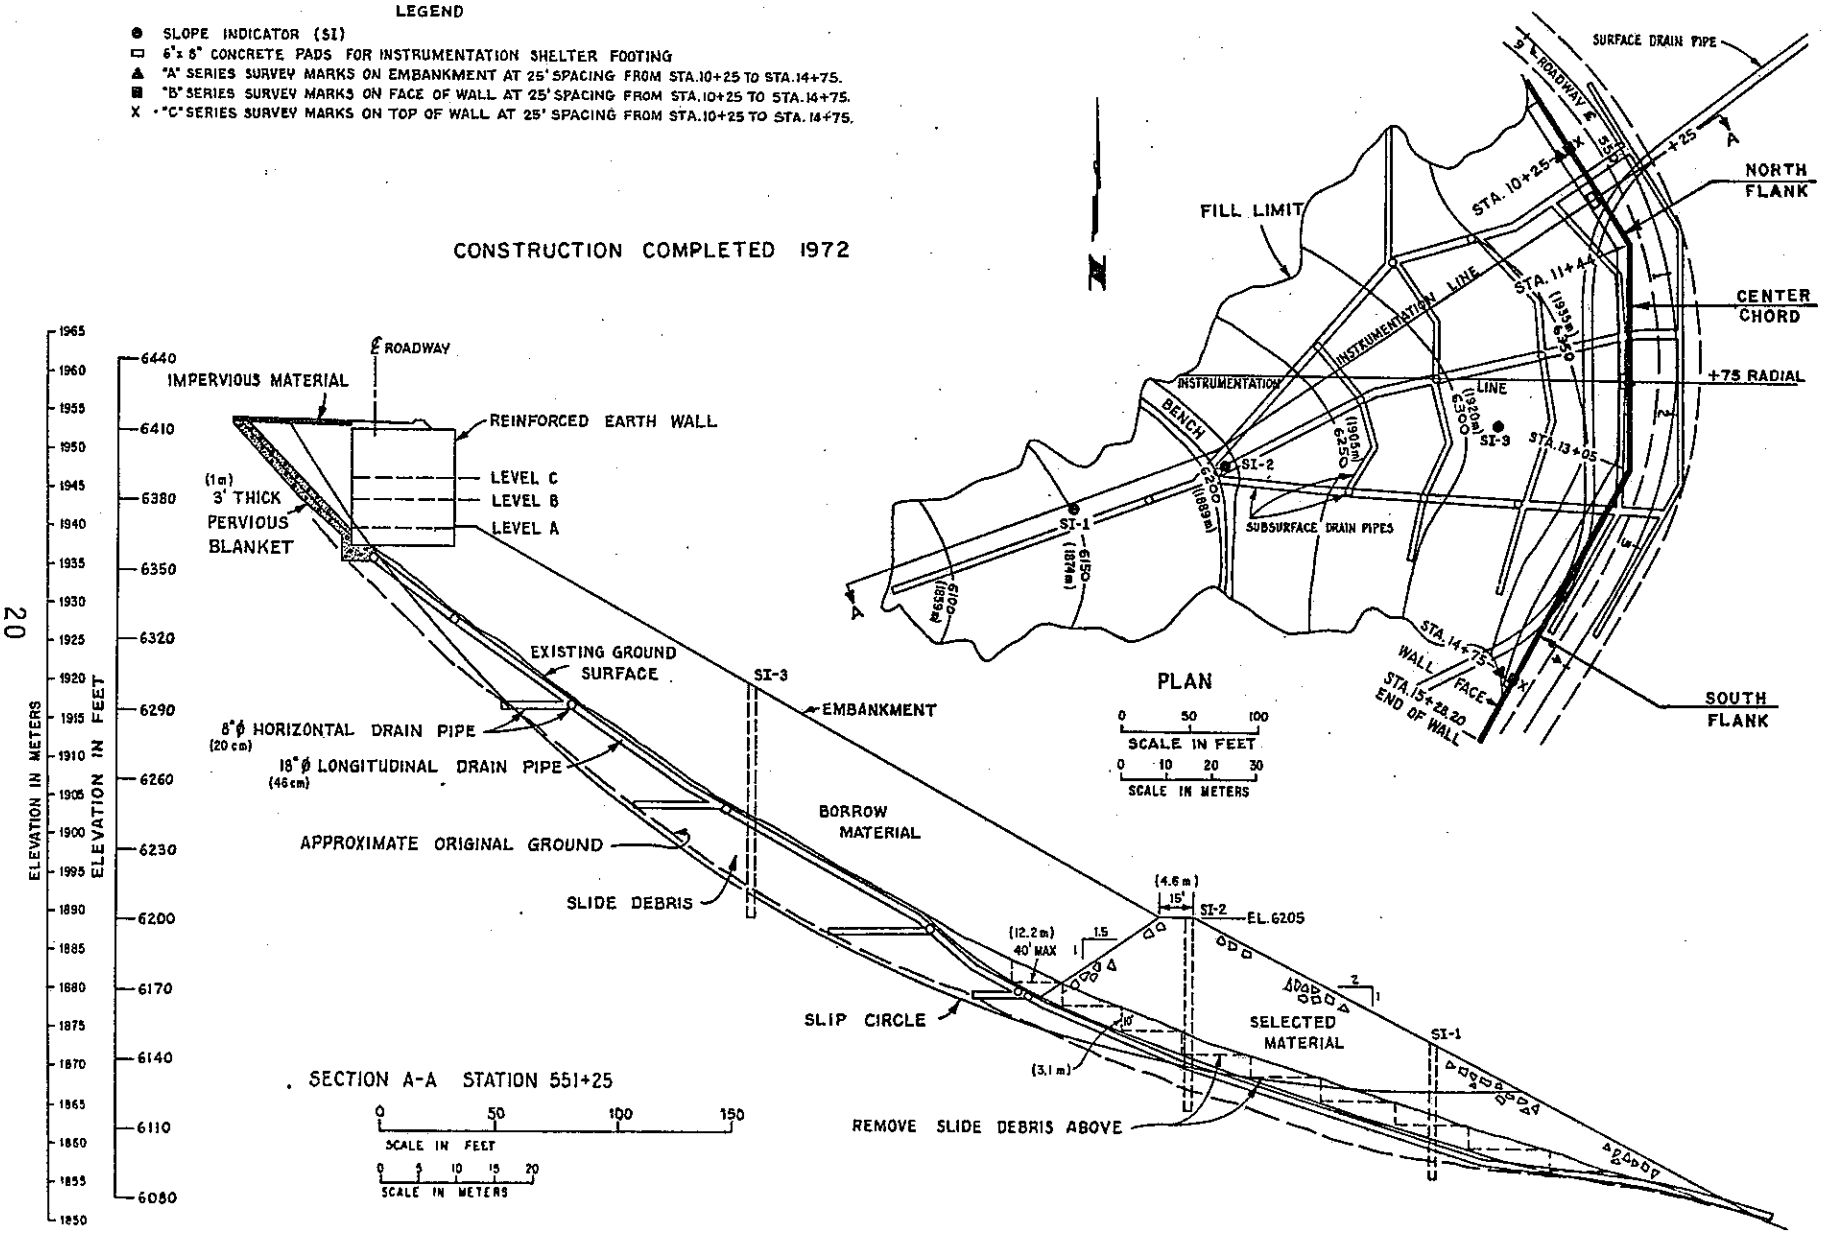
FIGURE 1

PLAN AND PROFILE

The reinforced earth wall on Route 39 was built over an active landslide area that would have posed serious problems for conventional embankment construction. The plan and profile of the constructed facility are shown in Figure 1. Since the wall's completion in 1972, several winter storms have continued to deposit slide debris above the roadway.

personnel below the pavement surface near the south flank of the wall above the pervious sand blanket behind the reinforced earth wall. (See Figure 1 Profile.) Maintenance forces were requested to identify the extent of the cavity and backfill it with either pea gravel or jetted sand. This would be followed by sealing the roadway surface with asphalt concrete to prevent infiltration of surface water. Maintenance elected to jetty sand into the cavity, which on observation appeared to provide a satisfactory repair. A similar crack was repaired in the same area during the spring of 1973.
