4. TITLE AND SUBTITLE
Fill Stabilization Using Non-biodegradable Waste Products-Phase II

5. REPORT DATE
November 1979

7. AUTHOR(S)
Wilfred S. Yee

9. PERFORMING ORGANIZATION NAME AND ADDRESS
Office of Transportation Laboratory
California Department of Transportation
Sacramento, California 95819

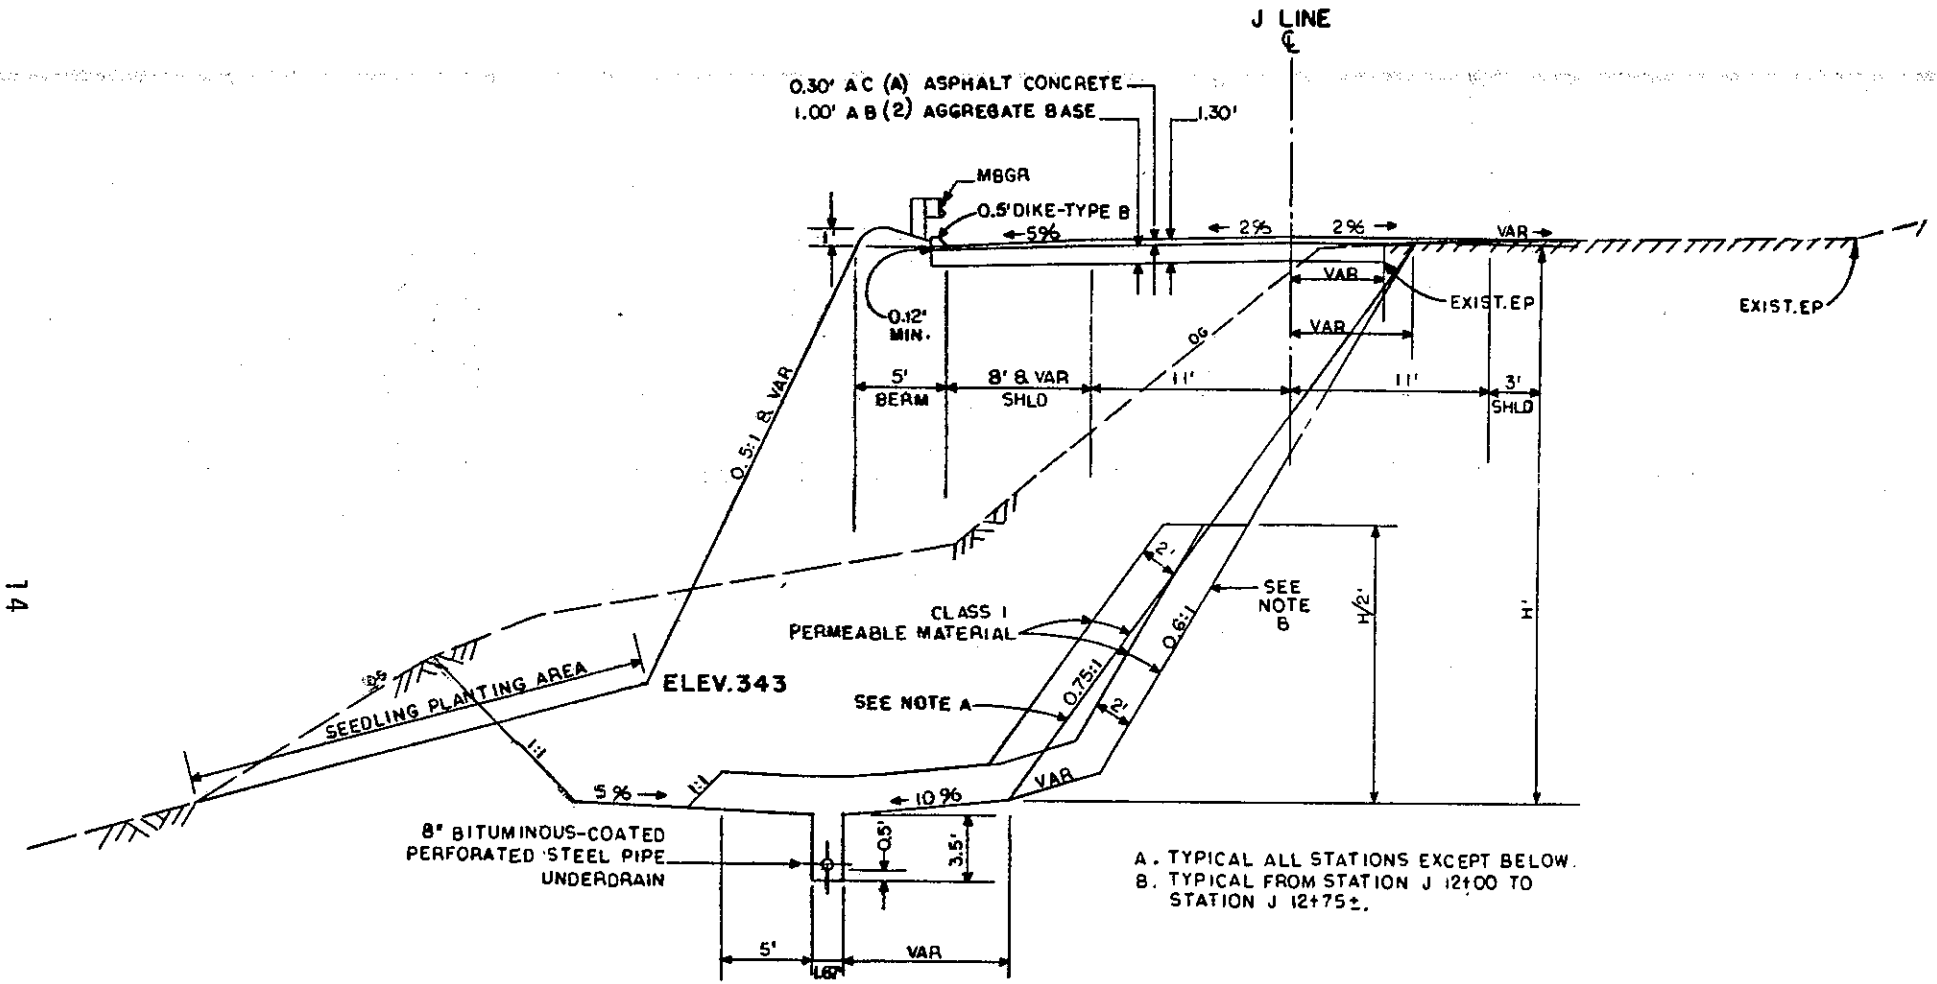
FIG. 3 TYPICAL X-SECTION NEW EMBANKMENT

As previously mentioned, the original plan carried the two ft permeable layer up the backslope of the reinforced embankment to within 15 ft of roadway level (see Figure 3). The decision to terminate drainage at this depth was based upon a lack of evidence of ground water migration at a higher elevation. However, the almost unprecedented rainfall of the winter of 1977-1978 raised ground water above roadway level at least locally as indicated by the seepage from an old horizontal drain approximately 5 ft above roadway level in the cut opposite the reinforced embankment (see Figure 33). The subject drain had been inactive for many years and was assumed to be plugged, if indeed it had ever intercepted ground water. Thus a substantial portion of the reinforced embankment was undrained under unusually wet conditions. That inadequate subsurface drainage was a prime factor in the local slide is demonstrated by the proximity of the undrained portion of the embankment to the zone of maximum movement as indicated by the slope indicator (Figure 33). To correct the problem, an additional permeable filled cut-off trench, 2 ft wide and about 16 ft deep, was constructed at the toe of the cut slope to intercept groundwater in the upper embankment zone (see Photo 15). Relief was accomplished by daylighting the trench downslope and interception by horizontal drains from the new bench.

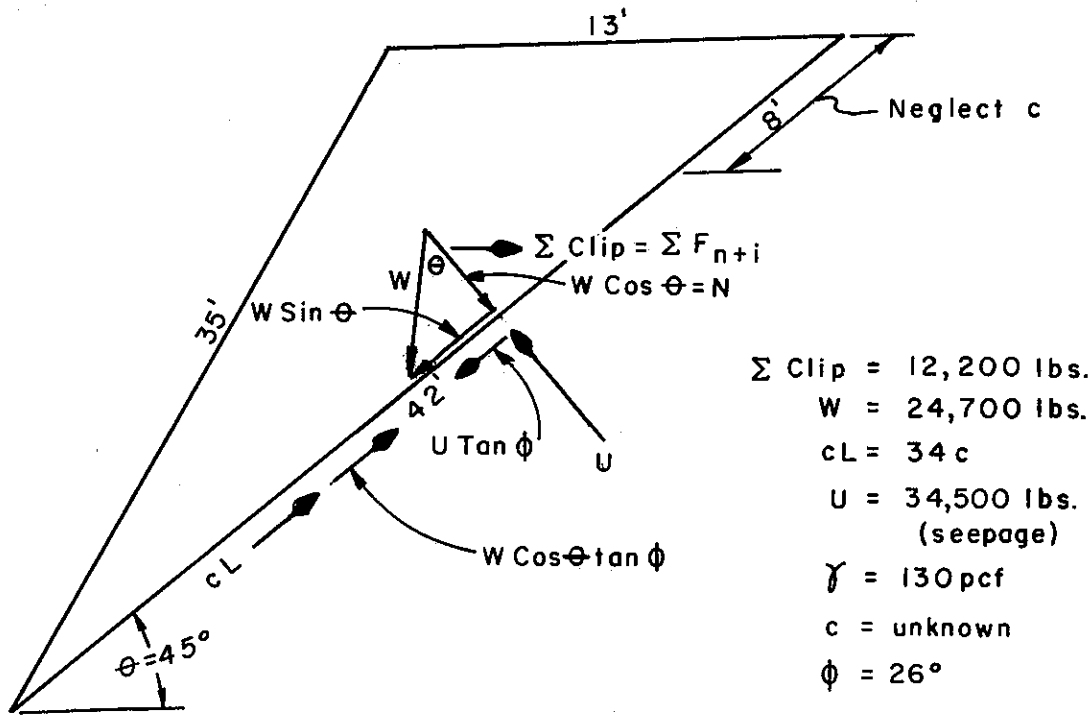
FIG. 34 FORCES ON FAILURE WEDGE

The total weight of the wedge shown in Figure 34 was estimated to be about 24,700 lbs excluding the eroded portion of the slope. The length of the slip face considered able to develop

a resisting cohesive force was estimated at 34 ft. Tension cracks had developed on the paved shoulder and the depth was estimated to be about 8 ft. The angle of the slip face from the horizontal plane was estimated in the field to be about 45 degrees.

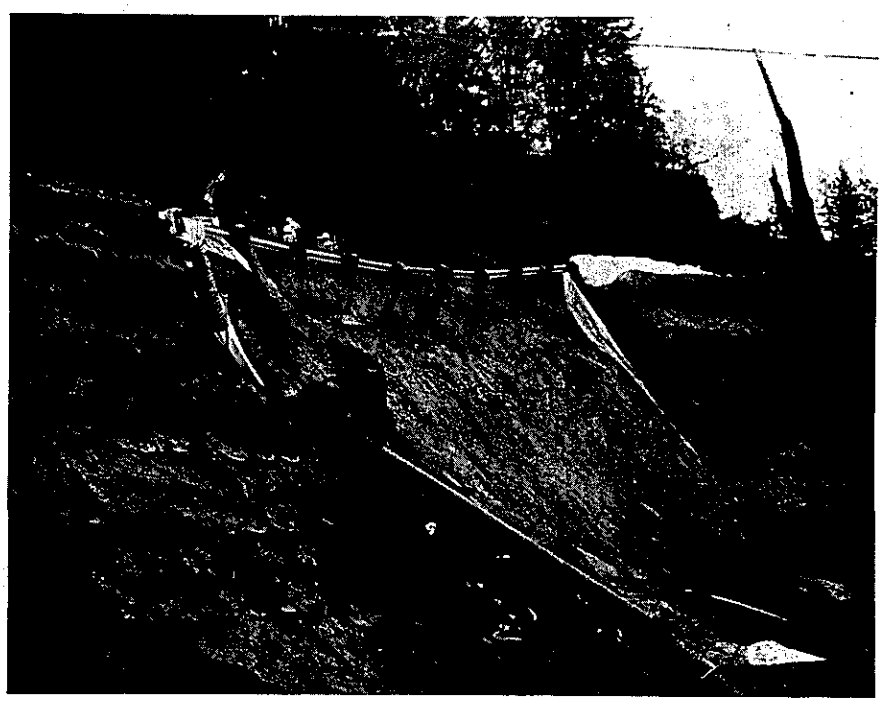
In the winter of 1978, following a period of almost unprecedented rainfall, a slipout involving approximately 5% of the reinforced embankment occurred, due primarily to an inadequate subsurface drainage system.

Photo 12 Local Embankment Slide

Repair of the embankment in the late fall of 1978 consisted of the construction of a tire reinforced buttress, improved slope protection, and the installation of additional subsurface drainage. The facility has been performing satisfactorily since completion of the repair in January 1979.

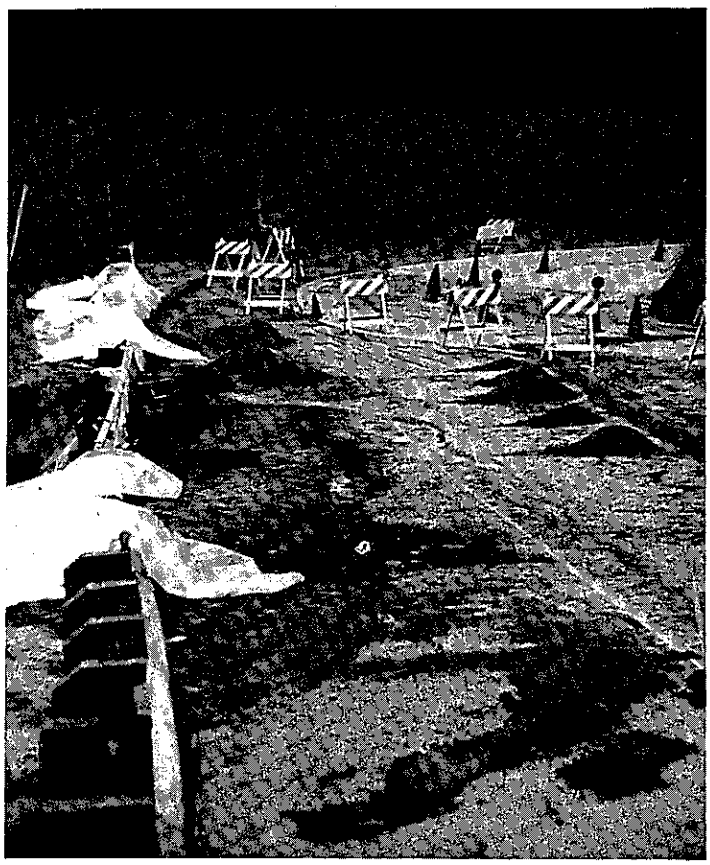
Photo 14 Settlement at Shoulder

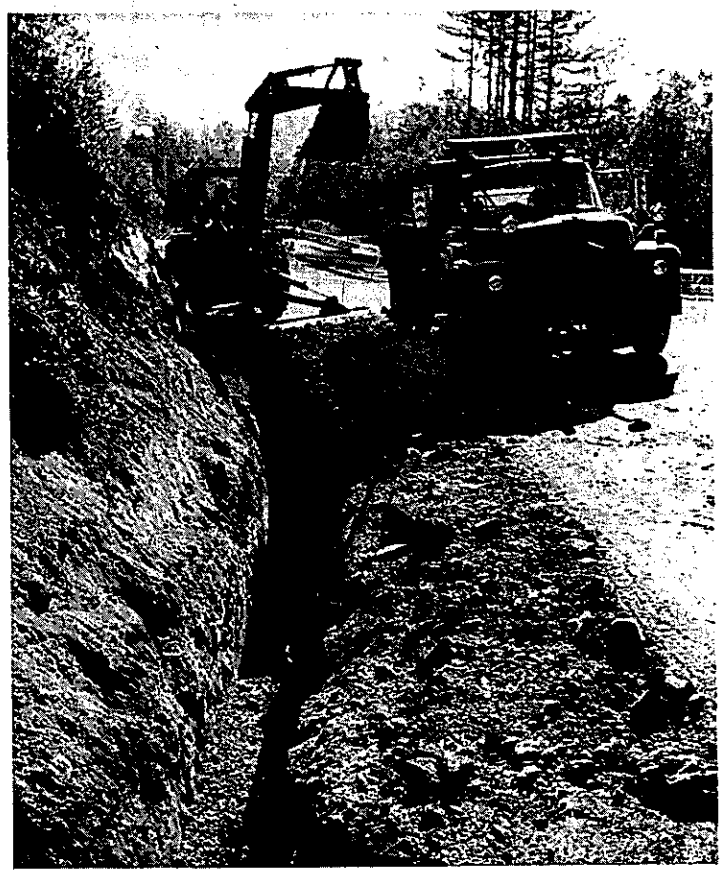
Photo 15 Cutoff Trench

An integral part of the repair was correction of an inadequate subsurface drainage condition.

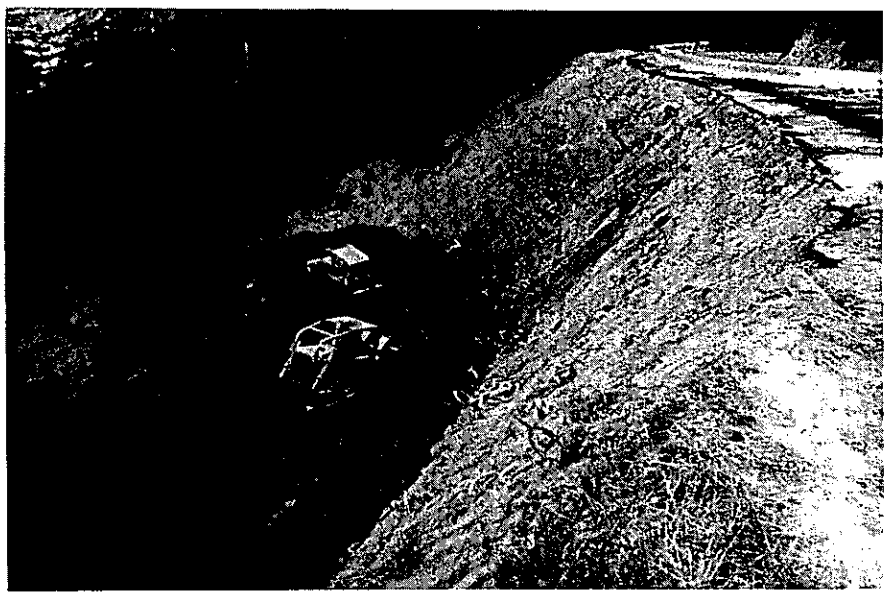
Photo 16 Strut Construction

Repair of the embankment was undertaken October 10, 1978 and completed January 18, 1979. The embankment was stabilized by installing sidewall sections cut from discarded automobile tires in the embankment strut as shown in Figures 36 and 37 similar to the original contract (see Photos 16 and 17). The

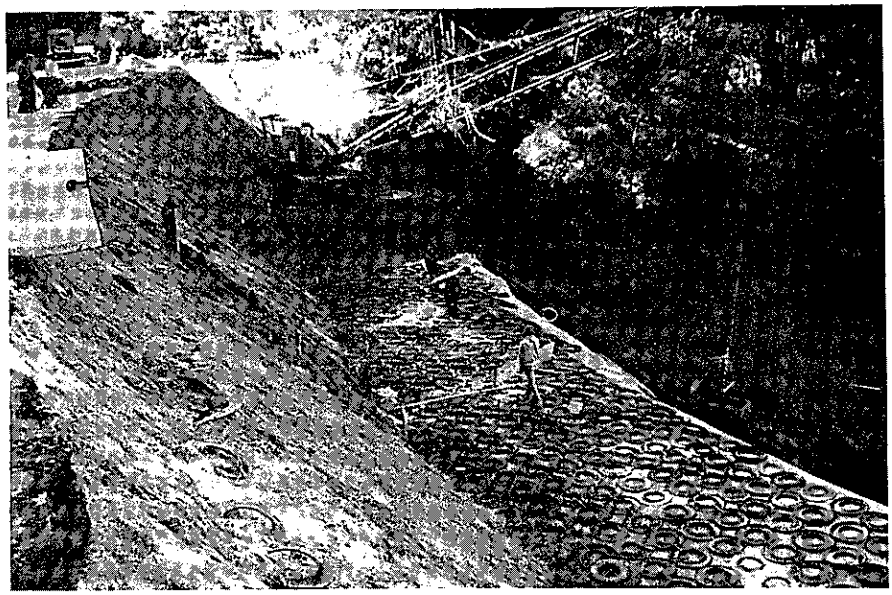
Photo 17 Strut Sidewall Mat

The tire sidewall reinforcing mats were installed at 2-ft intervals. Tires were fastened in two directions to form a mat without overlap. Each row was extended through the full width of the strut and connected to the existing sidewall mats at the face of the original embankment. Placement of the tires started at the existing sidewalls and conformed to the original sidewall pattern (see Photo 18). Slack was eliminated or minimized by tensioning the mats so that clips were in contact with beads of the tire sidewalls. The first level of tire sidewalls was installed at Elevation 342 (see Figures 36 and 37). Relative compaction of the earth between layers of mats was 90 percent.

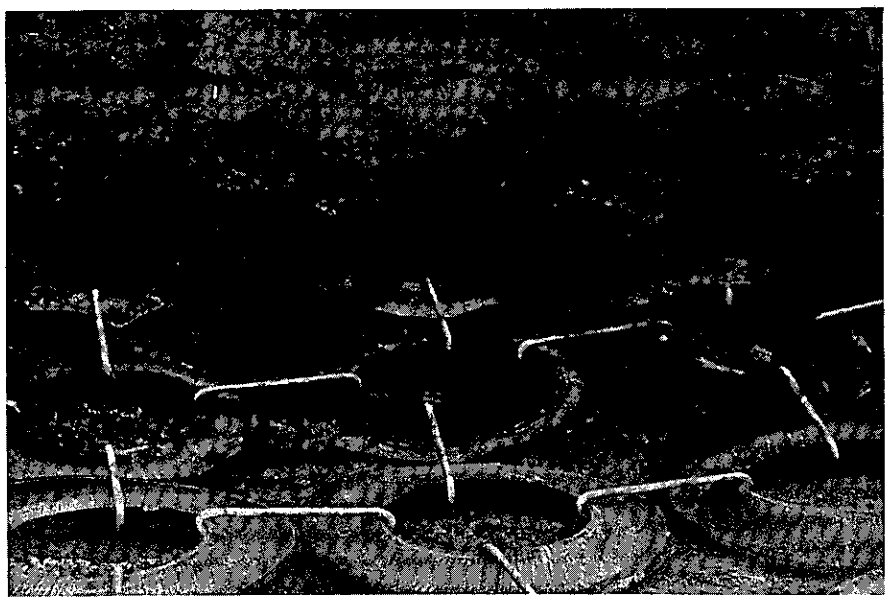
Photo 18 Sidewall Connected to Existing Mat

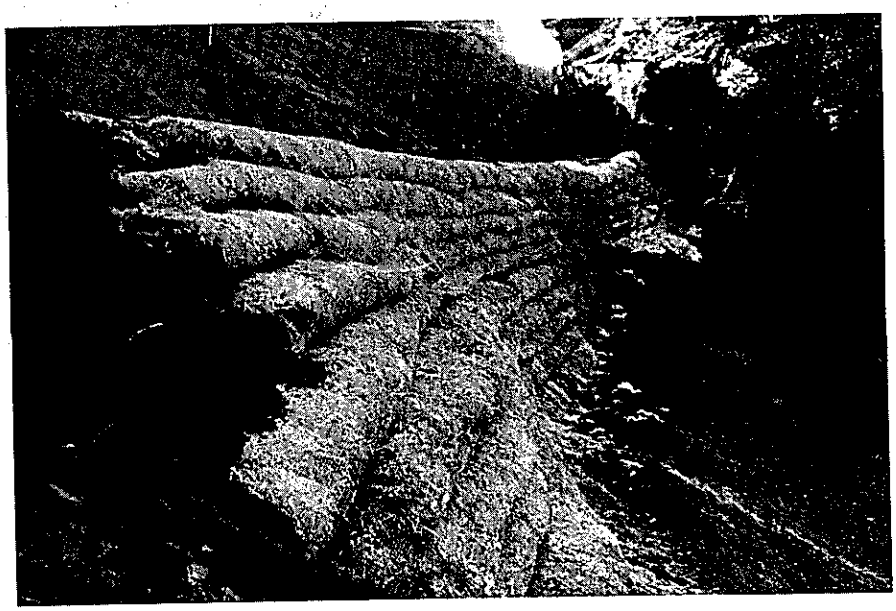
Photo 20 Strut Slope Erosion Control (Wire Mesh)

wrapping of the wire mesh, they could achieve the minimum dimensions shown on Figure 39. Adjacent edges and ends of the wire mesh strips were overlapped a minimum of 6 inches and tied securely at 18-inch intervals with 14-gage wire or hog rings (see Photos 19 and 20).

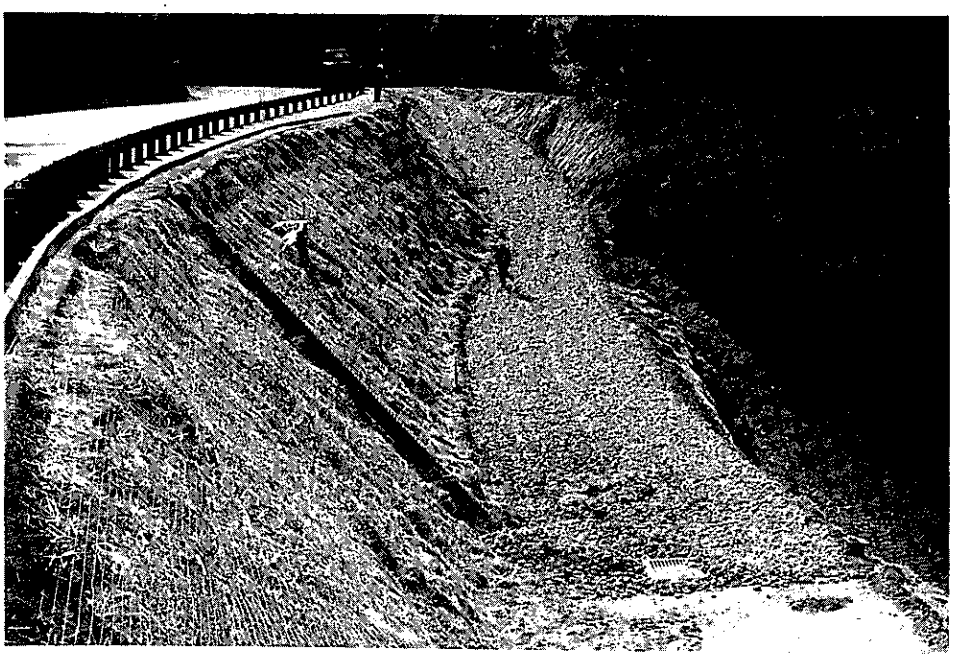
Photo 21 Cut Slope Erosion Control (Wire Mesh)

Cut-slope erosion control consisted of a biodegradable mat, straw, and a welded-wire mesh (see Photo 21). Prior to placing straw, the biodegradable mat was placed horizontally across the slope and anchored in place with 4-inch steel staples. The biodegradable mat was in 3-ft wide rolls with a minimum length of 100 ft. The mat consisted of seed, fertilizer, and peat moss bonded together between a polyester insulating mesh and Number 11 tissue paper. Straw was spread evenly to an uncompacted thickness of not less than 6 inches over the areas to be stabilized. Following the straw, galvanized 1-inch by 2-inch by 60-inch, 14-gage welded wire mesh was laid carefully and evenly across the slope. The wire was drawn taut and securely anchored to existing tire sidewalls as shown in Figure 40. Adjacent edges of the wire mesh strips were securely tied at 18-inch intervals with 14-gage wire or hog rings (see Photo 21).

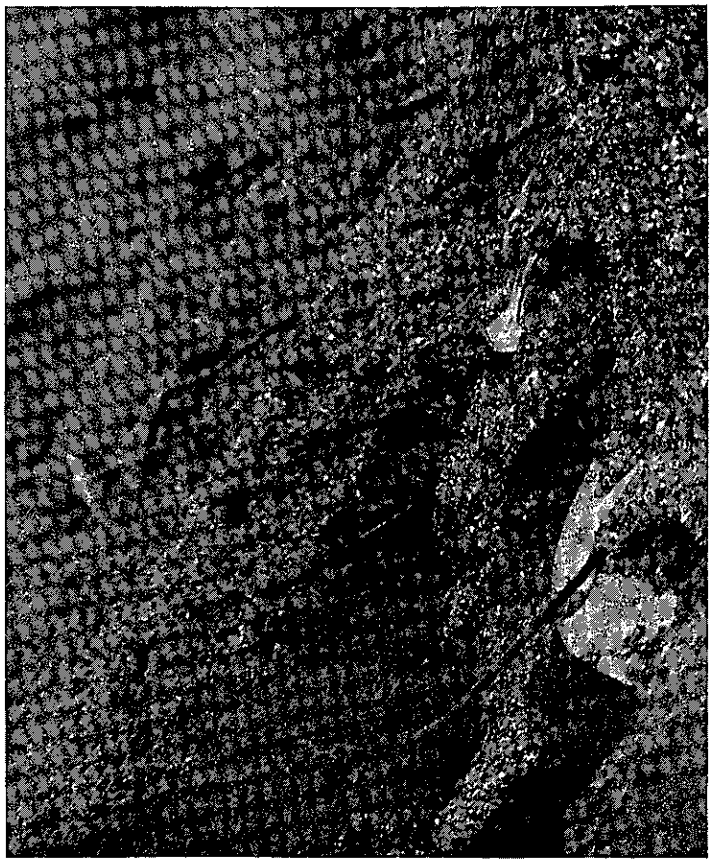
Photo 22 Clip Failure
