4. TITLE AND SUBTITLE
Crash Test of Cone Truck for Operator Safety

5. REPORT DATE
October 1986

Final Report

CRASH TEST OF CONE TRUCK FOR OPERATOR SAFETY

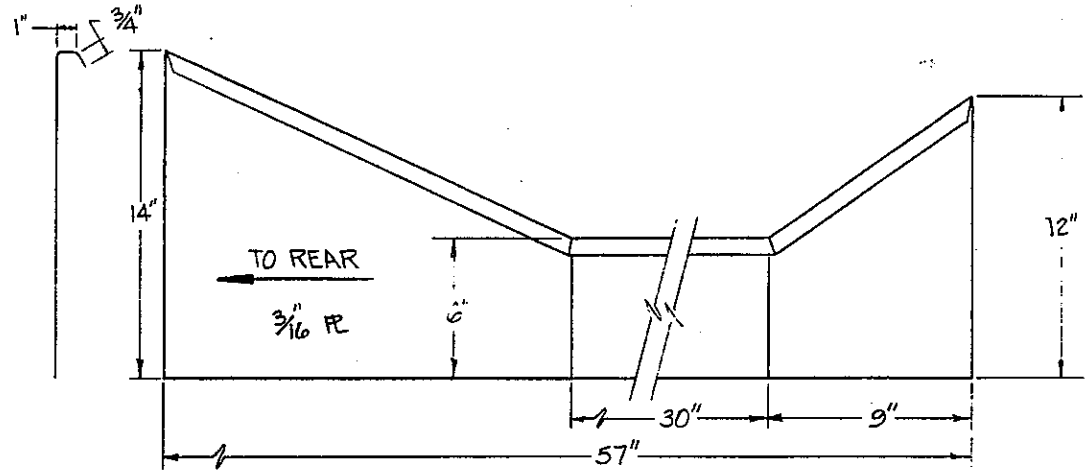
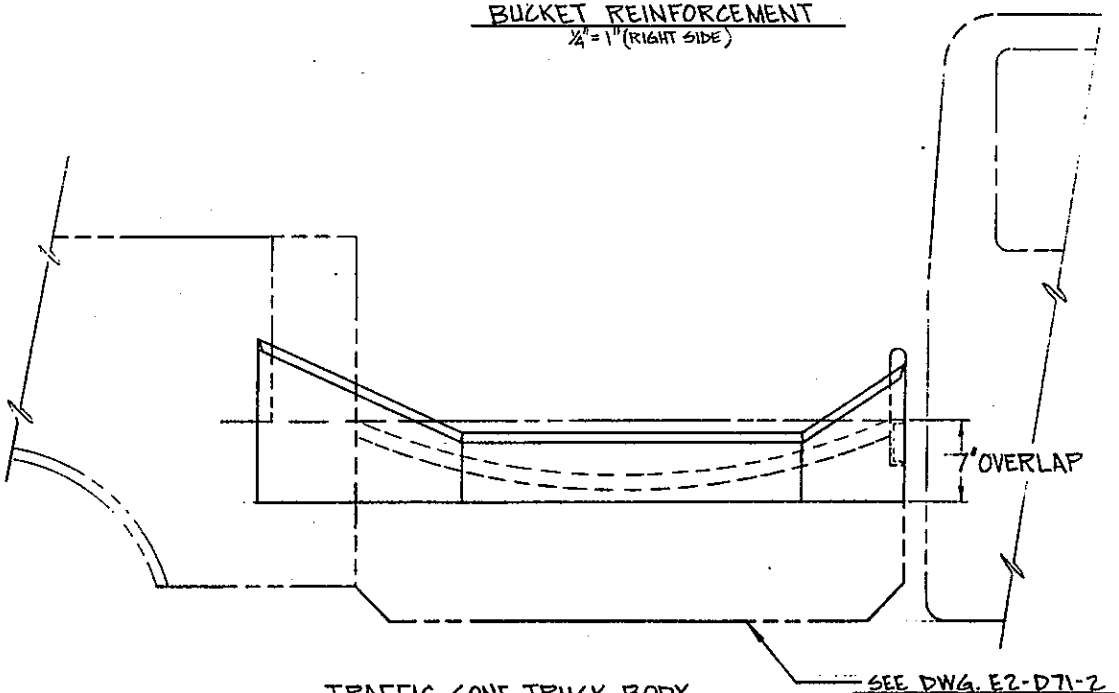
Figure 1

BUCKET SIDE REINFORCEMENT FOR TRAFFIC CONE TRUCK BODY

2. The attachment used in test 423 and 424 should be installed on a limited number of cone trucks for field evaluation. Attachment could result in hampering cone setting/retrieving process, entrance into body, etc.

3. If attachment hampers operation of cone truck, an alternate solution should be devised and field tested. If attachment does not hamper operation, all cone trucks should be retrofitted.

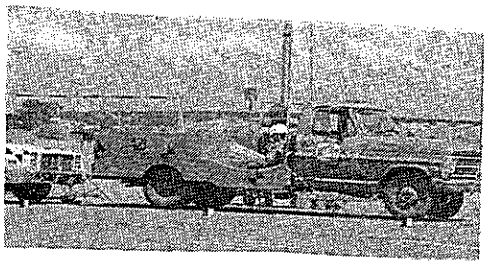
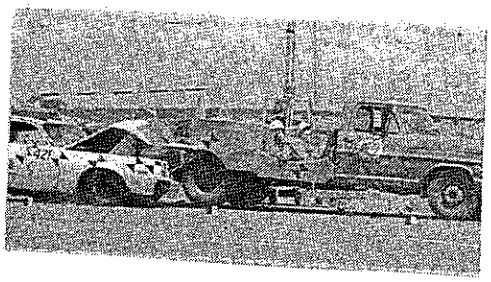
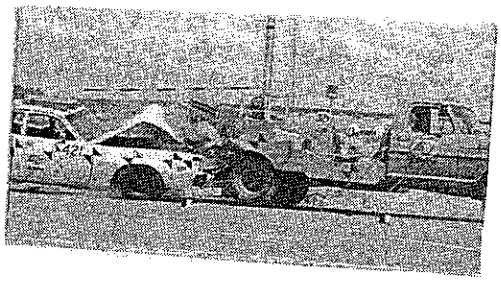
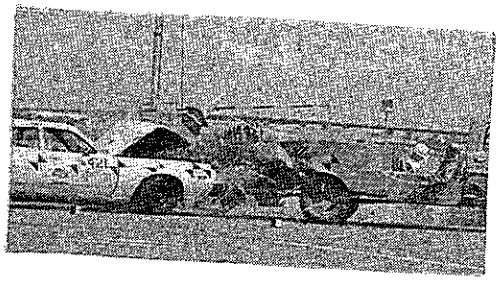
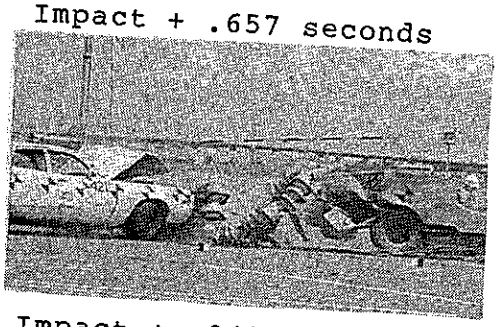
DATA SUMMARY SHEET — TEST #421

The rear sheet metal of the cone truck was severely crushed while leaving the operator's compartment damage free. Sam (dummy) was tossed about loosing his hardhat but remaining belted in his position. The cone truck was driveable after the test.

The car was severely damaged and undriveable.

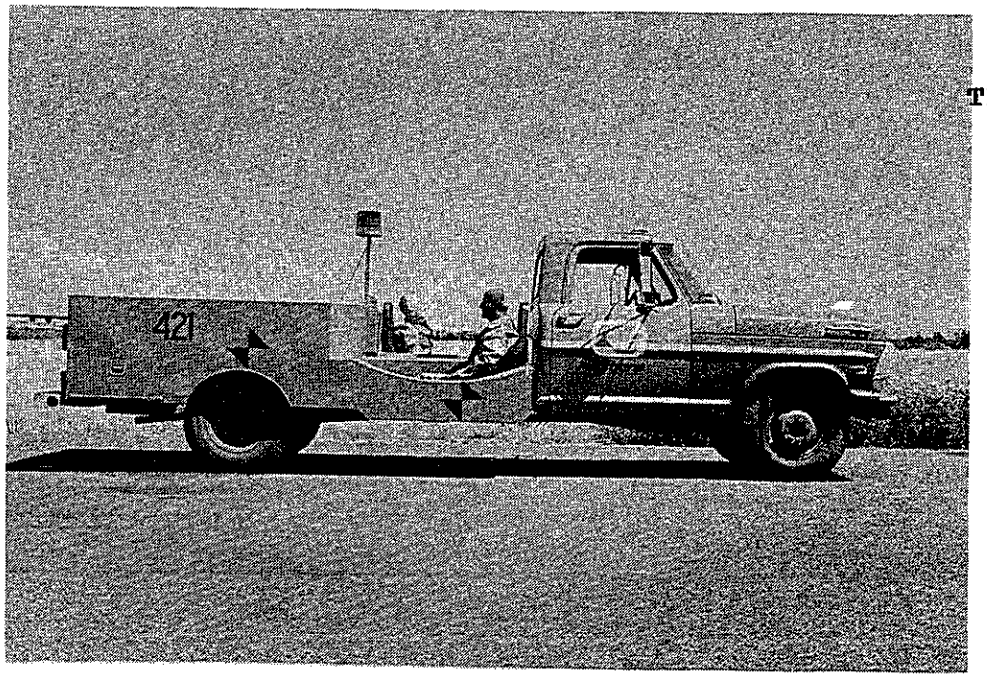
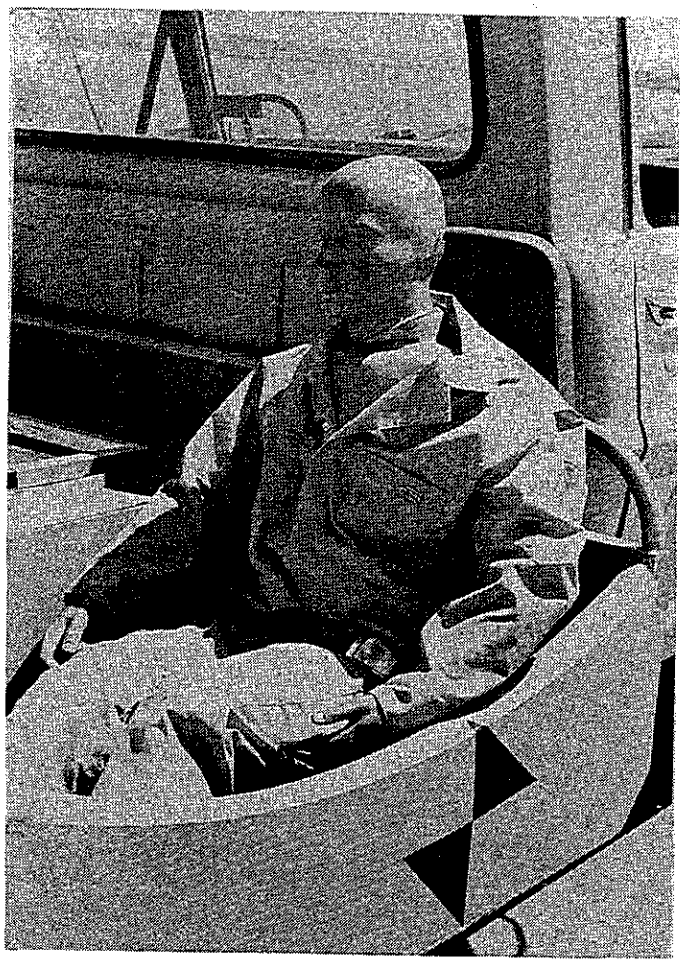
FIGURE 421-2

CONE TRUCK
BEFORE IMPACT

SAM BUCKLED UP
BEFORE IMPACT

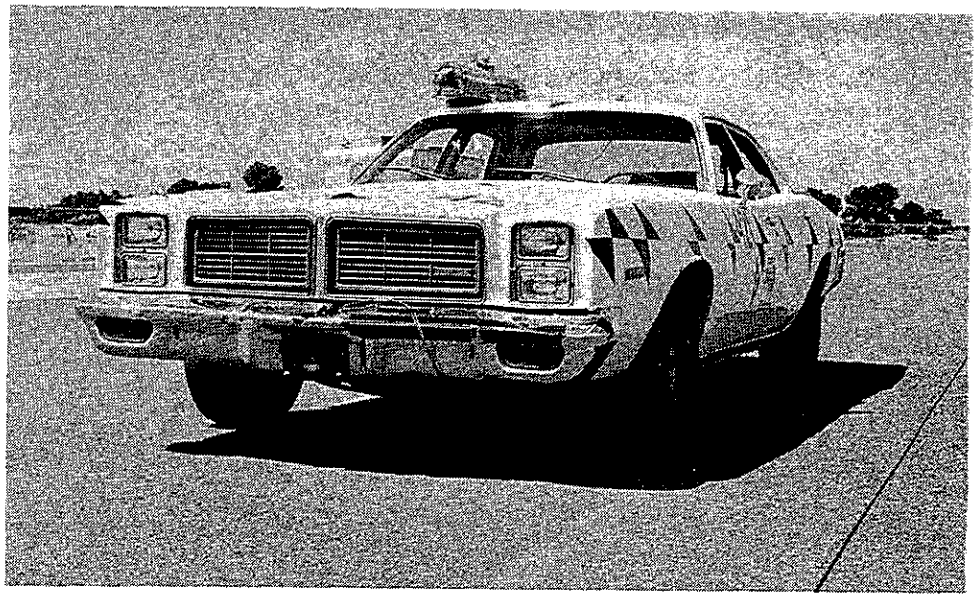
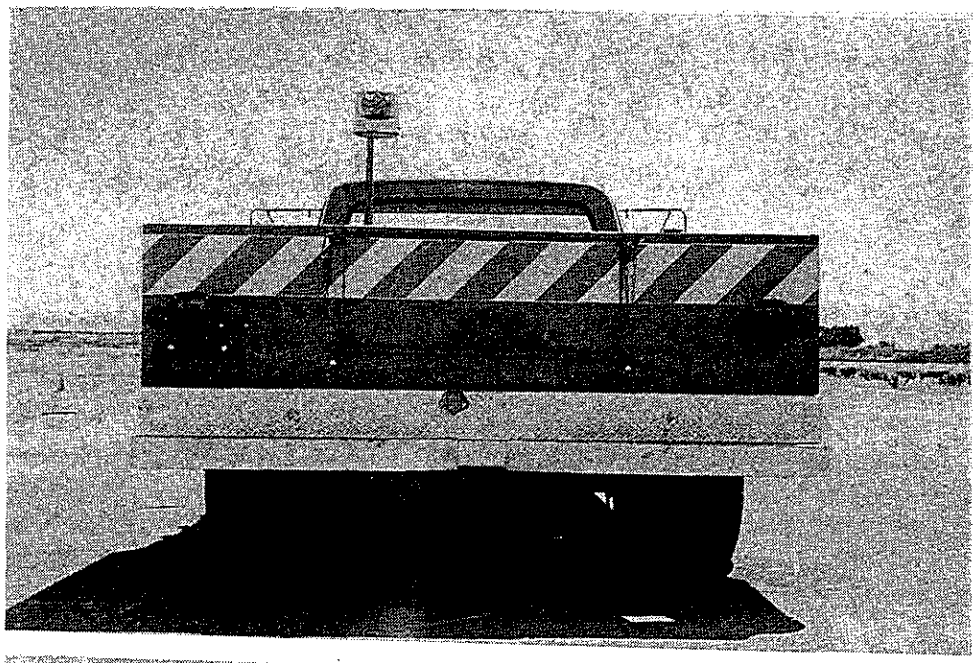
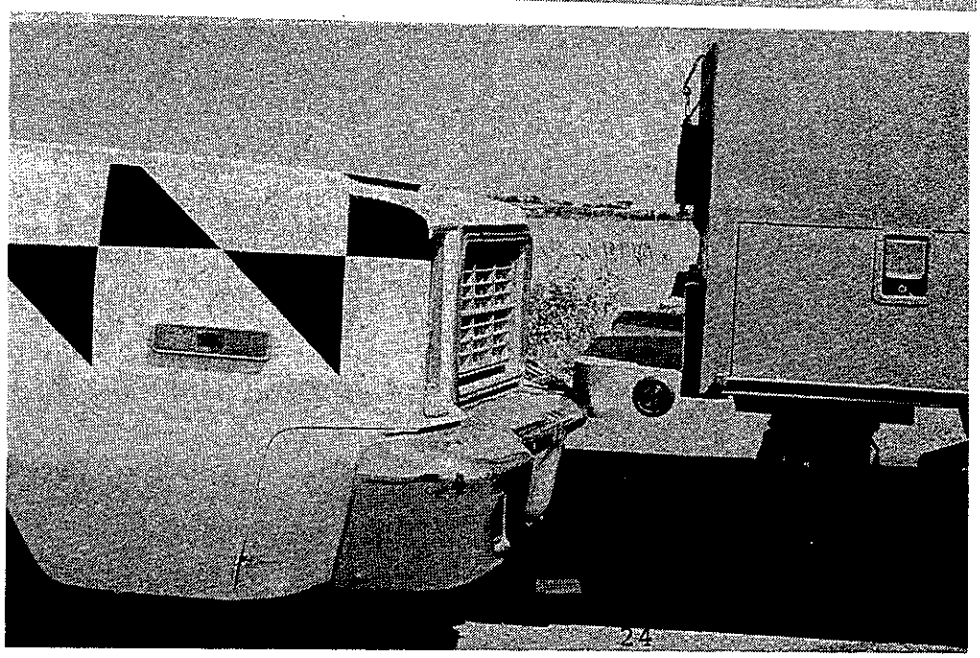
FIGURE 421-3

TEST VEHICLE
BEFORE IMPACT

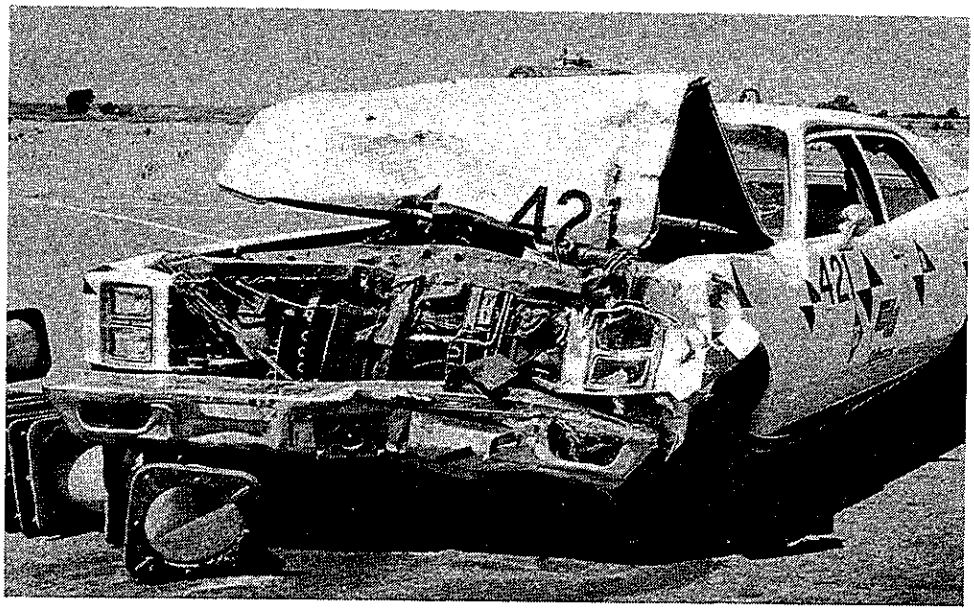
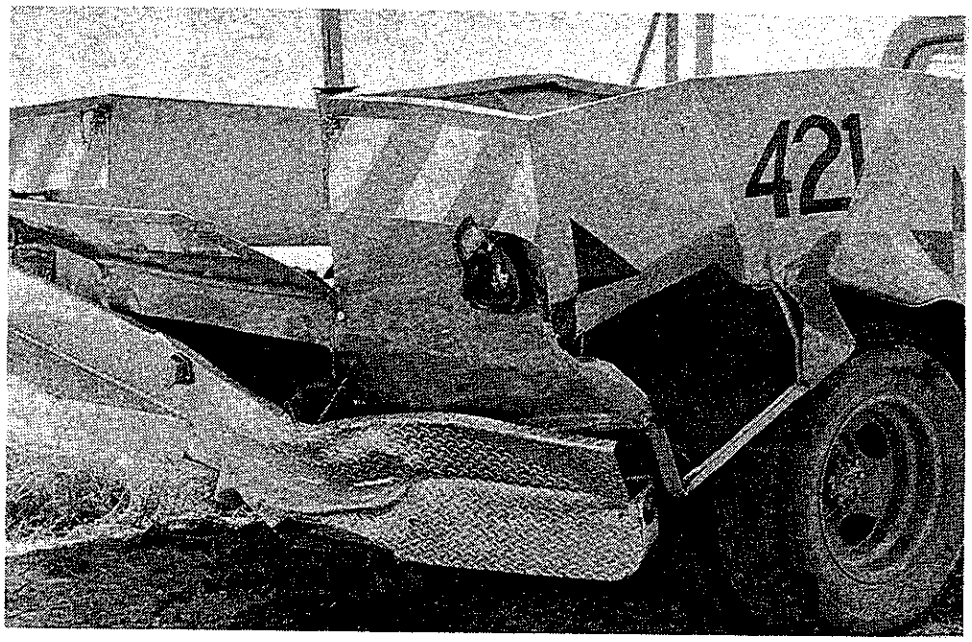
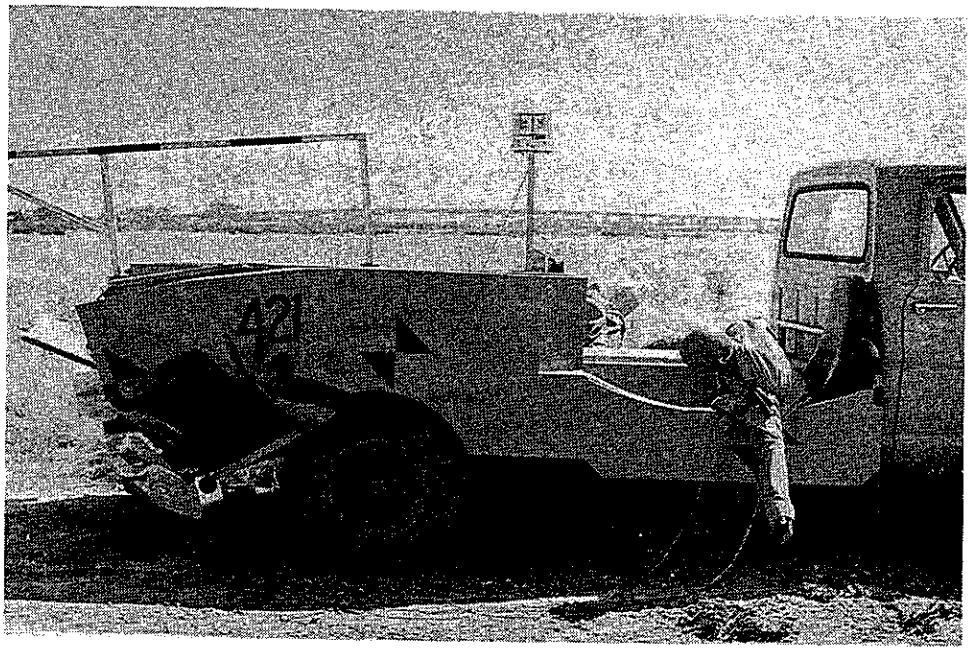
FIGURE 421-4

TEST VEHICLE
AFTER IMPACT

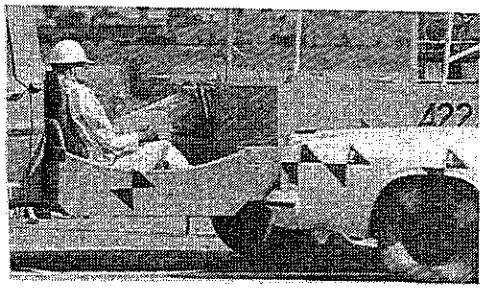
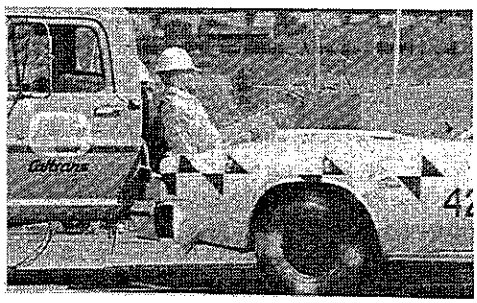
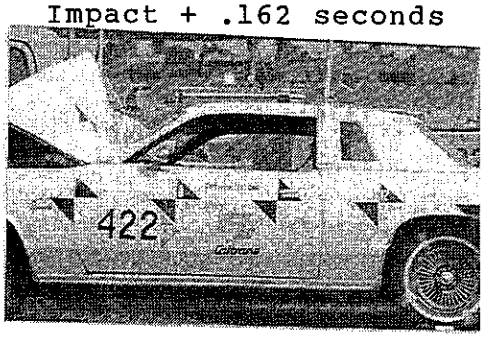
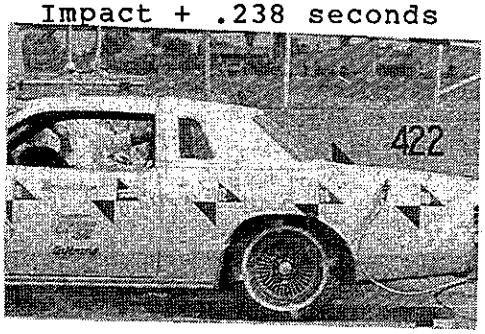
DATA SUMMARY SHEET TEST #422
TEST DATE SEPTEMBER 23, 1983

In test 422 (first 25° angle test), the front corner of the impacting car's hood rode over the rail of the cone setter compartment. This allowed the corner of the hood to penetrate and damage the dummy that was in the cone setters position. In the following two tests (423 and 424), an attachment (see Figure 1) was fabricated and installed as shown. Neither in test 423 nor 424 was it possible to repeat the circumstances that resulted in the hood penetrating the cone setter compartment of test 422. At re-evaluating test 422, it was concluded that impacting the cone truck at an angle produced an opening for penetration at 30 inches above ground level. Also as the impacting angle increases, the more likely the impacting vehicle's bumper system will prevent the hood from reaching into the compartment.

The operator's compartment was left undamaged, only scratched paint remained. The right front corner of the car's hood penetrated the operator's position and severely damaged the right arm and knee of Sam. Sam remained belted in the operator's position. The cone truck was driveable after the test.

The car was severely damaged and undriveable.

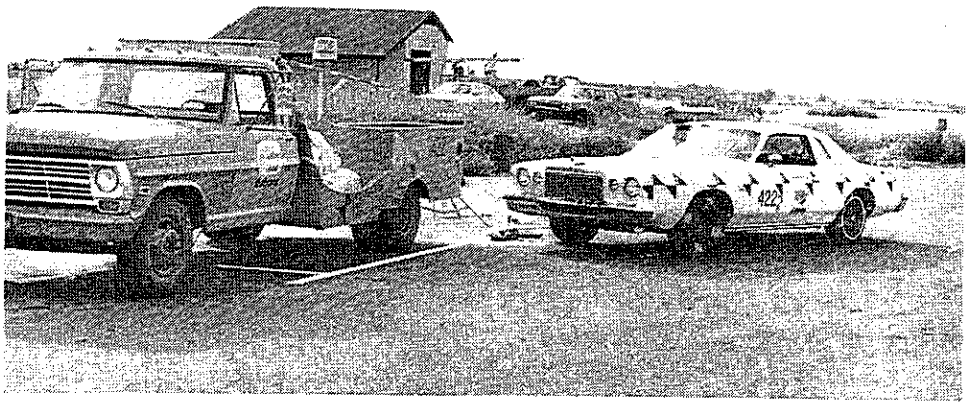
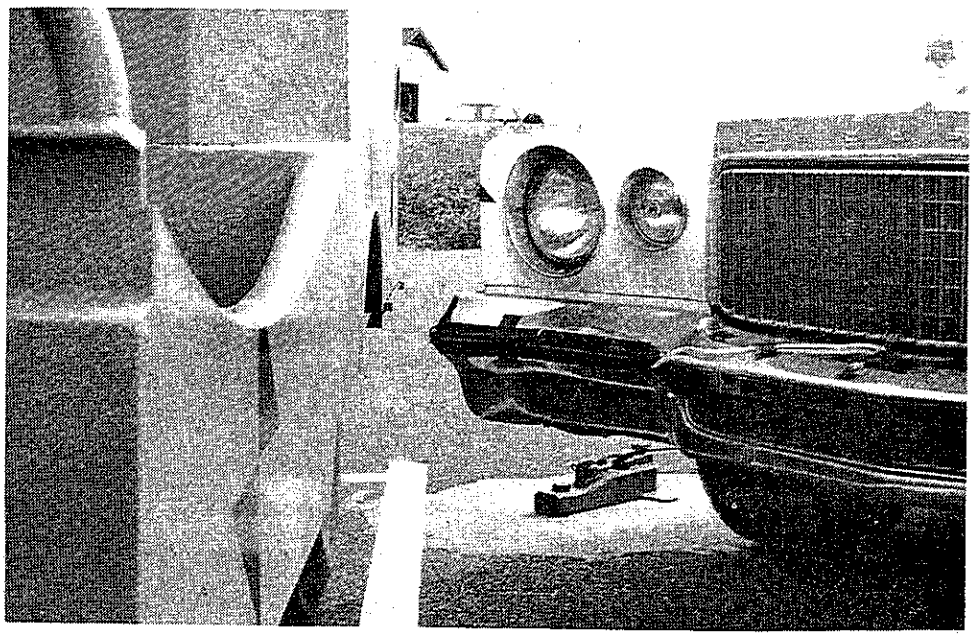
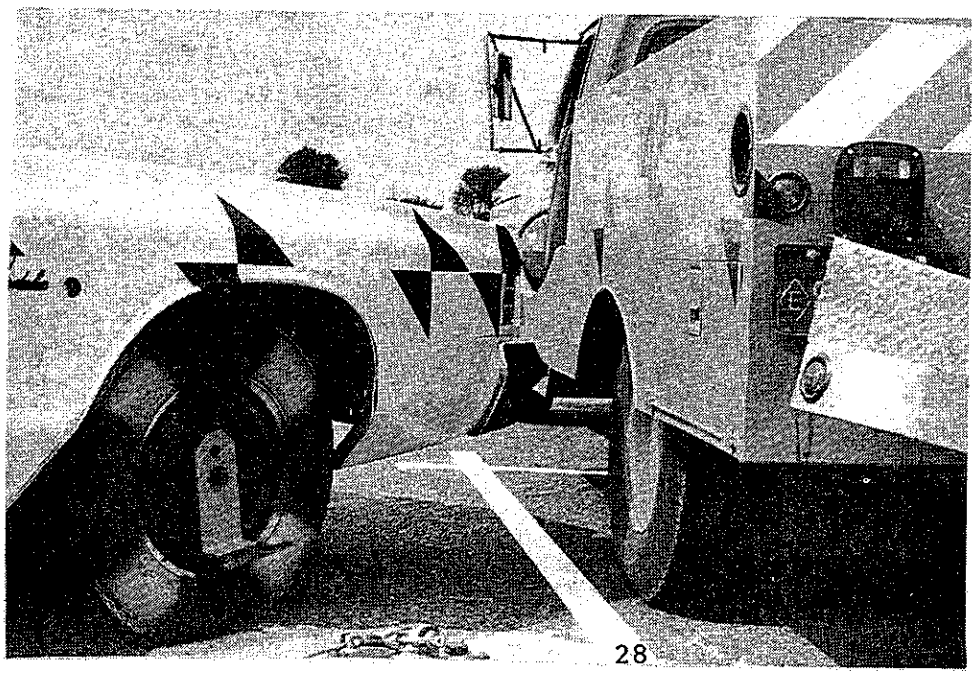
FIGURE 422-2

TEST VEHICLE
BEFORE IMPACT

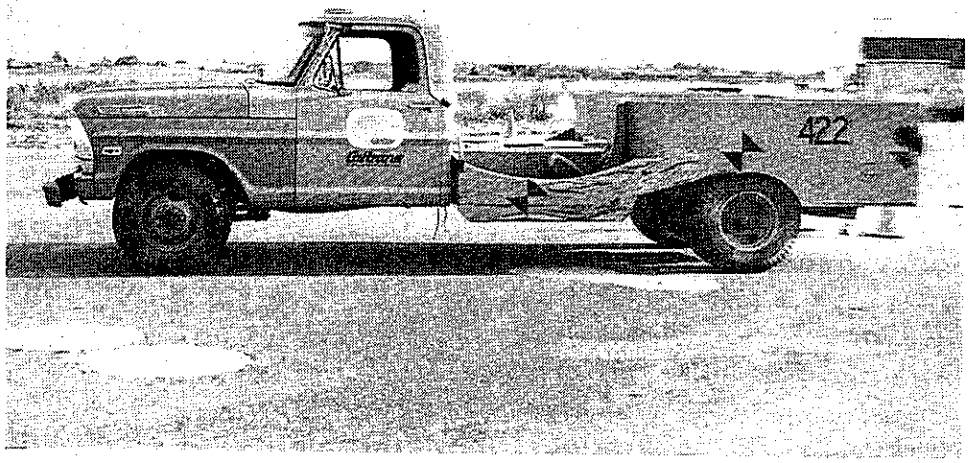
FIGURE 422-3

TEST VEHICLES
AFTER IMPACT

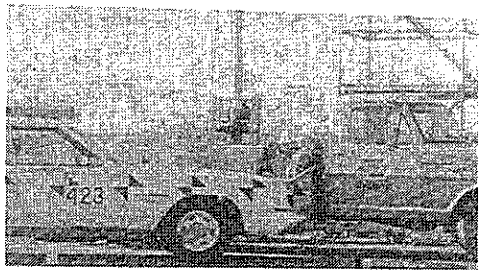
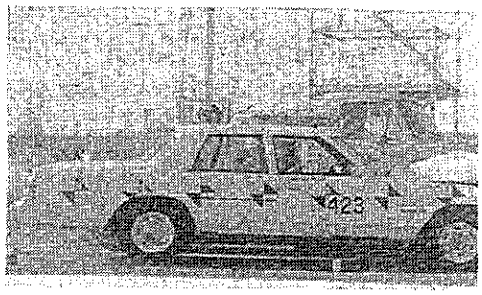
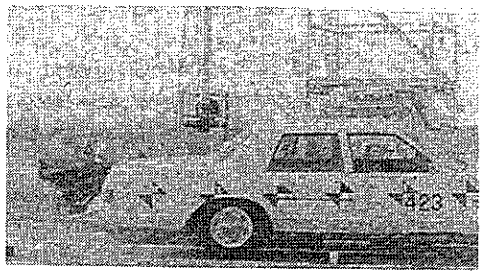
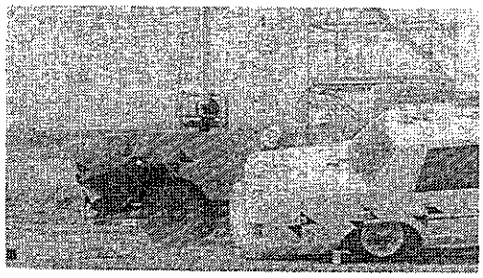
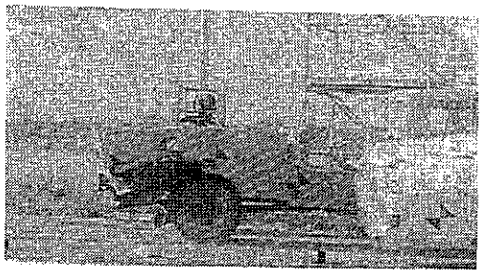
DATA SUMMARY SHEET TEST #423
TEST DATE DECEMBER 11, 1984

The operator's compartment was left undamaged, only scratched paint remained. Sam was tossed about but remained belted in the operator's position and was not damaged. The attachment appeared to reduce the possibility of the hood penetrating the operator's compartment. The right side of the cone truck cab and right front axle were damaged. The truck was not driveable.

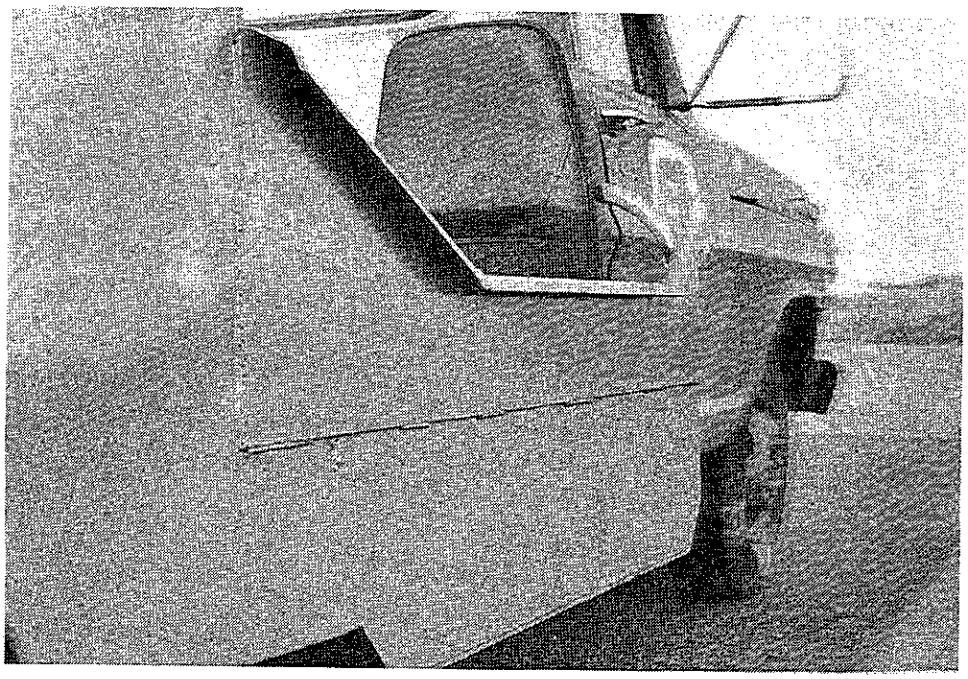
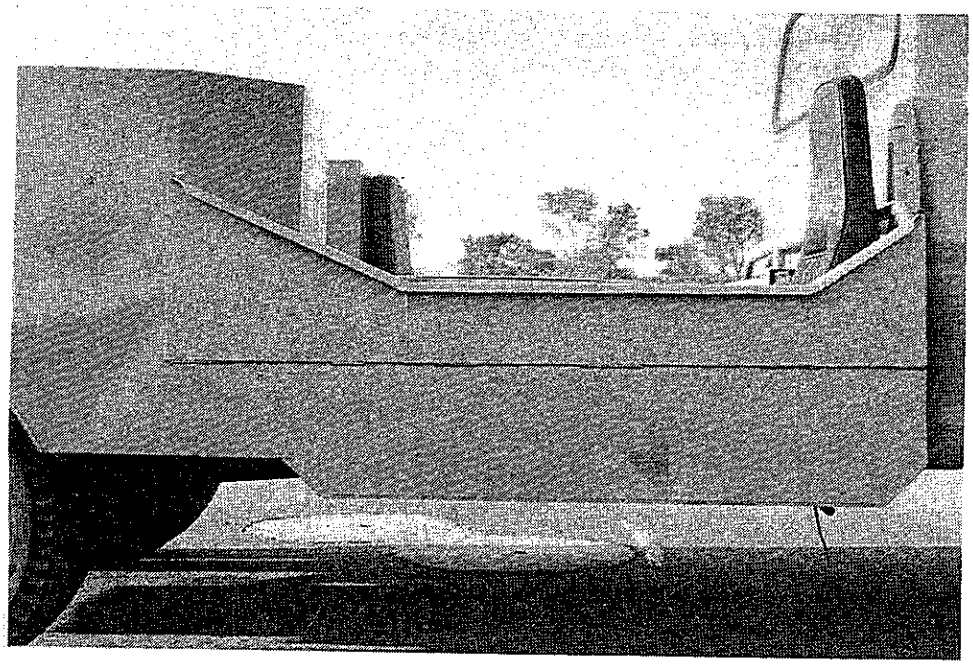
FIGURE 423-2

Test 423 was an angle impact of the cone truck body. This test was conducted to determine if an attachment to increase the height of the operator's compartment would prevent Sam from being damaged, as in Test 422.

ATTACHMENT ADDED
AFTER TEST 422

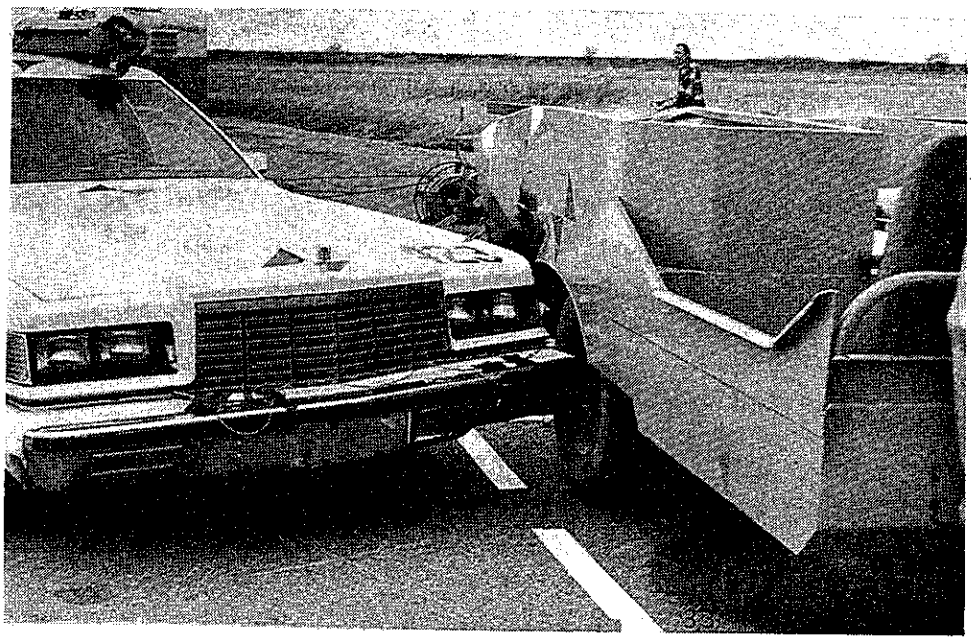
FIGURE 423-3

TEST VEHICLES
BEFORE IMPACT

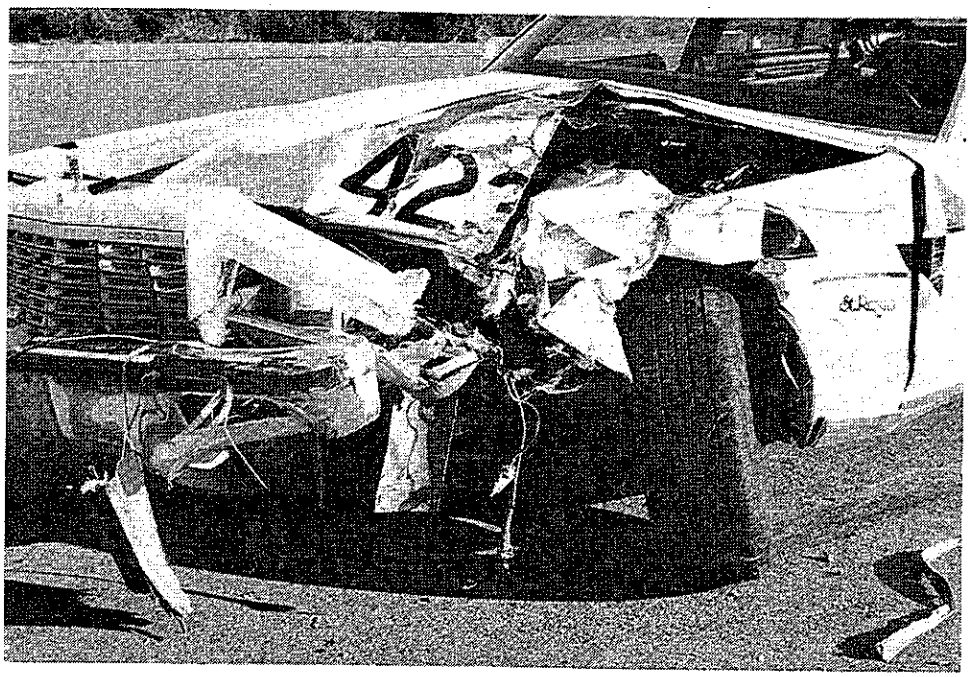
FIGURE 423-4

The front left side of the car was severely damaged and undriveable.

TEST VEHICLES
AFTER IMPACT

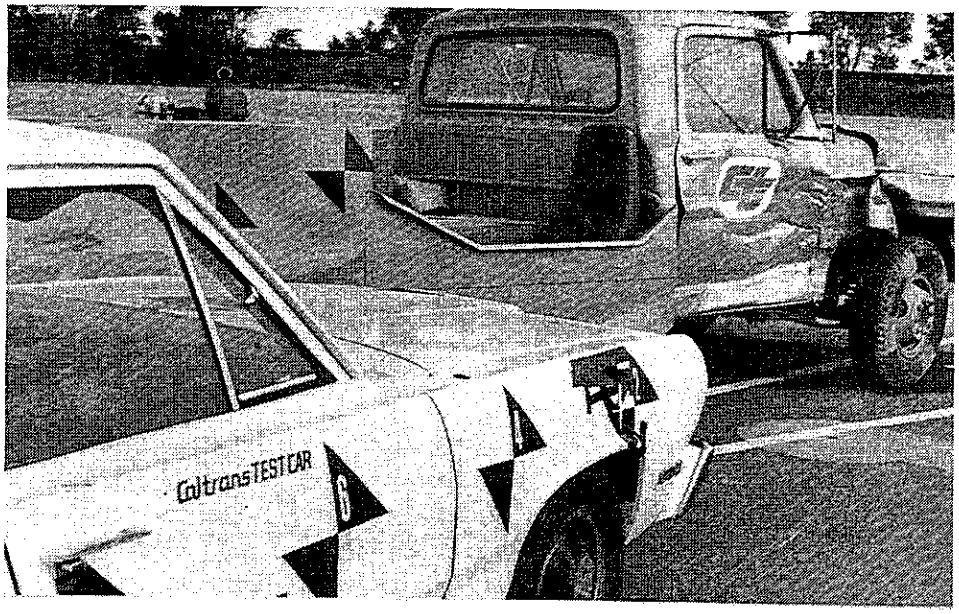
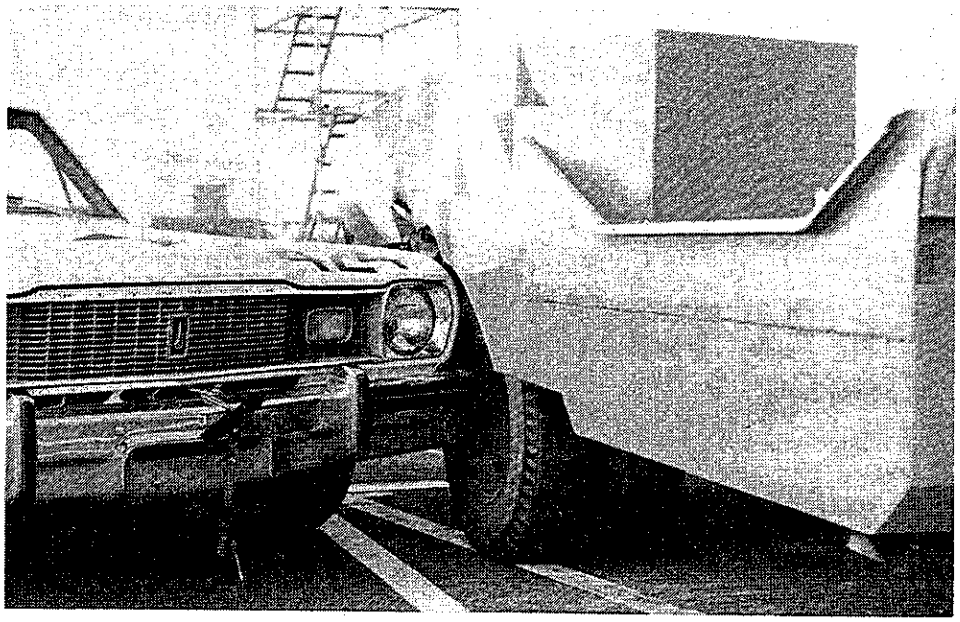
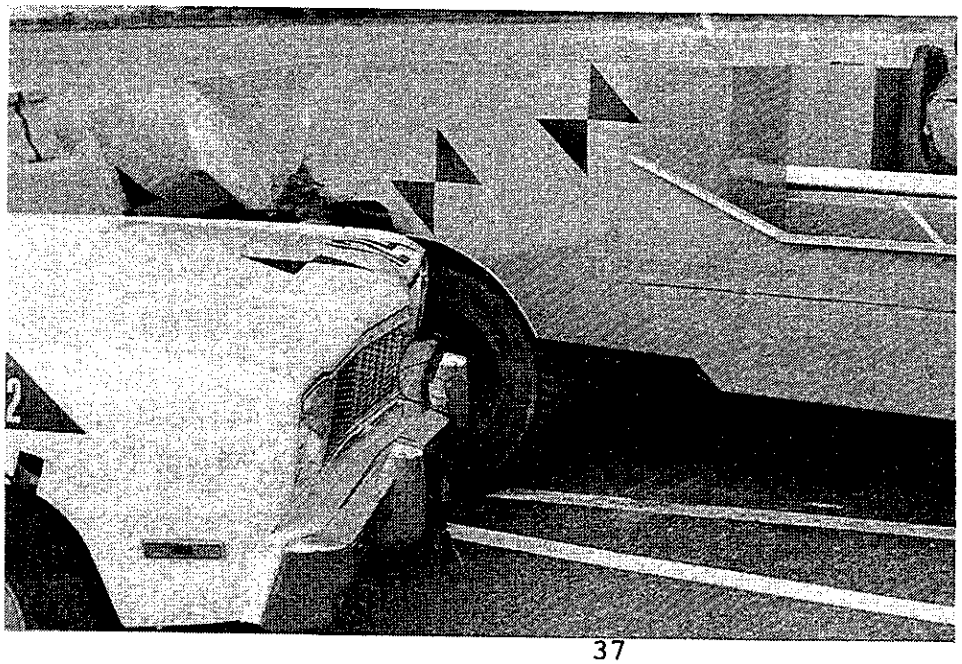
FIGURE 424-2

TEST VEHICLE
BEFORE IMPACT

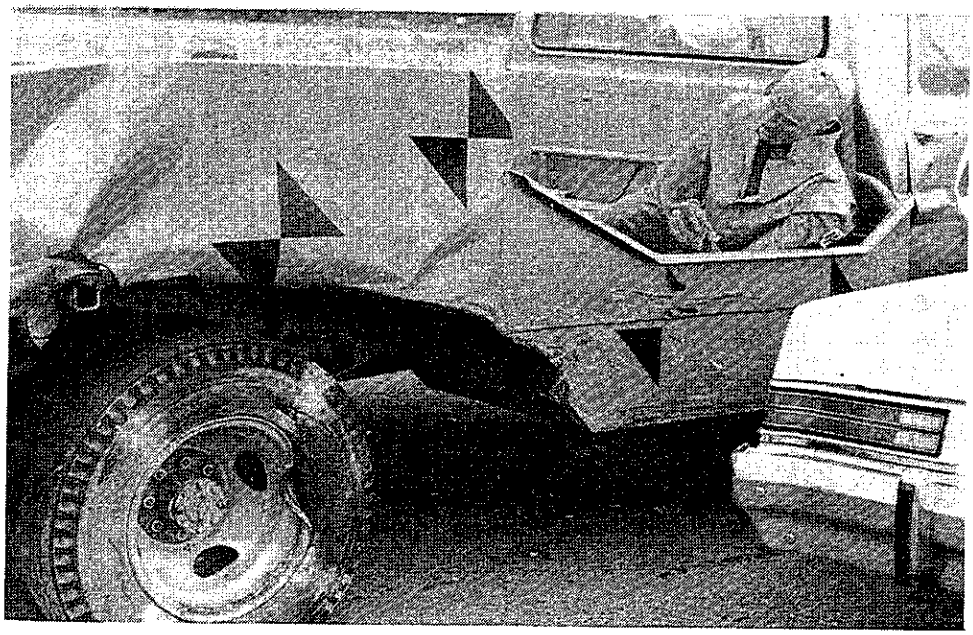
FIGURE 424-3

In tests 422, 423, and 424 (all at 25° angle), the impact was centered on the cone setters compartment. In all three tests, the compartment was left free of any structural damage.

TEST VEHICLES
AFTER IMPACT

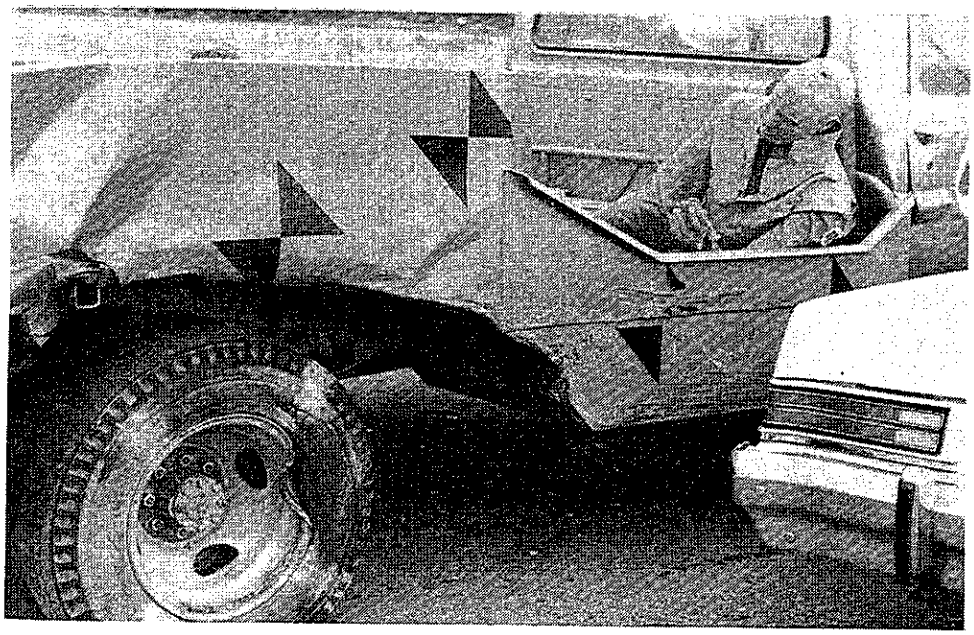
FIGURE 424-3

TEST VEHICLES
AFTER IMPACT

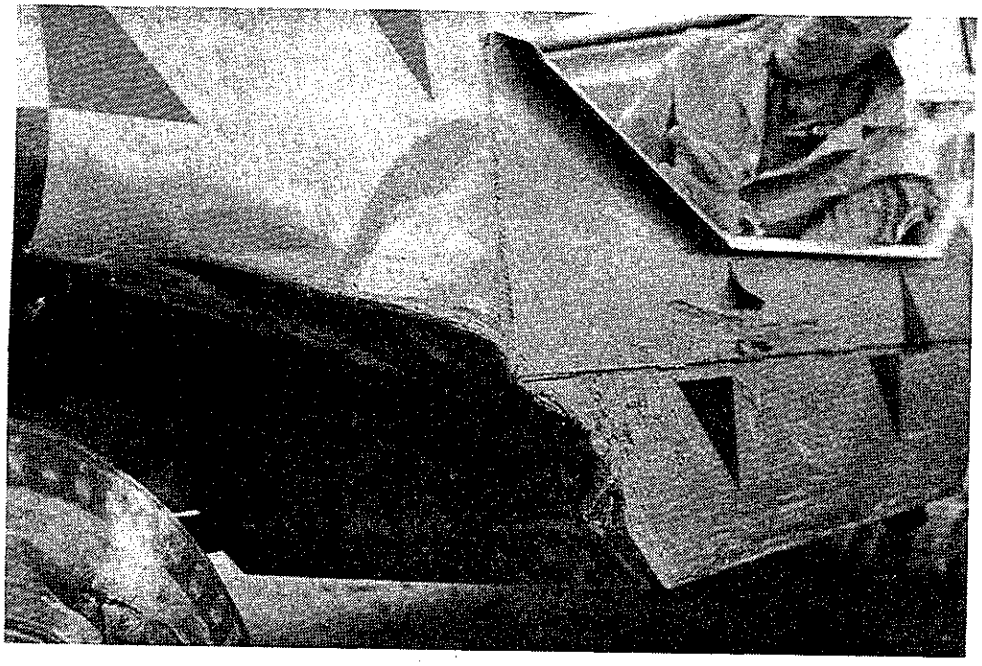
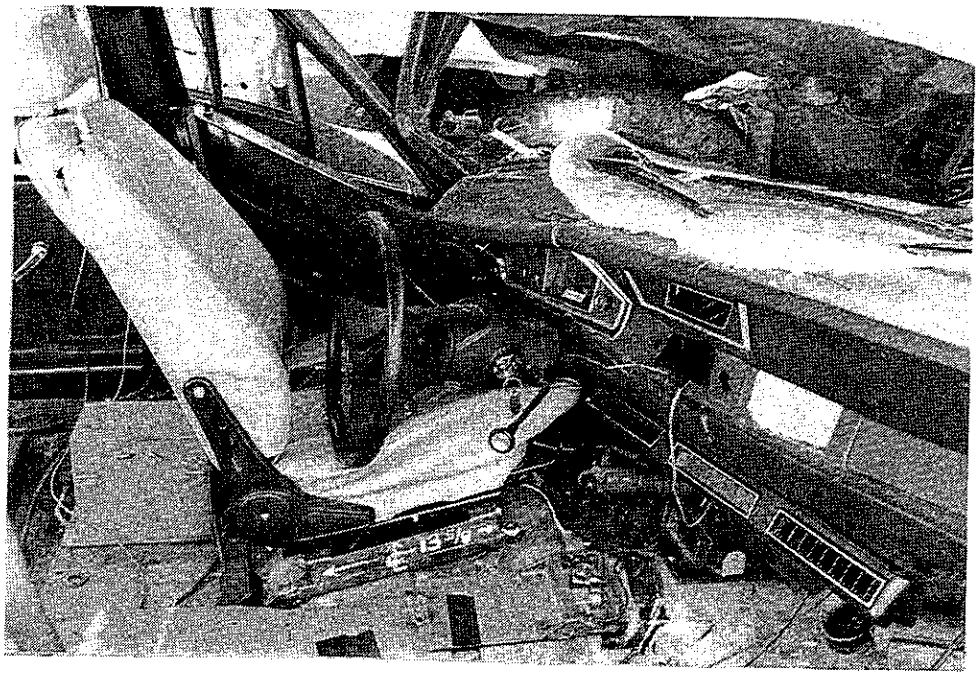
FIGURE 424-4

TEST VEHICLES
AFTER IMPACT
