Performance of Transportation Systems During the 9/3/2000 Yountville Earthquake

by Mark Yashinsky, Caltrans Office of Earthquake Engineering

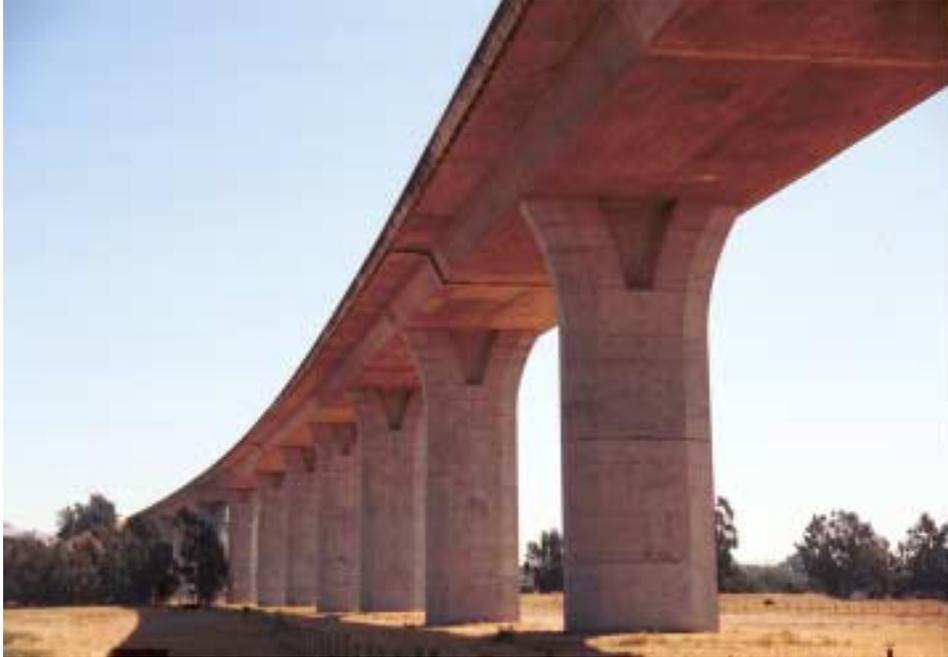
Figure 7. The Napa River Bridge and OH.

- **The Napa River Bridge and Overhead** (Br. #21-0049) was built in 1977. It is a 13 span precast, segmentally constructed, concrete box girder bridge that carries State Route 29 over the Napa River (see Figure 7). The bridge is supported on tall single-column bents and end-diaphragm abutments; all on pile caps that were retrofitted in the 1990's. The structure is composed of four frames separated by three unusual hinges. Instead of a bench for the longer cantilevered span to rest on, they are supported by concrete pistons with steel stoppers. The earthquake widened the hinge openings (and moved the bearings) an inch or two, but the very large gaps (Figure 8) are a pre-existing condition (Figures 9 and 10).

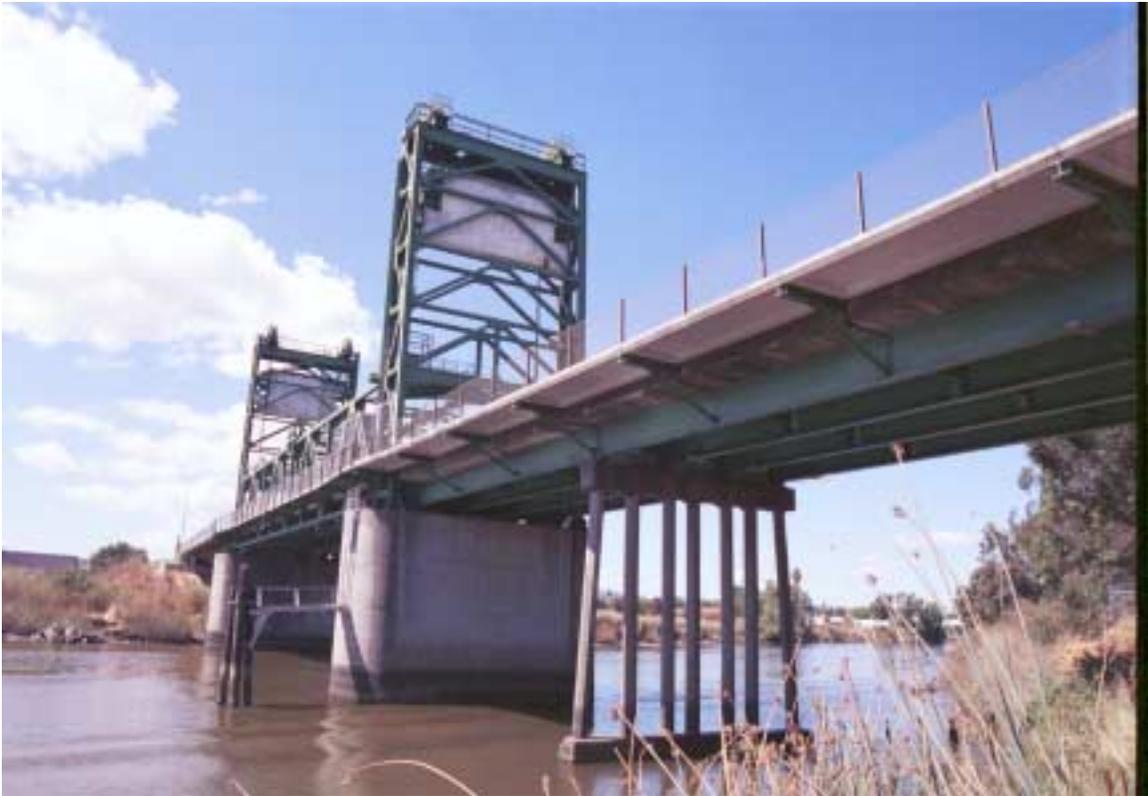
Figure 11. The Maxwell Bridge.

- **The Maxwell Bridge** (Br. #21-0075) is a two-lane vertical lift bridge (with a main span of 132 ft) that was built in 1949 (Figures 11 and 12). It was recently retrofitted to provide greater seismic resistance for the maximum credible earthquake. This retrofit included some work to the towers that carry large concrete counterweights to lift the bridge. The main vertical tower members are 'double (back-to-back) angle sections from which small squares were (almost completely) gas-cut out to allow the counterweight to move freely both transversely and longitudinally after knocking out the cut pieces (instead of banging against the tower legs during the earthquake). The metal squares were left in so the guides on the counterweight wouldn't bind against the holes. During the earthquake, the retrofit worked perfectly, with the guides knocking out the cut metal squares, thus allowing it to swing without hitting the tower legs (Figure 13 and 14). However, the metal squares fell onto the roadway, which could have banged up a vehicle or even endangered a driver if the earthquake had occurred when someone was on the road. Therefore, the designer has asked that the plates be tack-welded back onto the channels (to help guide the counterweight) and that little chains should be attached to keep the plates from falling onto the roadway during the next earthquake.

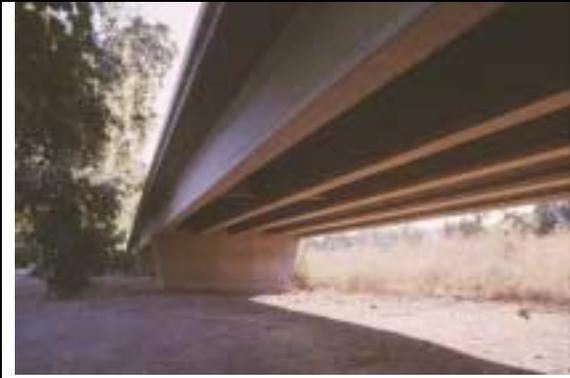
Figure 14. Yountville Crossroads Bridge.

- **The Yountville Crossroad Bridge** (Br. ##21C-0116) is a two-lane, locally owned bridge that crosses over the Napa River and Conn Creek just east of Yountville. The superstructure is six simple spans of five precast concrete I-girders on elastomeric rubber pads and with a continuous deck (Figure 14). The substructure is pier walls and seat-type abutments. There was a pre-existing problem at this bridge. The elastomeric bearings had delaminated, allowing the deck to settle onto the exterior shear keys of the eastern abutment and causing the concrete to spall and expose some reinforcement. The spall was patched however, the bearings were never replaced and during the earthquake, the precast I-girders of the eastern span moved sufficiently to spall the exterior shear keys again (Figure 15). Otherwise, the bridge was in good condition.
