A Study of Various Paint Systems Applied to Leffingwell and San Simeon Creek Bridges in a Corrosive Marine Atmosphere

April 1964

State of California
Department of Public Works
Division of Highways
Materials and Research Department

Progress Report

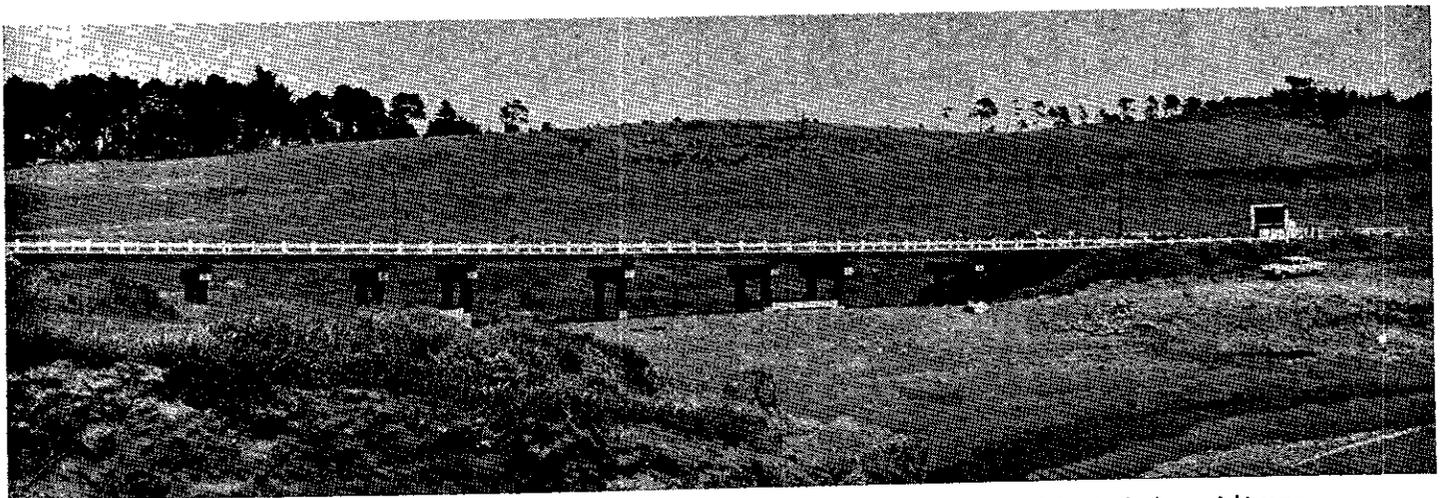
FIGURE 2—A photograph of the actual bridge shown in the diagram above. Note the beach and surf line in the lower right corner.

The Leffingwell Creek Bridge is situated just north of the town of Cambria on Road V-SLO-56-B (State Sign Route 1) in San Luis Obispo County and is close to the shoreline of the ocean as shown in Figure 2. It is a low level structure containing eight steel stringer spans with a concrete deck supported on concrete piers and abutments. The 24-foot wide concrete deck shields the steel girders to a limited extent from rain thereby allowing salt to accumulate in heavier deposits than would occur if the steel were more exposed as in a superstructure. This bridge and several others similarly situated with respect to the
