September 1973

LANDLOCK AS A SPRAY-ON EROSION CONTROL AGENT

TRANSPORTATION LABORATORY
RESEARCH REPORT
CA-DOT-TL-1139A-140-73-32

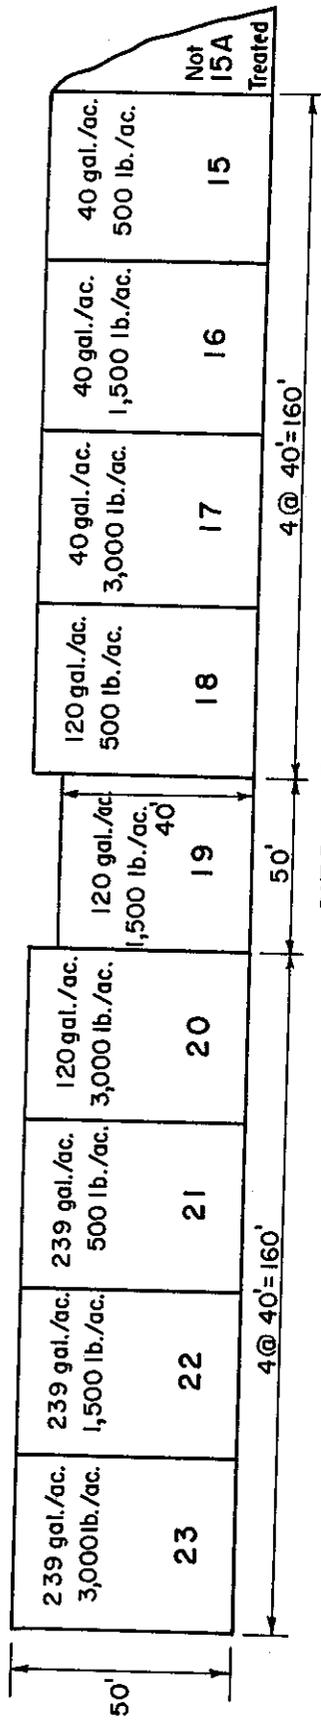
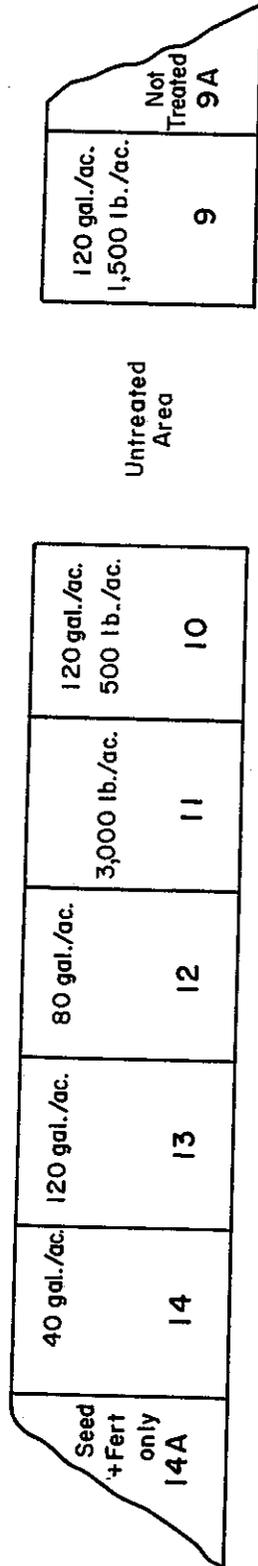
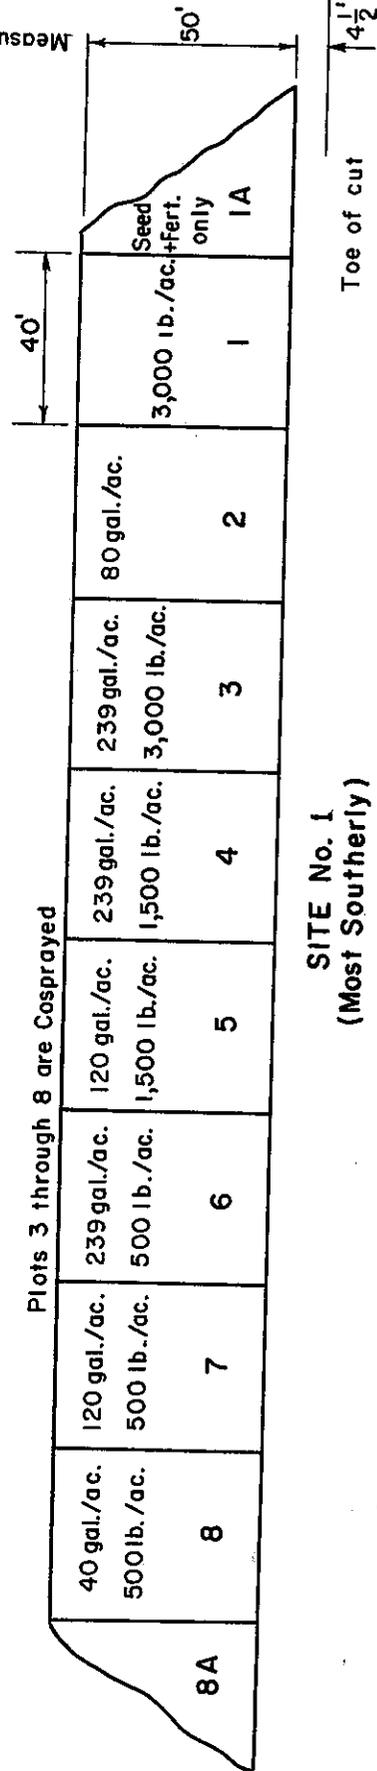
Figure 1 SOIL EROSION CONTROL PLOTS NEAR COLLIER TUNNEL

On March 24, Plots 3 through 8 of Site #1 (the southerly test site) were cosprayed with varying amounts of polymer and fiber. Plots #12 through #14 and #2 were sprayed with varying amounts of polymer while the plots in Sites #2 and #3 (Plots 9-11 and 15-23) that were previously sprayed with varying concentrations of fiber were sprayed with varying concentrations of polymer over the fiber. See Figure 1 for complete descriptions of each plot. The cuts treated in this area had 1:1 slopes in faulted and fractured sedimentary and metasedimentary rocks. Spring and fall inspections were made at this installation, including photographs, during the following year.

SITE No. 3
(Most Northerly)

Plots 9, 10 & 15-23... Sequence of spraying: 1. Seed + Fertilizer, 2. Fiber, 3. Polymer

SITE No. 2

Plots 3 through 8 are Cosprayed

SITE No. 1
(Most Southerly)

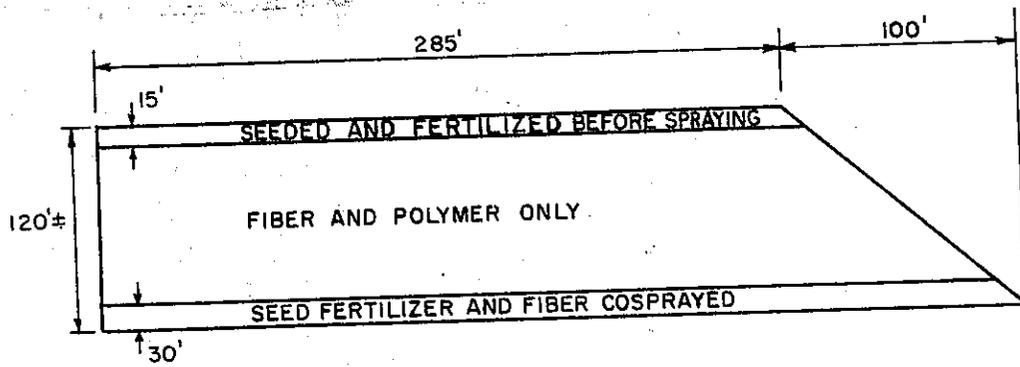
Figure 2 I-5 - SISKIYOU COUNTY NEAR WEED

On June 23 and June 24 in 1972 Landlock and fiber were cosprayed on the slope at the rate of 240 gals. of polymer and 600# of fiber per acre. Also applied to the slope were 613#/A of nutrients and 25#/A of seed mixture (see Appendix A). The seeds and nutrients were cosprayed with the polymer and fiber except at the toe of slope. The center had no seed, and the top was preseeded. This 1:1 slope was cut through volcanic debris. See Figure 2 for the slope description. Spring and fall photographic records were kept of the erosion at this location.

The stress of frost-heave and the freeze-thaw action broke the Landlock blanket into small pieces which, due to the steepness of the slope, fell to the gutter (see Plates 1 and 2). The treatment did, however, appear to increase the growth in the fertile cut flanks before it failed.

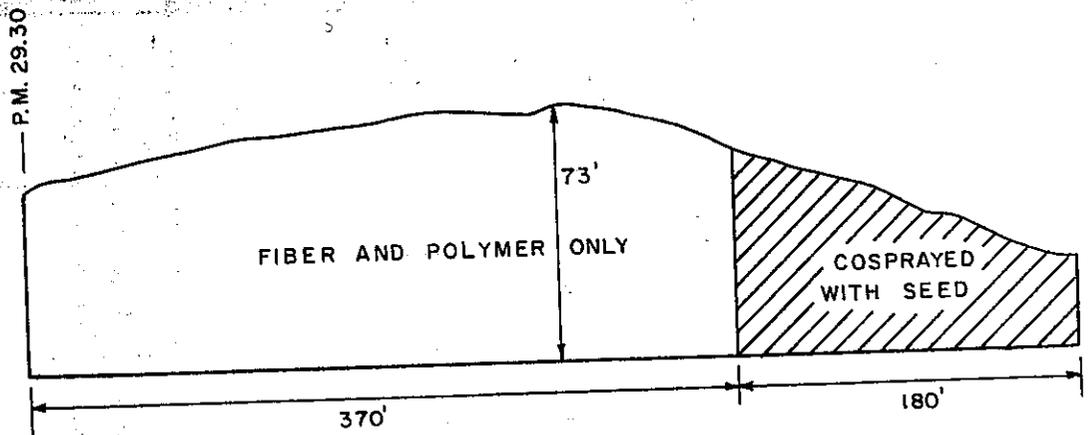
Figure 3 I-80 - NEVADA COUNTY NEAR FARAD

This slope was treated on June 22, 1972. The treatment was with 240 gals. of polymer/A and 600#/A of fiber. The seed mixture and rate was the same as at Weed (I-5 Siskiyou) with 420#/A of nutrients (see Appendix A). The polymer and fiber were cosprayed with the seeds and nutrients over the glacial deposit exposed in this 1:1 slope. See Figure 3 for the slope configuration. Spring and fall photographic records of the erosion were taken.

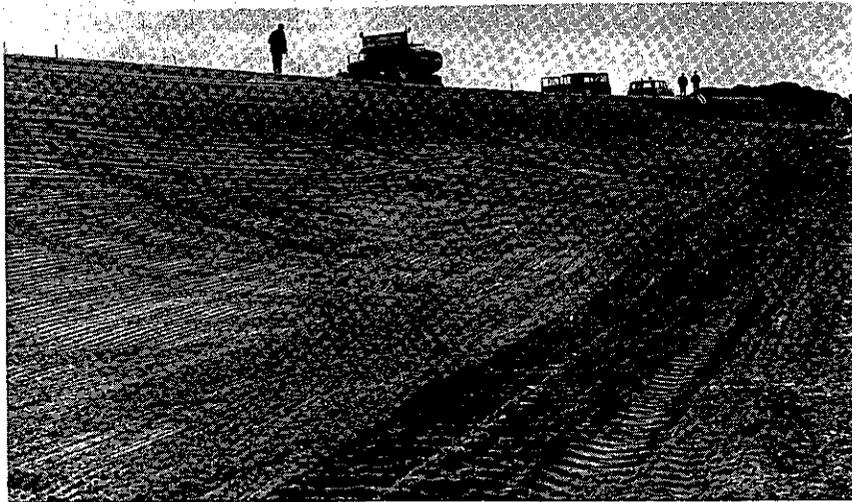
Plate 1

The construction of fills on Road 05-Mon-1 through Fort Ord was accomplished using beach sand. This type of material is frequently highly erosive so it appeared to offer a good opportunity to test erosion control materials. Mr. Al Jorge, Resident Engineer, arranged for a test area on a 2:1 fill slope adjacent to Non-Com Road. The slope was brought to grade and smoothed by dragging a heavy chain across the slope. The appearance of the slope after preparation is shown in Plate 1.

The results of these tests can be seen in Plates 1 through 18. The odd numbered plates show the appearance of the plots at the time of treatment and the even numbered plates show the appearance of the same plots after 10 months of weathering. Plate 19 shows the ice plant which was used for temporary erosion control adjacent to the test plots.

3M Test Area

12-15-71

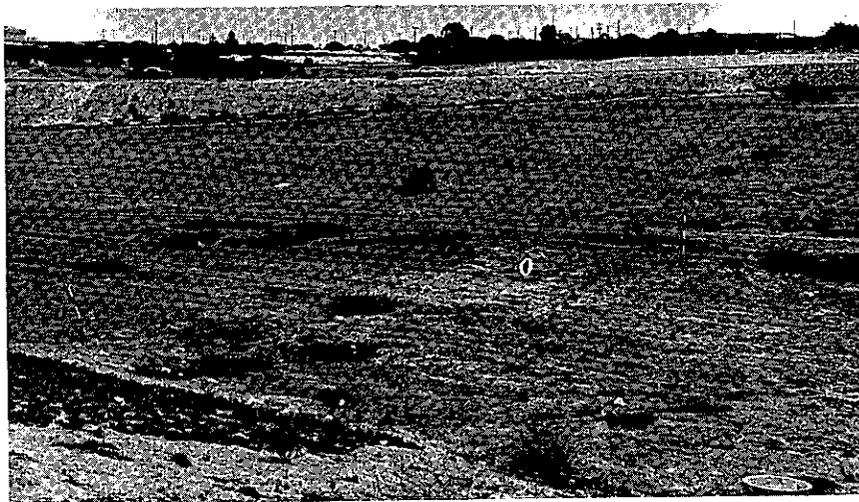
Plate 2

3M Test Area

9-10-72

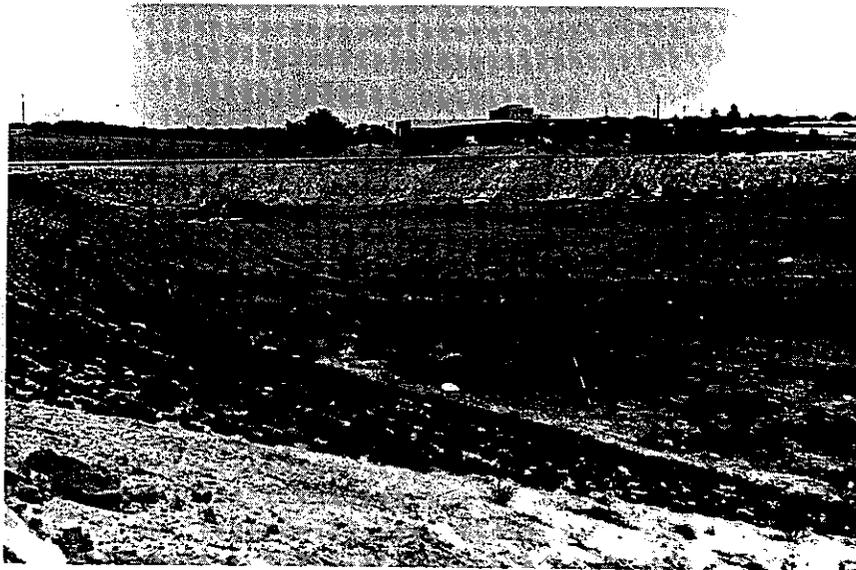
The appearance of these test plots after one season is shown in Plates 20 through 32. No photos were taken at the time of treatment because we were not aware of the application.

Plate 20 - DCE-70 Test Area after
treatment

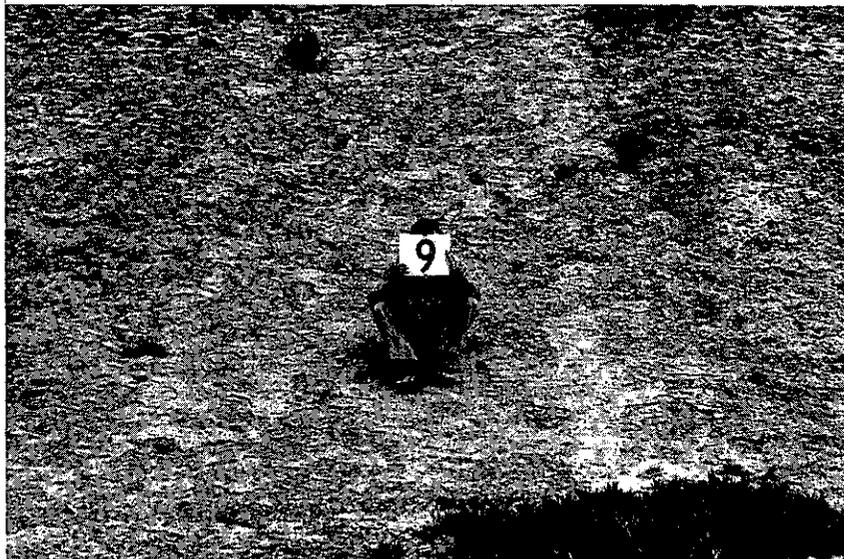
#30 The ice plant is below the
9-10-72 treated area
