CA-DOT-TL-6392-5-74-14

Dynamic Tests Of Metal Beam Guardrail, Series XXVII

Transportation Laboratory
California Division of Highways
Sacramento, California 95819

Interim Report

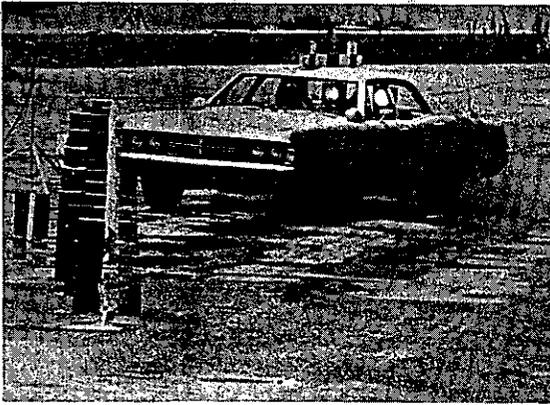
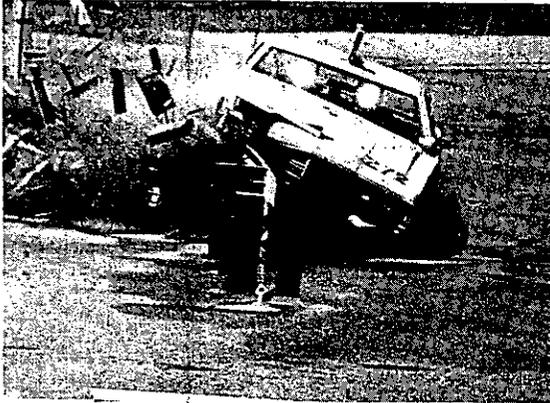
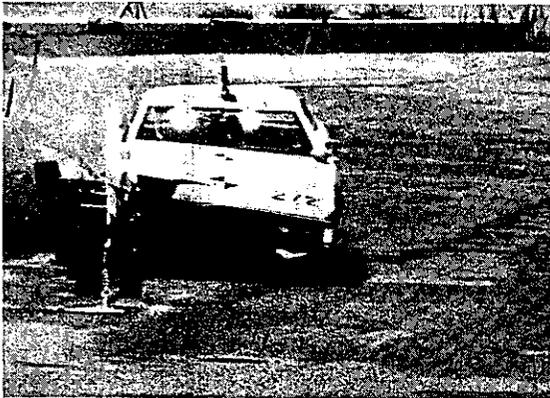
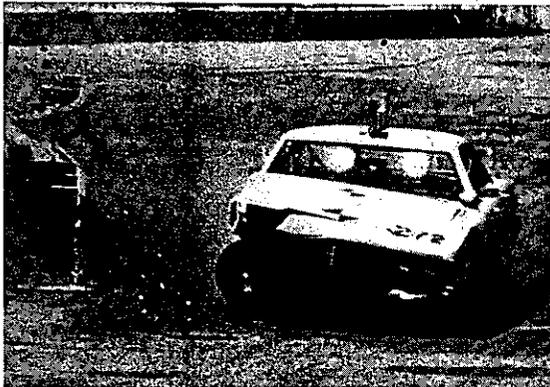
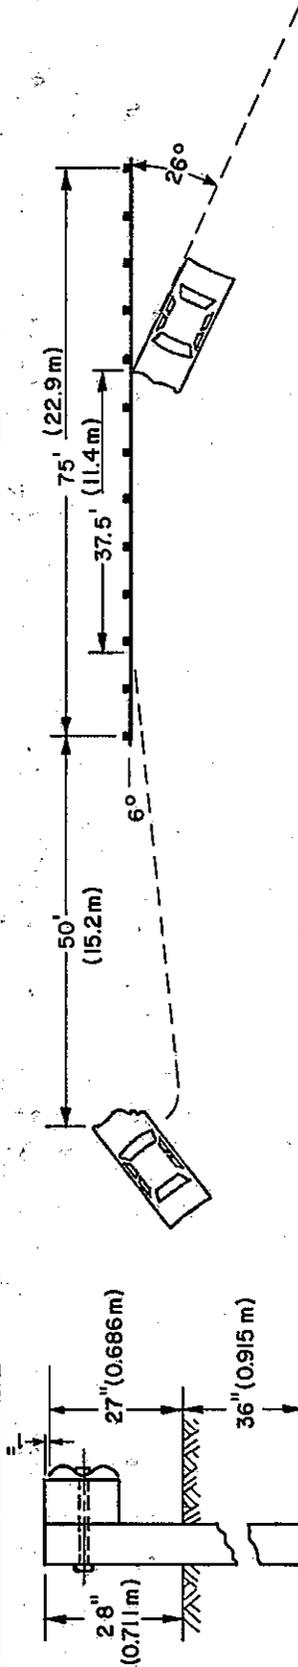
FIGURE 12, TEST 272

There was little rise or roll imparted to the vehicle during impact until it was nearly parallel to the barrier. Then the vehicle rolled away from the barrier about 15° and the right front end rose about 0.9 ft (0.274 m). The vehicle traveled smoothly through impact and had an exit angle of the vehicle c.g. of about 6° and an exit heading angle of 0° so that it stayed close to the barrier and almost parallel to it. Figure 12 shows sequential photographs of the impact event.

Principal damage to the vehicle included: a severely crushed right front bumper and fender, severe damage to the right front wheel, cracked windshield, crushed and jammed right front door, right door post torn loose at roof, and crimps in the roof on the right side. The car could not be driven away. There was no intrusion of vehicle parts or barrier components into the passenger compartment. Vehicle damage is shown in Figure 31 in Discussion of Test Results.

Two guardrail posts, #8 and #9, near the point of impact were destroyed and pieces of the posts and their blocks were splintered and broken and thrown behind the barrier. Two other posts, #4 and #7 and their blocks were split. The metal beam was partially flattened and raised near the area of impact. Maximum displacement of the posts at ground level was one foot. Table 5 in the Discussion of Test Results shows the post movement at ground level. Figure 22 in Discussion of Test Results shows the barrier damage.

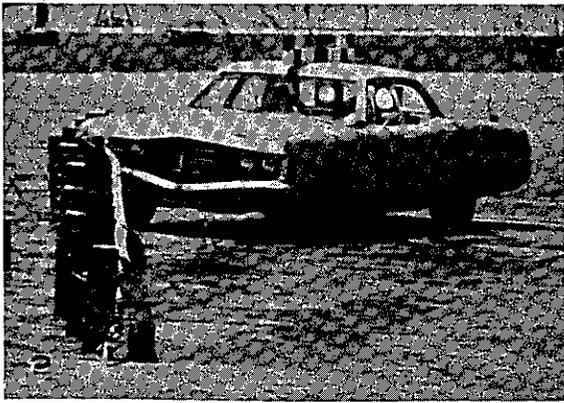
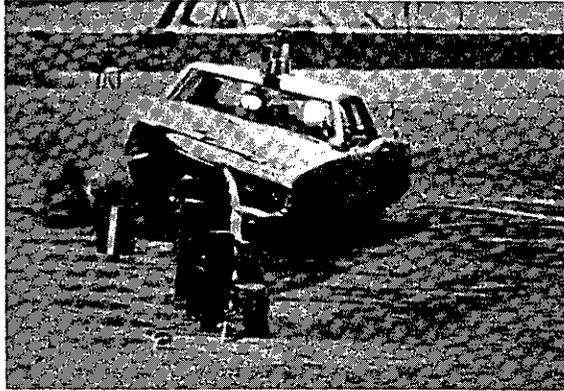
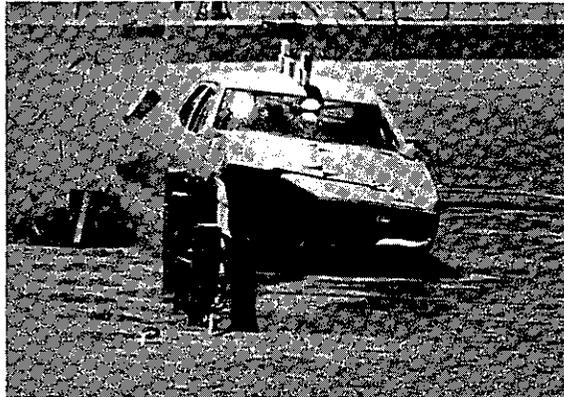
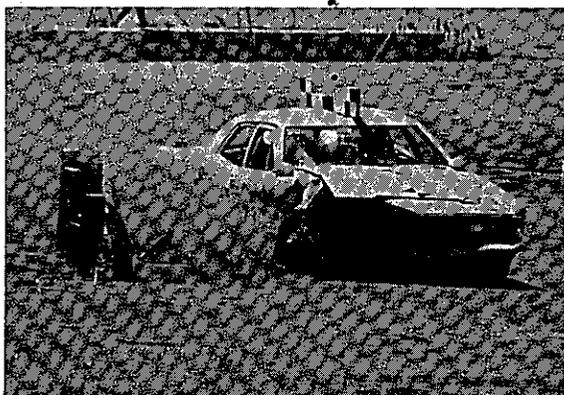
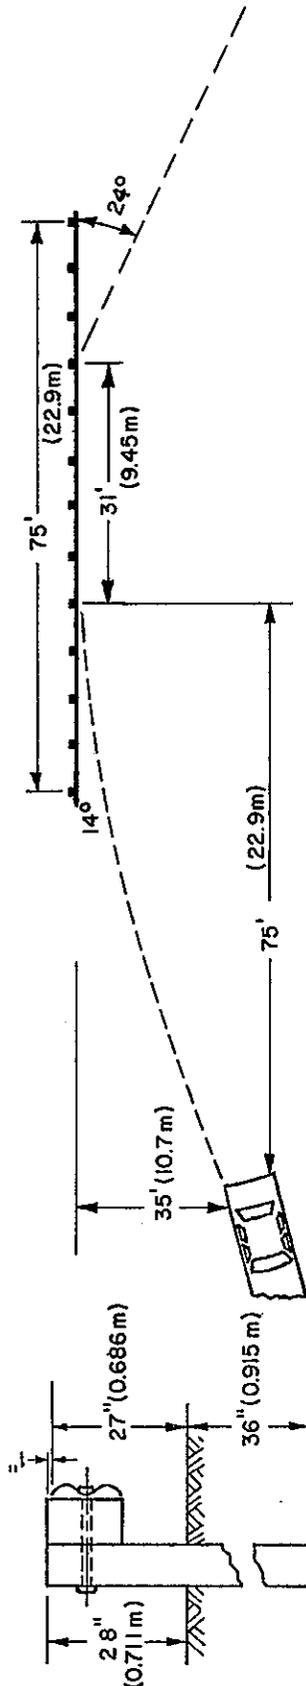
FIGURE 13, TEST 273

Vehicle behavior was very similar to that in Test 272. There was little rise or roll imparted to the vehicle during impact until it was nearly parallel to the barrier. Then the vehicle rolled away from the barrier about 15° and the right front end rose about 0.8 ft. (0.244 m). The vehicle traveled smoothly through impact. The exit angle of the vehicle c.g. was 14° which was the same as the exit heading angle of the vehicle. This angle gradually increased as the vehicle moved away from the barrier. Figure 13 shows sequential photographs of the impact event.

right door post torn loose at the roof. The car could not be driven away. There was no intrusion of vehicle parts or barrier components into the passenger compartment. Vehicle damage is shown in Figure 32 in Discussion of Test Results.

Two guardrail posts, #6 and #7, near the point of impact were destroyed. A third adjacent post, #8, was splintered and one post near each end of the barrier was split. Three blocks were broken and thrown behind the barrier along with some of the splintered post debris. The beam was partially flattened and raised near the area of impact. Maximum displacement of the posts at ground level was 1.65 ft (0.503 m) perpendicular to the barrier at post #5. Table 5 in the Discussion of Test Results shows the post movement at ground level. Barrier damage is shown in Figure 23 in Discussion of Test Results.

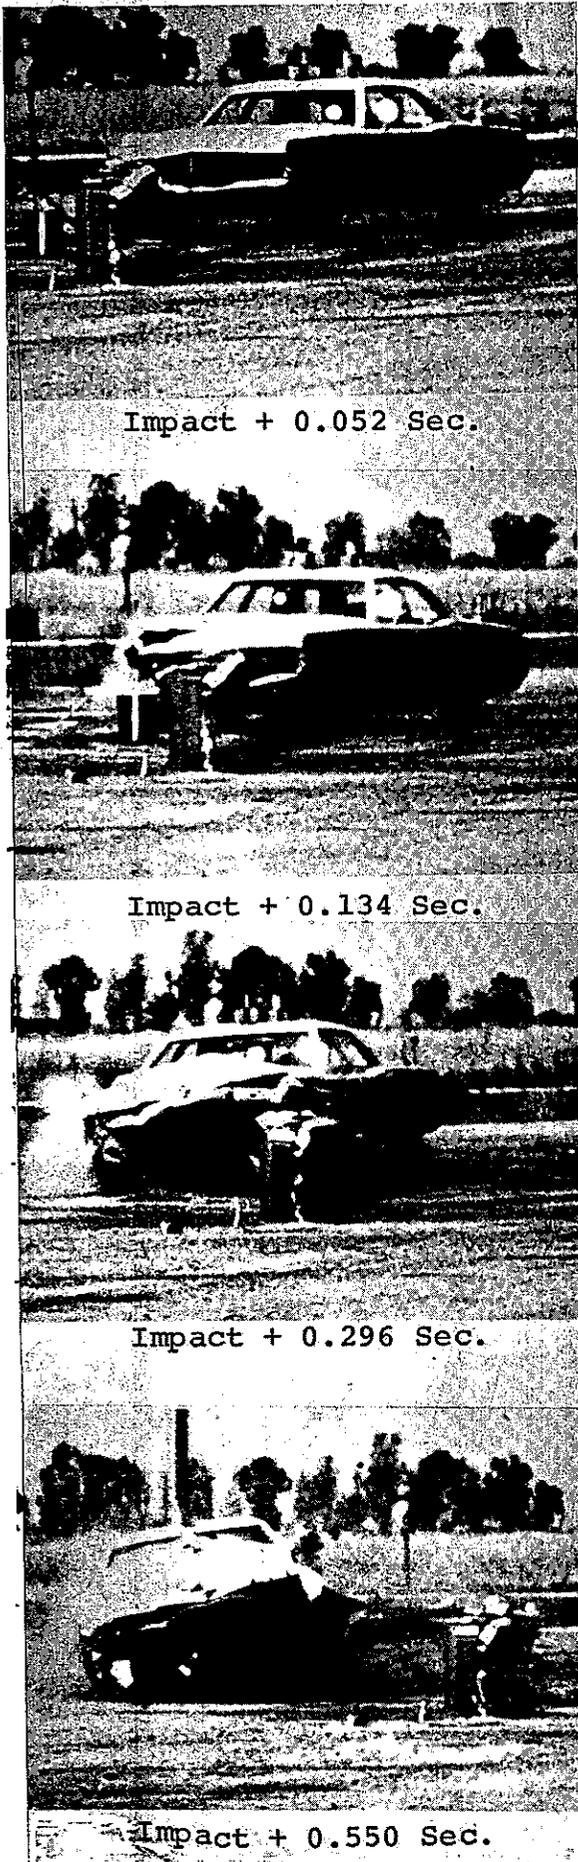
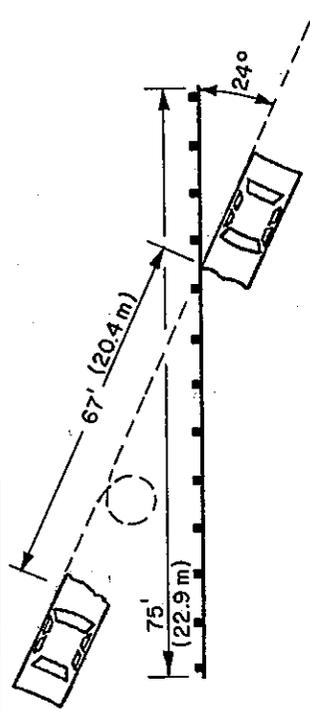
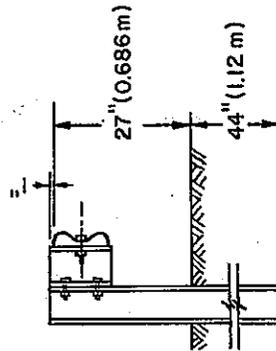
FIGURE 14, TEST 274

Principal damage to the vehicle included: severely crushed left and right front fenders and bumper, broken headlights, crushed hood, the engine moved upward about 12 inches (0.305m), the left front door jammed, and the left and right front tire movement were restricted. The car could not be driven away. There was no intrusion of vehicle parts or barrier components into the passenger compartment. No marks were apparent on the dummy or vehicle interior that would indicate a dummy to vehicle impact except for a five inch (127 mm) deformation of the steering wheel away from its original plane. The dummy was found lying on its right side on the car seat. The driver's seat back was broken. Vehicle damage is shown in Figure 33 in Discussion of Test Results.

Shearing of the "W" section beam occurred at the downstream edge of post #6 (posts numbered from upstream end). The beam was detached from post #6 and bent back around post #5. Two major bends occurred in the downstream segment: the first where post #7 had been attached and the second at the upstream edge of post #8. All 13 posts were twisted and displaced; post #1 was displaced 18 inches (0.457 m) downstream, and post #13 was displaced 15 inches (0.381 m) downstream. Posts #5, #6 and #7 were twisted and bent down near the ground about their minor axes with virtually no displacement of the posts in the ground. Slippage of the cable through five cable clips occurred at the upstream anchorage. These clips had been torqued to 50 ft-lbs (6.92 m-kgf) twice, including once on the day before the test. The bolt between the beam and block was sheared at posts #2, #3, and #12, and this bolt pulled through the beam at posts #5 #6, #7 and #8. At post #7 one bolt connecting the block to the post pulled through the flange of the block. The block at post #6 was buckled flat, and local buckling of block flanges occurred at several posts near impact. Barrier damage is shown in Figure 24 in Discussion of Test Results.

The barriers impacted in Tests 272, 273 and 276 all met the above requirements. There were no indications that the barriers were on the brink of failure. The barrier impacted in Test 274 was penetrated which was unacceptable. An analysis of that failure is described in a later section. Figures 22 through 25 show barrier damage for all four tests. Figures 26 through 30 show closeup views of posts near the impact area for Test 276. The backup plates at posts #4 and #8 clearly resisted excessive bending of the W-section beams at the posts. Samples of soil from the barrier test site were tested. A copy of the soil report is contained in the Appendix in Section D. This report indicates the soil was quite strong. It consisted of a layer

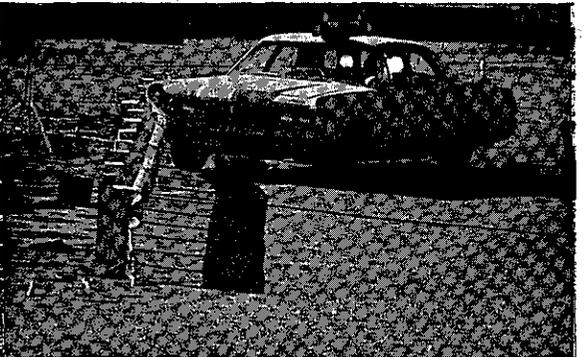
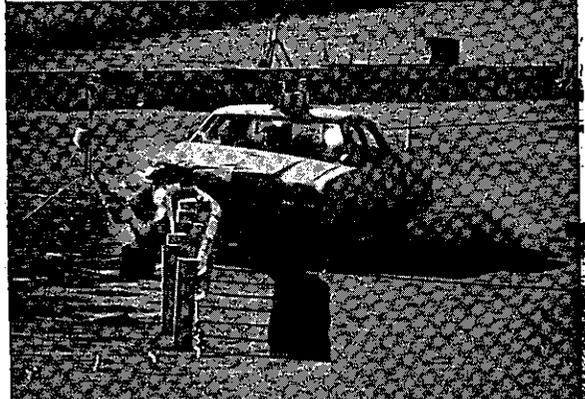
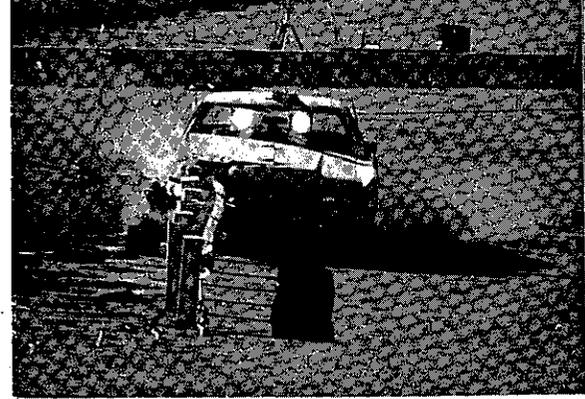
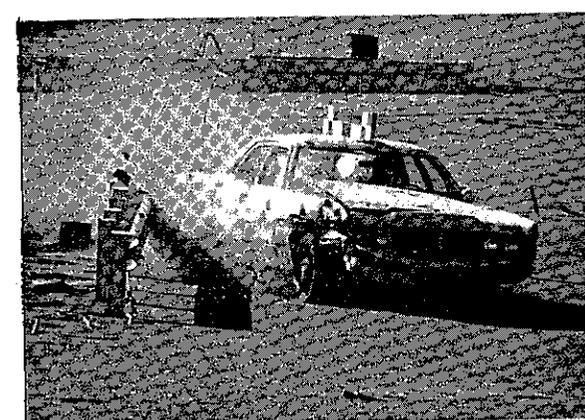
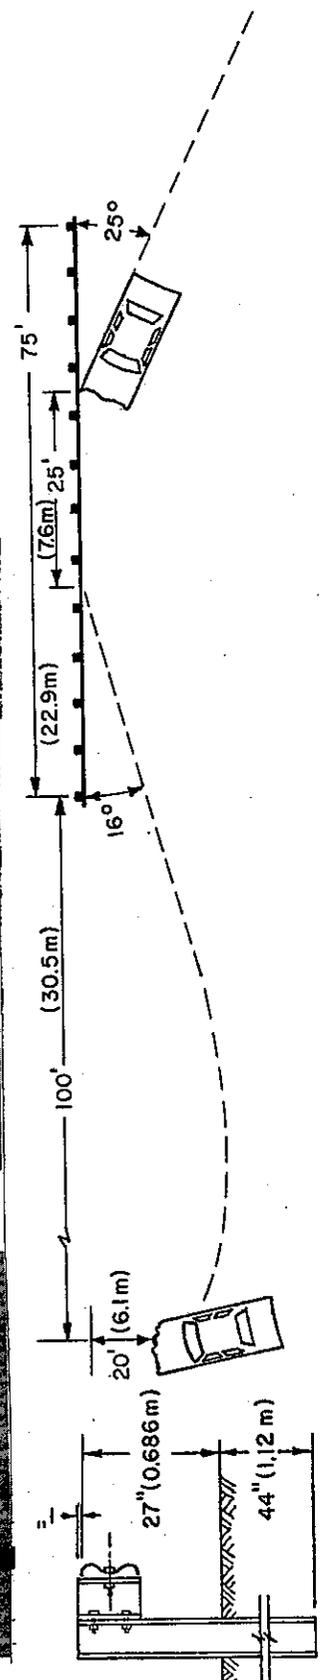
Principal damage to the vehicle included: severe crushing of the right front fender and bumper, jamming of the left and right front doors, damage to the right front wheel structure, and moderate crushing of the right rear fender. Vehicle damage is shown in Figure 34 in Discussion of Test Results.

Barrier damage consisted mainly of moderate twisting and bending of posts #5, #6 and #7 although none of the posts were bent to the ground. Separation of the metal beam guardrail from the steel post block occurred only at post #6. Severe buckling of the blocks occurred at posts #5, #6, and #7. A maximum of 3/8" (9.5 mm) slippage of a beam splice occurred at post #5. Minor twisting of the posts and blocks occurred at posts #4 and #8. Barrier damage is shown in Figures 25 through 30 in Discussion of Test Results.

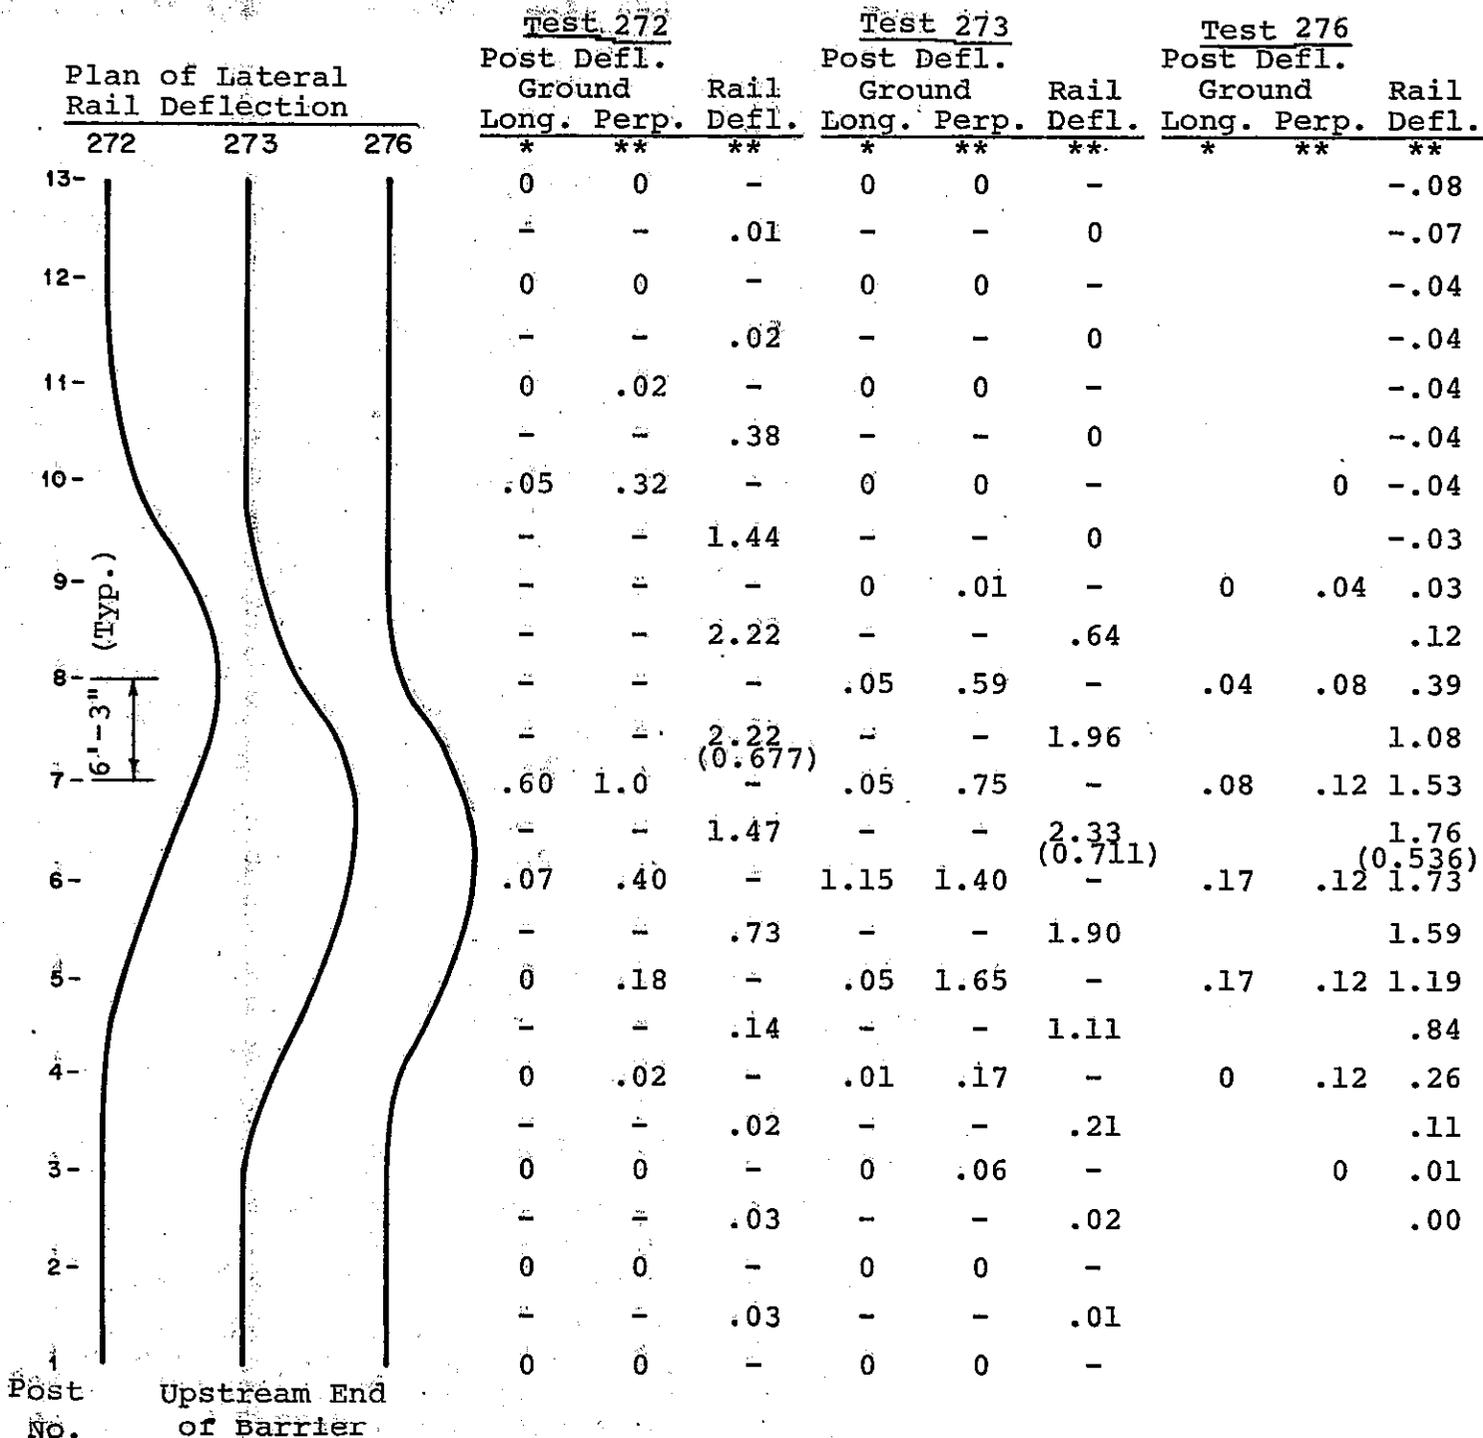
Table 5 shows the barrier rail and post deflections for Tests 272, 273 and 276. The diagram on Table 5 and Figures 22 through 25 show that the rail deflected in a smooth curve as desired. The figures also show the damage to the barrier posts at the area of impact.

The deflection of the rail in Test 276 is less than that for Tests 272 and 273 and may account for the relatively low longitudinal vehicle deceleration. Table 6 compares the barrier rail deflections of these tests with other test series. This table clearly shows that the permanent barrier rail deflections were in the same range as those recorded for previous test series. It should be noted that the vehicle kinetic energy at impact for Tests 272, 273 and 276 was appreciably higher than that for other tests in the table. Barrier damage in Tests 272 and 273 was very

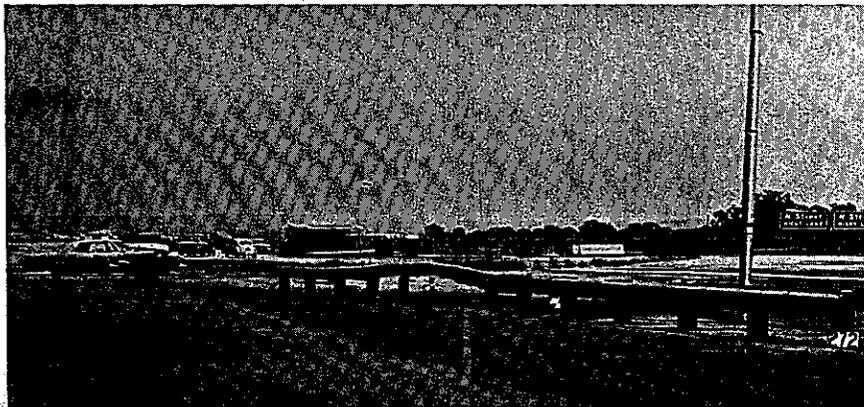
Figure 35, Test 272 Final Vehicle Location

Figures 35 through 38 show the test vehicles in their final position after impacting the test barriers. There is no easy answer to explain the variance in post impact trajectories. Various factors may have an effect including barrier deflection, vehicle crush and damage to the wheel, time when brakes are actuated by remote control, amount of rise and roll, paving surface condition, etc.

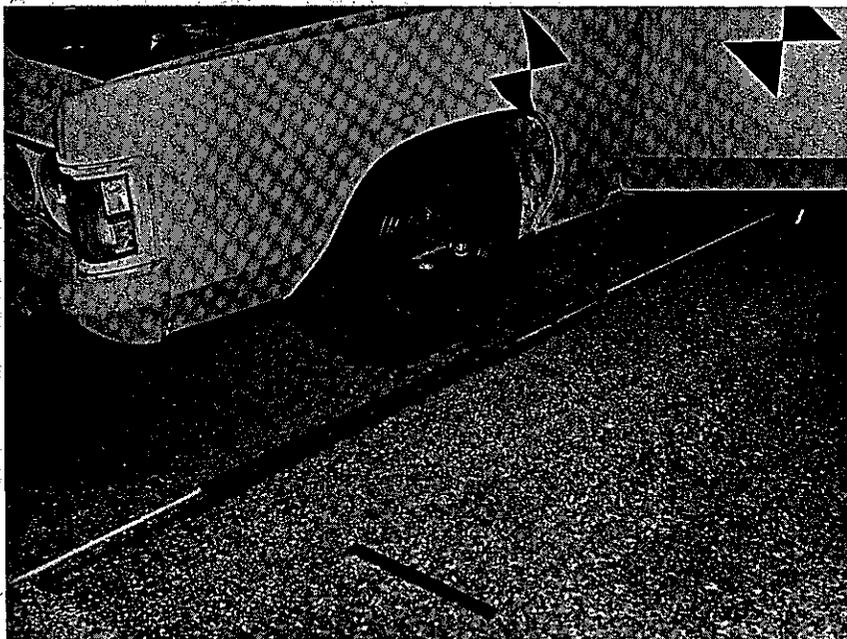
Figure 1A, Cable Guidance System Used in Test 276

For Test 276 the above procedures were followed except that instead of remote steering a cable guidance system was used to direct the vehicle into the barrier. The follow vehicle was used for remote braking. The guidance cable, anchored at each end of the vehicle path, passed through a pipe attached to a bracket on the left front wheel spindle of the vehicle. A steel angle driven into the ground near the barrier projected high enough to knock the bracket off the vehicle just prior to impact so that the vehicle was free of the cable. Figure 1A shows the guidance bracket attached to the vehicle.

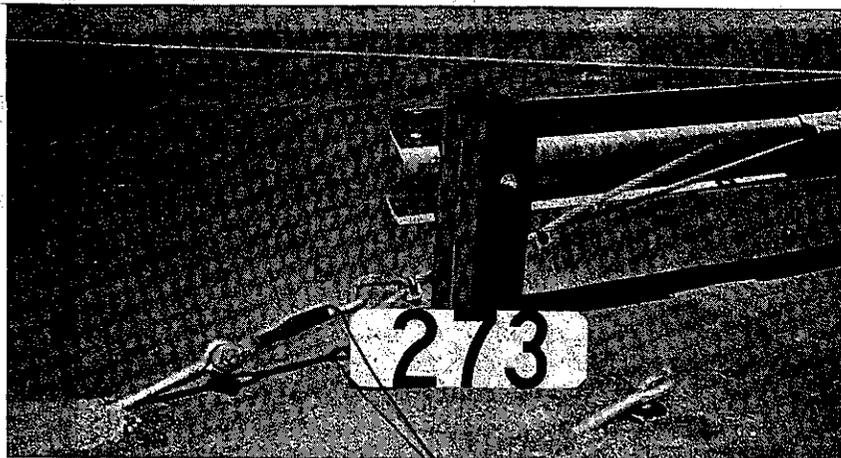
Figure 4A, Strain Gaged Clevis on Cable End

A strain gaged clevis was used on the upstream end anchor, Figure 4A, to measure loads in the cable for all four tests and in the downstream anchor for Tests 273, 274 and 276. Records from these strain gages are shown in Figures 16A and 17A.

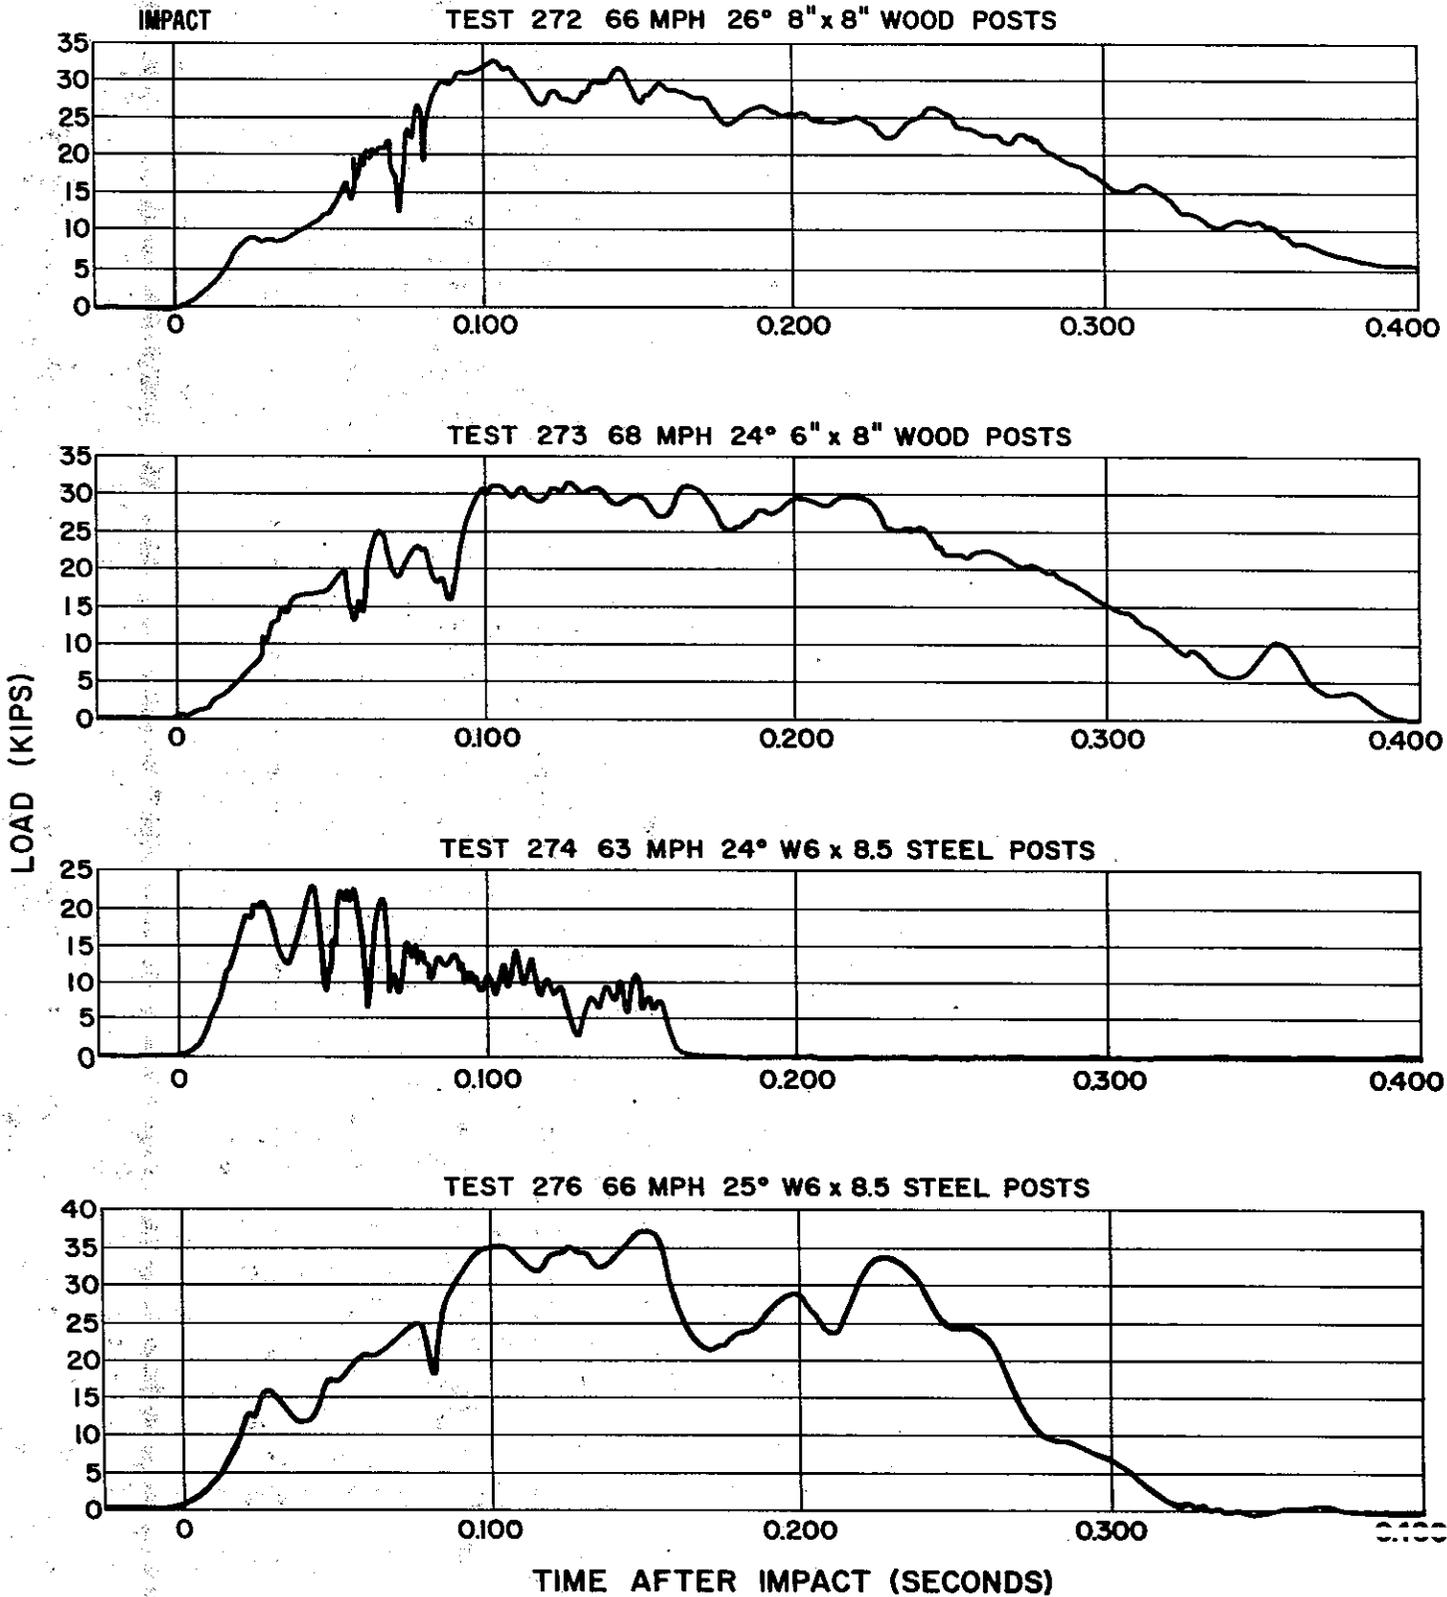
Figure 16A UPSTREAM ANCHORAGE LOAD VS TIME

<u>Time After Impact</u>	<u>Event</u> (Reference Figure 19A)
I (Impact) + 0 to I+25 (milliseconds)	The rate of onset of load in the upstream cable is much higher for steel posts than wood posts. (Figure 16A). The wood posts, possessing much higher torsional rigidity, help the cable anchor carry the load.
I + 25 to I + 50	Upstream cable slips slightly, say 1"± (2.5 cm), due to the high rate of onset. The loss of tension in the W-section decreases its beam strength - the compressive bending stresses exceed the tensile cable stresses allowing the beam to buckle at post #5. Because of this hinge, post #5 is not moved (perpendicular to rail) prior to being impacted by the car.
I + 50 to I + 60	Post #5 is solidly hit by the car. The upstream cable slips drastically.
I + 60 to I + 80	The upstream posts are bent severely as they attempt to carry the tension in the upstream beam. The downstream anchor carries tension in accordance with the tension carried by the upstream posts.

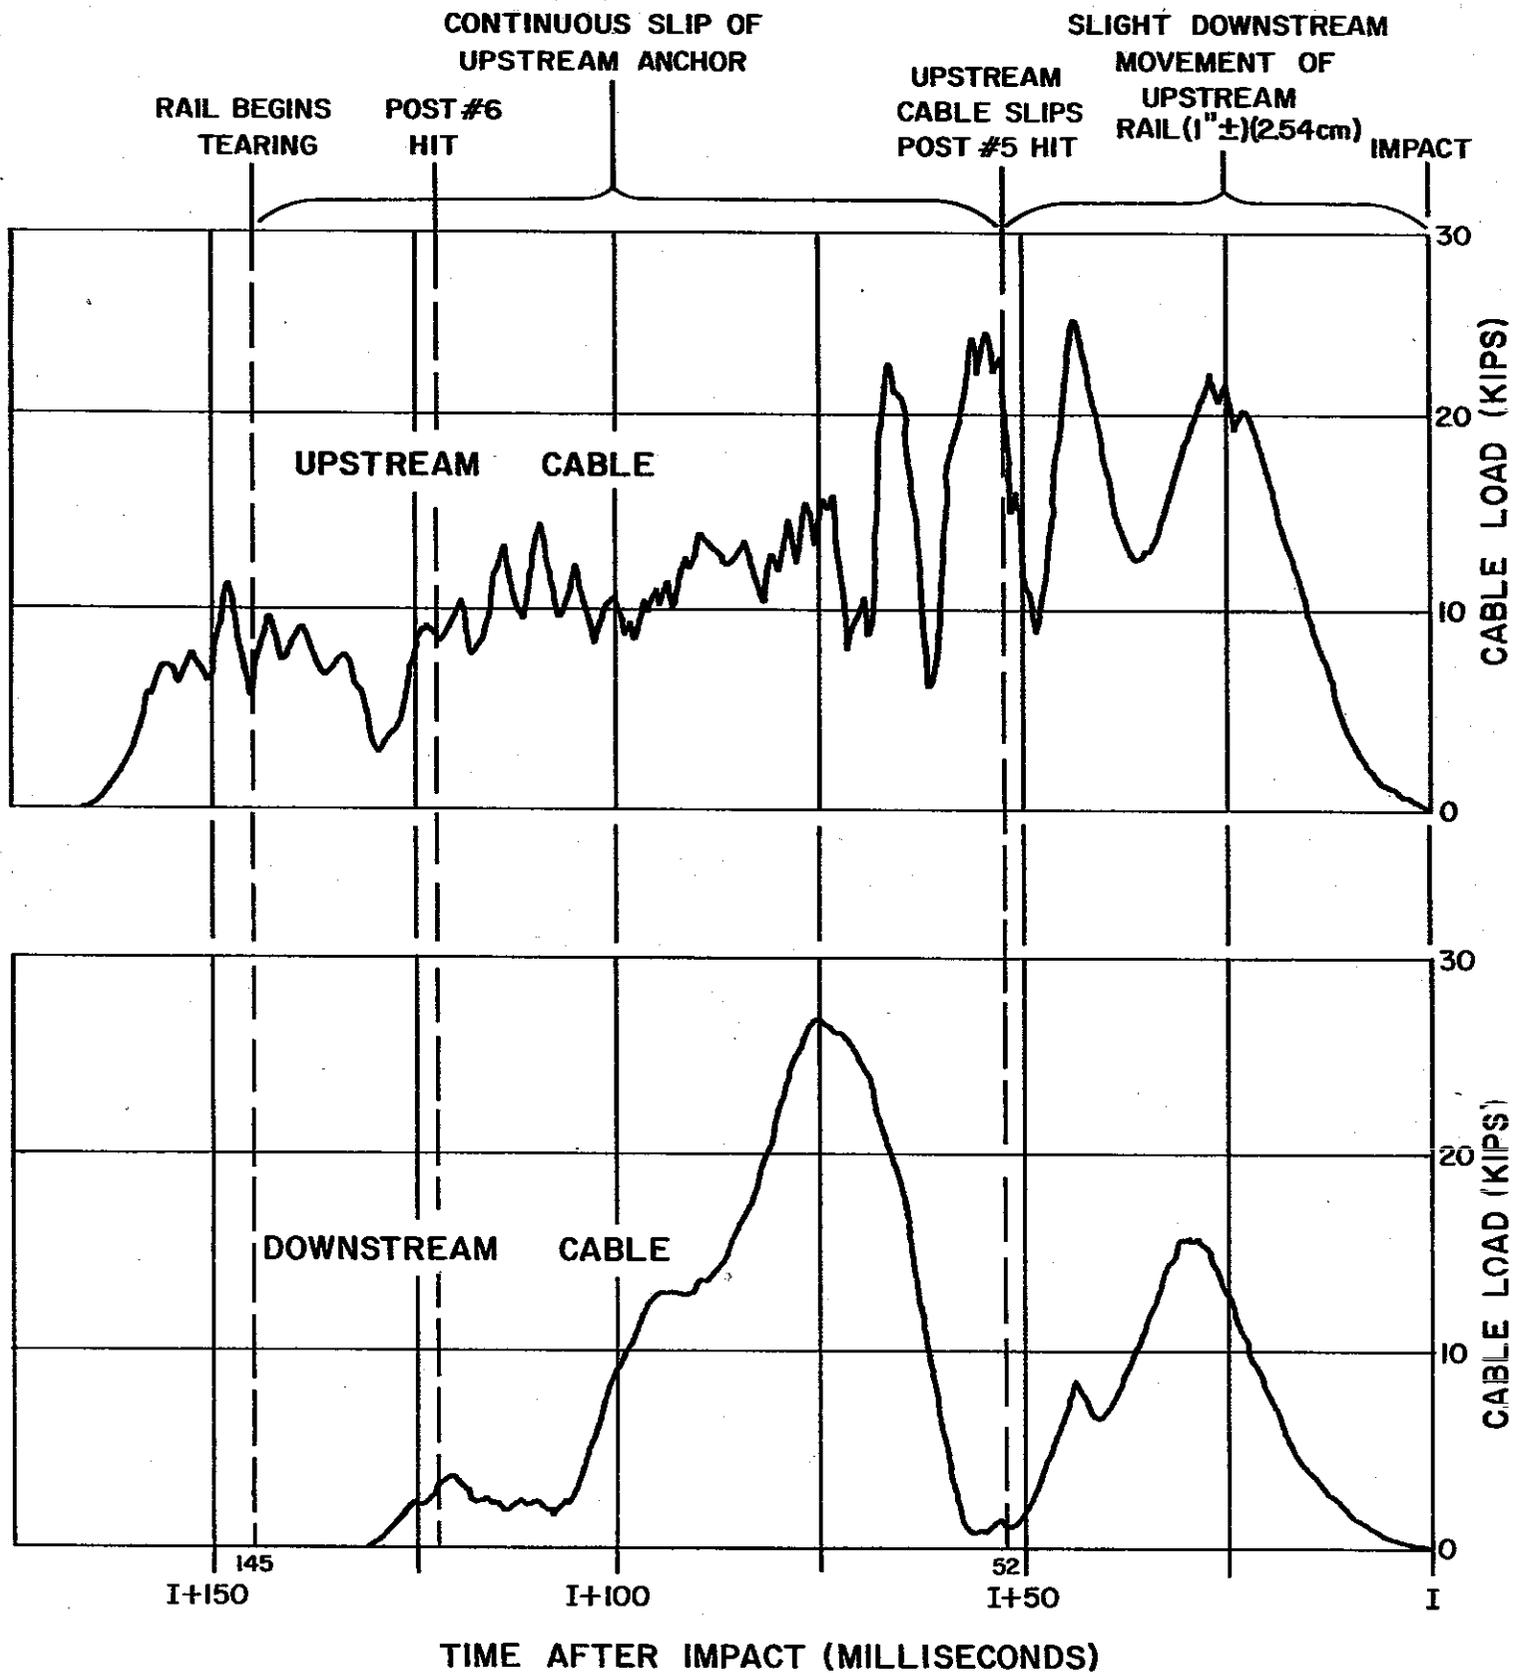
FIGURE 19A, TEST 274

The following analysis is made with reference to Figure 19A which shows load vs. time of the end anchor cables during impact and events observed on the data movies at the specified times. Figure 20A also relates to this analysis.

I + 80 to I + 120	Rail has pocketed so far that car is tending to push rail downstream. Upstream anchor continues to slip.
I + 120 to I + 150	Post #6 is solidly hit by car. At upstream end, the bolts connecting the W-section to the blockouts are sheared off (or torn through rail).
I + 150	Rail is under engine compartment of car when it tears at the <u>downstream</u> face of post #6 (Figure 18A).
I + 205	Car hits post #7 which pushes the remaining portion of the downstream rail downstream.

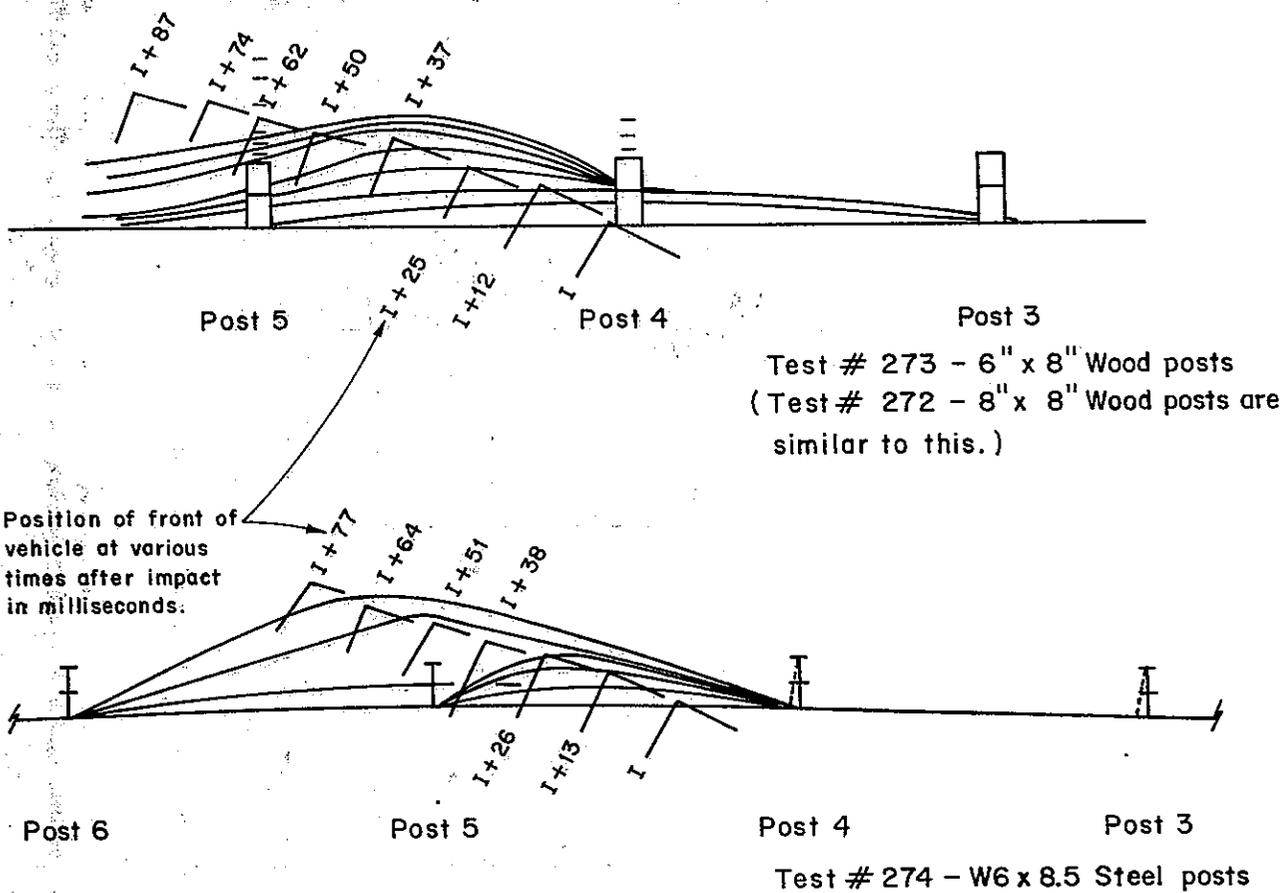
FIGURE 20A

1. Buckling of the blockouts did not occur prior to failure.
2. The steel posts did not move prior to being impacted. The wood post in our Tests 272 and 273 and the steel posts in Southwest Research Test #120 did move prior to impact[3]. (Figure 20A)

These are tracings from overhead camera #2, as viewed on the Vanguard Motion Analyzer. Note that the steel posts do not move prior to being impacted by the car.
