FHWA/CA/TL-80/17

Roadway Damage During The San Fernando, California, Earthquake Of February 9, 1971

February 1981

Office of Transportation Laboratory
California Department of Transportation
Sacramento, California 95819

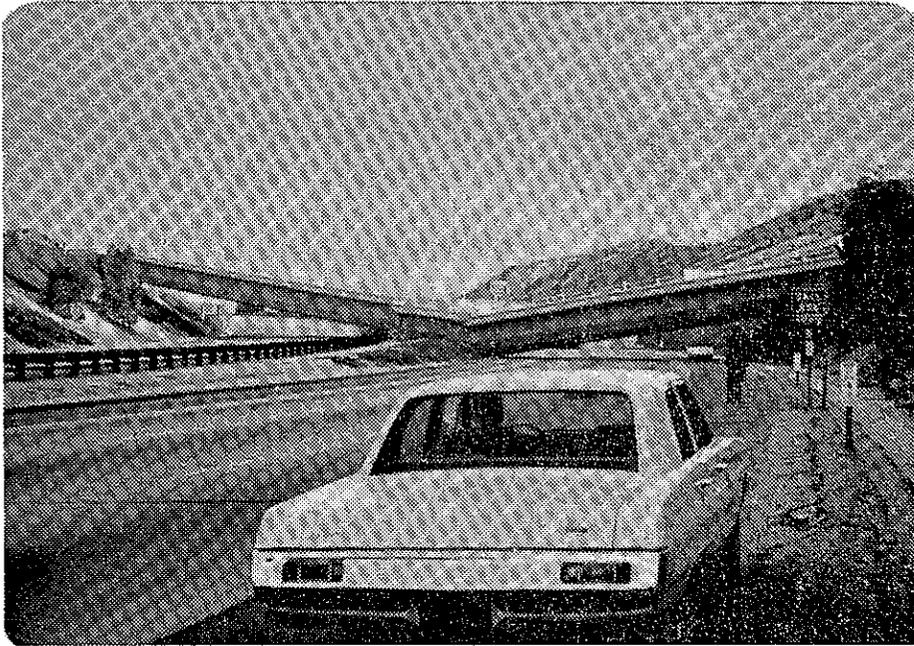
The most notable damage in the separation area was the collapse of the Route 5 southbound truck freeway bridge over Route 405 as shown in Photos 6, 7 and 8. A discussion of bridge damage may be found in Reference 5.

Photo 7. Looking northerly at the collapsed Route 5 southbound truck freeway bridge over Route 405.

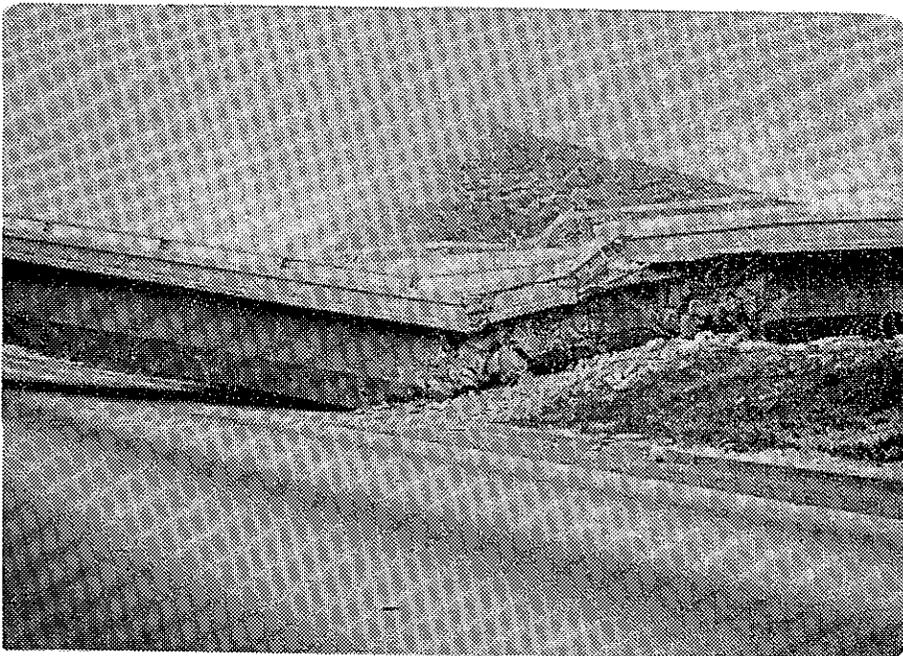
Photo 8. The center portion of the collapsed Route 5 southbound truck freeway bridge.

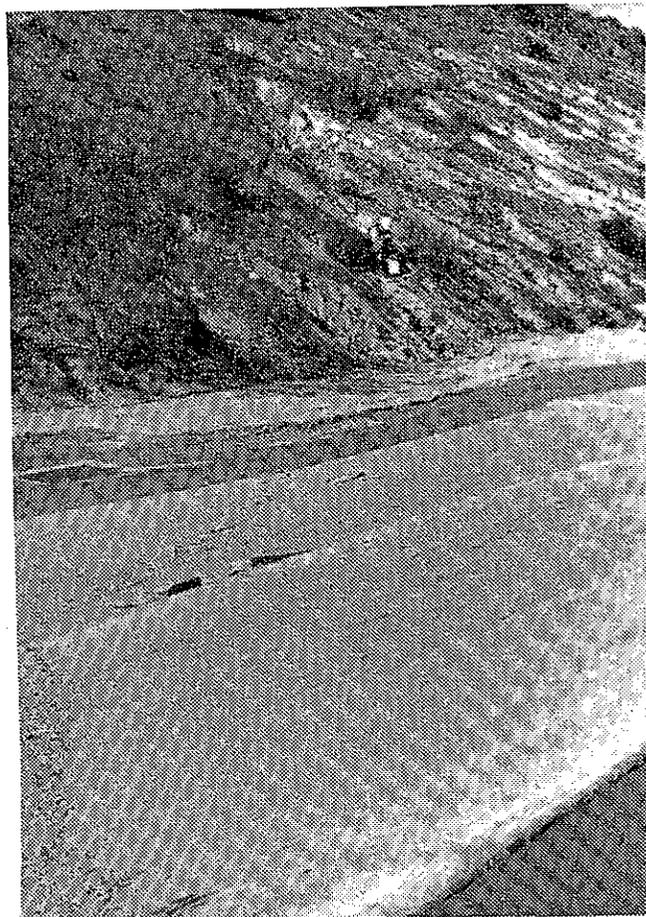
Faulting occurred at this location in an east-west trend through the dark patch across Route 5 shown in Photo 6, upper right. The faulting is shown in more detail in Photos 9, 10, and 11. Two feet of reverse fault displacement, north over south, occurred. The writers believe the faulting continued in a westerly direction across Route 405 in a zone several hundred feet wide (see Ref. 2, p. 19, Item 6).

Photo 10. Looking westerly across truck lane pavement. Fault trace extended up cut slope in background.

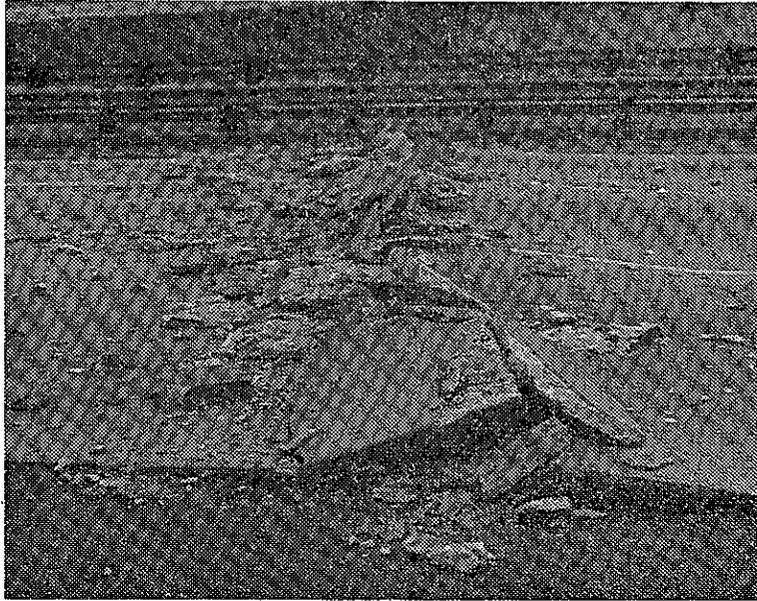
Undulations of the pavement, either visible or detectable when riding over the zone, were noted. Photo 12 is a southerly view of Route 405 across this zone. Immediately to the west of the photo a one-half foot rise in the ground was noted, northside up, but an actual break could not be found. A detail of the pavement buckle in the center of the photo is shown in Photo 13.

Photo 13. Looking westerly across northbound lanes of Route 405. Pavement break is on a general projection of nearby fault trace mapped by authors.

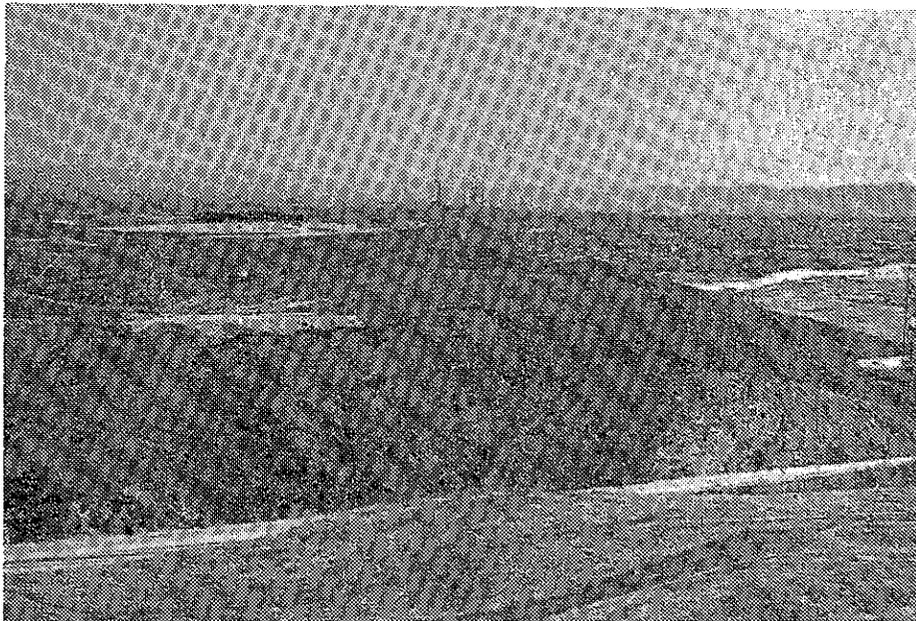
An earthquake-induced slump failure occurred at this location in a cut slope, shown in the center of Photo 14. The failure was confined entirely to the upper three-fourths of the 100-foot high cut.

Photo 14. Looking westerly across Route 5. Note slide in cut slope.

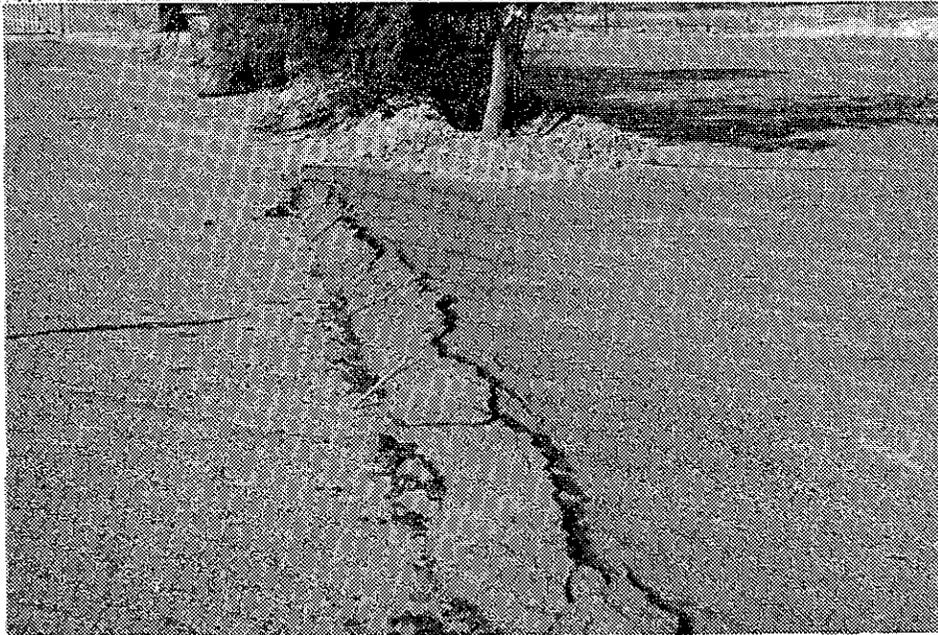
Paved grounds of the Caltrans' maintenance yard immediately east of the slide suffered various amounts of pavement breakage. An example is shown in Photo 16 which illustrates a one-foot thrust of pavement, north over south. Another compressional feature was noted across Blucher Avenue, south of the slide where the roadway enters a cut section (Photo 6); however, details of the feature were not recorded.

Photo 16. Looking westerly at maintenance station parking area. Note pavement breaks and thrusting of north over south.

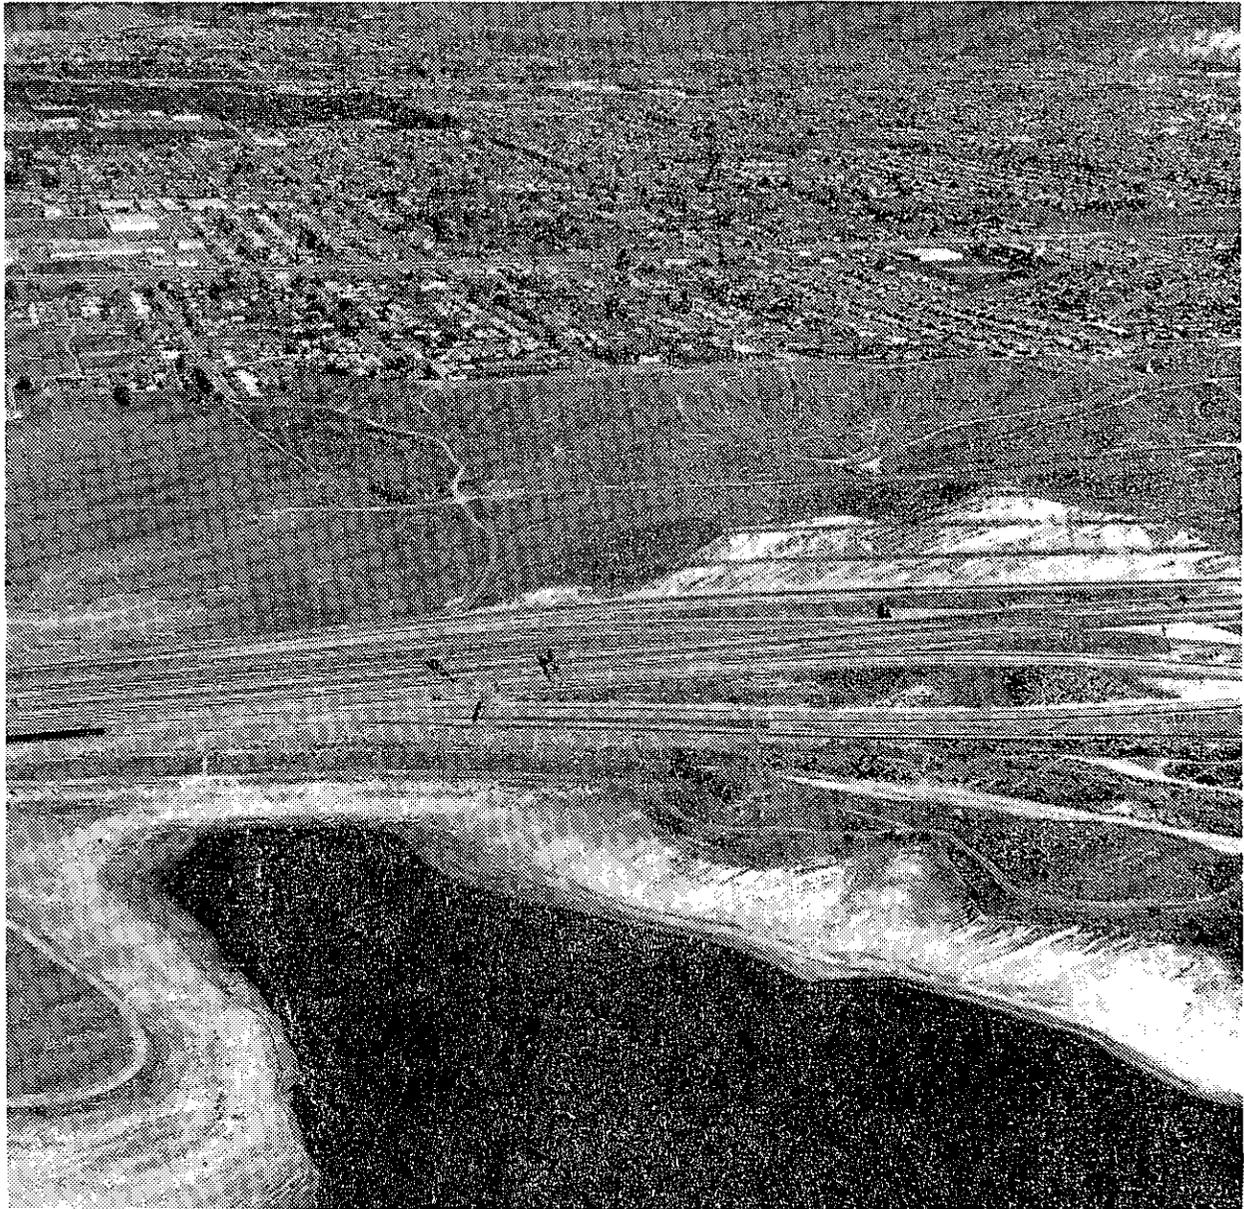
Immediately north of the 5/405 separation, the roadway crosses a canyon on about 45 feet of fill as shown in Photo 17. The embankment, founded on saturated, relatively weak fine-grained alluvial deposits, experienced vertical and lateral movement due to the foundation soil behavior. Cracking in slopes on both sides of the fill (Photos 18 and 19) suggest that much larger movements typical of foundation failures would have occurred had strong motion been of a longer duration. Vertical movement resulted in pavement slab displacements as shown in Photos 20 and 21.

Photo 17. Looking northeasterly at Route 5. Note roadway embankment and pavement patches in left center of photo.

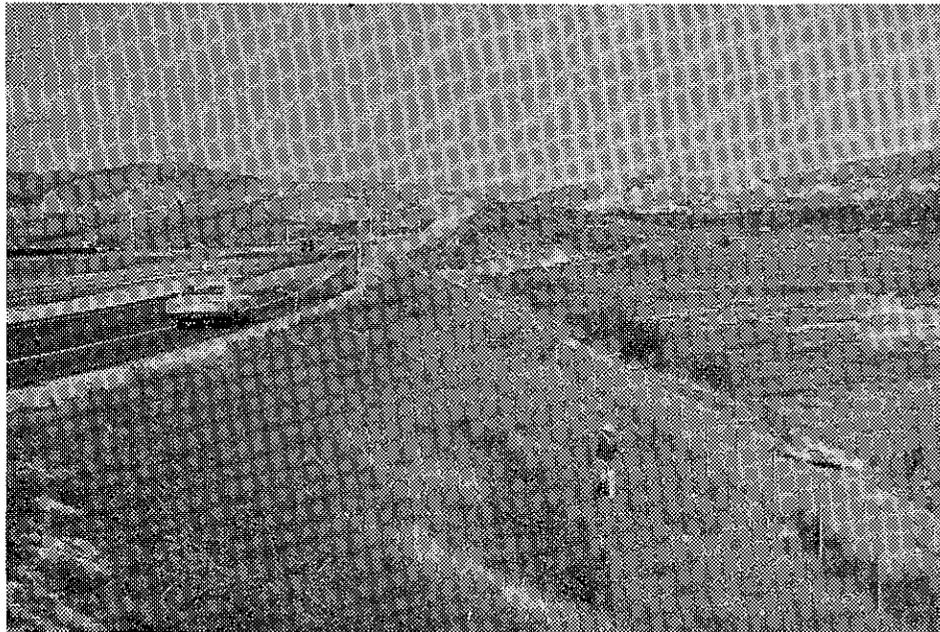
Photo 18. Looking northerly along easterly slope of Route 5 embankment.

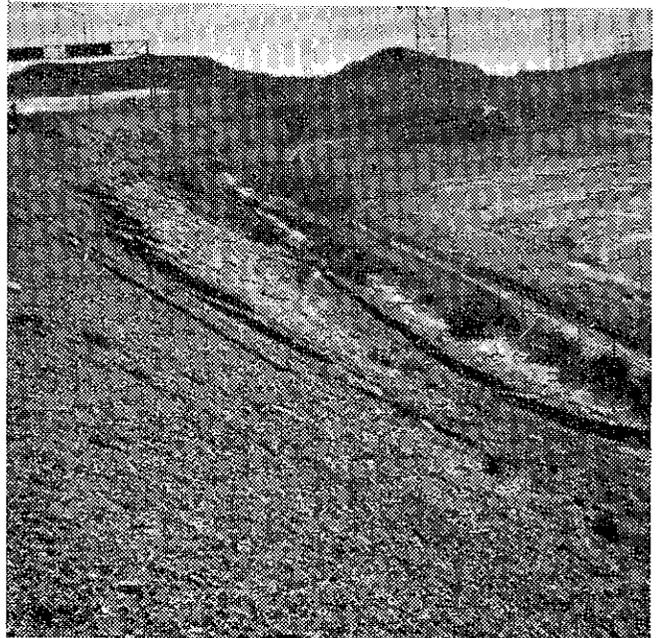
Photo 19. Looking south at westerly slope of embankment. Note cracks and lateral movement in slope.

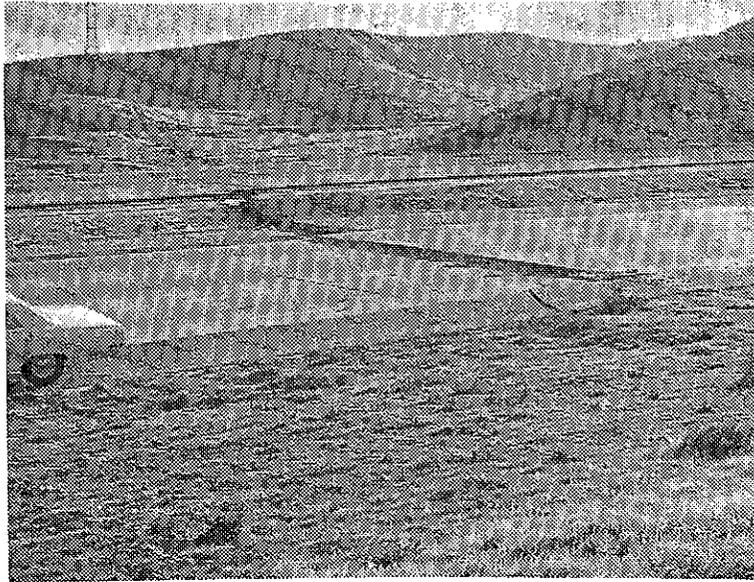
Photo 20. Vertical displacement along pavement slab joints near fill/cut contacts.

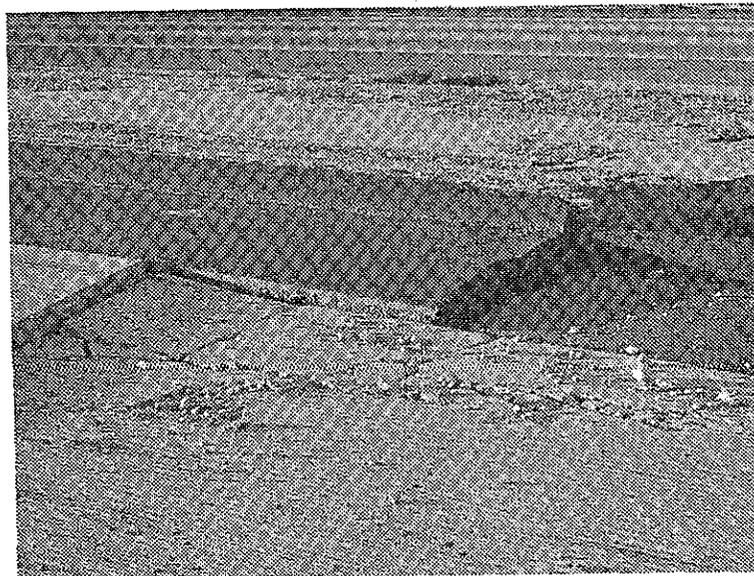
Concrete pavement slabs were thrust together near the south cut-fill contact as shown in Photos 22 and 23, as well as being separated along the same contact shown in Photo 21. Longitudinal separation occurred between pavement slabs due to fill lateral movement as shown in Photo 24.

Photo 21. Vertical displacement along pavement slab joints near fill/cut contacts.

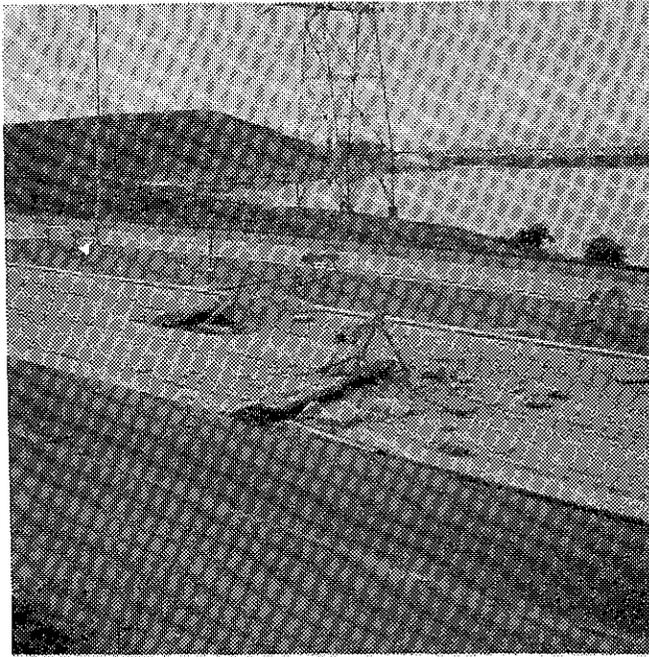
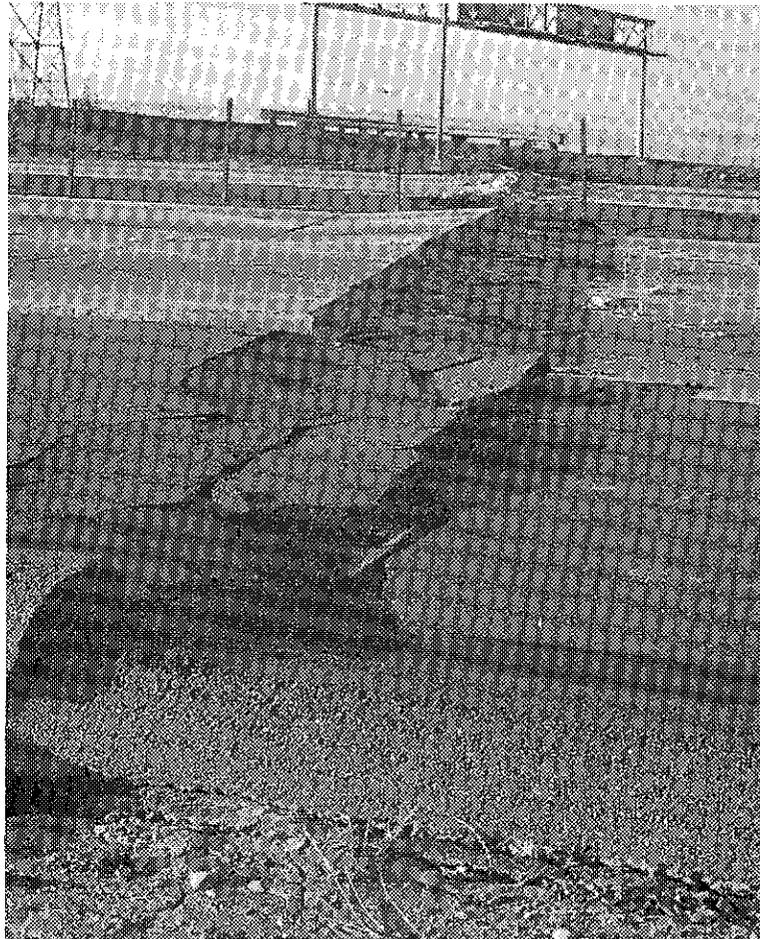
Photo 22 and 23. Breaking and overriding of pavement slabs at transverse joints due to longitudinal thrusting action.

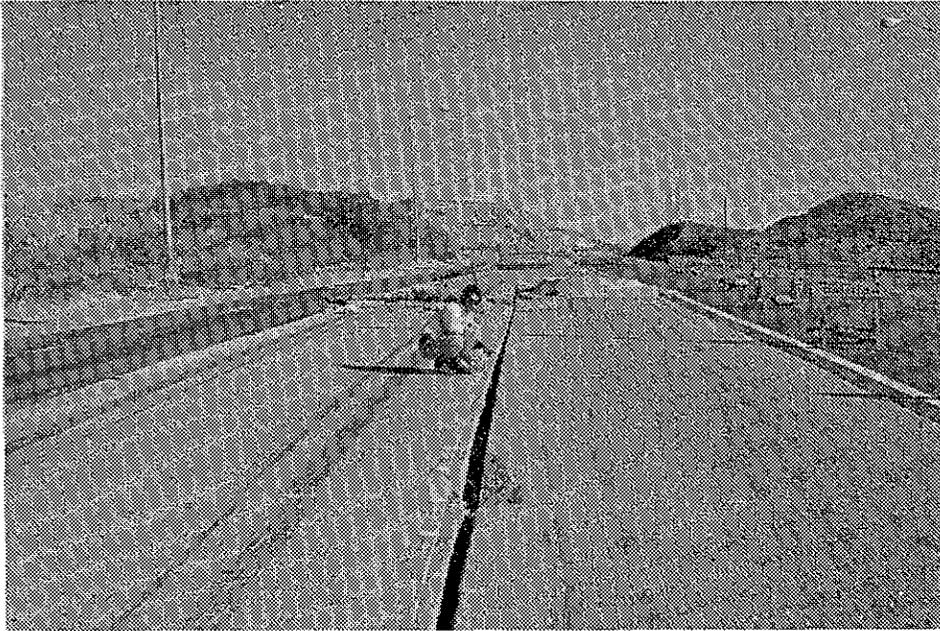
Photo 24. Slab separation along longitudinal joint due to lateral fill movement.

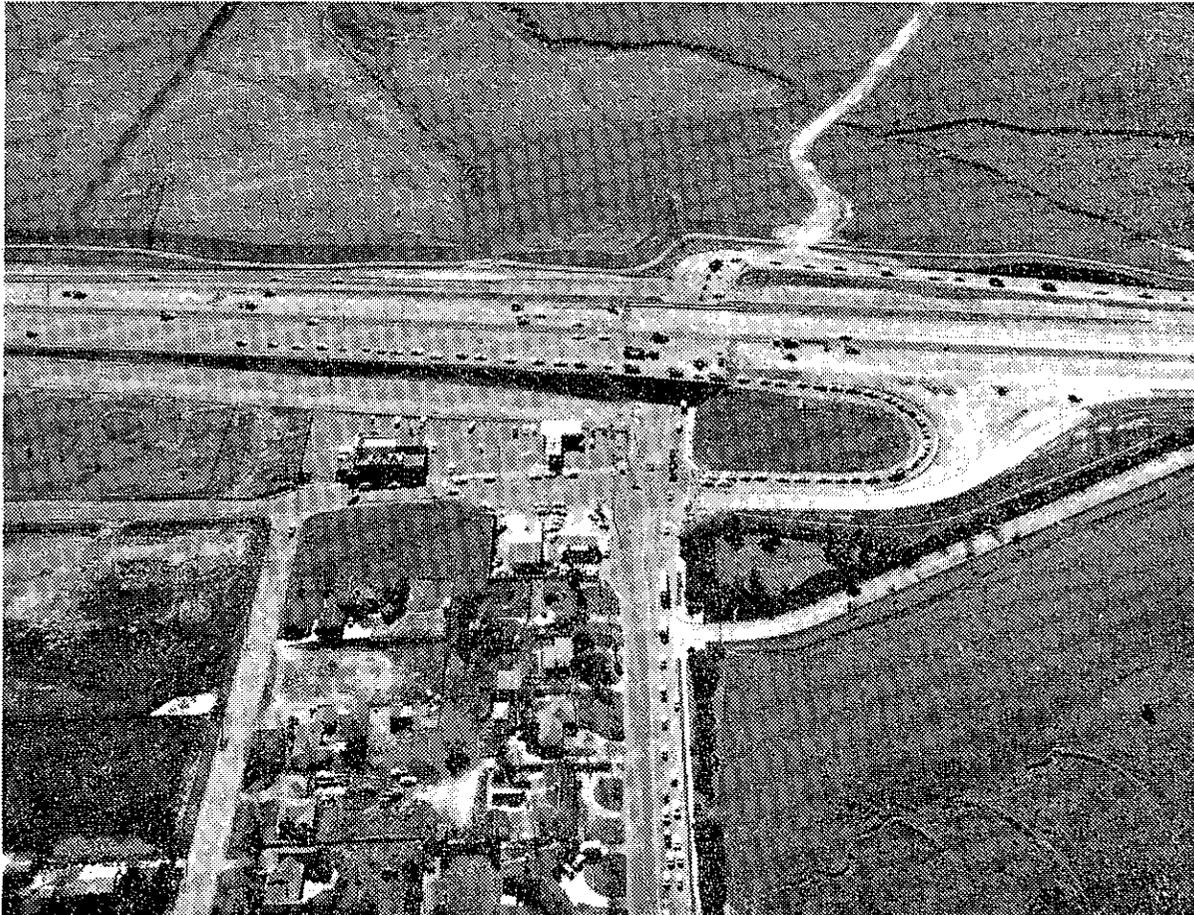
At the time of the earthquake a bridge widening project was under construction at the Roxford Street Interchange, shown in Photo 33. In addition to structural damage shown in Photos 34 and 35, settlement occurred in approach fills and structure backfill shown in Photo 36.

Photo 33. Looking westerly at the Route 5/Roxford Street Interchange.

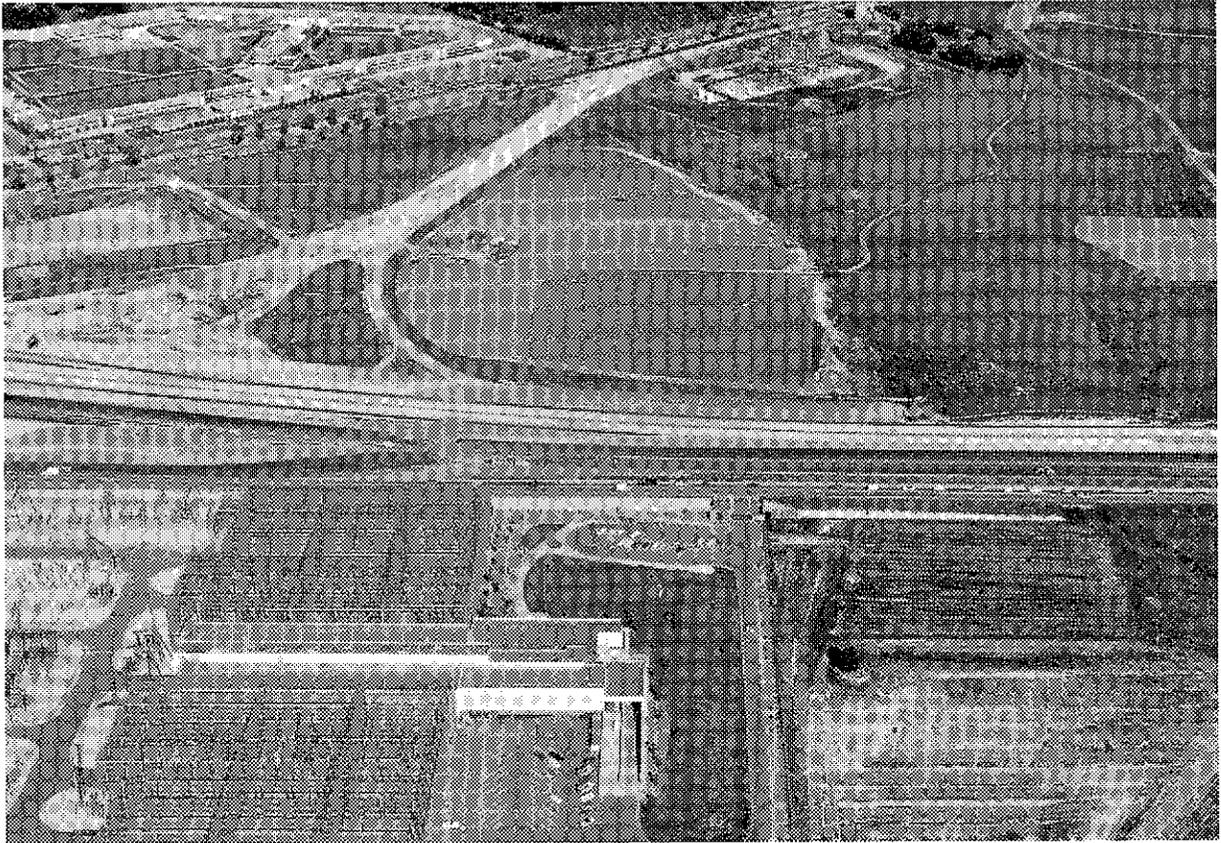
Roadway settlement of a few inches occurred at the cut to fill contact shown in Photo 37, right of center. A low fill crosses the drainage-way that follows the alluvium contact with a slight hill made up of bedded sediments. From this location, the roadway is essentially constructed along the natural ground profile for a 1/4-mile distance, northward.

Photo 37. Looking easterly at Route 5. The Sylmar Converter Station is shown in lower left. Juvenile Hall complex is shown in middle left.

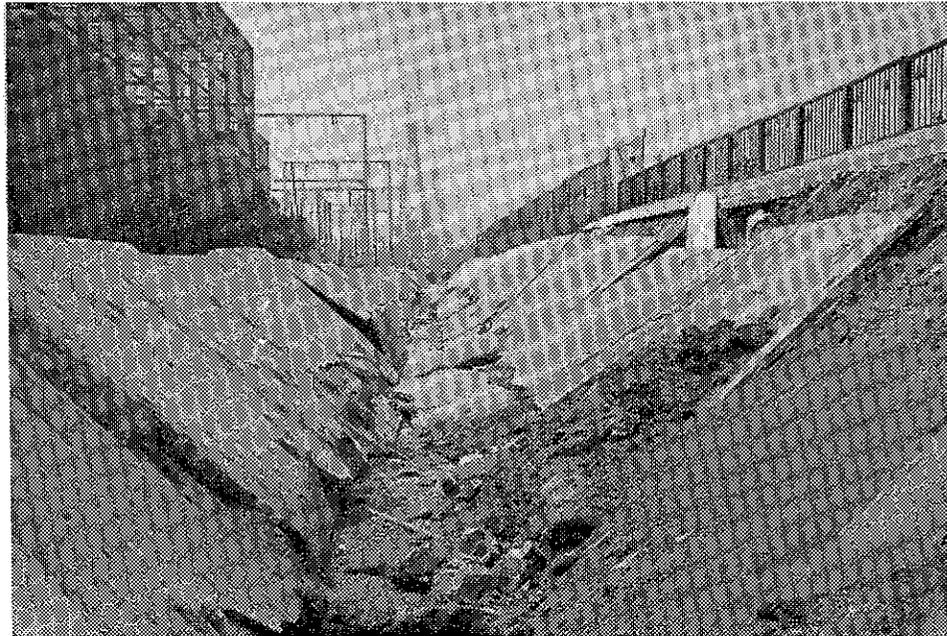
Photo 41. Looking north along concrete lined drainage channel between Route 5 (right) and the Sylmar Converter Station (left). Lateral movement of Juvenile Hall slide (right to left) was largely absorbed by the channel.

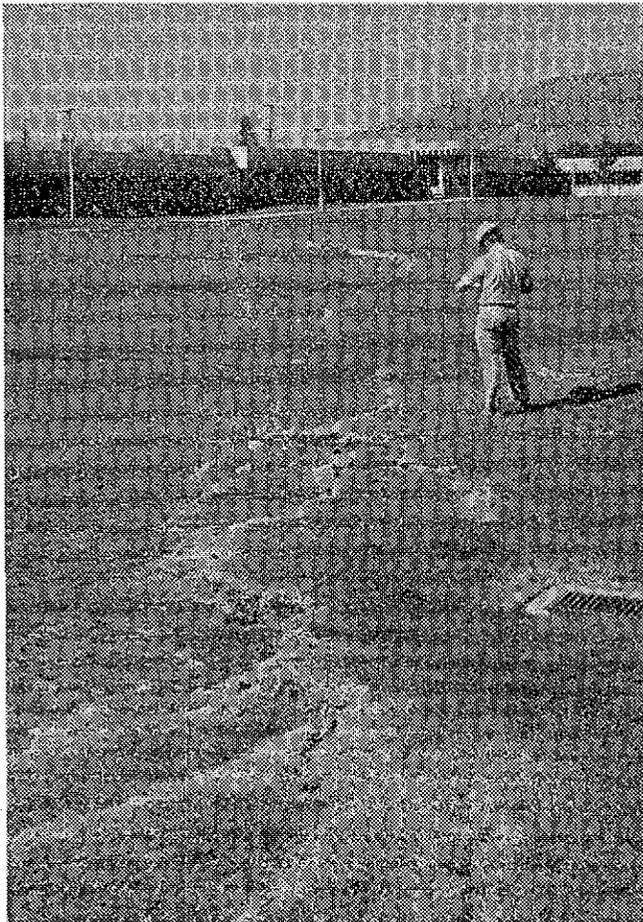
Photo 43. Northern flank of slide, viewed from inside Juvenile Hall complex.

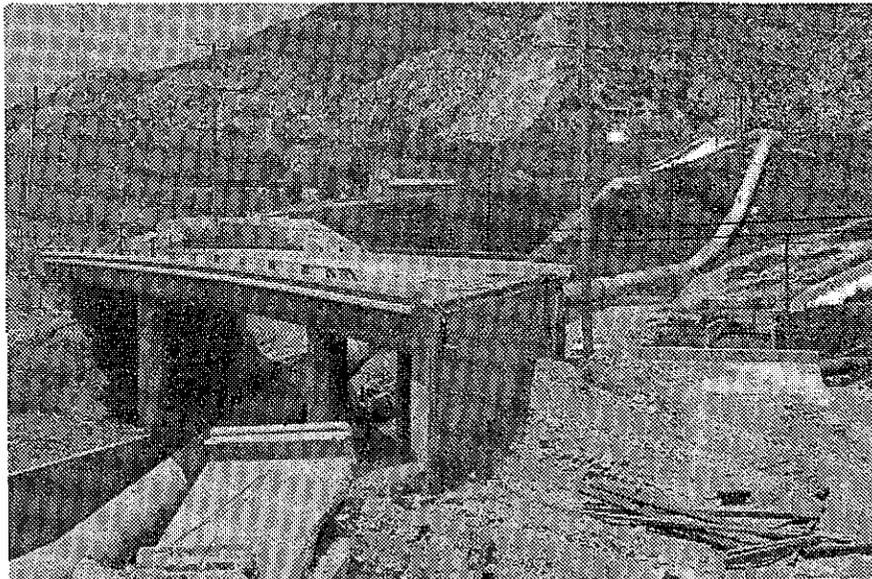
Foothill Boulevard crosses the northerly end of the aqueduct structure (Bridge No. 53-1011) on about 22 feet of fill above the deck, and then, proceeding northwesterly, immediately crosses the penstock on Bridge 53c-316 (extreme left center of Photo 44). A closer view of the two structures is given in Photo 51. Shortly after the earthquake, fill material was removed from the deck of Br. 53-1011 to relieve stress on the sheared deck of the structure. Photo 52 is a view of the deck soffit, the portion that was overlain by about 22 feet of fill.

Photo 51. Looking northeasterly at Bridge 53c-316 which carries Foothill Boulevard over the penstock. Immediately to the right of the bridge, the uncovered deck of the aqueduct structure, Bridge 53-1011, is visible.

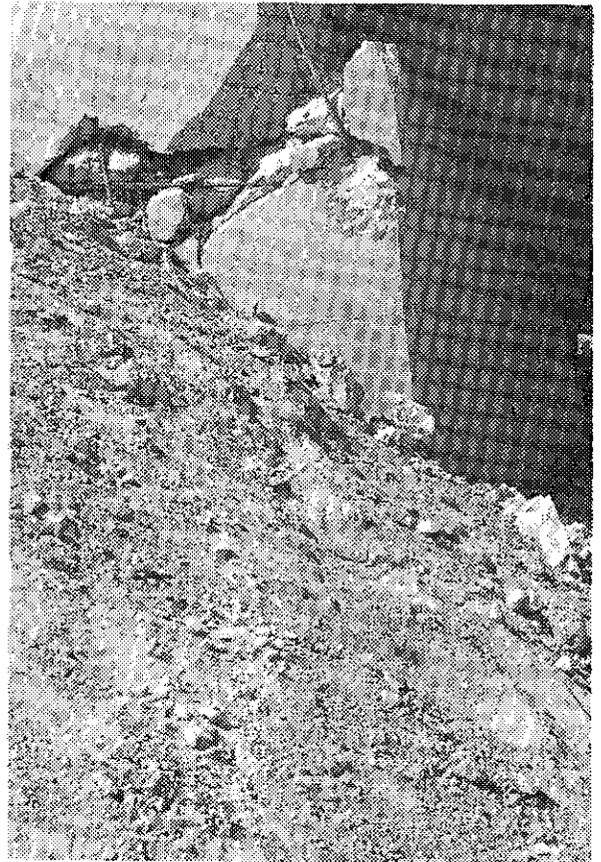
The westerly approach was constructed in cut section with both the bridge abutment and wingwalls founded on spread footings. Backfill at the paving notch settled several inches, while the bridge deck and wingwall remained in essentially the same place, as shown in Photo 55. The abutment failed in shear and rotation about a horizontal axis as shown in Photo 56 and tended to arch the deck as can be seen along the neat line of the concrete guardrail shown in Photo 57.

Photo 56. Damaged westerly abutment of Balboa Boulevard Overcrossing.

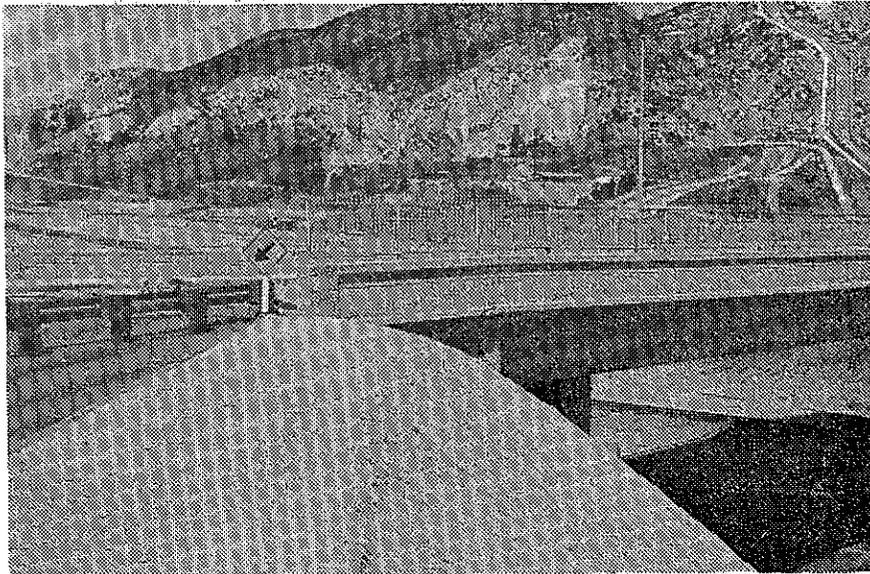
Photo 57. Looking northeasterly at westerly abutment of Balboa Boulevard Overcrossing. Note slight arch in structure caused by abutment movement.

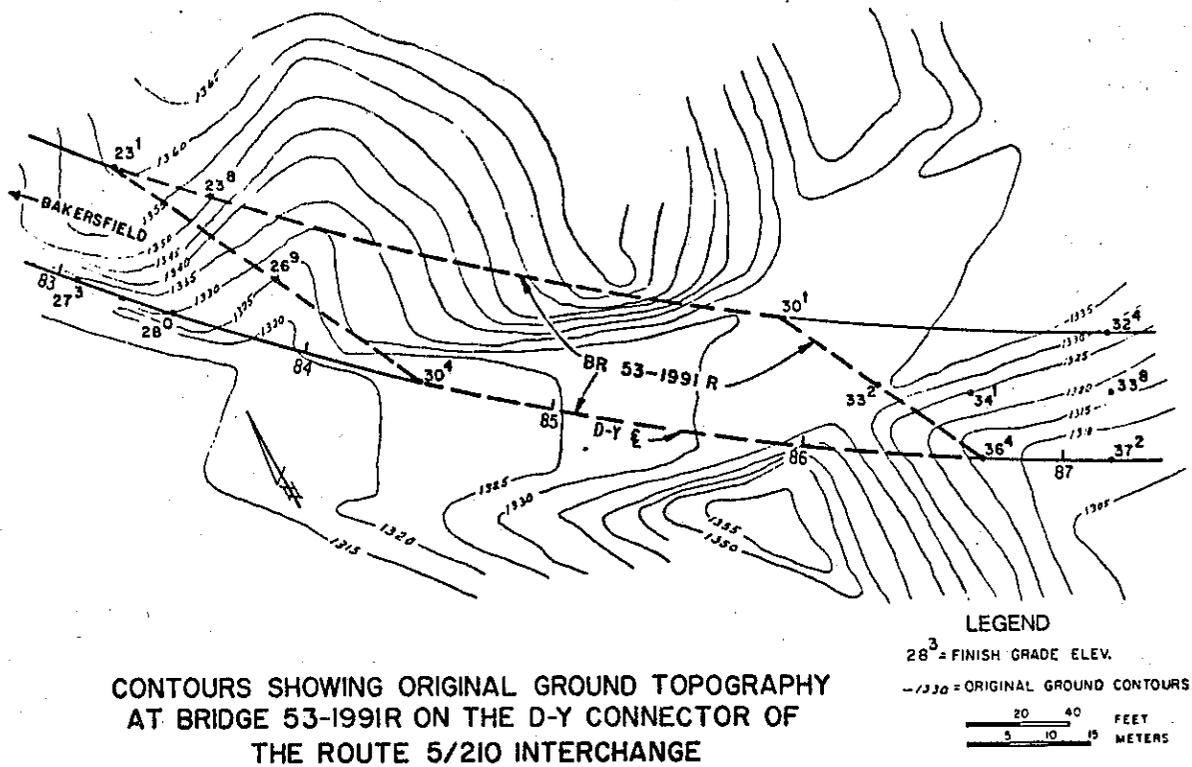
FIGURE 14

The approaches to this structure (Br. 53-1991R) are a combination of cut and fill. Figure 14 shows the original ground topography with the structure superimposed over it. The entire bridge is founded on spread footings in original ground that is composed of very dense sand, gravelly sand, and sandy gravel with cobbles of the Saugus formation. "Settlement" at the easterly bridge approach, Photos 58 and 59, was about two feet at its maximum. At the westerly abutment, "settlement" was several inches; with a portion of the resulting distress to pavement shown in Photo 60.

CONTOURS SHOWING ORIGINAL GROUND TOPOGRAPHY AT BRIDGE 53-1991R ON THE D-Y CONNECTOR OF THE ROUTE 5/210 INTERCHANGE

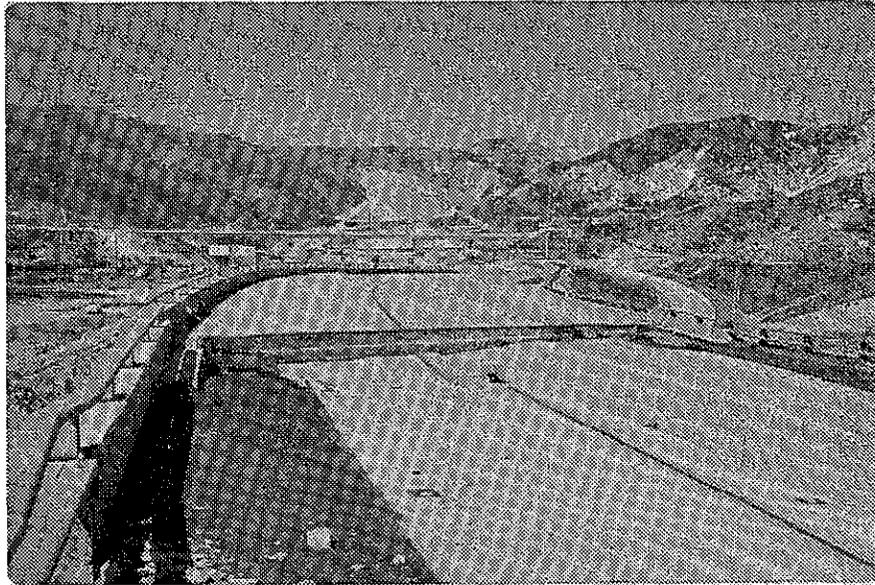
Photo 58. Settlement at the easterly approach to Bridge 53-1991R on the D-Y Connector, Route 5/210 Interchange.

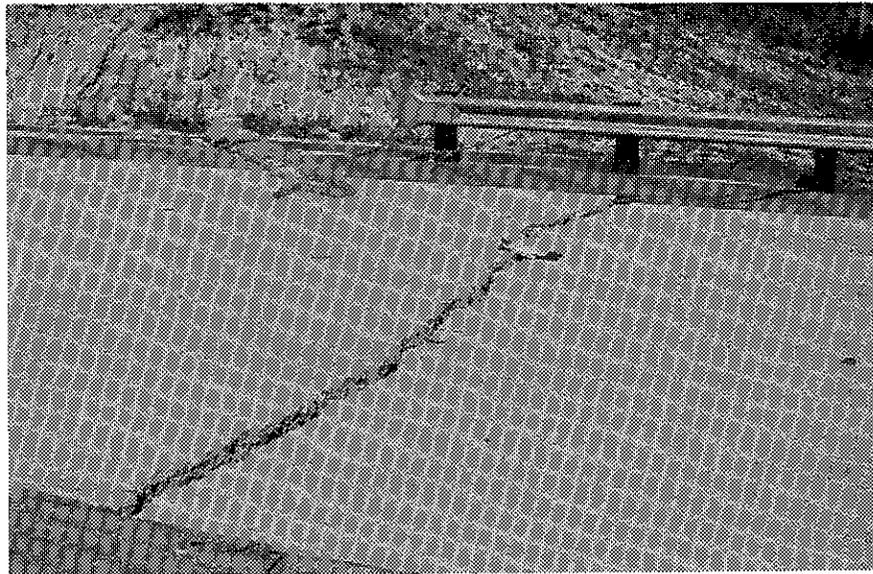
Pavement and soil-cracking occurred in the general area of the cut-fill contact shown in plan on Figure 6. From Connector C-Y the cracking diverged away from the contact in a southerly direction. The cracking progressed from one crack across Connector A-Y, Photo 63, to a zone approximately 200 feet wide south of Connector C-Y. Individual cracks show up to one inch of horizontal separation and generally 1 to 2 inches of vertical separation with the east side down relative to the west. Photo 64 shows the pavement displacement across Connector D-Y and Photos 65 and 66 show the cracking and displacement across Connector C-Y. No cracking on either fill slope was found in this zone. However, south of the toe of fill for a distance of about 70 feet cracking was observed in original ground.

Photo 63. Looking northerly at transverse pavement crack at the cut/fill contact on A-Y Connector. Note horizontal and vertical separation along crack.

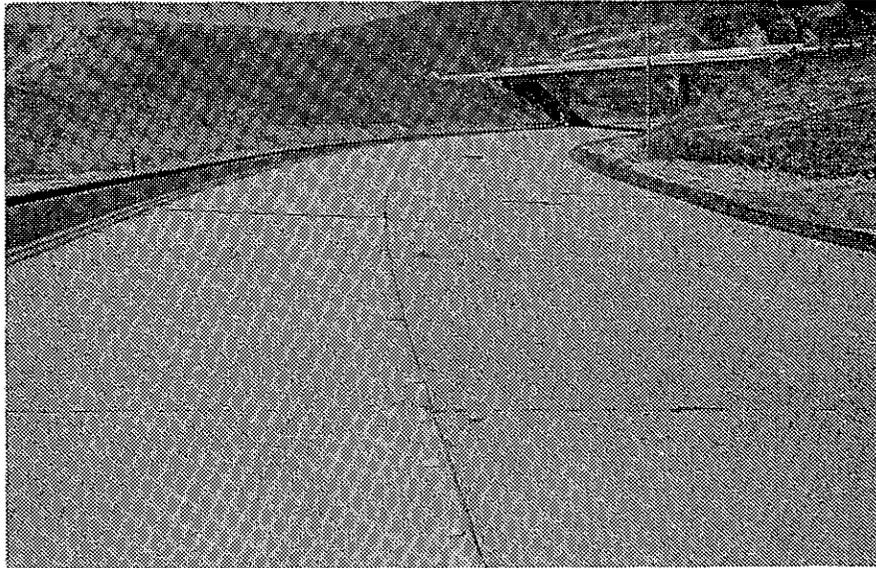
Photo 64. Looking northwesterly at pavement slab displacement through cut/fill zone on Connector D-Y.

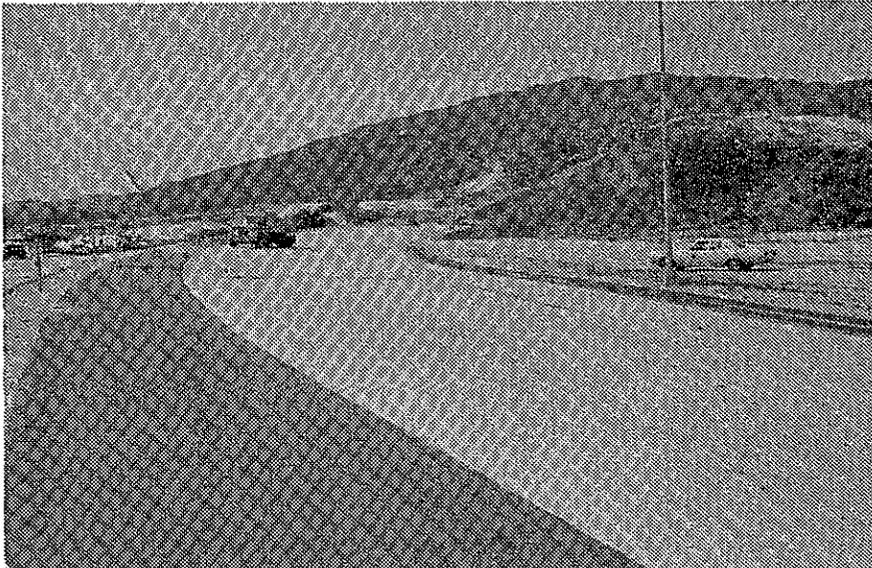
Photo 65. Looking northwesterly at pavement slab displacement through cut/fill zone on Connector C-Y.

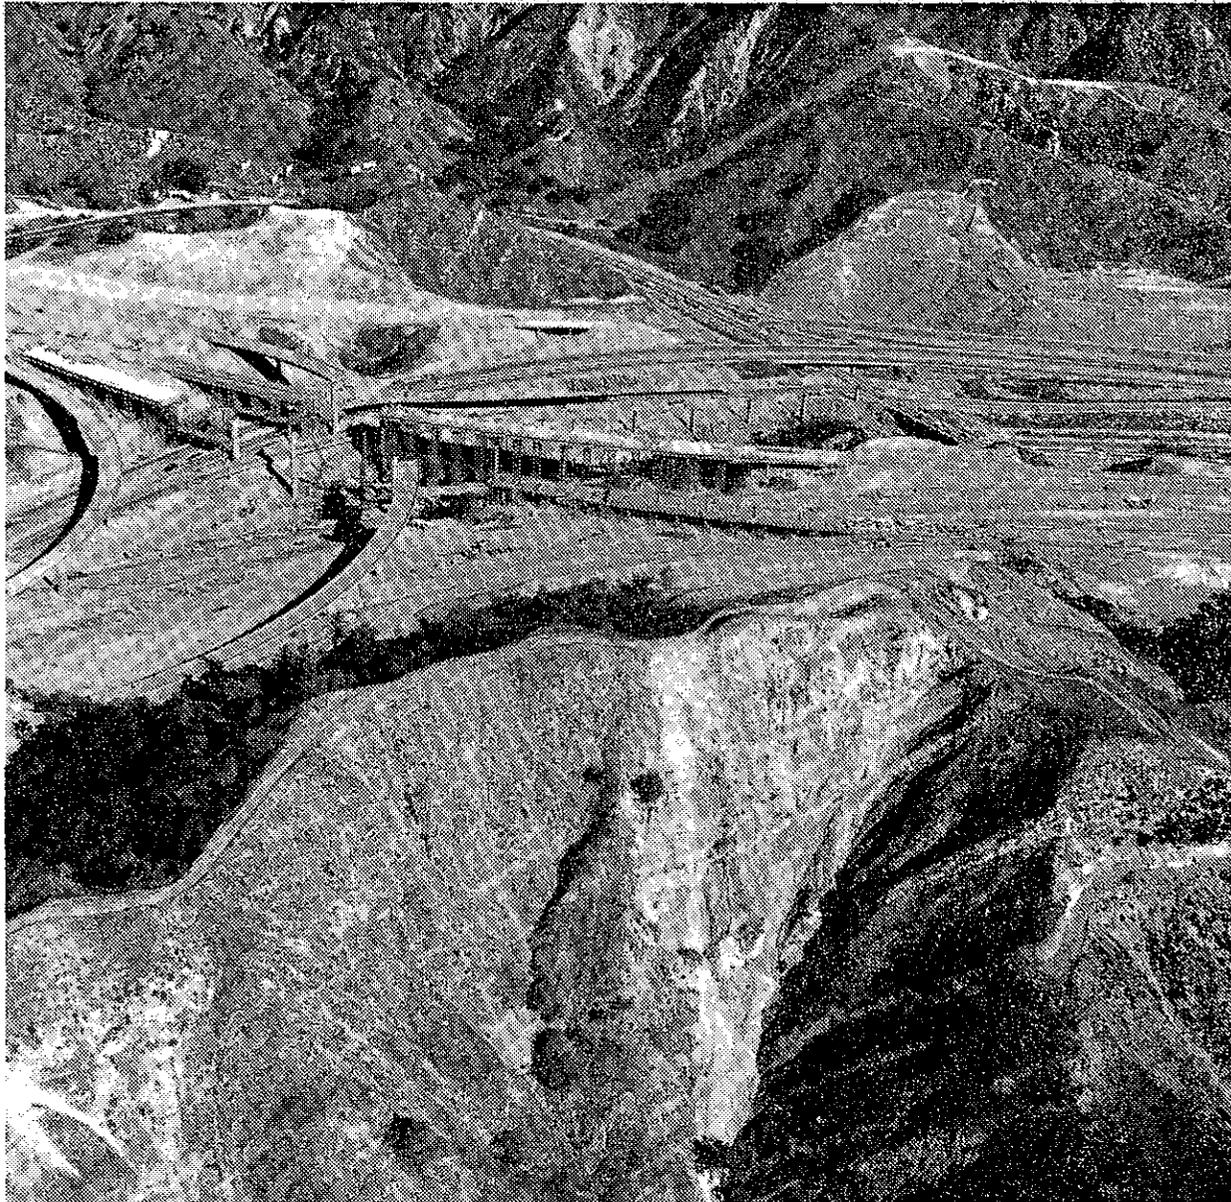
Photo 69. Looking easterly at the Route 5/14 Interchange.

A slump landslide that occurred in a cut slope is shown in Photos 69 (upper right) and 79. The slide, which did not encroach upon the roadway, occurred in a clayey silt with a high moisture content.

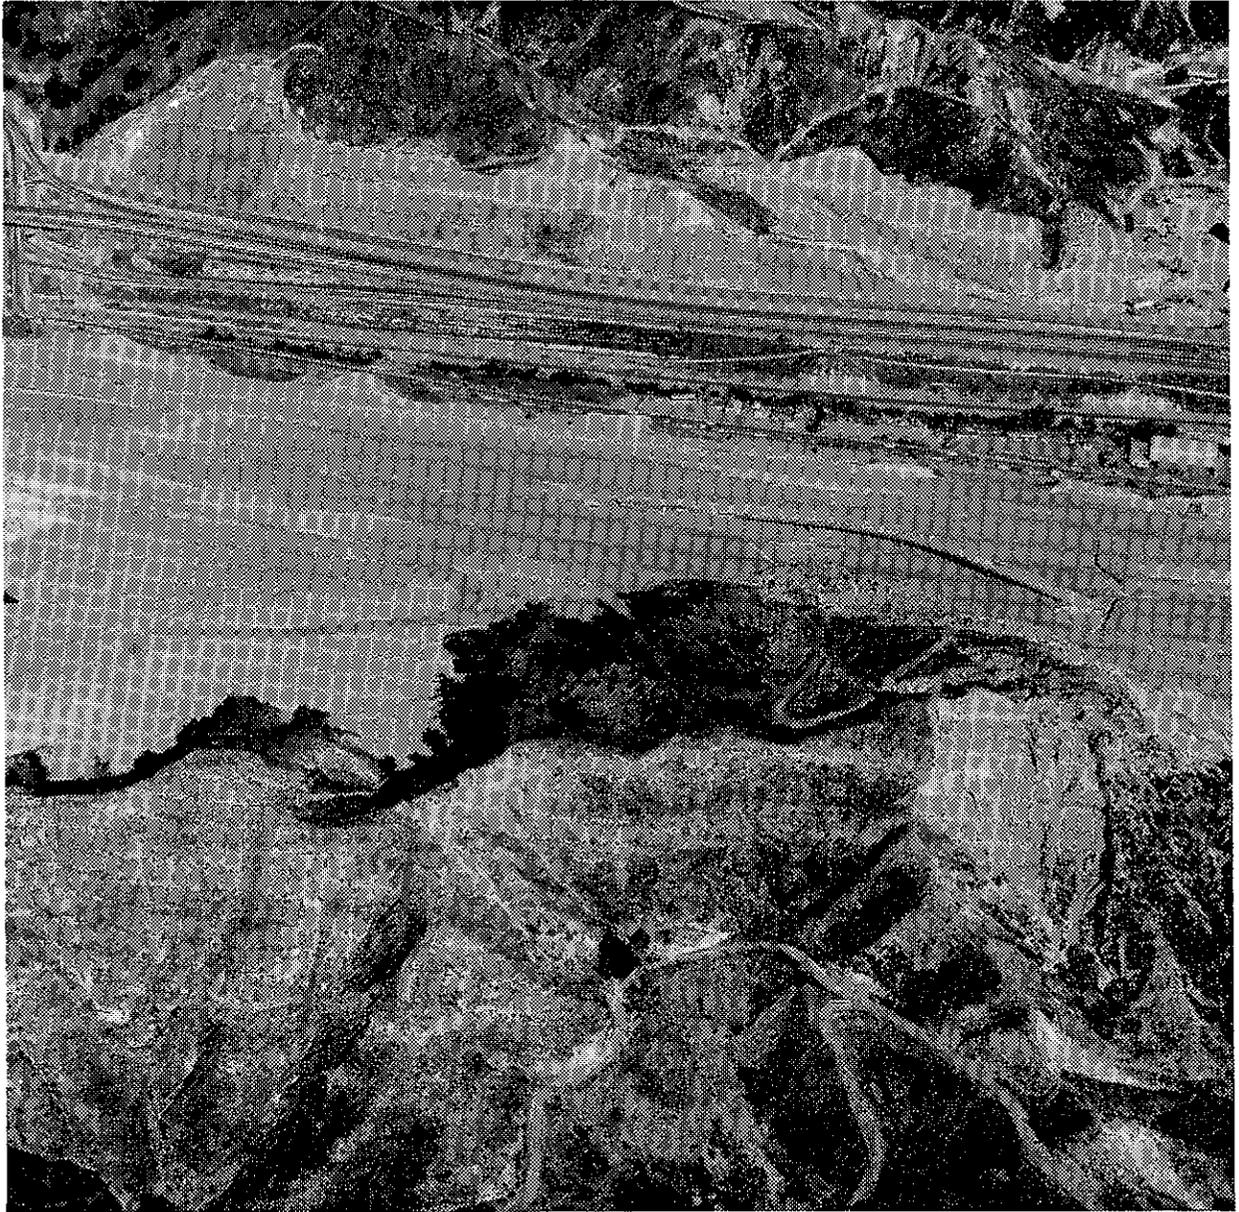
Photo 70. Looking easterly at Route 5, immediately south of the Route 5/14 Interchange.

the cut left a nob with a rather high slenderness ratio. The bedding planes of the friable sediments dipped toward the cut face, and the top of the slide was at the apex of the cut and a very steep natural slope facing west. The top of the slide and west-facing slope may be seen in the lower right of Photo 70.
