FHWA/CA/TL-80/17

Roadway Damage During The San Fernando, California, Earthquake Of February 9, 1971

February 1981

Office of Transportation Laboratory
California Department of Transportation
Sacramento, California 95819

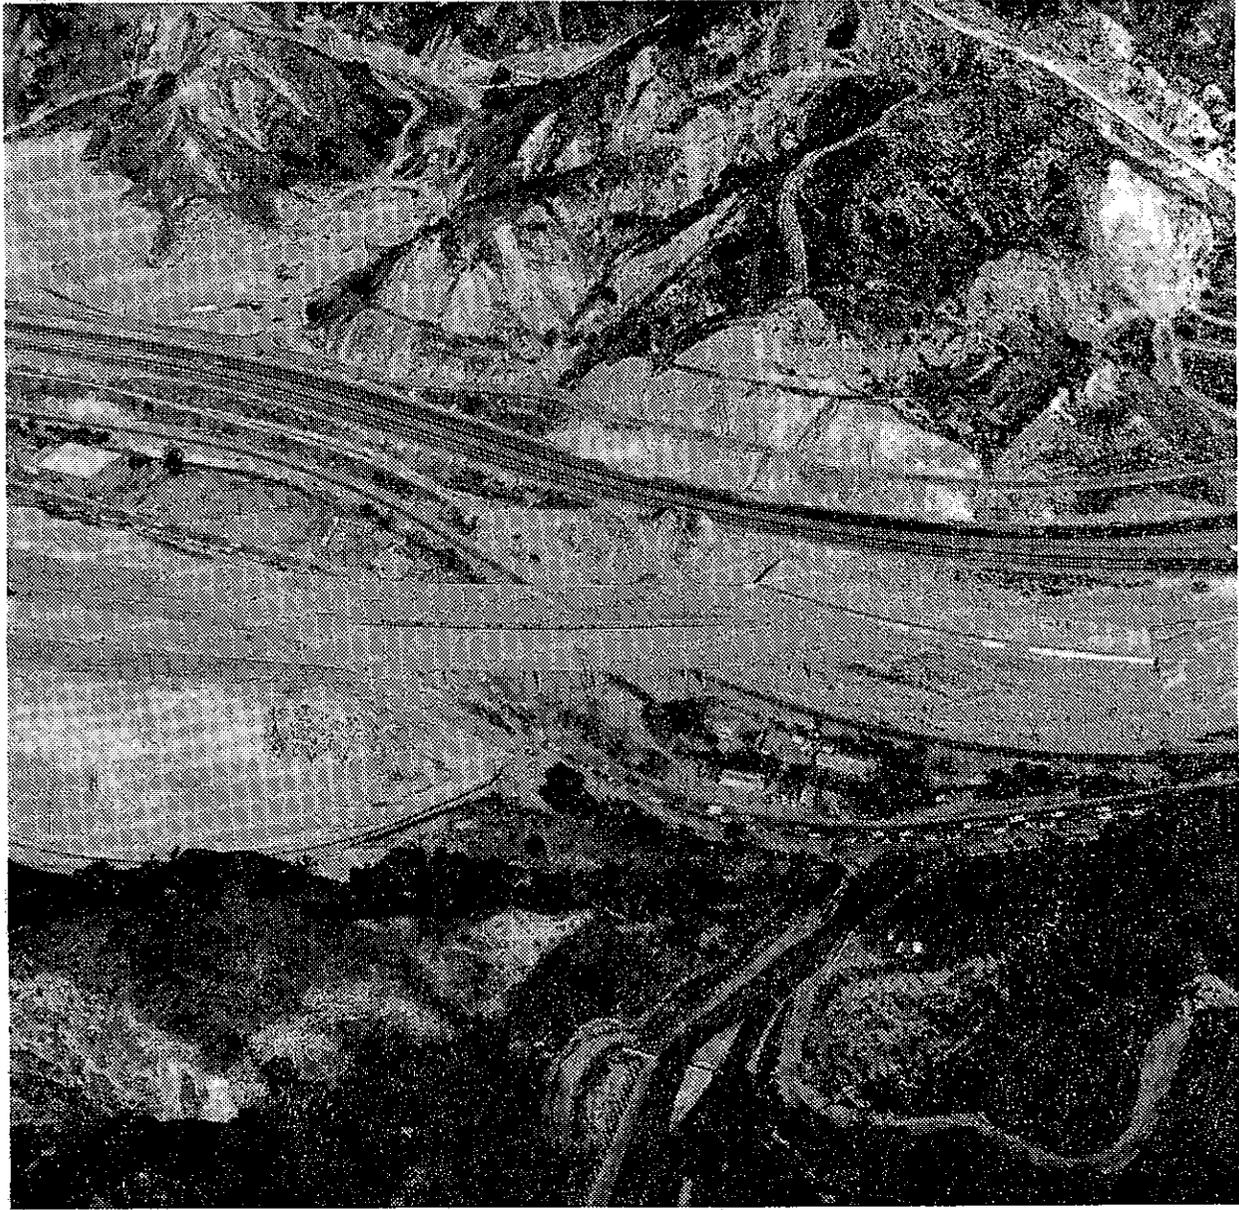
Photo 71. Looking easterly at Route 5.

Cracking of both soil and concrete occurred transverse to the highway at this location. Photo 71 shows roadway concrete broken (right center above the curved reinforced concrete box structure) at what appears to be very near the cut-fill contact. Photos 74 and 75 are close-ups of this break, looking east. Soil cracking occurred through the above concrete box structure and continued westerly into the bridge abutment area (barely visible right of center in Photo 71). The hills to the east of the roadway along the trend of the cracking were shattered in a 100-ft wide zone. The above cracking appears to follow closely the upper Santa Susana thrust fault as mapped by others (Ref. 5, Vol. III, p. 213, Figure 1). East of the shattered slopes a large rockfall occurred, which is visible in Photo 71 (top right).

Rockfalls occurred in the steep, well-indurated sandstone cut face (upper right central portion of Photo 71).

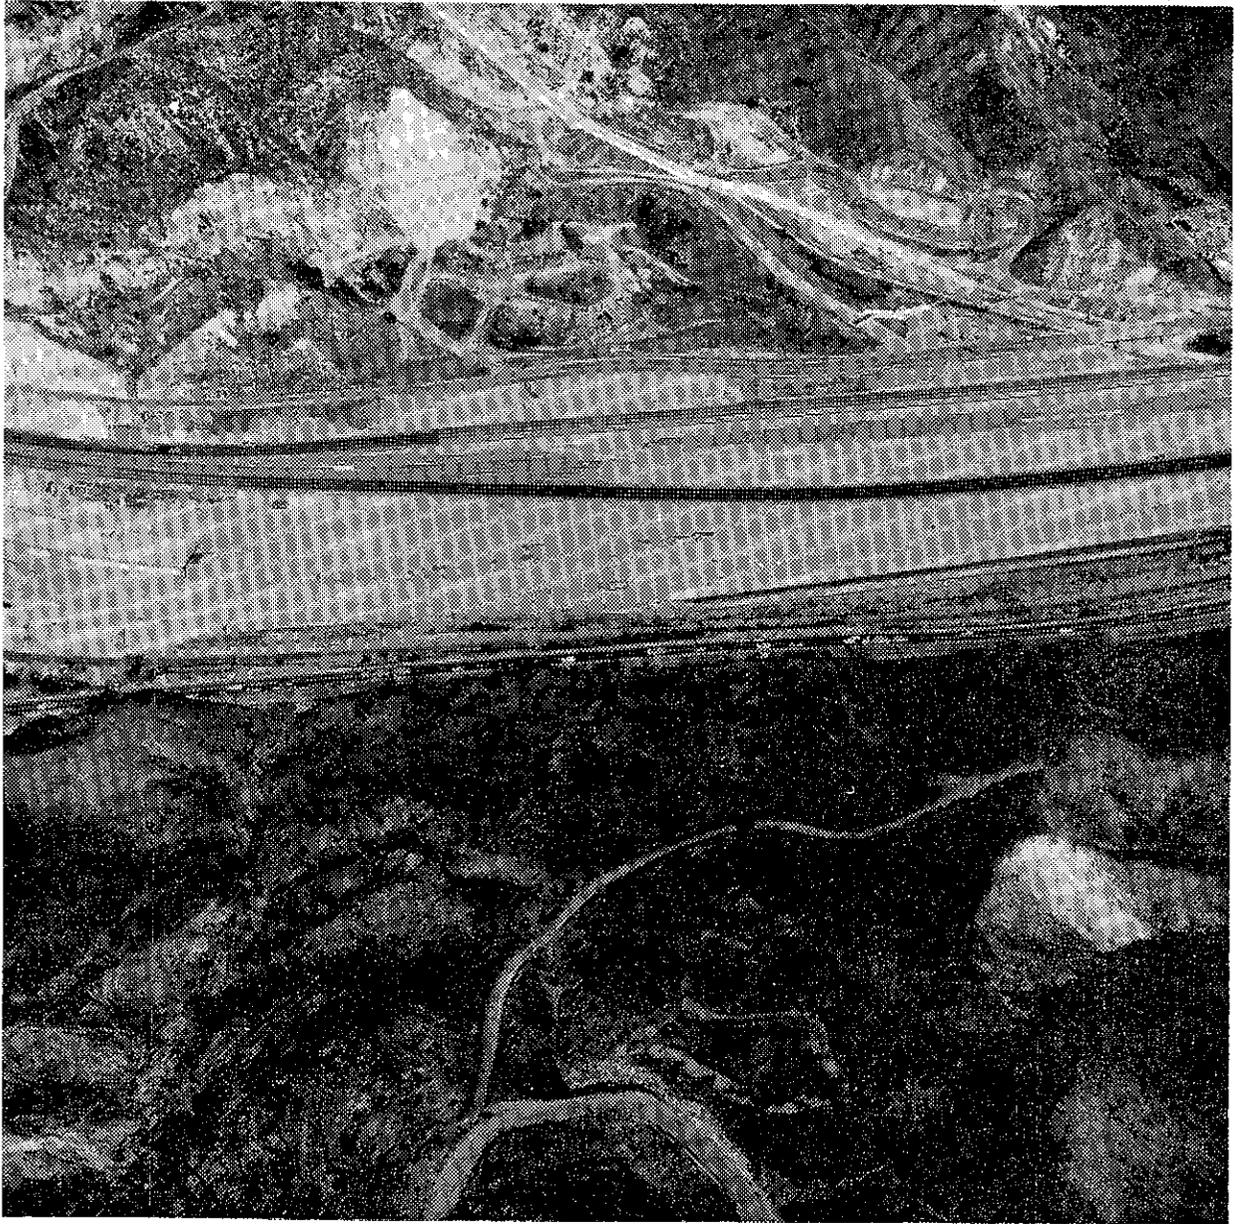
Photo 72. Looking easterly at Route 5 immediately north of Balboa Boulevard Overcrossing.

Very little soil or pavement distress was found in this area. A crack across the asphalt pavement of temporary Route 5 (right central portion of Photo 72) showed 1/2-inch of lateral displacement, south side moved west relative to north side. About 450 feet north of this offset, a tension crack appeared in the pavement with one inch of separation.

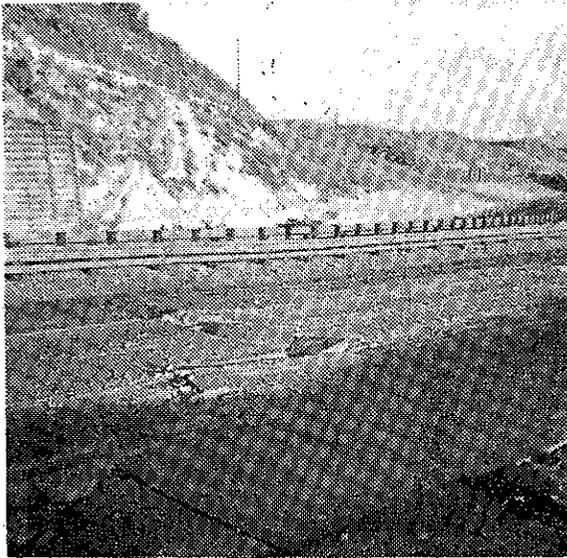
Photo 74. Looking easterly at pavement damage on Route 5 north of Balboa Boulevard.

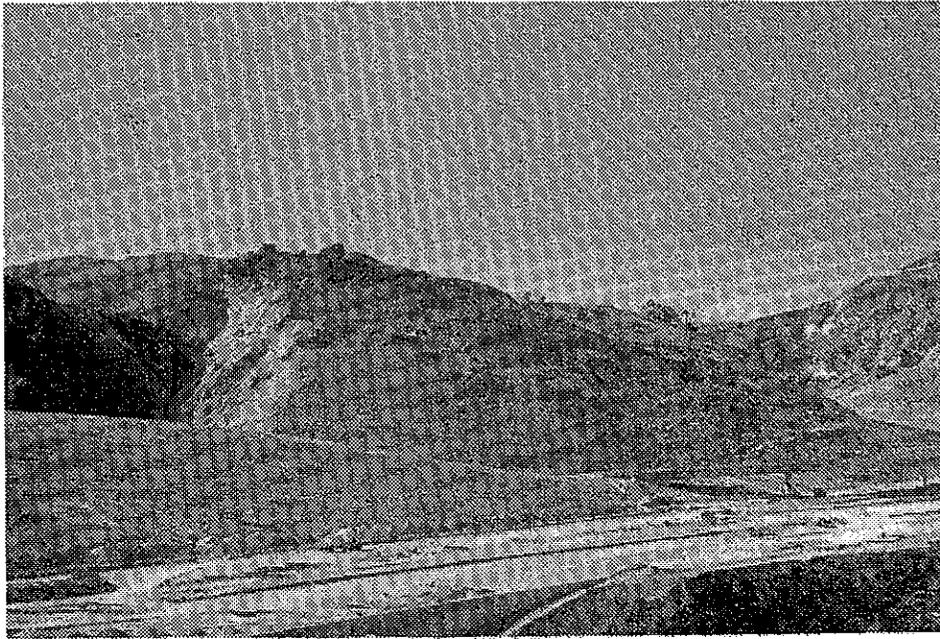
A large landslide occurred in a cut slope at this location (Photos 77 and 78). Had the roadway been completed, frontage road access from one approach would have been blocked by the slide. An interesting aspect of this slope is that

Photo 77. Looking westerly at a cut slope slide immediately south of the Route 5/14 Interchange.

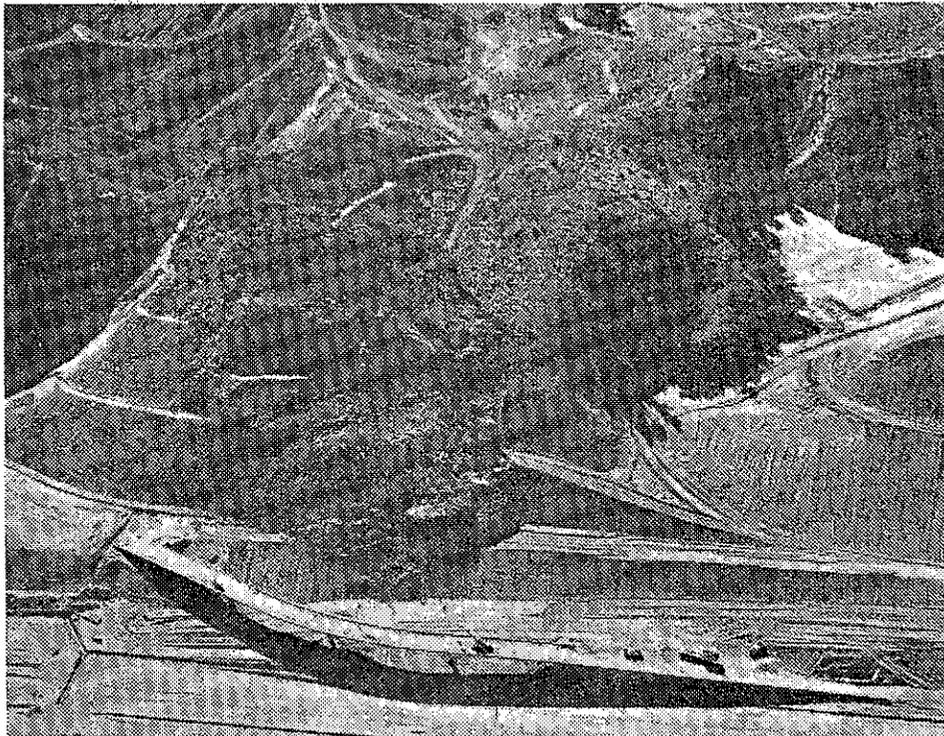
Photo 78. Aerial view of slide shown in Photo 77. Note blockage of unfinished connector by slide debris.

the cut left a nob with a rather high slenderness ratio. The bedding planes of the friable sediments dipped toward the cut face, and the top of the slide was at the apex of the cut and a very steep natural slope facing west. The top of the slide and west-facing slope may be seen in the lower right of Photo 70.

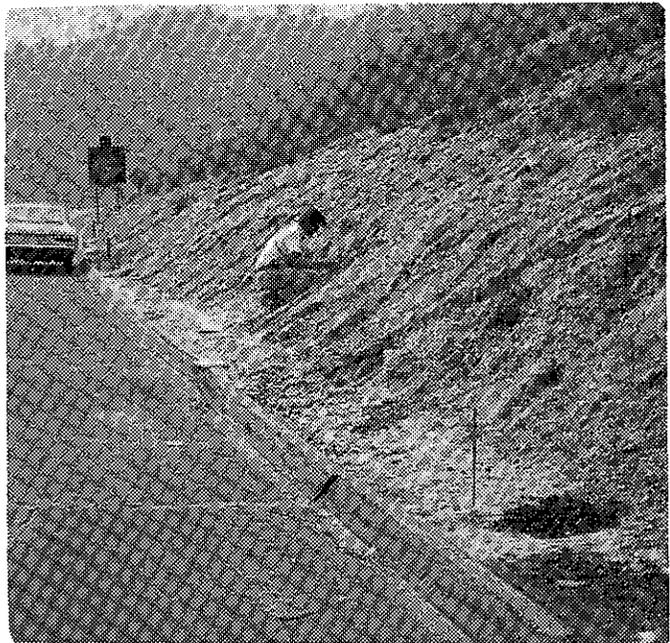
Further north, a cut slope on the east side of the highway had ground breakage behind the top of cut as shown in Photos 82 and 83.

Photo 82. Ground breakage at top of cut slope on east side of Route 5.

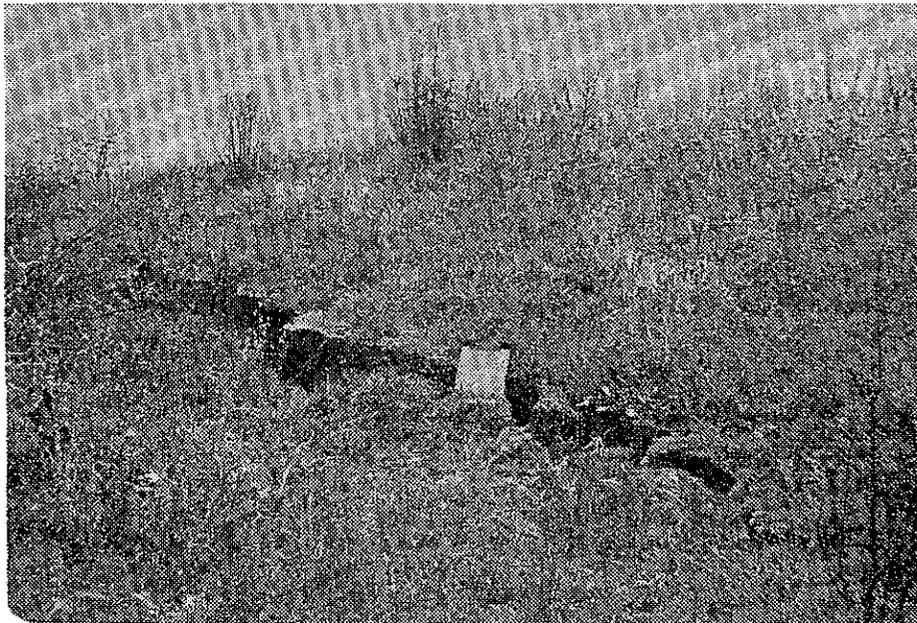
Photo 83. Ground breakage at top of cut slope on east side of Route 5.

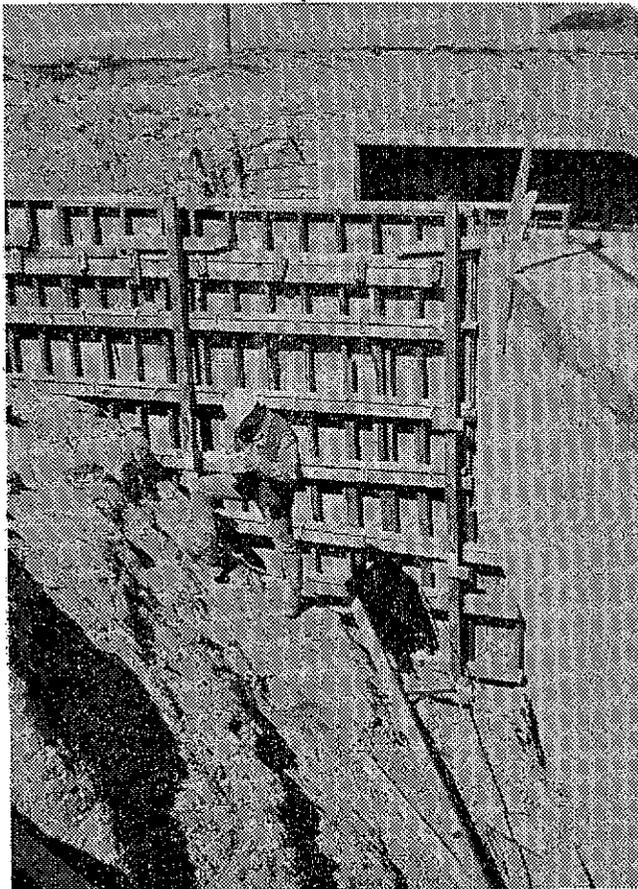
Photo 86 shows 8 to 10 inches of backfill settlement that occurred at the west abutment of the westbound structures for the Via Princessa Undercrossing. Photo 87 shows the area to be backfilled at the west abutment of the eastbound structure. Assuming that construction practices were similar for both structures, a comparison of the two photos show the settlement was confined to the backfilled area. It is probable that the settlement resulted from spreading during seismic shaking as the wingwalls were not yet constructed. The abutments of the structures were either sheared or distressed similar to that shown in Photo 88, with the exception of the west abutment of the eastbound structure.

Photo 87. Abutment prior to backfilling at the Via Princessa Undercrossing.

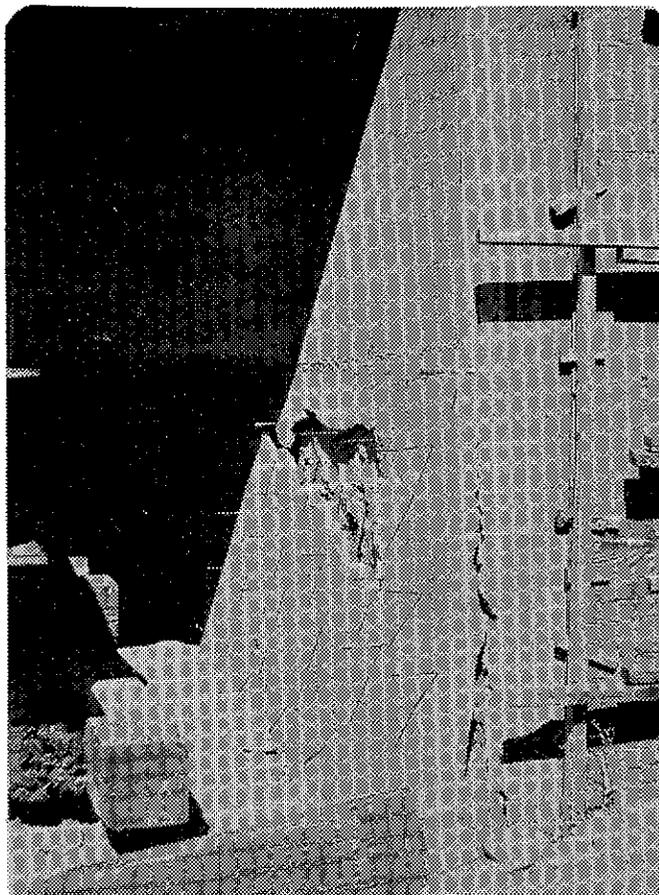
Photo 88. Typical abutment damage through the eastern portion of Route 14.

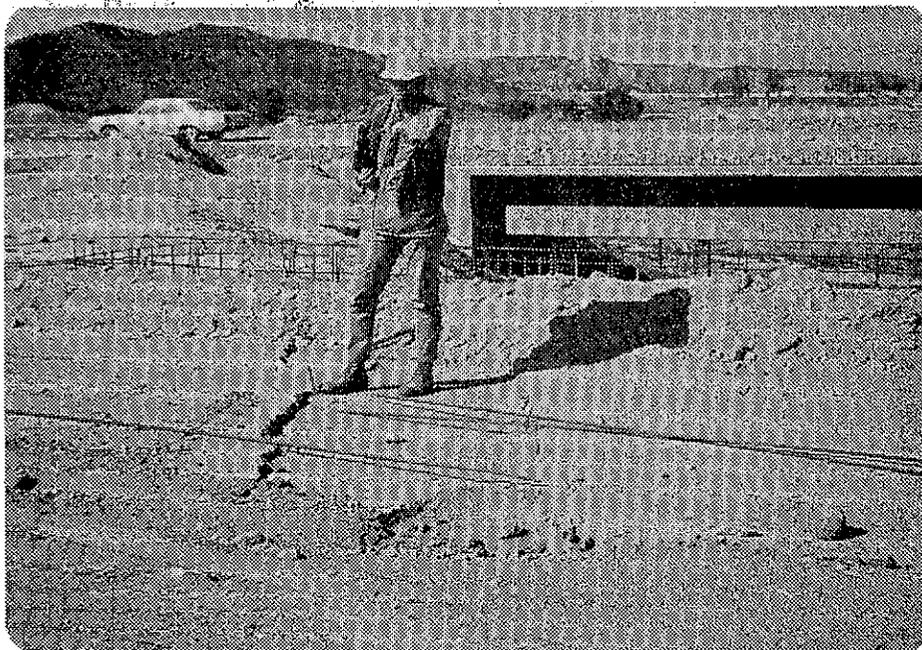
Backfill settlement of 6 to 8 inches at the west abutment of the westbound roadway structure of the Santa Clara River Crossing is shown in Photo 89. The settlement was confined to the backfilled area of the abutment. No displacement of the wingwalls and abutment wall (constructed as a unit) was noted. Photo 90 shows a few inches of backfill settlement at the west abutment of the eastbound structure. The abutment and wingwalls were constructed as a unit and no bridge damage was detected. Again, the settlement appears to be confined to the backfilled area.

Photo 90. Abutment backfill settlement at the Santa Clara River Bridge (west abutment, east-bound structure).

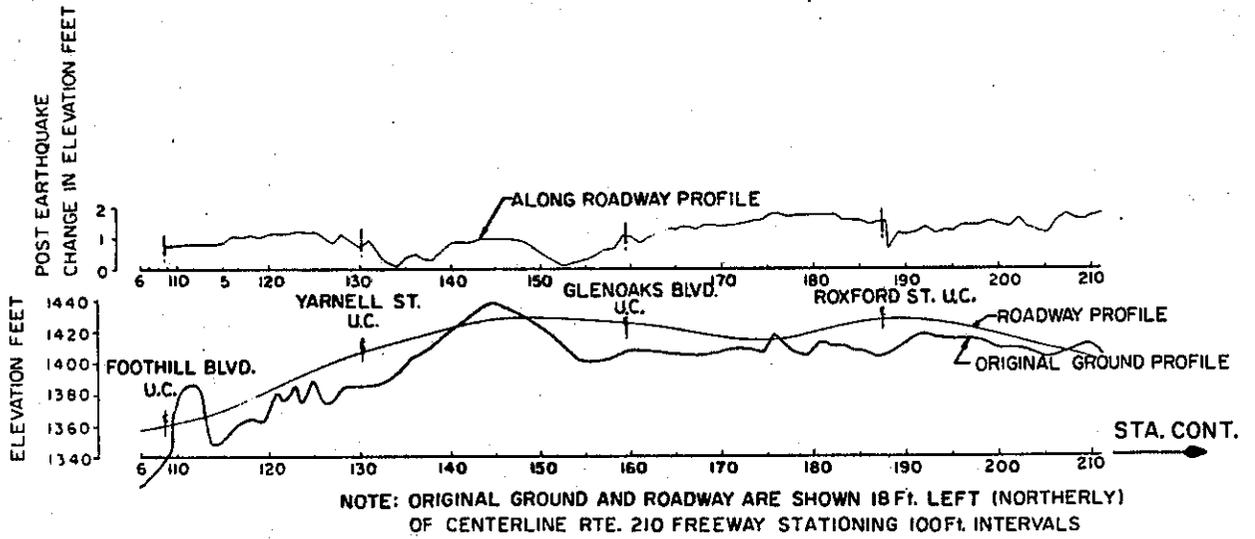
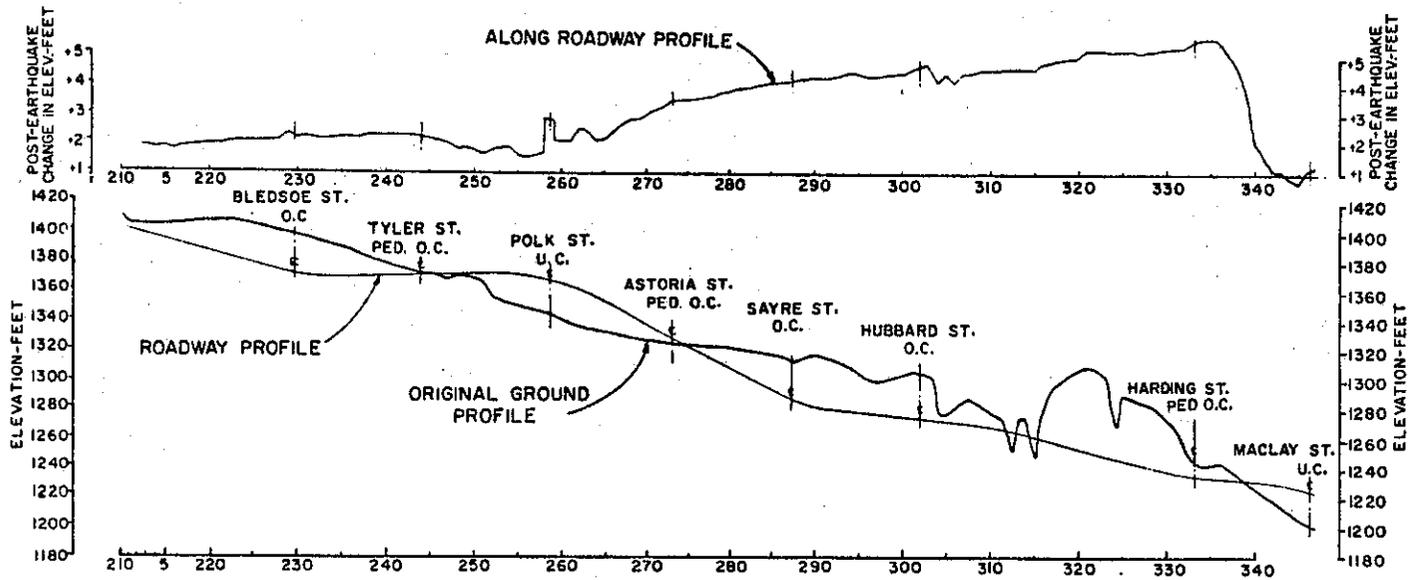
FIGURE 17

The completed portion of Route 210 and the surrounding topography are shown in Photo 92. Profiles of original ground, roadway design gradeline, and a post-earthquake change in elevation profile of the roadway are shown in Figure 17. As-built plans were used in the compilation of Figure 17 for the roadway and original ground profiles. Post-earthquake elevation surveys of the roadway were compared to the as-built profile and the change in elevation for each station is plotted on the figure.

ROUTE 210 DESIGN AND ORIGINAL GROUND PROFILE AND POST QUAKE CHANGE IN DESIGN PROFILE

Pavement slab separation of the longitudinal construction joint of 1/2-inch to 1-1/4-inches occurred in the westbound roadway for a length of 560 feet at this location. Fill height through this section varied from 12 feet at the east limit to 24 feet at the west limit as shown in Figure 17.

An undulating roadway surface, shown in Figure 17, was the result of tectonic uplift combined with differential settlement in the roadway embankment and underlying gravelly sands.

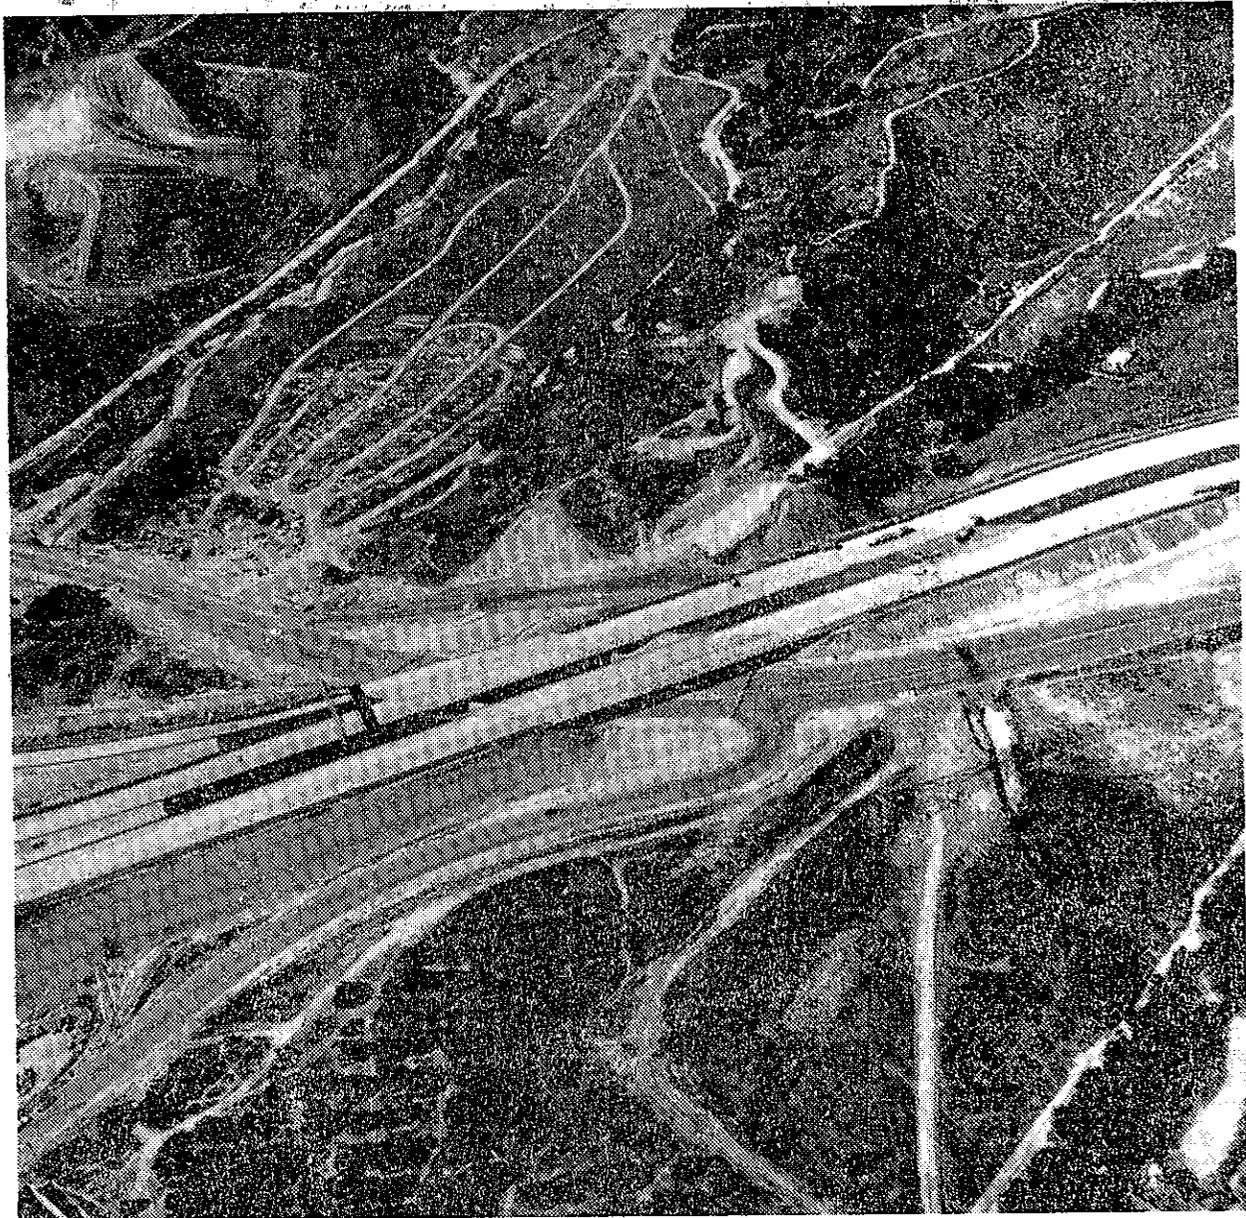
In addition to the structural damage to the Foothill Undercrossing (Photo 93), embankment distress in the form of shear cracks and settlement occurred at the approaches. Backfill settlement measuring up to one foot resulted in approach slab breakage.

Photo 93. Looking northerly at the Foothill Boulevard Undercrossing.

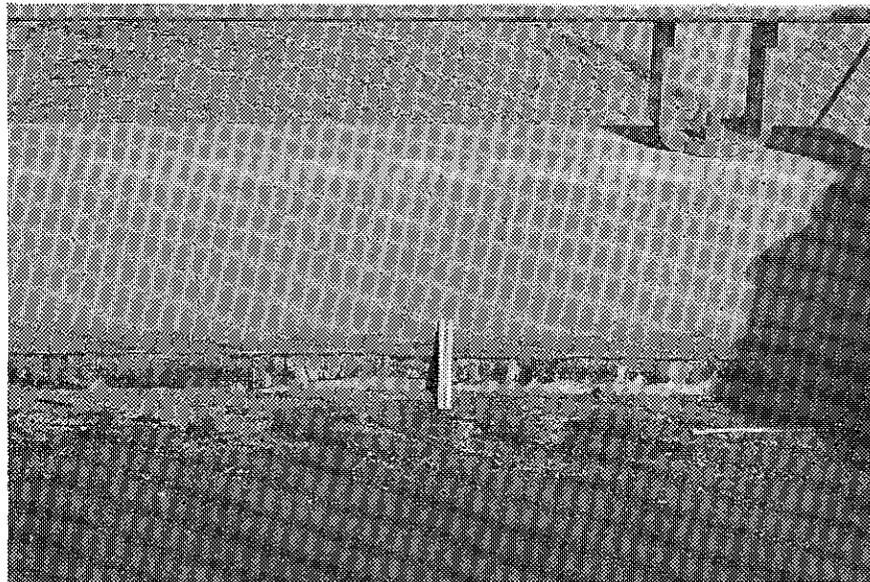
Fills at the Yarnell Street Undercrossing (Photo 94) settled about three inches at the west approach (Photos 95 and 96) and about six inches at the east approach. Photo 97 shows cracking and settlement in the median at the wing wall. Again, settlement appears to be the combined result of densification of fill and underlying aluvium caused by the seismic shaking.

Photo 96. Same location as Photo 95. Note settlement of AC shoulder pavement relative to wingwall.

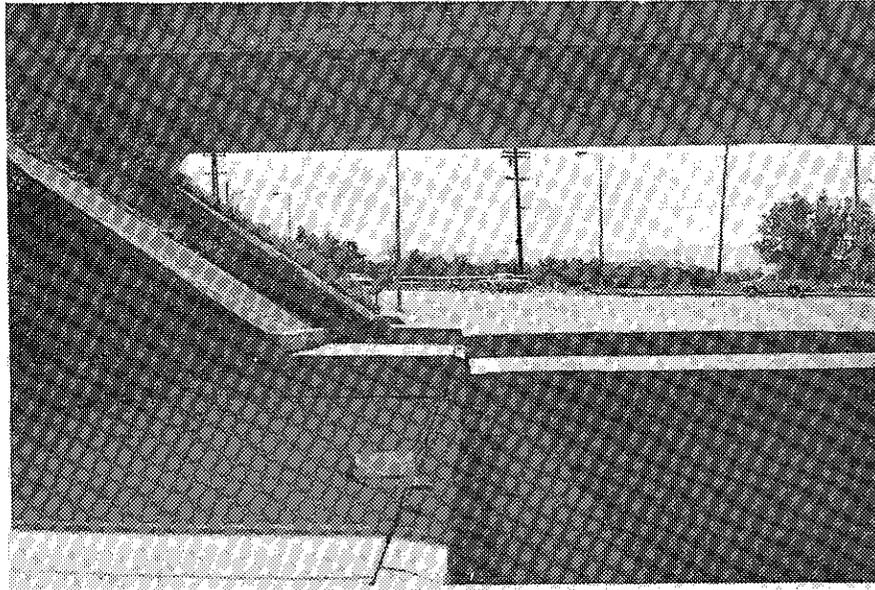
No structural damage to the bridges was found (4), but concrete slope paving beneath the superstructures caused minor damage to the concrete sidewalks and curbs along Glenoaks Boulevard (Photo 99).

The slope paving, which settled about 3 inches at the bridge abutment and about 2 inches at the sidewalk, transmitted forces from the abutments to the sidewalk and curbs.

Photo 99. Looking south along Glenoaks Boulevard. Note rotated and displaced curb due to lateral force of displaced slope paving that was transmitted through sidewalk.

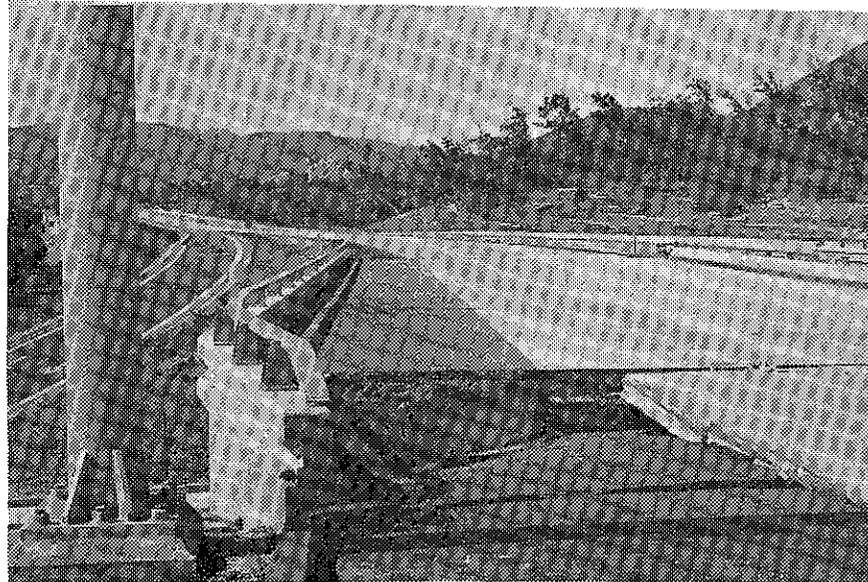
Seismic shaking at the I-210/Roxford Street Interchange (Photo 102) appears to have been much more intense than that to the west for a distance of about one mile along the freeway alignment. The east abutment for the eastbound structure separated from the pilings and the structure shifted about three feet to the south as shown in Photo 103. Fill spreading and settlement disrupted the roadway profile (Photos 104 and 105). Pavement slab separation and longitudinal cracks resulted from fill displacement (Photos 106, 107, 108, and 109). A compression buckle formed in asphalt concrete pavement in the eastbound off-ramp (Photos 105 and 110). Lateral shear displacement of fill is evidenced by bulging and a developed thrust offset near the toe of fill at the west approach to the eastbound bridge. Bulging occurred at the toe of fill along the eastbound off-ramp for a distance of several hundred feet.

Photo 103. Looking west at the eastbound structure of the Roxford Street Undercrossing. Note rotational movement of structure.
