| 4. TITLE AND SUBTITLE<br><b>INVESTIGATION OF THE CRASHWORTHINESS OF BARRIER MOUNTED HARDWARE:<br/>BARRIER MOUNTED SIGN AND SIGNPOST</b> | | 5. REPORT DATE<br><br><b>June 2011</b> | |
| 9. PERFORMING ORGANIZATION NAME AND ADDRESS<br><b>Roadside Safety Research Group<br/>California Department of Transportation<br/>5900 Folsom Blvd.<br/>Sacramento CA. 95819</b> | | 10. WORK UNIT NO. | |

# INVESTIGATION OF THE CRASHWORTHINESS OF BARRIER MOUNTED HARDWARE: BARRIER MOUNTED SIGN AND SIGNPOST

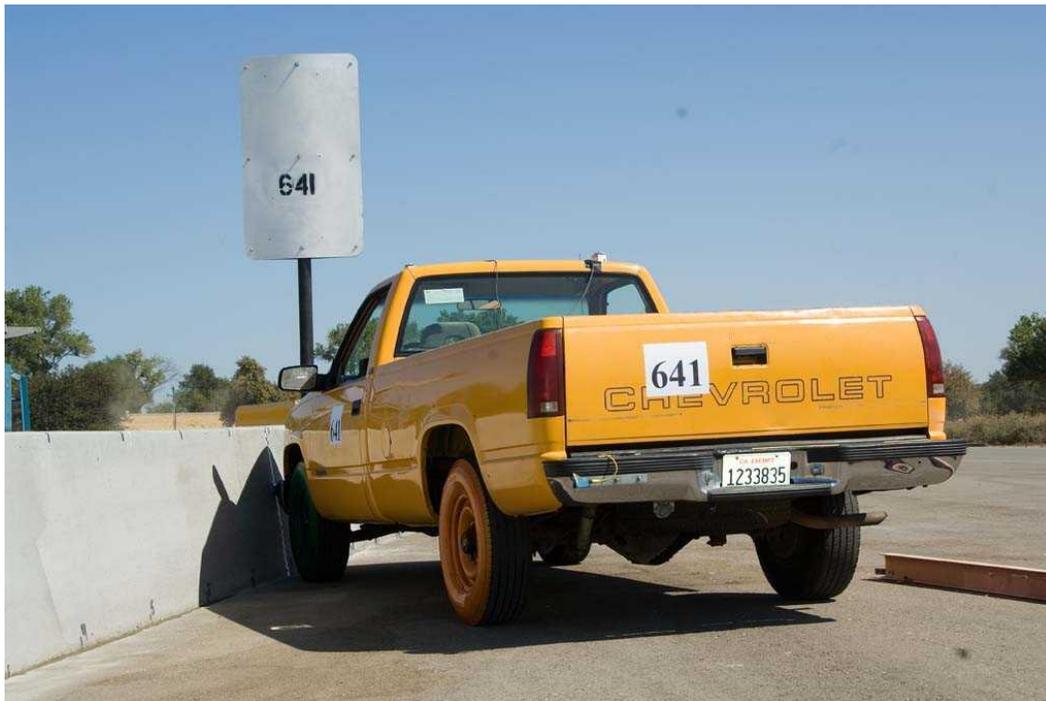
Figure 2-3 Downstream View of the Barrier and Vehicle SS641

There was only cosmetic damage to the barrier. The signpost saddle was pushed 19 mm (0.75 in) downstream and the two bolts were also bent slightly downstream. The sign pole had a dynamic deflection of 10.6° and a static deflection of 3.4° leaning downstream of impact.

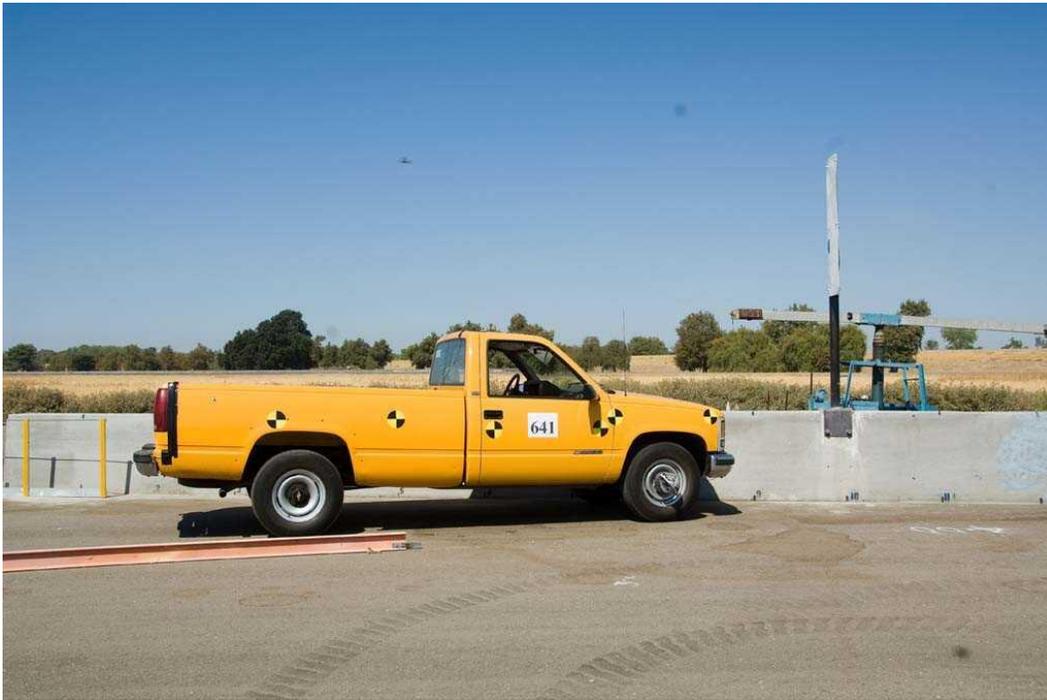
Figure 2-4 Side View of the Barrier and Vehicle SS641

The driver's side front quarter of the vehicle sustained significant damage in the initial impact with the barrier. The amount of damage increased as the hood impacted the signpost. The front left wheel was pushed backward 340 mm (13.4 in) from its initial location. The hood penetrated the windshield by 250 mm (9.8 in) measured from the bottom center of the windshield to the resting place of the hood. The vehicle's battery had been thrown out of the engine compartment but was still held in place by the negative terminal cable. The top of the driver side door had buckled outward from the vehicle's frame. The jagged slice down the side of the vehicle caused by the signpost bolts is due to the sustained contact with the barrier. Inspection of the occupant compartment revealed that the dashboard was pushed back 202 mm (8.0 in) toward the driver. The driver side had a peak loss of 98 mm (4.0 in) measured between the bottom of the dashboard and the floorboard.
