4. TITLE AND SUBTITLE
Development And Evaluation Of Raised Traffic Marker, 1971 -1974

9. PERFORMING ORGANIZATION NAME AND ADDRESS
Office of Transportation Laboratory
California Department of Transportation
Sacramento, California 95819

13. TYPE OF REPORT & PERIOD COVERED
Final 1971-1974

FINAL REPORT
CA-DOT-TL-5152-3-75-20
DECEMBER 1975

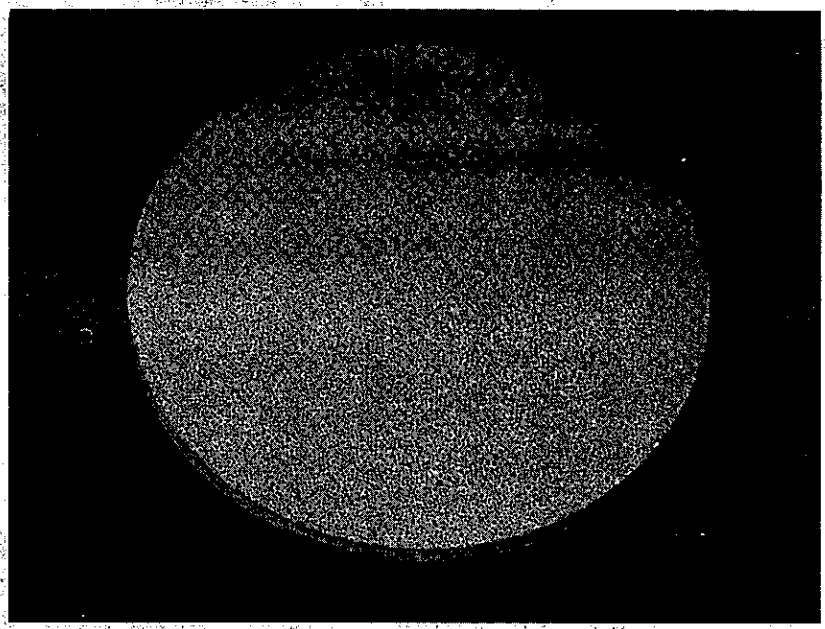
Figure 1. New cement pavement marker showing glass beads.

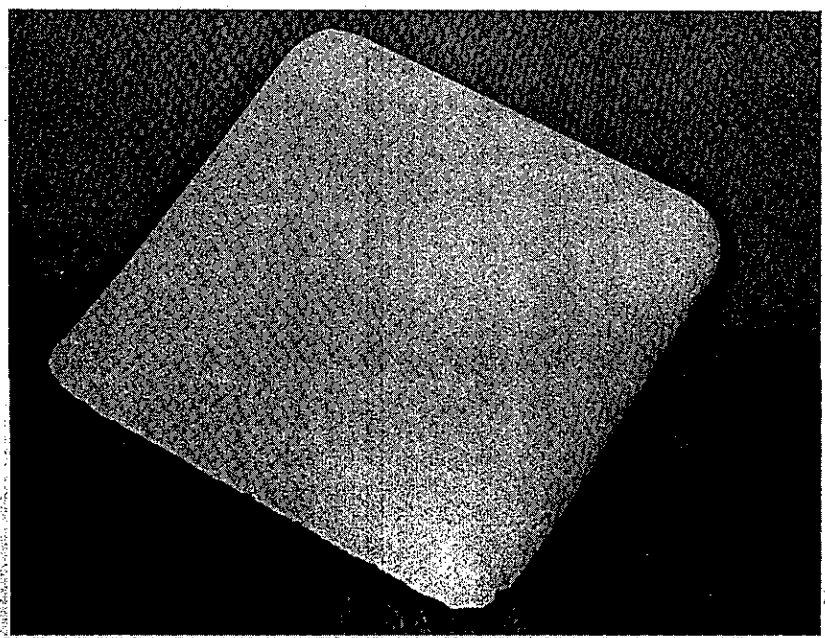
Figure 2. New cement wedge.

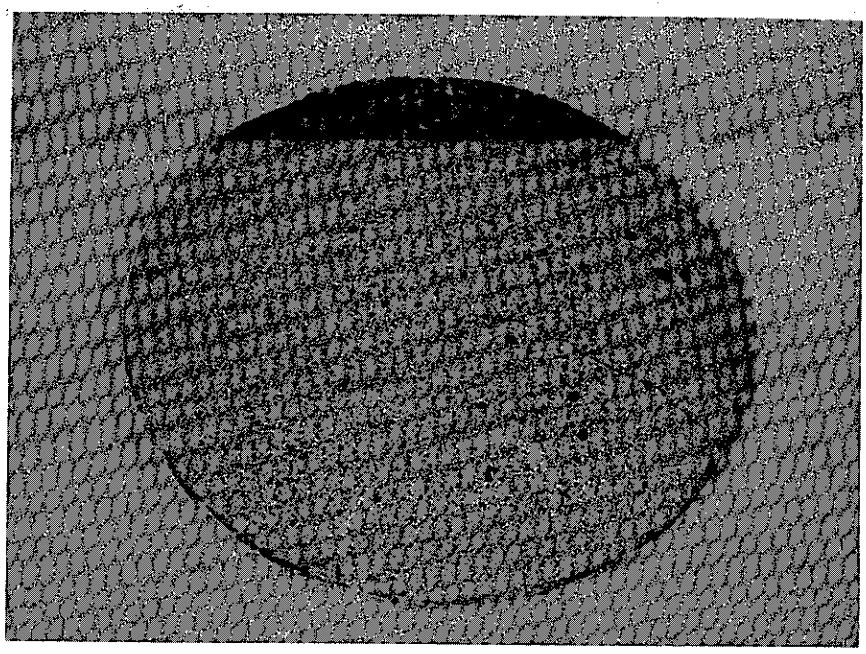
Figure 3. Cement pavement marker. Removed from experimental test section after 2 years service. Note overall gray coloration which tends to match highway pavement.

After being on the roadway for about one year, it was observed that their usefulness as daytime delineators was generally inferior to the control ceramic buttons (see Figure 3). The only time they were equal to, or better than, the ceramic button was when the sun was very low and behind the driver. Under these conditions, the sunlight was reflected by the beads and the whole marker had a tendency to "glow".

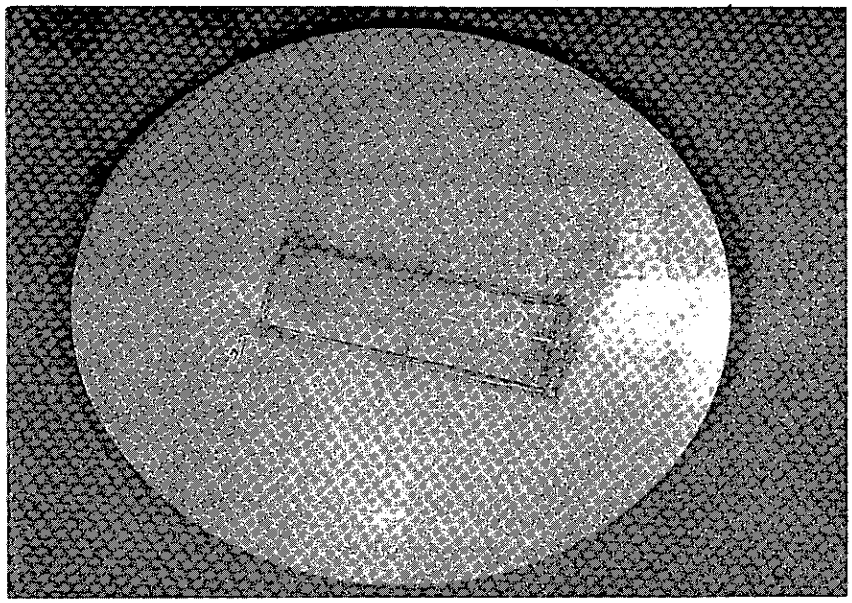
These markers (see Figures 6 and 7) have a ceramic body with a reflective tape enclosed behind a quarter-round acrylic rod. Earlier designs of this marker were not satisfactory because of rapid breakage of the acrylic or glass rod. Modifications of the body design near the rod have resulted in this latest design.

Figure 6. Ceramic marker with reflective tape incapsulated behind 1/4 round acrylic bar. This marker is a slightly modified version of an earlier model.

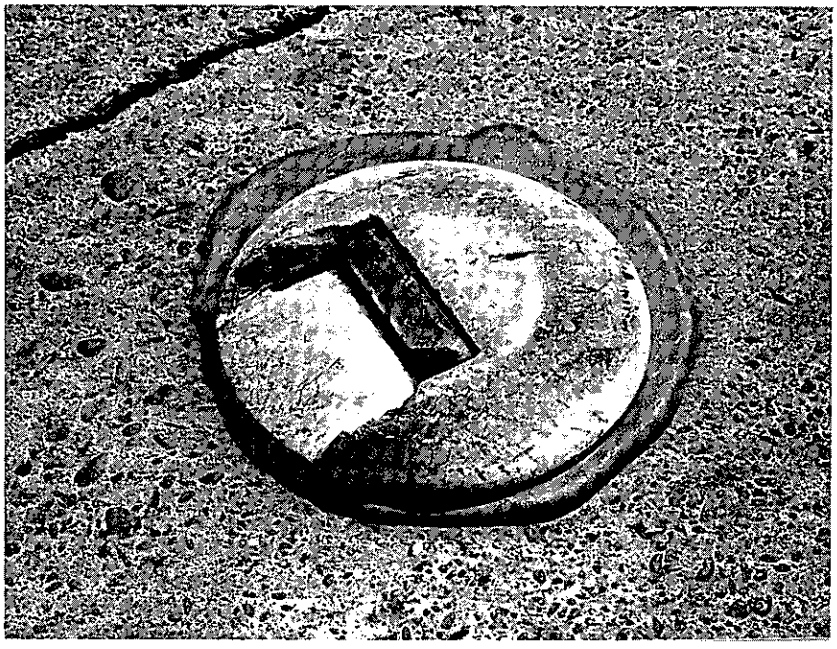
Figure 7. Marker in Figure 6, after one year service in high traffic density area of freeway. This marker was typical of several installed in test section. Nighttime visibility of this unit was severely decreased due to water penetrating the seal between the acrylic bar and reflective tape.

After three years, the markers placed on Highway 50 began to show marked decrease in reflectance. Nighttime observations indicated 40-50% of the units between lanes 3 and 4 had an unacceptable level of reflectance. The initial thought was that the failure in reflectance of these units was due to the acrylic rod breaking; however, after all 50 markers from the South Sacramento test area and several from the Highway 50 area were removed for examination, it was observed that several markers that had acrylic bars which were relatively undamaged did not show any appreciable reflectance either visually or when tested in the Essna Photometer. Closer observations showed that the seal between the acrylic rod and type had failed which permitted moisture and/or mud, road dust, etc., to enter immediately destroying the reflective properties of the tape.

Seal failure between the acrylic rod and reflective tape was not observed in previous models of this marker since the acrylic rod was not as protected and broke before the seal failed.

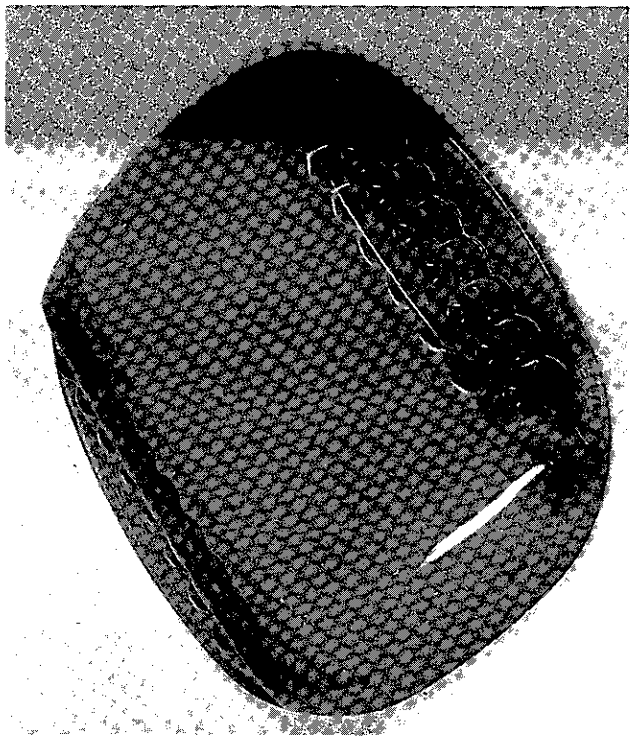
Figure 8

These markers have a shell of tempered glass and a wax-type substance for a fill (see Figure 8). Six units were placed on the South Sacramento Freeway in May 1973. Nighttime observations of these markers just after their installation indicated substandard reflectance. After three weeks, four of the six were completely destroyed leaving a black lump of wax on the road (see Figure 9). The remaining two markers were destroyed within three months.

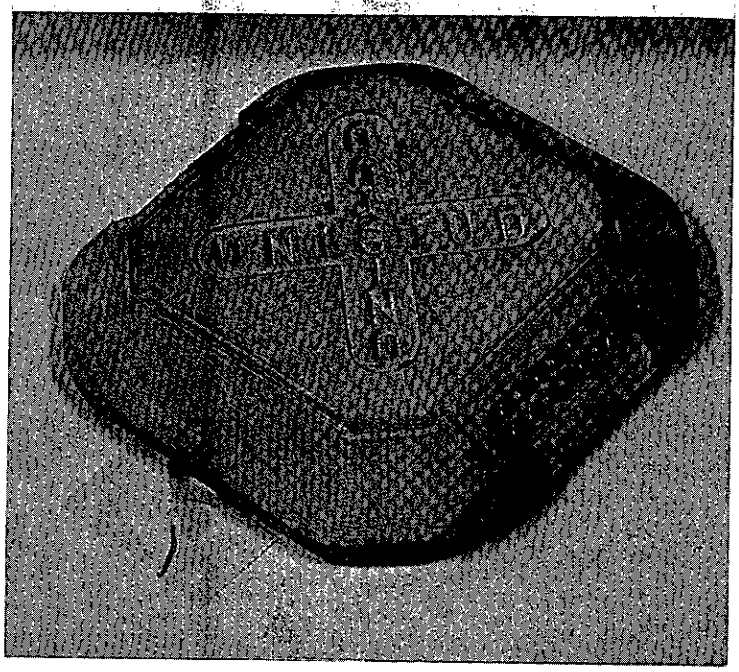
Figure 10
New

The body of this marker is made of solid rubber-type material with front and rear replaceable reflective units. Each unit, for two-way traffic, consists of 16 small glass eyes imbedded in plastic (see Figure 10).

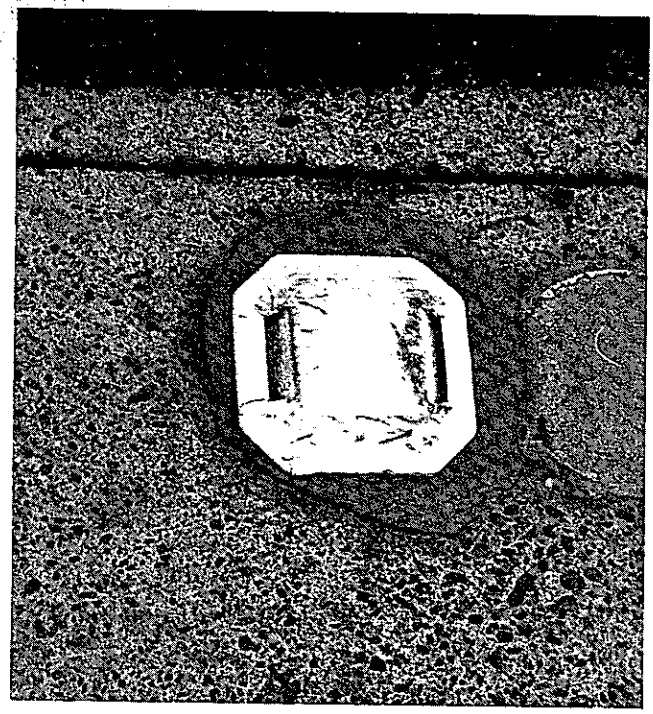
Figure 11
After 6 months
on Freeway.

Several of these reflective markers were placed in a test installation on the South Sacramento Freeway. After two to three months, several of the reflective elements were missing from the markers (see Figure 11).

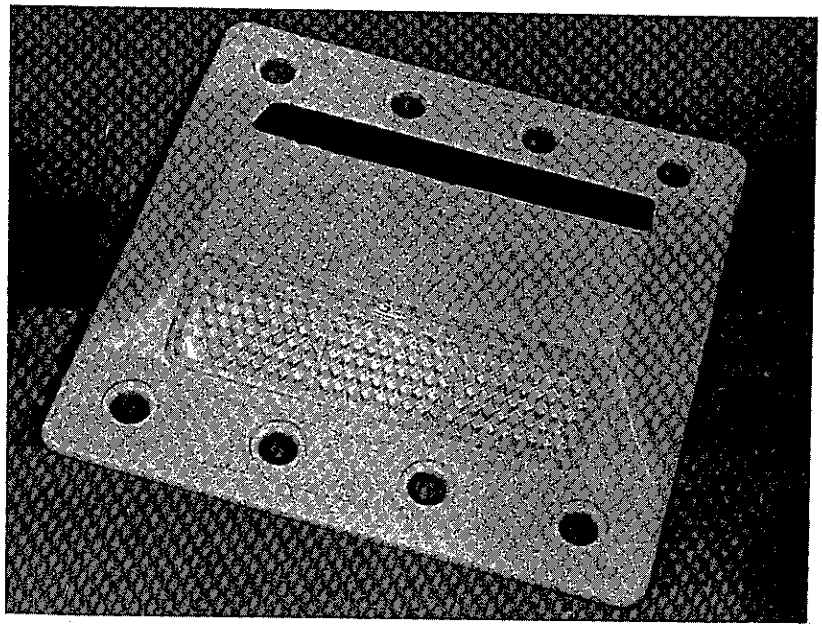
The specific intensity of the clean lens averaged 4-5 candle power/ft. candle which is about the value specified for our standard reflective marker, with approximately 4/10 the lens area. Fifty of these markers were placed on the South Sacramento Freeway during the latter part of 1971. After three months, the cases and lens area of the experimental markers were considerably dirtier than the standard reflective control markers. Several markers were removed from the roadway for close examination. Approximately 80% of all markers examined had some penetration of mud and/or water behind the lens. The presence of moisture in an air backed retroreflector destroys the reflectance. Several markers suffered severe case damage in the lens area and portions of many lenses were missing (see Figures 12 and 13).

Figure 12. New reflective marker with air backed cube corner reflectors.

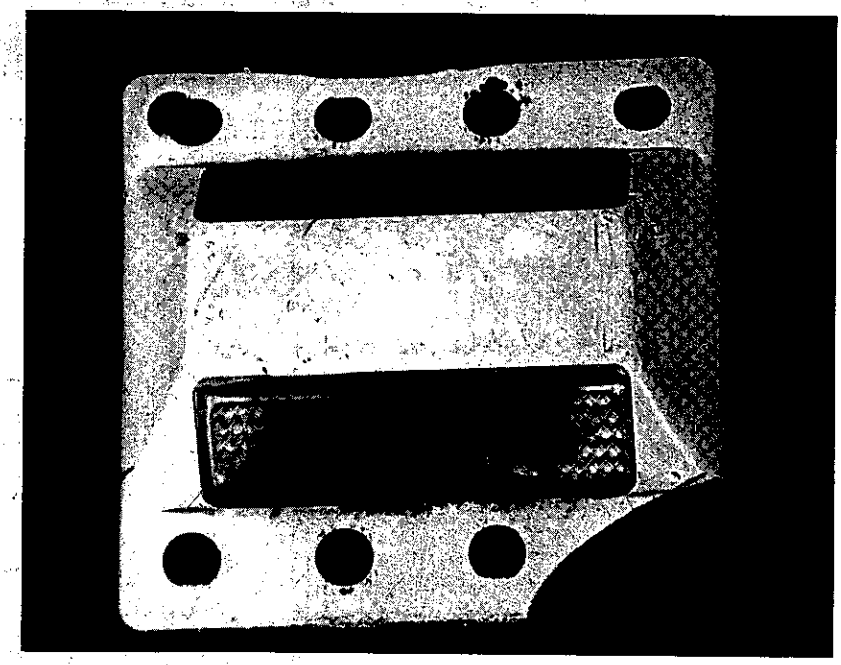
Figure 13. Air backed reflective cube corner markers after three months heavy traffic. Note moisture penetration into rear of lens area which destroys retroreflectance properties.

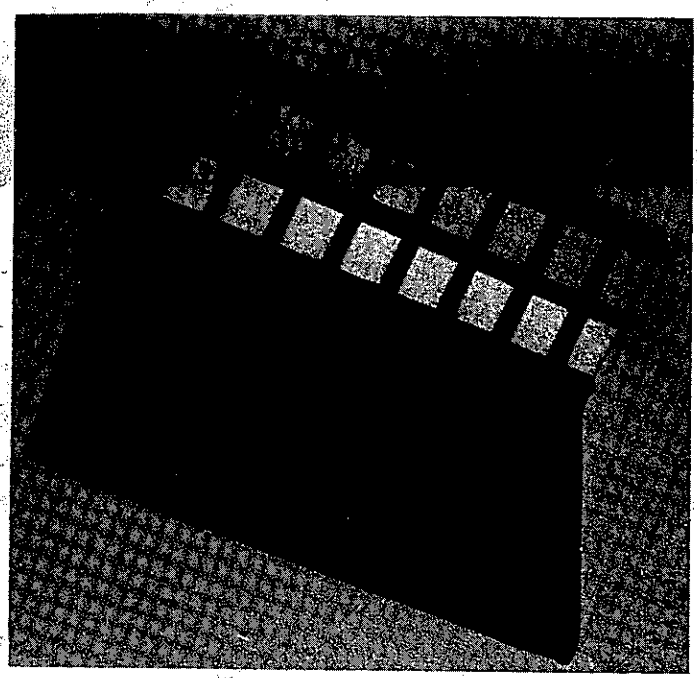
Figure 14

These rubber units were designed primarily for use where only temporary delineation is required. The reflective area consists of two reflective tapes -- one for dry nighttime reflectance and one for wet nighttime reflectance (see Figure 14). The specific intensity of the dry tape is about 1.0 and the specific intensity of the wet tape is about 0.5. The units are supplied with butyl rubber adhesive.

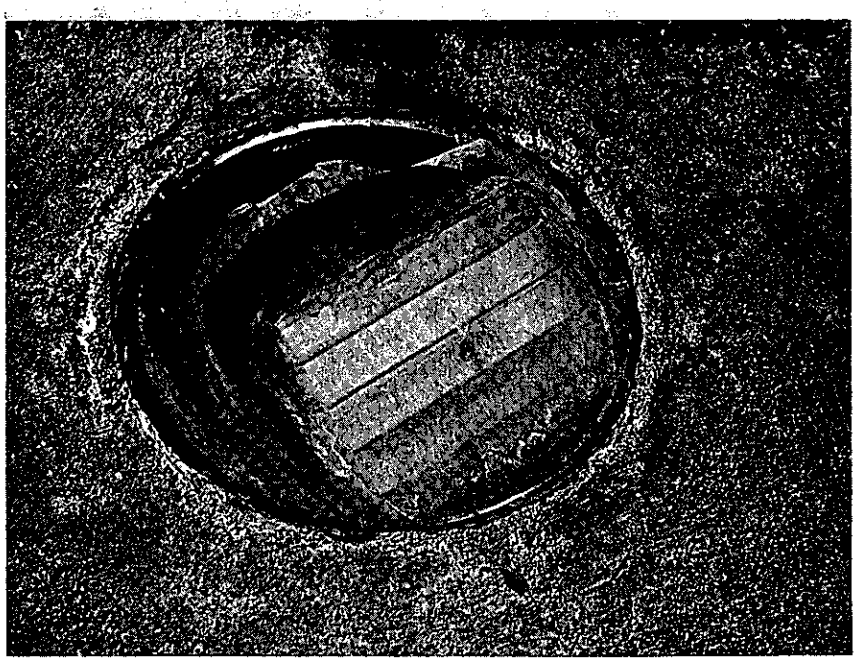
Figure 15

When observed, five of the test markers had torn tops which allowed water to enter the case. The remaining marker was intact and probably functional.

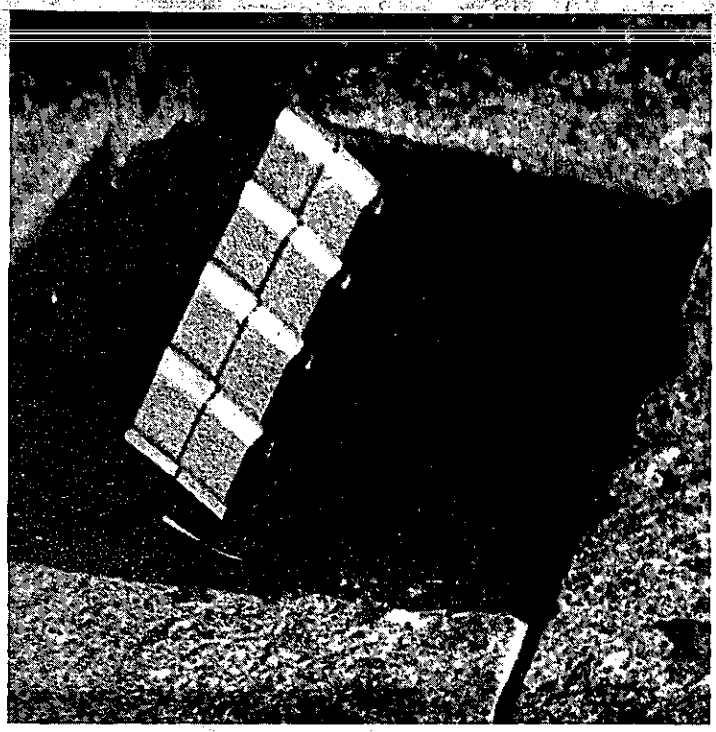
Figure 16
New

These markers were evaluated along with Rowland's snow marker. After several passes with a snow blade, only one marker remained on the road. This marker suffered major damage to the reflective portion and would be ineffective as a nighttime delineator (see Figures 16 and 17).
